# **Bumpstead Hall Farm, Helions Bumpstead, Essex: archaeological record**

**report prepared by  
Leigh Alston MA**

**CAT Report 443**  
October 2007

*This report provides a written and photographic record at English Heritage (2006) Level 3 of a complex of former farm buildings that includes a grade II listed aisled barn. It is intended to fulfil a condition of planning permission for domestic conversion and has been prepared to a brief designed by the Historic Environment Management team of Essex County Council (September 2006) and an associated Written Scheme of Investigation (CAT, September 2007).*

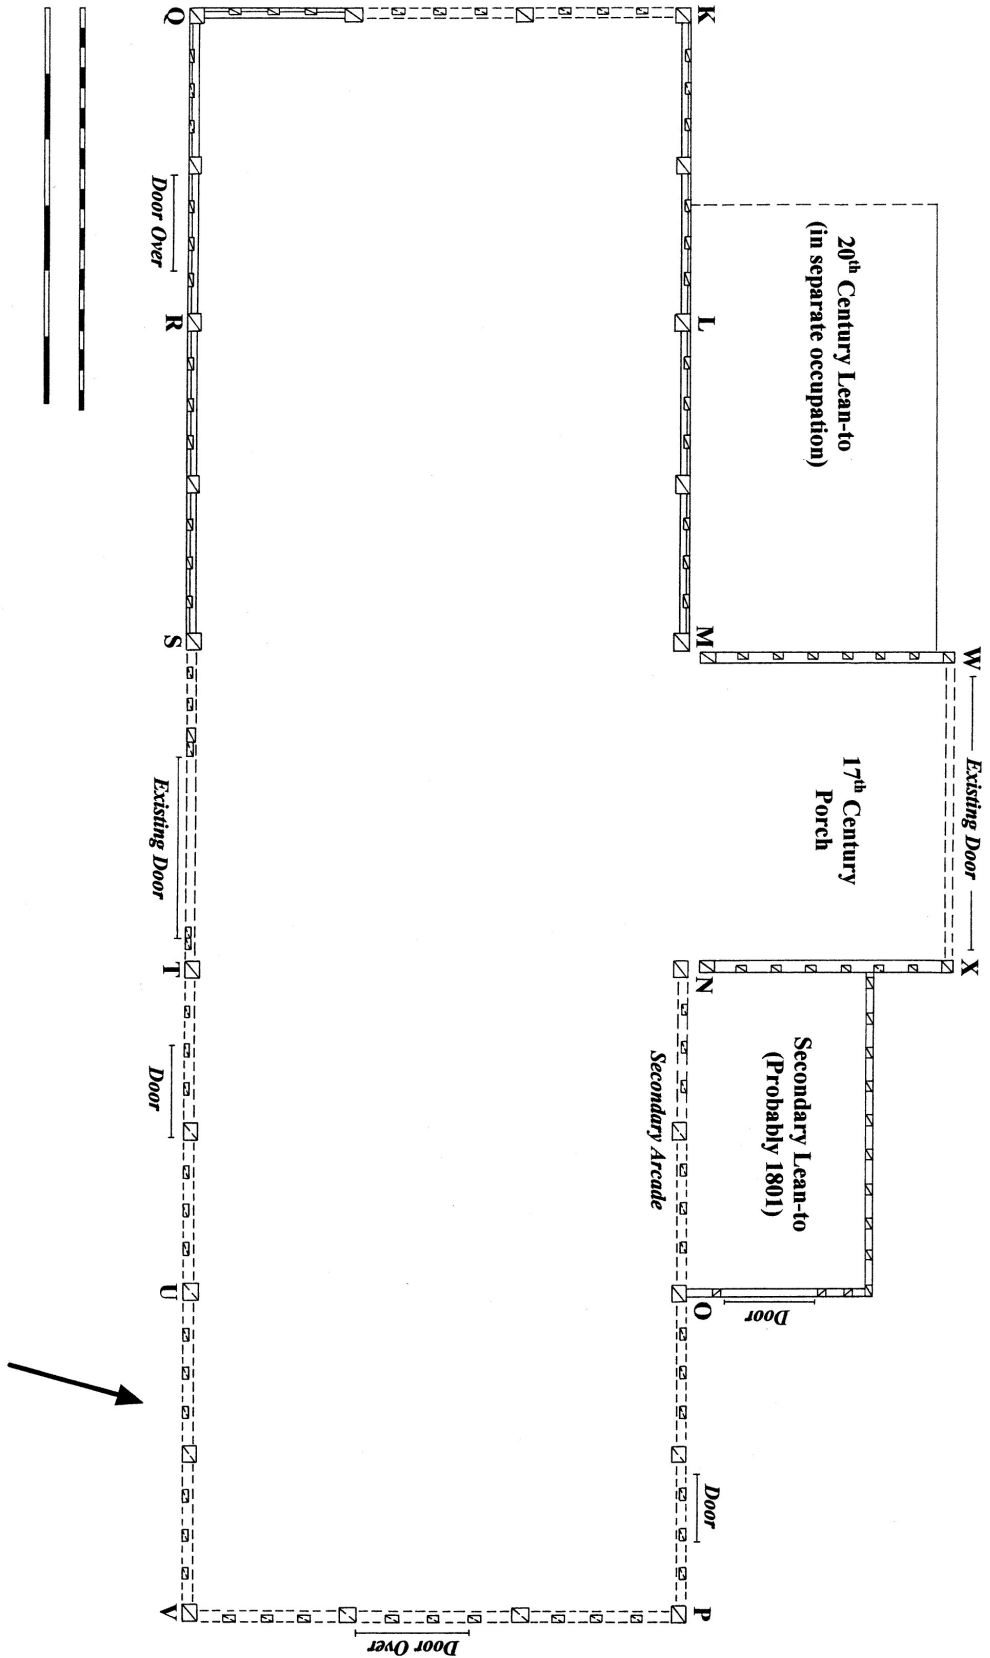
Fig 2 Barn 1: ground-plan.

A lean-to extension lies in the angle of the 17th-century porch and bay N-O, as shown in Figure 2. The original external wall of this bay was entirely removed and a new roof-plate inserted with substantial bolted knee-braces to posts N and O, thereby creating a short aisle. The new outer wall retains its original studs, all of which were re-used from a 15th- or 16th-century building, together with original lath-and-plaster infill which is nailed to the external weather-boarding. A door lies in the eastern gable but this may be a secondary feature. The addition of this aisle or lean-to can probably be dated accurately by an inscription on the western face of post N, which appears to have been renewed at the same time: 'IS / 1801 / July ?18'. The 'I' of this period can also be read as 'J', and may relate to the contemporary owner (Stubbing or Salway). A second lean-to occupies the angle of the porch and bay L-M, but this is currently in separate occupation and was not examined internally. Its outline is shown on the first Edition Ordnance Survey of 1877, but its present fabric appears to date only from the 20th century.

The 20th-century reconstruction incorporated a number of secondary entrances, as indicated in Figure 2, and two high doors that presumably opened onto grain floors of which no trace now remains. The interior has been stripped of any agricultural fixtures or fittings and the barn has most recently served as a machinery and tractor shed with a concrete floor.

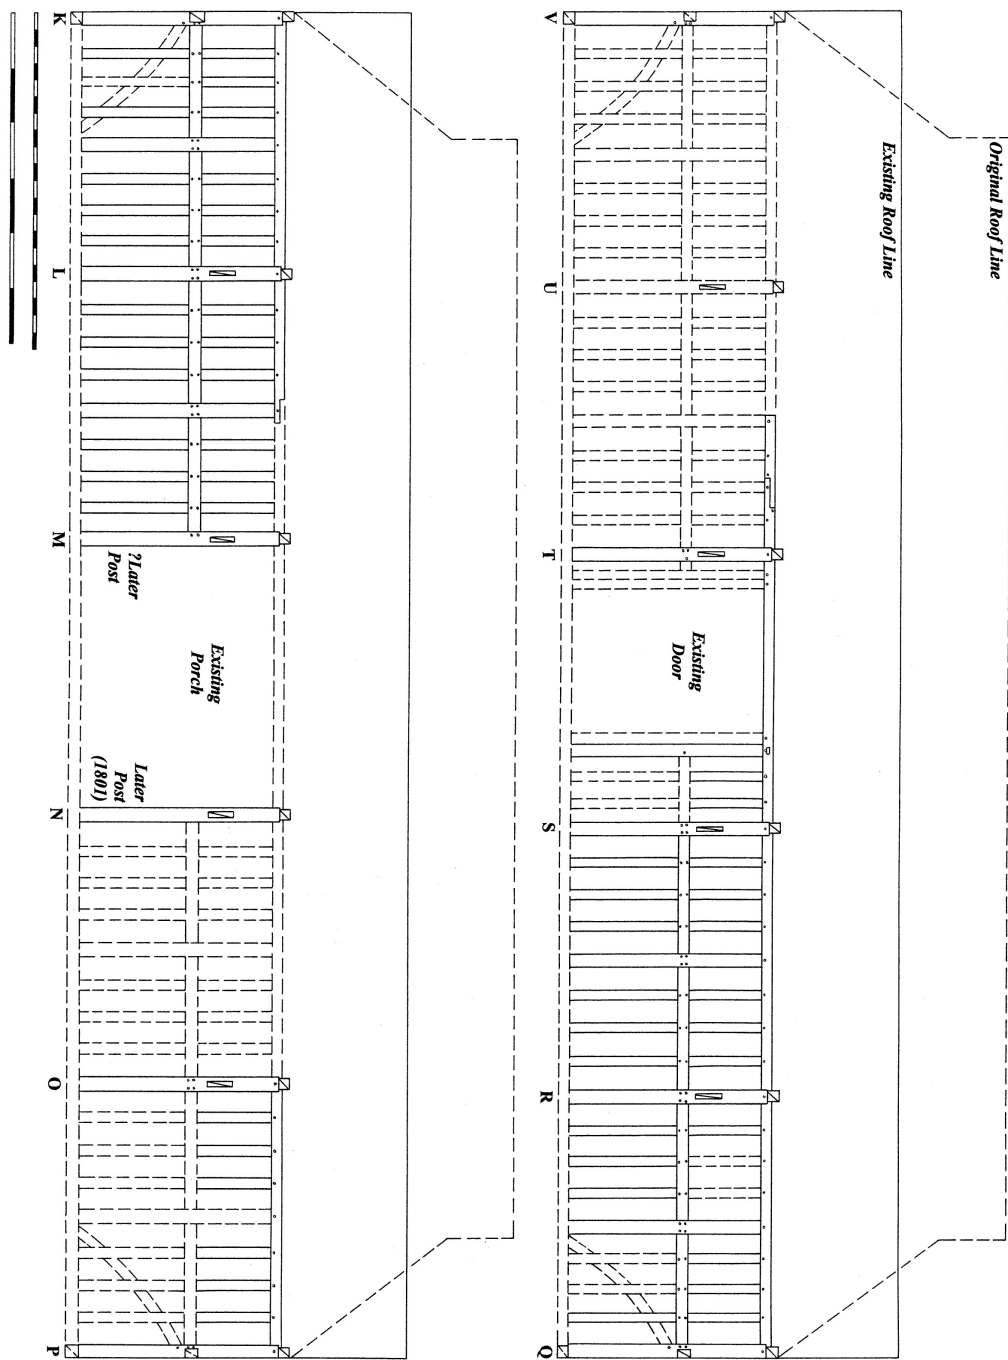
Fig 3 Barn 1: southern internal elevation V-Q (top), and northern internal elevation K-P (bottom).

The roof-plates are currently 3.45 m (11 feet 4 inches) above the present ground-level but several storey posts about the concrete floor and any remaining ground sills are buried; it may therefore be assumed that the plates were originally at least 23 cm (9 inches) higher to account for the likely proportions of these sills. The remaining studs are 1.3 m tall between the roof-plates and mid-rails (52 inches) and 1.9 m beneath the mid-rails (76 inches). The principal storey posts are linked by arch-braces to the tie-beams, as shown in Figure 4, and a pegged mortise in the centre of each tie would have held the crown-posts of the missing original roof structure. The gables were identical, as shown in Figure 5, with two intermediate posts dividing the mid-rails, and appear to have been hipped as neither gable tie-beam contains stud mortises in its upper face. The southern roof-plate preserves an original scarf joint of standard edge-halved-and-bridled form (bay U-T in Fig 3).

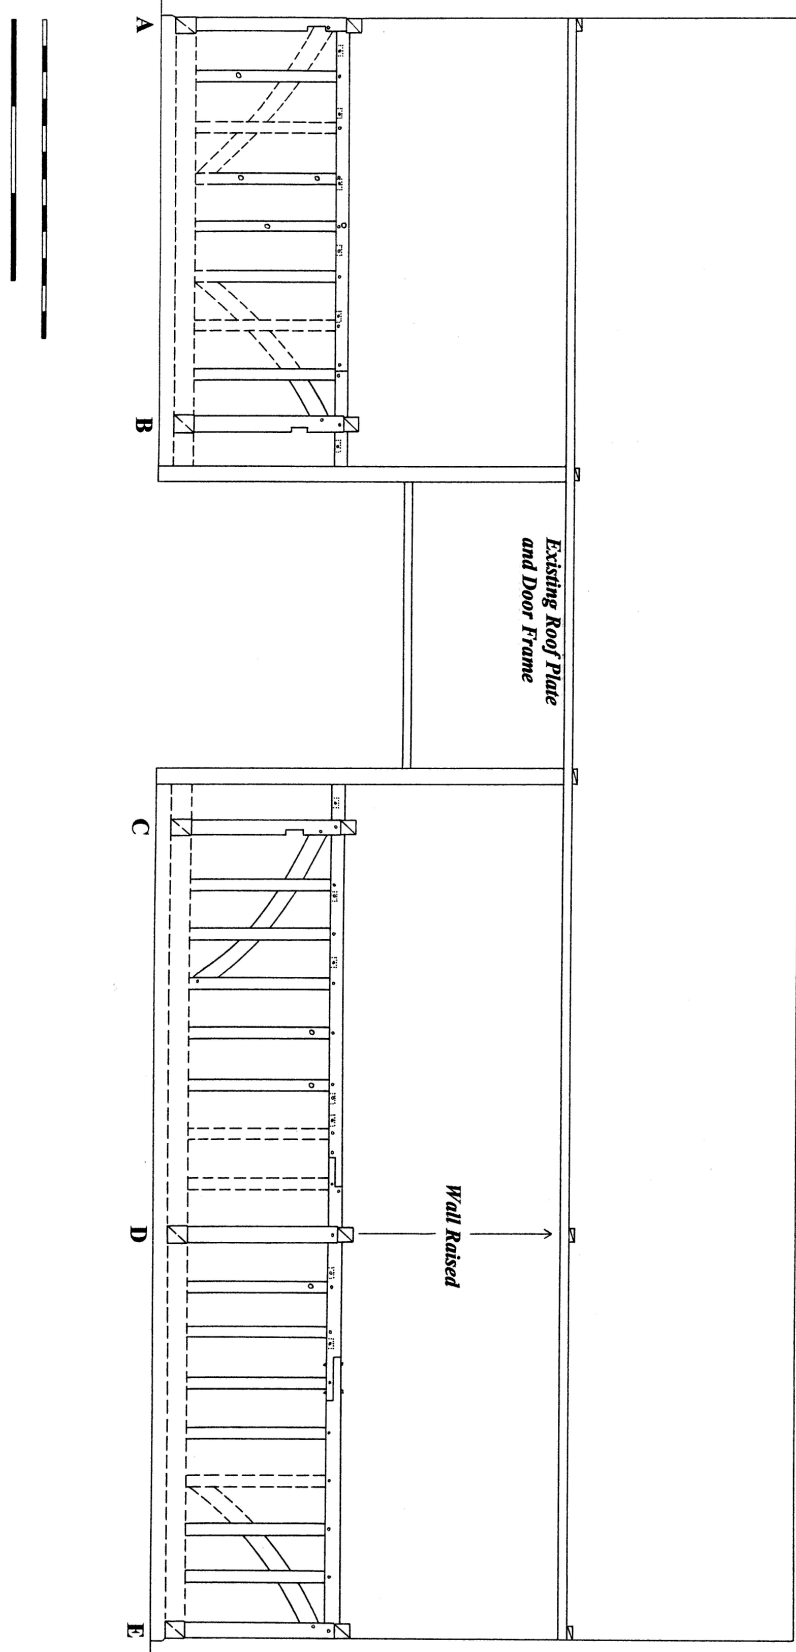
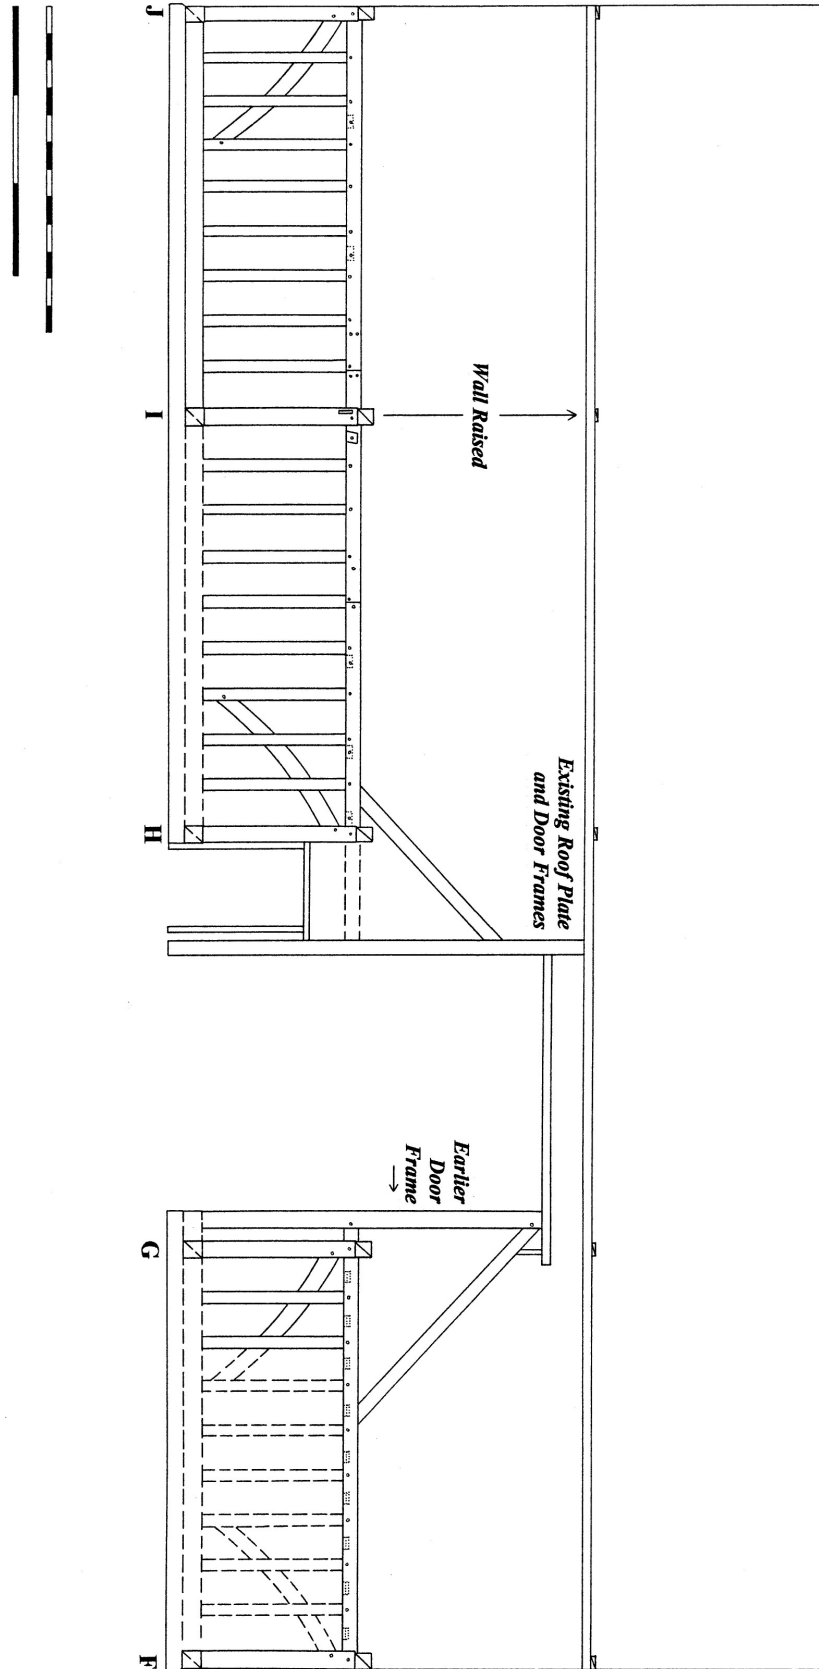
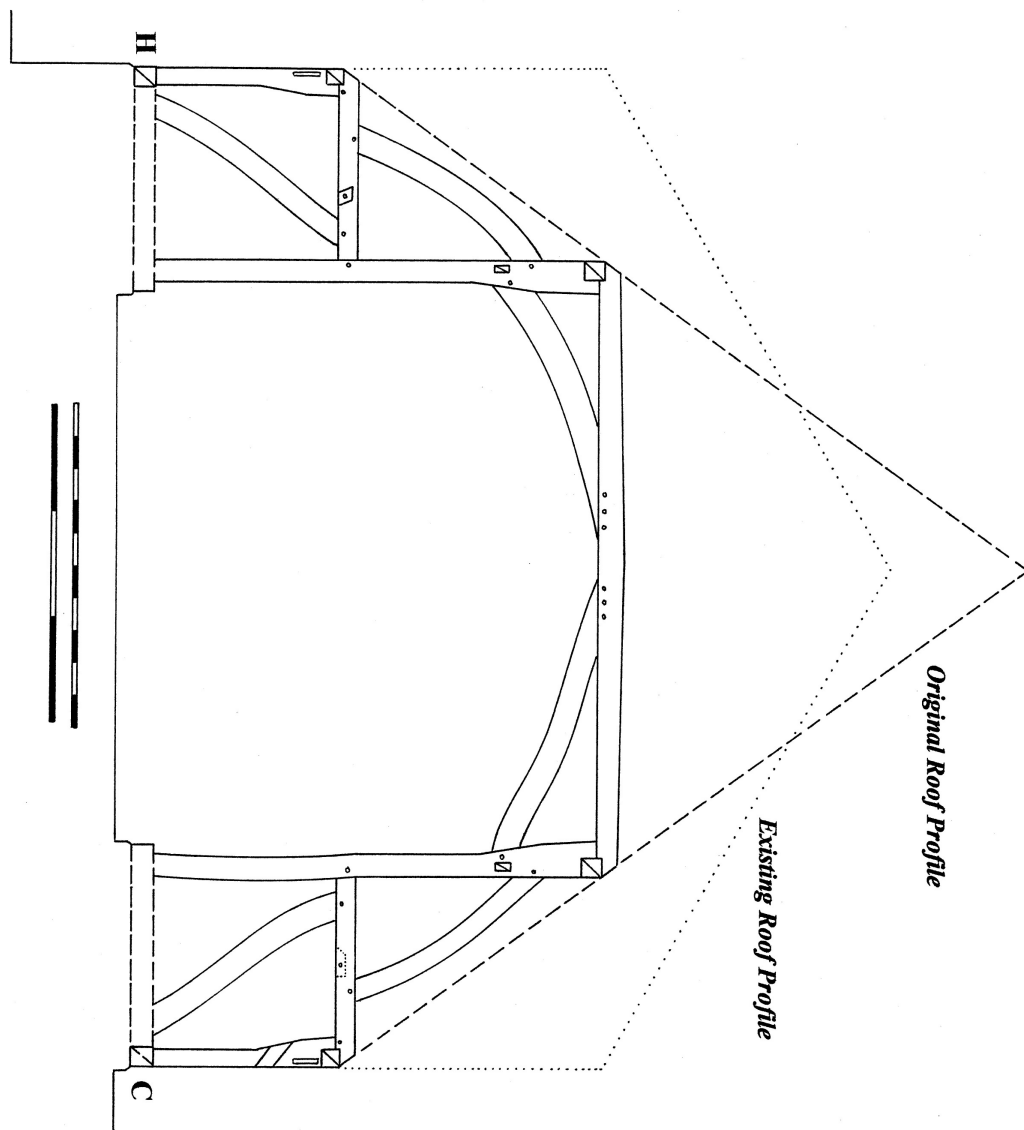
The easternmost of the two timber-framed and weather-boarded barns extends to 18.5 m in overall length by 9.4 m in width (60 feet 9 inches by 31 feet). The structure contains four aisled bays of approximately 4.4 m (14 feet 6 inches), and the 'nave' of each aisled truss is 19 feet wide (inclusive of storey posts). The frame incorporates a high proportion of re-used timber from at least one earlier aisled building of probable early 14th-century date, and the proportions of the individual components varies considerably in consequence. Those wall studs which appear to be primary to the present building are of relatively small scantling at 13 cm by 9 (5 inches by 3.5). The studs are spaced more closely in the southern elevation (F-J) where each bay contains 8 studs, than in the northern elevation (A-E) where there are only seven; similarly, the eastern gable E-J contains eleven studs between its arcade posts where the western gable (F-A) contains only ten, although in other respects the framing is symmetrical. This creates infill panels of 38 cm (15 inches) to the south and west, and 43 cm (17 inches) to the north and east. These panels were infilled by wattle-and-daub as indicated by stave notches in the studs, but only the re-used sections of roof-plate contain the V-grooves which are found throughout barn 1. This differential stud spacing is a common feature in domestic houses, but less so in agricultural structures, and suggests the externally exposed framing was designed to be seen primarily from the road to the south and the approach from Steeple Bumpstead to the east, rather than from the farmhouse to the west. A building contract of 1459 or 1460 for a barn in Bradfield near Bury St Edmunds specifies that the studs of its front gable and the 'farm side' are to be 18 inches apart and those of the rear gable and 'back side', 22 inches (Cambridge University Library Add. 7318 f.9). 'Close studding' was a fashion feature that could significantly affect the cost of a structure and was used for display purposes. Both elevations and gables of barn 2 were also enhanced by symmetrical external stud bracing at each corner and adjacent to the threshing bay (the penultimate western bay), as shown in Figures 7-9.

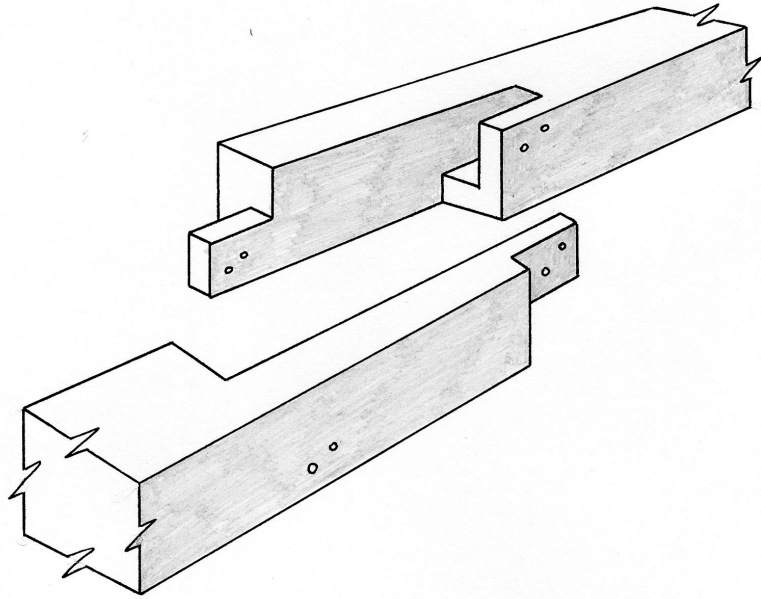
Fig 11 Barn 2: detail of arcade-plate scarf joint.

of timber explains the unusual variety of scarf joints in the roof-plates, which include an edge-halved-and-bridled type of typical 15th- and 16th-century form (bay C-D) together with several face-halved-and-bridled scarfs of typical 17th-century form (bays A-B, J-I and I-H). Bay D-E contains a crude edge-halved joint secured by four or more vertical face pegs, and links a re-used section of plate to a primary timber which lacks infill grooves and empty stud mortises (and is therefore original to the present barn). The arcade plates (which are not obviously re-used) contain several scarfs which represent an unusual hybrid between the standard edge-halved-and-bridled and face-halved-and-bladed-forms (normally of the 16th and 17th centuries respectively): these joints are face-halved, but their 'blades' resemble tenons insofar as they do not rise or descend through the full section of the plate. Cecil Hewett illustrated a similar joint in *English historic carpentry* (fig 269, p 268), but with only one 'housed' blade rather than two, and cited an example at Wiggons Barn in Helions Bumpstead.

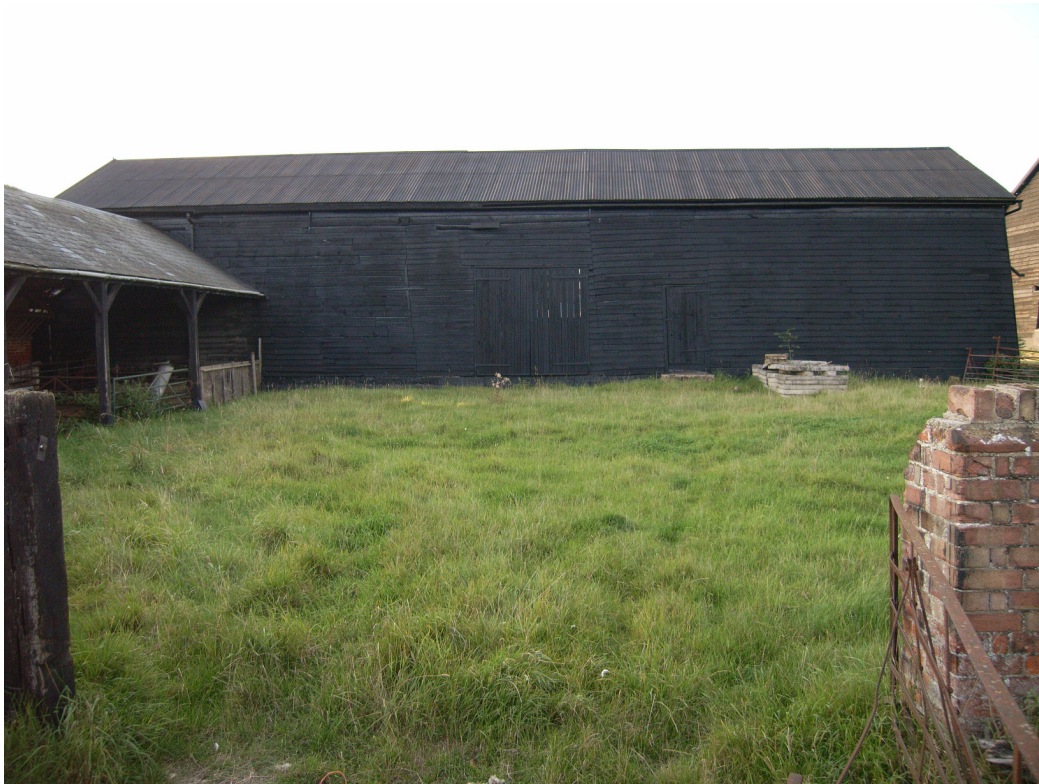
A1.1 Barn 1: exterior from south, showing elevation Q-V.

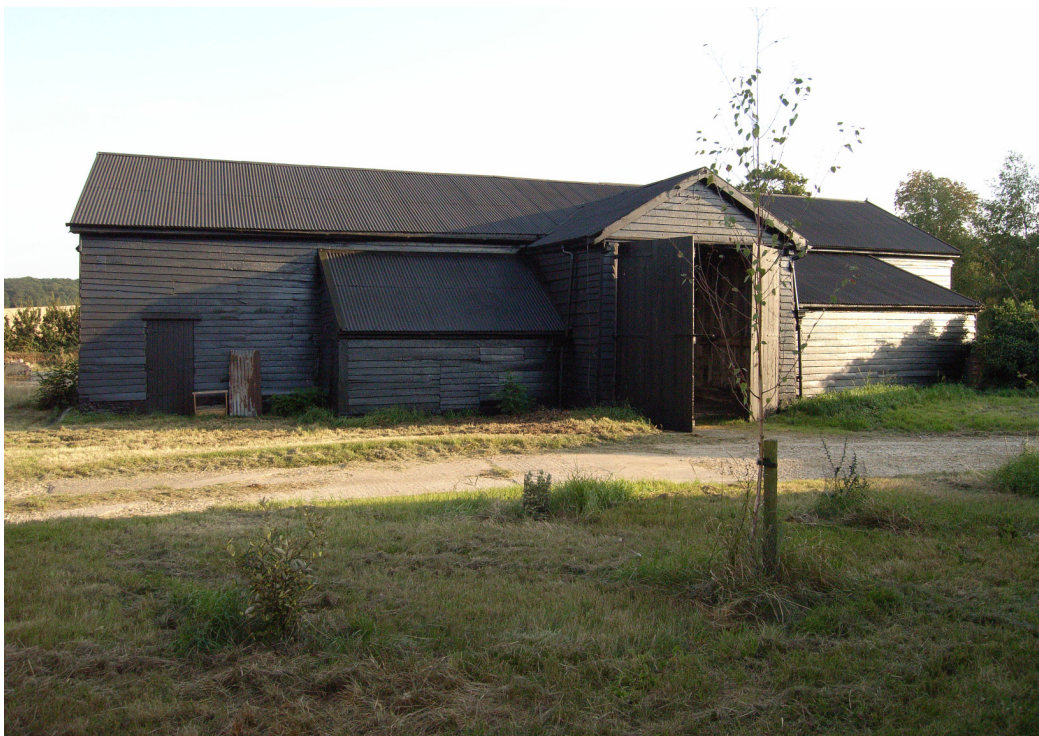
A1.2 Barn 1: exterior from north, showing later porch and lean-to.

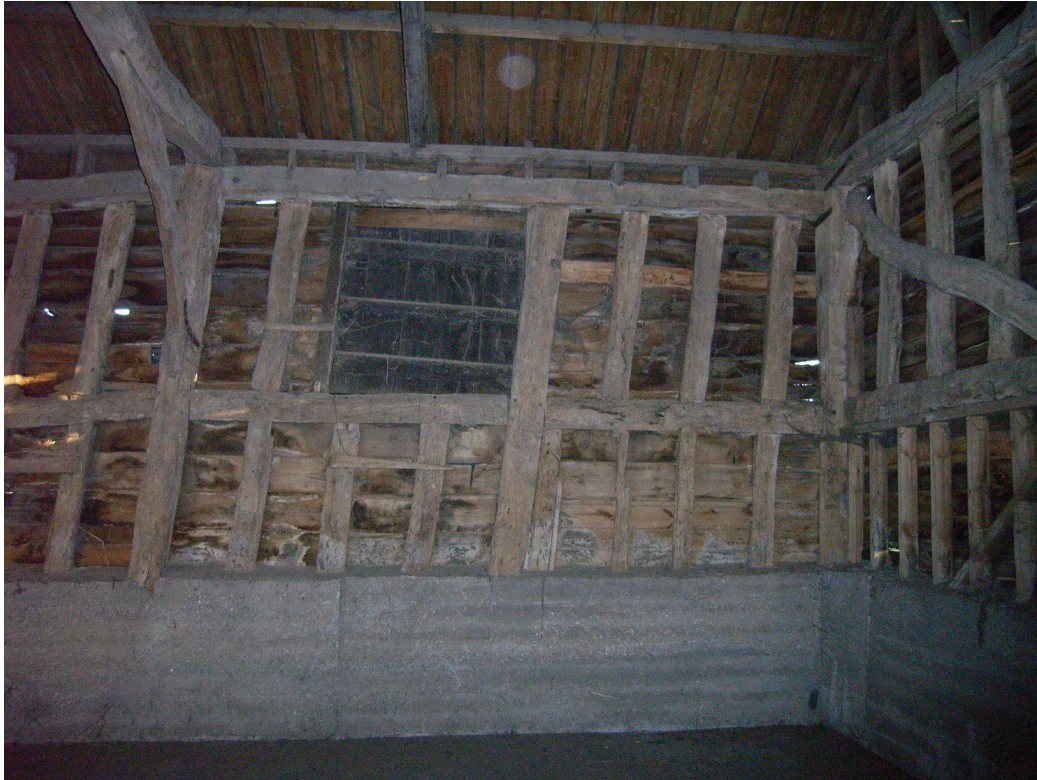
A1.5 Barn 1: internal bay R-Q showing largely original framing and later door above mid-rail (western gable to right).

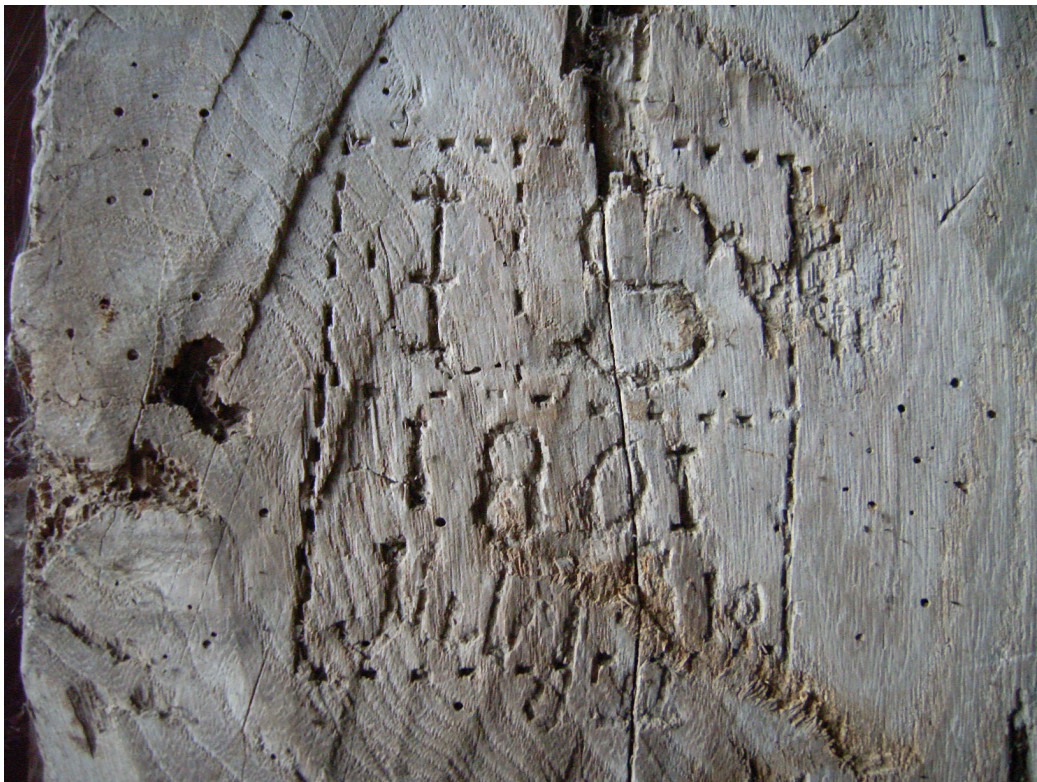
A1.6 Barn 1: detail of carving to western face of post N: 'IS 1801 July 18'.

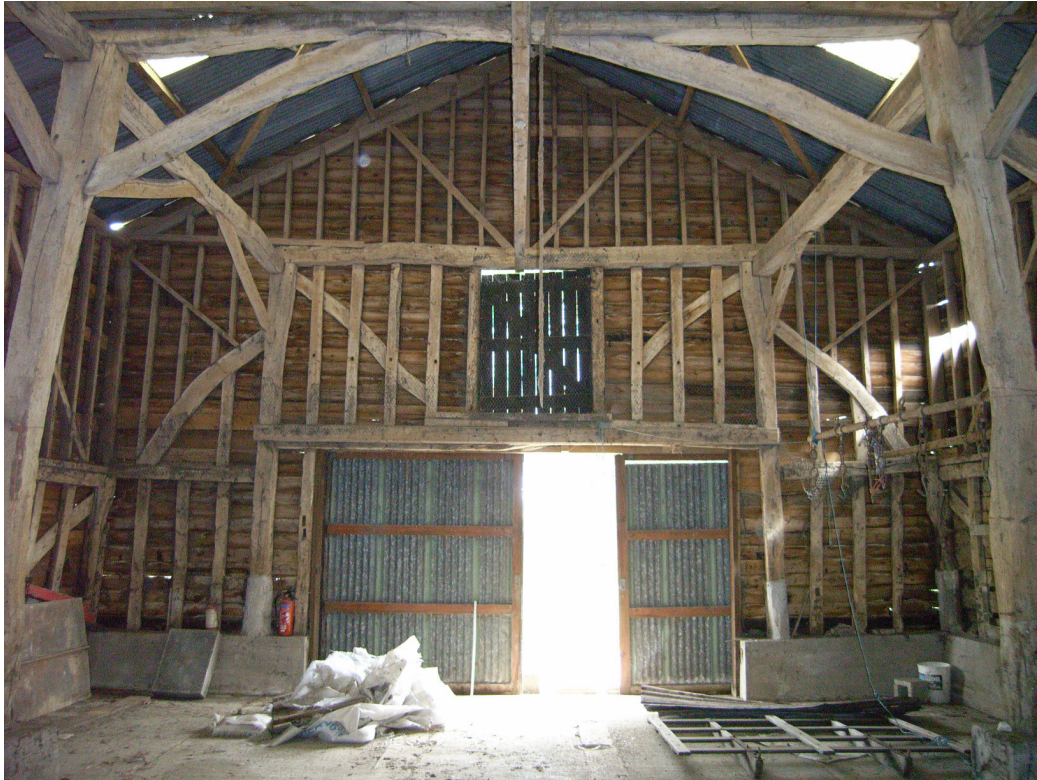
A1.9 Barn 2: interior of gable E-I showing late 20th-century sliding doors below mid-rail with early 20th-century door above.

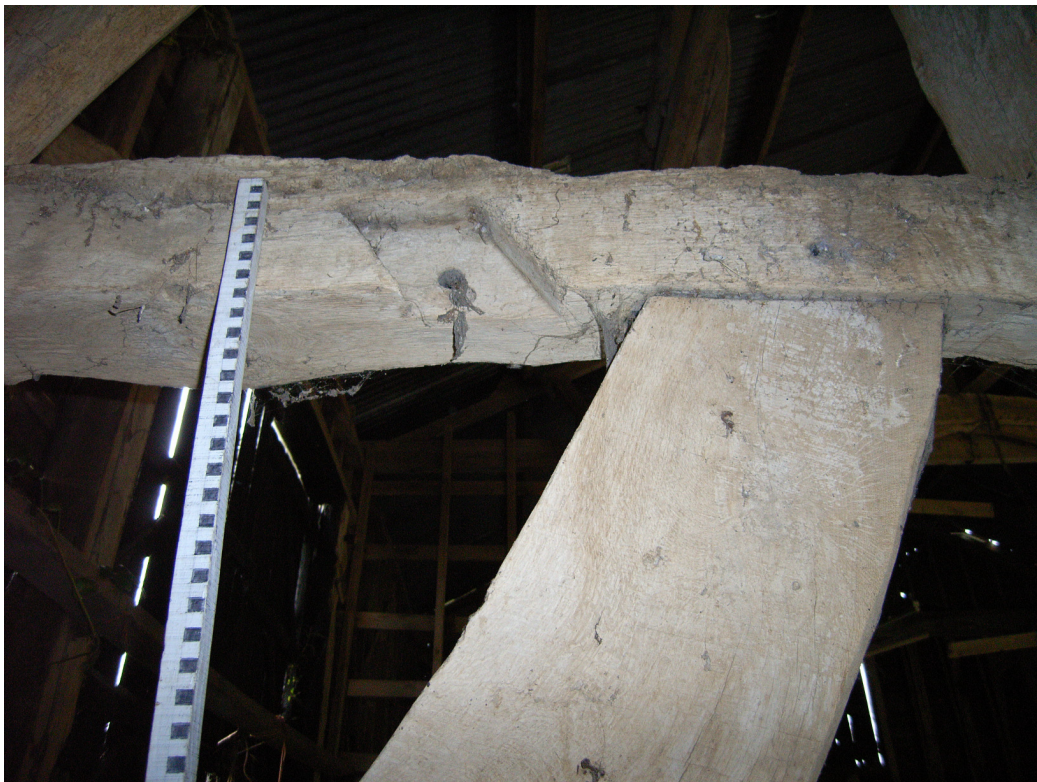
A1.10 Barn 2: detail of empty lap joint in re-used aisle tie to post I.

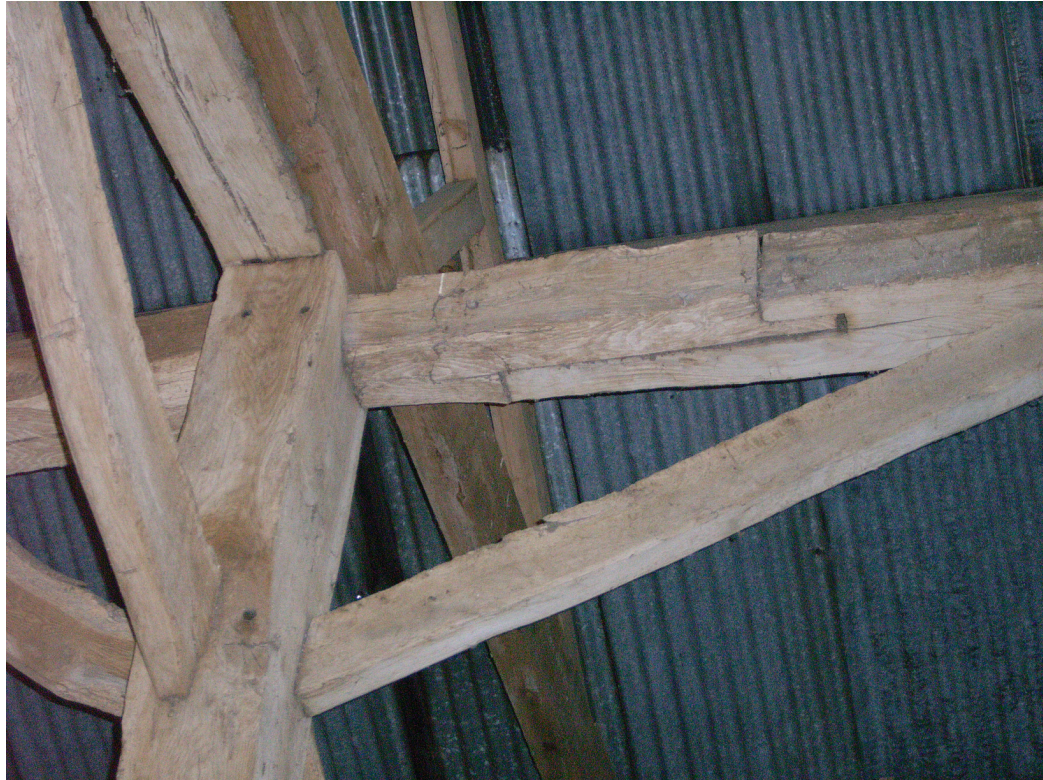
A1.11 Barn 2: detail of face-halved scarf with housed blades in bay I-H.

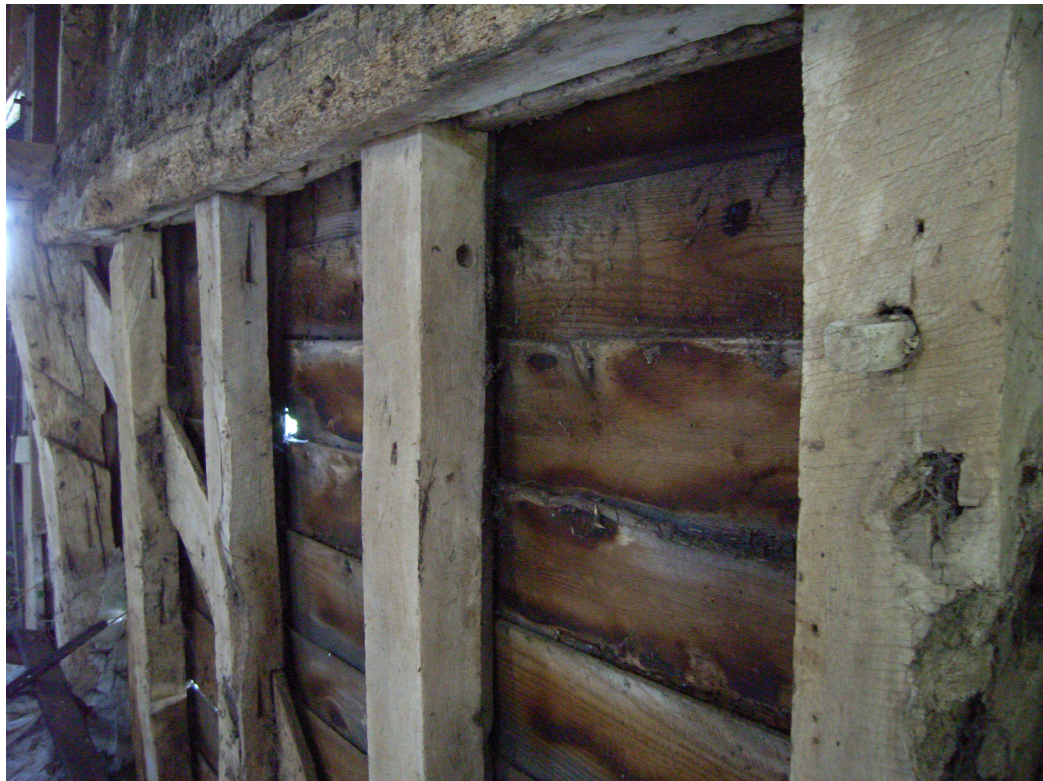
A1.12 Barn 2: detail of original studwork in bay C-D showing infill notches, external brace and passing brace trench in re-used post C to left.

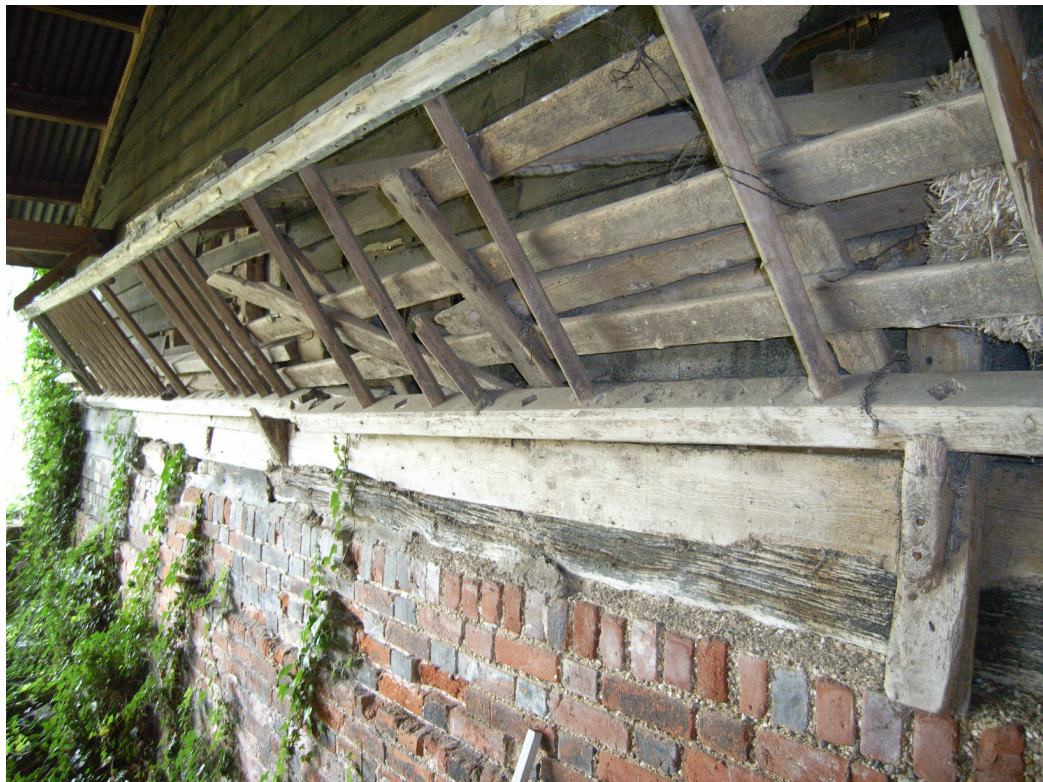
The hay-rack at the shelter's northern end consists of diamond-section rungs in the usual manner, and is 1.6 m (5 feet 3 inches) above ground-level. Its rungs are largely lacking and a number of horizontal rails have been inserted as a repair. Wooden rail fencing and straw bales bear witness to its most recent use as a sheep

A1.16 Shelter 3: detail of hay-rack from south-east showing secondary rack within.
