Historic building record of Old Hall, Church Road, Boreham, Essex

CAT Report 534
December 2009

Historic farm buildings, Old Hall, Church Road, Boreham, Essex

Historic building record

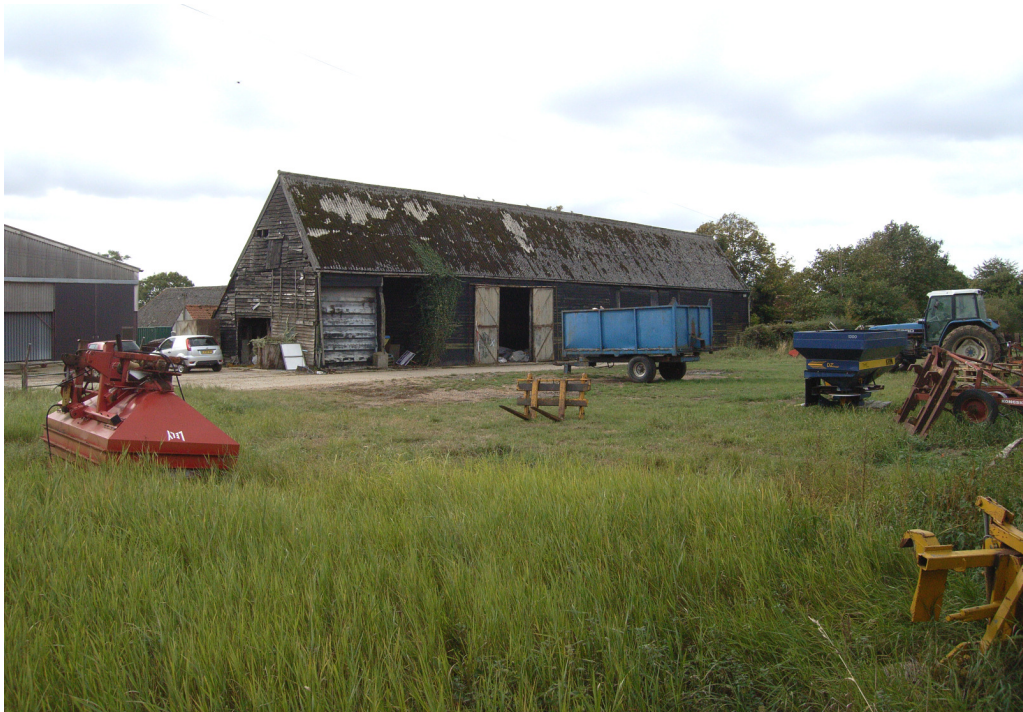
A2.1 General view of site from north-east showing barn (1) in centre with farmhouse in trees to right and modern roadside barn to left. The milking parlour (7) and former cart lodge (8) are visible between the barns.

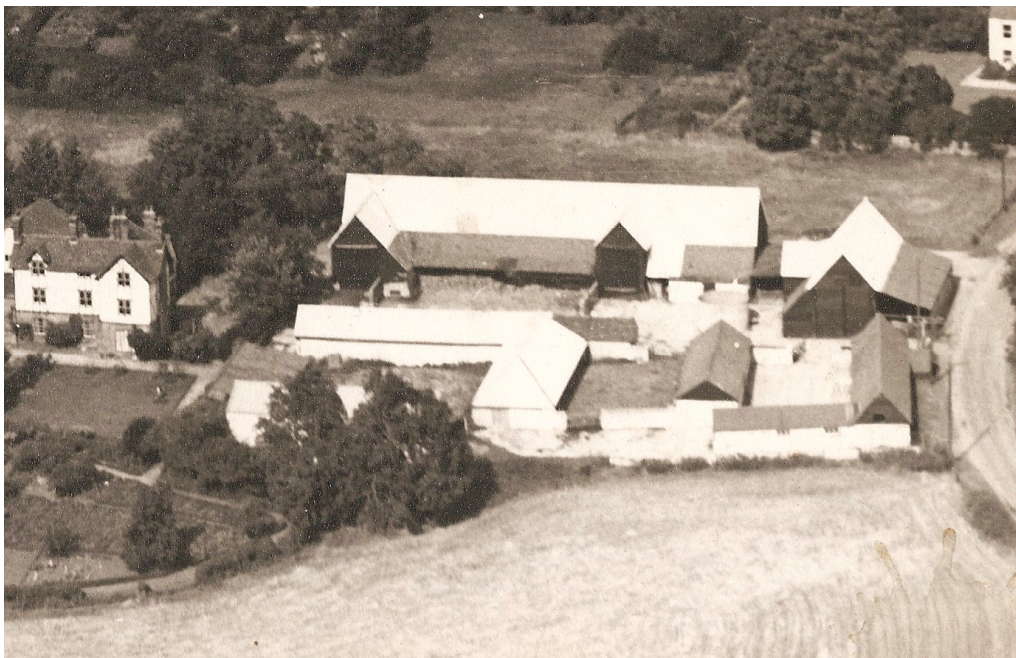
A2.2 Aerial photograph of *circa* 1960 from south showing demolished historic farm buildings adjoining road to right and farmhouse to left (in possession of current owner).

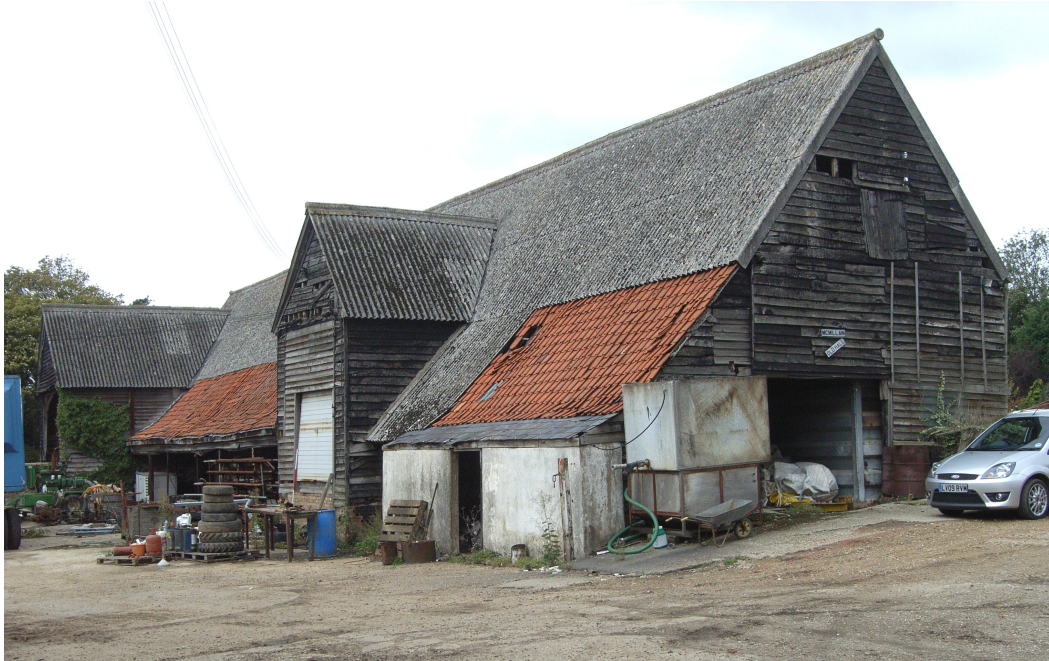
A2.3 Exterior of barn from south-east showing 17th-century western porch (2) to left and 19th-century eastern porch (4) to right with continuous lean-to sheds (2, 5 & 6) to southern yard elevation. The corrugated asbestos replaced thatch, but the pantiles and slate to the sheds survive from the 19th century.

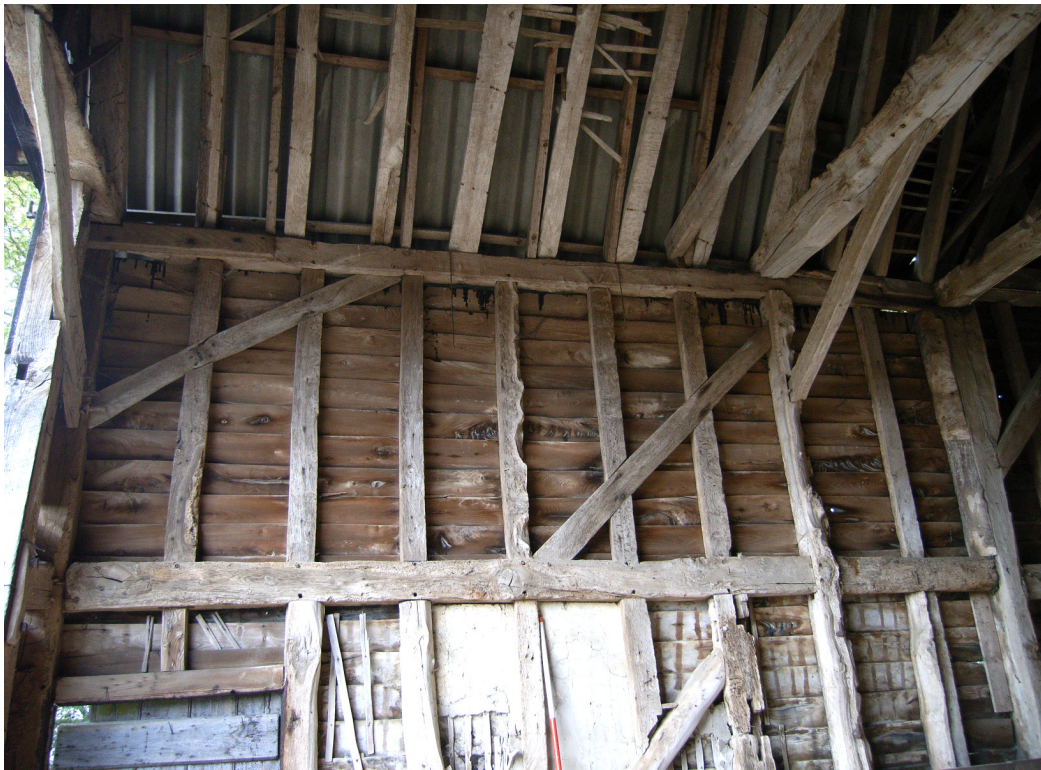
A2.4 Western internal elevation of 17th-century porch (2) showing trenched stud braces and arch-braced open frame to right (the studs below the mid-rail have been replaced).

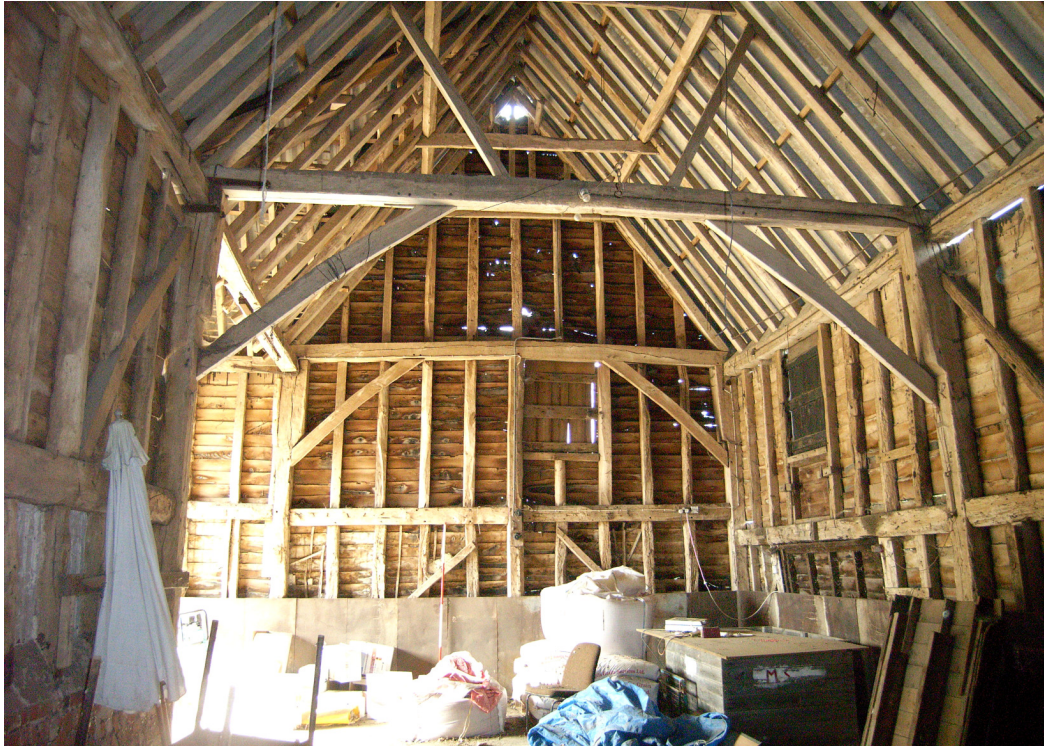
A2.5 Western interior of barn showing open frame of truncated gable and arch-braces flanking threshing bay (A).

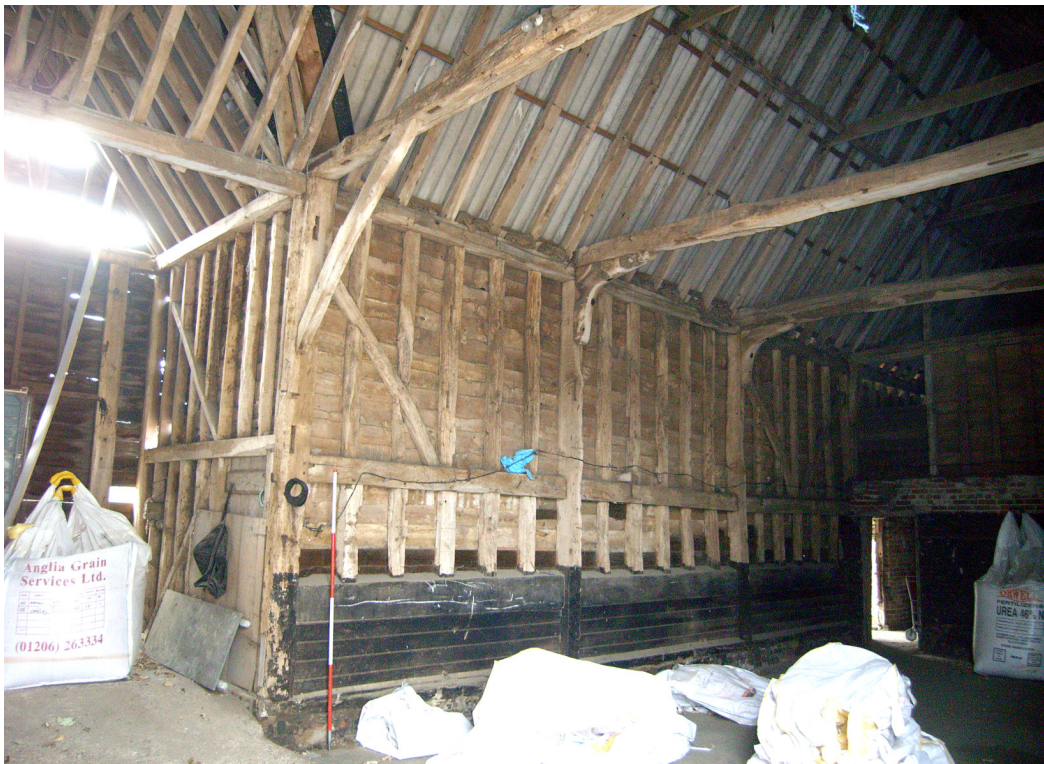
A2.6 Internal southern elevation of central bays G-F showing the eastern porch (4) to left and the brick granary in bay D to right. Note the re-used timber, primary stud braces and bolted knee-braces of the 19th-century walls.

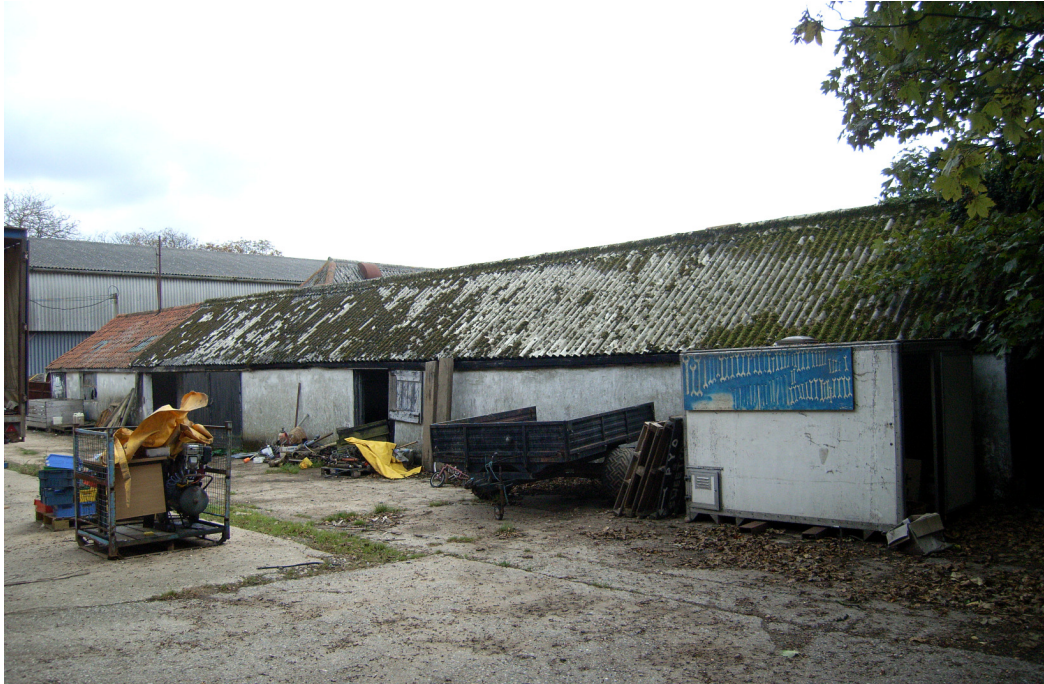
A2.7 Northern exterior of single-storied milking parlour (7) from north-west.

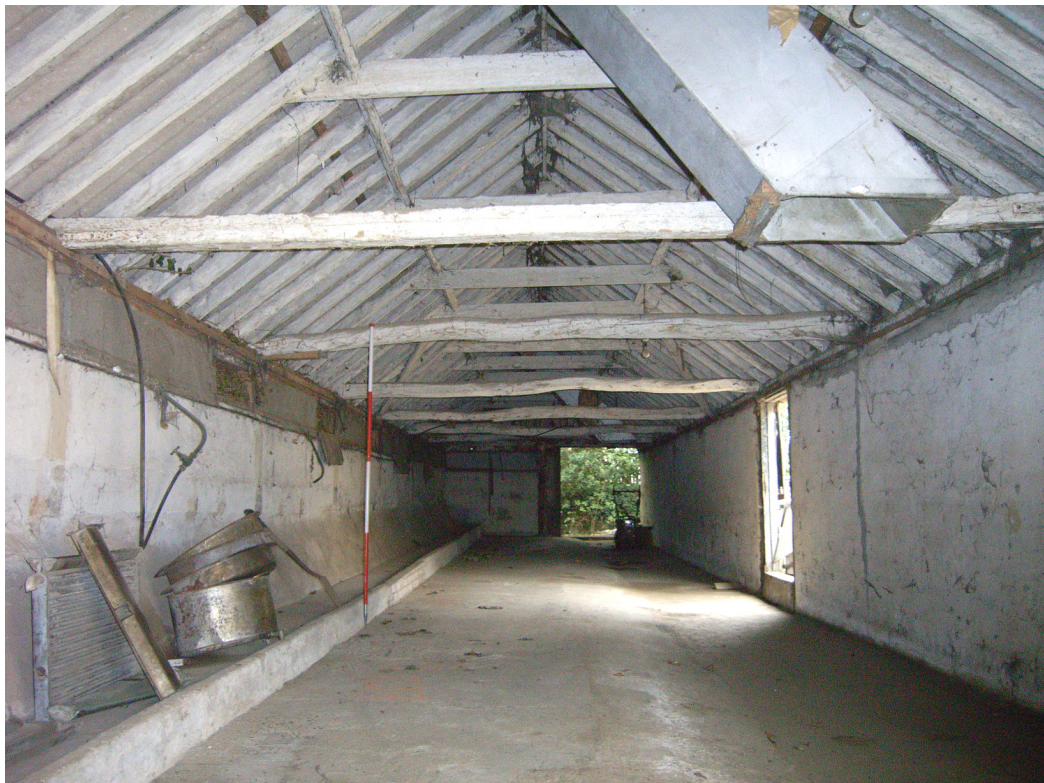
A2.8 Interior of milking parlour (7) from east showing cattle trough to left and door to northern yard to right.

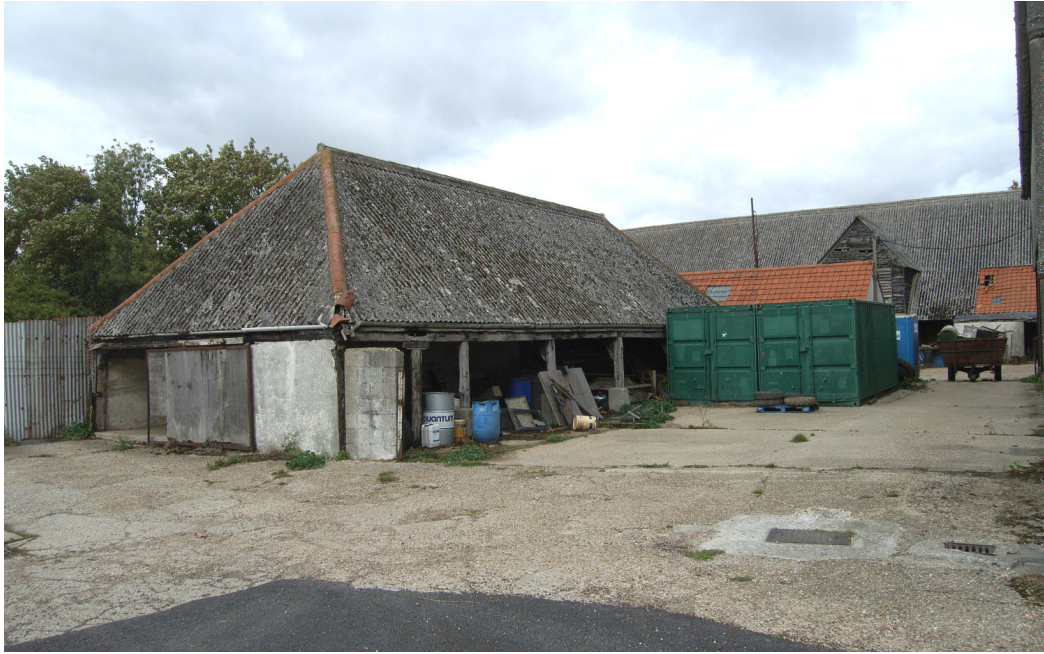
A2.9 Exterior of cart lodge (8) from south-east showing barn in rear to right.

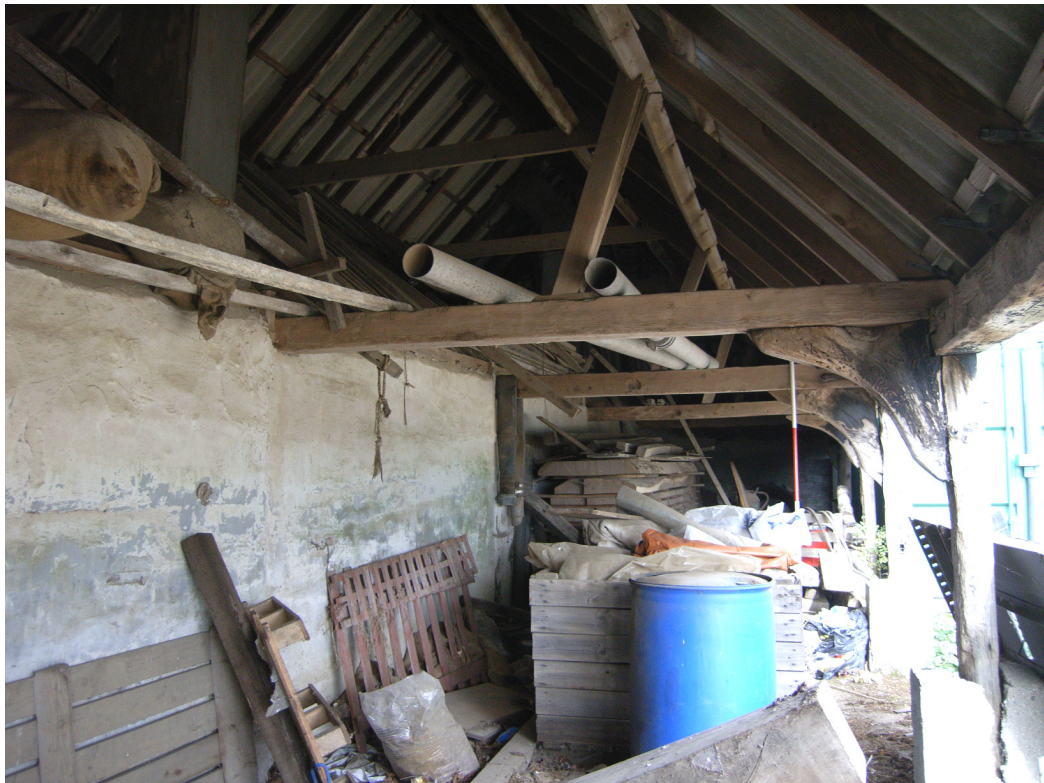
A2.10 Interior of cart lodge (8a) from south showing original bolted knee-braces to right and inserted milking parlour to left.
