Report on archaeological investigations in the Braxted folly at Braxted Park Estate, Great Braxted, Essex.

**report prepared by
Adam Wightman**

CAT Report 555
January 2011

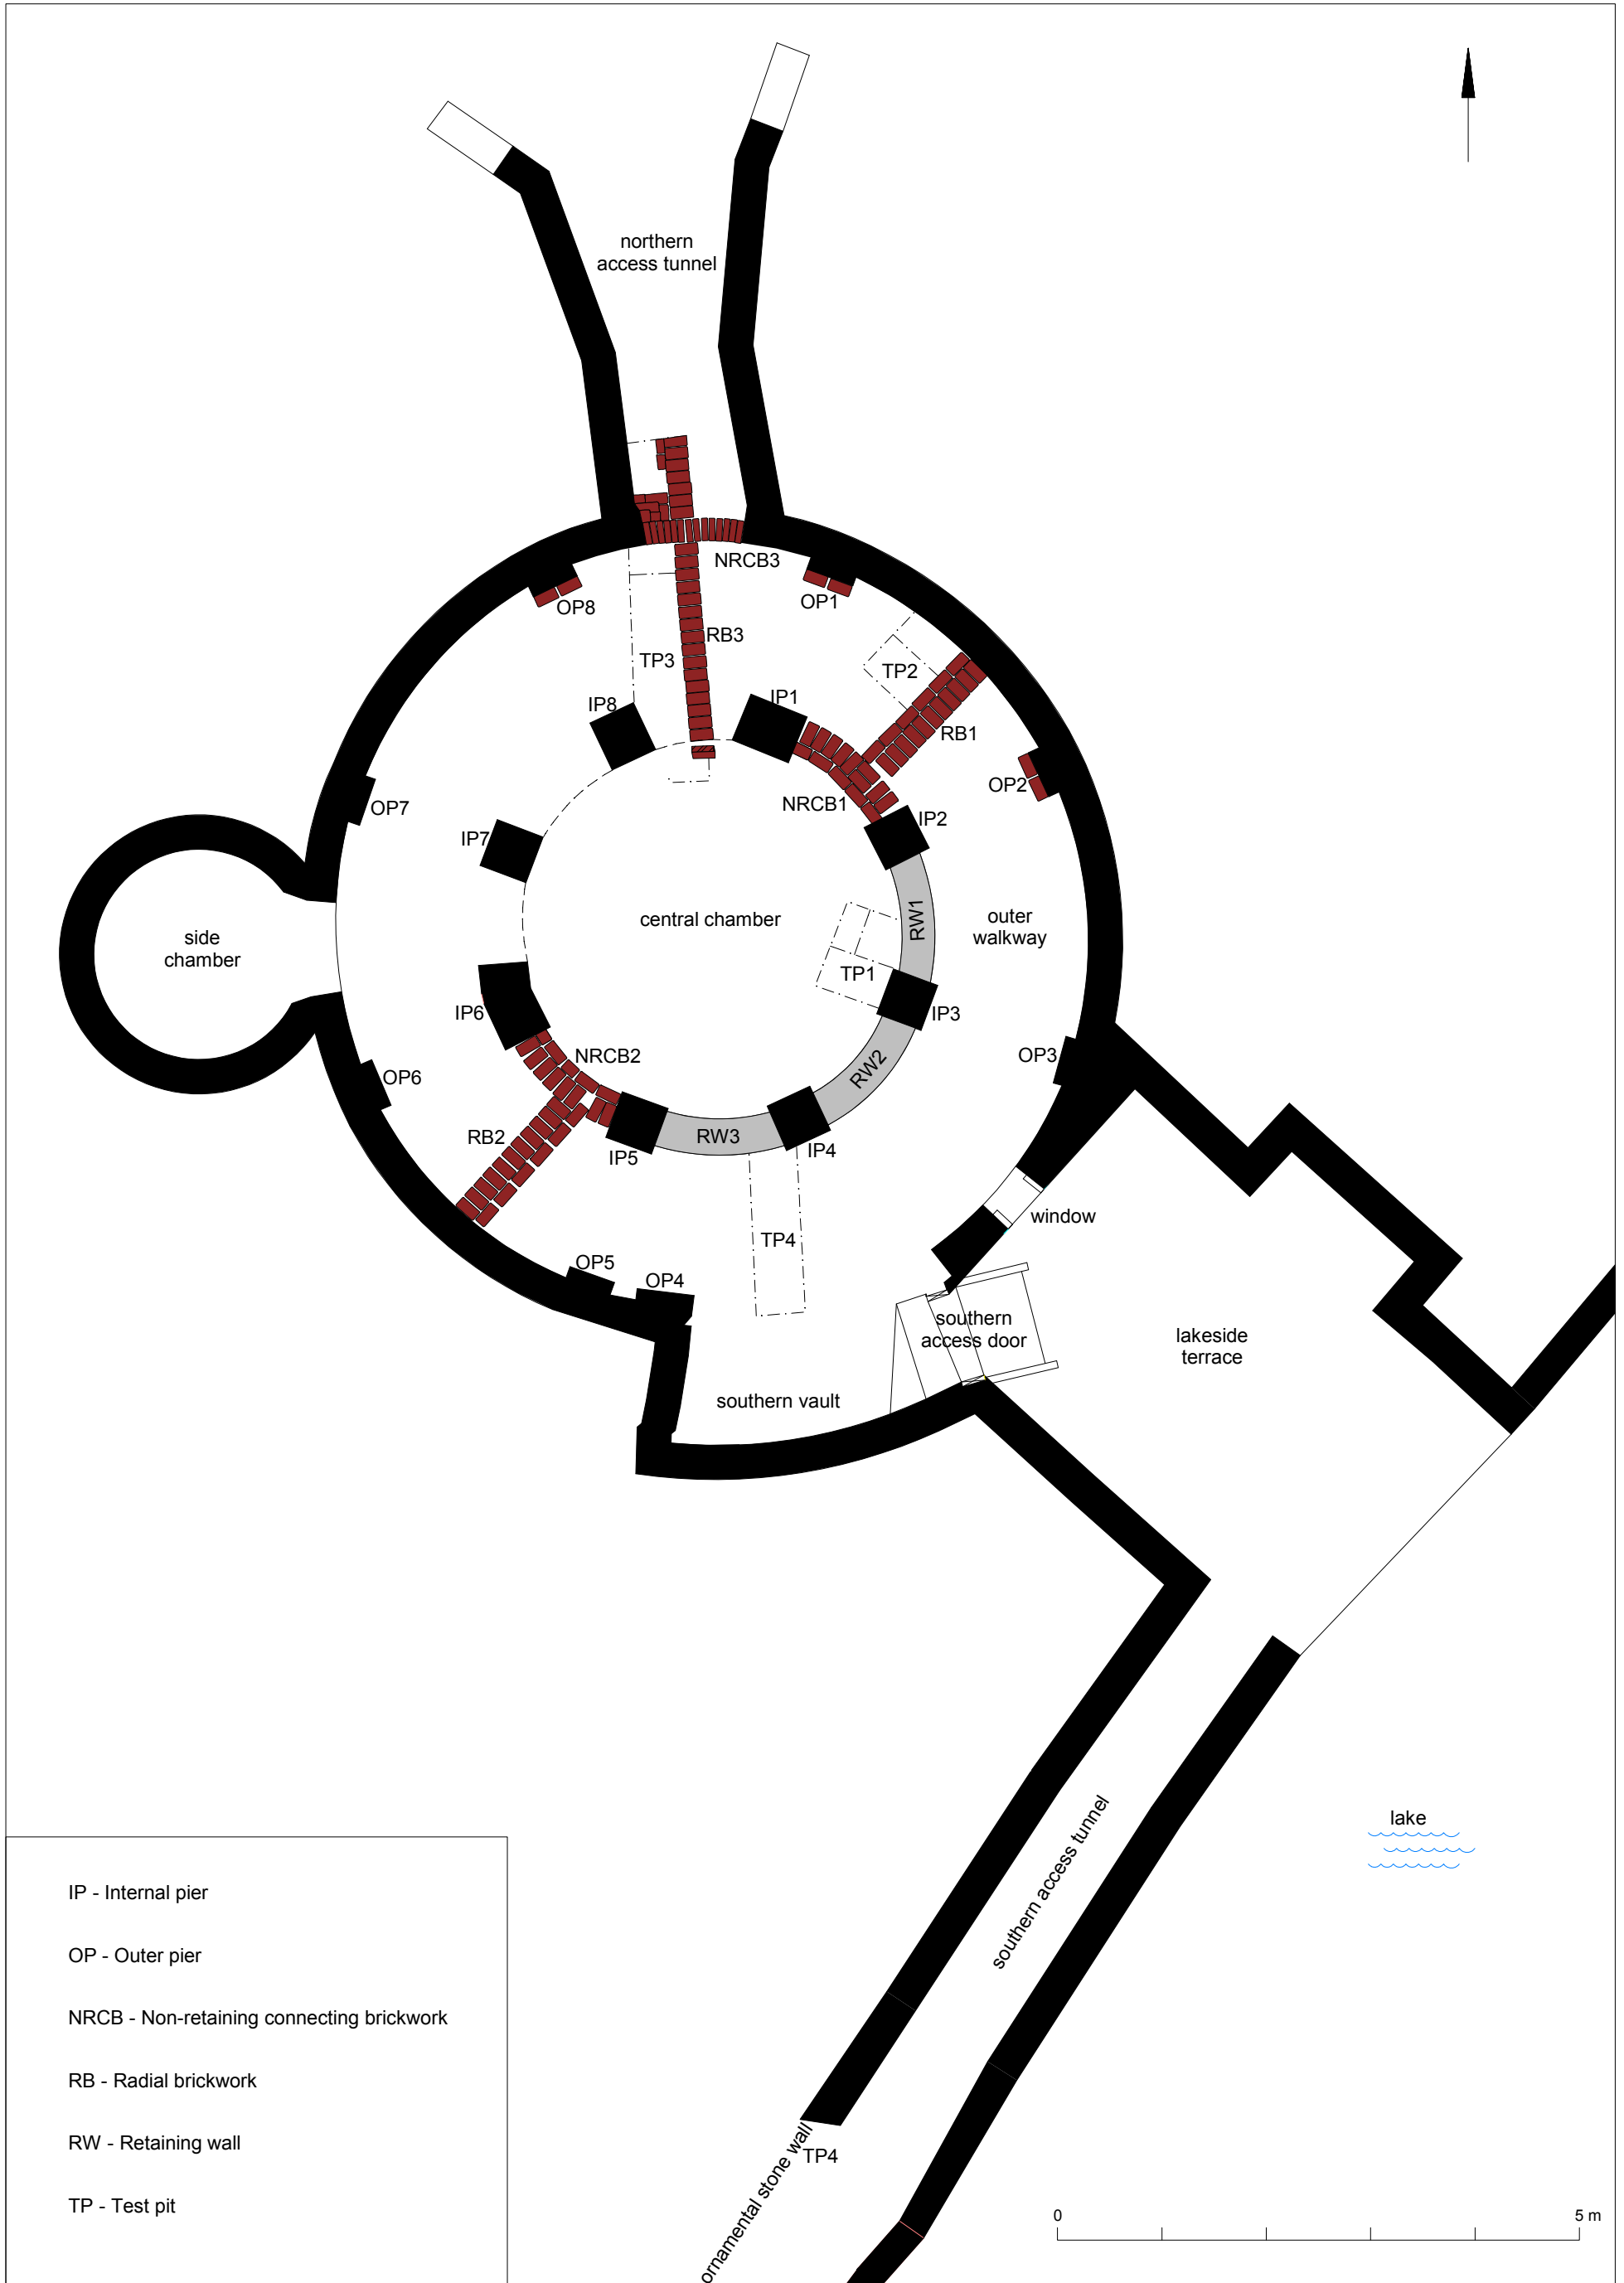
Fig 2 The layout of the structure.

Work within the structure took place in two phases. This section combines the findings of both of these phases. For a plan of the layout of the structure with the abbreviations used for different structural features, consult Figure 2.

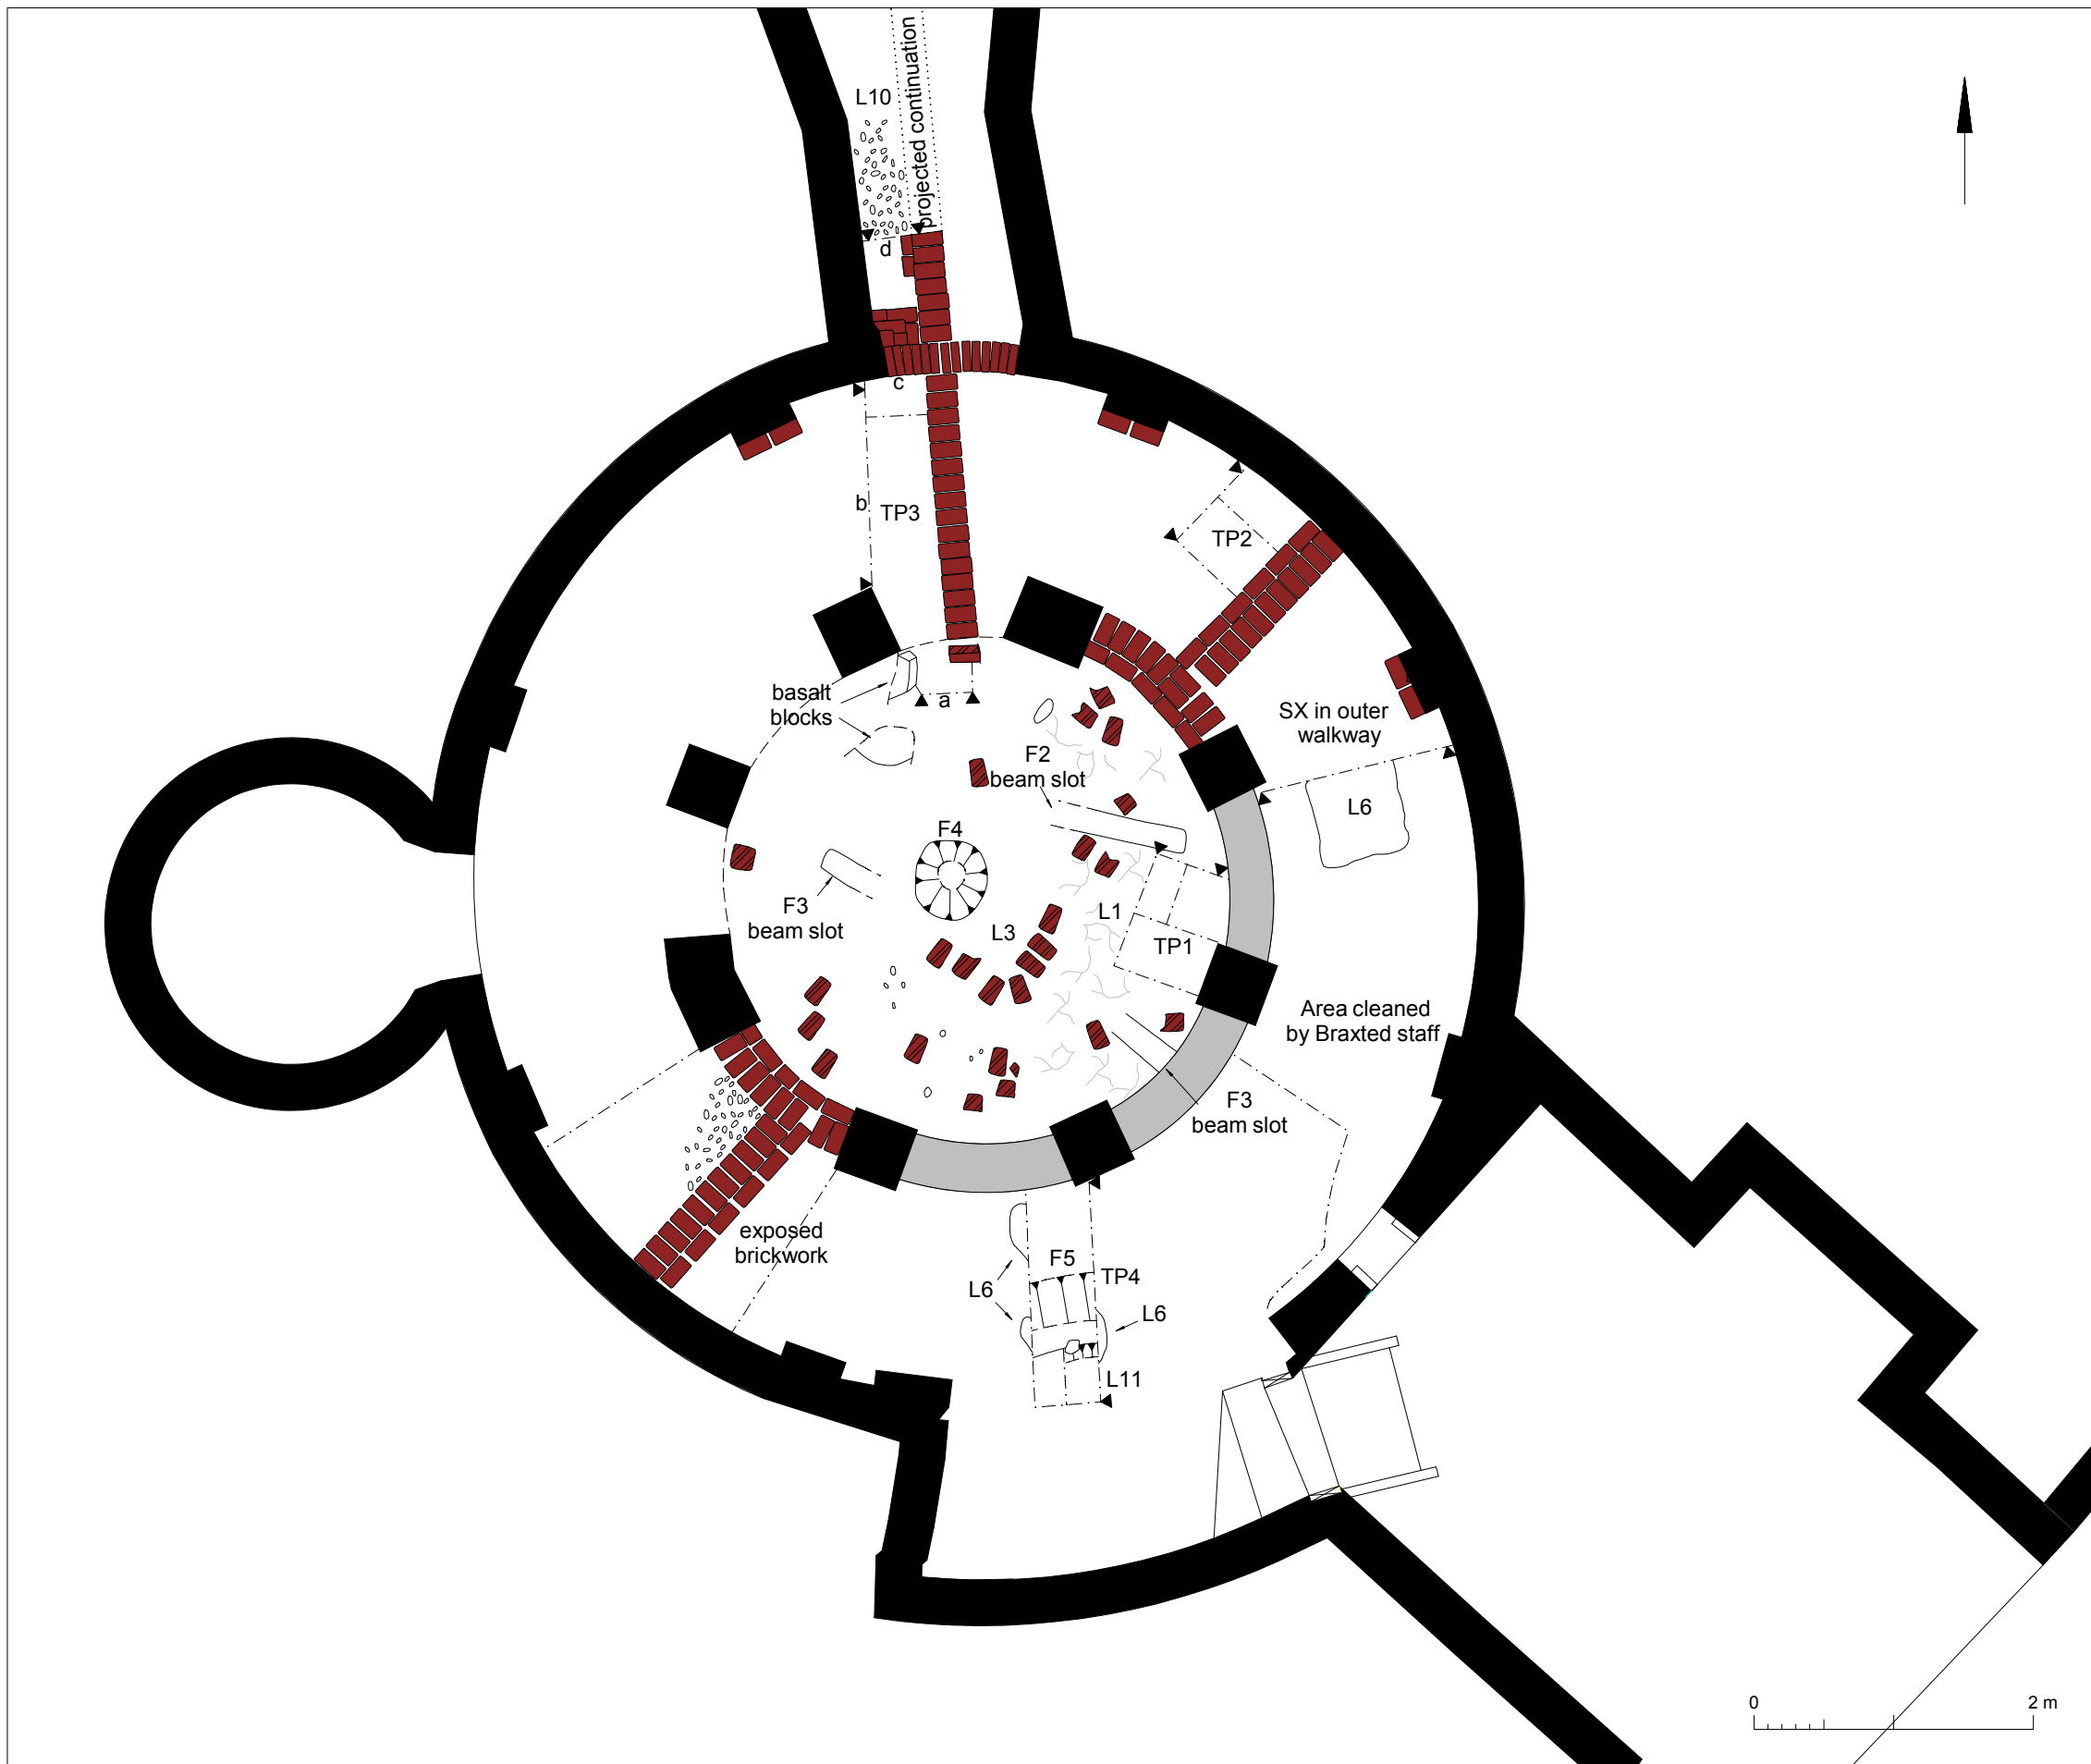
Fig 3 Results.

approximately 200mm of L8 had been removed. Further down the slope, near to IP2 where numerous burrow entrances were located, a section was recorded across the walkway (Fig 3). A thin layer of L8 overlay the limewash (L6), which sealed redeposited clay (L7; Fig 7). L7 was thick in this area, probably because it had been used to create a gradual slope from the high point behind IP3 down towards the northern entranceway as no evidence for any steps in the structure was observed.

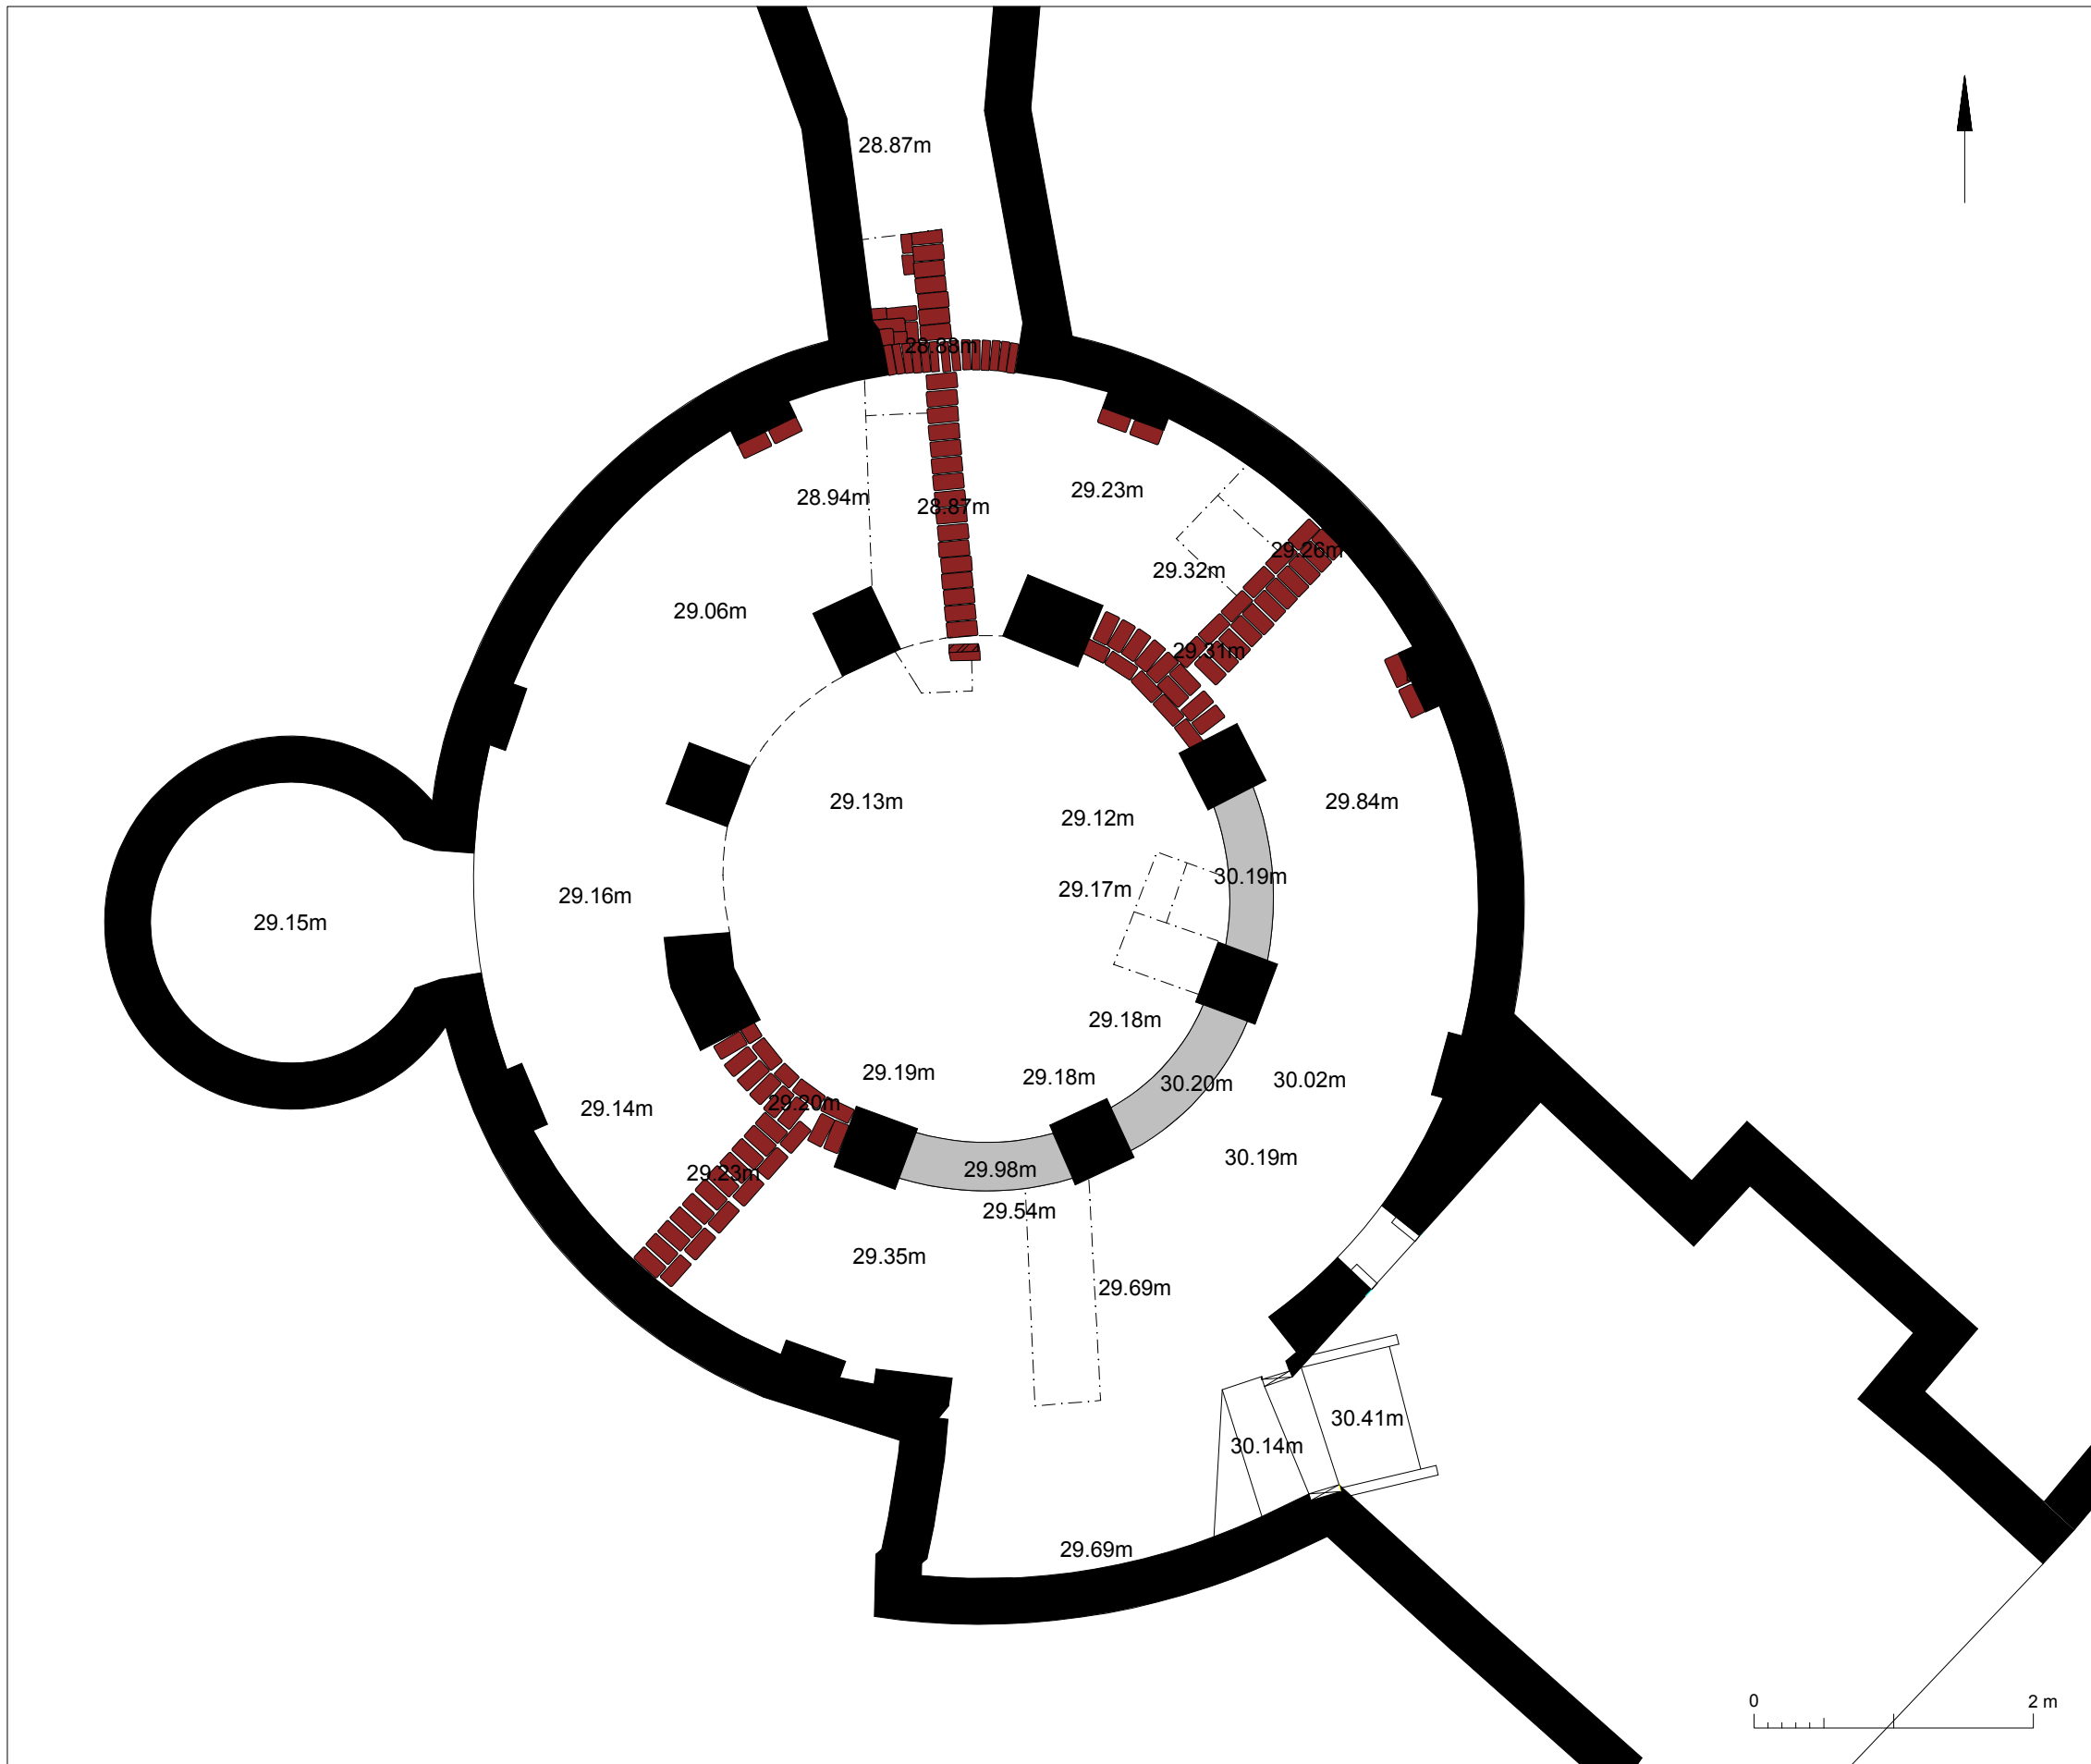
Fig 4 Heights inside the structure.

The ground-level in the outer walkway rises notably from the north-west of the structure to the south-east (Fig 4). TP3 was located on the lower level of the outer walkway and TP2 and TP3 were located on the slope (Fig 2). A considerable quantity of loose building material (brick, stone, etc) and other deposits had accumulated in the outer walkway. Notably, in the south-east behind Sections 1 and 2 of the revetment wall (RW1 and RW2); in the east near the entrance to the side chamber; and in the northern entranceway where it joins the main structure. Much of

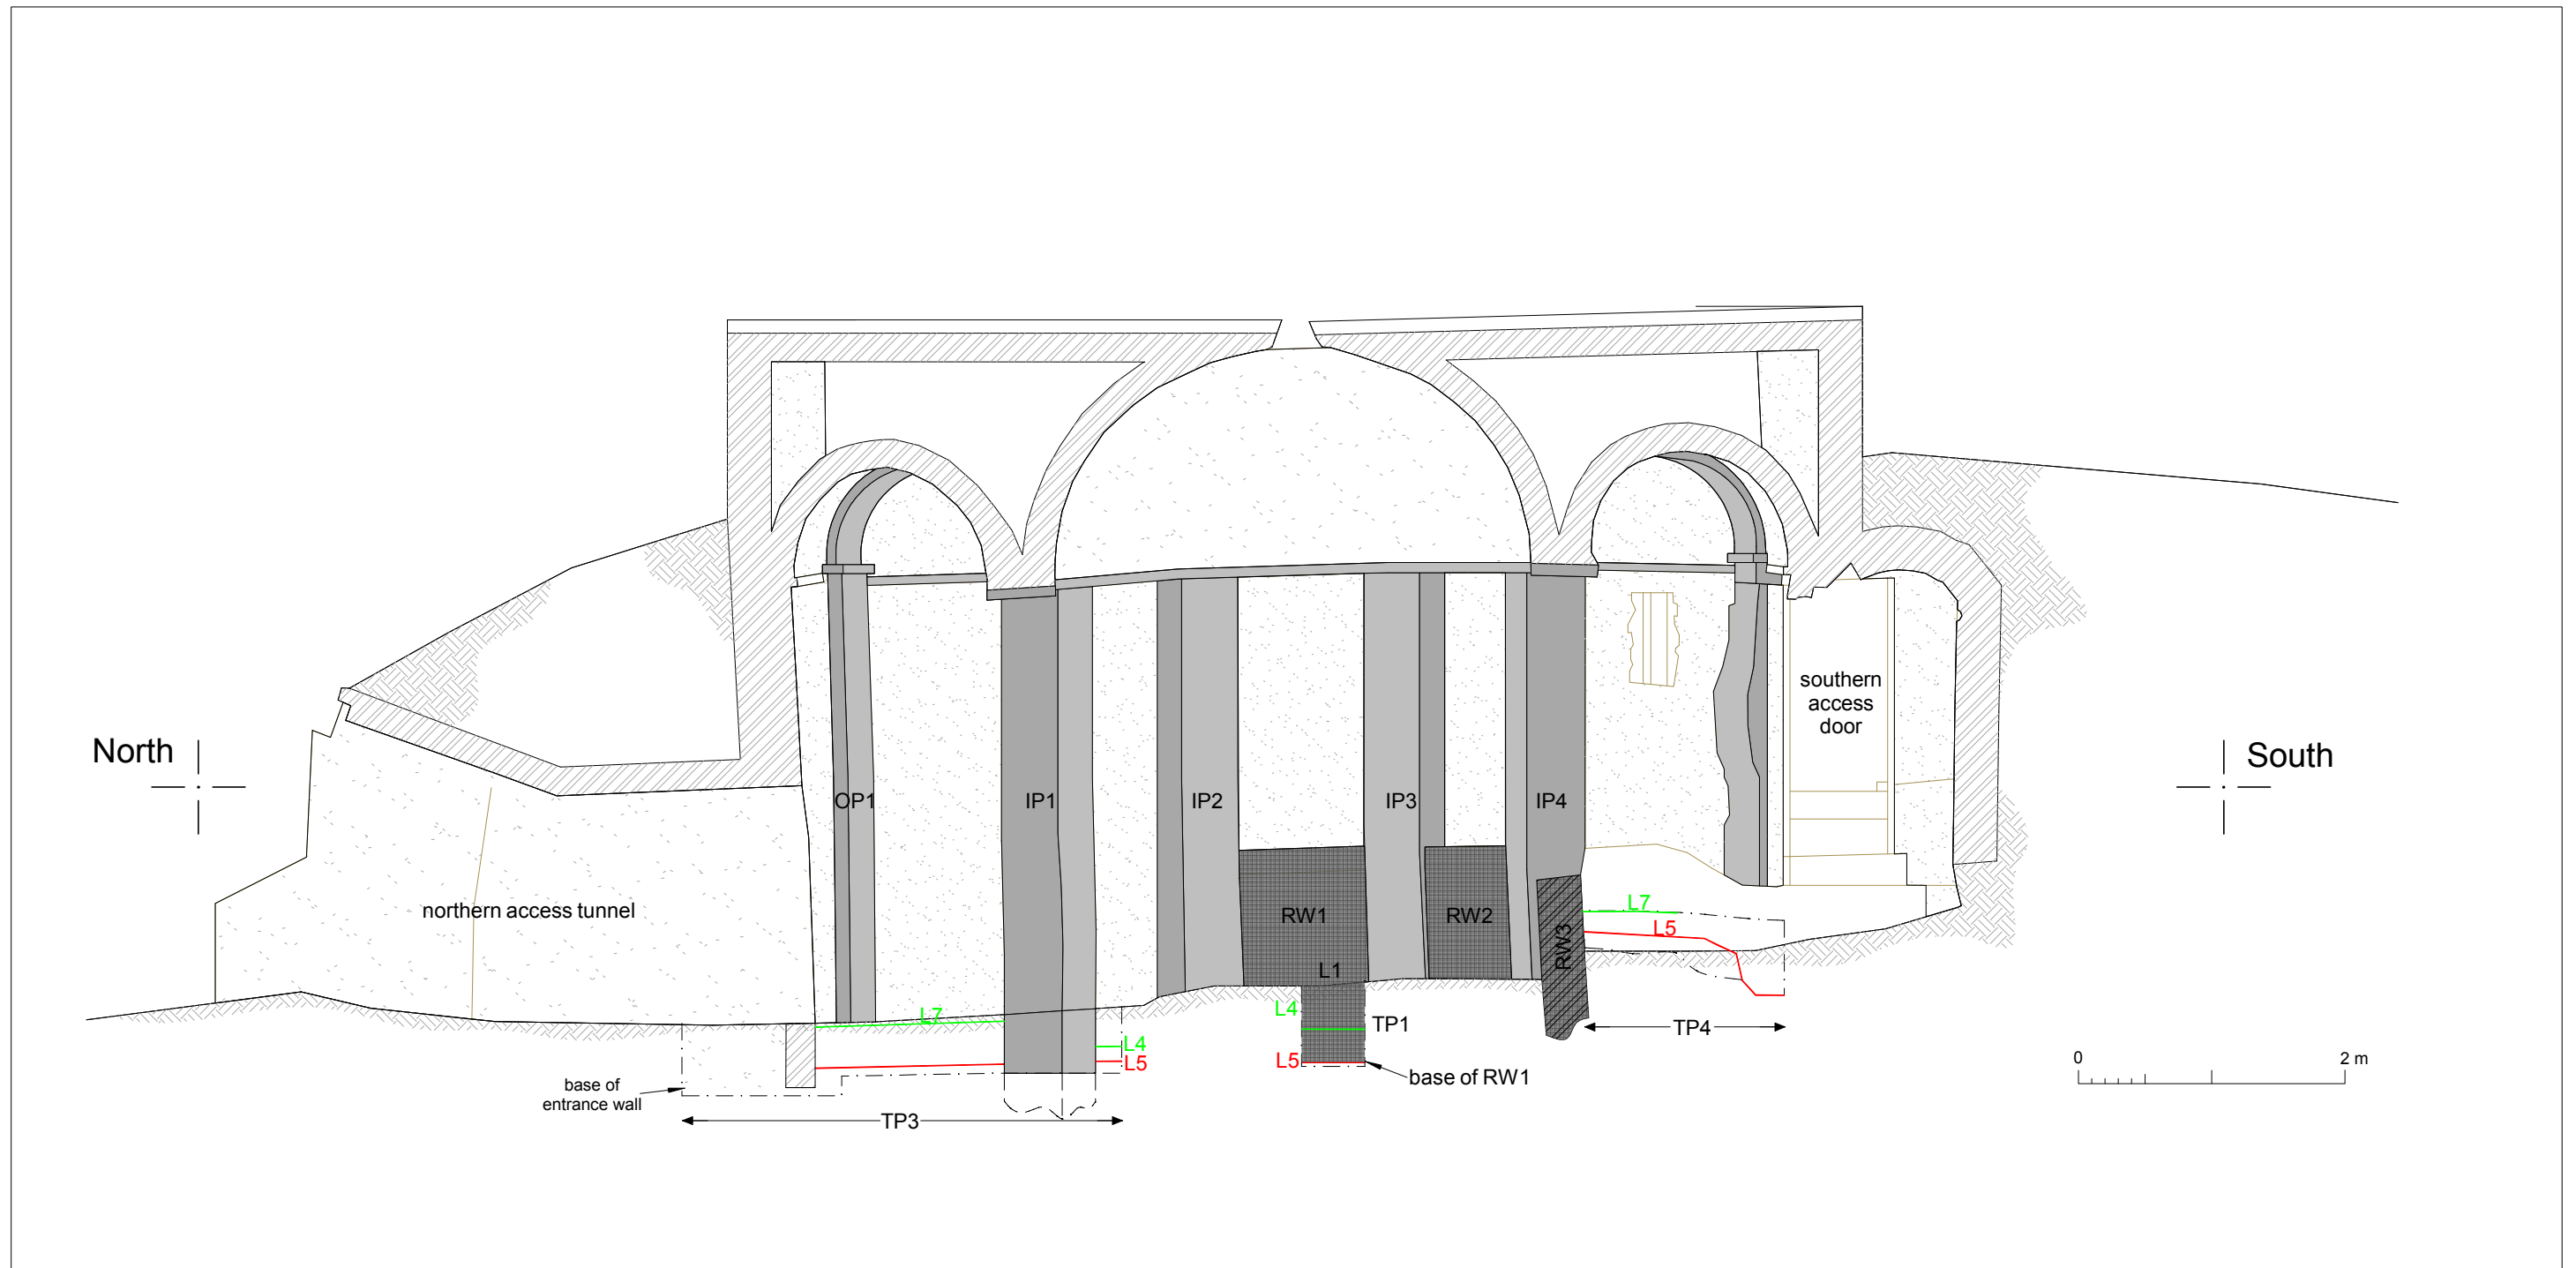
Fig 5 Section across the structure showing the top of the redeposited clay (L7/L4), and the natural clay (L5), in TP1, TP3 and TP4.

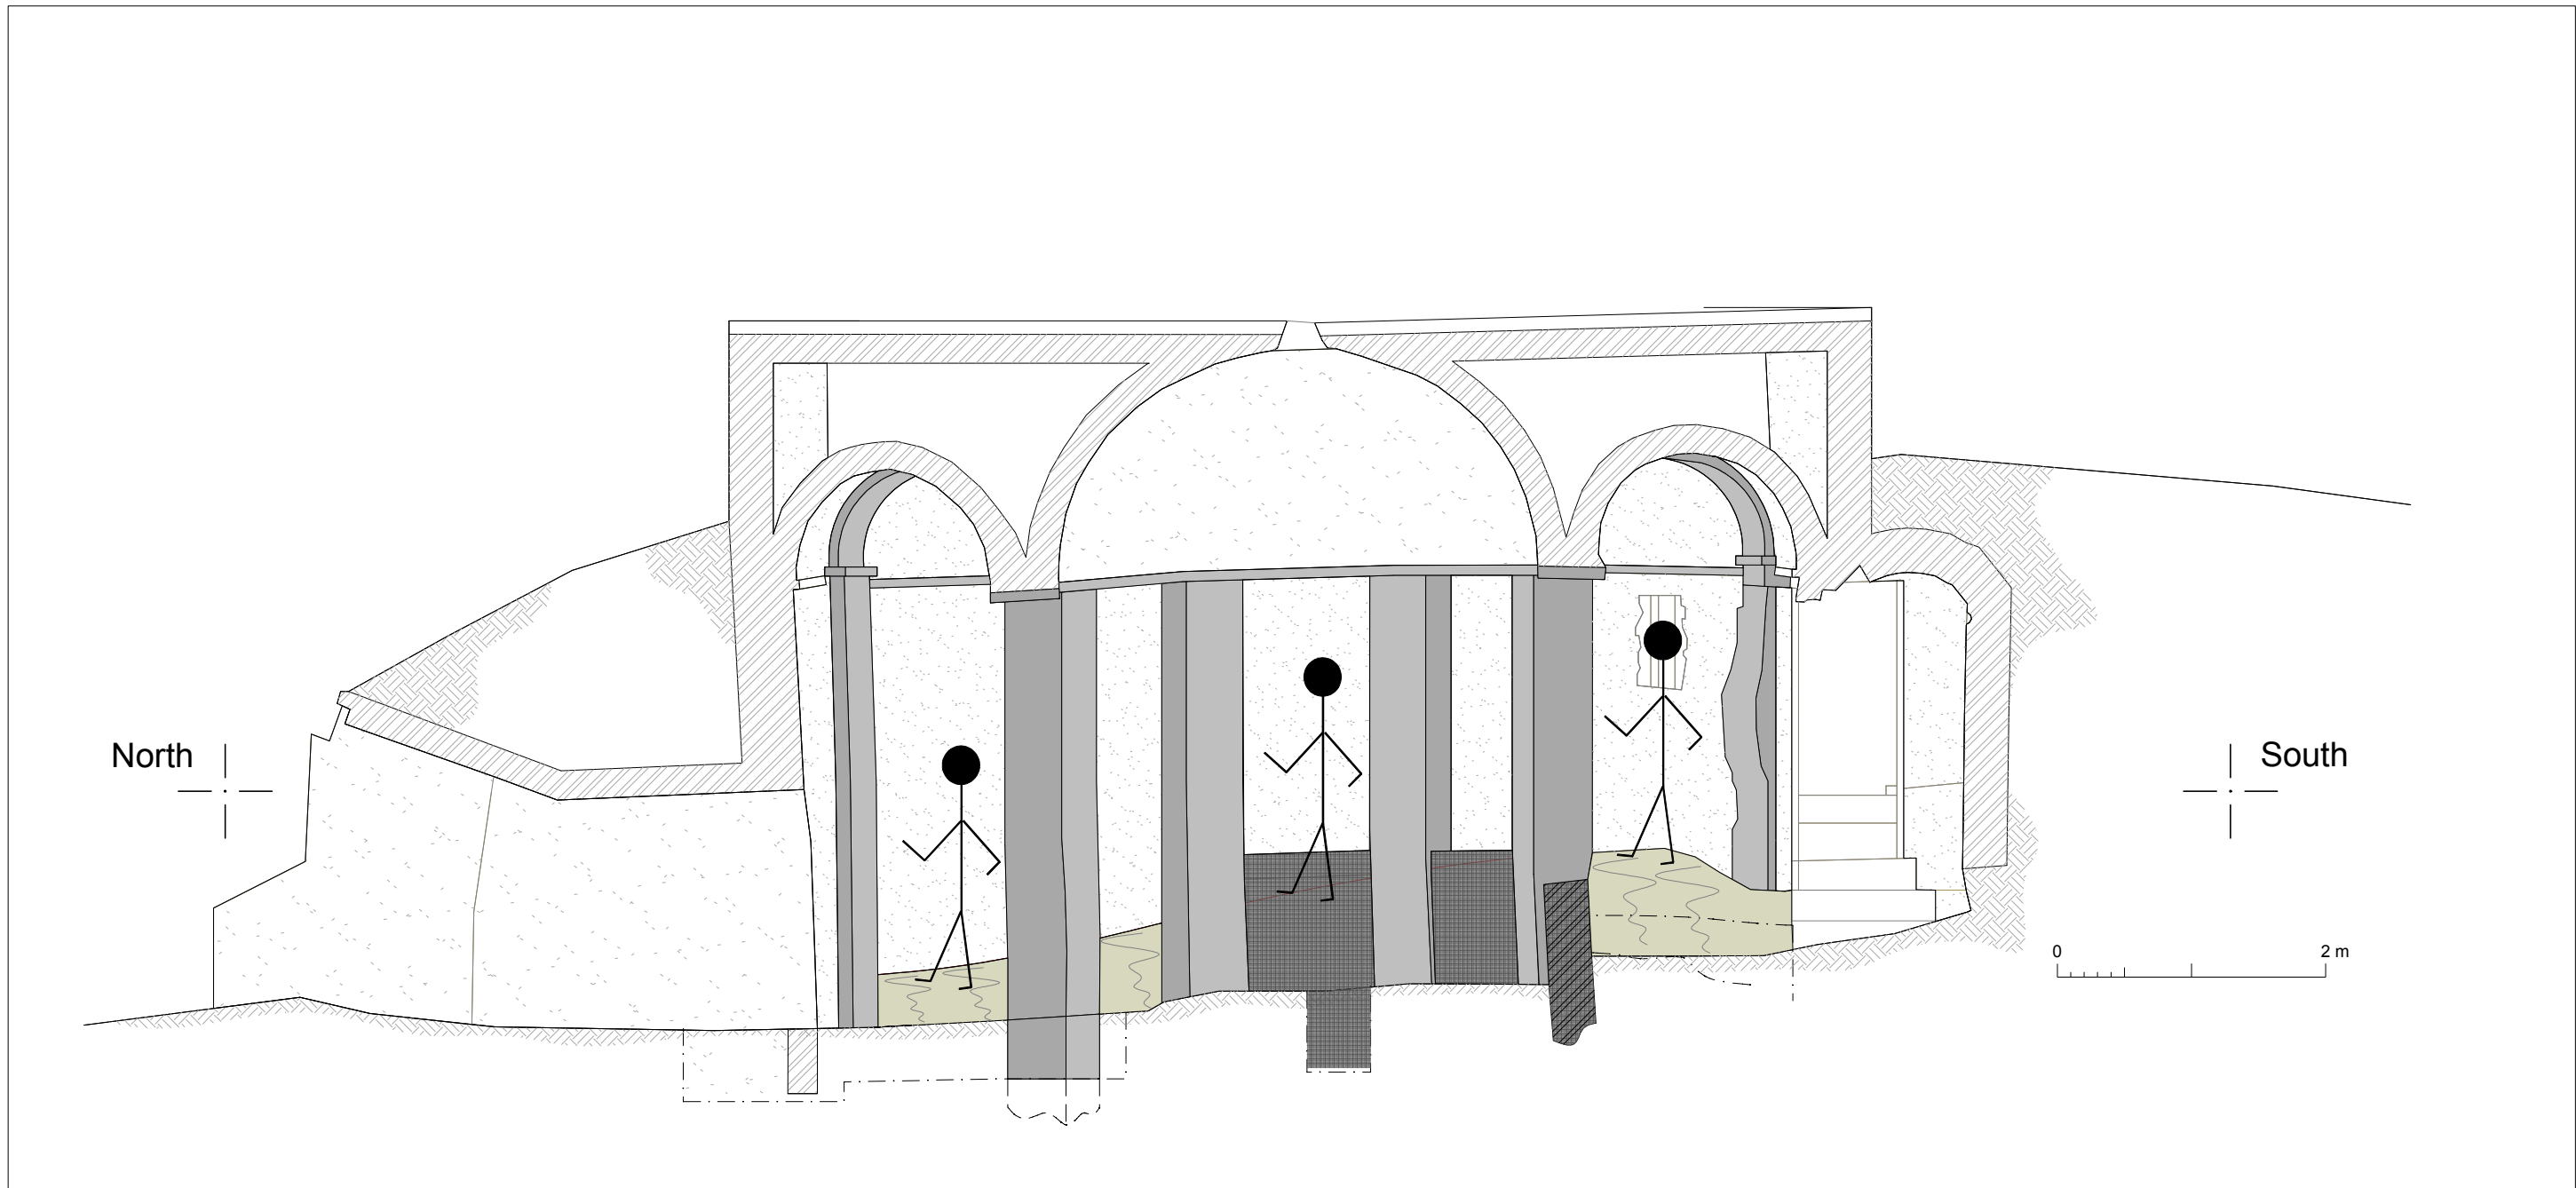
ascertained. However, it was distinguishable from the overlying layers by the absence of brick and mortar and its greater solidity. The only place in the outer walkway where redeposited clay does not overlie the natural clay is at the highest point within the structure, behind RW2 in the south-east. Instead of removing a considerable quantity of soil and clay from this area and then using bricks to build up the height of the wall, this section of the outer wall has been constructed on higher ground than that to the north-west. Consequently, the outer walkway in the south-east is notably higher than to the north-west. This can be seen by comparing the height of the redeposited clay L7 and the natural clay L5 in TP3 and TP4 (Fig 5). Revetment walls were constructed between four of the inner piers in the south-east so that the central chamber could be made level (Figs 2 & 5). The desire to construct a level surface in the central chamber is indicated by the comparable heights at which the natural clay (L5) was encountered in TP1 and TP3 (28.58m AOD and 28.55m AOD respectively; Fig 5). Redeposited clay was used to grade the slope between the higher and lower areas of the outer walkway to create a ramp (Fig 6).

Fig 6 Section showing the slope in the outer walkway based on the height of the redeposited clay (L7).

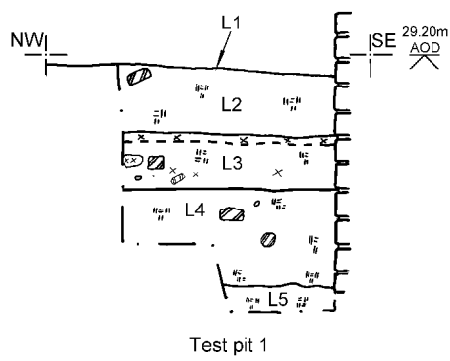
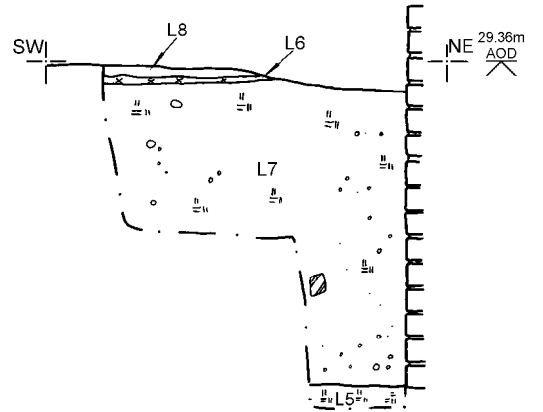
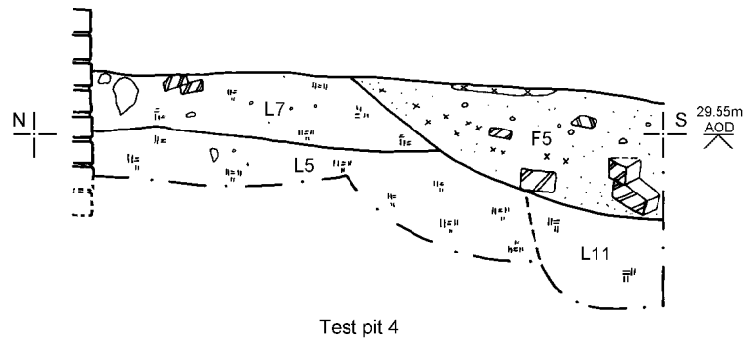
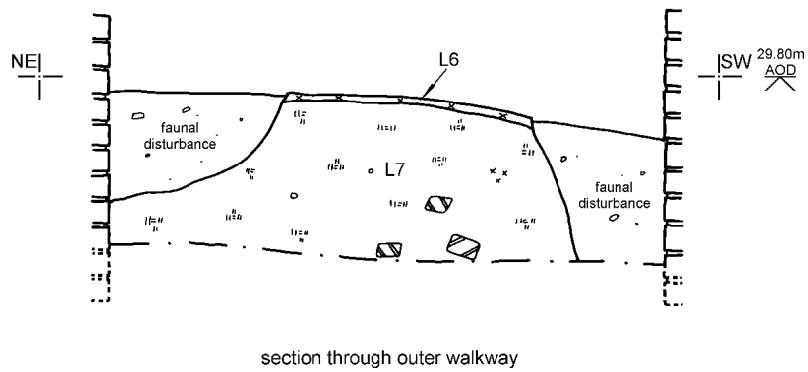
Fig 7 Sections.

Test-pit 1 was located against RW1 Revetment Wall 1) and IP3 (Internal Pier 3) (Fig 2). The size of the test-pit decreased as depth increased due to the solidity of the clay encountered. The layer of probable limewash (L1) was only 4mm thick and directly overlay the compacted clay layer L2, which contained loose soil and brick fragments (Fig 7). Beneath L2 was a layer of clay with frequent brick and mortar fragments with a dense lens of mortar at the top of the layer (L3). Underlying L3, another clay layer very similar in character to L2 was uncovered (L4). L4 sealed the dark yellow/brown natural clay (L5). Upon discovery of the natural clay, it became clear that the two clay layers previously encountered (L2 and L4) were redeposited natural clay with loose soil and brick fragments incorporated. It is possible that L4 is the backfill material in the foundation cut for the revetment wall, although the presence of brick fragments in the clay at some distance from the wall suggests that L4 was more widespread. All of the deposits within the structure were very dry, in particular where the redeposited clay met the brickwork due to the absorption of moisture from the clay into the bricks. Excavation of TP1 ceased when the lowest course of bricks in the revetment wall was encountered. This roughly corresponded with the bottom of L4 and the top of the natural clay L5 on which the lowest course of bricks was situated (Fig 7).

Only a thin layer of loose sediment (L8) overlay the redeposited natural clay (L7) in TP4. L7 was notably thin in TP4, with undisturbed natural clay (L5) uncovered 200mm below the existing ground-level (Fig 7), notably higher than it had been identified elsewhere in the structure. A feature containing dense mortar and frequent brick fragments (F5) was cut through L7 and L5 in the southern end of TP4. The feature may be associated with the addition on the lakeside terrace. At the southern end of TP4, the natural clay was softer, darker, and moist (L11; Fig 3). The clay was homogeneous, contained no inclusions, and had an ephemeral edge with the solid natural clay L5. This may have resulted from a natural water-carrying feature such as a stream once flowing across the site where the structure stands today.
