**Pig sheds  
at Lindsell Hall, Lindsell,  
Essex  
July 2011**

**report prepared by  
Chris Lister**

CAT project ref: 11/07c  
Saffron Walden Museum accession code: 2011.61  
NGR: TL 6472 2708 (c)

**CAT Report 611**

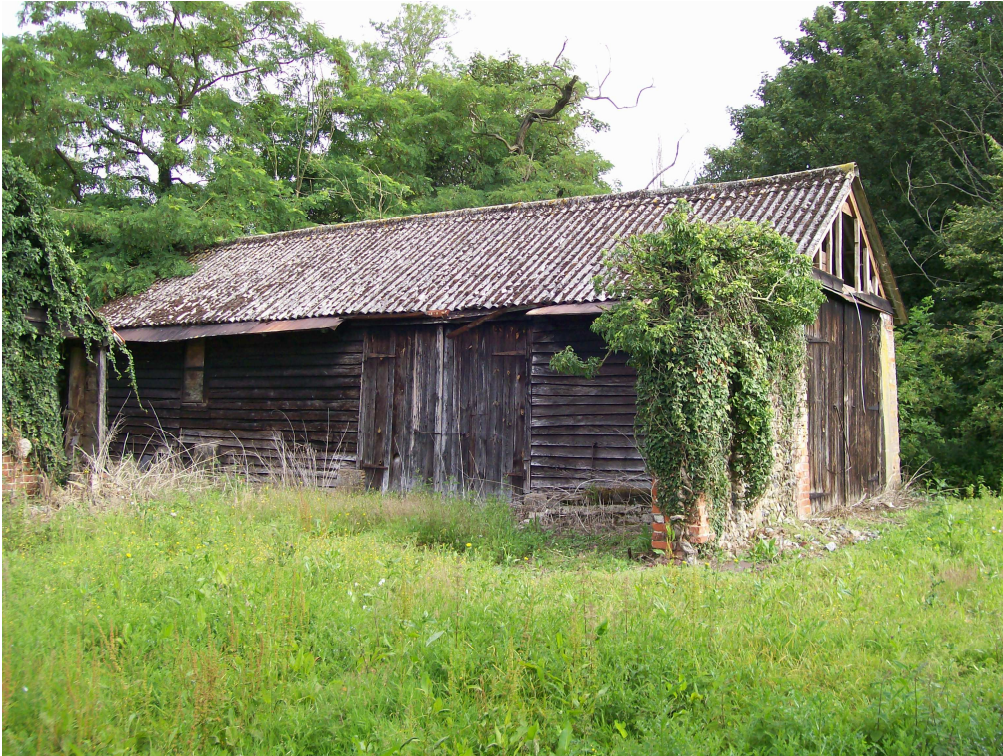
This is rectangular in plan with five bays, and is constructed of flint walls with brick quoins to the north and west, whilst the south wall is timber-framed clad in horizontal weatherboarding (Plate 1). The east wall is almost entirely taken up with a large pair of wooden doors. A second pair of doors is in the south elevation. This side of the building was originally open with a series of four posts supporting an eaves beam upon which the roof was supported. The roof is of timber trusses sitting above the posts with purlins supporting corrugated asbestos sheeting (Plate 2). The main posts in the south elevation are supported by concrete plinths and are a mix of re-used roughly-squared timbers and un-planed timber with nailed straight braces to the wall plate. The exceptions to this are the braces in the central bay, which are re-used knee braces. However, these have also been nailed to the posts and the eaves beam (Plate 3). At the centre of this bay, the eaves beams are joined with a pegged scarf joint. A loft has been inserted above the three bays to the west.

**Plate 1 Building 1.**

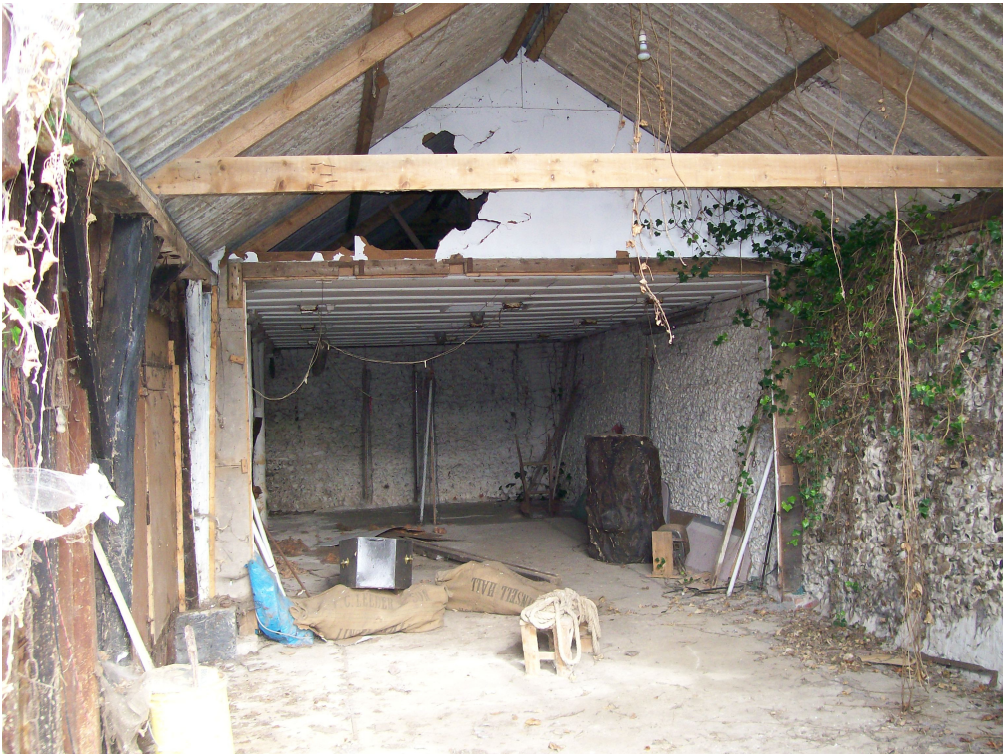
**Plate 2 Interior of Building 1 showing flint walls and modern roof.**

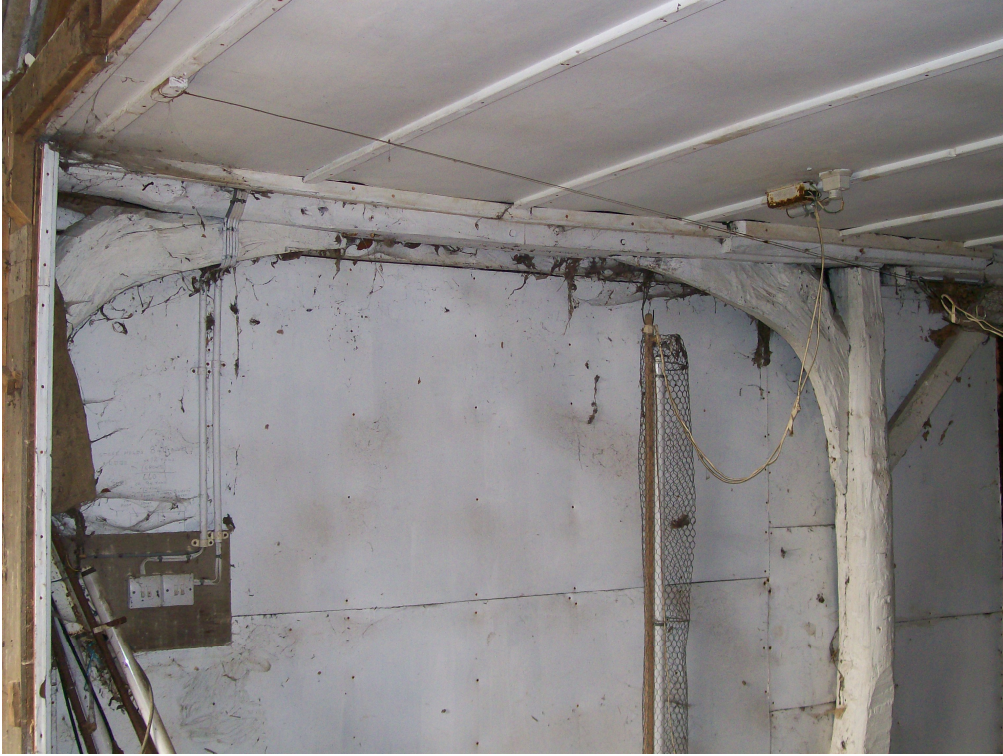
**Plate 3 Building 1 re-used knee braces and scarf joint.**

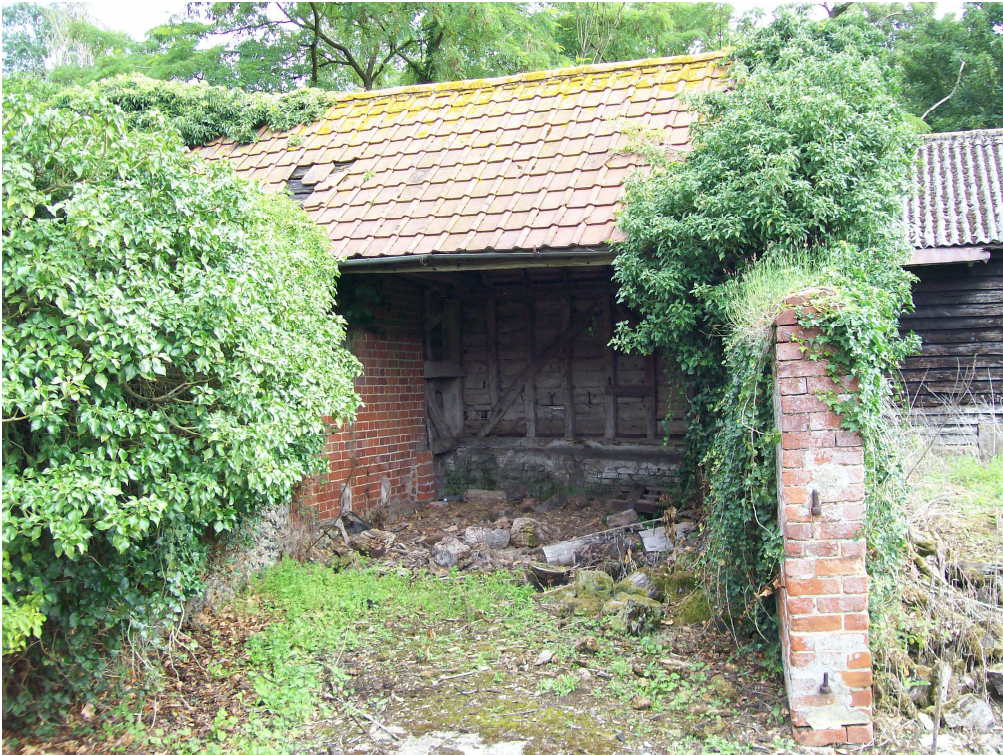
Building 2 is a parallelogram in plan divided into five bays, with timber-framed walls clad in horizontal weatherboarding to the north and west, with the east wall being red stock brick laid in English bond and the south wall open (Plate 4). The roof is supported on the south side by an eaves beam supported by a series of freestanding brick walls that are not joined to the north wall and project beyond the eaves. One of these freestanding walls is brick beneath the roof and flint with brick quoins at either end where it projects into the yard. Large re-used tie beams span the width of the building above the brick walls. The roof is supported on closely-spaced rafters which carry sarking boards with ceramic pan tiles above. The timber-framed wall sits upon a brick plinth with original sill beams, posts and bracing, but the wall-plate has been replaced (Plate 5). The majority of the timbers are re-used and the framing has been nailed together in many places. Bays 4 and 5 have noggin to half the height of the wall. Carpenters' marks are present on one of the posts (Plate 6). There is a channel cut into the floor in the gap between the north timber-frame wall and the freestanding brick cross-walls. The projecting brick cross-walls originally extended further into the yard. Remains of this can be seen in the dirt of the yard surface. Iron hinges on the end of the east brick wall (Plate 4) indicate the presence of a gate – this gate was found lying inside the building.

**Plate 4 Building 2, bay 1 with the original timber-frame wall to the rear and the later brick cross-walls.**

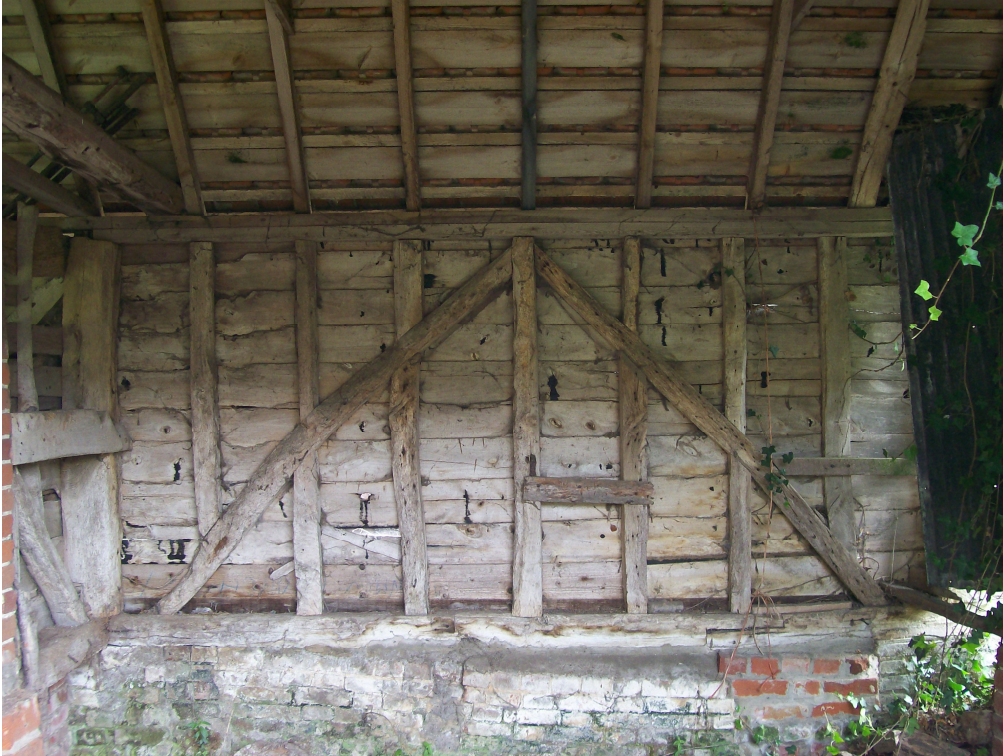
**Plate 5 Building 2 original timber-framing of the north wall with scarf joint on sill beam.**

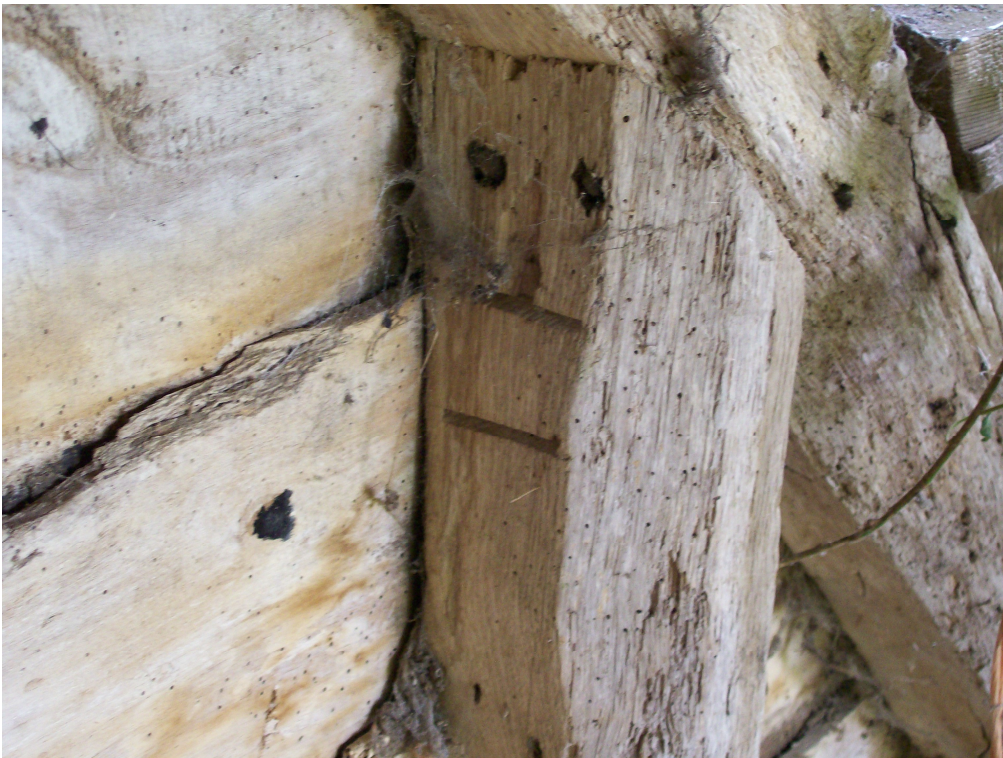
**Plate 6 Carpenters' marks and nails holding the frame of Building 2 together.**

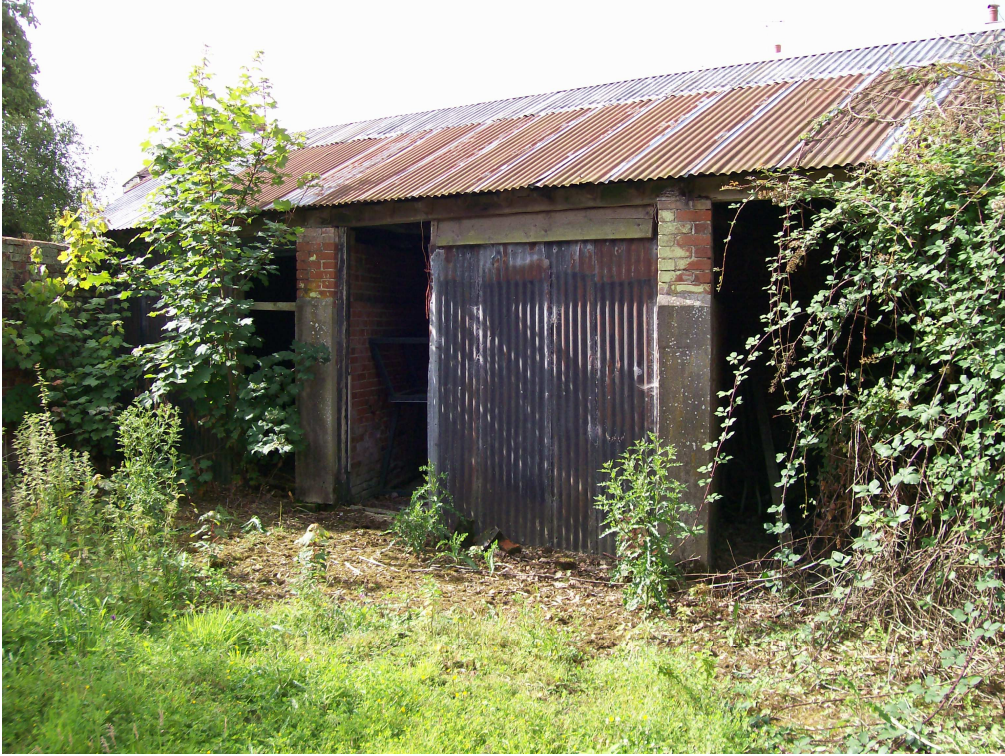
This is also a parallelogram in plan (Plate 7). The south and east walls are of red stock brick laid in Flemish bond, whilst the west wall is of flint with later brickwork on top (Plate 8). Two internal freestanding cross-walls of red stock brick in English bond divide the building into three bays. The north side is open. Both east and west walls project north past the eaves. Remains in the surface of the yard indicate these had returns and formed enclosed spaces with the freestanding walls. A large-section eaves-beam and a similar sized wall plate sit upon the brick walls. These support four large-section, re-used tie beams and a series of closely spaced rafters with purlins and collars (Plate 9). The roof itself is of galvanised corrugated iron. All of the timber in the roof (apart from the tie beams) is relatively new and machine-cut.

**Plate 7 Building 3 showing the open-fronted bays.**

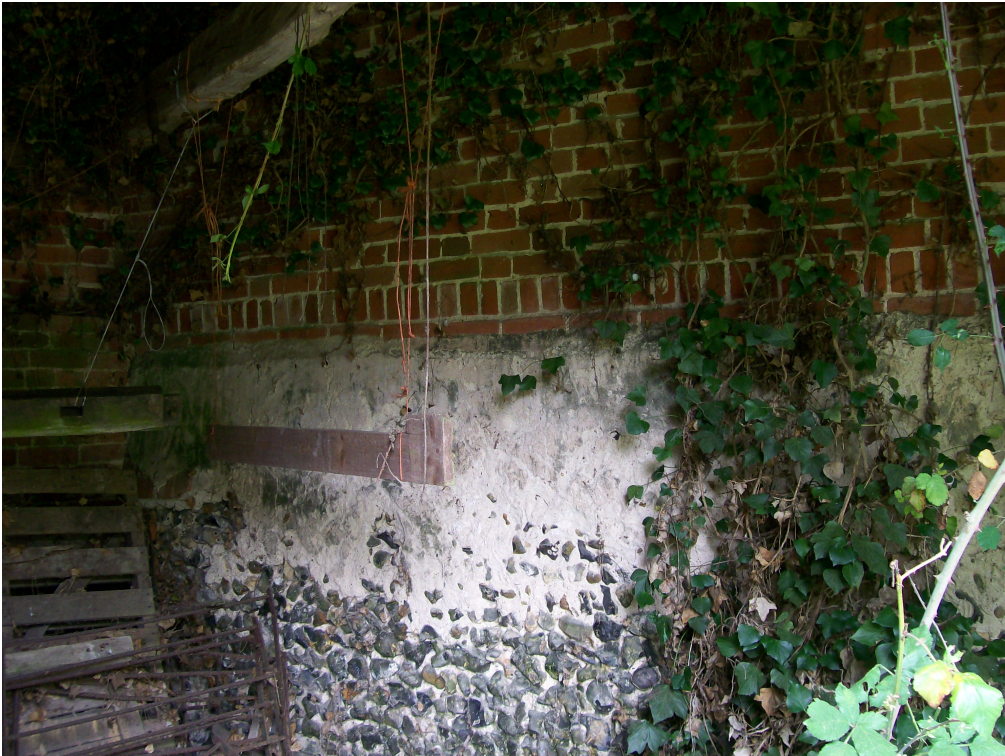
**Plate 8 The flint wall separating Buildings 3 and 4 with later brickwork on top.**

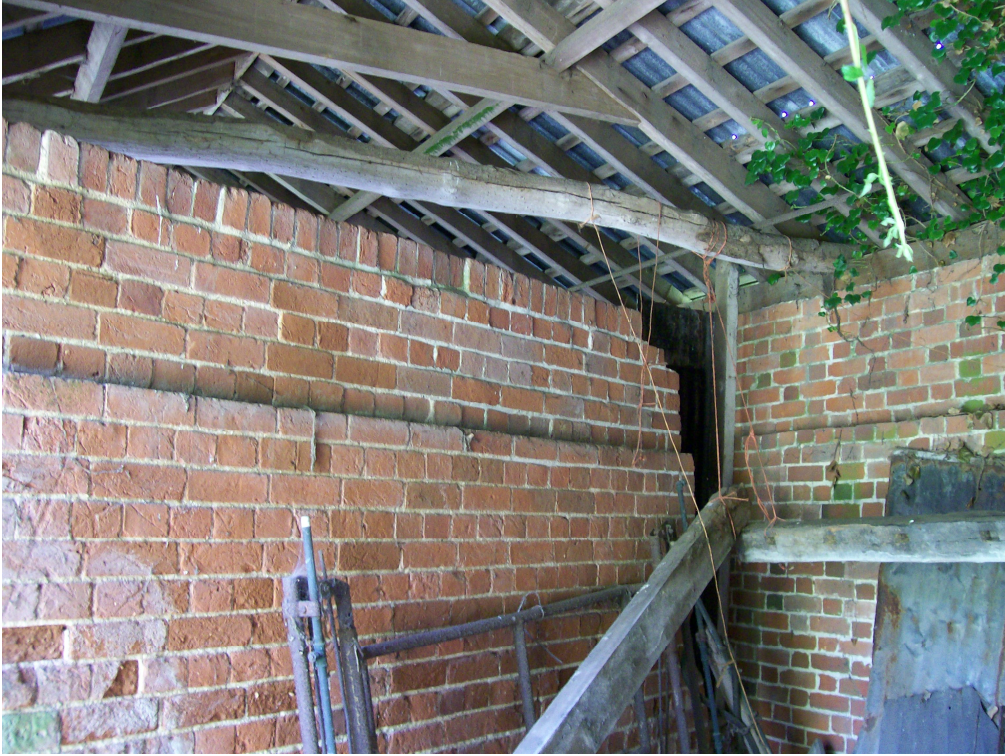
**Plate 9** Interior of Building 3 showing the freestanding brick wall and re-used tie beam.

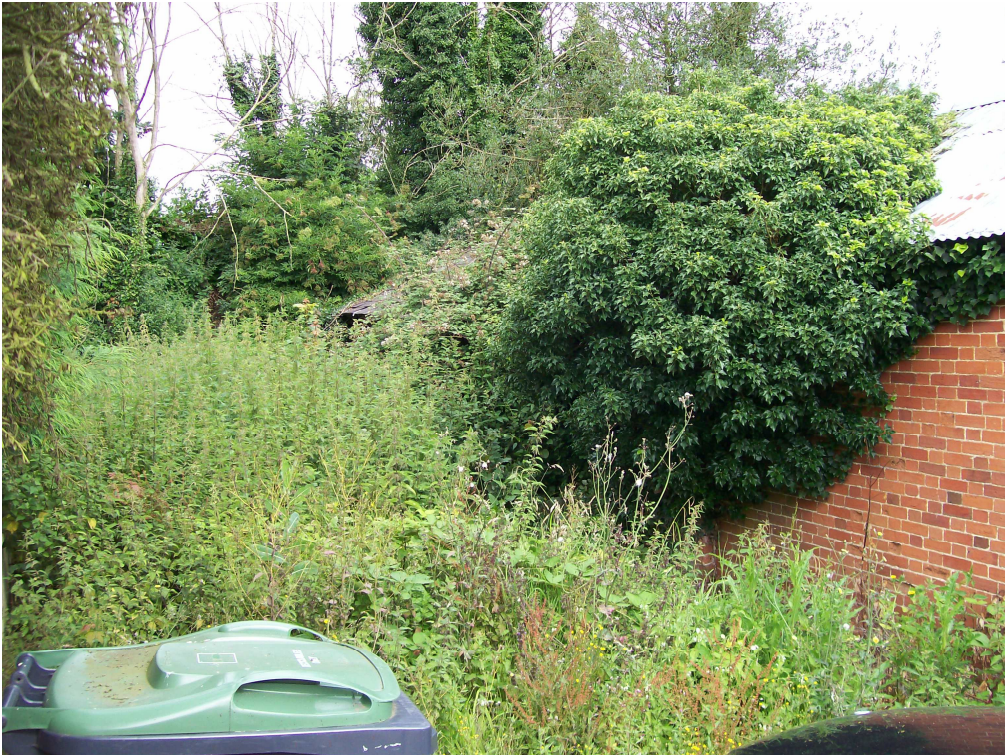
Building 4 is another parallelogram (Plate 10). It shares its east wall (flint with brick above) with building 3 and the flint boundary wall to Priors' Hall forms the west wall. The north wall is of red stock brick laid in English bond, whilst the south side is open. The south side has four large, square-section posts supported by concrete plinths. These appear to be re-used timbers: they support an eaves-beam that is modern, as

**Plate 10** The south side of Building 4, showing the difficulty the vegetation presented.

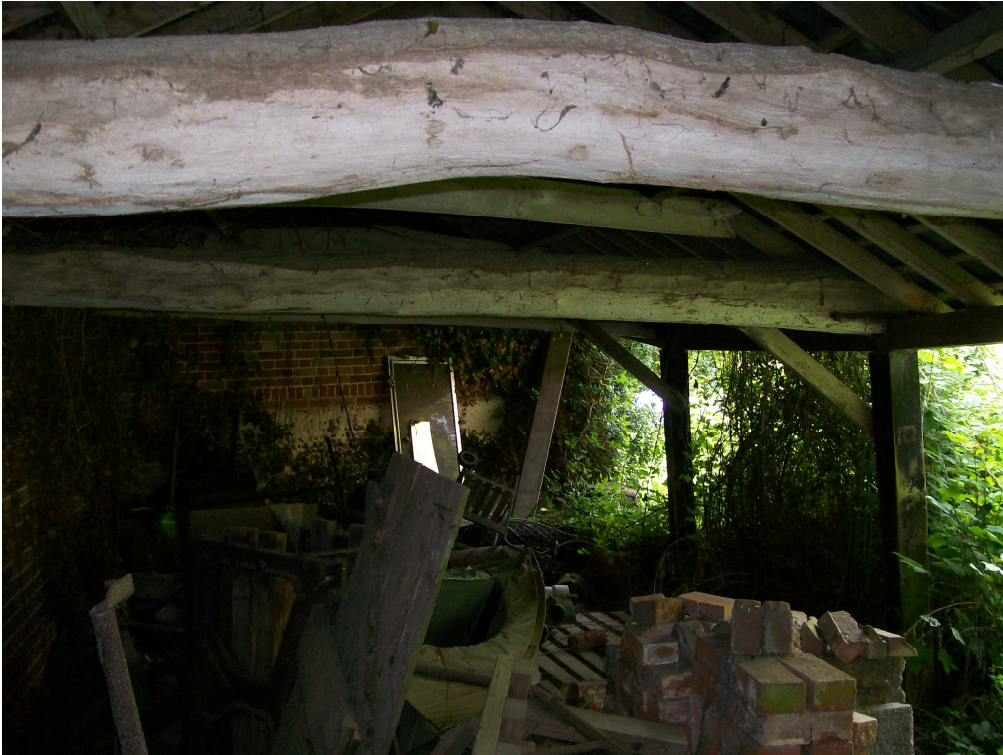
is the wall-plate to the north. Re-used tie beams sit upon the posts and modern straight braces have been nailed between post and tie beam (Plate 11). The roof is of closely-spaced rafters and purlins supporting slates.

**Plate 11 Interior of Building 4 showing the large re-used tie beams and the modern nailed straight bracing.**
