**Building recording at
Wall Farm,
Ford End,
Great Waltham, Essex
December 2011**

**report prepared by
Chris Lister**

**commissioned by
Alun Design Consultancy Ltd
on behalf of
R E Butler and Son**

CAT Report 625
March 2012

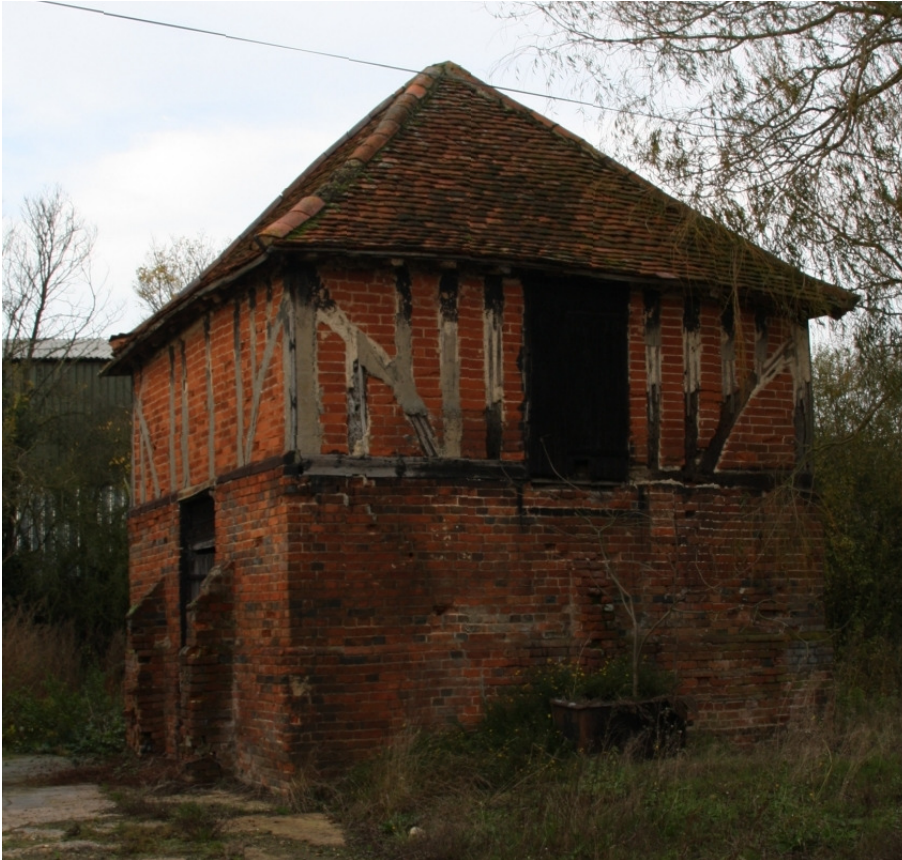
This building is a two-storeyed 5m by 5m square structure with a red brick-built lower storey and a timber-framed upper storey with brick nogging (Plate 1), located north of Barn 2 on the edge of the dry pond. The bricks of the lower storey are un-frogged with dimensions of 110mm by 220mm by 58mm, quite weathered and laid in irregular bond with a lime mortar. There is a plinth just under half of the height of the lower storey. The bricks used for the nogging in the upper storey are more orange than red with dimensions of 110mm by 220mm by 65mm and are laid with a grey mortar. The timber-framing has been obscured by the application of a cement render held on vertical laths nailed to the frame. This has degraded in many places. The roof is pyramidal and covered with peg-tile.

Plate 1 17th-century dovecote.

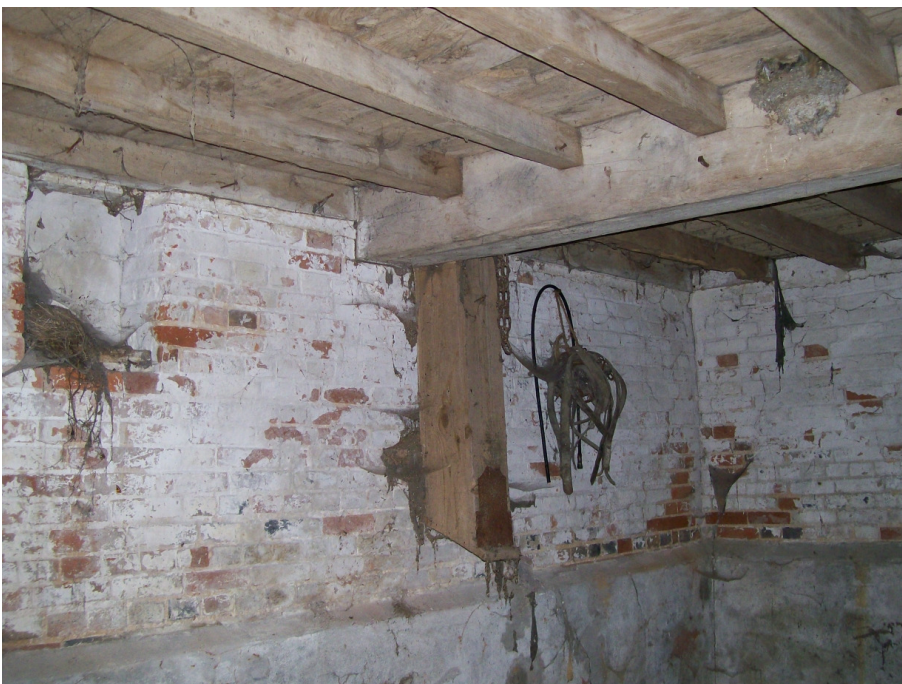
The interior of the lower storey has a concrete floor and the plinth has been rendered with concrete. The walls are whitewashed and there is a small window near the north end of the east wall. An identical window is located at the south end of the west wall. Both windows have been blocked with brick. A bridging beam, 22cm wide by 28cm deep, extends east to west across the building, supported on the brick walls, and carries the floor joists of the upper storey. On the north side of this, attached to the west wall, is a grain chute (Plate 2).

Plate 2 17th-century dovecote, lower storey interior showing blocked window and grain chute.

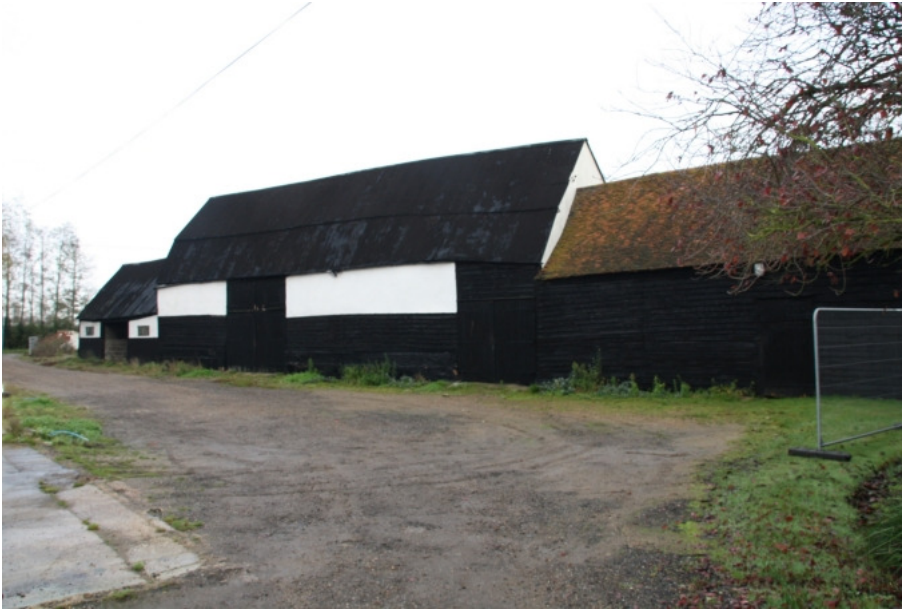
Structure 1c is a timber-framed, five bay barn with a gambrel roof of black-painted corrugated iron sheeting (Plate 3). Externally, the lower register is covered with black-painted horizontal weatherboarding, whilst the upper register is plastered and painted white. The frame sits on a dwarf wall of black-painted brick (dimensions 233mm by 110mm by 60mm) in a staggered English bond, and is constructed from a mix of original and re-used oak timbers. The re-use of timbers is most apparent in the posts, trusses and wall plates where more complicated joints are required. The floor of the barn is of concrete and the interior of the dwarf walls has been rendered in concrete. Bay 1, at the north end of the barn, has jowled corner posts of 20cm by 20cm scantling with sill beams of the same dimensions. The end cross frame has a central post with girding beams either side, each of 22cm by 16cm scantling. Either side of this central post, both above and below the girding beams, are four studs of 13cm by 13cm scantling with gaps of 34-40cm. All of the studs are single-pegged to

Plate 3 Barn 1, (left to right) structures 1b-d.

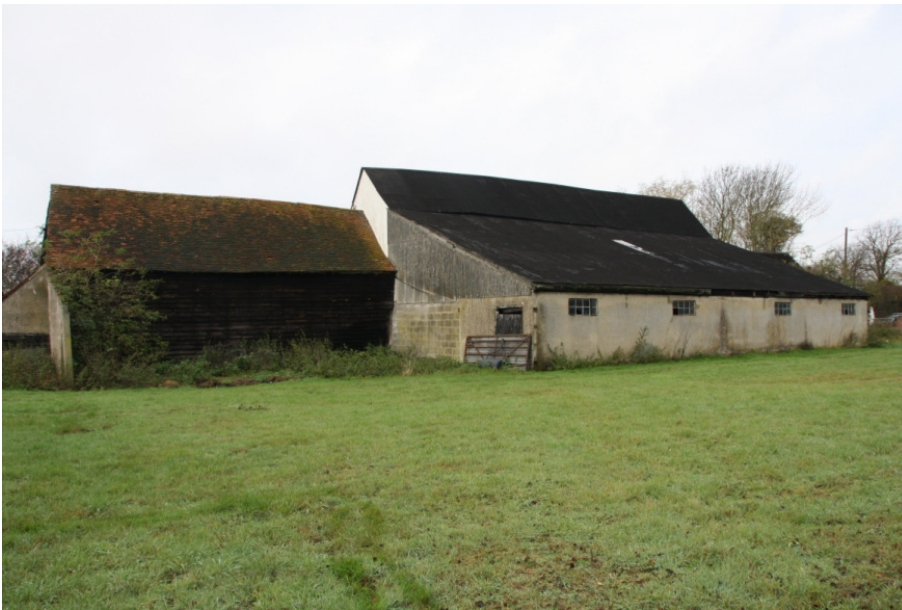
Structure 1a is a 20th-century extension located to the east of the main range, extending the length of structure 1c (Plate 4). It has a shallow mono-pitch roof of corrugated iron sheeting and walls of concrete blocks covered in a concrete render. The east elevation has four metal-framed windows of eight lights below the eaves. A wooden door is located in the south elevation. The roof is supported on long rafters rising from the east wall and attached to the first purlin of structure 1c's roof. The rafters are supported by a line of six square posts extending the length of the structure and straight bracing projecting from the wall plate of structure 1c. The floor is of concrete and the structure appears to have been used for storage, rather than housing livestock.

Plate 4 Barn 1 showing (from left to right) structure 1d with lean-to extension and remains of later shelter shed, and structure 1a projecting from the east side of structure 1c.

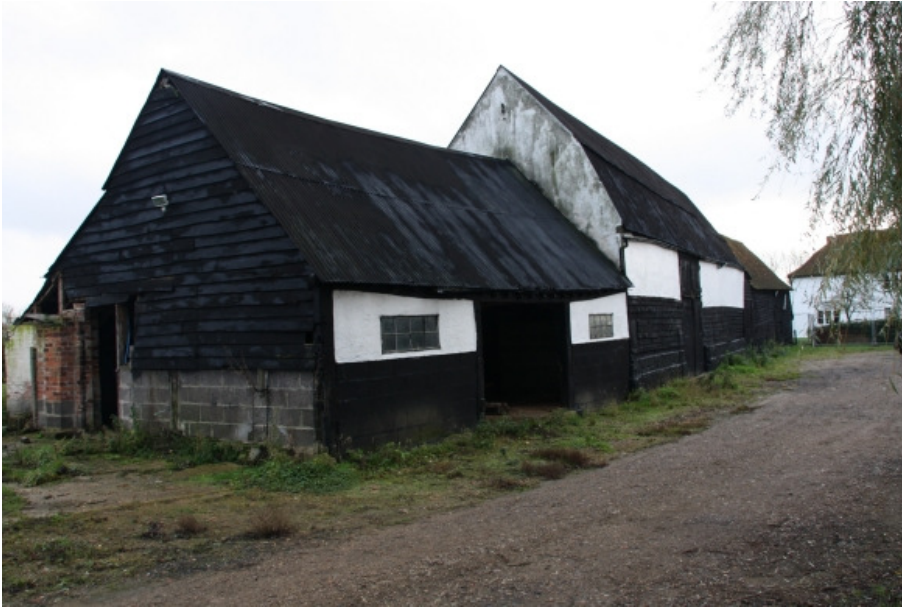
Structure 1b is located at the north end of Barn 1 and is a rectangular timber-framed building of three bays, with an extension to its east side (Plate 5). The gabled roof is of black-painted corrugated iron sheeting which has been extended to the east at a shallower pitch to cover the extension. The north wall has unpainted breeze block infill to half the height of the posts and the entire north-east corner is constructed of red stock brick. Above the breeze block wall the frame is clad in black-painted horizontal weatherboarding. A doorway is located between the brickwork and the first post of the frame. This brickwork is a remnant of a 19th-century building, demolished in the late 20th century. The east wall of the extension is clad in corrugated iron sheeting over a timber frame. The west elevation has half-height walls of black-painted breeze blocks in the outer bays. The outer bays (1 and 3) have white-painted plaster above the breeze blocks with a metal-framed window of eight lights in each. These windows are identical to those in structure 1a. The centre bay (2) is open to the interior.

Plate 5 Barn 1, structure 1b with lean-to extension to the left and infill of the west bays.

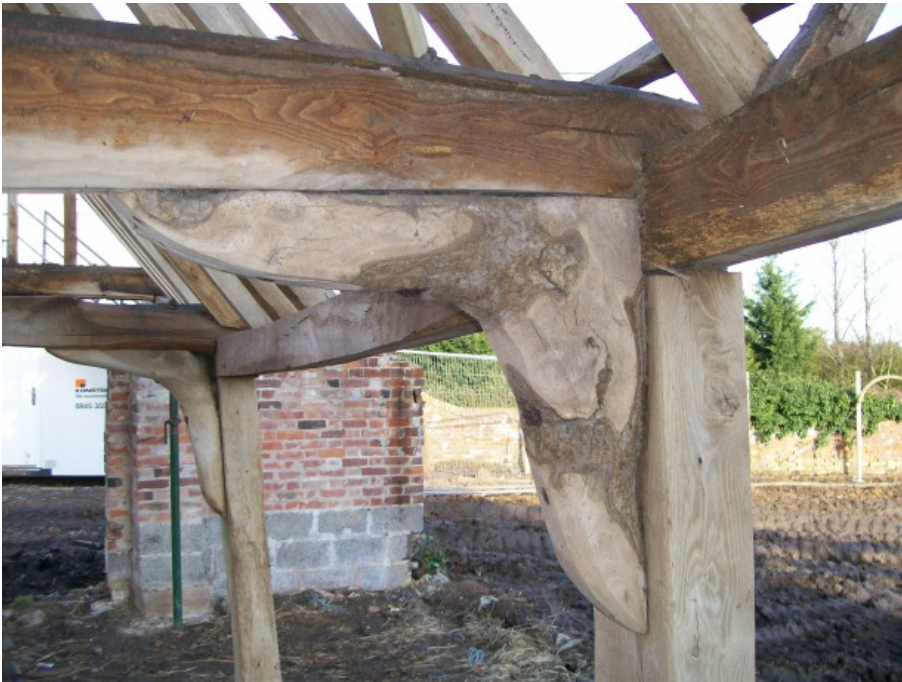
Plate 6 Barn 1, structure 1b; detail of hanging knee brace of truss B, with bark attached.

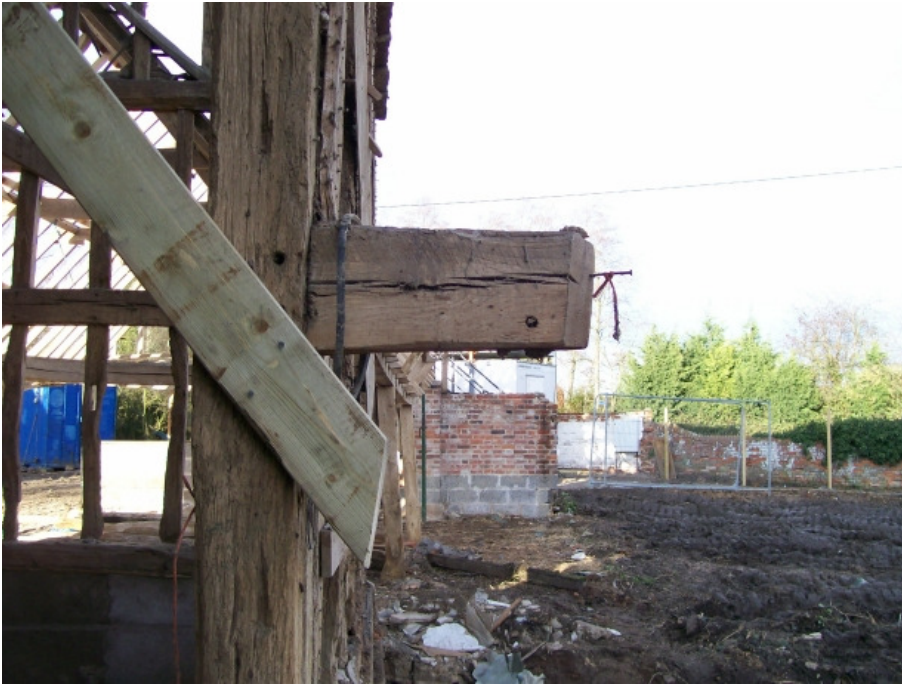
Bay 2 has an entrance in the west side and is completely open to the east. The west entrance has a pair of outward opening doors held on posts inserted next to the posts of trusses A and B. These doors are split with the top third capable of independent movement. The lintel of this entrance is higher than the wall plate of bays 1 and 3 and the rafters have been shortened to accommodate it. The timber forming the lintel, although re-used, is not the original wall plate. On the east side the opening is the full width between the posts of trusses A and B and grants access into structure 1a. Inclined timbers rising from the tie beams of these trusses to the centre of bay 2, and the remains of a girding beam and a wall plate projecting from the east face of the post of truss A, indicate a midstrey has been removed from this side of bay 2 (Plate 7).

Plate 7 Barn 1, structure 1c; evidence for midstrey to the east of bay 2.

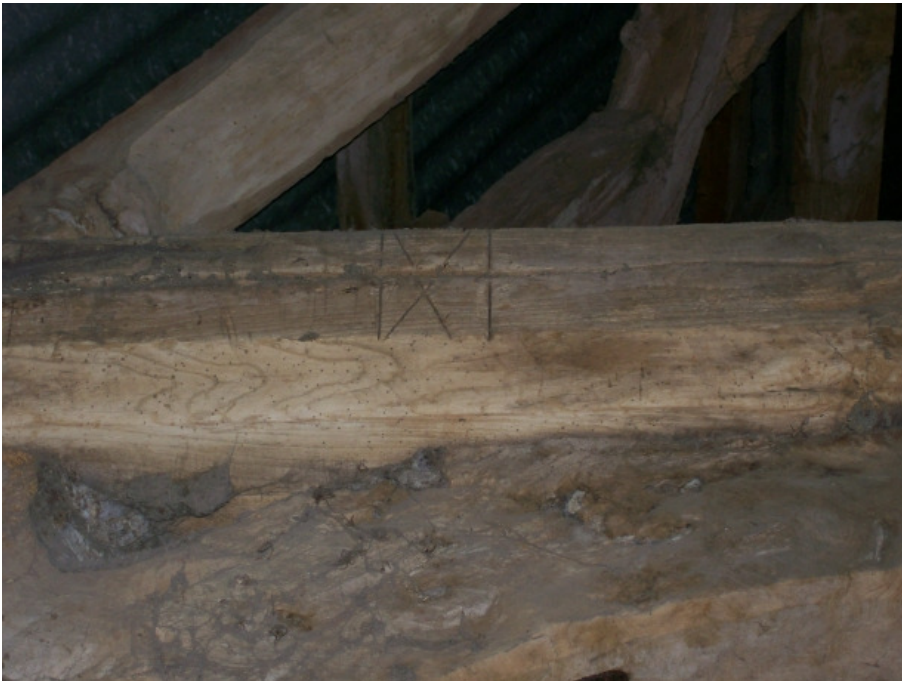
Truss C has straight posts, each with a bolted knee brace, supporting a straight tie beam. Above the tie beam the arrangement of the roof timbers is identical to that of truss B, except that the curved brace rising from the tie beam meets the principal rafter at the base of the small knee brace rather than at the first purlin. There is a scratched carpenters' mark (X) on the north face of the east post and a chiselled (IXI) on the south face of the tie beam, above the west knee brace (Plate 8).

Plate 8 Barn 1, structure 1c; carpenters' marks on truss C above hanging knee brace.

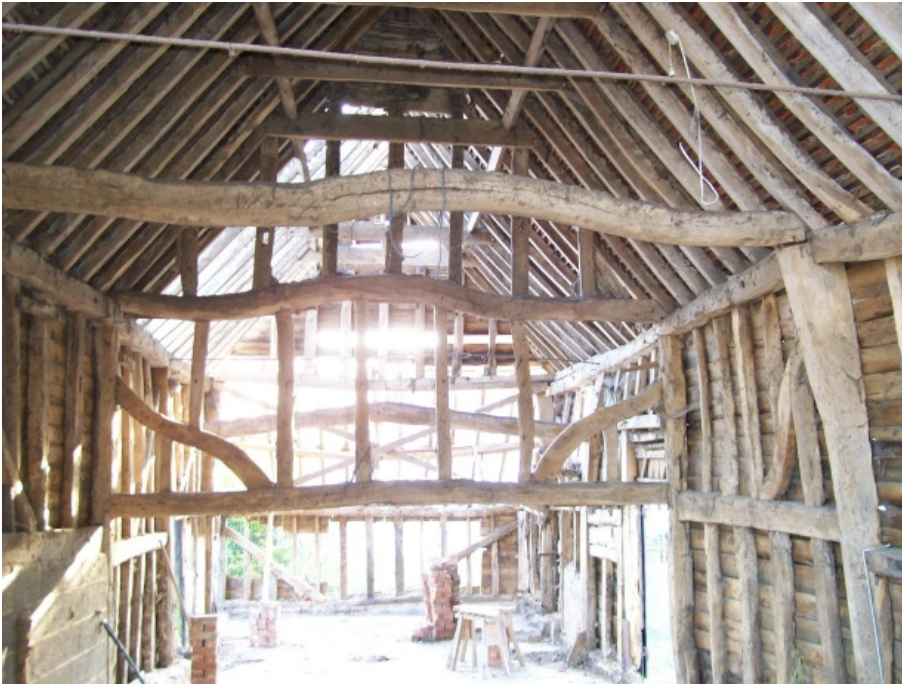
Plate 9 Barn 1, structure 1d; truss C with ogee braces.

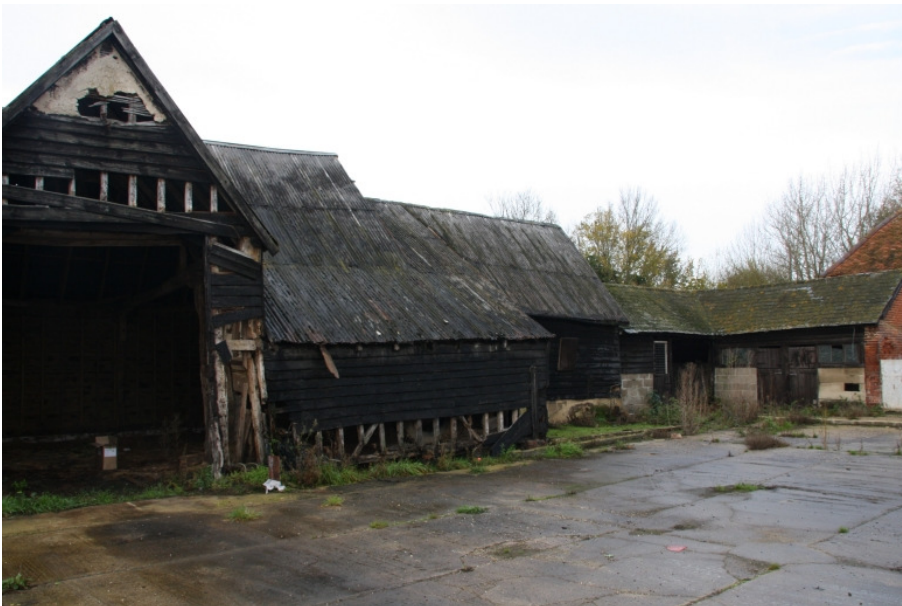
Barn 2 is a long range of buildings aligned north to south on the west side of the farmyard and comprises four separate structures numbered 2a-d on Fig 7 (Plate 10).

Plate 10 Barn 2, (left to right) structures 2a-c, with structure 2d in the foreground .

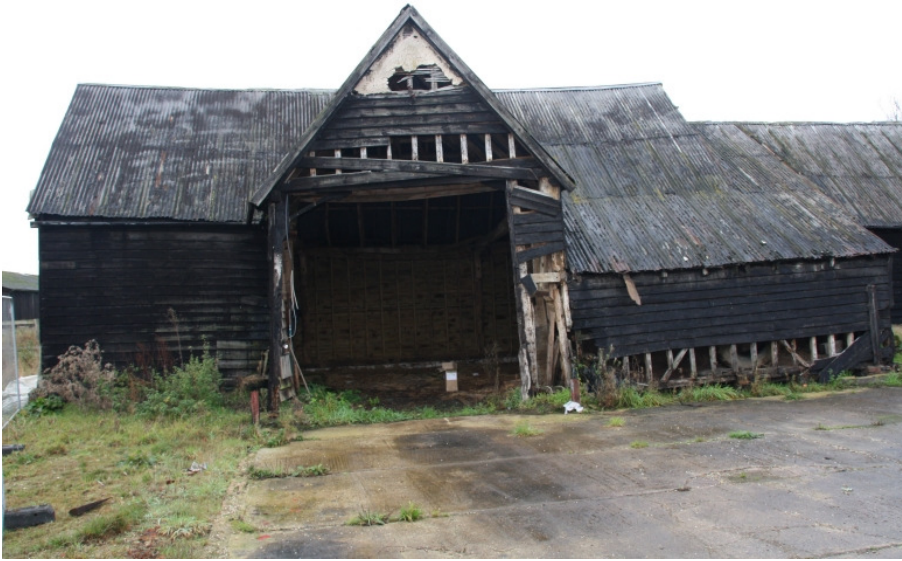
Plate 11 Barn 2, structure 2a; threshing barn with lean-to 2d to the right.

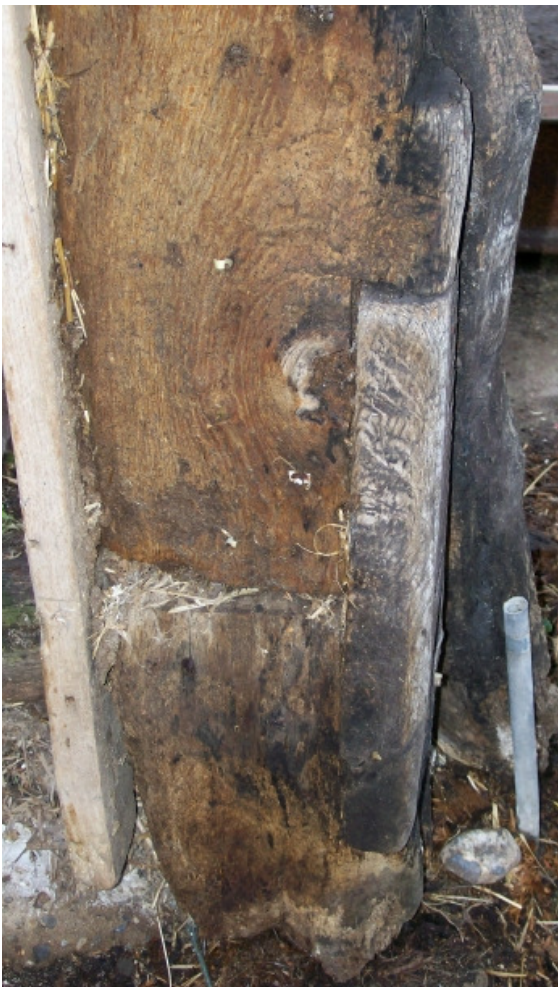
Plate 12 Barn 2, structure 2a; remains of threshold leap in surviving midstrey doorpost.

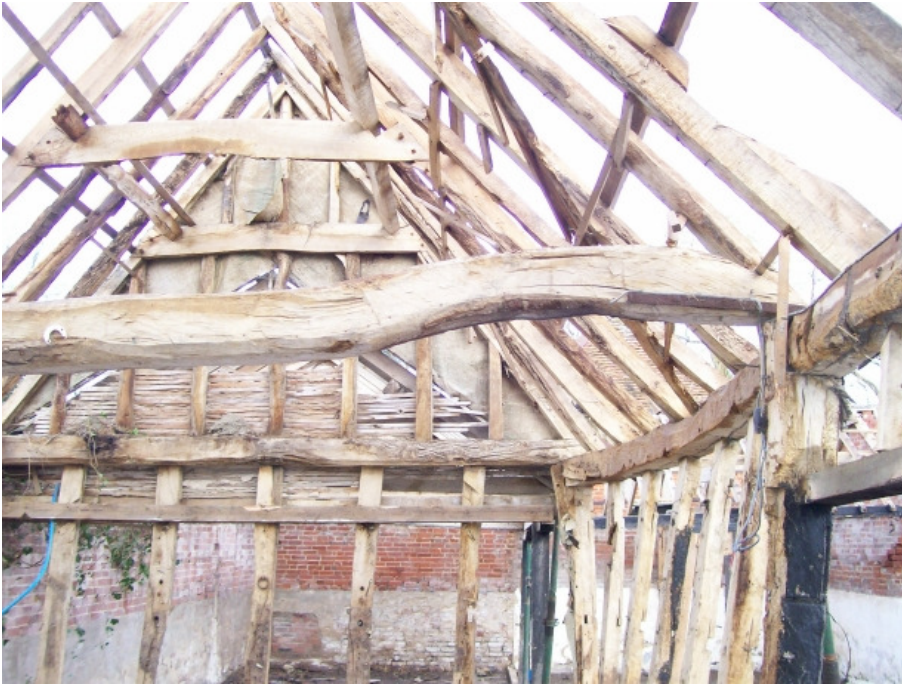
Plate 13 Barn 2, structure 2b; exposed timber frame showing curved and chamfered tie beam.

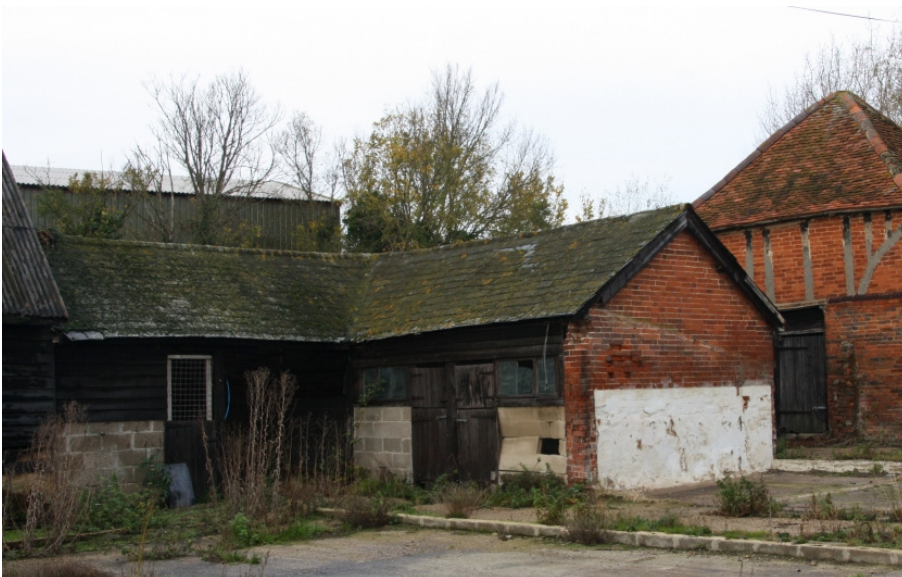
Structure 2c is an L-plan stable block with irregularly bonded red stock brick walls to the west, north and east and timber fronting facing south onto the farmyard (Plate 14). In the 20th century the elevations facing the farmyard were walled with a combination of breezeblock and horizontal weatherboarding. The original elevations were most likely a series of four stable doors with weatherboarding surround. This was attached to five machine-cut posts topped with pillows supporting the wall plate. The floor throughout is of concrete and the entire space has been sub-divided by half-height brick walls. The roof is of machine-cut timbers with nailed collar clasped purlins, covered in slate. A concrete base and weathering on the exterior of the east wall suggest a small mono-pitch roofed building has been removed.

Plate 14 Barn 2, structure 2c; L-plan stable block with dovecote to the right.

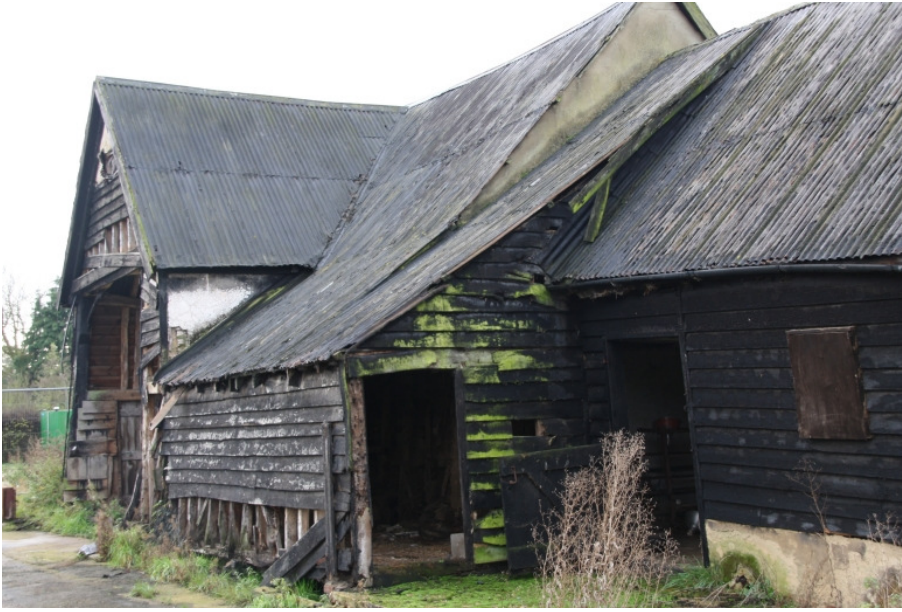
Structure 2d is a timber-framed lean-to on the east side of bay 3 of structure 2a that extends north across part of 2b (Plate 15). It has an entrance in its north elevation and is constructed from machine-cut timbers. The roof is of corrugated iron sheeting and extends from the eaves of bay 3 in structure 2a and from the ridge line of structure 2b at a slightly shallower pitch. The north wall stands on a brick dwarf wall, whilst the east wall has a single, centrally located brick pier providing support.

Plate 15 Barn 2, structure 2d; lean-to covering the exterior of structure 1a and partially covering the exterior of structure 1b.
