**Historic building recording  
at Mudwall Farm,  
High Easter Road,  
Barnston, Essex  
April 2013**

**report prepared by  
Chris Lister**

**commissioned by  
Alun Design Consultancy Ltd**

**CAT Report 702**  
May 2013

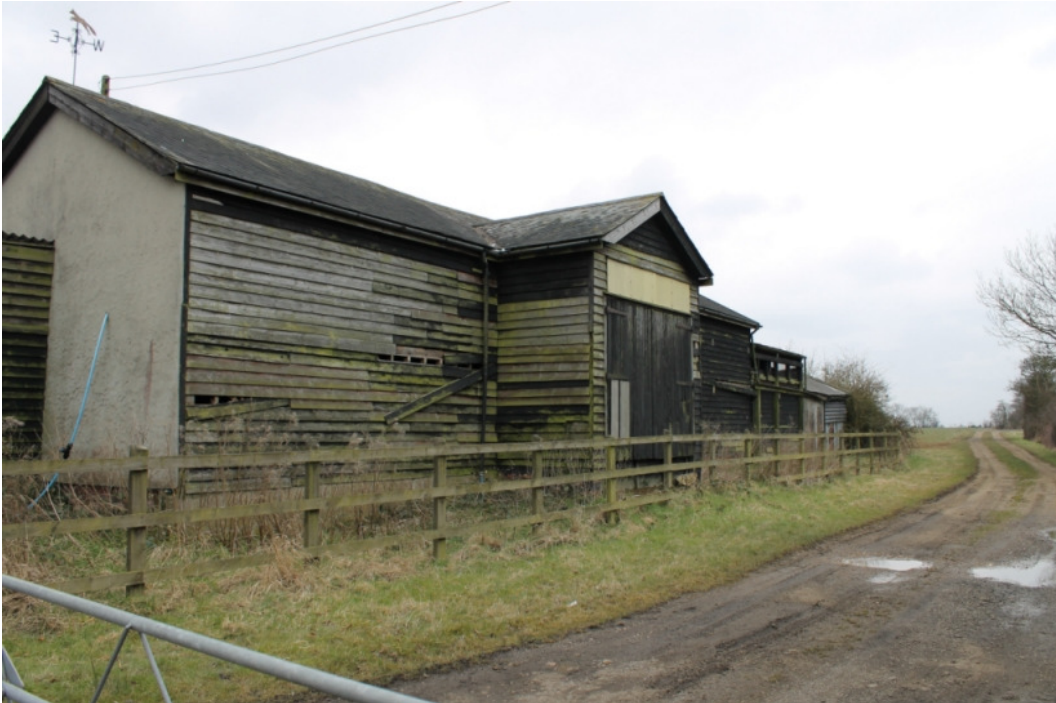
This structure is a rectangular timber-framed and gabled barn, 6.7m wide x 19.5m long, aligned north-east to south-west and clad in a combination of black-painted horizontal weatherboarding and render (Plate 1). There is a midstrey projecting from the north-west elevation and the entire structure sits on a plinth constructed from red brick with dimensions of 223 x 100 x 60mm laid in English bond with an offset. An exposed section of the plinth on the south-east side of the barn shows that at least part of the foundation is formed from mortared flints.

**Plate 1** North-west elevation of barn - view south-east

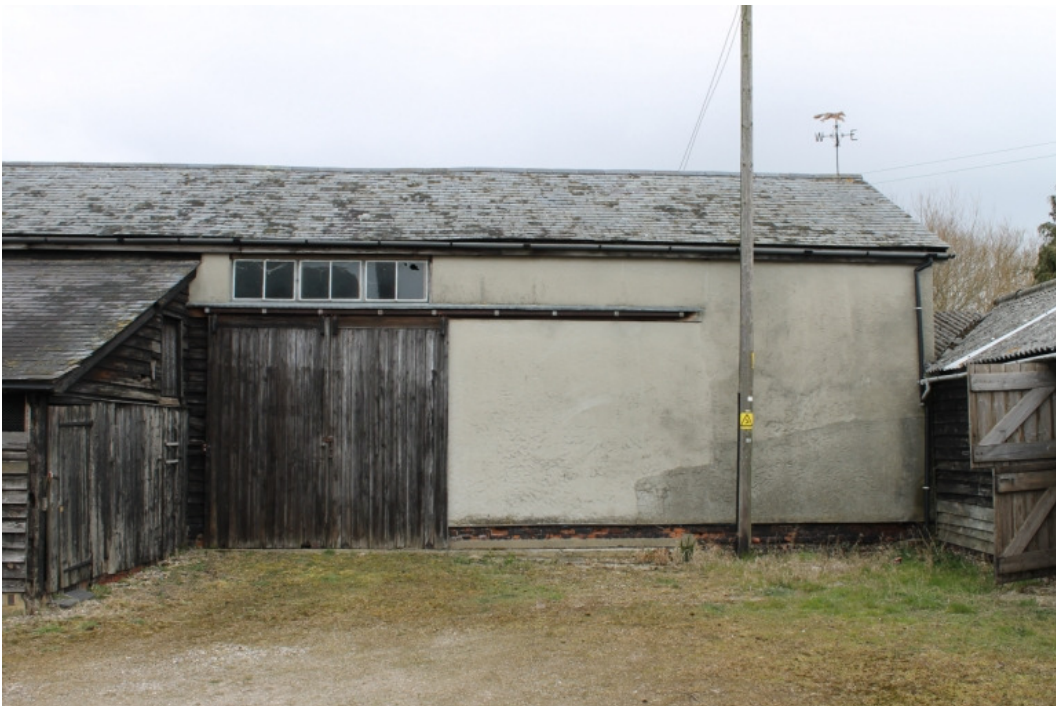
Where there are single storey extensions at both ends of the barn the exposed gables are rendered. The roof is of slate with a ceramic ridge and there is a weather vane in the shape of a running fox at the north-east end of the ridge. The south-east elevation has a lean-to and next to this is an inserted sliding door with a range of six lights above (Plate 2). This sliding door can be opened as one complete unit or as two separate halves. The iron door pull is stamped 'Henderson Romford' and the latch is stamped 'Henderson Barking' and indicate the entire sliding door arrangement is from the world-famous manufacturers of agricultural sliding doors and garage doors, P C Henderson Ltd, originally located at Barking, Essex. The Romford stamp on the door pull dates the door to post 1955 as this is when manufacturing was moved from Barking. The sliding door replaced earlier barn doors and the render on the exterior of this part of the barn must be contemporary with the installation of the Henderson door.

**Plate 2** South-east elevation showing inserted Henderson sliding door, with lean-to cattle shed to the left and stable block to the right – view north-west

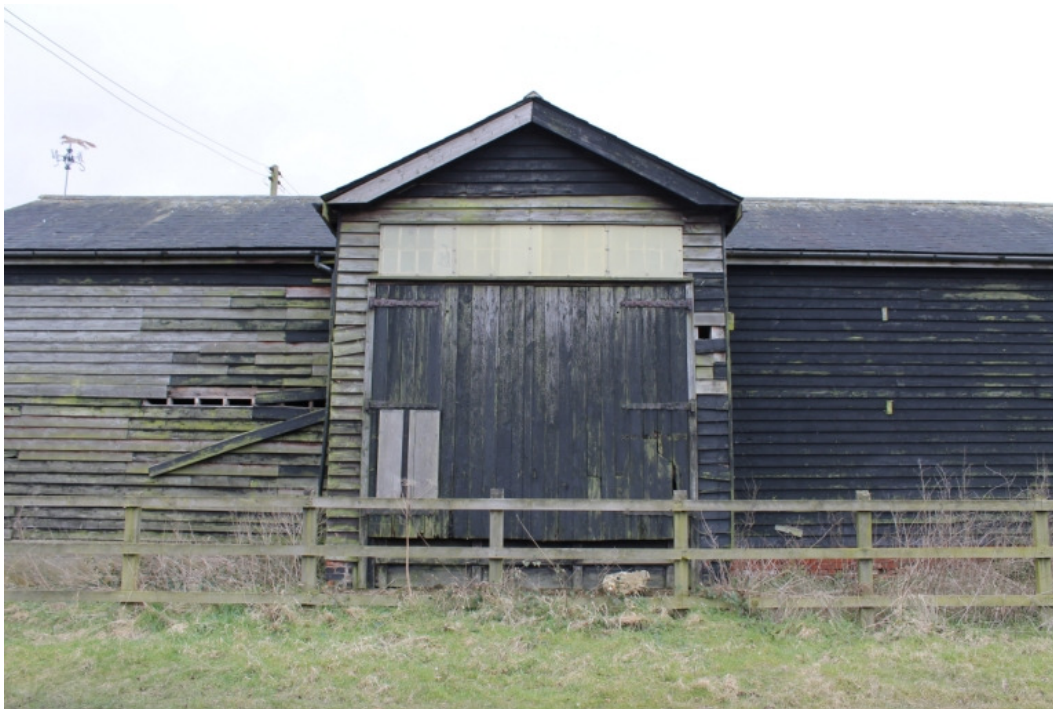
The north-west elevation is completely weatherboarded with what appear to be the original doors and threshold leap to the midstrey (Plate 3). The doors have six ornate strap hinges held on pintels (Plate 4) and a range of four metal-framed windows, each of eight lights, has been inserted above the doors.

**Plate 3** Midstrey to barn with original doors, threshold leap and inserted metal-framed windows – view south-east

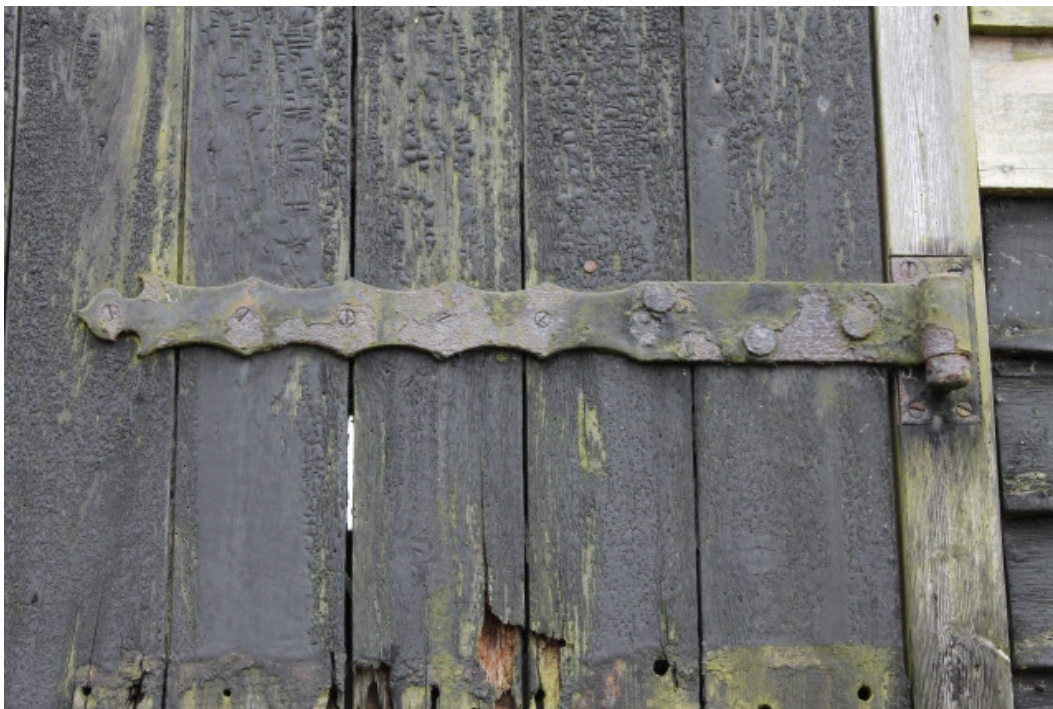
**Plate 4** Detail of ornate strap hinge to midstrey door

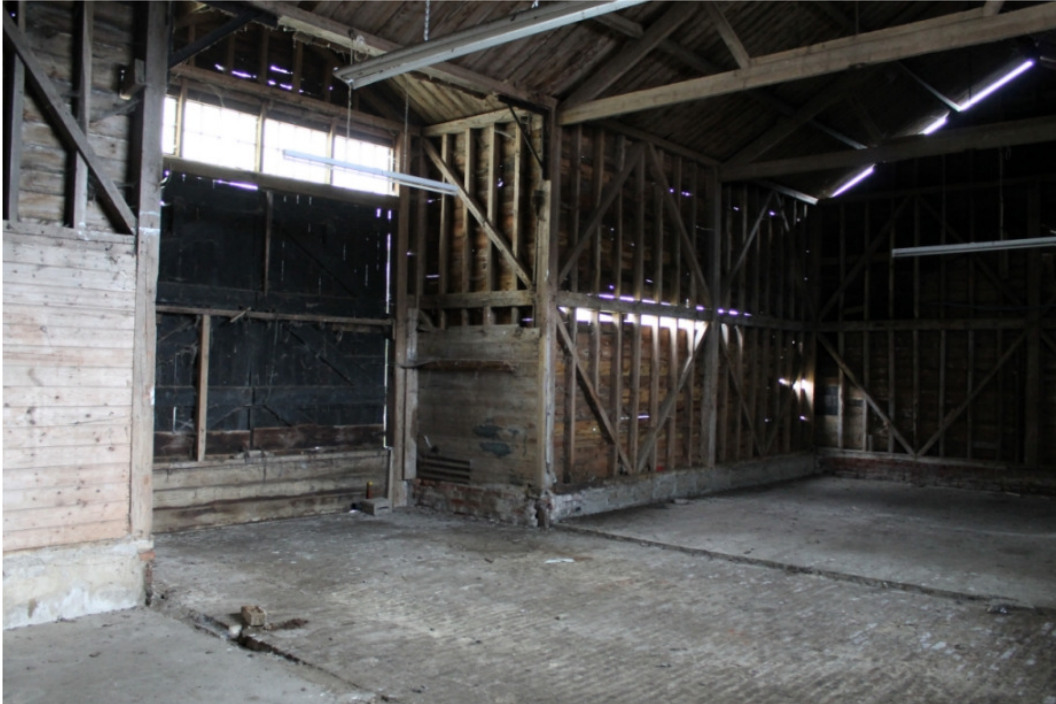
**Plate 5** Interior of the barn showing the midstreay threshold leap and brick threshing floor – view east

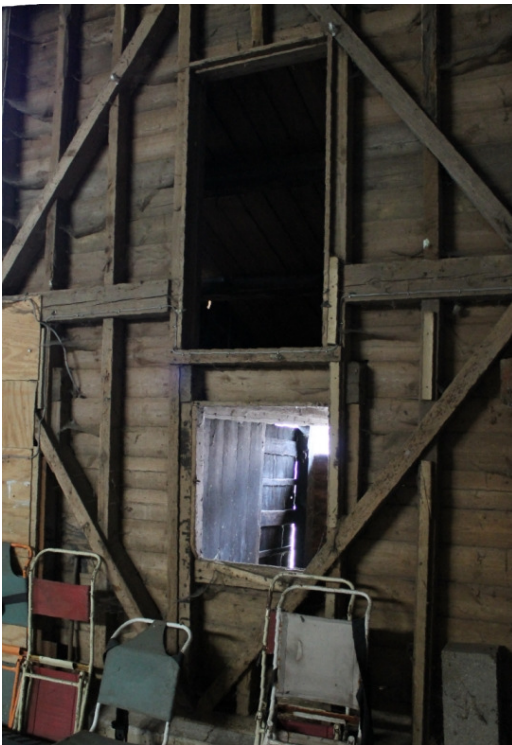
**Plate 6** Barn, bay 3 showing inserted hatch to cattle shed and inserted doorway to chaff loft - view north-west

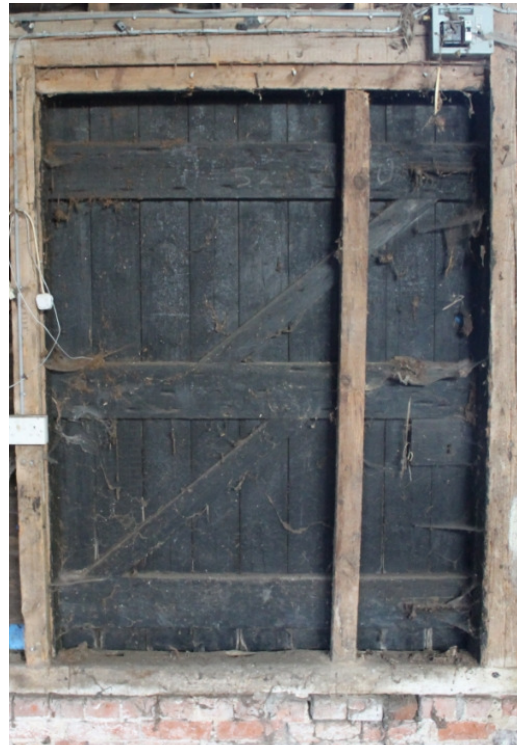
**Plate 7** Barn, bay 5 inserted door - view south-east

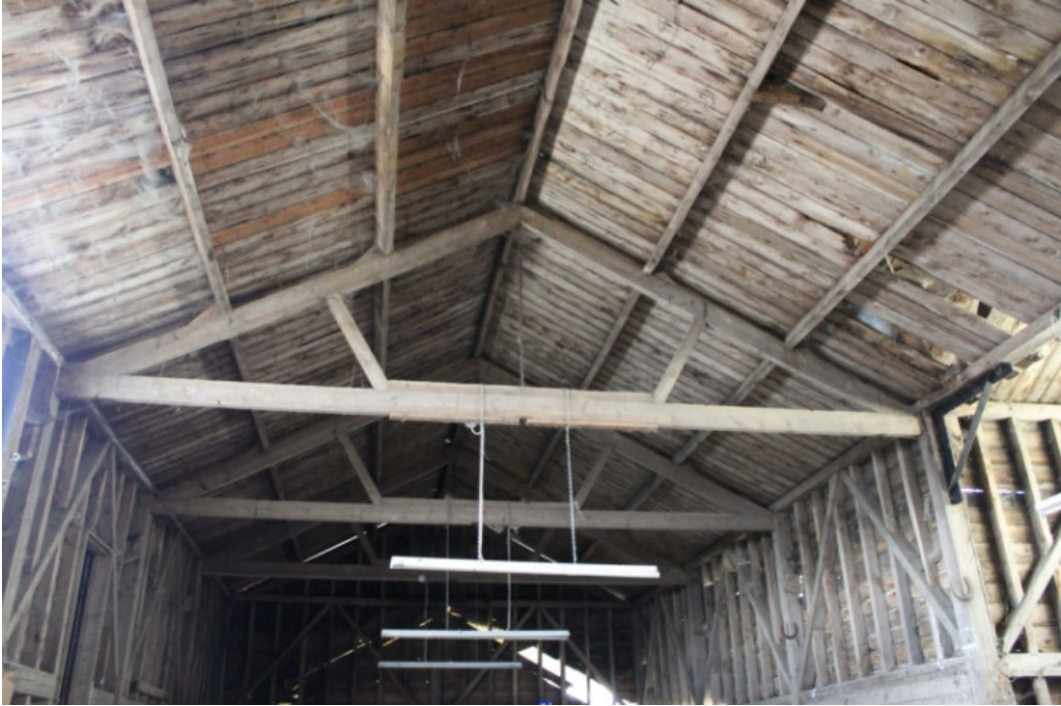
The roof is carried on closed trusses of simple design (Plate 8). Instead of sitting on the wall plate or heads of the principal posts, the tie beams are joined to the sides of the posts with the principal rafters rising from the outer ends of the tie beam (Fig 7). There is no bracing between the posts and tie beams. The truss is held under tension by an iron king bolt passing through the tie beam, the heads of the rafters and then through the ridge board. The tie beams and principal rafters are large-section timbers, approximately 170mm x 70mm. Inclined struts and a straining sill provide additional strength for the truss. The trusses support two purlins to each pitch (held in position by wooden cleats) which, in combination with the ridge board and wall plate, support sarking boards.

**Plate 8** Barn, detail of truss C – view south-west

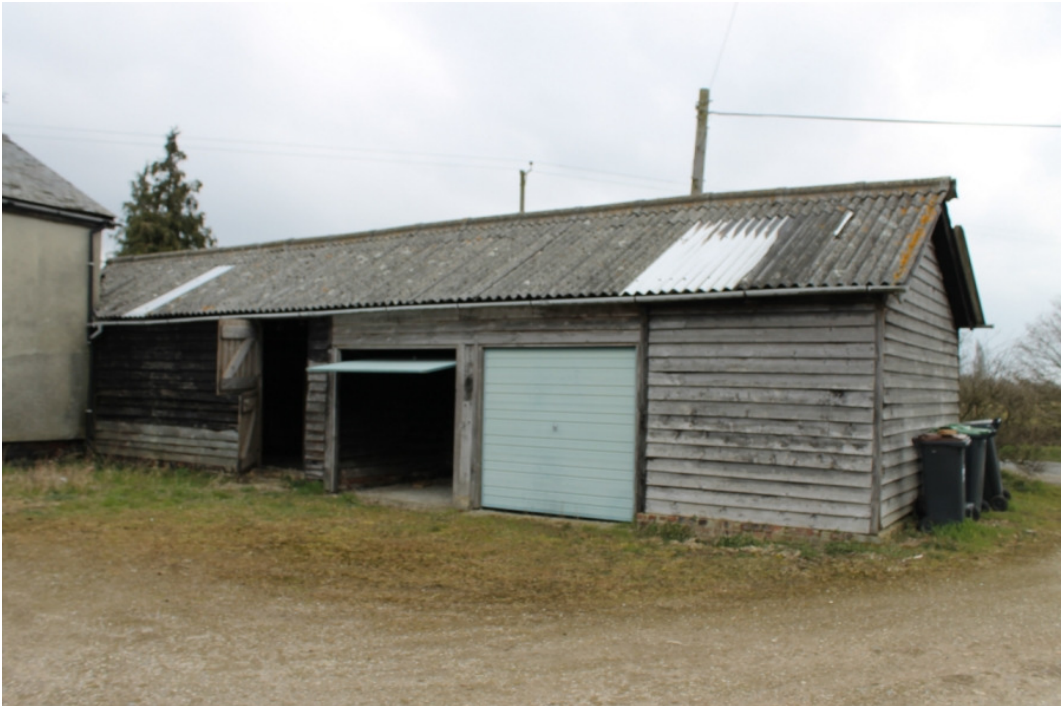
The stable block is a single storey structure 4.8m wide x 16.9m long, orientated north-west to south-east and located perpendicular to the barn (Plate 9). The short elevations and the north-east elevation (parallel to High Easter Road) are clad in horizontal weatherboarding. There are no adornments to these elevations apart from a single tethering ring on the north-east wall. The south-west elevation presents two distinctly different parts. The first extends from the barn and is characterised by black-painted horizontal weatherboarding (identical to that on the north-west and north-east elevations) that terminates in a traditional stable door. The remainder of the structure is clad in unpainted horizontal weatherboarding and has two inserted metal garage doors, the handles of which are stamped 'Henderson'. Apart from where it has been removed by the inserted garage doors, the entire structure sits on a red brick plinth laid in irregular bond. An exception to this is the south-east end where the plinth has been rebuilt in modern brick which has dimensions of 220 x 105 x 61mm.

**Plate 9** Stable block with converted two-bayed horse shed to the right and carhorse stable to the left of the Henderson garage doors

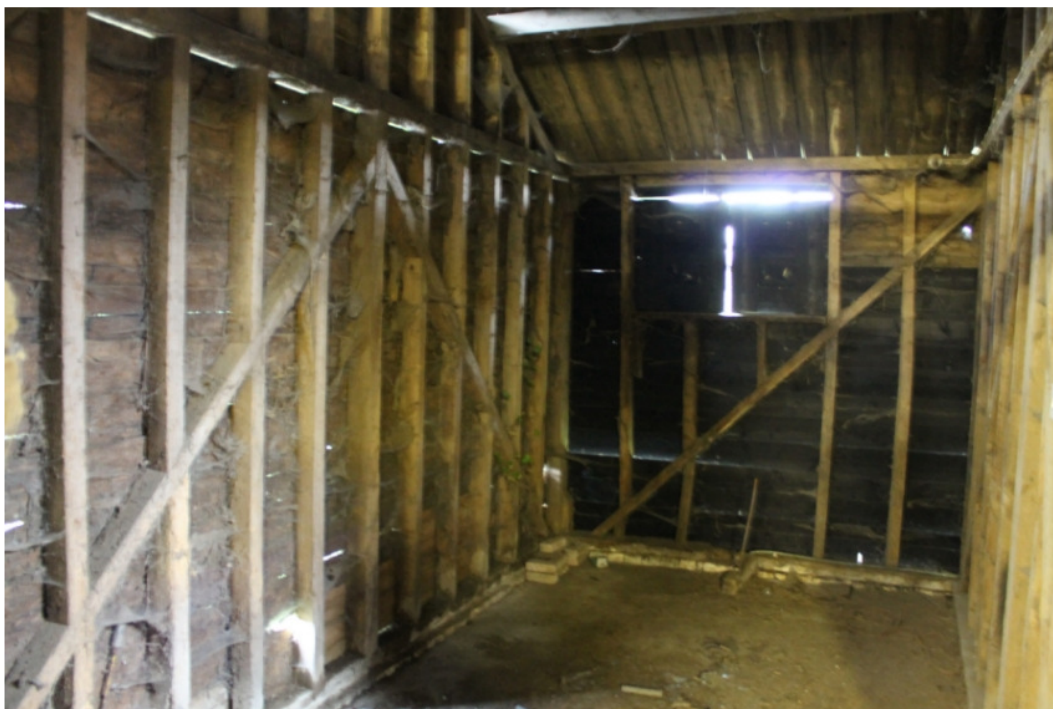
**Plate 10** Stable block showing north-west tack room - view north-east

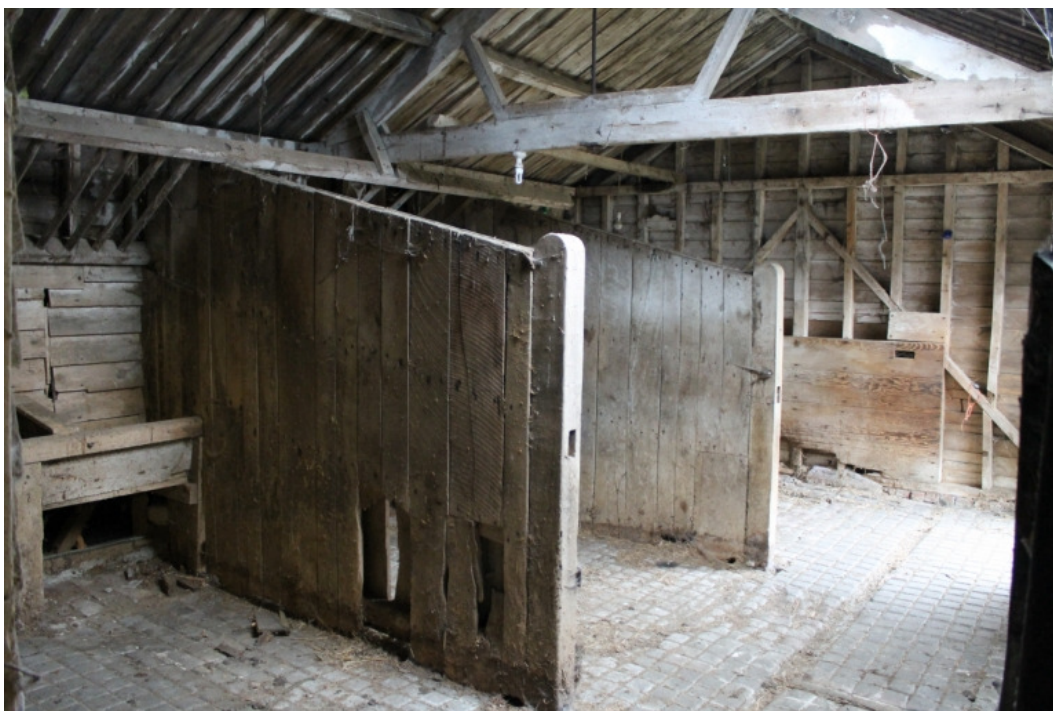
**Plate 11** Stable block showing interior of carthorse stable – view south-east

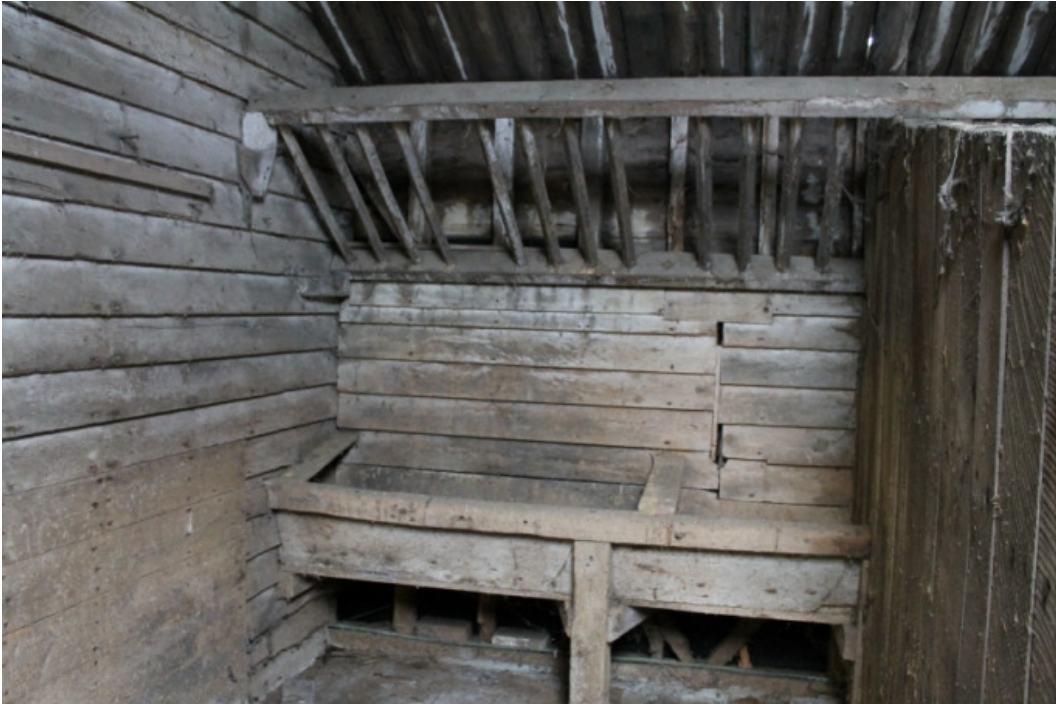
The carthorse stable (Plate 11) is divided into three stalls, each fitted with a manger for oats and a hay rack above (Plate 12). The ribs of the hay rack are made of diamond-section timbers. The manger in stall 3 has two tethering rings attached to it – these have been removed from stalls 1 and 2. The interior walls are clad in horizontal planking with the exception of the south-west wall, which displays the timber frame. There is also a blocked window in this wall, concealed on the exterior by the weatherboarding. The floor is of blue pavior bricks with an inset drainage gully. External access to the carthorse stable would have been through the stable door opening onto stall 3.

**Plate 12** Carthorse stable, stall one showing manger and hay rack – view north-east

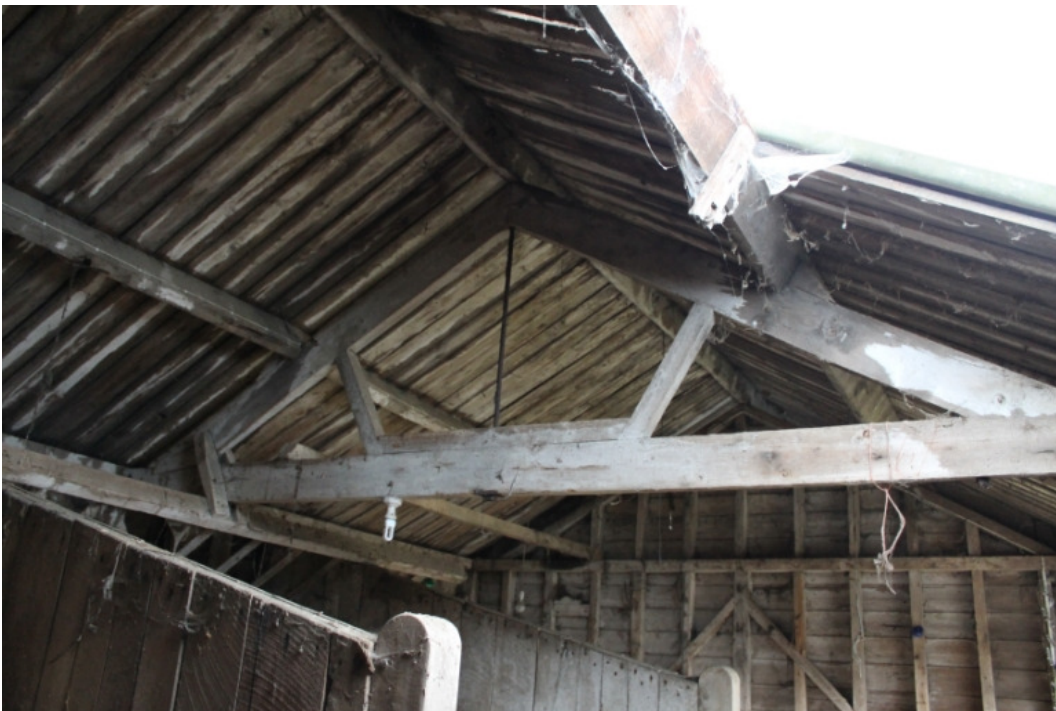
**Plate 13** Carthorse stable, truss A - view south-east

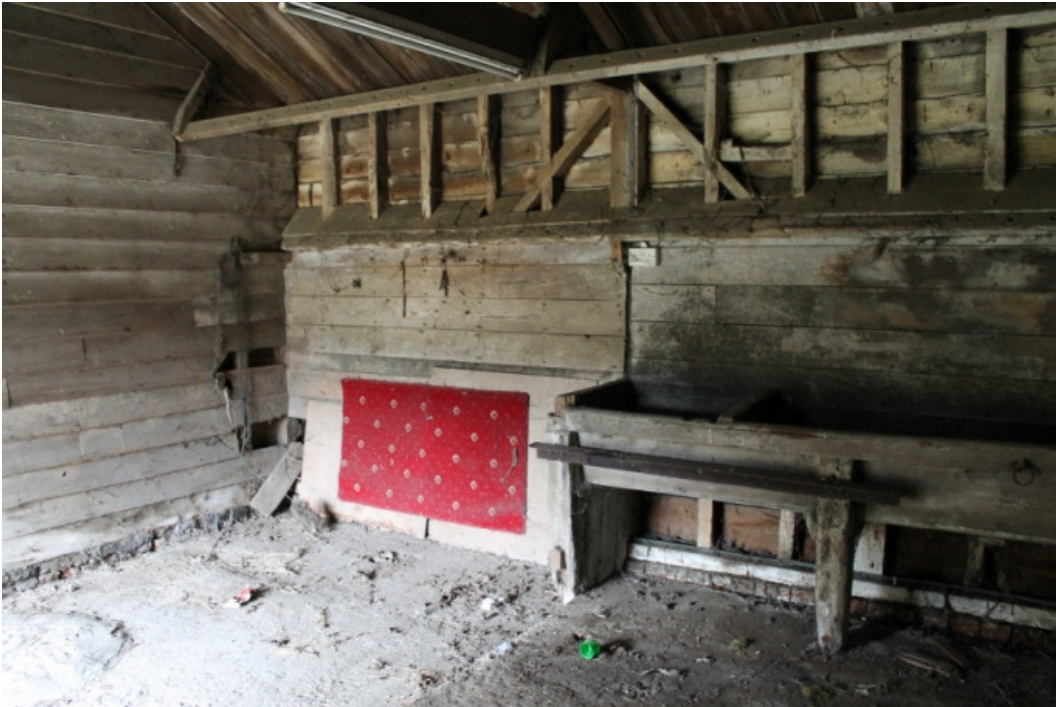
**Plate 14** Stable block, two-bayed horse shed showing surviving manger and hay rack – view north

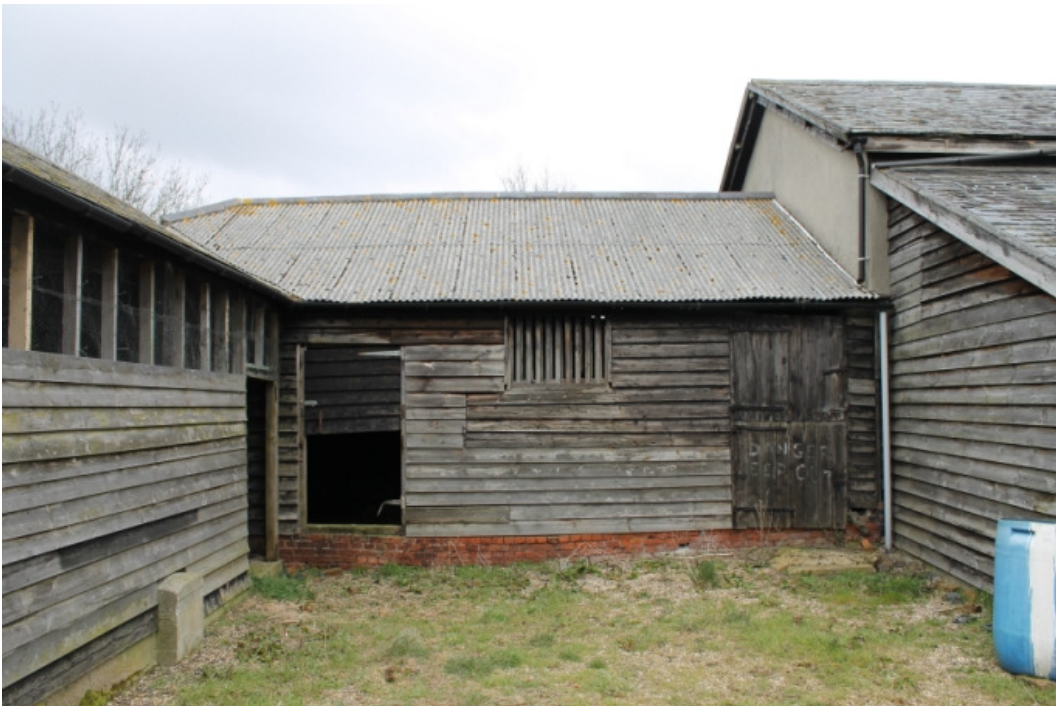
The cow house is a single storey timber-framed structure 6.9m wide x 5m long attached to the south-west end of the barn (Plate 15). It sits on a red brick plinth with dimensions of 223 x 100 x 60mm laid in English bond. The south east elevation (facing the farmyard) is clad in black-painted horizontal weatherboarding and has a traditional stable door and a hit-and-miss window. The north-west elevation (facing the fields) is clad in black-painted horizontal weatherboarding. The roof originally had a simple gable end but the pitch on the field side has been raised and the resulting roof covered in corrugated asbestos sheeting.

**Plate 15** Cow house with hit-and-miss window and traditional stable door - view north-west

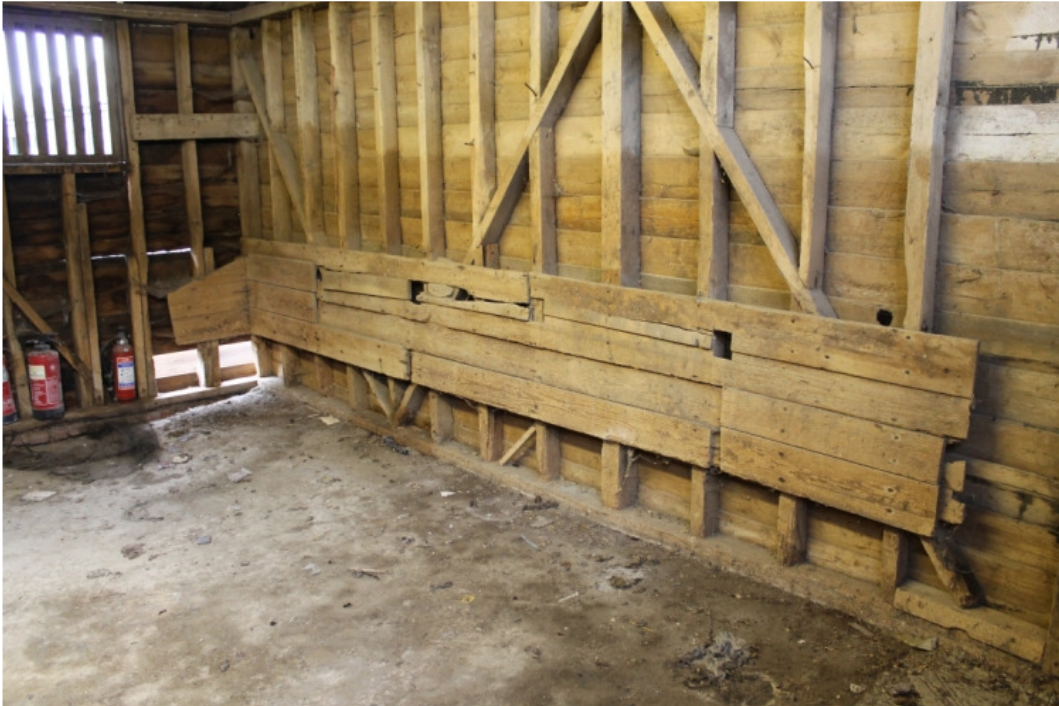
**Plate 16** Cow house interior showing remains of manger - view south-west

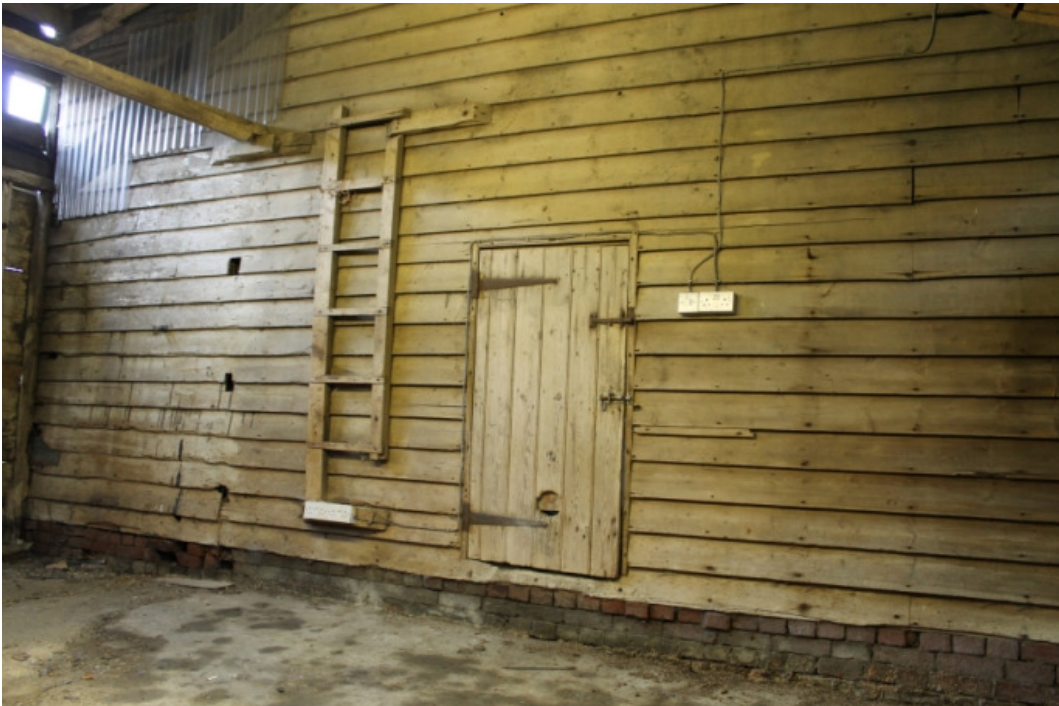
**Plate 17** Cow house interior showing fixed ladder to chaff loft with slots for the rails of the calves' pounds to the left of the ladder - view north-west

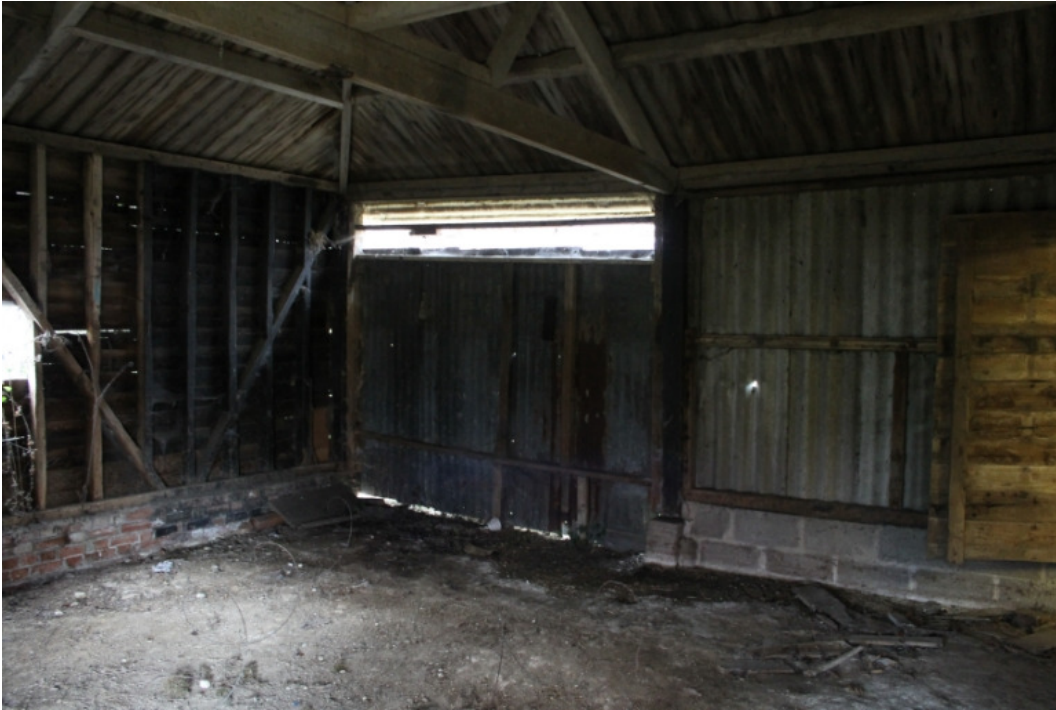
**Plate 18** Chaise house interior showing the blocked open front with the central post and concrete buffer - view north-west

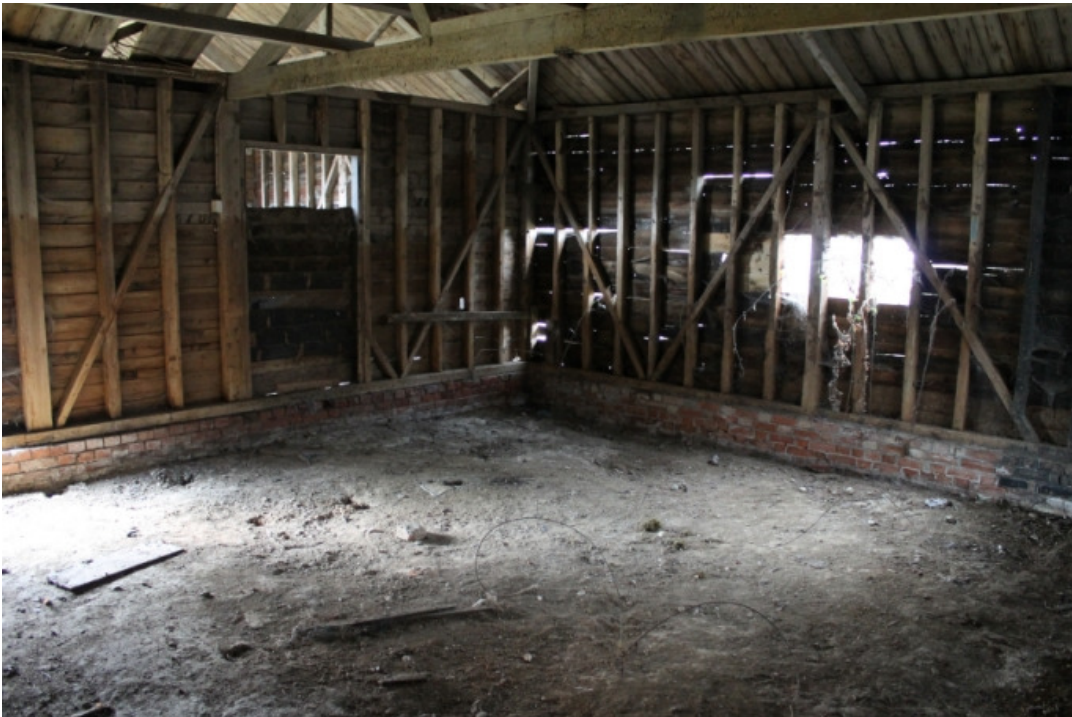
The south-west and south-east walls are of machine-cut timbers, with principal posts having dimensions of 150mm x 150mm and studs with dimensions of 100mm x 50mm. Straight braces fall from the corner and centre posts, passing through the studs to the sill beam. The open front has a centrally located post with a concrete buffer (Plate 18). A doorway has been inserted into the south-east wall providing access to the later cattle shed, although this has subsequently been blocked (Plate 19).

**Plate 19** Chaise house interior showing the inserted and subsequently blocked doorway to the 'four-bayed' cattle shed - view south-west

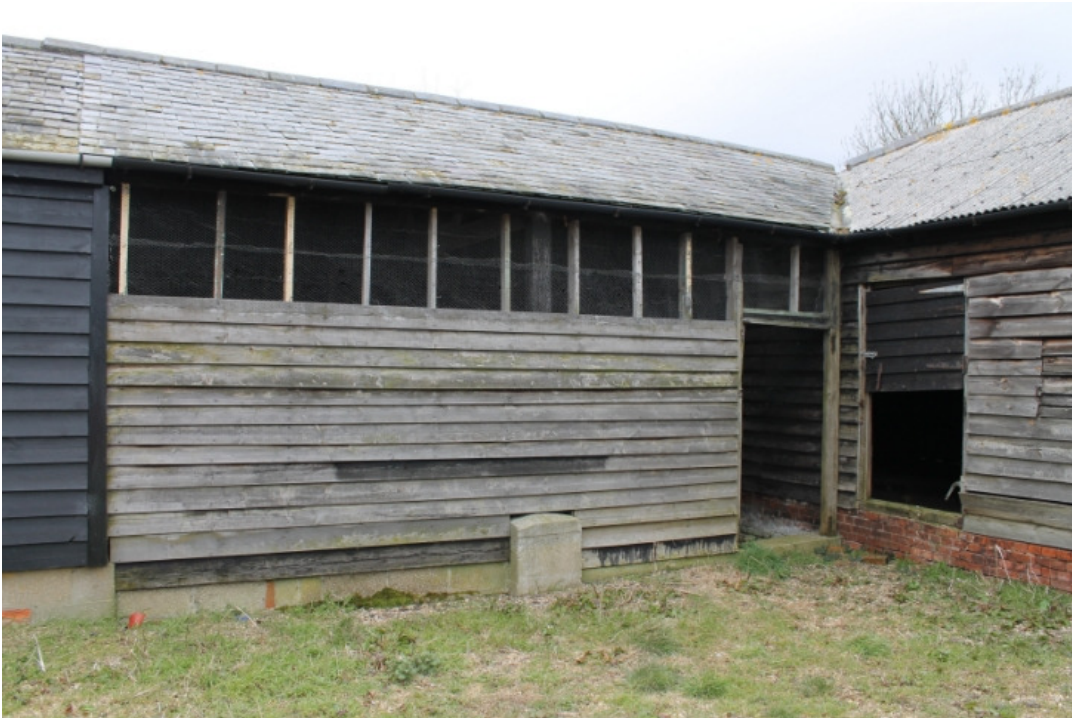
**Plate 20** 'Four-bayed' cattle shed showing the blocked open front with the chaise house to the right - view west

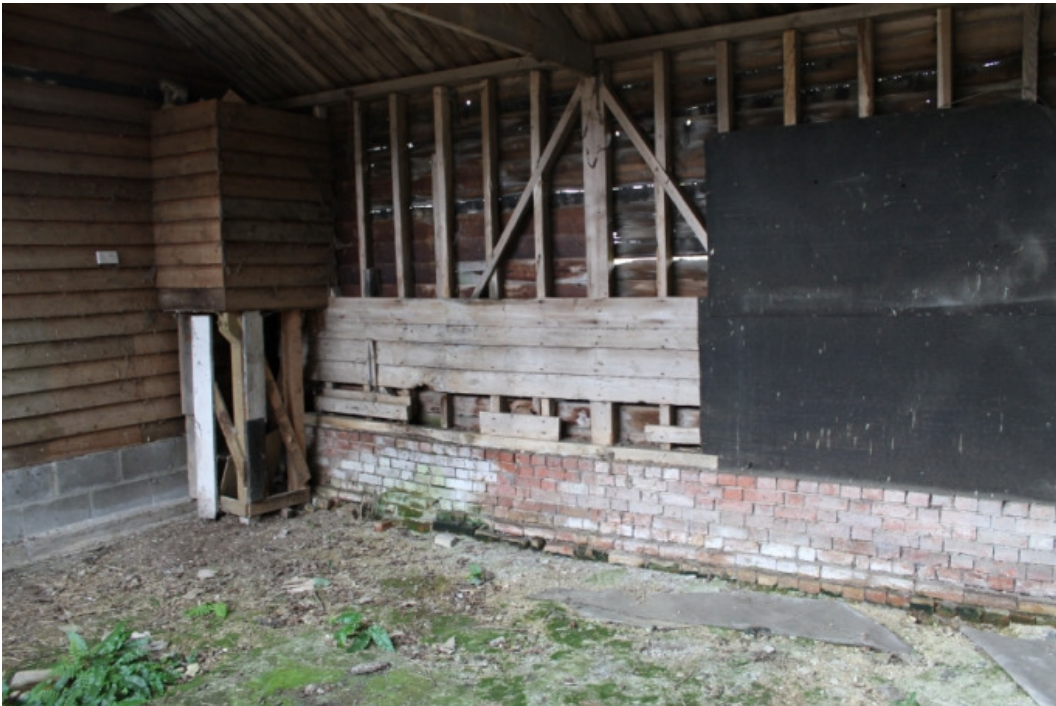
**Plate 21** Interior of the 'four-bayed' cattle shed showing the remains of the manger - view west

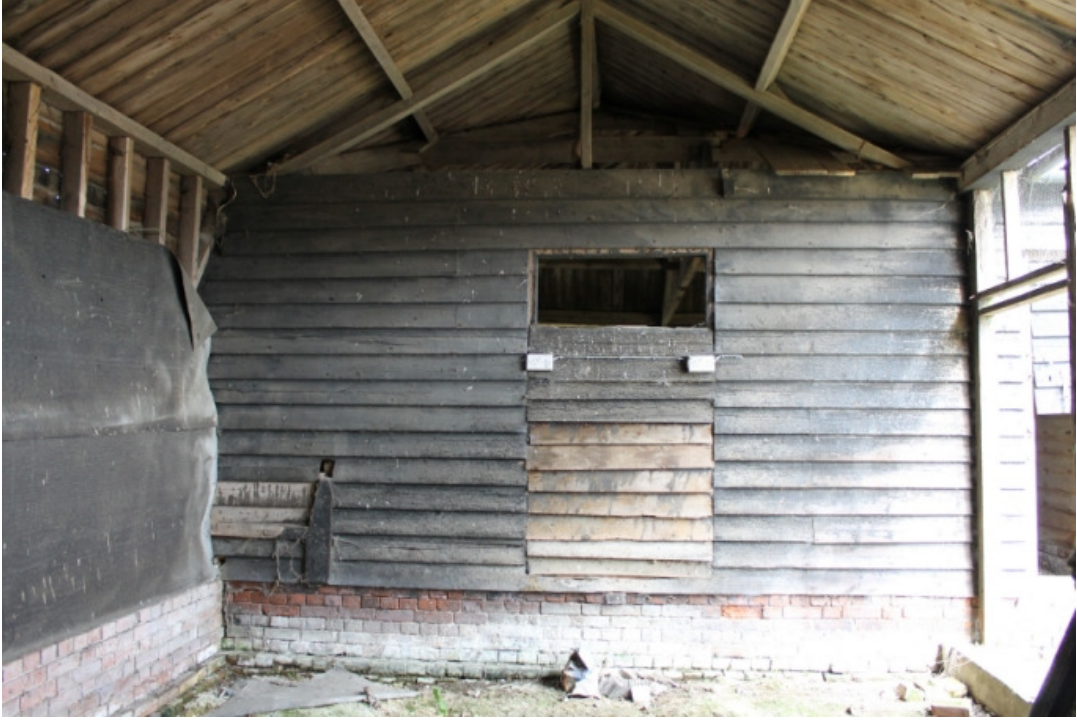
dividing wall to the chaise house. This has the original principal rafters rising to meet the head of a short king post. The later ridge board and purlins rest on this truss (Plate 22).

**Plate 22** Interior of the 'four-bayed' cattle shed showing the original short king post truss and remains of the manger – view north-west

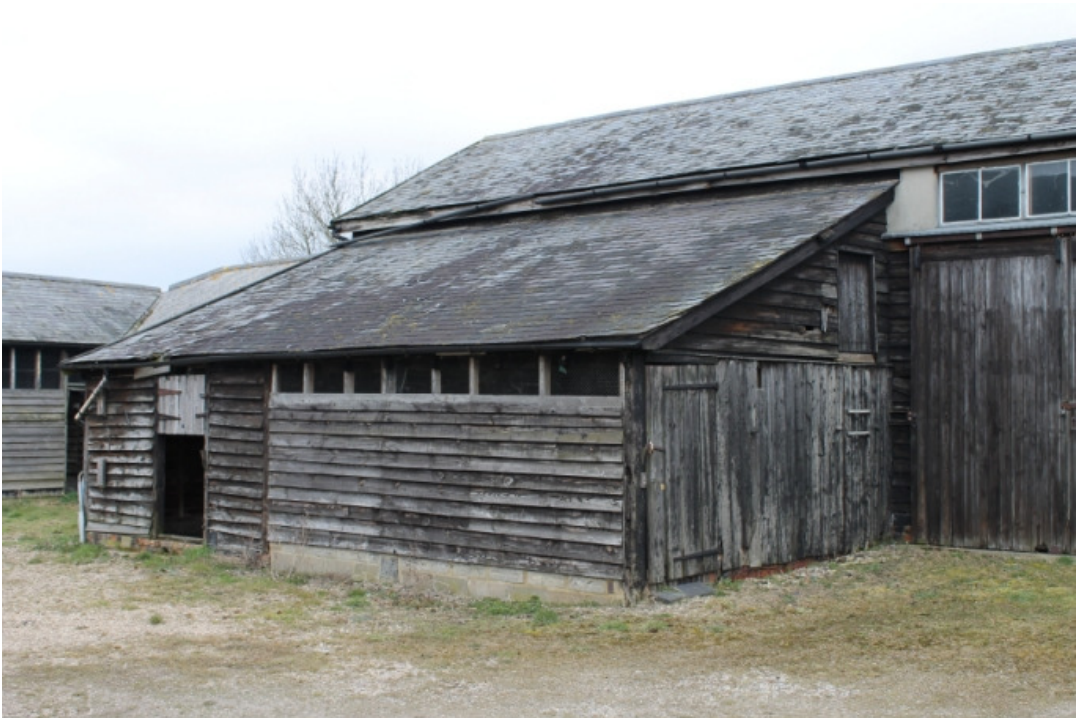
**Plate 23** Lean-to cattle shed showing blocked open front and door to chaff loft - view north-west

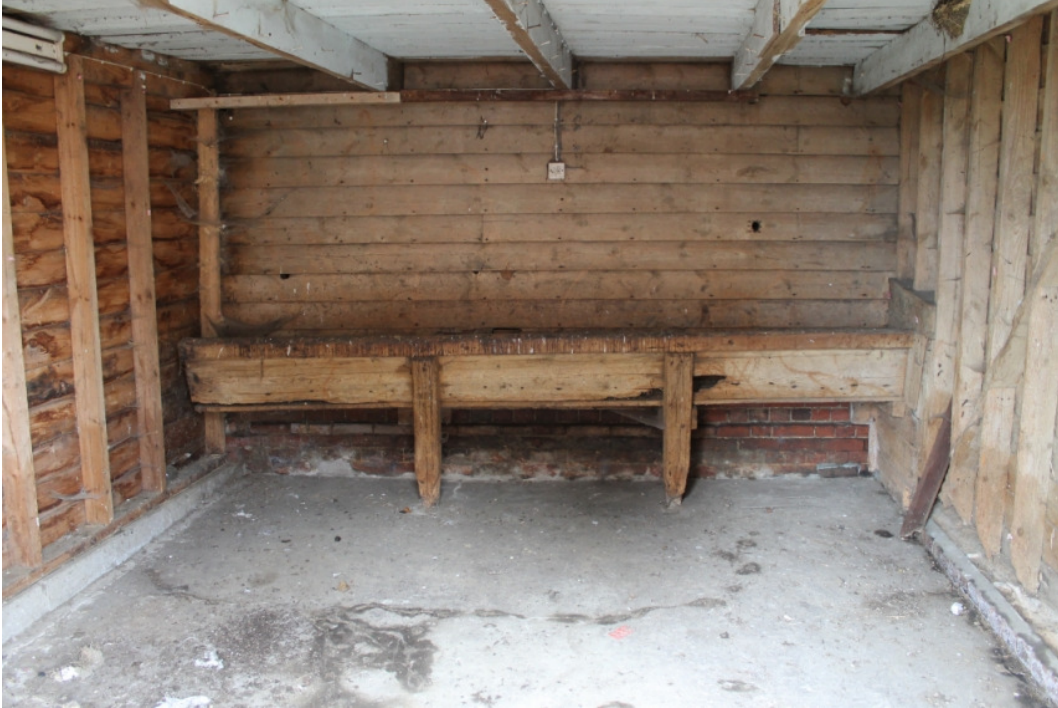
**Plate 24** Lean-to cattle shed showing manger with chaff loft above – view north-west

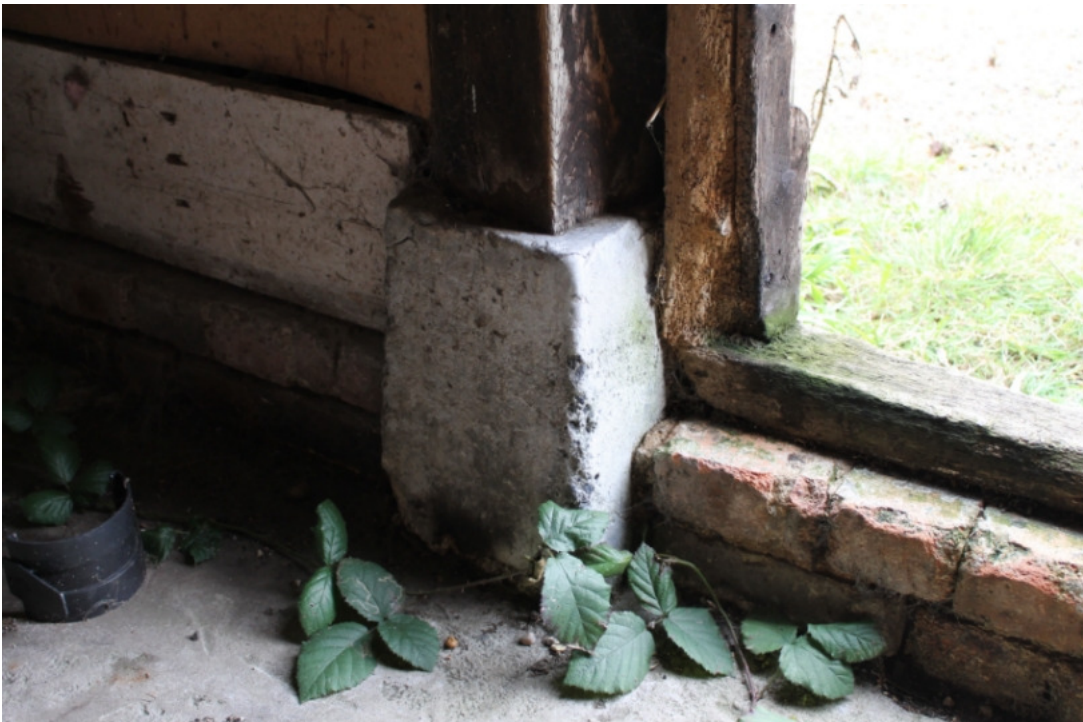
The interior of the smaller shed has eight evenly-spaced modern timbers rising from a shallow sill beam on the rebuilt plinth of the south-west wall and a dividing timber-framed wall with eleven studs, with dimensions of 100mm x 50mm, carried on a modern brick plinth to the north-east. This is clearly an insertion to the cattle shed. The floor is of concrete and there is a manger along the wall shared with the barn (Plate 24). From the interior it becomes clear that the structure was originally an open-fronted building as there is a post with dimensions of 150mm x 150mm with a concrete buffer which the brick plinth abuts (Plate 25).

**Plate 25** Detail of post with concrete buffer indicating an open front to the lean-to cattle shed

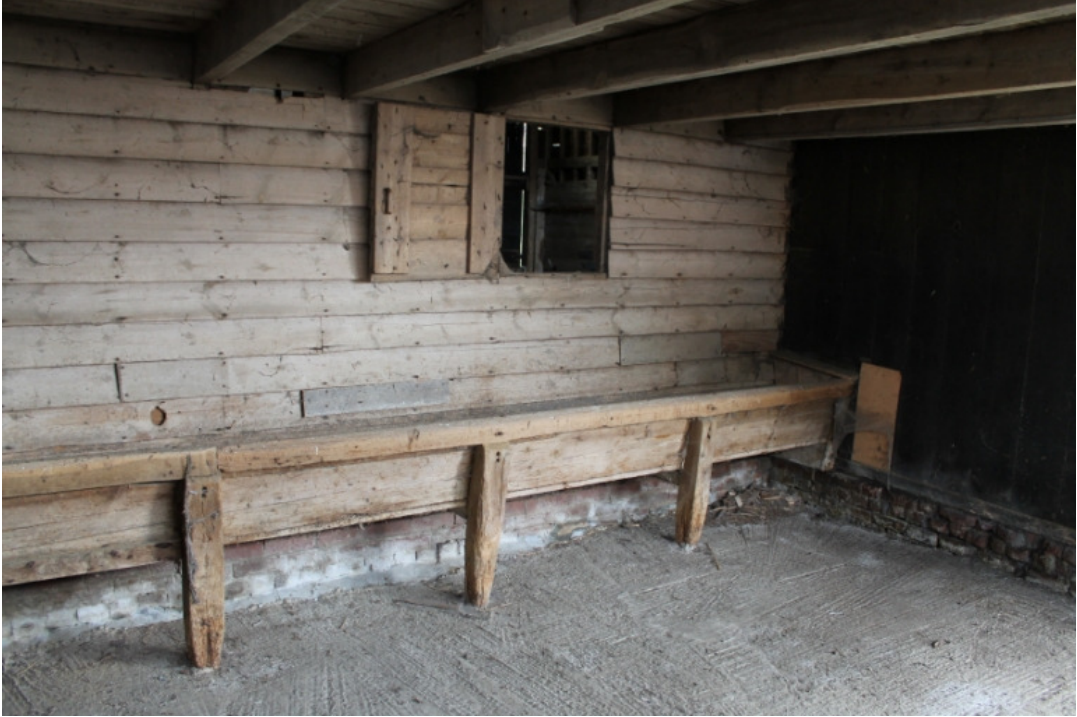
The interior of the larger of the sheds also has a square post with a concrete buffer and the manger continues through the inserted dividing wall along the entire length of the shed. The plinth of the north-east wall is original but any studs have been obscured by vertical planking. The floor is of concrete and there is a small hatch in the barn wall above the manger (Plate 26).

**Plate 26** Lean-to cattle shed showing manger with chaff loft above and hatch into main barn – view north
