**Historic building recording
at King's Farm Barn, Bishops Lane,
Alphamstone, Essex
March 2014**

**report prepared by
Chris Lister**

**commissioned by
Andrew Stevenson Associates
on behalf of
Mr and Mrs Franco**

CAT Report 767
May 2014

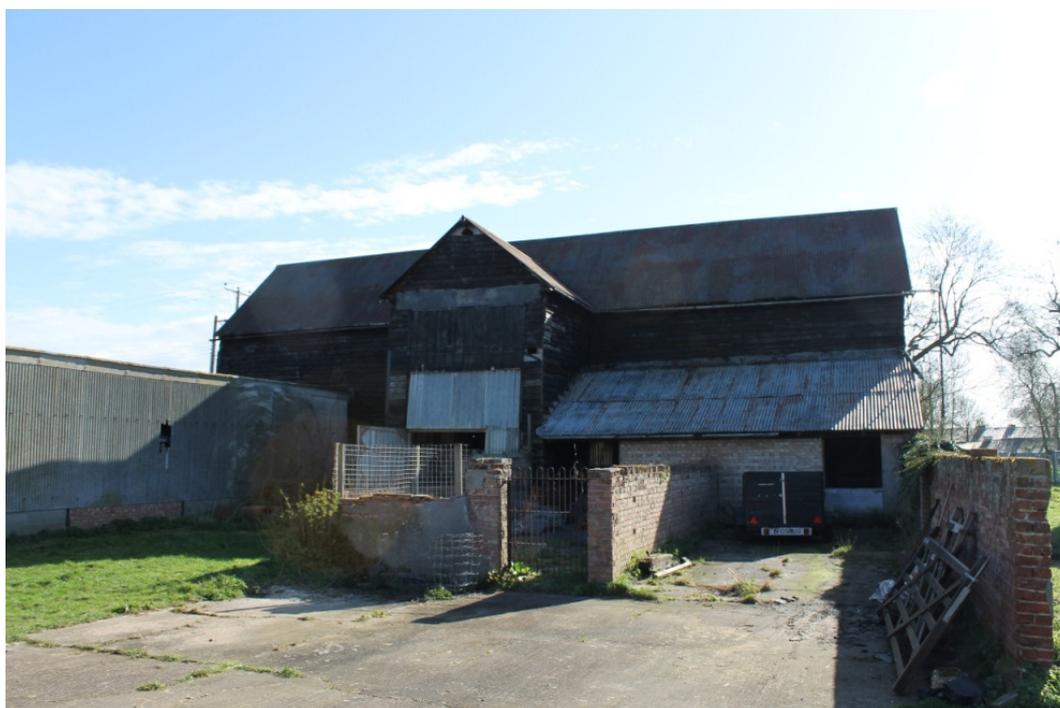
The barn is a rectangular timber-framed building, 21.7m long x 6.75m wide, with a centrally-located midstrey projecting from the north-west elevation (Plate 1). It is constructed from softwood timbers and the entire structure sits upon a plinth of red brick with dimensions of 226 x 115 x 65mm, laid in Flemish bond above a chamfered course and in English bond below it (Plate 2). The barn is clad in black-painted horizontal weatherboard and the gabled roof is covered with corrugated iron sheeting. To the south of the gabled midstrey, the north-west elevation has a single-storey lean-to, originally open-fronted but subsequently enclosed by a wall constructed from later Fletton brick. An animal pen, also constructed from Fletton brick, extends into the yard from the front of this lean-to. Although map evidence suggests there was a second lean-to on the other side of the midstrey this, and the shelter shed perpendicular to the barn, have been replaced by a single-storey range with a mono-pitch roof, which is built on top of the farmyard wall. The door opening in the midstrey is exceptionally high; reaching to the eaves. Although the lower barn doors have been replaced, the upper section retains the original barn doors, which are held on simple strap hinges (Plate 3).

Plate 1 North-west elevation of the barn - view north-east

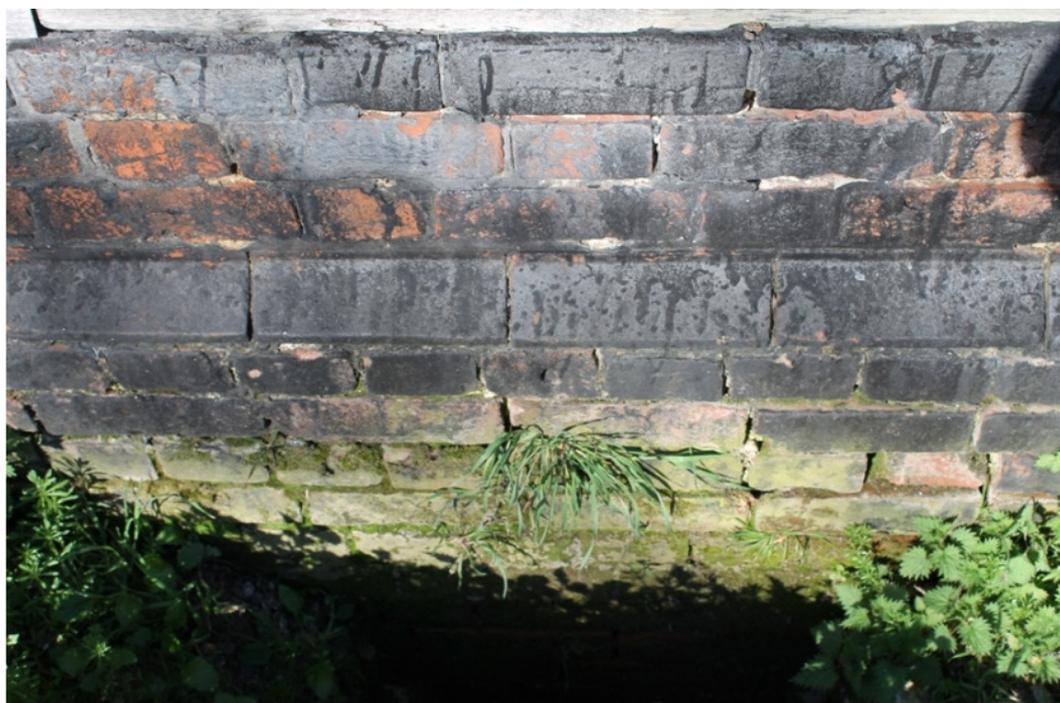
Plate 2 Detail of the brick plinth, with Flemish bond above the chamfered course and English bond below

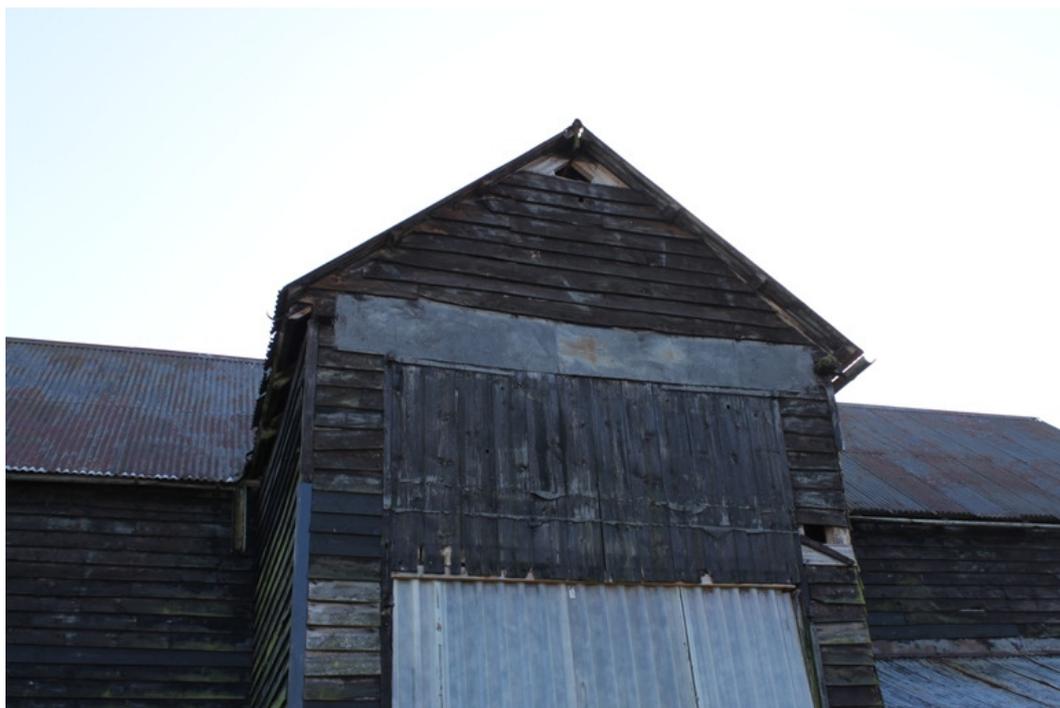
Plate 3 Surviving portion of the full-height barn doors in the midstrey - view south-east

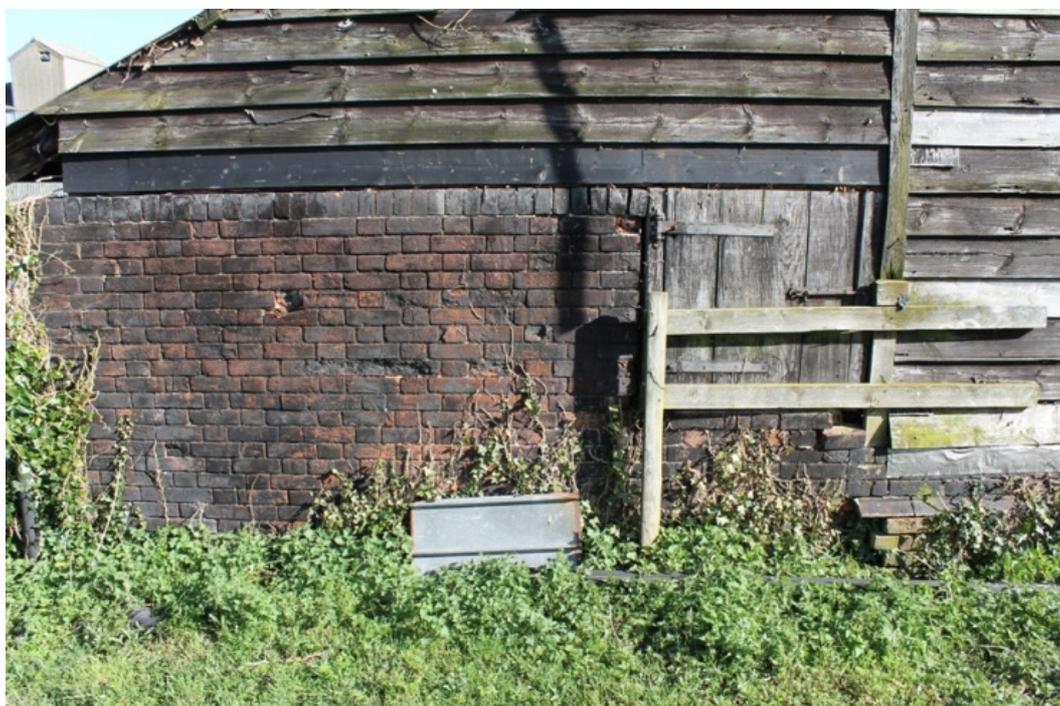
of the lean-to is predominantly of brick, laid several courses higher than the farmyard wall and with a small feed door within it (Plate 4). As with the north wall, the brickwork is Flemish bond and supports the roof timbers of the lean-to. The feed door has hinges identical to those on the stable block, suggesting the lean-to was constructed at the same time as the barn and the farmyard walls.

Plate 4 South-west elevation of the lean-to, with Flemish bonded brickwork and the feed door with hinges identical to those of the stable block - view north-east

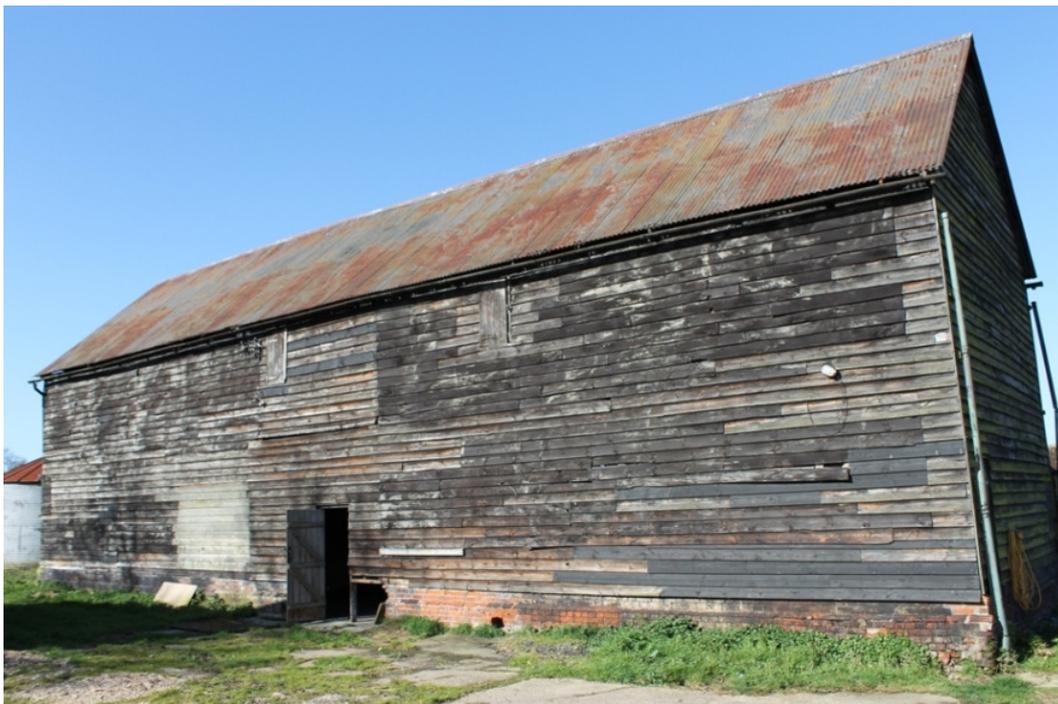
The south-east elevation has an off-centre doorway and two pitching doors below the eaves (Plate 5). The weatherboarding indicates that there were originally full height doors in the centre of the elevation, the opening for which has since been blocked. The plinth to either side of the doorway has been rebuilt in Fletton brick, although a section of this is missing next to the door (Fig 2).

Plate 5 South-east elevation, showing the blocked cart door opening and the inserted pitching doors below the eaves - view south-west

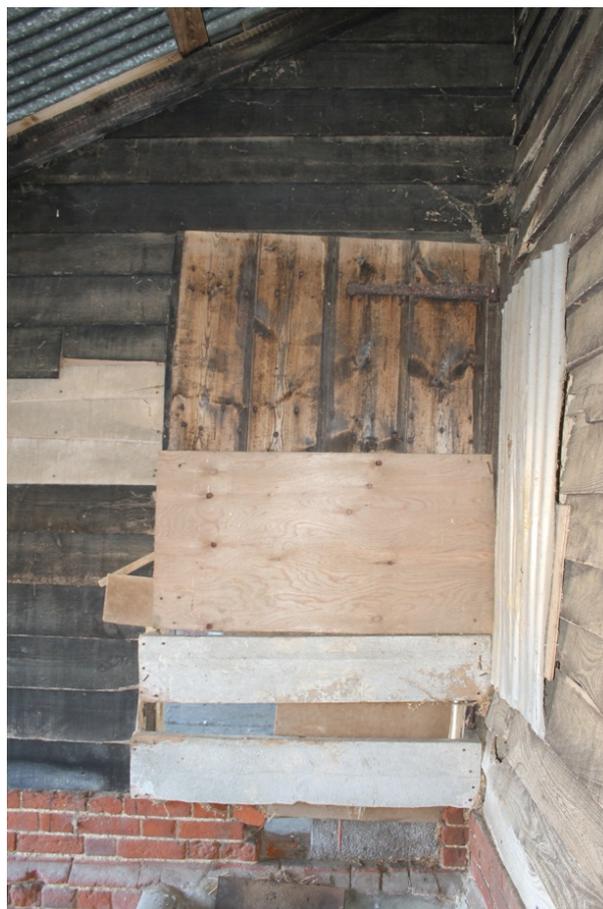
Plate 6 Remains of original door in side wall of midstrey - view north-east

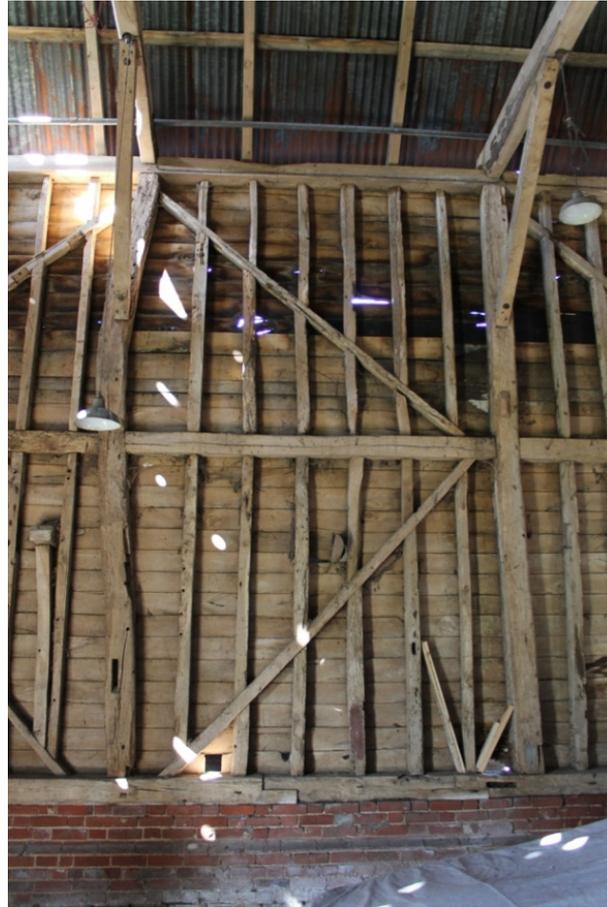
Plate 7 Framing of bay 6, showing the primary bracing forming a diamond pattern - view north-west

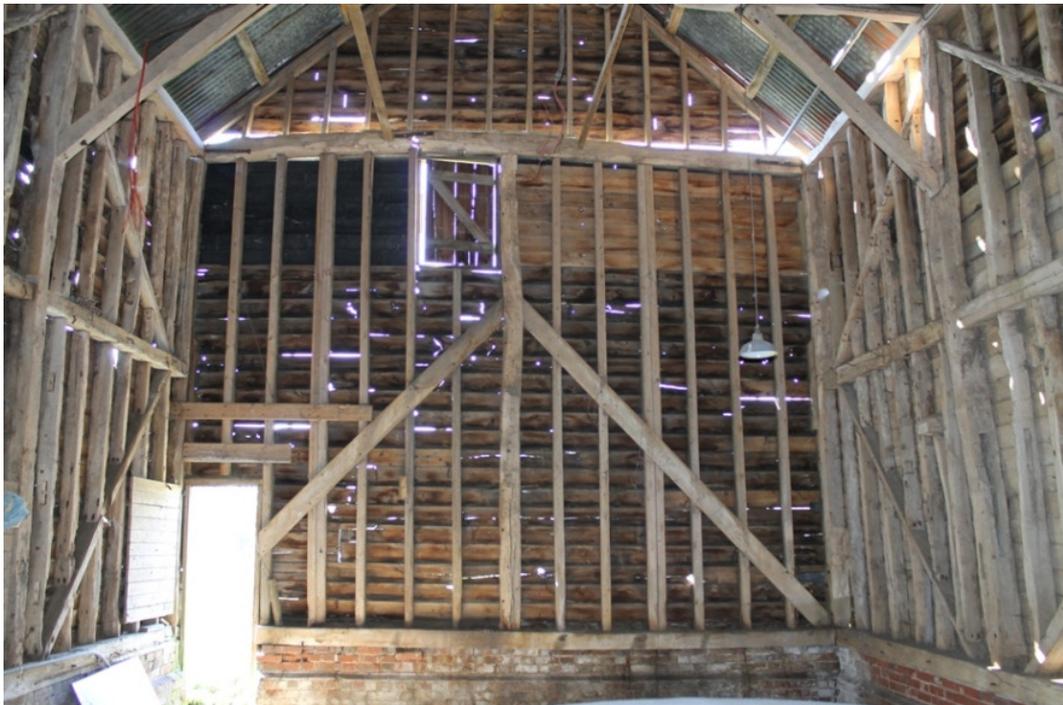
4). The frame of the south-west gable end has been completely rebuilt due to collapse. Although the wall plate, sill beam and the corner posts have been salvaged, the latter needing new bases scarfing to the main body of the post, the studding has been replaced with modern machine-cut timbers, reinforced with nailed plank bracing (Fig 6, Plate 8). This collapse was probably caused by pressure placed upon the frame when the sill beam and plinth was cut by the insertion of the doorway at the south-east corner.

Plate 8 The south-west frame, rebuilt after collapse, with modern machine-cut studs and nailed plank bracing – view south-west

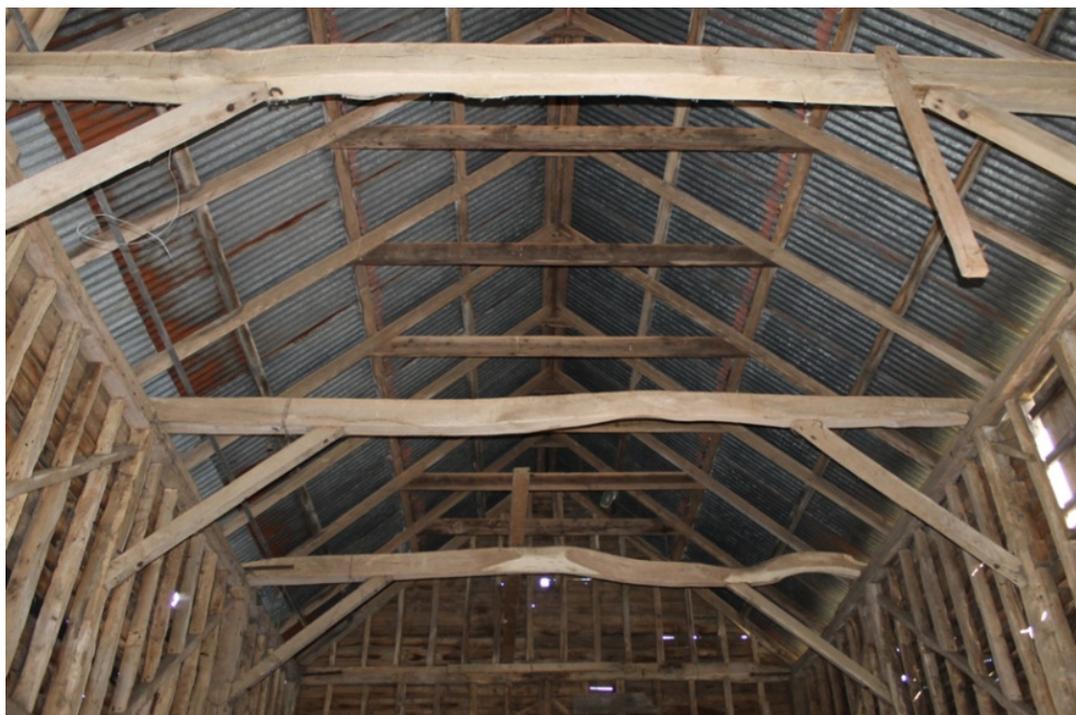
The tie beams are original to the building and, although machine-cut, illustrate the difficulty in obtaining straight timbers long enough to span a structure of this width (Plate 9). Several of the tie beams have a sinuous profile, indicating that smaller trees were chosen to provide the timbers, rather than those with a continuous square section which were sourced from larger trees. Straight braces, attached to the intermediate posts and the tie beams by a bolt and two nails, support the tie beams (Fig 7). The heads of each tie are strengthened by iron strapping.

The tie beams are the only surviving members of the roof trusses. The original principle rafters, purlins and collars have been replaced by a modern roof with a covering of corrugated iron sheeting (Plate 9). The original roof covering can only be guessed, but comparison with the farmhouse and other surviving buildings on the farm suggest it was probably peg tile or slate, rather than thatch.

Plate 9 The original tie-beams with the replacement roof above - view north-east.

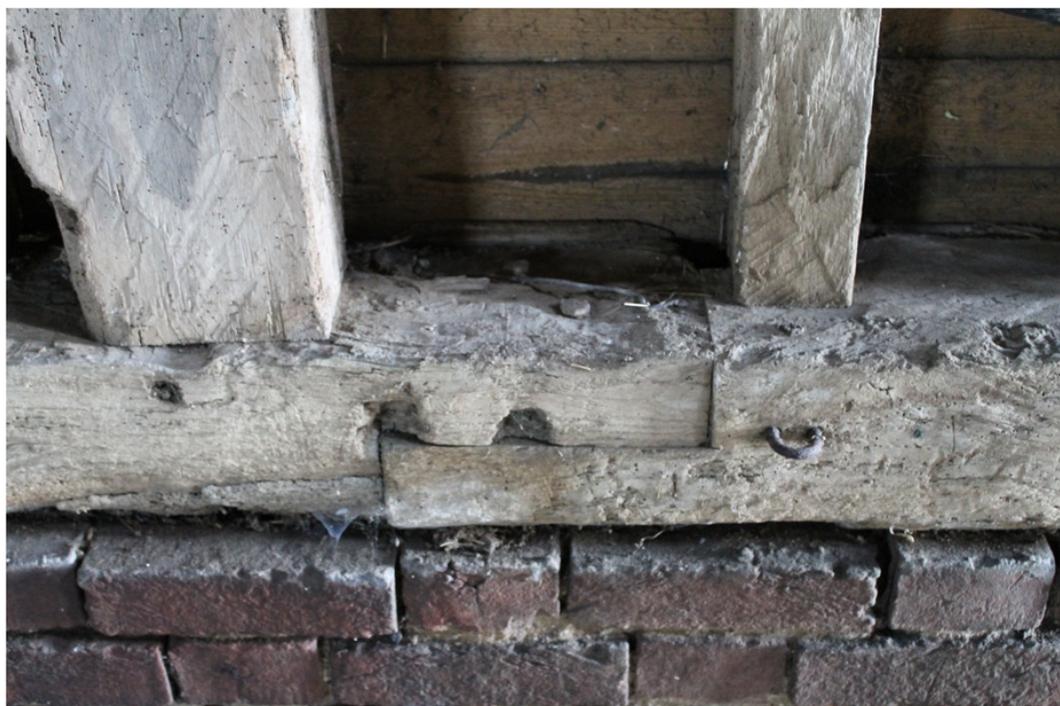
There are a number of scarf joints on the sill beam (Fig 2). These are all simple edge-halved joints secured with two wooden pegs (Plate 10). The wall plate has more varied scarf joints. The south-east wall plate has a face-halved scarf, secured by four pegs, in bay 2 and face-halved scarfs, with bladed abutments secured by four pegs, in bays 4 and 5 (Fig 4, Plate 11). The north-west wall has face-halved scarfs, with bladed abutments secured by four pegs, in bays 2 and 6 (Fig 3). There are edge-halved and bolted scarf joints in bays 3 and 5, close to the heads of the midstrey corner posts.

Plate 10 Detail of edge-halved scarf joint, secured by two pegs in the sill beam of bay 6 – view south-east

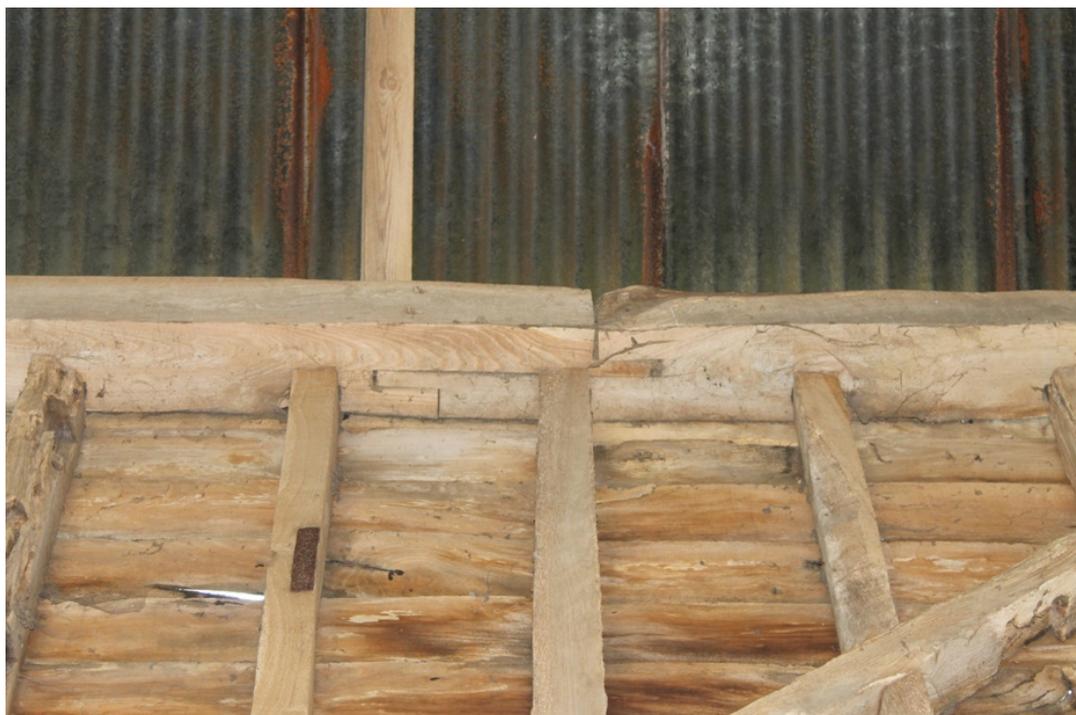
Plate 11 Face-halved scarf joint with bladed abutments, secured by four pegs in the wall plate of bay 5 – view south-east

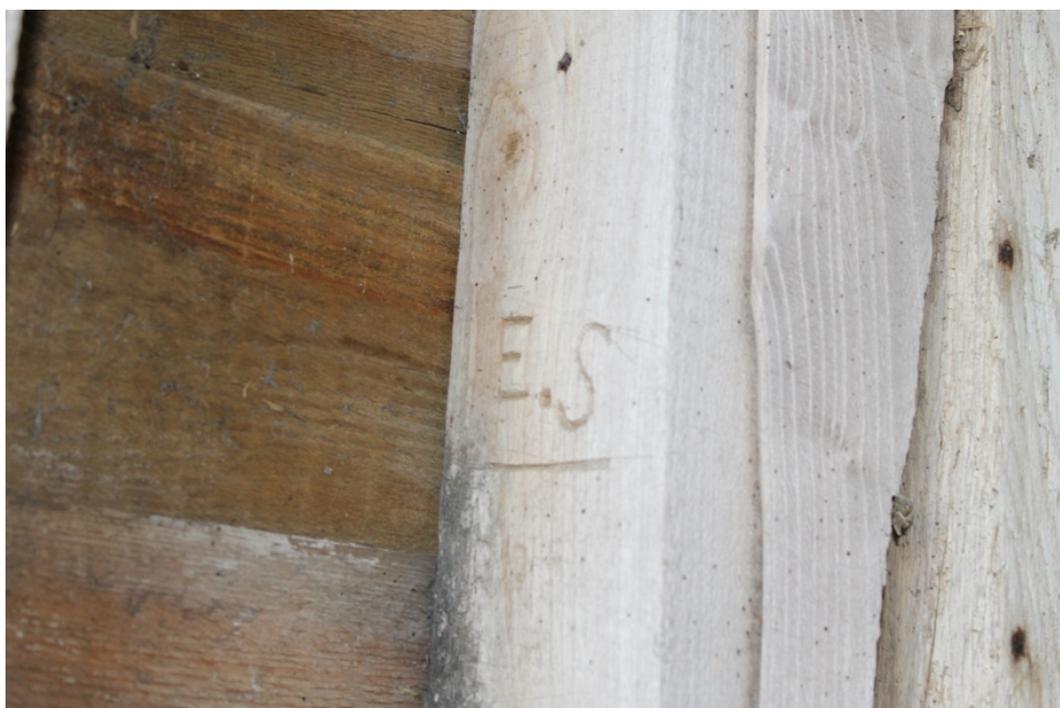
Despite the high proportion of re-used timbers in the structure, no evidence for carpentry or Baltic marks was observed. One instance of graffiti was discovered on the north-east midstrey wall: the initials 'E.S' were carved on a stud next to the internal corner post (Plate 12). These initials do not match the name of anyone encountered during the historical research of the farm and it is not possible to place a firm date to them. It is probable that they were carved there by a farm worker or possibly a carpenter during the alterations to the barn.

Plate 12 The initials 'E.S' carved into a stud in the north-east wall of the midstrey - view east

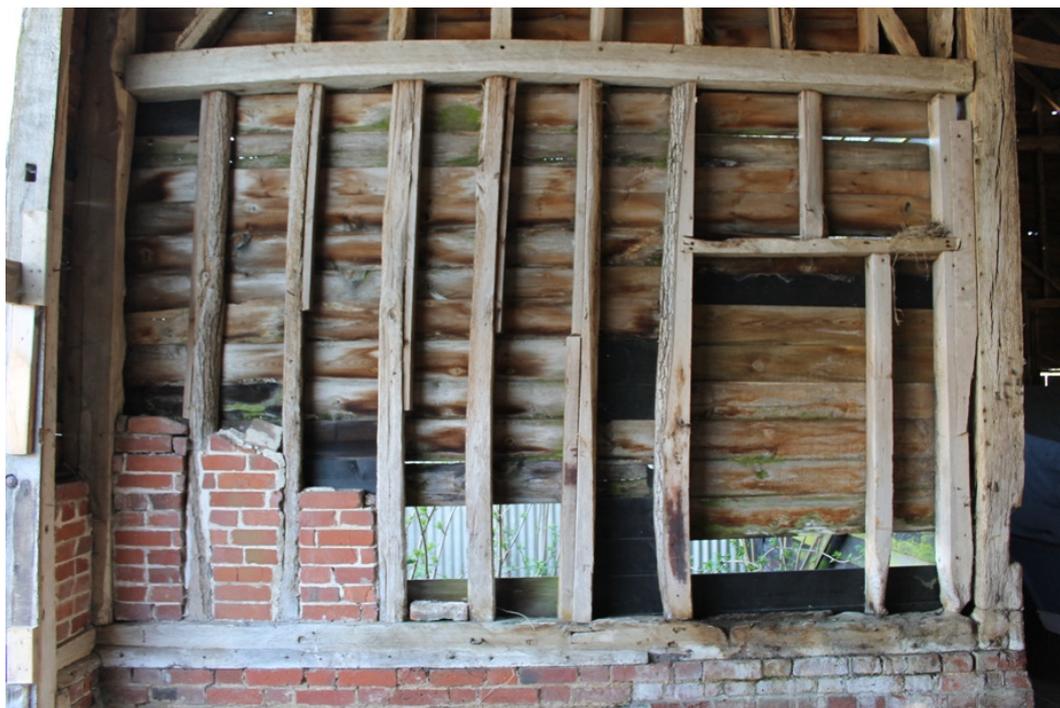
The midstrey offers one final point of interest. Brick nogging is present between the first few studs of the lower registers on both sides of the midstrey (Plate 13). There is no apparent trace of nogging between the other studs of the midstrey or in any other part of the barn's frame. It is possible that the nogging was inserted to strengthen the outer corners of the midstrey, perhaps in order to provide greater structural integrity where farm carts could potentially crash into the building.

Plate 13 Remains of brick nogging between studs of midstrey wall - view north-west
