**Historic building recording
at Shalford Hall Farm barns,
The Street, Shalford, Essex
February 2015**

**report prepared by
Chris Lister**

**commissioned by
Alun Design Consultancy Ltd
on behalf of
Mr Allan Stevenson**

CAT Report 841
July 2015

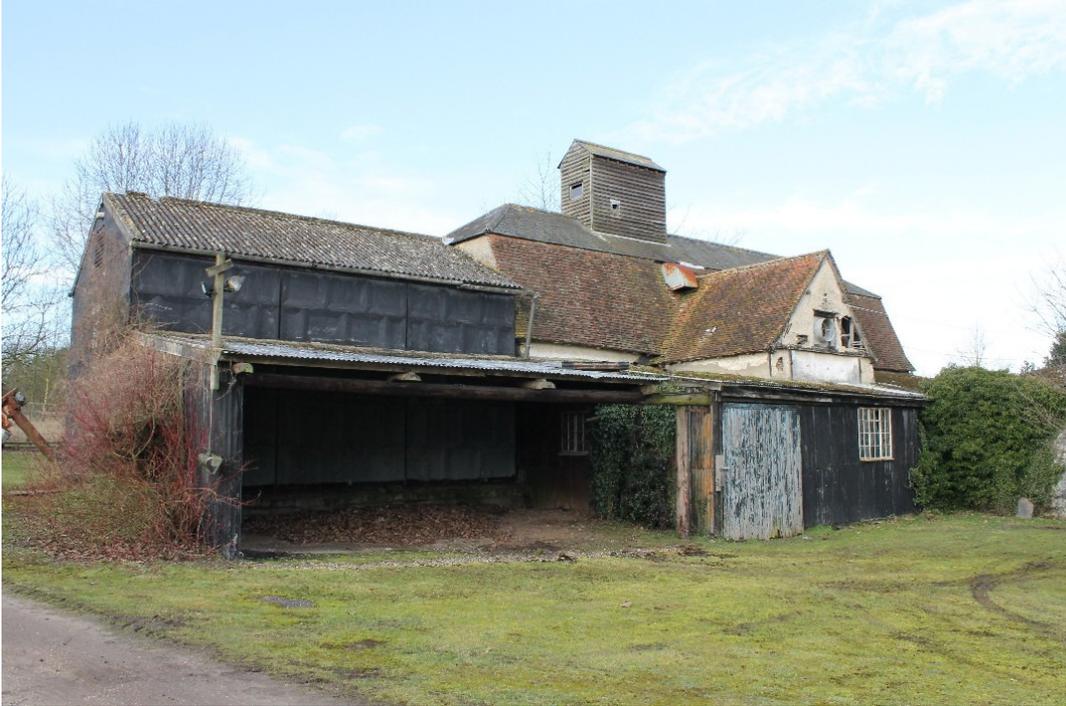
The main range of the barn has a half-hipped mansard roof (Plate 1), the lower slopes of which are clad in plain clay tiles. The upper slopes are clad in slate, clearly an alteration to the roof, probably carried out when the timber-clad housing for the grain hoist was installed on top of the ridge. The roof of the midstrey is clad in plain clay tiles.

Plate 1 North-east elevation of the Grain Barn, partially obscured by 20th-century outbuildings - view north-west

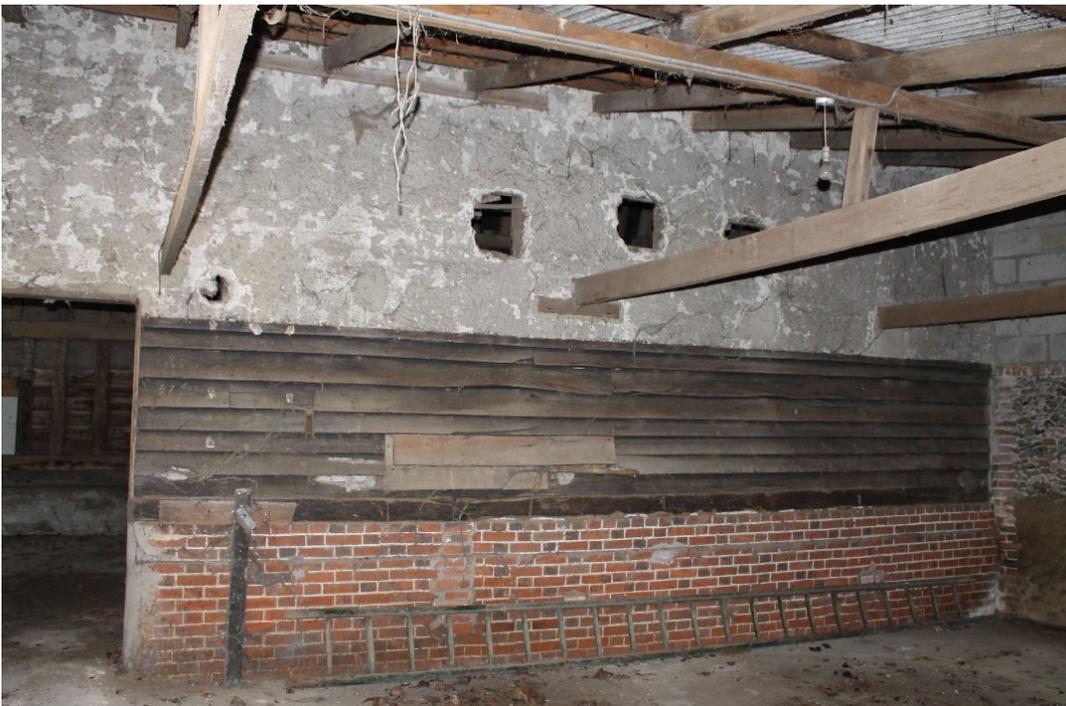
The Grain Barn is a rectangular timber-framed building, 19m long x 7m wide, aligned north-west to south-east, with an off-centre midstrey projecting from the north-east elevation (Plate 1). The barn sits upon a plinth of red brick with dimensions of 220 x 110 x 70mm, laid in Flemish bond. The exterior appears to have been weatherboarded to the lower portion of the framing with wattle and daub render above, although this survives in only a few locations and has subsequently been covered by a modern render (Plate 2, Figs 3-6).

Plate 2 Detail of the brick plinth to the Grain Barn with weatherboard above this and then render covering the upper portion of the frame – view west.

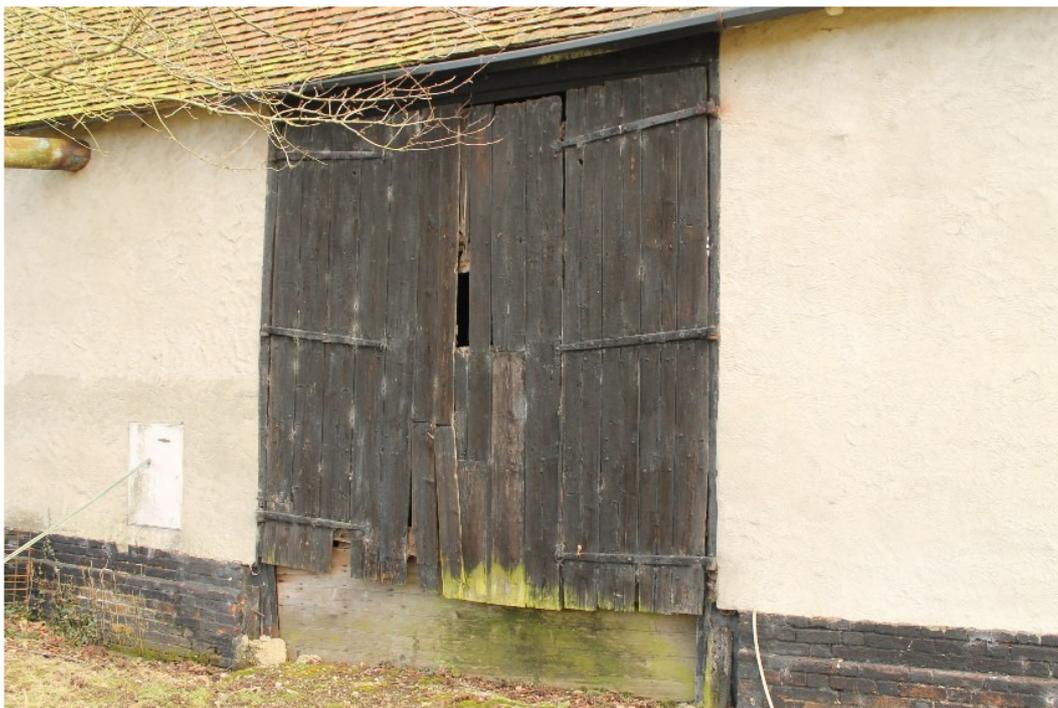
The north-east elevation (Fig 3) has an off-centre midstrey projecting from it, in line with a pair of full height barn doors in the south-west elevation (Fig 4). The midstrey doorposts have recesses for a threshold leap and there is a modern equivalent of a threshold leap in the south-west doorway, although the recesses have been replaced by iron stanchions. Although the barn doors have been replaced they appear to retain the original strap and pintel hinges (Plate 3).

Plate 3 Full-height barn doors in the south-west elevation of the Grain Barn with original strap and pintel hinges - view north

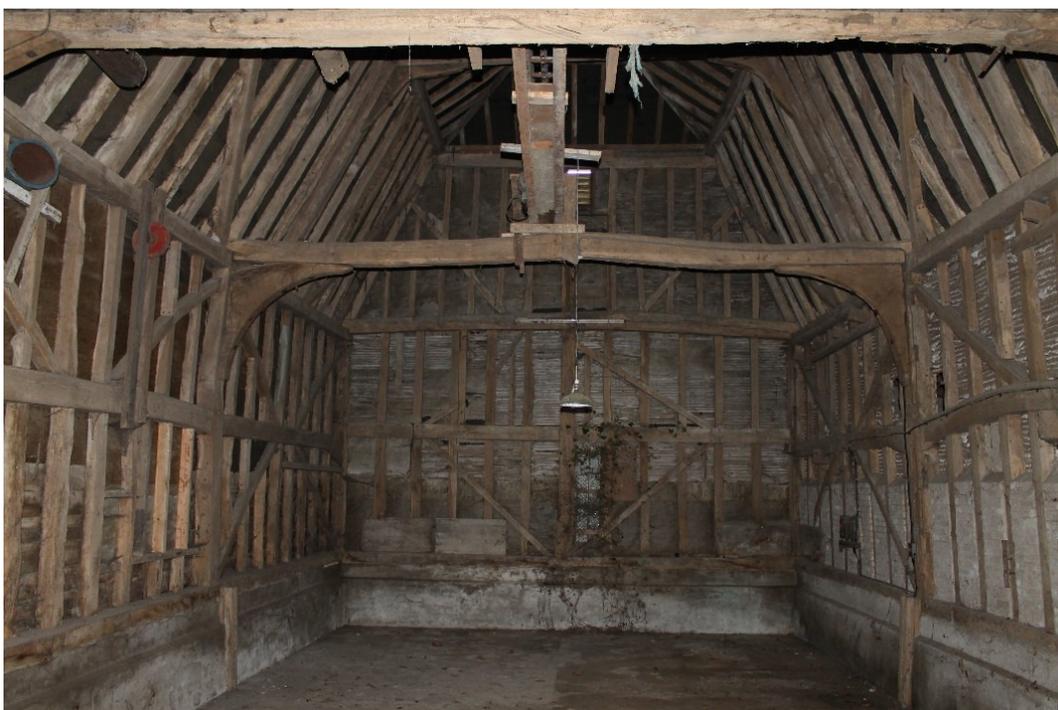
The barn is constructed from large-section hand-sawn hardwood timbers and is divided into 4 roughly equal bays (Plate 4, Fig 2). The sill beams, girding beams and wall plates all seem to be original to the building with a mixture of original and re-used timbers forming the studs. Several of the storey posts and girding beams display natural curves, particularly the girding beam to the south wall of bay 1, which has a 35- 40 degree bend at one end that has been incorporated into the studding of the corner post (Fig 8). The internal face of the brick plinth has been rendered with concrete making it impossible to visualise the brick work.

Plate 4 Interior of the Grain Barn - view north-west

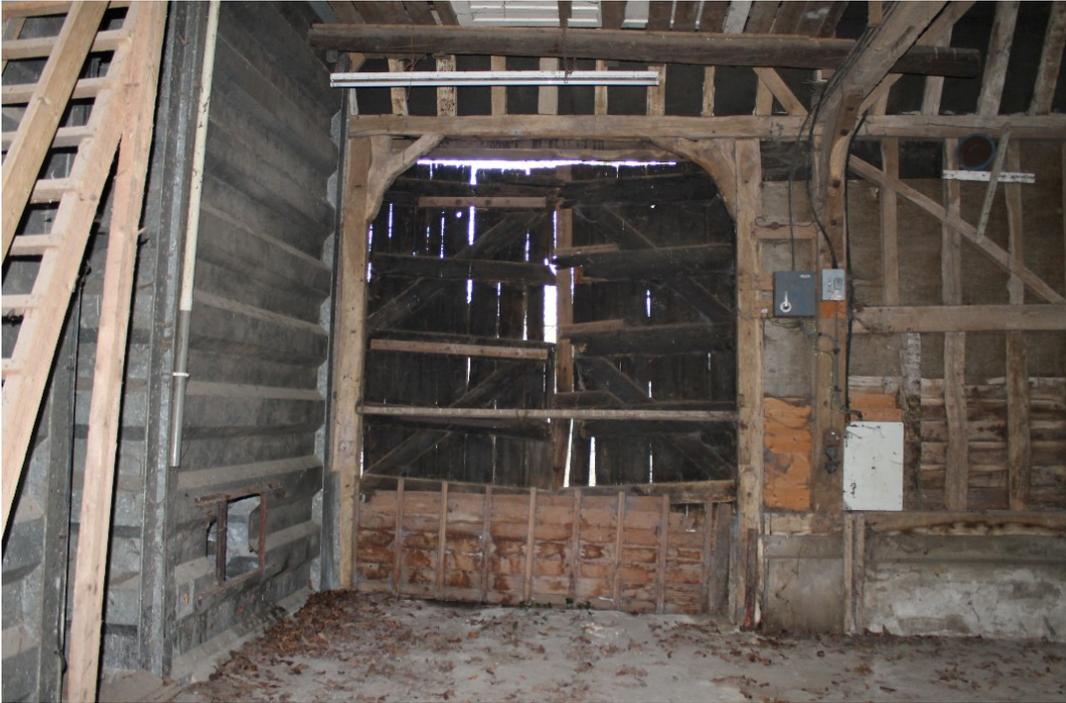
Bay 1 has primary bracing to upper and lower registers on both sides, which are single-pegged to the girding beams and storey posts. Bay 2 has primary bracing to the upper registers but not the lower registers. A doorway has been inserted through the north-east wall of bay 2 and the north-east side of bays 1 and 2 have brick nogging to two thirds of the height below the girding beam (Fig 7). Bay 3 is the midstrey but all trace of the threshing floor has been removed by the modern concrete floor. The barn door opening in the south-west frame of bay 3 appears to be original. It has a modern threshold leap but the recesses for this have been replaced by iron stanchions. The doorposts have knee braces, formed from roughly squared Y-shaped branches of a tree (Plate 5, Fig 8).

Plate 5 Barn doors in south-west wall of Grain Barn with roughly squared knee braces - view south-west

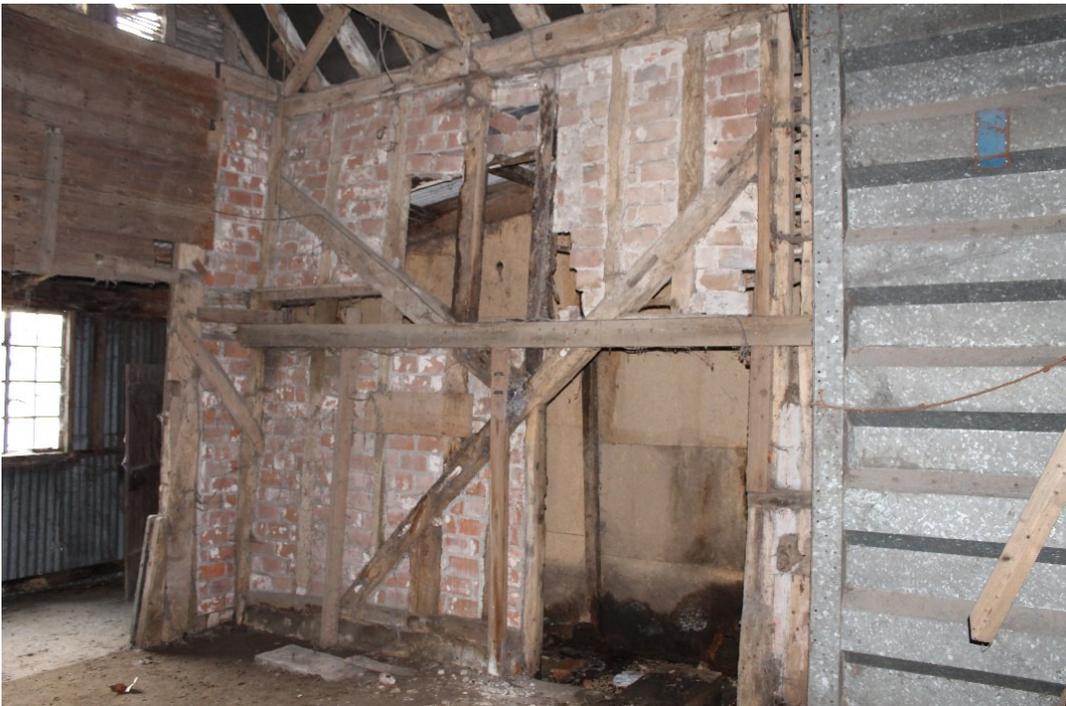
Plate 6 South-east wall of the Grain Barn midstre showing the Y-shaped bracing and brick noggin - view east

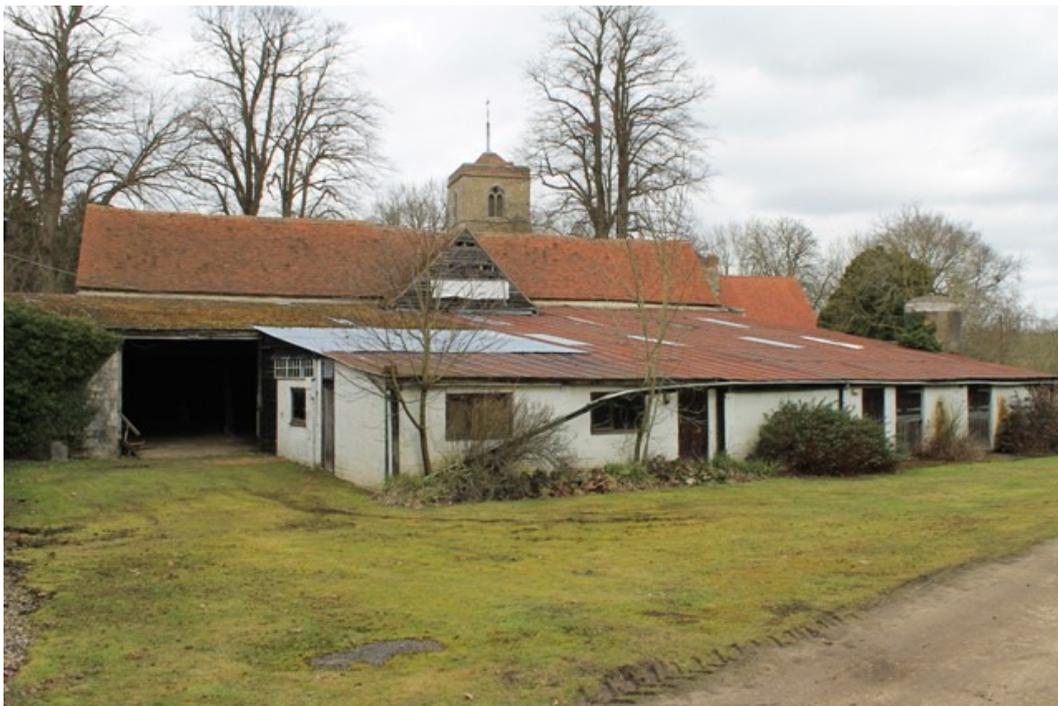
Plate 7 South-east elevation of the Church Barn with 20th-century outbuildings in the foreground and St Andrew's Church behind - view north

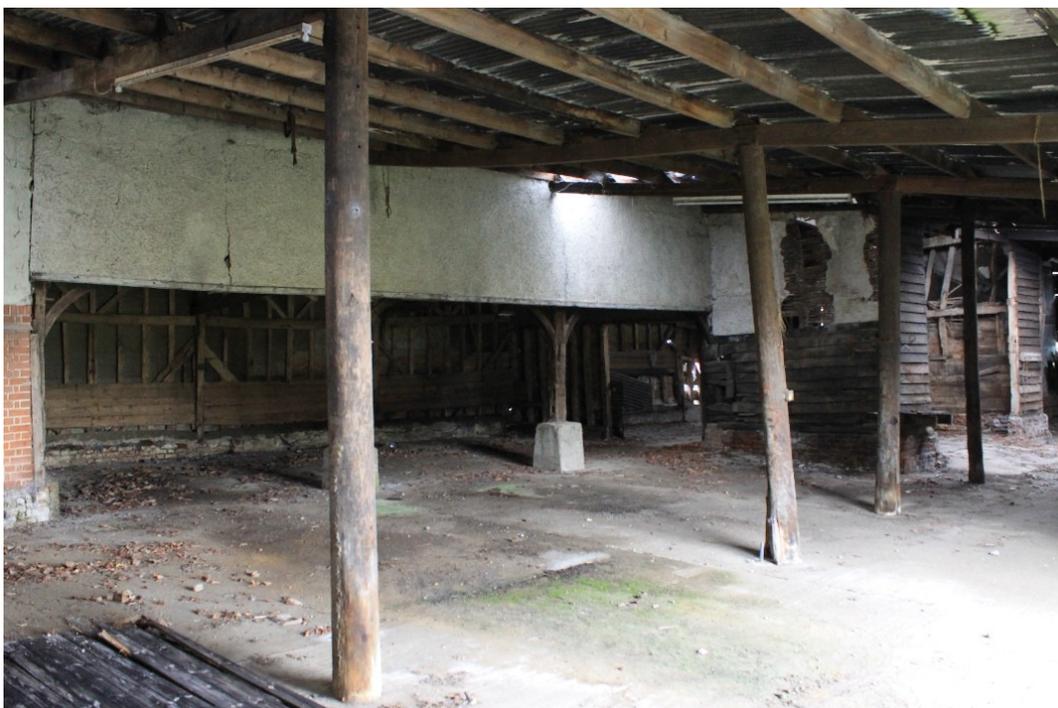
The south-east elevation is almost entirely hidden behind 20th-century outbuildings (Plate 8) which has had the effect of turning the area in front of the barn into a covered yard. Part of the frame to this elevation, south-west of the midstrey, has been removed converting this part of the barn into a cart lodge (Fig 13).

Plate 8 The south-east elevation of the Church Barn, concealed beneath/behind the 20th-century outbuildings – view north-east

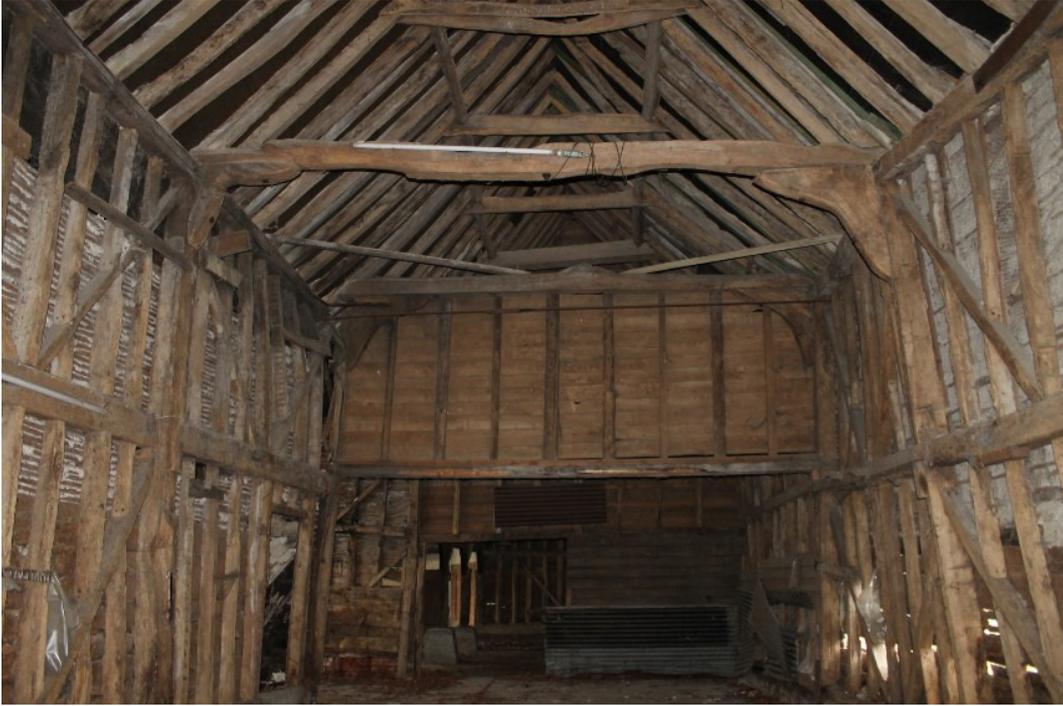
The interior of the Church Barn is divided into seven bays, three roughly equal-sized bays to either side of the midstrey bay which is much wider (Plate 9, Fig 12). The frame consists of hand-sawn hardwood timbers with posts of varying dimensions, girding beams and wall plates, all of which include many re-used timbers (Figs 17-21). The studs are not of uniform scantling and consist of both re-used timbers and timbers original to the building, although the deteriorated state of the posts and studs makes differentiating this very difficult.

Plate 9 The interior of the Church Barn with the dividing walls to the sides of the midstrey - view south-west.

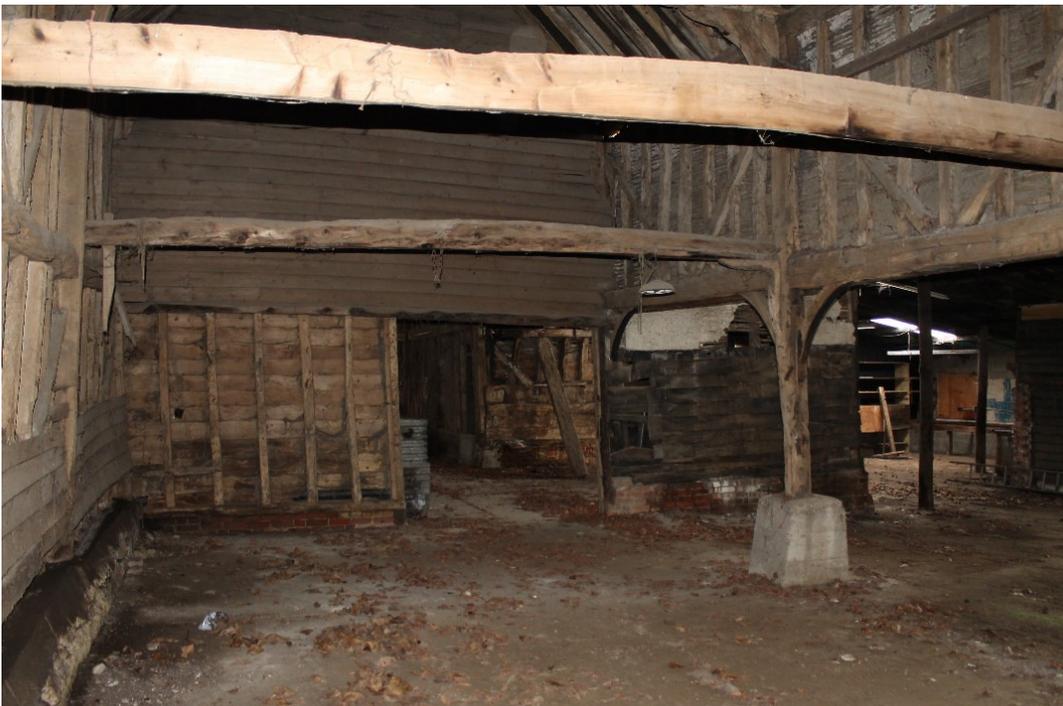
Bays 1-3 have been converted to a cart lodge by the removal of the lower registers of the south-east wall (Plate 10). The storey posts were retained when this was carried out and machine-cut arched braces have been nailed to the underside of the girding beams and the sides of the posts to provide additional support (Fig 17). The exposed mortices for the removed studs are clearly visible in the underside of the girding beams.

Plate 10 The interior of bays 2-3 in the Church Barn, converted to a cart lodge by the removal of the lower framing – view east

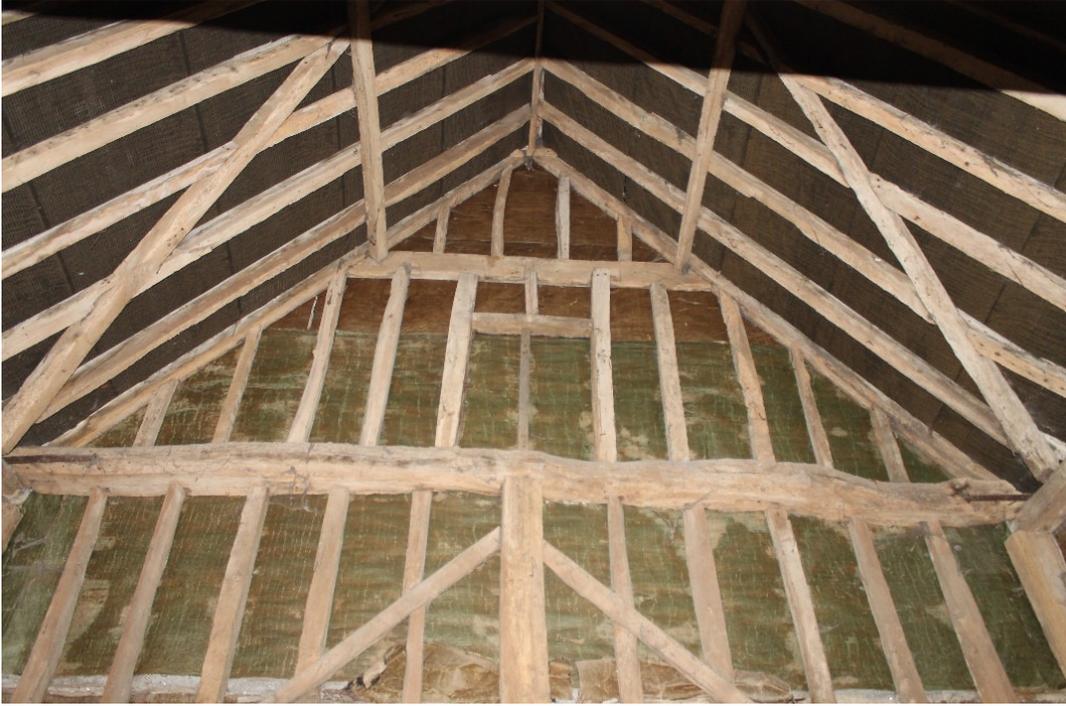
The south-west gable has square-section corner posts and a central storey post, with girding beams either side of the storey post. Primary braces form a rough diamond pattern (Fig 20). Above the gable wall plate there is a centrally-positioned opening for a pitching door, which has been blocked and was probably an alteration rather than an original feature (Plate 11).

Plate 11 South-west gable frame of the Church Barn with inserted window above the wall plate – view south-west

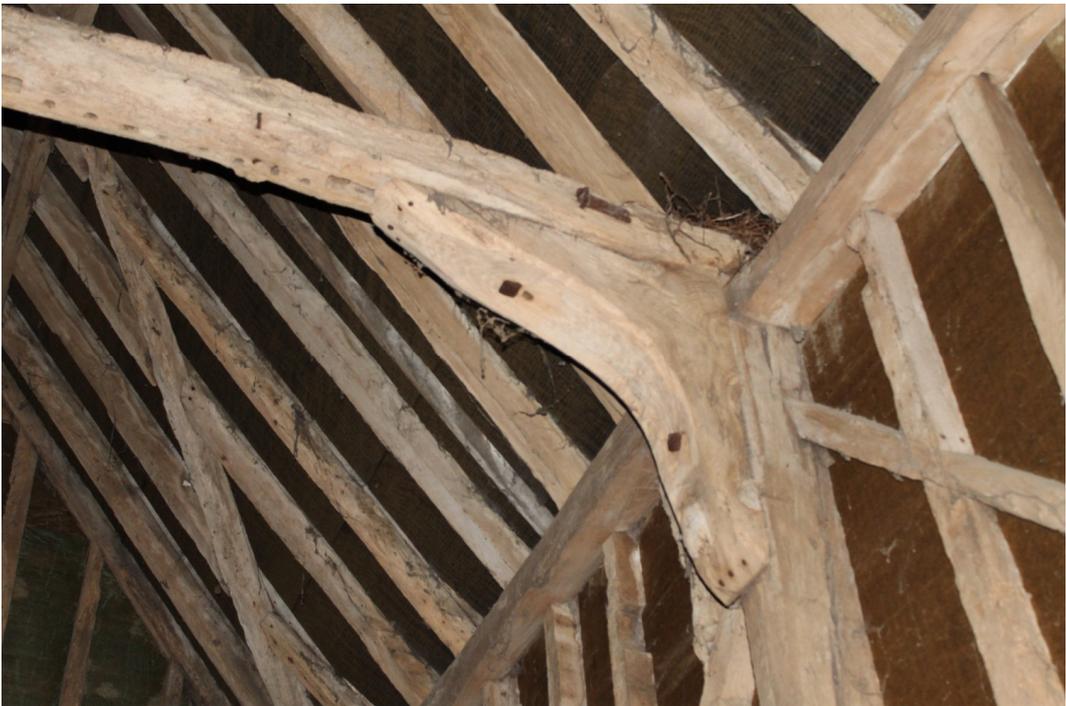
The large-section tie beams (several of which are re-used beams with exposed mortises and peg holes for a much larger brace) are supported on large hewn knee braces, bolted and nailed to the post and tie beam (Plate 12, Fig 21).

Plate 12 Large hewn knee brace supporting re-used tie beam of truss A in the Church Barn - view west

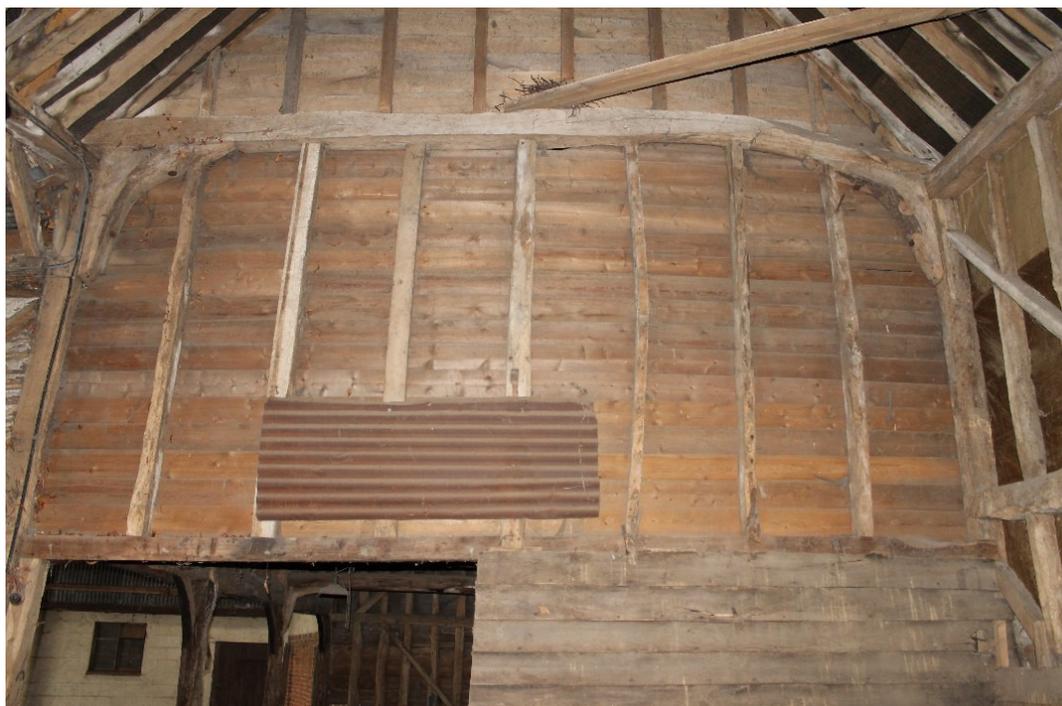
Dividing walls have been inserted between bays 3-4 and bays 4-5. The dividing wall between bays 3-4 has been inserted underneath the tie beam of truss C, which has two hewn knee joints double-bolted to the tie beam and posts. This wall sits on a low brick plinth with a sill beam supporting studs clad in planking (Plate 13, Fig 12). The visible studs appear to be machine-cut timbers, which suggest that the wall is a later feature. An original opening in this wall has been widened by the removal of two of the studs. The dividing wall between bays 4-5 starts at the height of the girding beams with the heads of the studs inserted into the underside of the tie beam to truss

Plate 13 Inserted dividing wall between bays 3-4 of the Church Barn - view south-west

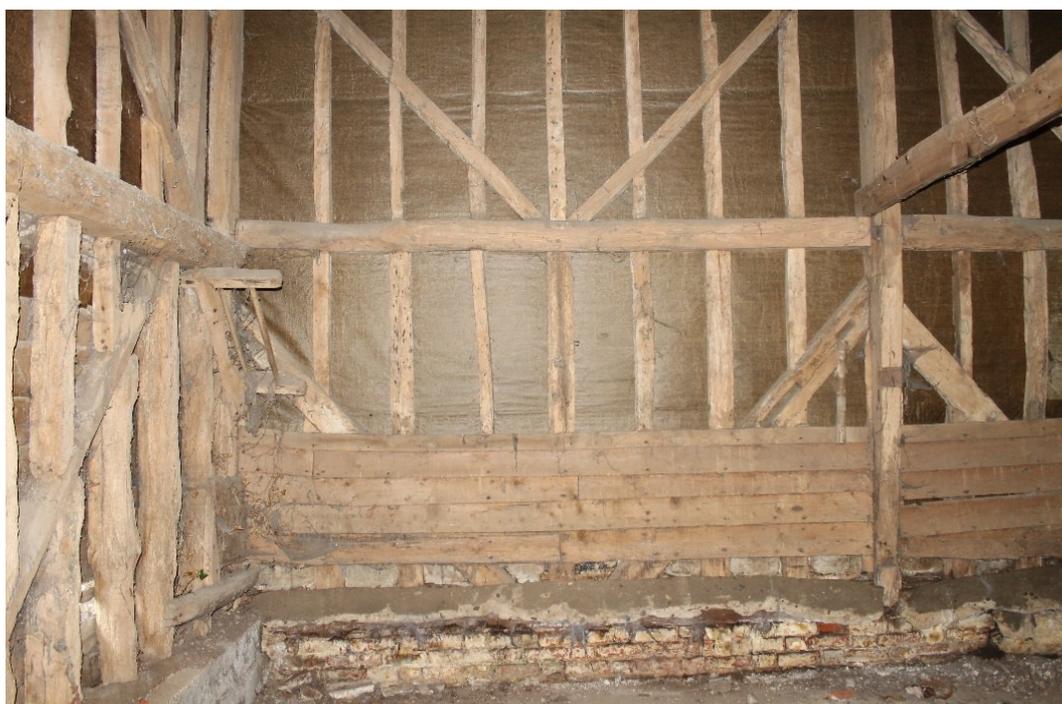
In addition to the alterations carried out to bays 1-3, trusses A and B have small, hewn knees supporting a cross beam that sits on top of the girding beams on both sides, single bolted to the posts and tie beam and with three nails at the tips of the knee braces. The north-west wall of bays 1-3 has plank cladding to a height of about 1.3m and in the corner of bay 1 there are the remains of a hay rack (Plate 14, Fig 12). This has circular-section mortices for the spindles rather than diamond-section ones, which are more usual. The hay rack and the plank cladding indicate that these bays were, at some point, used to house livestock.

Plate 14 Plank cladding to wall of bay 1 and remains of hay rack, indicating bays 1-3 of the Church Barn were once used to house animals - view north-west

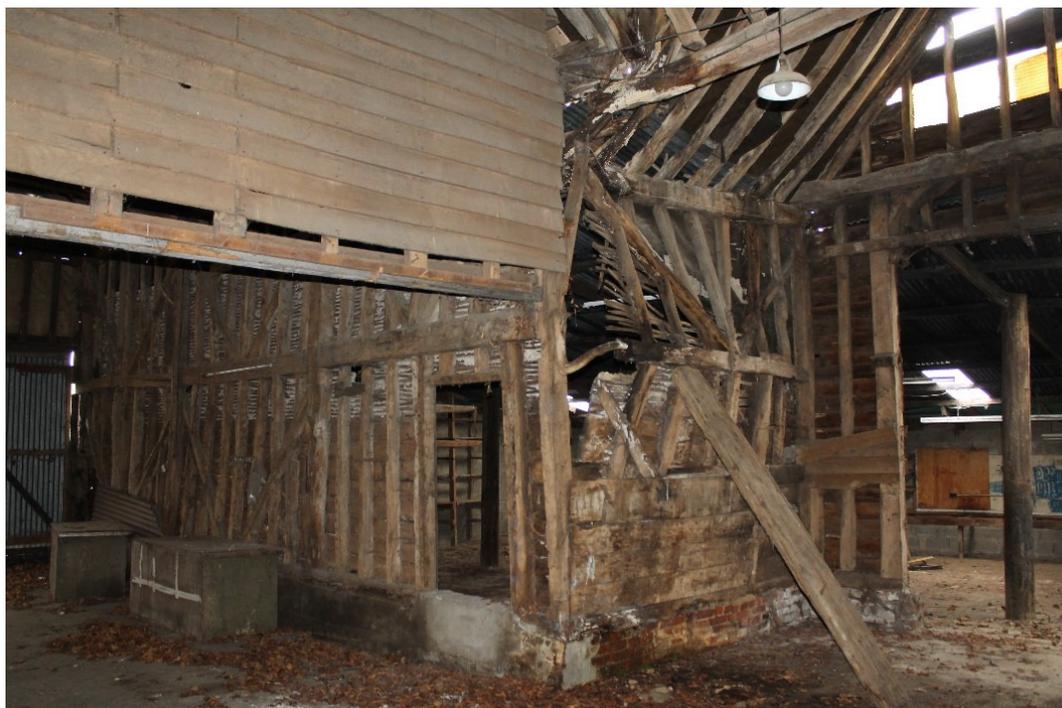
The midstrey projecting from bay 4 is carried on a plinth of red brick with dimensions of 226 x 110 x 65mm, laid in irregular bond. The north-east wall of the midstrey is in a very bad state of repair and is propped by a baulk of timber (Plate 15, Fig 19). The frame is divided by a girding beam with the lower portion of the bottom register obscured by wide-section planking. The lower register has a single brace falling from the post of truss D to the sill beam and the upper register has diagonal bracing falling from both corner posts. The wall plate, although in a very poor state of repair, appears to be original. The south-west frame of the midstrey has diagonal bracing falling from both corner posts in each register. Wide-section planking covers the lower half of the bottom register (Plate 16, Fig 20).

Plate 15 The north-east frame of the midstrey to the Church Barn - view south-east

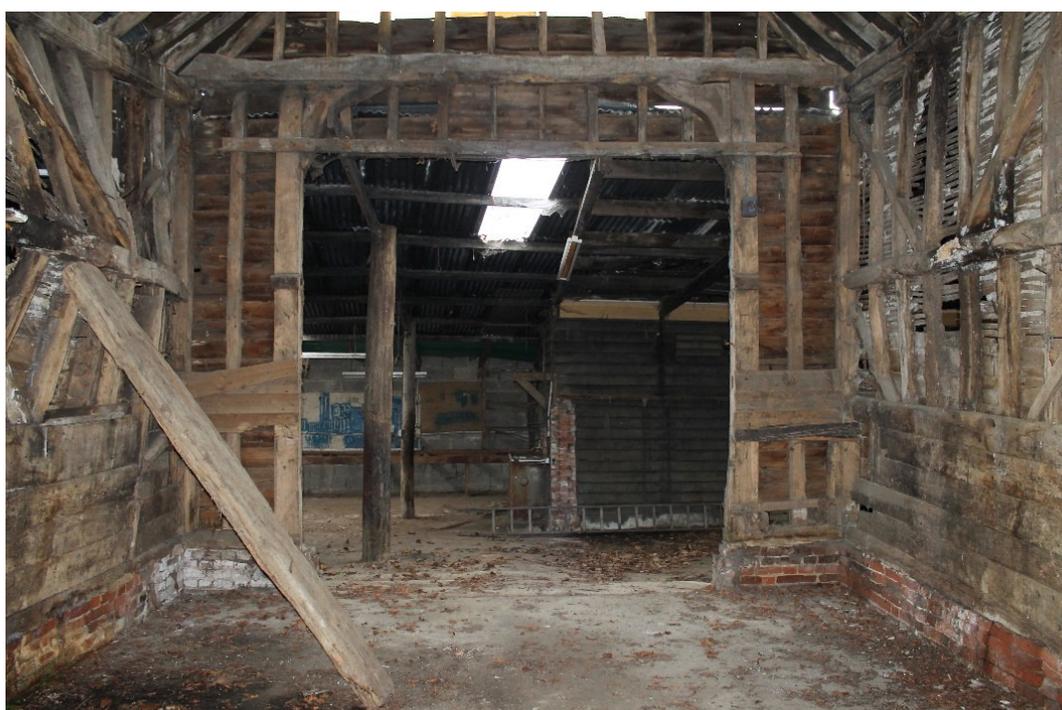
The midstrey barn doors were held on square-section door posts with small knee braces supporting the gable tie beam, all of which appear to be original timbers, although the barn doors themselves have been removed, as have the pintels for the barn door hinges. There is no evidence for a midstrey leap, although there are recesses for the locking bar for the barn doors. The studs above the gable tie beam appear to be original and the roof retains the original rafters, including centrally-positioned principle rafters with a double-pegged and trenched collar beam.

Plate 16 The midstrey to the Church Barn - view south-east

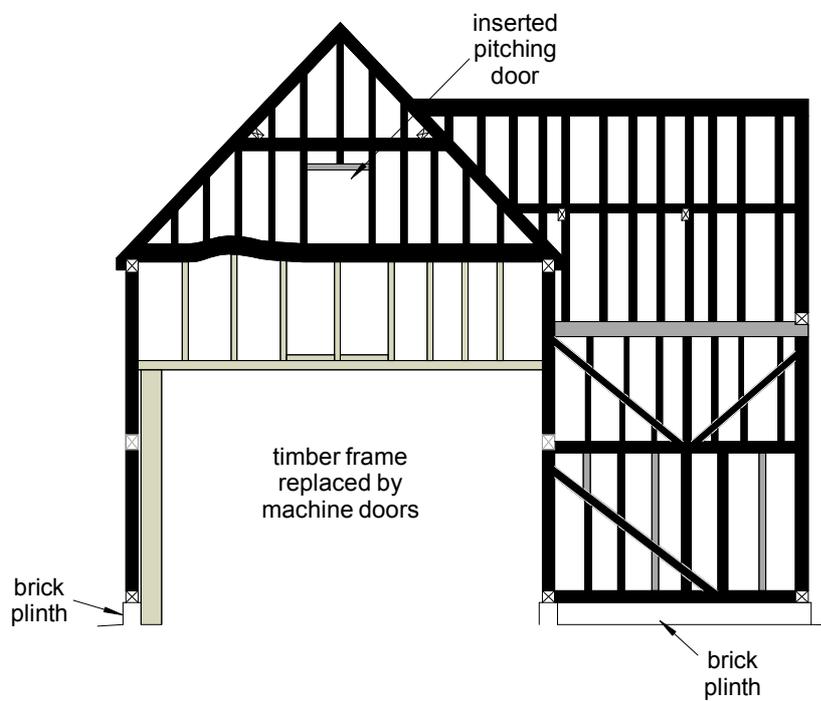
Fig 19 Frame drawing of the north-east wall to the Church Barn, indicating the locations of original, re-used and replacement timbers.

The north-east gable frame has been completely removed below the wall plate and replaced with a large set of doors for farm machinery (Fig 19). Above these doors there is an area of vertical studding, obviously not original, with a large window formed from corrugated plastic sheeting. Above this, in the middle of the gable, a pitching door has been inserted.
