**Historic building recording at
Greenacre Farm, Smallgains Lane,
Stock, Essex, CM4 9PR**

February 2018

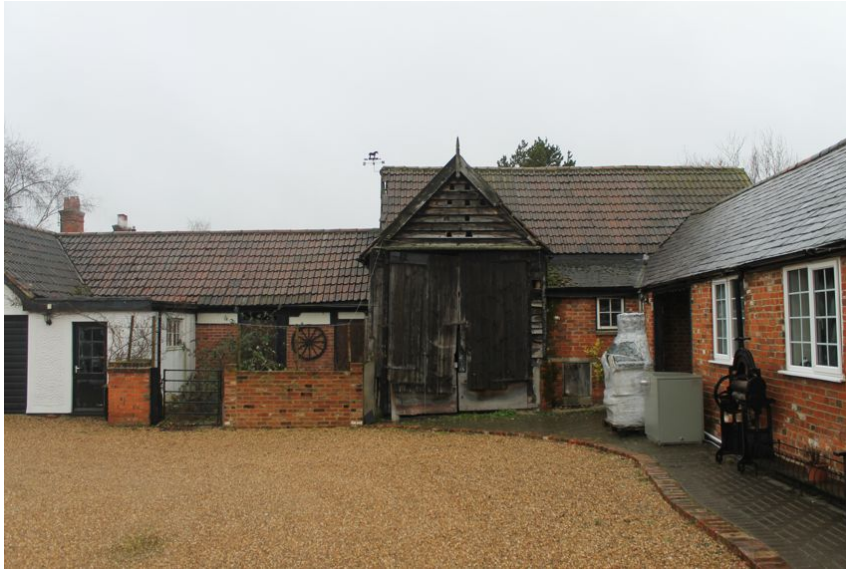
Photograph 3 Eastern elevation of barn, lean-to and building A.
Photograph taken facing west.

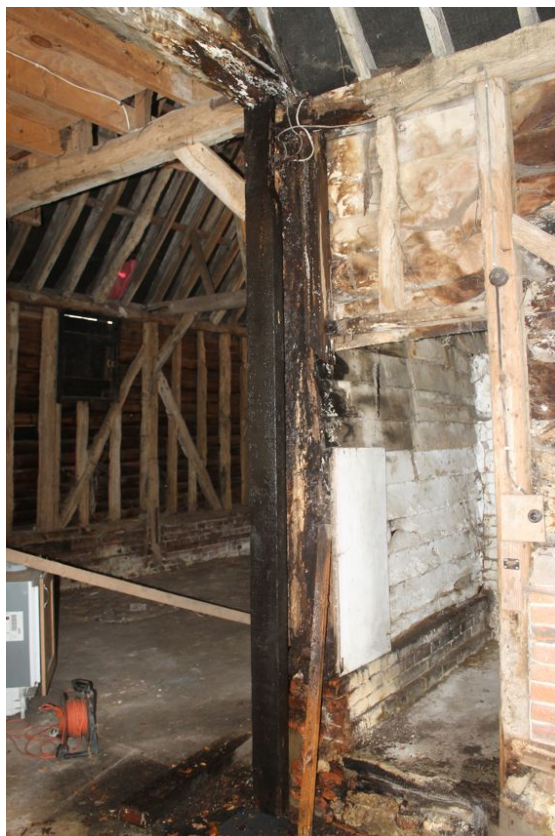
Photograph 11 The heavily water-damaged eastern principal-post between bays 2, 3 and the midstrey. Photograph taken facing north-west.

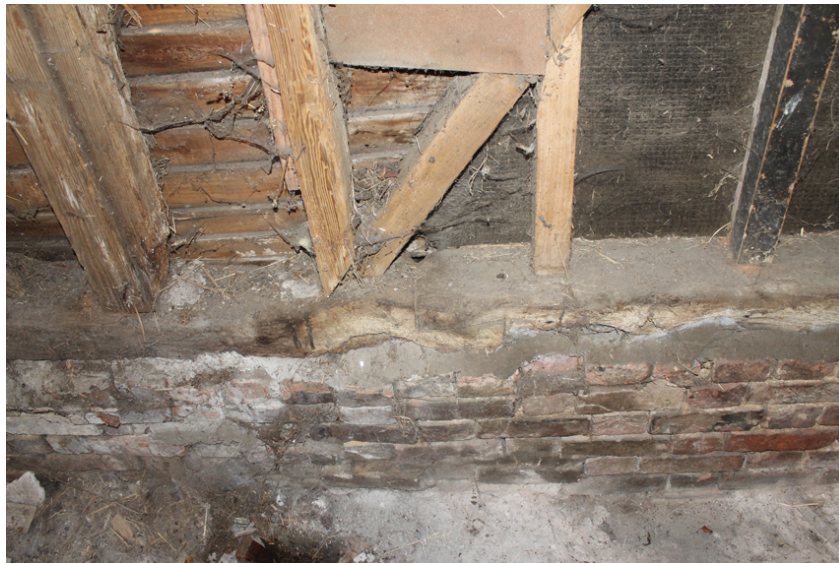
Photograph 18 Scarf joint on southern sill-beam in bay 3. Edge-halved scarf with square abutments. Photograph taken facing south.

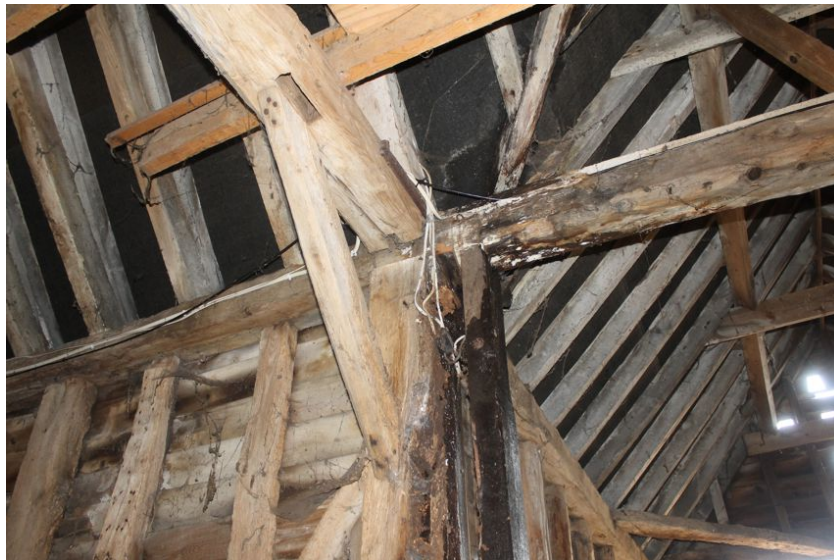
Photograph 22 Apex of principal-post on eastern elevation between bays 2 and 3. Showing heavy water-damage, empty mortise on tie-beam and scarf joint to immediate south (right) of principal-post. Photograph taken facing north-east.

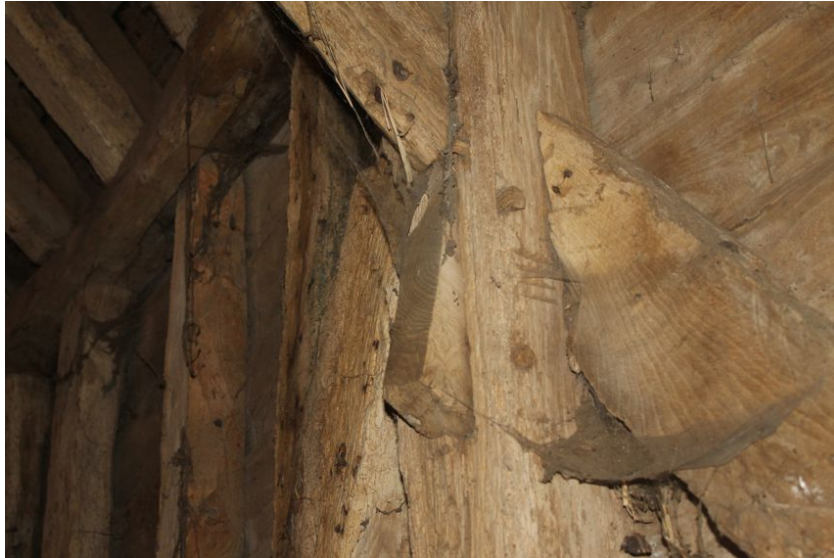
Photograph 23 Sawn of brace in mortice on eastern principal-post between bay 1 and 2. Carpenter's mark 'IIII' visible. Photograph taken facing north-east.
