**Historic building recording at
Frogs Hall Farm,
Bambers Green Road,
Takeley, Essex, CM22 6PE**

November 2019

CAT Report 1540
April 2020

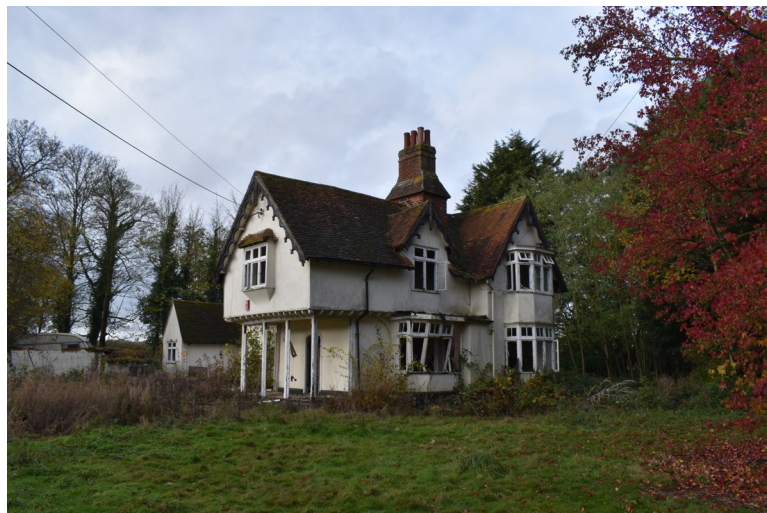
Photograph 2 Modern eastern and southern elevations, showing bay-window extensions, replacement windows and altered chimney. Photograph taken facing north-west.

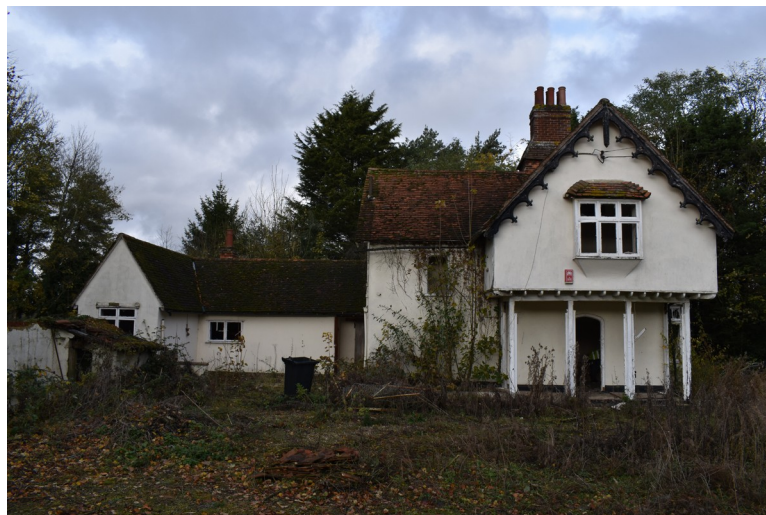
Photograph 4 Southern elevation of building. Photograph taken facing north.

The two-storey ranges have a large chimney projecting from their centre, rising high above the ridge-line (Photograph 4). On the western face of this chimney stack is a section of moulded brickwork in the design of a shield (Photograph 5). The single-storey ranges also have a chimney, but it is of a far more modest design.

The south elevation of the house has a projecting upper-storey supported on six-posts, forming a veranda below (Photograph 4). Centrally positioned below the veranda is a doorway into the house (although no door survives). The veranda is floored with brick paviors and until recently the posts supporting the upper-storey each had a pair of decorative spandrels between them. The southern facing gable of the two-

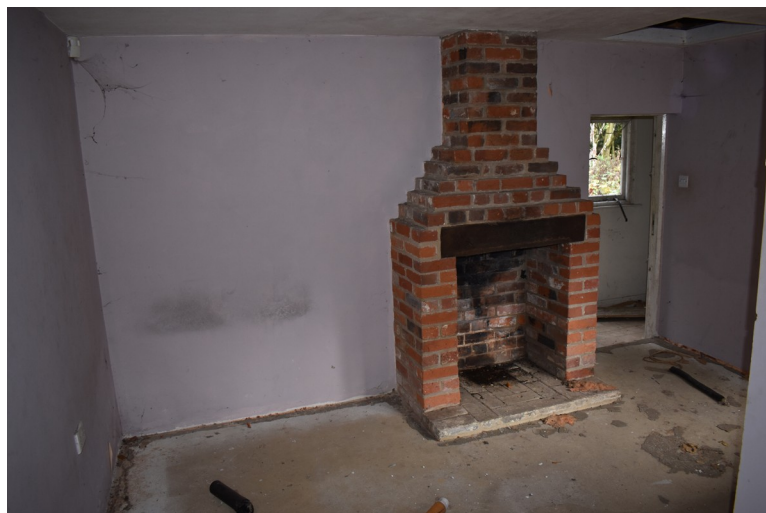
Photograph 12 Interior of room 3, showing rebuilt fireplace. Photograph taken facing north-east.
