**Historic building recording at  
Shonks Farm,  
Mill Street, Hastingwood,  
Essex, CM17 9JQ**

**August 2019**

**CAT Report 1680**  
June 2021

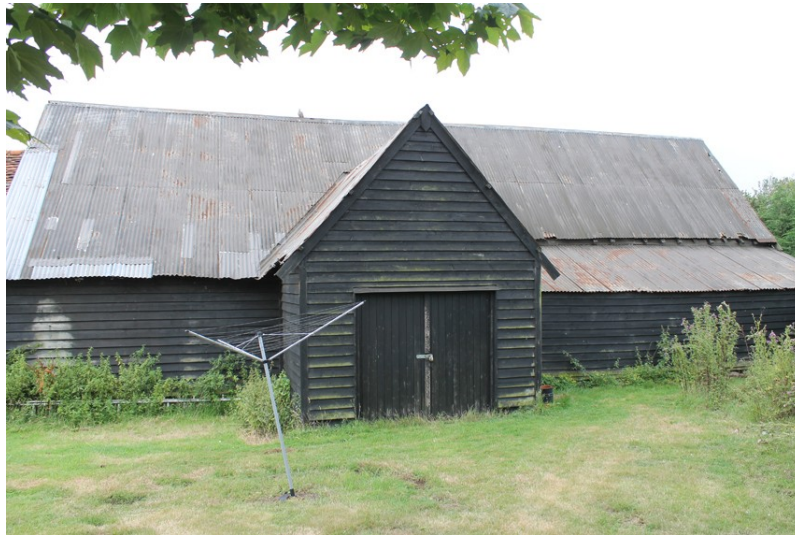
The north-east elevation of the threshing barn contains a centrally-located small midstrey flanked on either side by a lean-to, the east one of which has a catslide roof (Photograph 1). The midstrey has a centrally-located set of double doors (Fig 4).

**Photograph 1** North-east elevation of barn, showing midstrey and lean-tos. Photograph taken facing south-west.

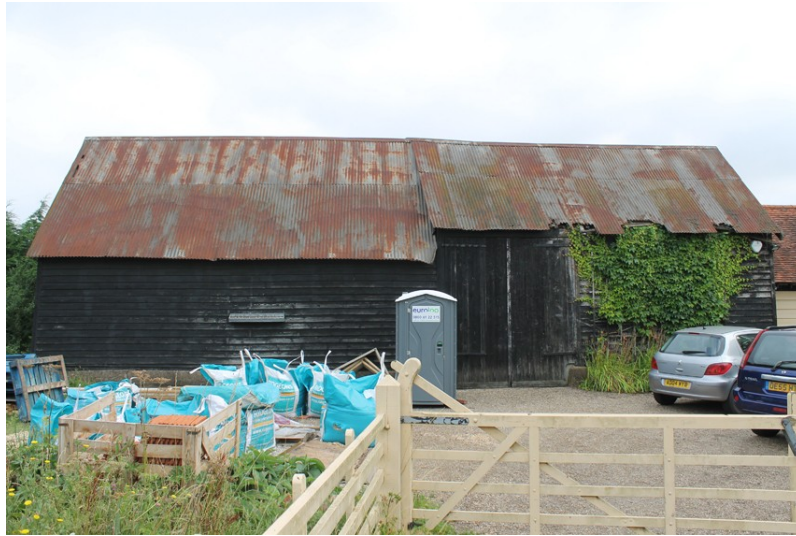
There is no visible brick plinth supporting the timber-frame of the barn, but around most of the frame the sill-beam of the barn is encased in concrete, which would mask any evidence of a supporting plinth (Photograph 2).

The south-west elevation of the barn has a pair of full-size vertically-planked barn doors, slightly off-centre to the building (Photograph 2). The principal-posts on either side of this doorway are set into substantial concrete buffers.

**Photograph 2** South-west elevation of the barn. Photograph taken facing north-east.

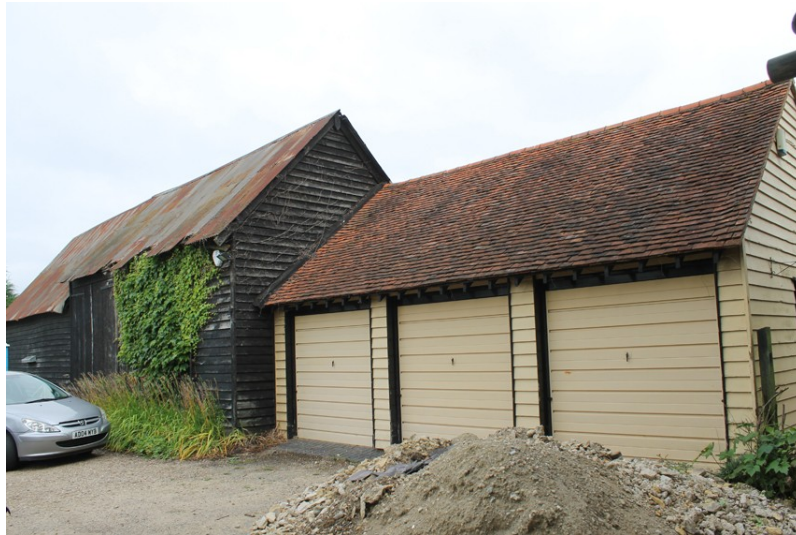
The south-east elevation of the barn is featureless and partially obscured by the modern garage built up against it (Photograph 3, Fig 5).

**Photograph 3** South-east elevation of the barn, with modern garage. Photograph taken facing north-east.

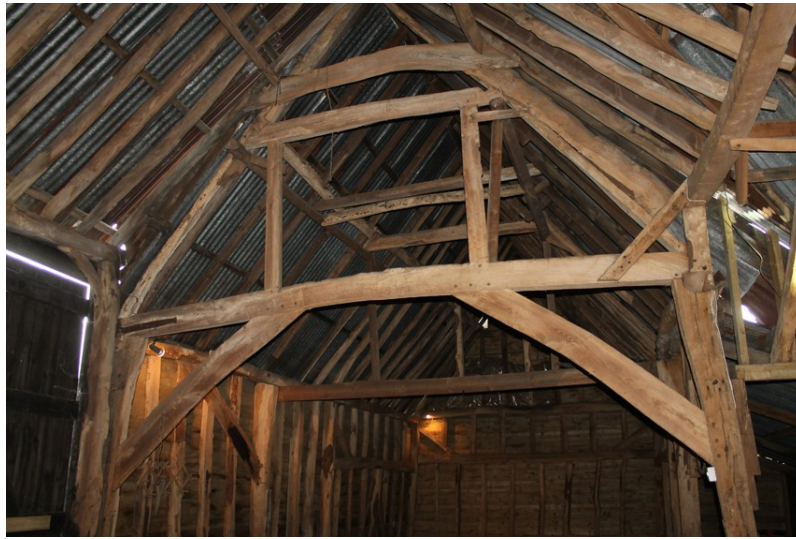
**Photograph 4** Detail of truss between bays 3 and 4. Photograph taken facing west.

Further emphasising this are the wall-plates in bay 3, which project slightly east from the truss, into bay 4, and are then cut (Photograph 4). The east side of the principal-posts between bays 3 and 4 has the same notches and grooves as observed elsewhere within bays 2 and 3.

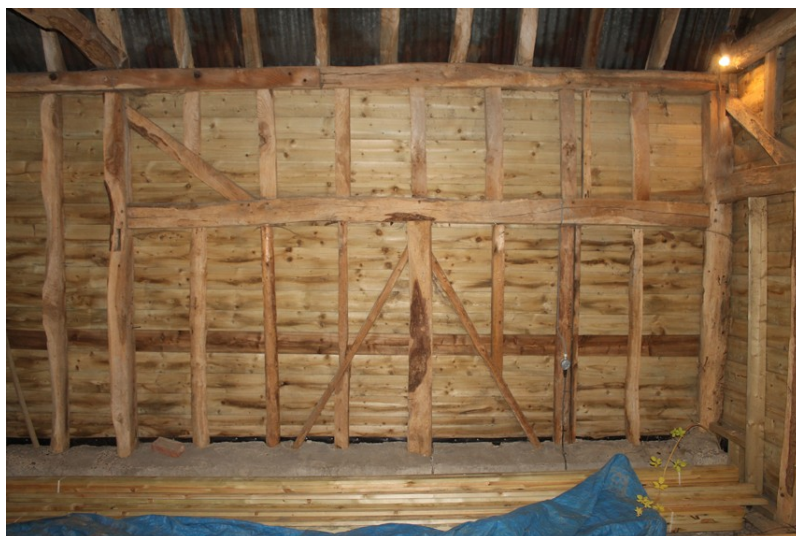
**Photograph 5** Detail of southern elevation of bay 1, showing girding-beam and nailed together lower-register. Photograph taken facing south-west.

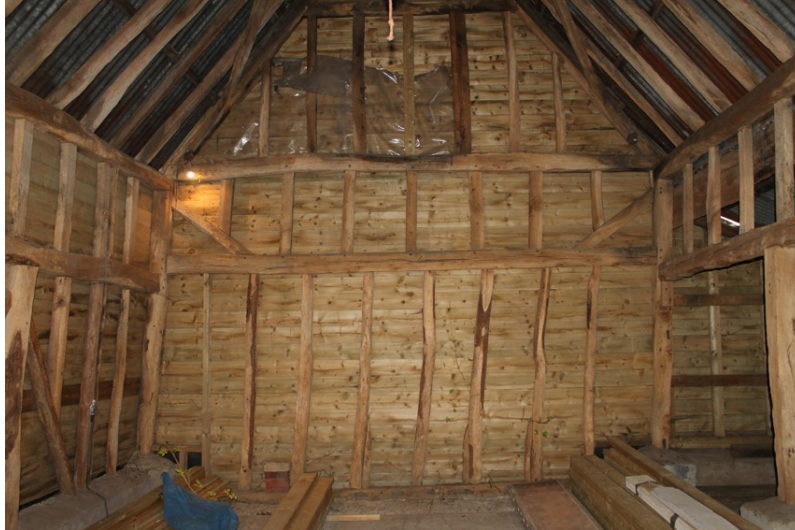
**Photograph 6** Western elevation of barn (in bay 1). Re-used sill beam with empty mortices visible. Wind-braces visible in roof above. Photograph taken facing north-west.

The roof above bay 1 is as described above, but with the addition of a wind brace on the western end of each pitch to further support the rafters (Photograph 6).

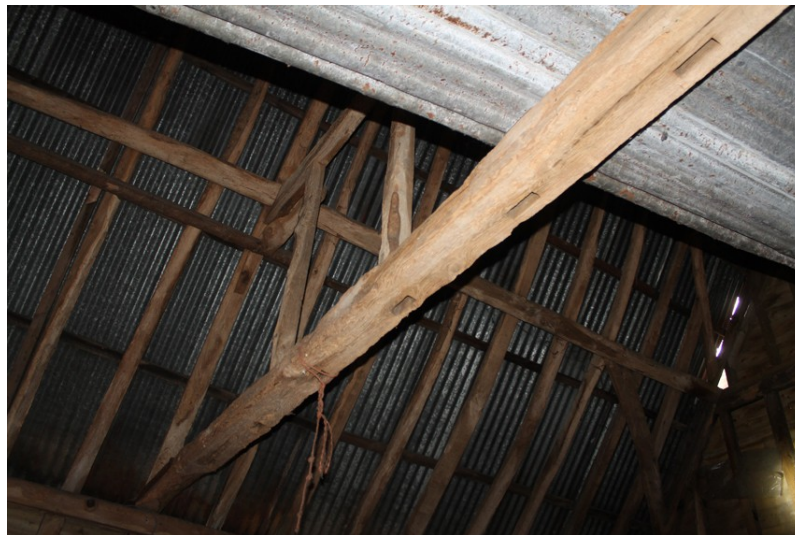
**Photograph 7** Detail of underside of tie-beam between bays 1 and 2, showing empty mortices. Photograph taken facing south-west.

The truss between bays 1 and 2 is all original and hand-sawn, and contains a substantial amount of empty mortices. This includes: on the underside of the tie-beam (Photograph 7), on the inner faces of north and south principal-posts supporting the tie-beam (Photograph 9) and the collar above has two empty mortices at either end, in addition to the queen struts (Photograph 8). Whether these mortices represent a previously removed division in this location, or are the result of re-use, is examined in the discussion (pg 17).

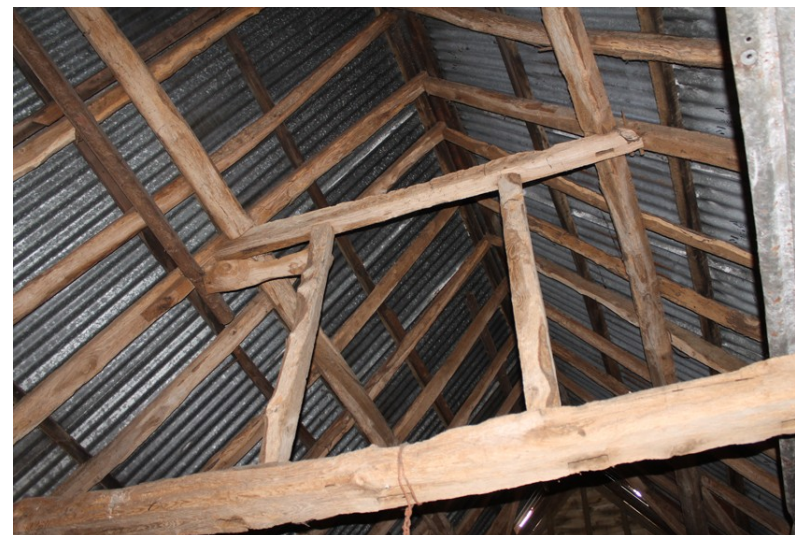
**Photograph 8** Detail of underside of collar between bays 1 and 2, showing empty mortices at each end, adjacent to queen-struts. Photograph taken facing east.

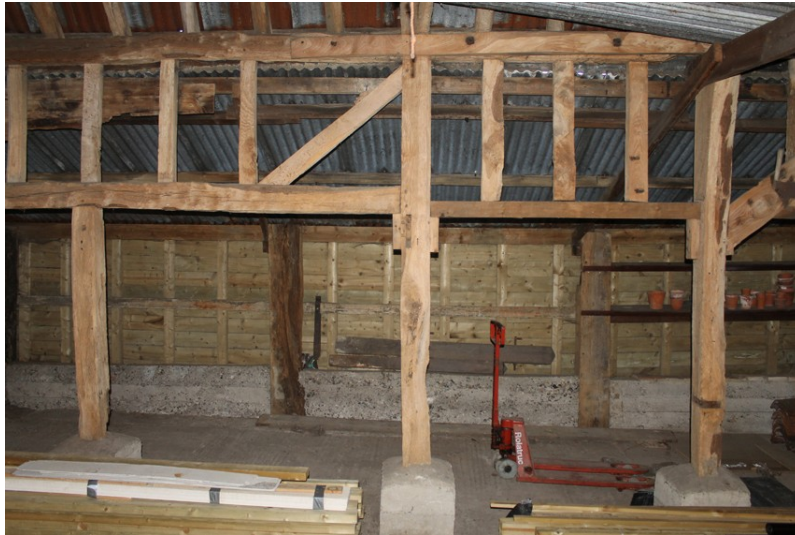
**Photograph 9** Detail of northern principal-post between bays 1 and 2, showing frames on either side. Photograph taken facing north-east.

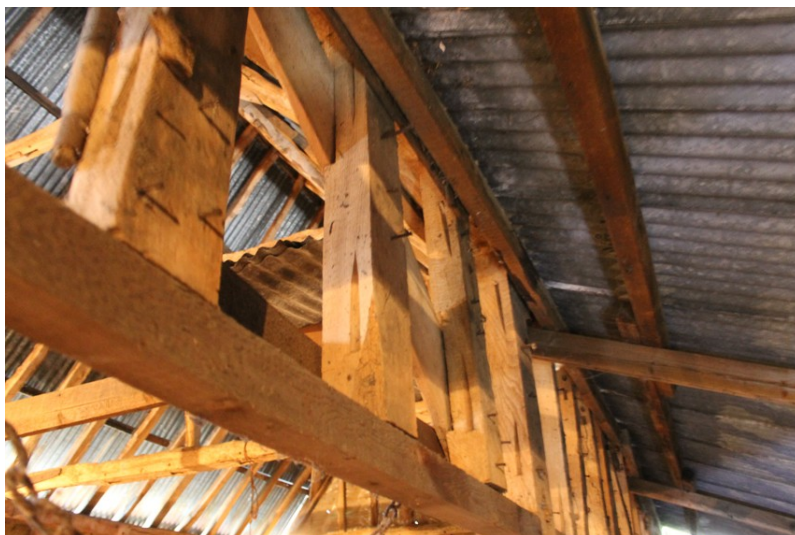
**Photograph 10** Detail of studs in bay 2, showing grooves. Photograph taken from western lean-to, facing west.

The series of grooves and notches on the timbers of bays 2 and 3 would have supported sections of infill within panels between the studs and posts (see pg 10). Although none of this infilling survives, it probably was either a form of wattle and daub or a type of timber panelling. Very similar notches were observed by CAT during a recent building recording of the 15th-century core of the White Hart Hotel in West Mersea (CAT Report 1324, 40), and during the renovation of that property intact sections of timber panelling were observed *in situ*, supported by wooden straps within the grooves. However, if this infilling method does date from the 15th century, it seems unlikely to have been present within the barn.

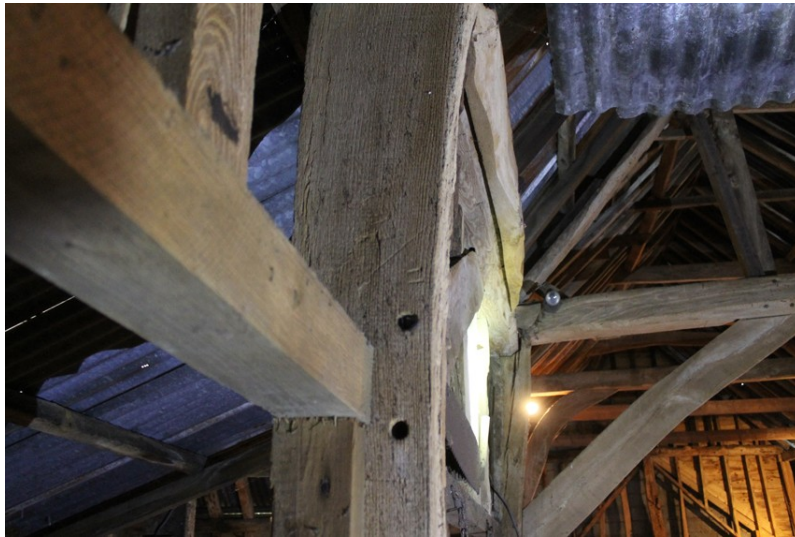
**Photograph 11** Detail of carpenter's mark "IV" on northern principal-post between bays 2 and 3. Photograph taken facing east.

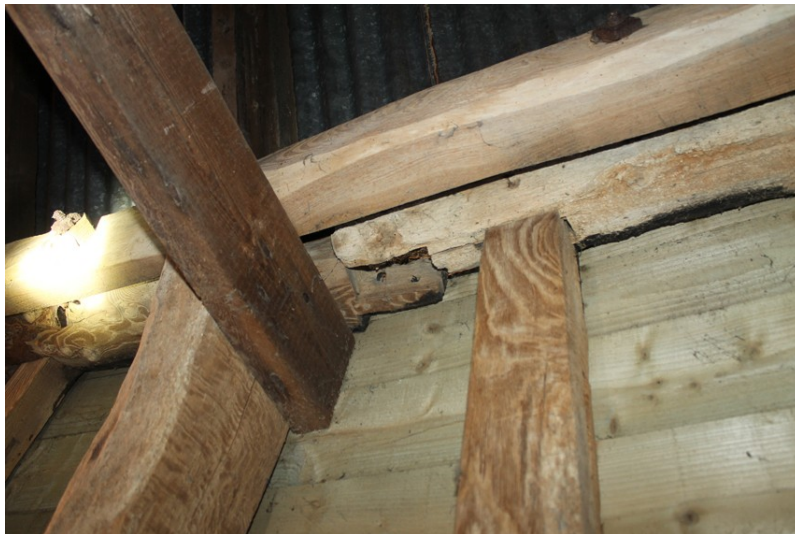
On the northern and southern wall-plates of bay 2 are two scarf joints, both just to the west of the principal-posts between bays 2 and 3. These scarf joints are partially sprung and difficult to identify. They appear to be straight bridlings in open mortices with vertical abutments and two edge pegs (Photograph 12).

**Photograph 12** Detail of partially sprung scarf joint in southern wall-plate of bay 2. Photograph taken facing south.

In addition, the scarf joints in the north and south wall-plates of bay 2 are very peculiar in form, comprising a straight bridling in an open mortice. This form of joint would seem to be far more appropriate for use in a sill-beam and appears wholly unsuited for use in wall-plates. Were they not directly supported by the principal-posts between bays 2 and 3 there is little doubt these joints would have failed, and indeed they have already sprung considerably (pg 11). Whether the presence of these unsuitable joints is the result of re-use of timbers or poor knowledge of carpentry techniques on the part of the builders is uncertain.

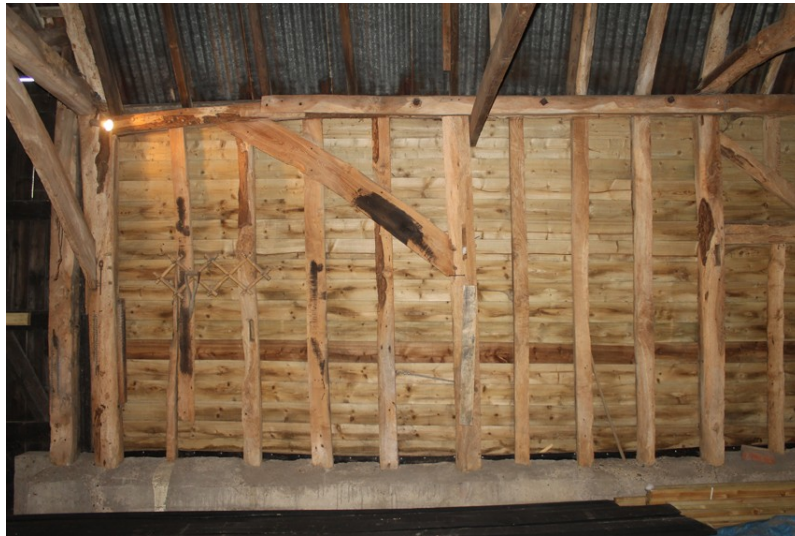
**Photograph 13** Southern elevation of bay 3, showing arched brace. Photograph taken facing south-west.

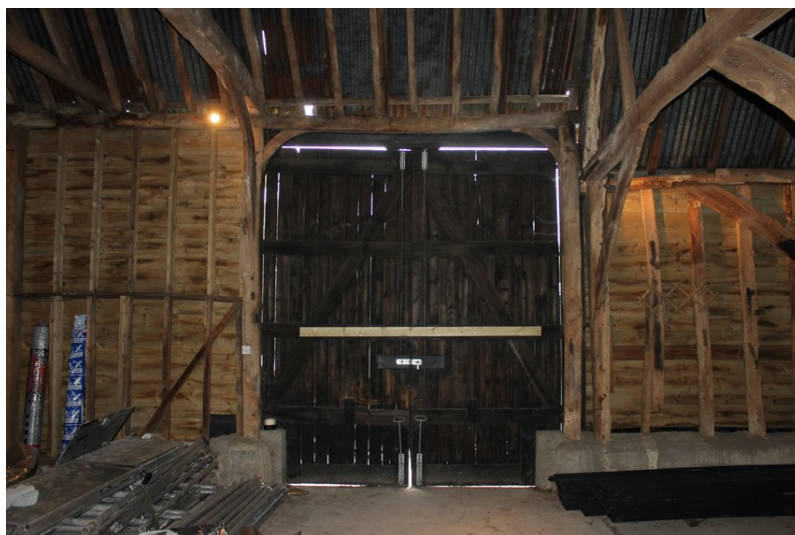
This bay measures 3.2m in width, and is the largest bay in the barn (Fig 3). With the midstrey directly to the north-east and with a full-height set of barn doors on its southern elevation, this bay would have at one time contained a threshing floor, presumably made of brick. Due to the full size of the barn doors and the opening for the midstrey, this bay actually has very little in the way of timber-framing. The posts on either side of the barn doors on the south elevation are substantial and hand-sawn. There are two small arched braces projecting from the posts that are nailed in place and serve to support the wall-plate above the doorway (Photograph 14).

**Photograph 14** Detail of barn doors in southern elevation of bay 4. Photograph taken facing south-west.

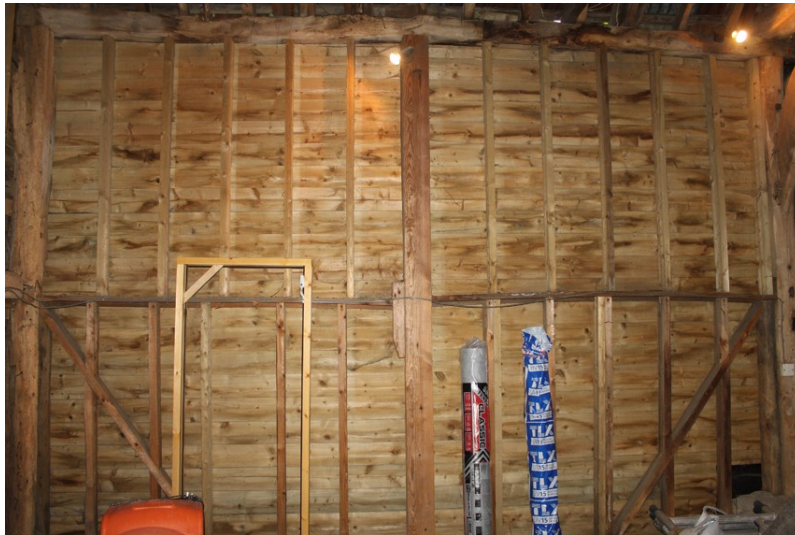
**Photograph 15** Southern elevation of bays 5 and 6, showing rebuilding using modern machine-cut timber. Photograph taken facing south-west.

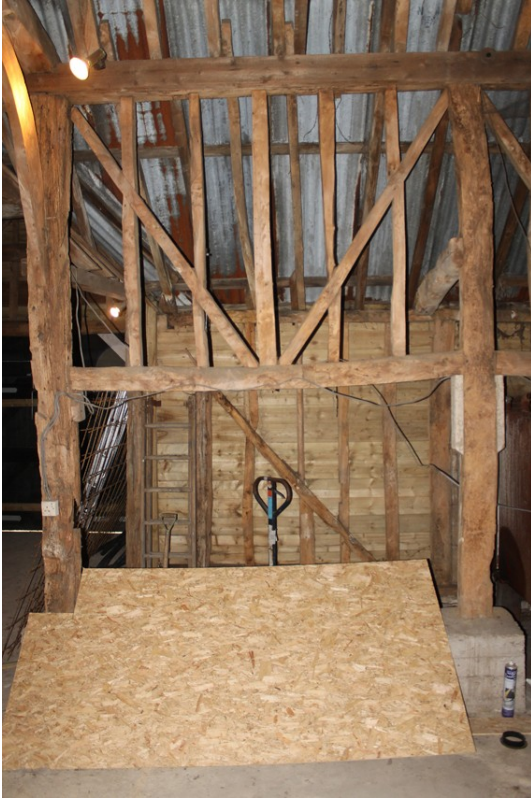
**Photograph 16** Northern elevation of bay 5. Photograph taken facing north-east.

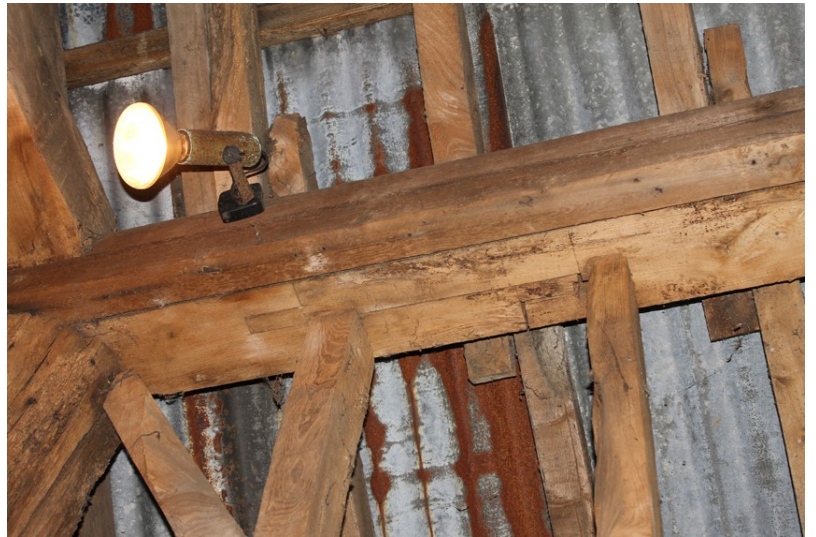
On the northern and southern wall-plates of bay 5 are two scarf joints. The one on the southern wall-plate is quite degraded, but they both appear to be face-halved bladed scarfs with two edge-pegs (Photograph 17).

**Photograph 17** Detail of scarf joint on northern wall-plate of bay 5. Photograph taken facing north.

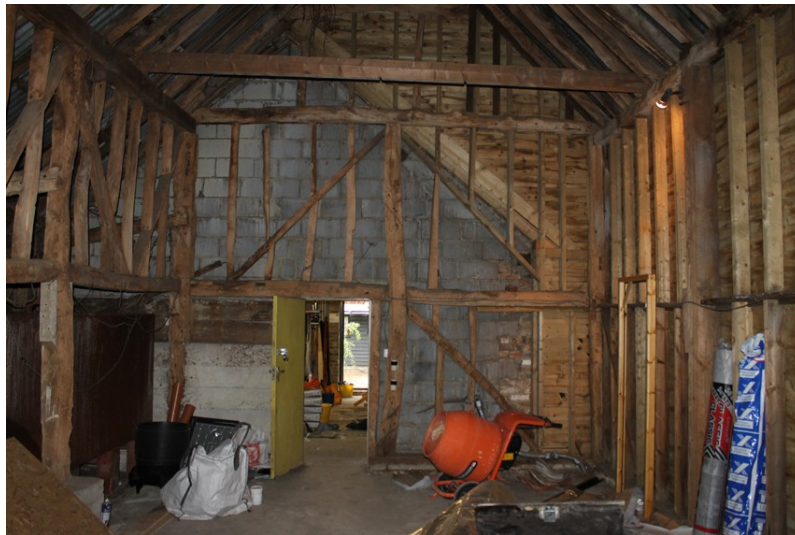
The east elevation of bay 6 (the eastern end of the barn) is constructed of a mix of hand-sawn and machine-cut timber and has a large amount of re-used timber in its make-up, including the girding-beam, corner-posts, wall-plate and intermediate-post (Photograph 18).

There is no tie-beam between bays 5 and 6, only a collar and the principal-posts. In the middle of both bay 5 and 6, however, are modern machine-cut beams jointed to the north and south wall-plates (Photograph 18).

**Photograph 18** Eastern end of barn (in bay 6), with re-used timber. Photograph taken facing south-east.

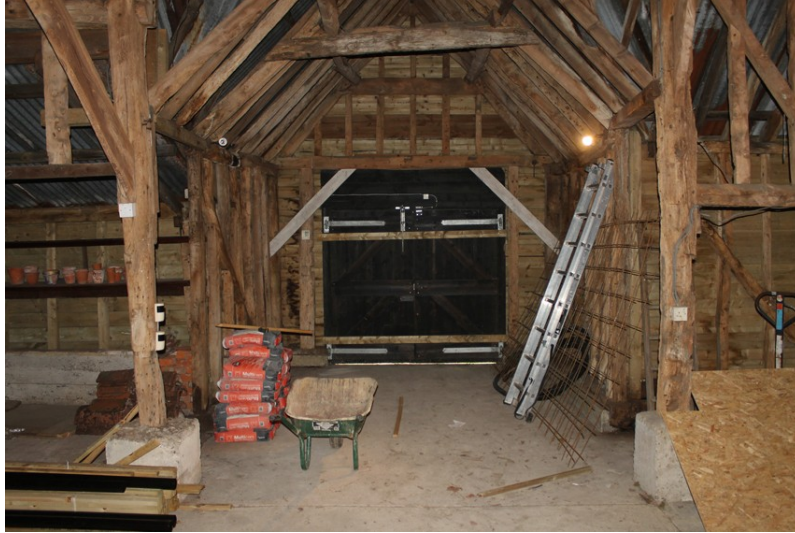
The timber-frame of the midstrey is largely constructed of hand-sawn timber, nailed-together and supported with through-bracing (Photograph 19). Like the majority of the barn, the midstrey's sill-beam is encased in concrete. The roof of the midstrey is made of hand-sawn timber rafters that join at a ridge-board and are supported by a centrally placed collar (Photograph 19). The eastern sill-beam of the midstrey abuts the sill-beam of the eastern lean-to (see below), but there is no jointing between the two structures.

**Photograph 19** Detail of midstrey, showing barn doors. Photograph taken from bay 4, facing north-east.

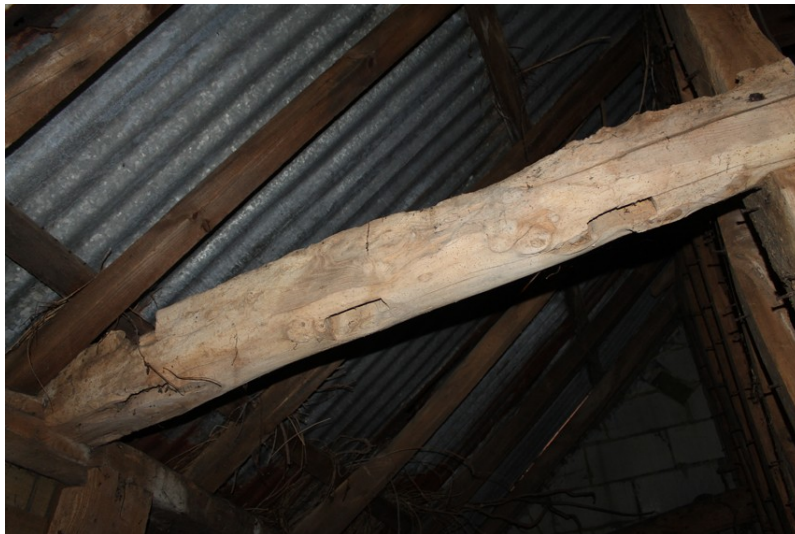
**Photograph 20** Detail of re-used beam in eastern lean-to, showing empty mortices. Photograph taken facing east.

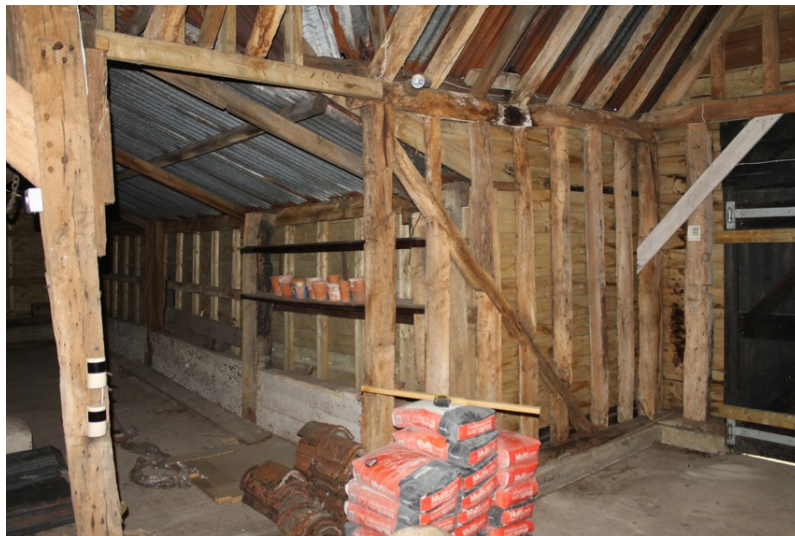
The timber-frame of this lean-to, including the roof, is entirely comprised of straight machine-cut timbers. The only exception to this is three large intermediate and corner-posts, with are hand-sawn, albeit in a very rudimentary fashion (Photograph 21). No scarf joints were observed in the frame of this lean-to.

This lean-to has no relationship at all with the midstrey and is clearly a modern addition to the barn.

**Photograph 21** Western elevation of midstrey, showing western lean-to to the left of frame. Photograph taken facing north-west.
