# Historic building recording of Foley House, 115 High Garrett, Braintree, Essex, CM7 5NU

CAT project ref.: 2021/02g  
NGR: TL 77626 27165 (c)  
Planning reference: 20/01391/FUL  
ECC site code: BTFH21  
OASIS project id: colchest3-417194

**CAT Report 1695**  
August 2021

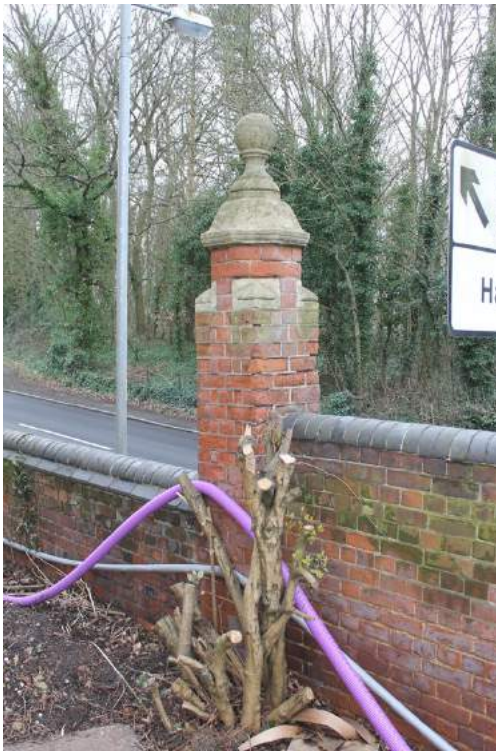
**Photograph 3** Brick pillar and stone corbel at original end of boundary wall surrounding Foley House. Modern inserted brick wall to left of frame. Photograph taken facing east.

The property boundary of Foley House is delineated on its eastern side by a red brick wall, laid in English-bond with queen closers and topped with a series of over-fired capping bricks. The measurements of the brickwork are similar to that of house's brickwork, and one of the end capping bricks is inscribed with "H. Doulton & Co", a manufacturer of bricks and stonewares in the late 19th century ([gracesguide.co.uk](http://gracesguide.co.uk)). This, combined with the similar nature of the brickwork to the house's fabric, suggests that the wall is probably the estates original eastern boundary. Two brick pillars, topped with carved stone corbels (Photograph 3), would have originally formed either side of a large opening in the wall, corresponding with the south-east elevation and its large ground-floor doorway (see below). This opening has since been infilled with a modern red brick wall (Photograph 3).

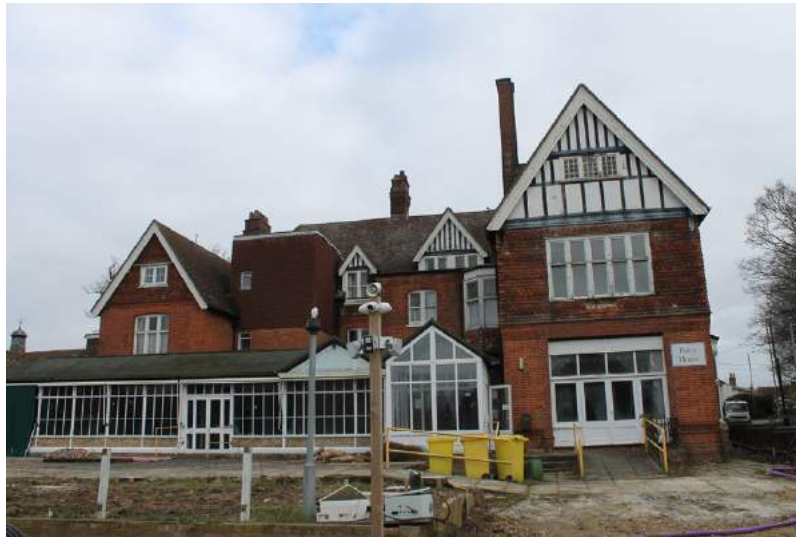
**Photograph 4** South-west elevation of Foley House. Modern extension out of shot to left of frame. Photograph taken facing north-east.

The south-west elevation of the building is extremely busy, with multiple ranges visible. The ground-floor is dominated by the conservatory, which has three rows of fixed windows (Photograph 4). The lower two rows are modern safety glass, but the top row is plate glass, and probably original. At the top of each mullion between the windows is a carved corbel supporting the eaves above, although some of these have been damaged (Photograph 5).

Beneath the windows of the conservatory are timber panels in-filled with regular brickwork, measuring 220mm x 100mm x 60mm and laid in stretcher bond. These appear to be modern insertions that have replaced either glass or wooden panels in these locations.

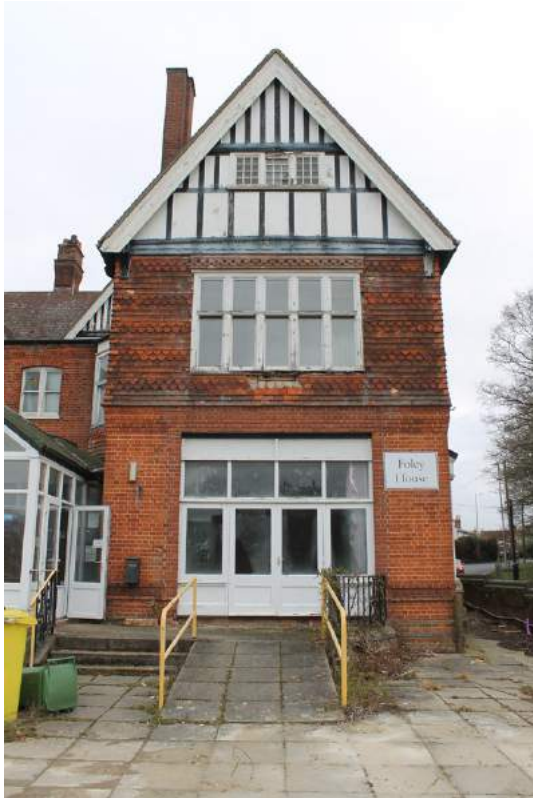
**Photograph 8** Detail of eastern-wing on south-west elevation. Replacement windows and brickwork visible on ground-floor. Photo taken facing north-east.

The first-floor of the east-wing on this elevation is covered in decorative hanging tiles. An original window with five two-light horned sashes and a moulded wooden-frame is also present on the first-floor (Photograph 8). The gable, as well as containing

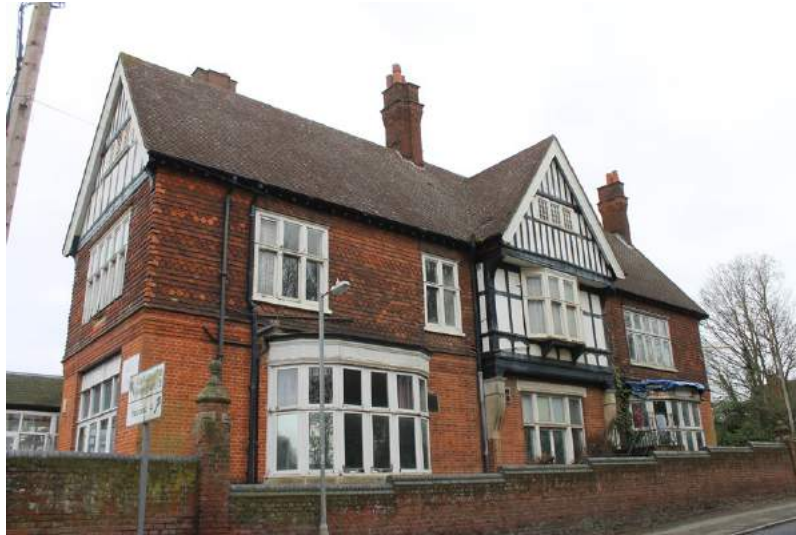
**Photograph 9** South-east elevation of Foley House. Photograph taken facing north.

The south-east elevation entirely comprises the eastern-wing, the only exception is the south-east elevation of the modern porch projecting off of the conservatory (Fig 9). On the ground-floor of the eastern wing are two bay windows, symmetrically placed on either side of the building. These bay windows have a carved stone sills and are filled with replacement 16-light casements, but originally would have contained narrow sash windows (Photograph 9).

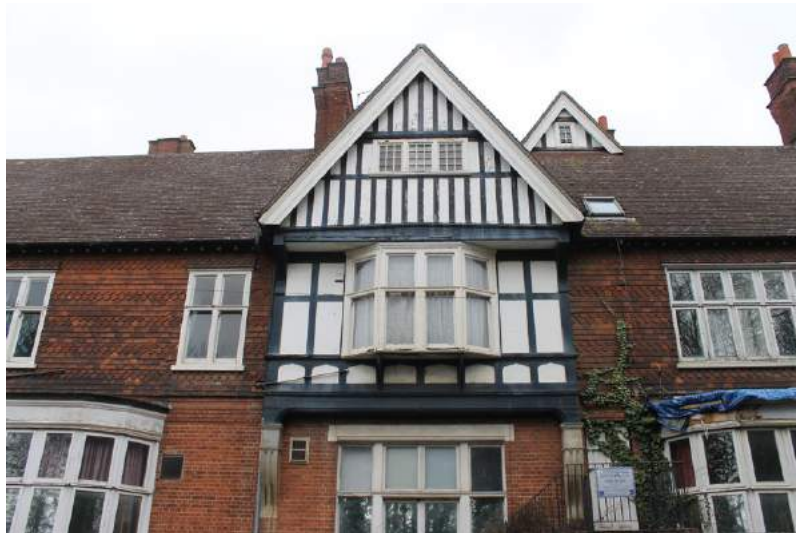
**Photograph 10** Detail of central projecting imitation timber-framed bay with oriel window on south-east elevation. Inserted modern door visible to right of bay. Photograph taken facing north-west.

Adjacent to, on the southern side of, the northern bay window on the ground-floor is an inserted six-panel modern door, around 1.1m above the ground-level (Photograph 10). It is accessed by an inserted, modern, metal staircase, that also now provides access to the original entrance on this elevation (see above), which originally would have been accessed by a flight of steps facing the road (Fig 9).

On the first-floor of this elevation is a large imitation timber-framed projecting bay, supported on carved stone corbels positioned either side of the original ground-floor entrance (Photograph 10). This suspended bay has a centrally-located oriel window containing four narrow horned sash windows (Photograph 10). Above this bay is a

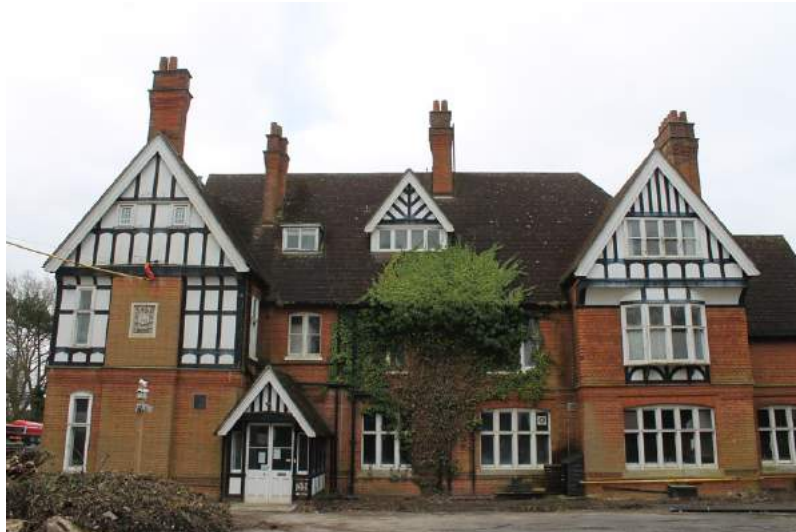
**Photograph 11** North-east elevation of Foley House. Photograph taken facing south-west.

The north-east elevation of the eastern wing has a single narrow two-light horned sash window on the ground-floor, with an identical one above it on the first-floor (Photograph 11). Above the first-floor is another projecting, jettied gable, containing two small modern plastic-framed 9-light casement windows (Photograph 11). This projecting gable and the first-floor are covered with imitation timber-framing, with the exception of a central projecting brick chimney-stack on the ground and first-floors. In the centre of this projection is a carved stone relief containing the date "AD 1885" and the initials "S.A.C" (Photograph 13).

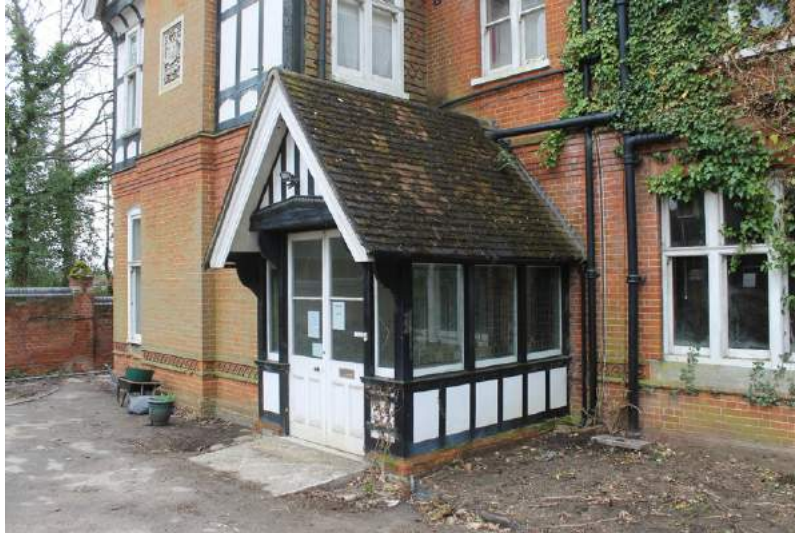
**Photograph 12** Detail of porch projecting from north-east elevation, with stained-glass windows visible. Photograph taken facing south.

The north-east elevation of Foley House has a small porch at the ground-floor level, with imitation timber-framing that mimics the framing on the gables around the building (Photograph 12). Although the doors and east facing windows on this porch are modern replacements, the original windows on its northern elevation are leaded and constructed of stained glass (Photograph 12).

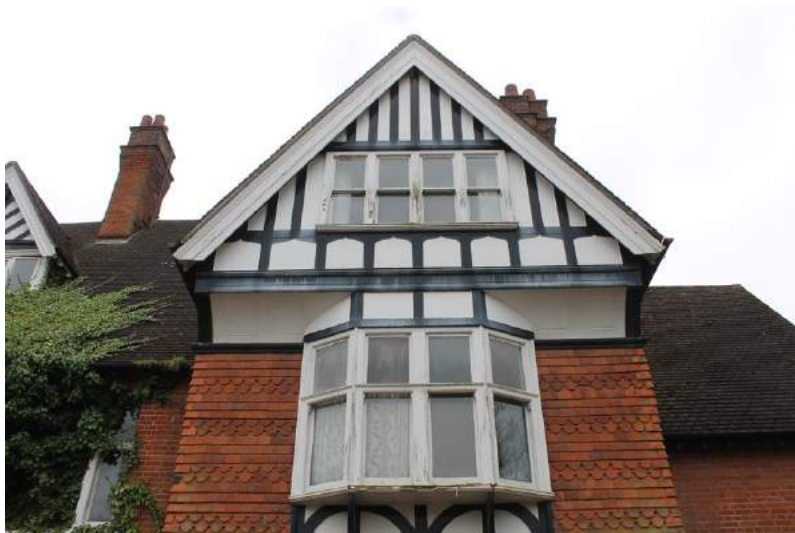
**Photograph 14** Detail of projecting bay at west end of north-east elevation, showing oriel window and jettied gable. Photograph taken facing south-west.

this oriel window the gable is jettied and has imitation timber-framing, along with four narrow horned sashes (Photograph 14).

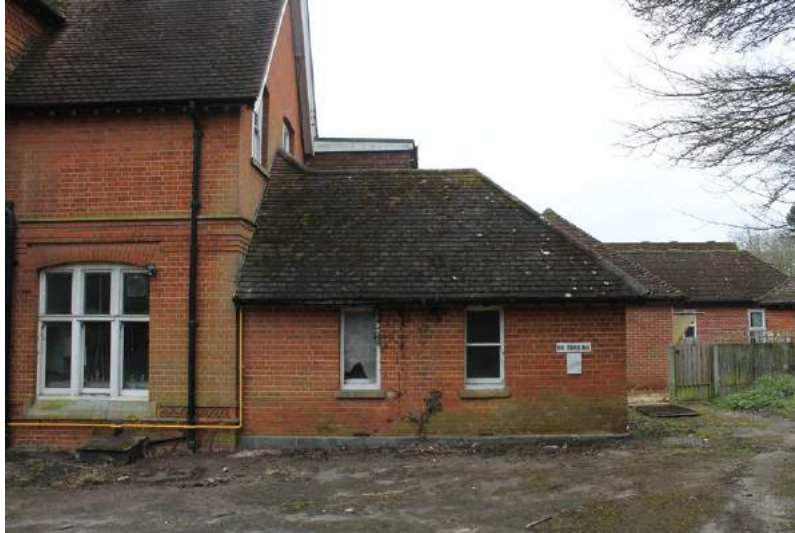
**Photograph 15** Single-storey range at western end of north-east elevation. Despite appearances, probably original. Photograph taken facing south-west.

The western end of this elevation contains a single-storey range (Photograph 15) with two narrow sash windows and identical brickwork to the main building (although the decorative tile course does not continue onto it).

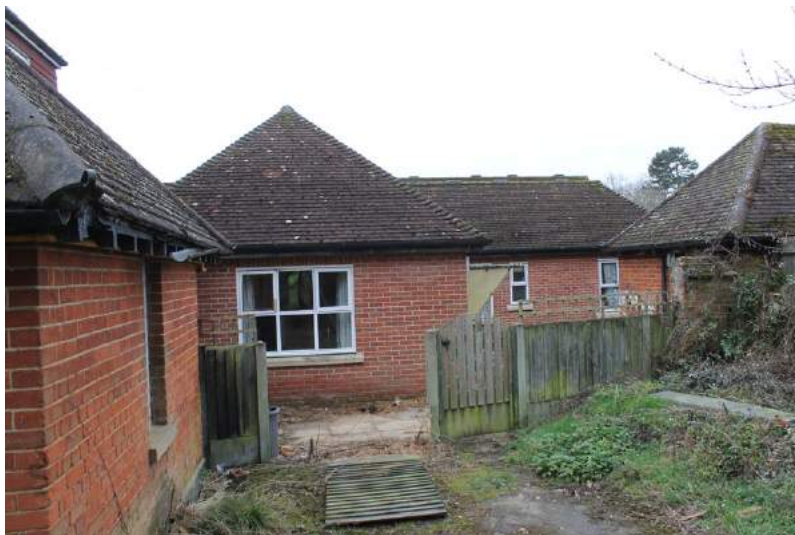
**Photograph 16** Modern extension on north-east elevation. Photograph taken facing south-west.

Further west still on this elevation is the rear of the modern range observed on the south-west elevation (Photograph 16).

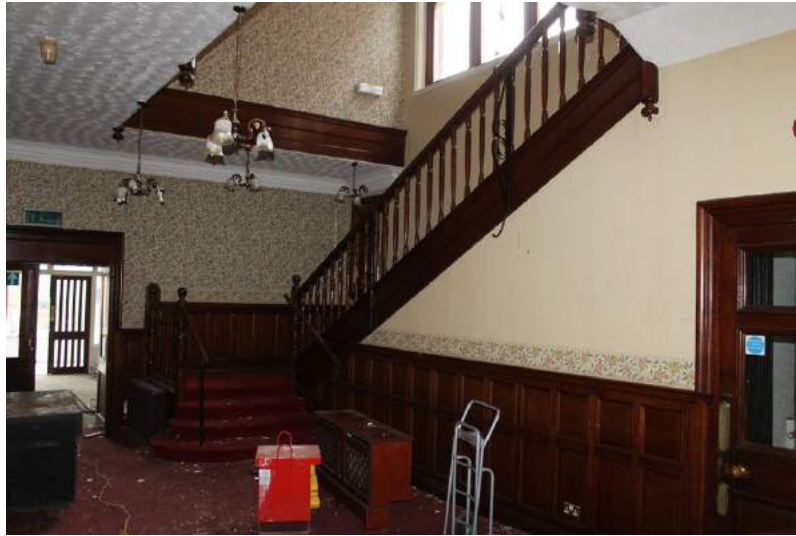
**Photograph 23** Room 8, showing original staircase. Photograph taken facing west.

Room 8 is the main hall of the house, and contains an original substantial wooden staircase rising to the first-floor, with turned balusters, and newel posts with ball finials (Photograph 23). The fireplace on the eastern wall of this room has been significantly altered, with a large modern brick surround added (Photograph 24). Similar to rooms 11 and 12, room 8 contains wooden-panelling. A series of large fixed windows on the north-west elevation provide light into the stairway (Photograph 23). Although clear today, originally these windows would have been filled with stained glass (as per the
