**Historic building recording at the Coach House, Wakes
Colne Mills, Colchester Road, Wakes Colne, Colchester,
Essex, CO6 2BY**

May 2021

CAT Report 1698
November 2021

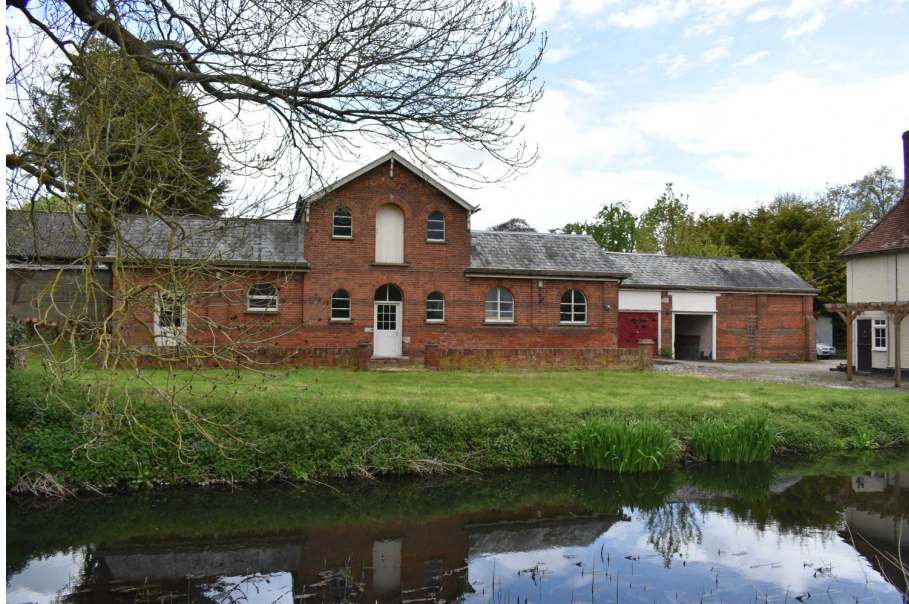
Photograph 1 South elevation of coach house - view north.

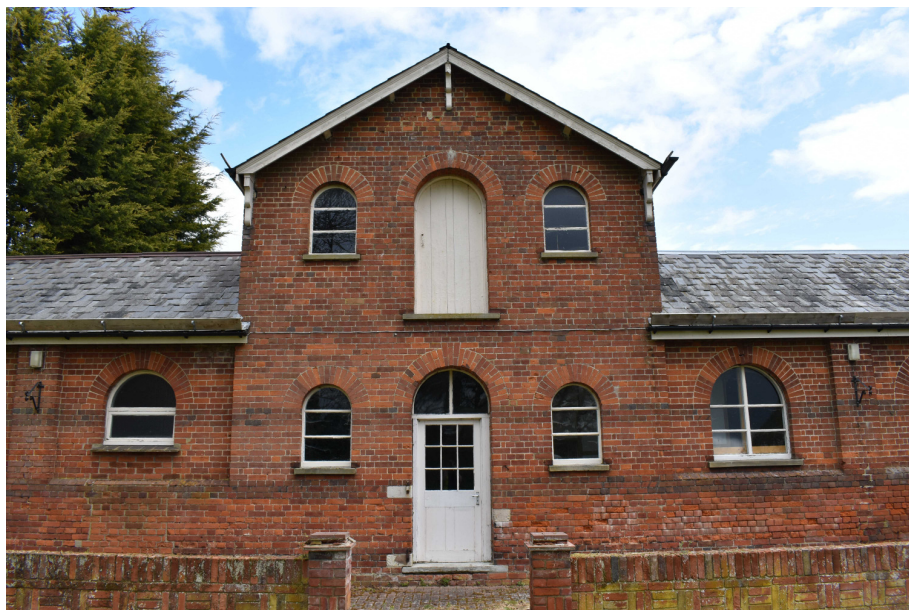
Photograph 2 South elevation of the main range - view north.

To the east of the cross-wing there are two large six-light windows, original to the structure (Photograph 2). On the brickwork between these windows a series of parallel lines has been carved into the bricks, possibly some form of tally (Photograph 5)

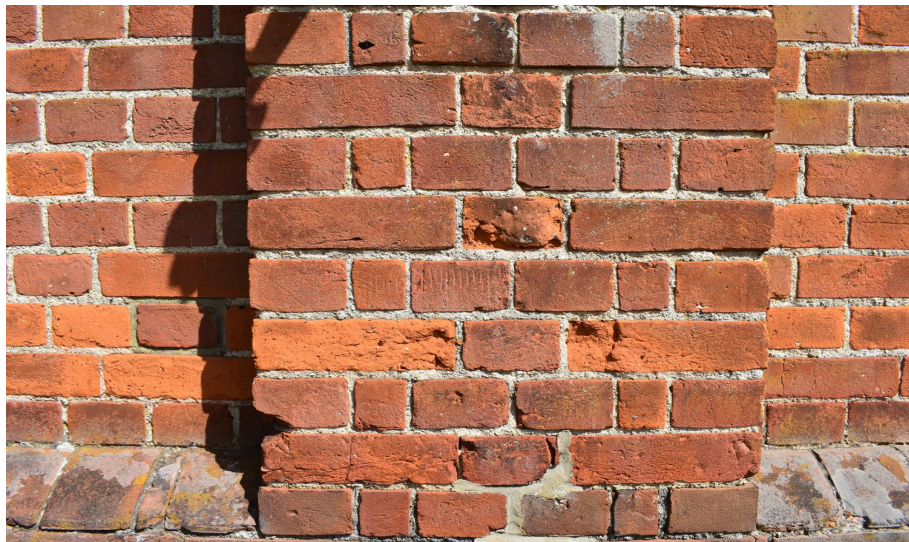
Photograph 5 Detail of graffiti on south elevation of the main range – view north

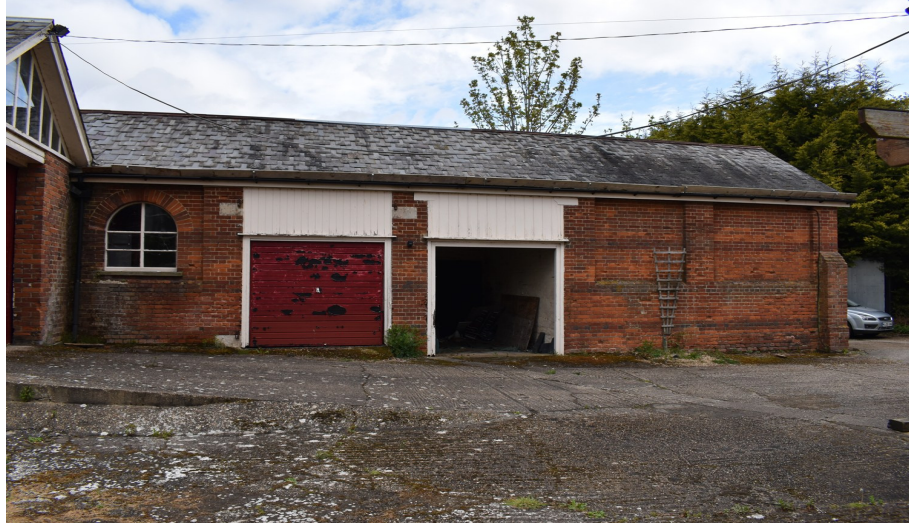
The south elevation of the secondary range has a six-light window identical to those on the main range and two large original openings (Photograph 6). Although these openings have subsequently been blocked with modern garage doors the presence of limestone blocks with iron pintles surrounding the west opening indicate that this was originally covered by a set of double carriage doors. The east opening is without any evidence for limestone blocks which suggests the opening was never equipped with doors. Although speculative this may indicate that a more expensive carriage was stored behind the western opening and that the eastern bay held a working cart associated with the mills' activities.

Photograph 6 South elevation of the secondary range – view north

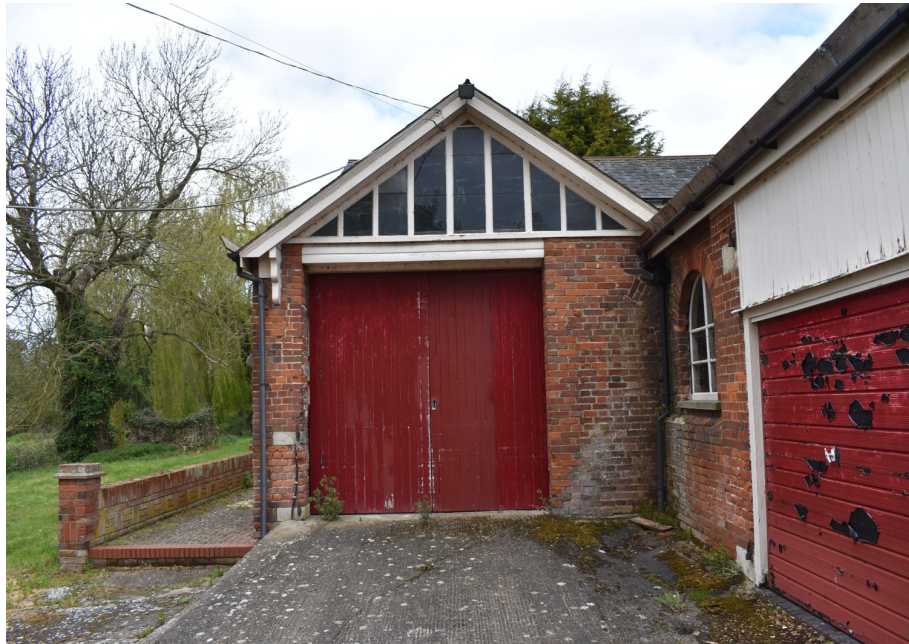
The eastern elevation displays the gabled ends of the main and secondary ranges with the second storey of the cross-wing above (the wall of which is shown to be finished in white-painted weatherboard rather than the brick which is common to the rest of the structure). The gable end of the main range has been substantially altered by the insertion of a pair of full height timber doors which has also removed much of the surrounding original brickwork (Photograph 8). However, enough of the original fabric survives to show that there was at least one stable door on this elevation, indicated by two limestone blocks with iron pintles to the southern edge of the elevation. The remains of a brick arch to the northern edge of the elevation indicates a second original opening, although it is unclear if this was for a window or a doorway. The brickwork of the gable itself has been completely replaced by modern timber-framed windows, although one original timber corbel survives.

Photograph 8 East elevation of the main range with an original stable door and second original opening compromised by later alterations – view west.

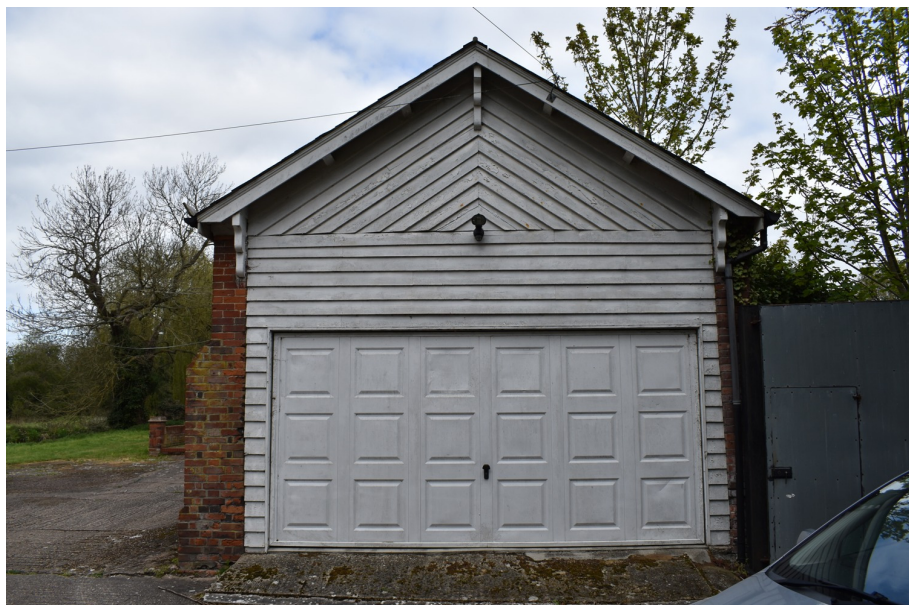
The eastern elevation of the secondary range is dominated by a large inserted garage doorway, surrounded by modern white-painted weather-boarding (Photograph 9).

Photograph 9 East elevation of the secondary range – view west.

Although the alterations to the east elevation of the secondary range have almost totally destroyed the original fabric, the presence of queen closers in the surviving brickwork on the south edge indicate that there was originally at least one doorway in this elevation. The original timber corbels and barge boards also survive.

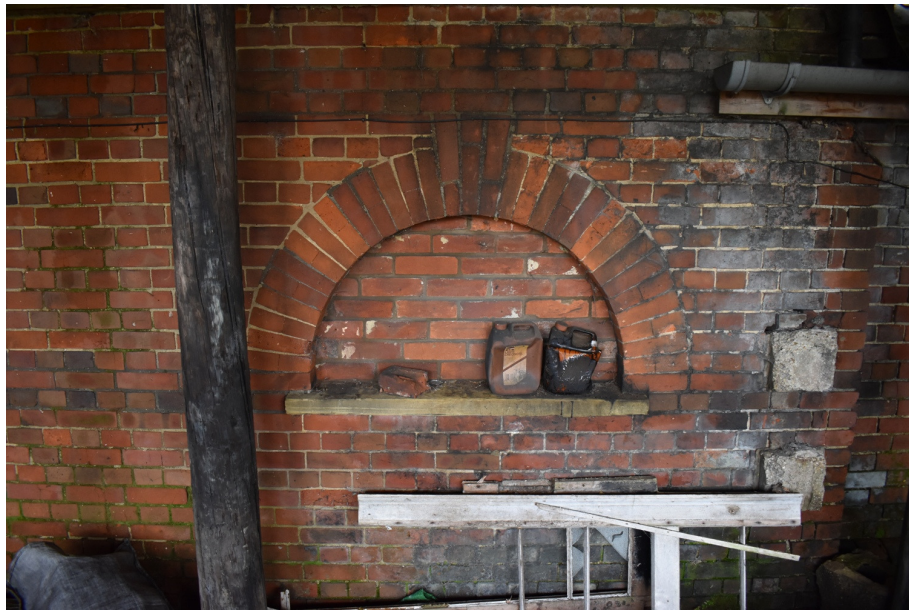
The northern or rear elevation of the main range is obscured by the presence of a large outbuilding constructed from modern timbers and clad in sheets of corrugated iron. This is open to the north which allowed access to the northern elevation of the main range. The upper storey of the cross-wing has two bricked-up window openings with arched heads truncated by two modern openings, to the east a larger window opening (subsequently infilled) and to the west a pair of timber pitching doors with strap hinges (Fig 3 – photography not viable due to the presence of the modern outbuilding). On its ground floor the cross-wing has two original semi-circular window openings with arched heads. These have been blocked with brickwork laid in stretcher bond (Photograph 10).

Photograph 10 Blocked window on the north elevation of the cross-wing to the main range – view south.

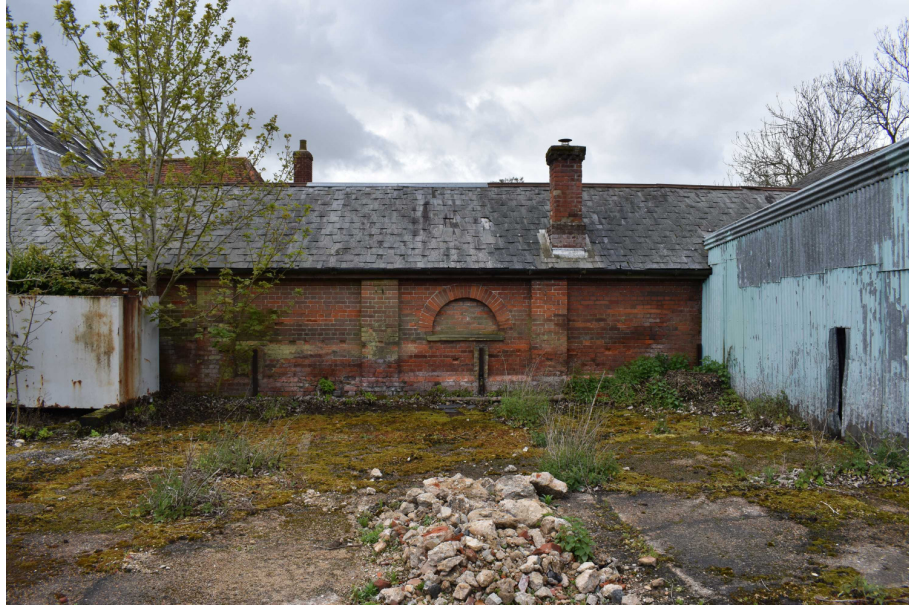
The north elevation of the secondary range has only one of these original windows (also blocked) with the remainder of the elevation displaying panels of plain brickwork (Photograph 11). A timber-framed six-light window has been inserted into the easternmost of these. An original chimney-stack survives above the slates of the roof to the secondary range – this appears to be the only chimney associated with the building.

Photograph 11 North elevation of the secondary range – view south.

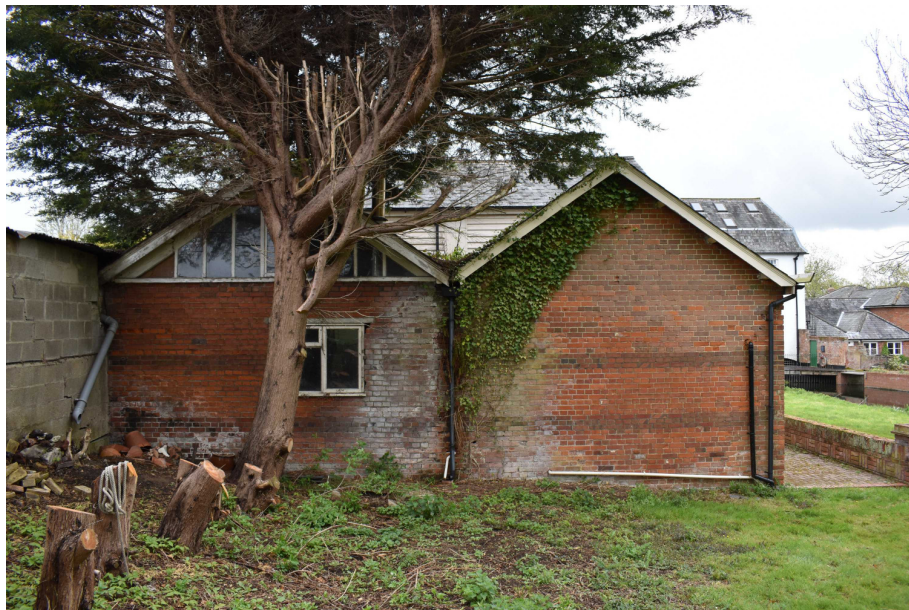
The western elevation (Photograph 12) has a double pitch roof resulting in two gable-ends with the two-storey cross-wing rising above. As with the east elevation this shows that the side of the cross-wing is formed from white-painted weatherboard rather than brickwork. The south gable comprises plain brickwork (the bands of decorative brickwork not withstanding) and it is likely that the northern gable end was also featureless prior to the replacement of the gable brickwork with six timber-framed windows (identical in construction to those inserted to the east elevation of the main range) and the insertion of a three-light window below this.

Photograph 12 West elevation of the main range - view east.

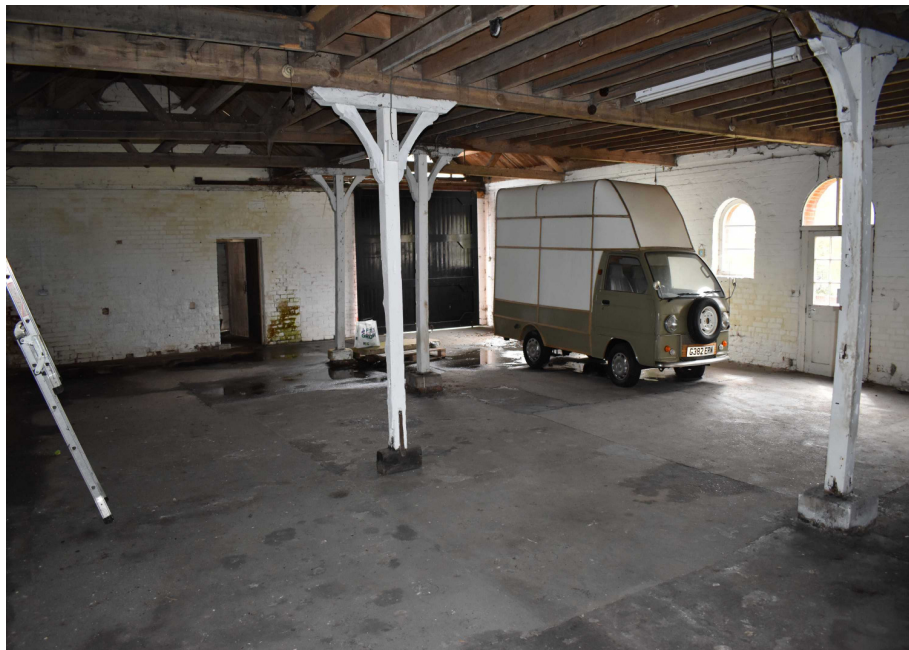
The largest room is located in and comprises the entire footprint of the main range (Room 1 on Fig 2) (Photograph 13) although inserted walls have created three small chambers in the west end (labelled Rooms 1a, 1b and 1c on Fig 2). The floor is of screeded concrete which either obscures or has replaced the original flooring which would have probably been formed from stable bricks. The ground-floor has five original posts, centrally located and aligned east to west although the central one has been relocated slightly to the north. The posts have straight-braces bolted on two sides and each support a tie-beam. There are a number of joists between the tie-beams supporting the floor of the cross-wing. Baltic timber marks are present on at least seven of these joists (Photograph 15). Mortices with the remains of sawn off tenons on the posts indicate this room was once subdivided (Photograph 14).

Photograph 13 Room 1 - view south-east.

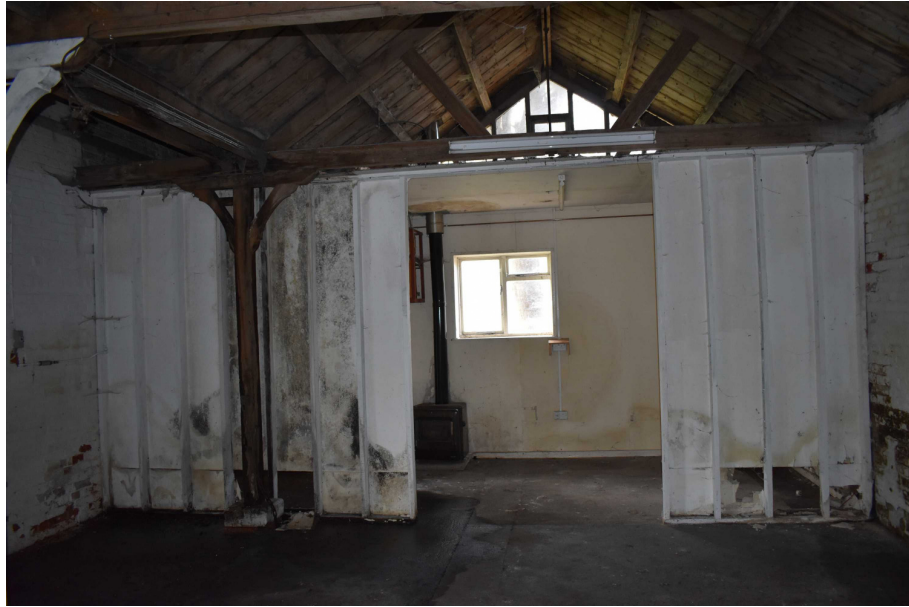
In the west end of Room 1 are three inserted rooms (Rooms 1a, 1b and 1c). The two smaller rooms have brick walls (Flemish-bond, brick dimensions 230 x 110 x 65mm) and are contemporary with one another. The larger of the three is formed by a timber stud-wall (Photograph 17) and appears to be a slightly later addition.

Photograph 17 Detail of inserted stud wall and original post in western end of Room 1 - view west.

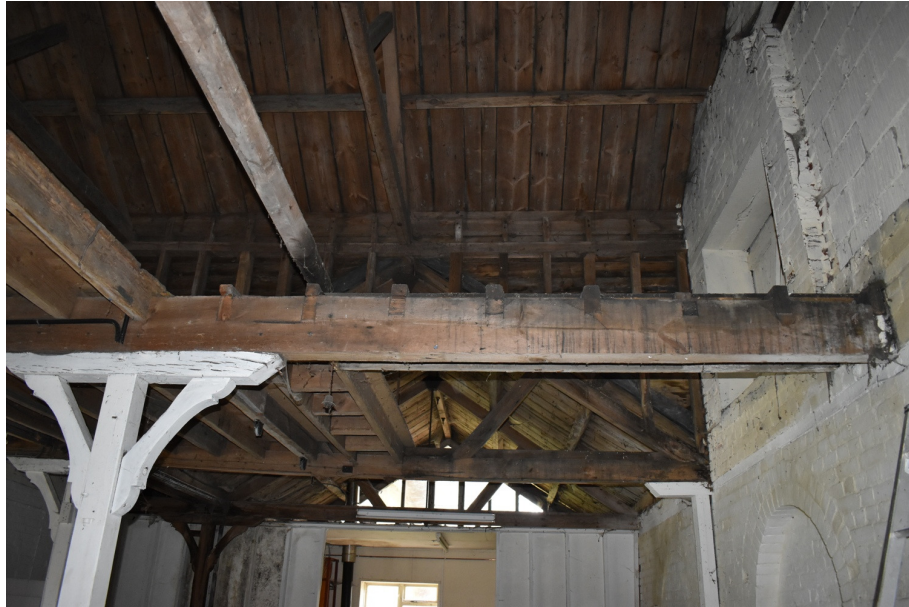
Photograph 19 Cut joists in the flooring of Room 6 - view west.

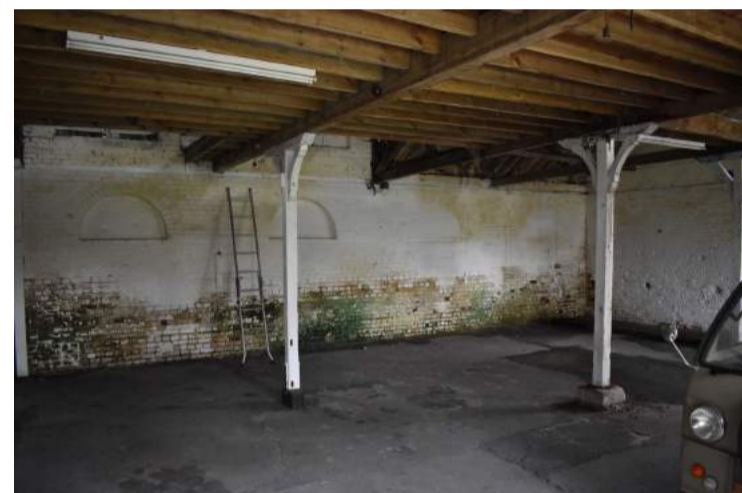
The north wall displays evidence of extensive water damage, probably a direct result of the increase in ground level to the north of the coach house.

ECC4613_Photograph_054
Room 1, showing extensive water damage to northern wall - view north-east.

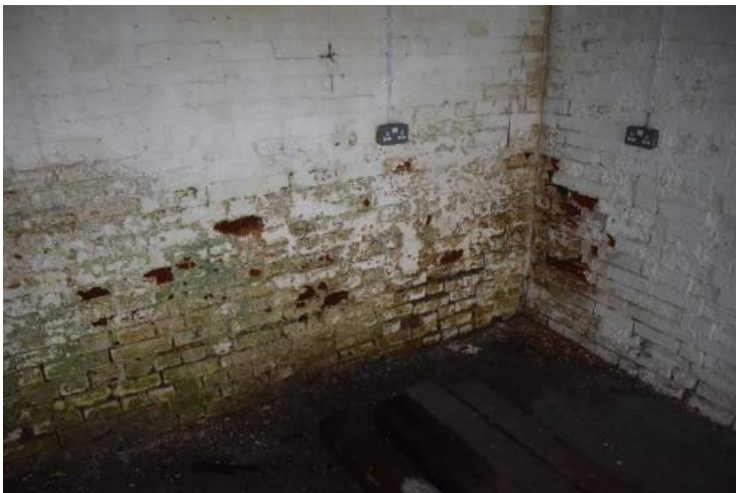
ECC4613_Photograph_061
Detail of water damage in Room 1's north-east corner - view north-east.

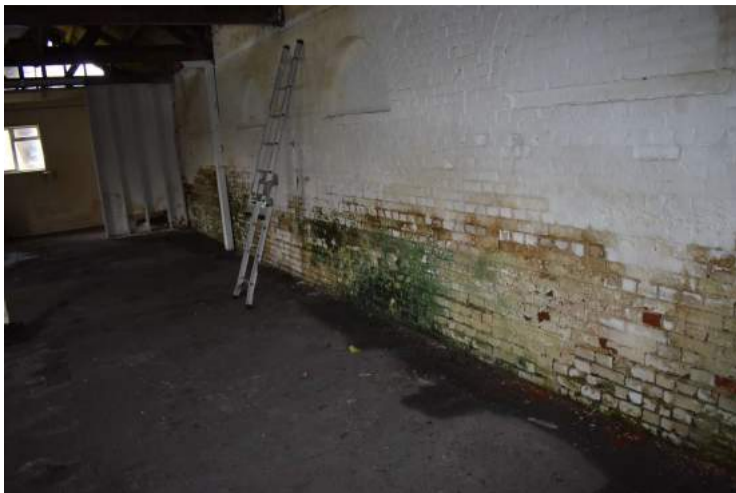
ECC4613_Photograph_062
Detail of water damage along northern wall of Room 1 - view north-west.

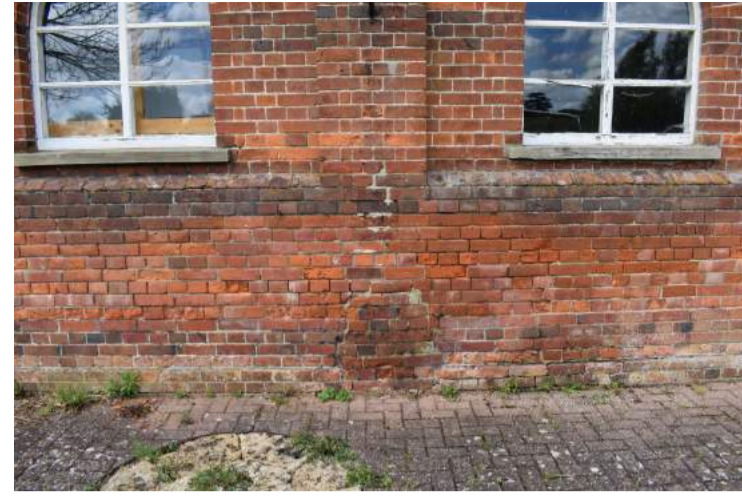
ECC4613_Photograph_147

Area of brickwork repair on southern elevation of coach house - view north.
