**Historic building recording of a cellar at Bentfield
Green Farmhouse, Bentfield Green, Stansted
Mountfitchet, CM24 8TH**

February 2022

CAT Report 1790
March 2022

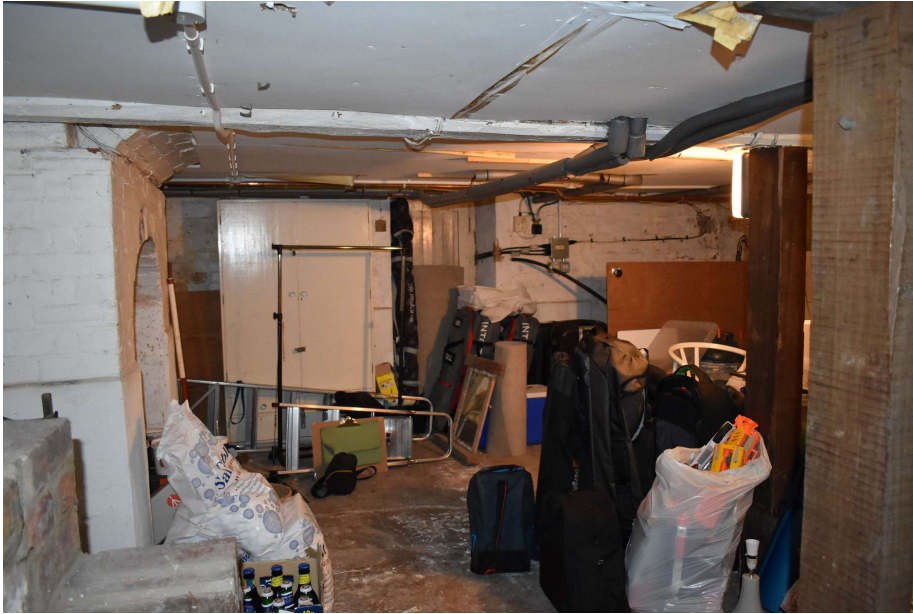
Photograph 1 Interior of cellar. Photograph taken facing east.

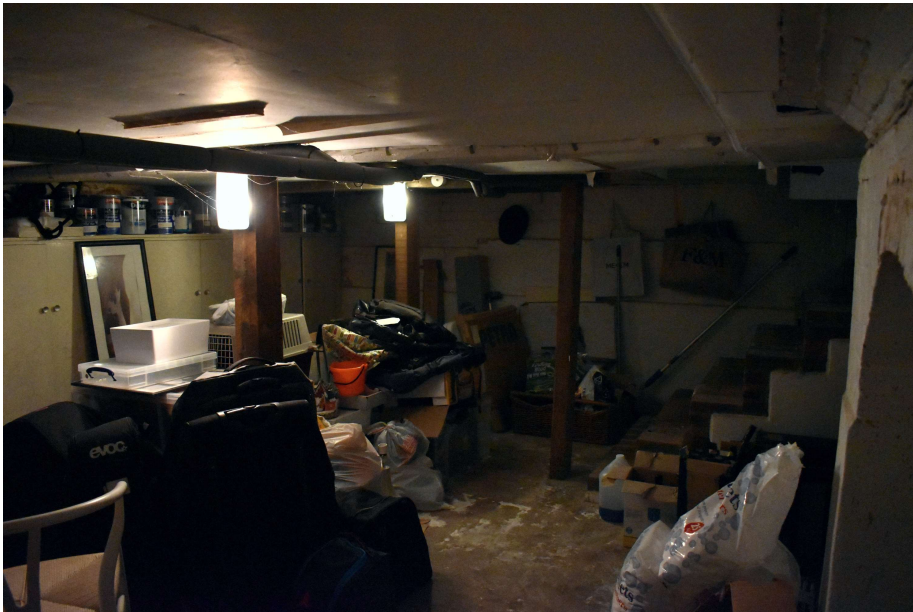
Photograph 2 Interior shot of cellar. Photograph taken facing south-west.

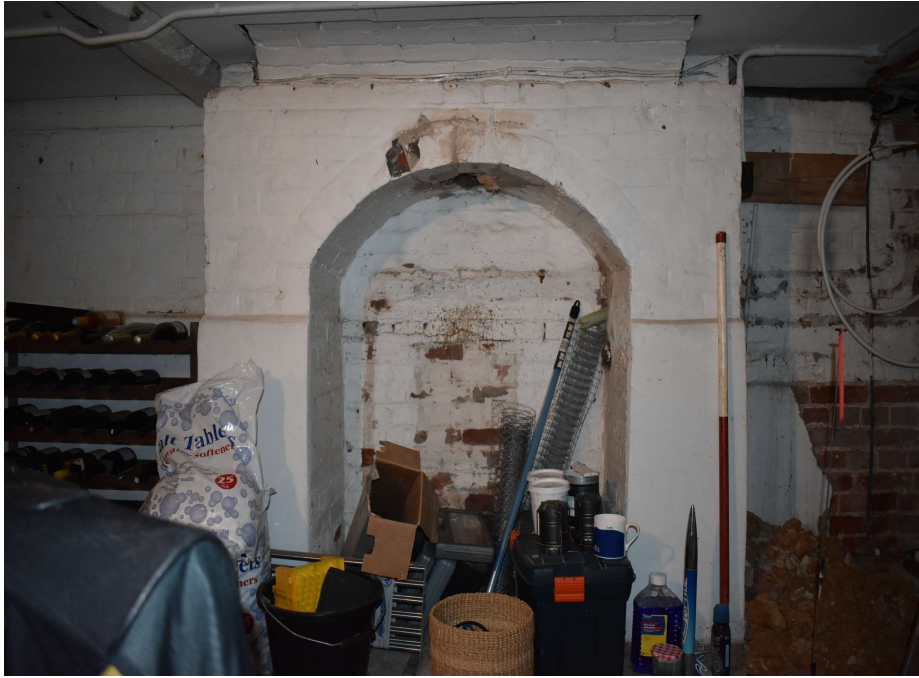
A brick arch is located on the northern wall. The arch is supported on straight brick piers. While it is clear the bricks used to construct the arch are not incorporated into the cellar wall, it is unclear if the rest of the structure is built into the wall or not. The arch also has a concrete skim on the outer surfaces, similar to the rest of the cellar walls. There is damage to the eastern side of the structure and at the top of the arch.

Photograph 3 Detail of the arch. Photograph taken facing north.

It is unclear whether the structure of the arch is incorporated into the walls of the cellar. If the cellar is original to the building, then it was simply built to provide strength to the chimney breast and fireplaces on the ground and first floors. If the cellar is a later addition, then the piers and arch were inserted to prevent the collapse of the existing chimney stack. Intrusive work to the existing brickwork and the removal of the many layers of white paint would be needed to answer this question definitively.

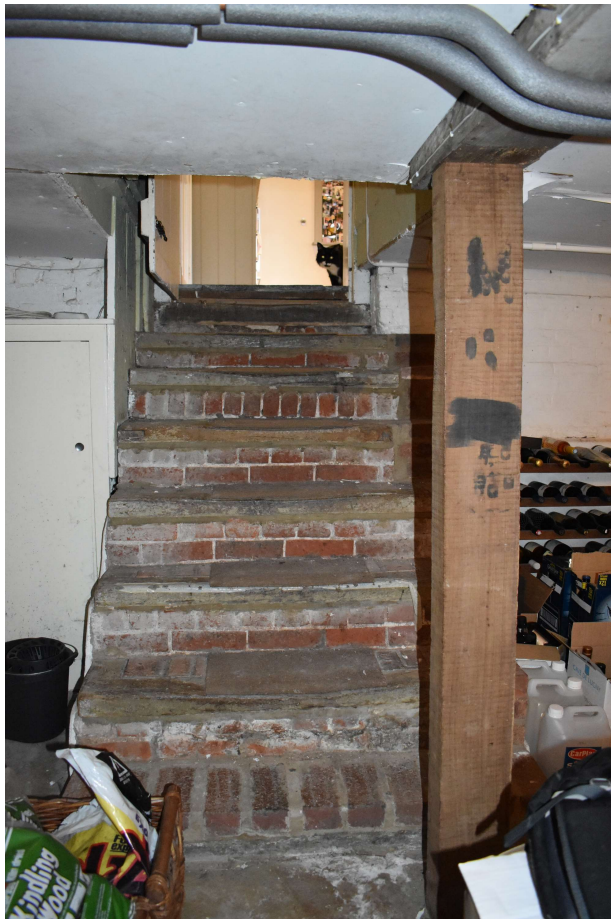
To the west of the arch is a modern staircase, which leads up into the kitchen of the house. The stairs are constructed from modern red brick with a timber tread. A modern cupboard is located in the north-west corner.

Photograph 4 Detail of interior stairs. Photograph taken facing north.

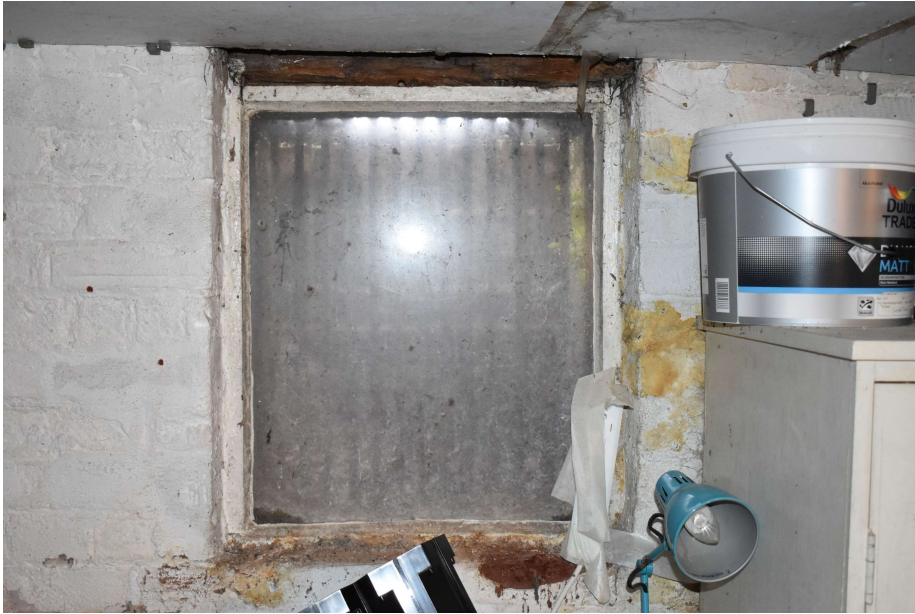
The southern wall has a single-light fixed inserted window with a timber lintel. The majority of the rest of this wall is obscured by modern cupboards. The western wall is a plain brick wall.

Photograph 5 Detail of window. Photograph taken facing south.

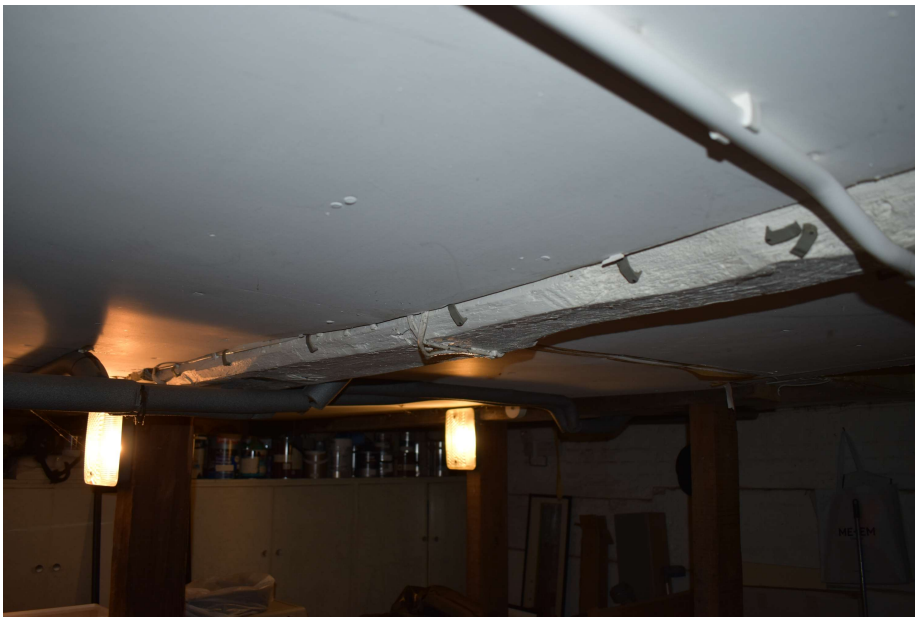
One original north-south bridging beam is present, which is supported by a modern post. A later bridging beam is located to the west of the original beam, and is supported by two modern posts. This beam does not extend to the full width of the room due to the staircase and cellar entrance.

Photograph 6 Detail of original bridging beam. Photograph taken facing south-west.

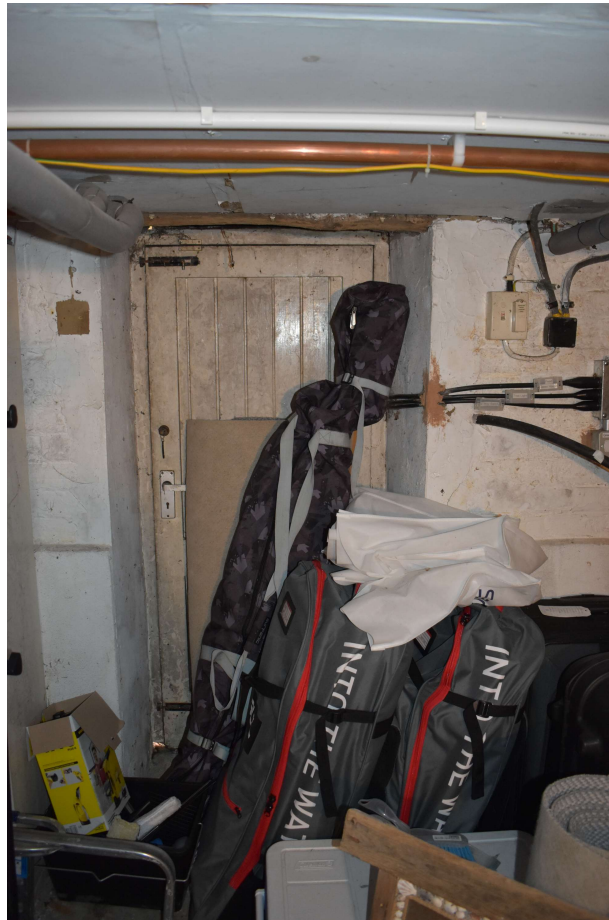
The eastern wall has a single timber door, which opens onto a set of external concrete steps. A modern sump pump is also present the south-west corner.

Photograph 7 Detail of eastern door. Photograph taken facing east.

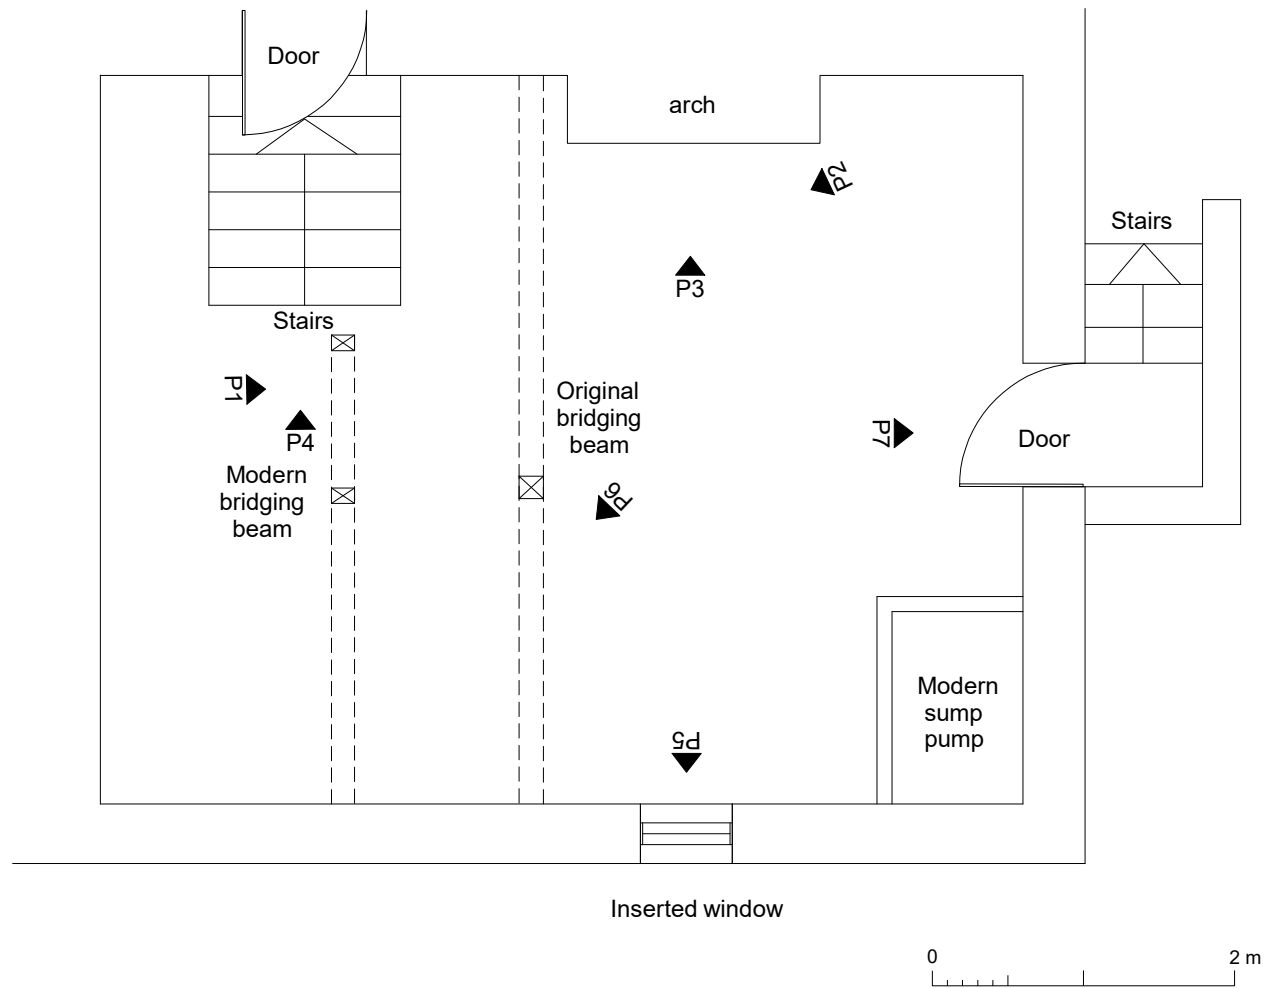
Fig 2 Cellar floor plan. Location and direction of photographs reproduced in text shown.

The cellar is approximately 6m by 5m and is located below the lounge and hall of the house. The walls are constructed of red brick (brick measurement: 230 x 60 x 100mm) laid in English-bond and are covered in a thick coat of white paint. There is a modern concrete skim on the lower 0.92m of the walls, also painted white. The floor is modern concrete.
