**CAT Report 1802  
September 2022**

**Historic building recording of a cart lodge at  
Purley Farm House, Purley Lane,  
Coggeshall, Essex CO6 1TH**

**CAT project ref.: 2022/02m  
ECC code: CGPF22**

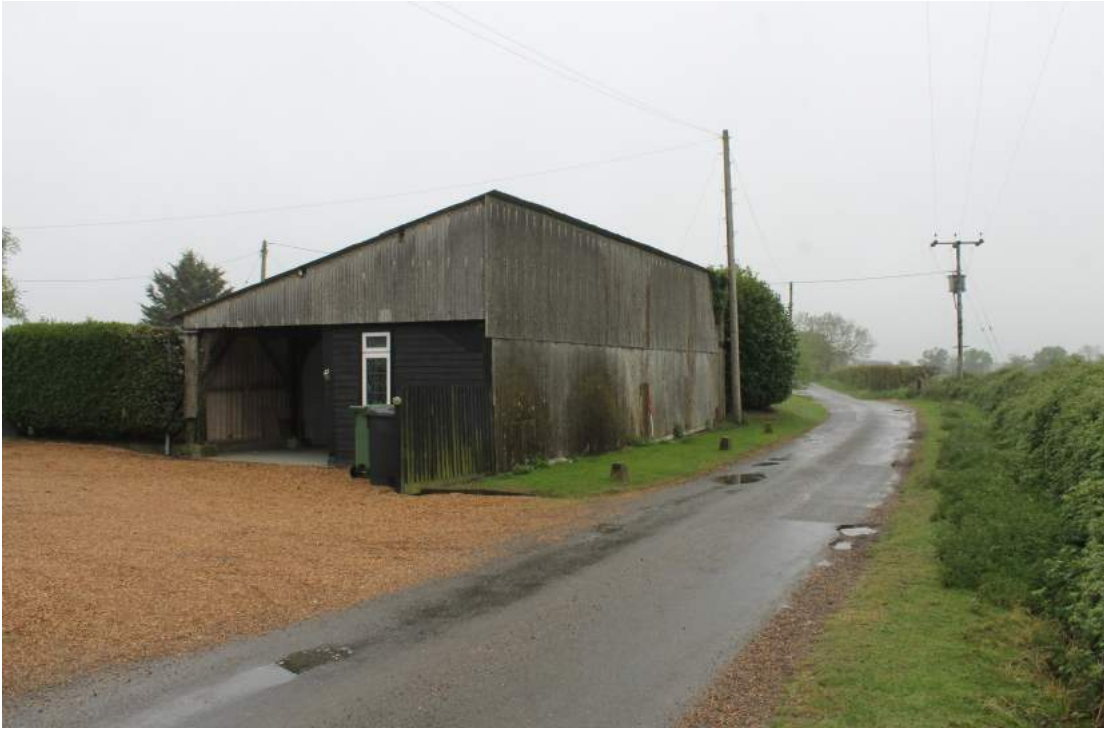
The building lies parallel to Purley Lane, but set back a short distance from the road with the northern elevation a featureless façade of corrugated asbestos sheeting (Photograph 1).

**Photograph 1** North and east elevations – view south-west.

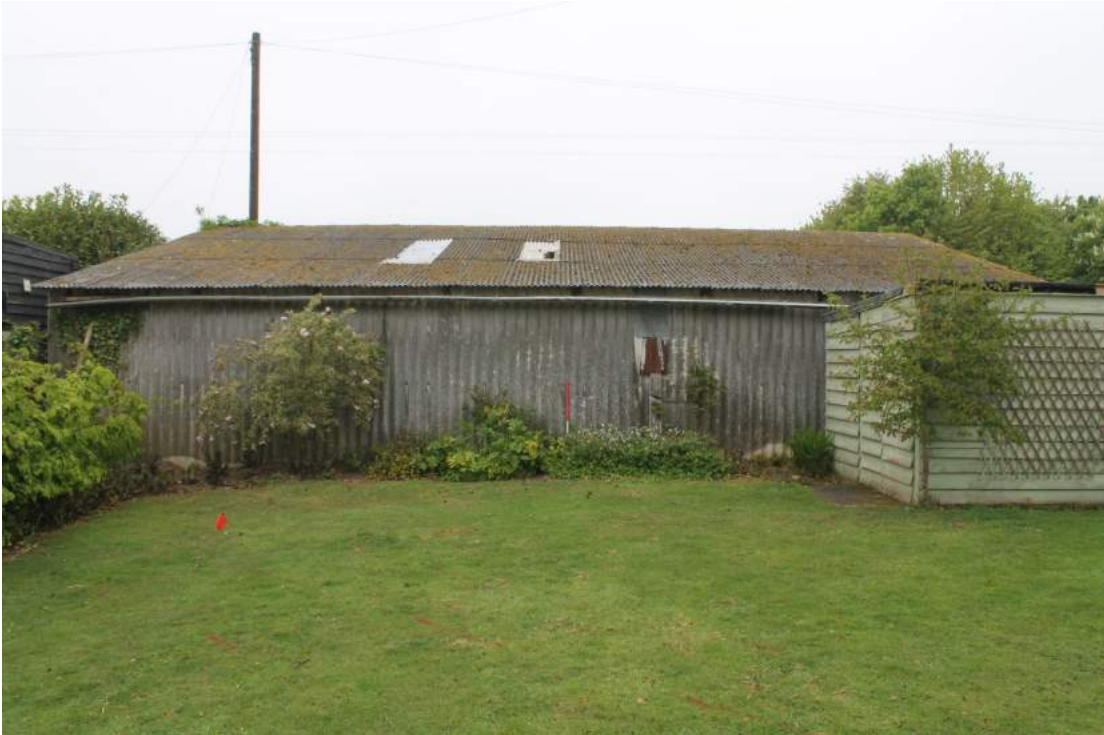
The south elevation is also featureless and fully clad in corrugated asbestos sheeting (Photograph 2). It was not possible to access the western elevation during the recording but it is assumed that this is also featureless and clad in corrugated asbestos.

**Photograph 2** South elevation – view north.

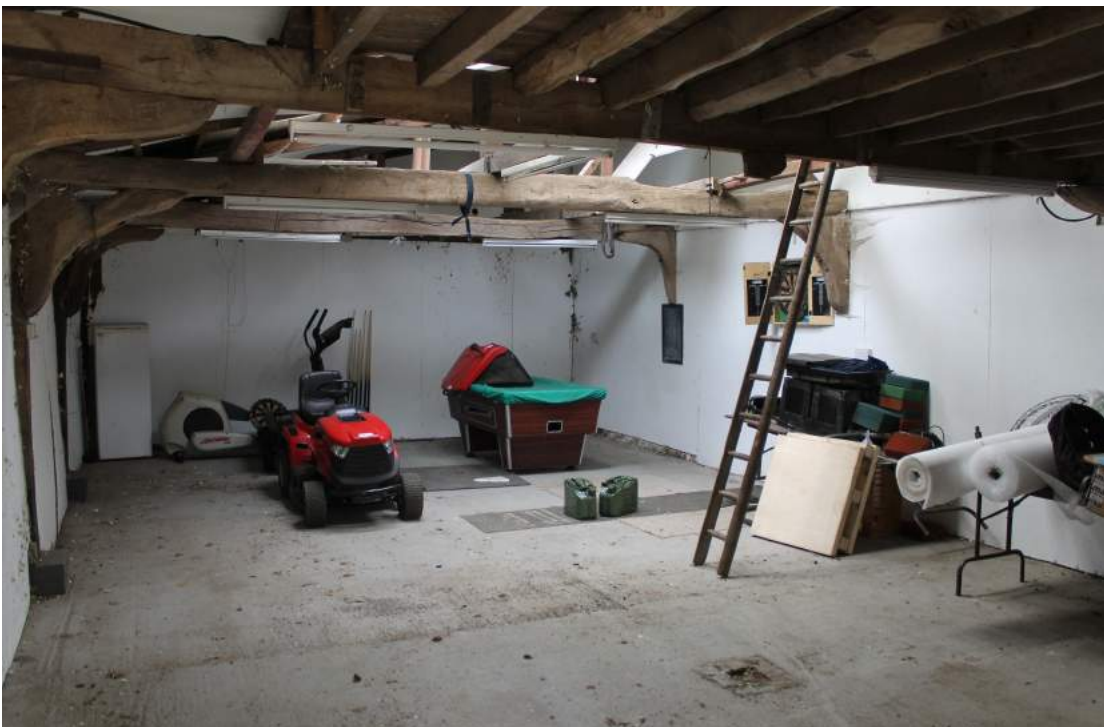
**Photograph 3** Interior of the cart lodge with the north wall to the right – view north-west.

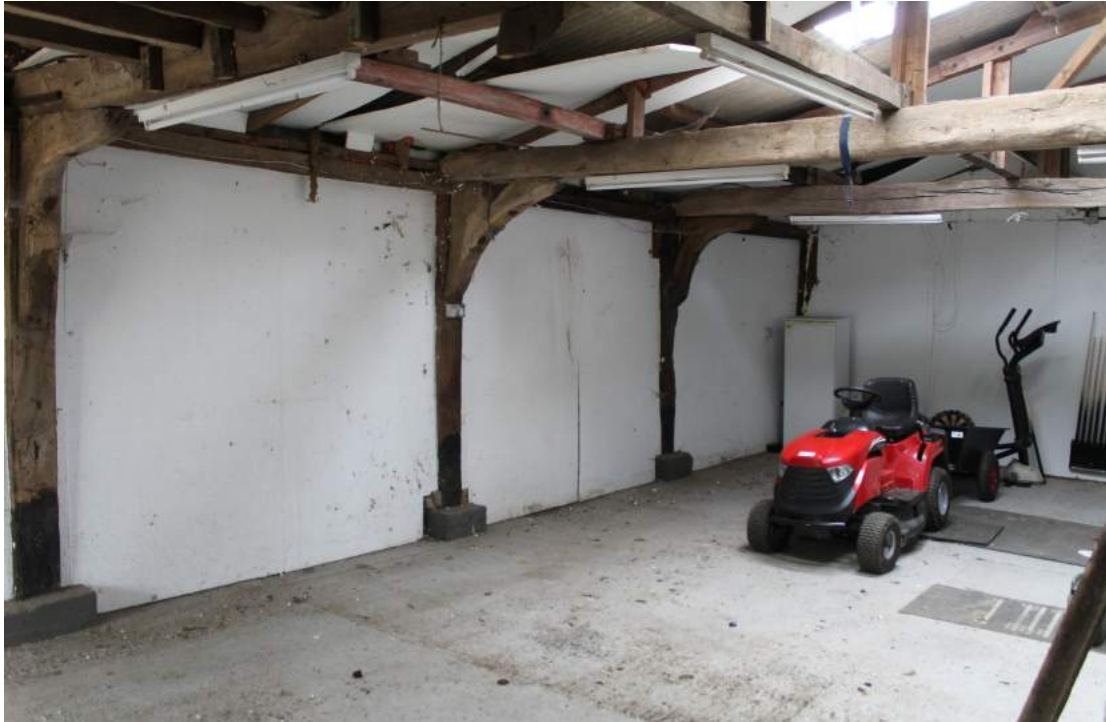
**Photograph 4** Interior of the cart lodge showing the south wall with its exposed posts and protective concrete shoes – view south-west.

The corner and intermediate posts in this wall each have a protective concrete shoe around their bases, a common feature of cart lodges designed to protect the posts from damage, although this is clearly a later addition. A concrete plinth has been inserted between the shoes.

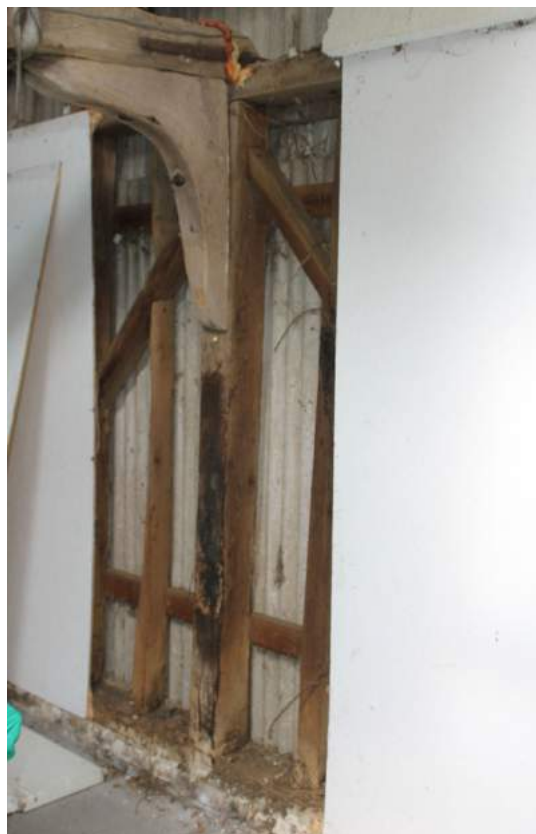
**Photograph 5**  
Exposed timber-frame  
of the north wall.

On the north wall the brick plinth supports a sill beam with dimensions of 90mm x 150mm from which rise straight, machine-cut intermediate posts and studs with through-bracing. The braces fall from the head of the posts to the sill-beam and comprise both machine-cut and hand-sawn timbers. Batons are attached to the posts and studs on to which the external asbestos cladding is affixed. A wall-plate is carried on the heads of the intermediate posts (Photograph 5).

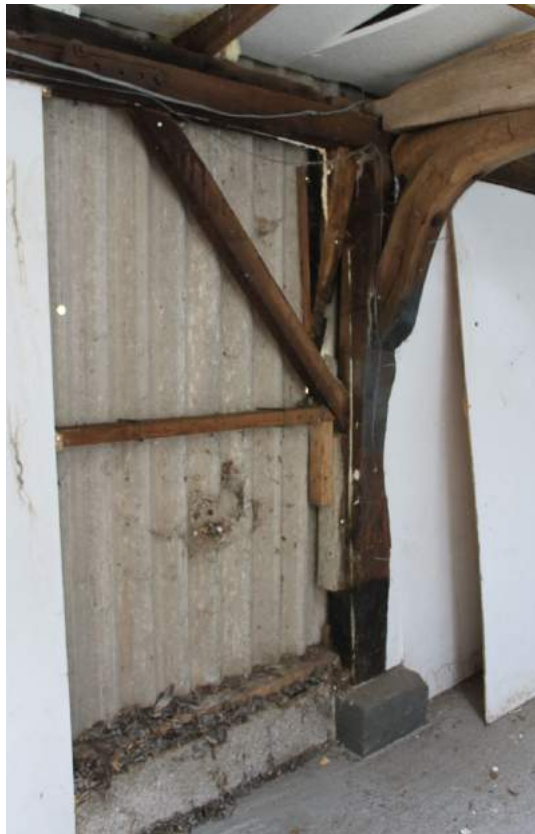
On the south wall the removal of the OSB sheeting did not expose any further original timber-framing other than the posts that were already visible. The spaces between the posts have been blocked by the insertion of inclined struts and a girding-beam. The inclined struts rise from the post to meet the wall-plate while the girding-beam is supported by a central post. The external asbestos cladding is attached to these posts (Photograph 6).

**Photograph 6**  
Inserted frame to the cart lodge openings on the south wall.

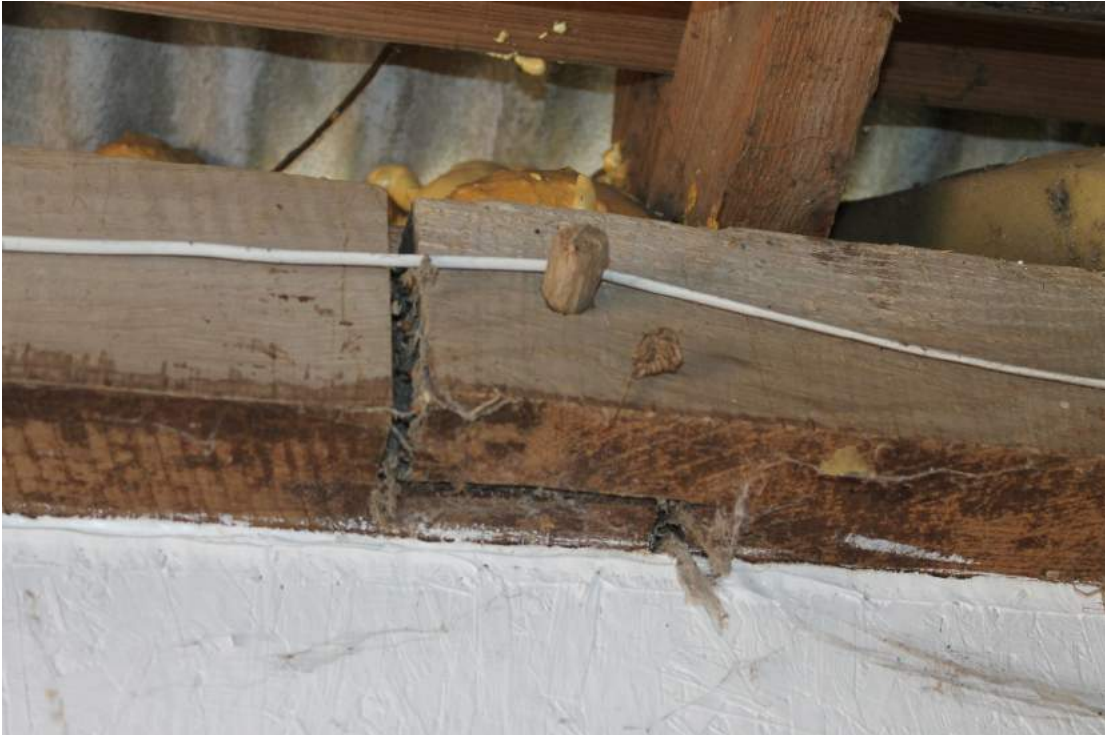
On the wall plate of the south wall, two face-halved and single-pegged scarf joints were identified on the wall-plate, one in bay 2 and one in bay 4 (Photograph 7).

**Photograph 7** Face-halved and single-pegged scarf joint in the wall plate of the south wall.

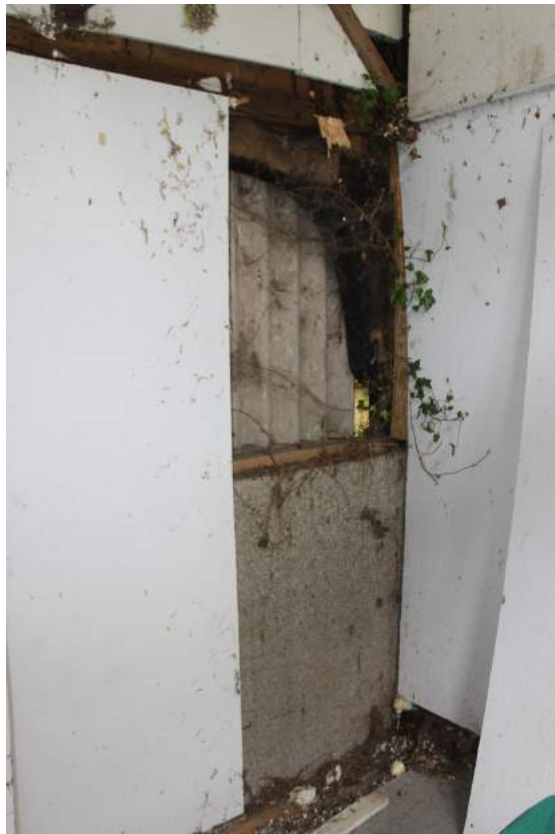
When the OSB sheeting was removed from the west wall, this exposed a half height wall of breeze blocks and no indication of the original framing (Photograph 8). No mortices were observed in the underside of the gable tie-beam or indeed in the underside of the eastern gable tie-beam. This suggests that either both gable tie-beams are replacements or that the short sides of the cart lodge were open to the elements.

**Photograph 8**  
Inserted breeze block wall to west end of the cart lodge.

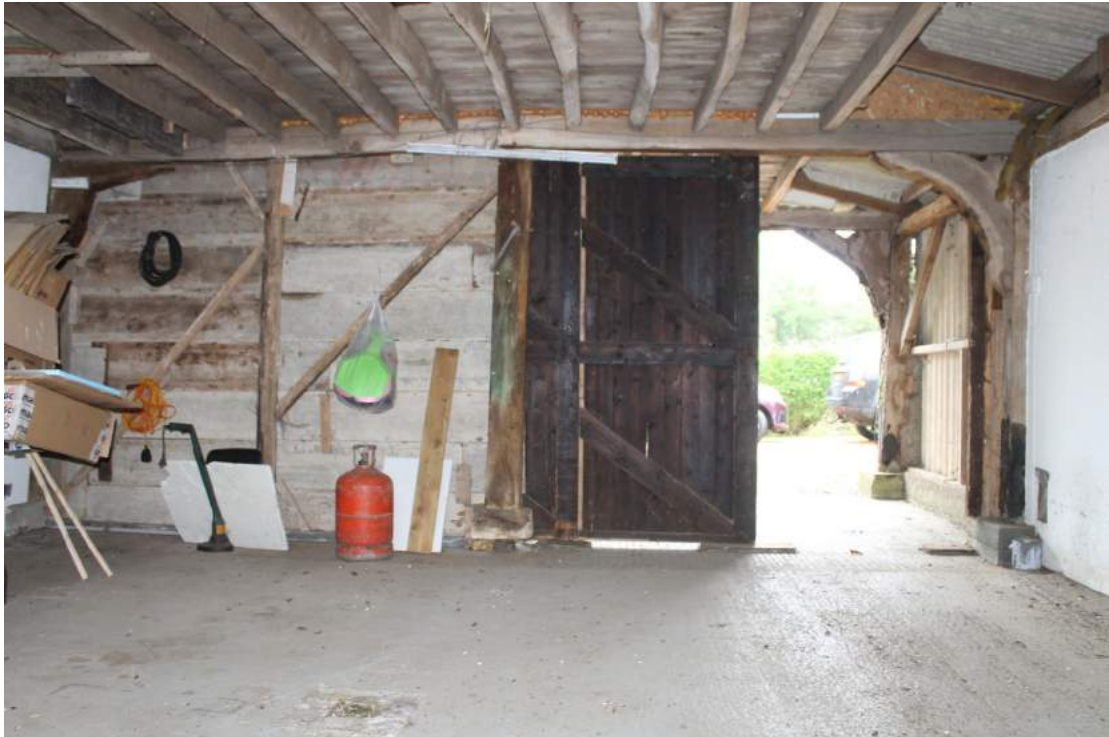
Bays B1-B4 are open, while bay B5 contains a recessed entrance way and a small inserted office. This has been created by the insertion of a wall between bays B4 and B5 directly below tie-beam T4 which is constructed from 300mm wide timber planks and has an opening for a large sliding door (Photograph 9). This divides the recessed entrance way and

**Photograph 9** Inserted dividing wall between bays B4 and B5 with the loft above.

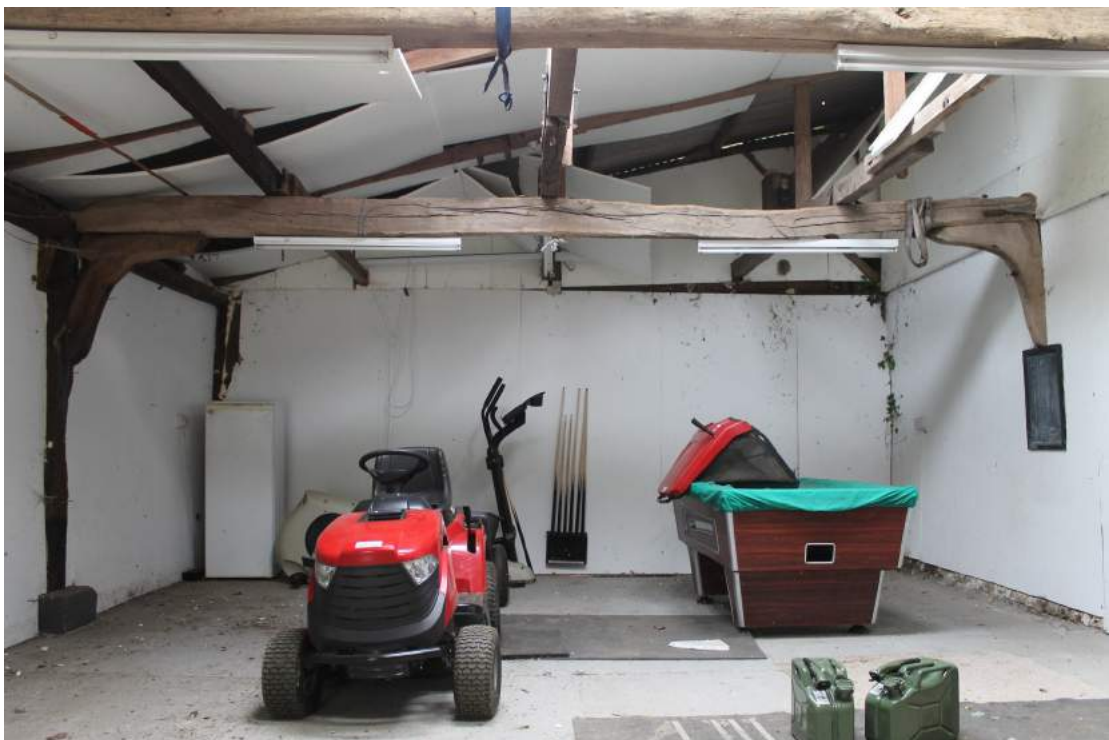
The intermediate posts support large section straight tie-beams (T1-T4 on Fig 2) with dimensions of 160-175mm x 200mm high, which are supported by knee braces at each end (Photograph 10).

**Photograph 10** Tie-beam T1 with knee braces – view west.

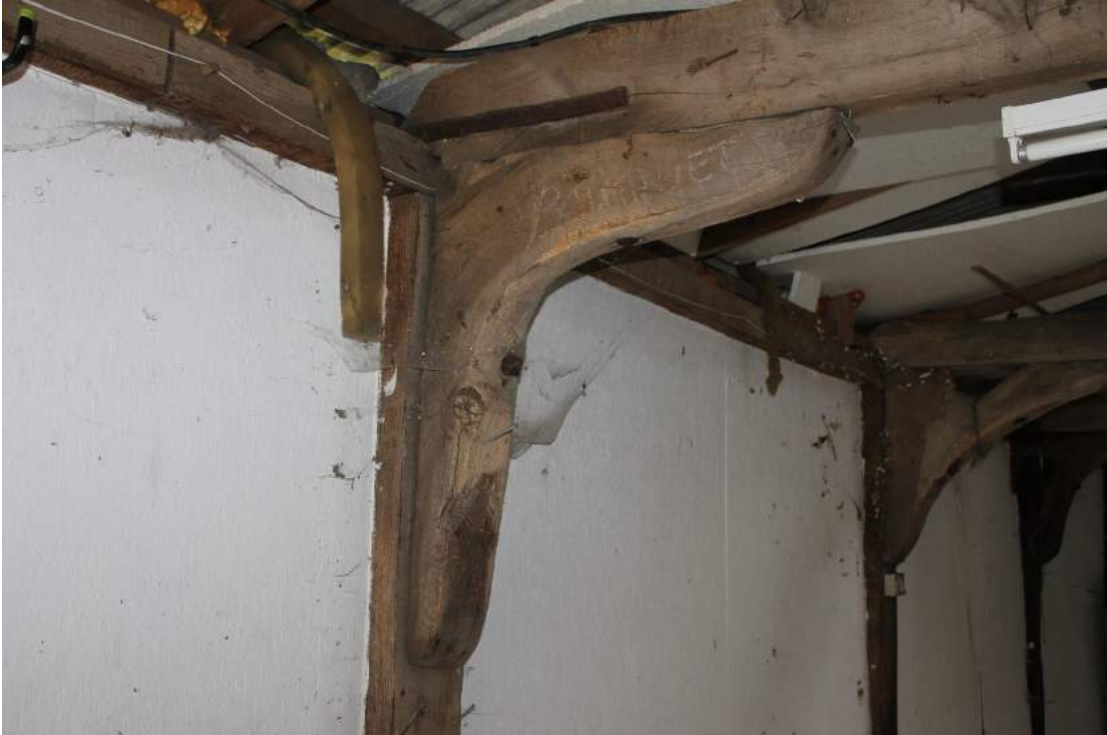
The knee-braces are attached to the intermediate posts by a single bolt and three iron nails and to the tie-beams in an identical fashion. A single iron staple is found on the opposing faces at each end of the tie-beams (Photograph 11) and a single carpenter's mark in the form of an incised 'll' is located on the west face of tie-beam T3 (Photograph 12). The tie-beams and knee braces are all re-used from an earlier building.

**Photograph 11** Knee brace at south end of tie-beam T3 showing iron bolts to the post and tie-beam and the iron staple at the end of the tie-beam – view south-west.

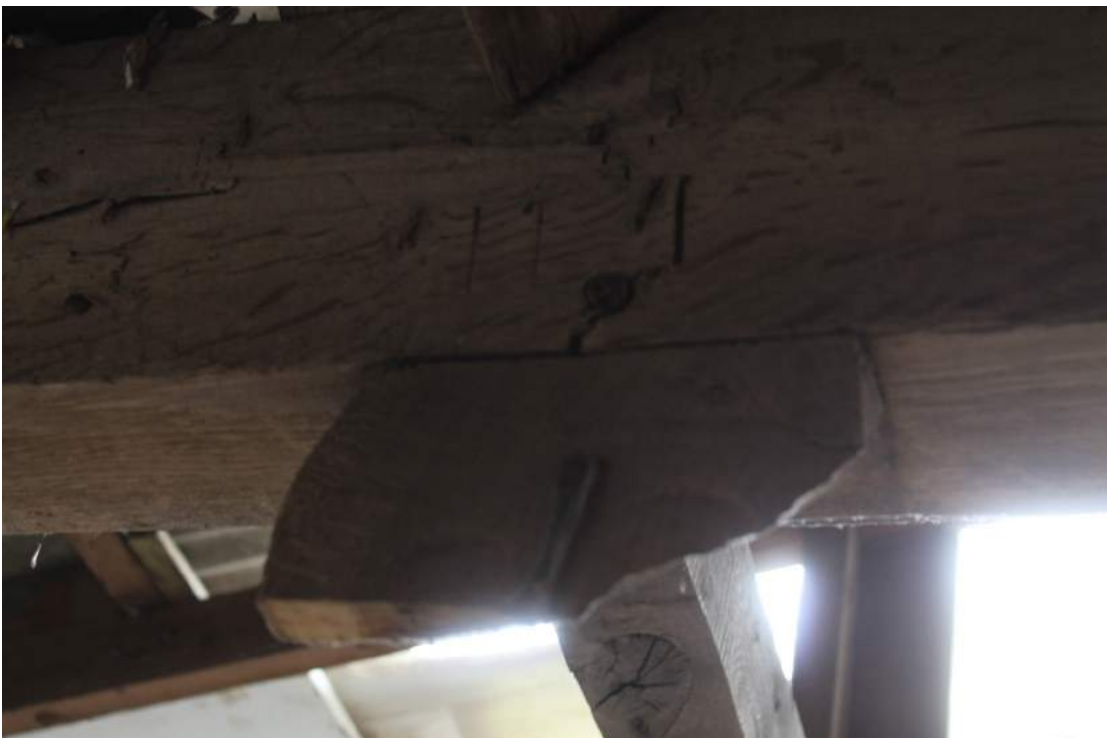
**Photograph 12** Carpenter's mark on tie-beam T3 above the remains of an inserted post to support the loft.

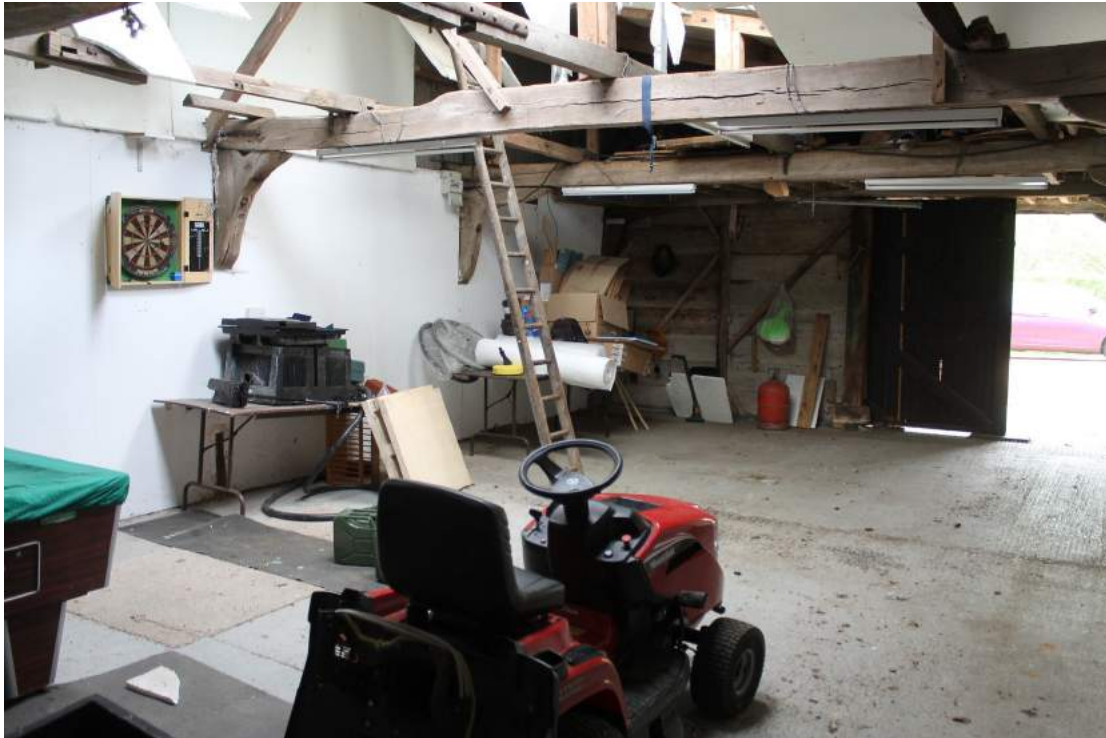
Located above bays B4 and B5 is a loft, carried on eleven timber joists, which are notched in to tie-beams T3, T4 and the eastern gable tie-beam (Photograph 13). Most of the joists comprise machine-cut timbers but a few are formed from split tree trunks. Several of the joists also display empty mortices, indicating they are re-used timbers. The joists start 1.10m in from the wall plates on each side and this suggests that, although the loft is probably not an original feature, it was inserted when the cart lodge had its original gabled roof with the reduced width a result of the restricted space formed by the triangular shape of the roof configuration.

**Photograph 13** Inserted loft above bays B4 and B5, accessible only by ladder – view north-east.

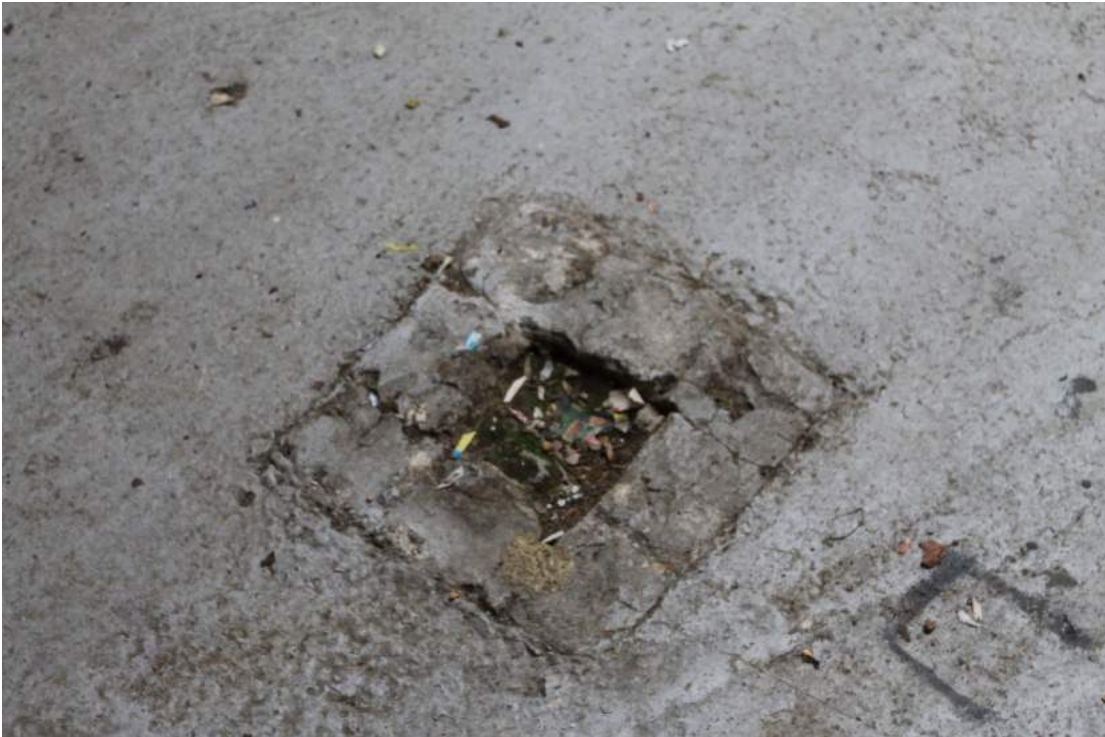
**Photograph 14** Scar in the concrete floor from the removal of the inserted post below tie-beam T3, which provided support for the loft.

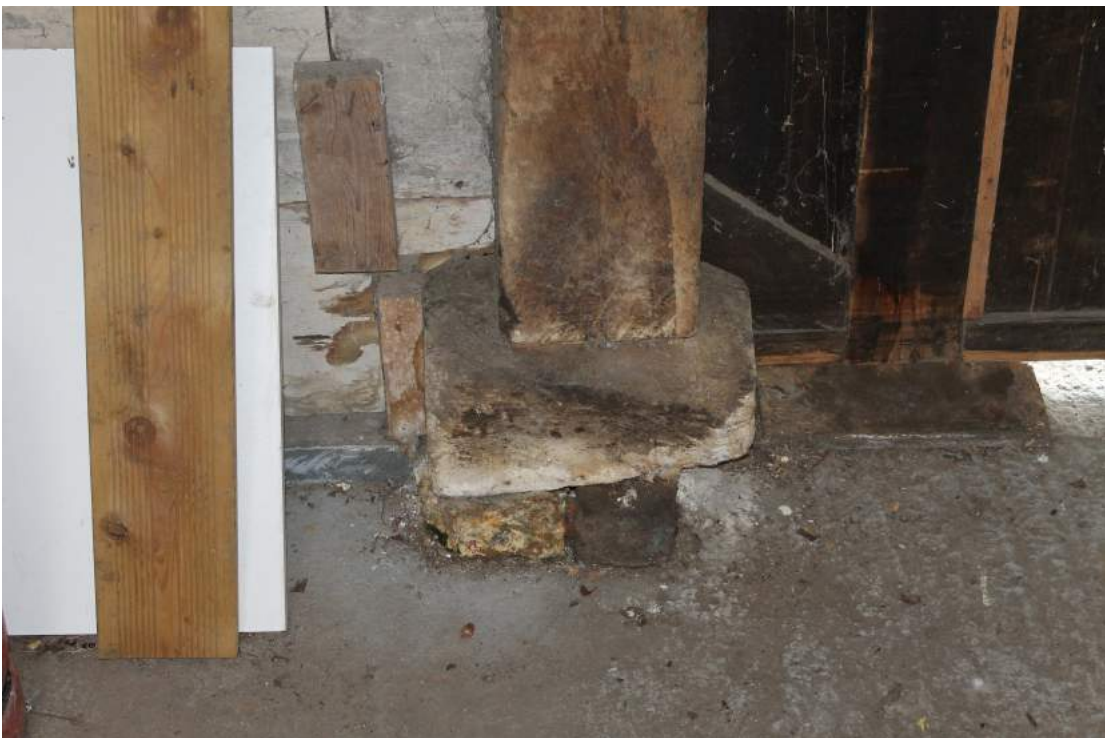
Additional support for the loft is provided by three posts inserted below the centres of tie-beams T3, T4 and the eastern gable tie-beam (see Photograph 9). The post below tie-beam T3 has been removed at some point but the remains of the post can be seen below the tie-beam (see Photograph 12) and a scar in the concrete floor corresponds to its position (Photograph 14). It is likely that the carpenter's mark observed on tie-beam T3 corresponds to the insertion of these posts rather than the framing of the cart lodge itself. The inserted post below tie-beam T4 has either been affected by rot at some point or was never sufficiently long enough when inserted, as the foot of this post sits on a timber pillow which is, in turn, carried on a pair of bricks (Photograph 15).

**Photograph 15** Inserted post below tie-beam T4 providing support for the loft, with a timber pillow carried on bricks – view east.

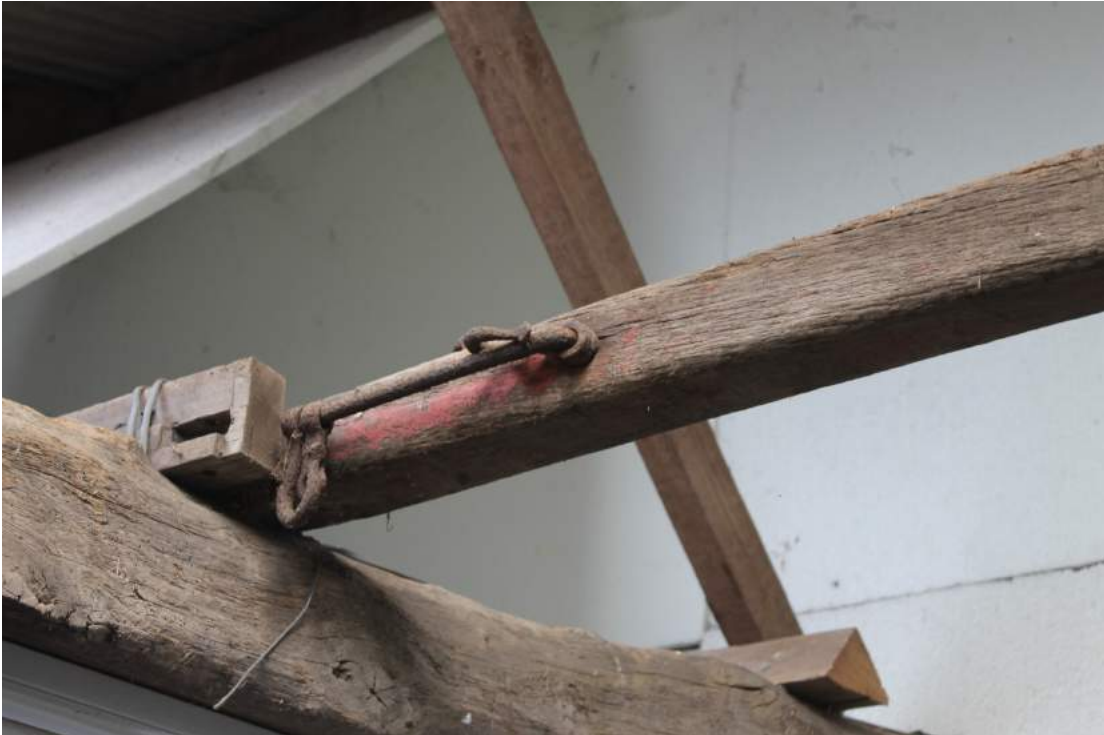
Three longitudinal timbers sit directly on top of the western gable tie-beam and tie-beams T1-T3 acting as a kind of purlin (see Photograph 10). These are formed from scrap timber, crudely spliced together and include a pair of waggon shafts over bay B3 (Photograph 16) and a door post over bay B2. After tie-beam T3, these timbers end and are replaced with the

**Photograph 16** Waggon shaft (complete with harness attachment) fixed to a section of door post to form a crude longitudinal purlin supporting the struts of the modern roof.
