**CAT Report 1854
Issued October 2022**

**Historic building recording of a barn at
Meadow Hall Farm, Parkhall Road, Gosfield,
Essex CO9 1SQ: June 2022**

**CAT project ref.: 2022/05e
ECC code: MHGF22**

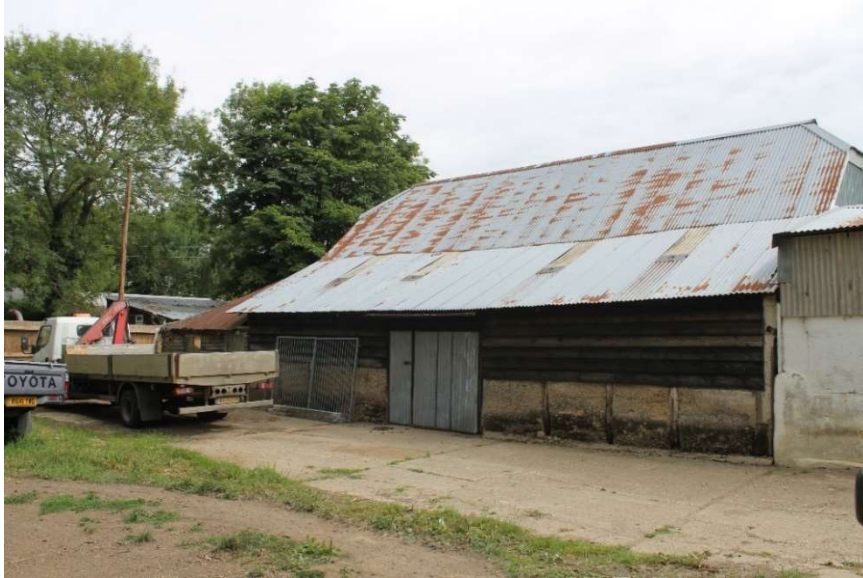
The combined structure is approximately 22m by 12.5m and comprises a timber-framed barn with a half-hipped roof and modern single-storey extensions on all sides (labelled A-D on Fig 3) all of which has been entirely roofed in galvanised corrugated sheeting. Extension A attached to the south-west elevation of the barn is a timber-framed lean-to with concrete infill between exposed posts and weatherboard above (Fig 4). A wide door formed from corrugated sheeting is located in the centre of the lean-to and appears to be a later insertion rather than an original feature of the lean-to (Photograph 1).

Photograph 1 The south-west elevation showing extension A – view north

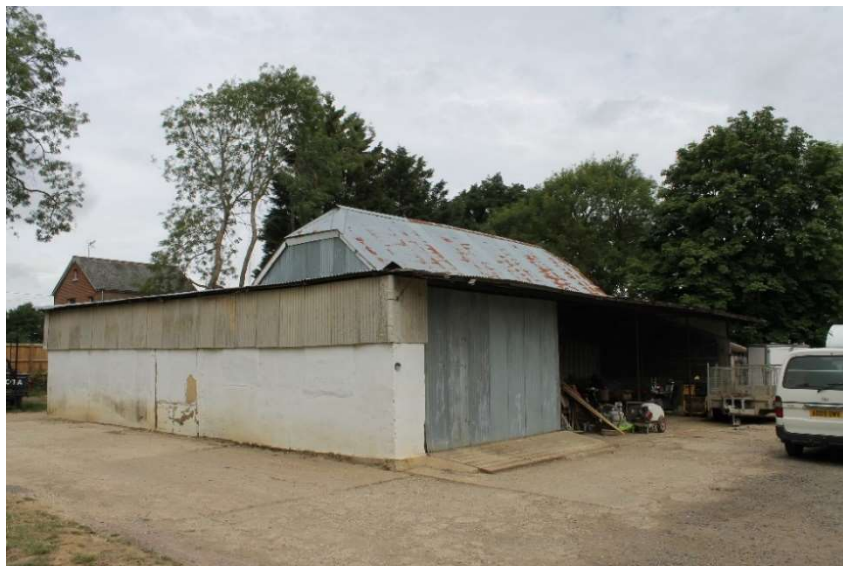
Extension B on the south-east side of the barn is more substantial and extends the full width of the structure (Figs 4-6). It is constructed from rendered blockwork with corrugated asbestos sheeting above. This originally had four window openings and a centrally positioned doorway on the south-east elevation and two windows on its north-east elevation, but these have all been infilled. External access to this extension is via a full height sliding door formed from galvanised corrugated sheeting on a steel frame located in the north-east elevation (Photograph 2).

Photograph 2 The south-east elevation showing extension B – view west

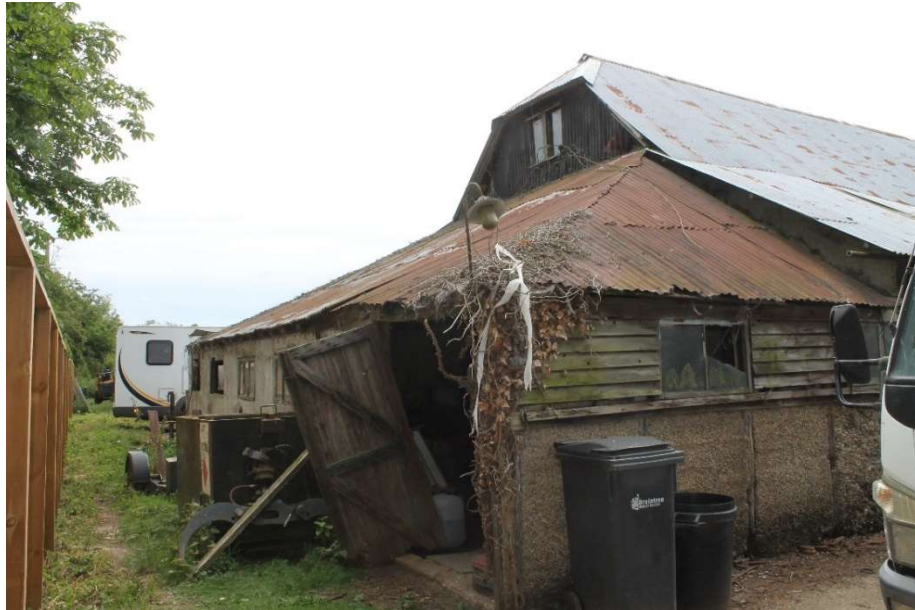
Photograph 3 Extension C on the north-west elevation – view east

Extension C attached to the north-west elevation of the barn is a single-storey lean-to predominantly built from rendered blockwork, but with its south-western wall clad in weatherboard above a concrete infilled timber frame, in a similar style to the wall of the south-west extension (Figs 4-5,7). Like extension B this also extends the full width of the structure. The north-western wall has five window openings and a double door. Only three of the window openings have any glazing and only one of the doors remains. The surviving windows are vertically-hung casements and both the short elevations (north-east and south-west walls) have two windows in the same style. The roof is corrugated sheeting and is considerably more rusted and weathered than the roof of the main building (Photographs 3-4).

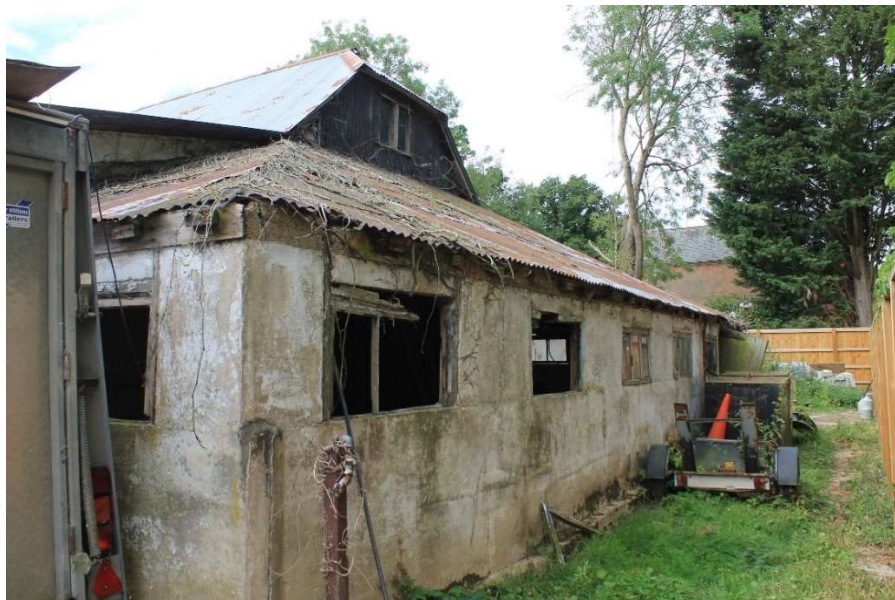
Photograph 4 Extension C – view south-west

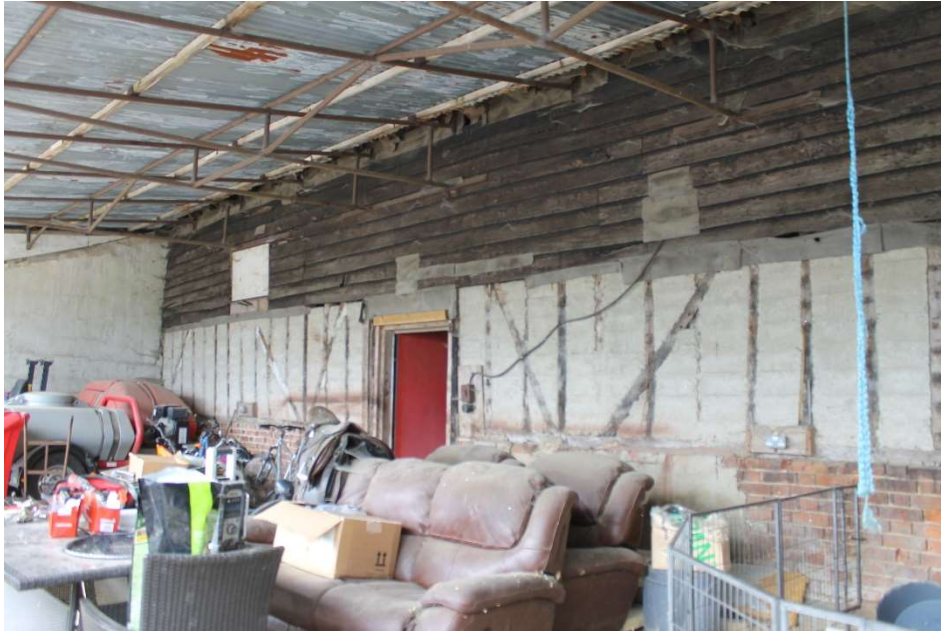
Extension D on the north-eastern side of the barn is less a building than it is an external yard area created by the insertion of a roof formed from galvanised corrugated sheeting supported on a metal framework attached to the barn between extensions B and C (Fig 6 and Photograph 5). Except for the north-west gable, visible above extension C, the area beneath the covered yard area is the only location where the exterior of the barn can be viewed (Photograph 5). The north-

Photograph 5 Extension D, the covered external yard showing the brick plinth and timber frame of the barn – view south

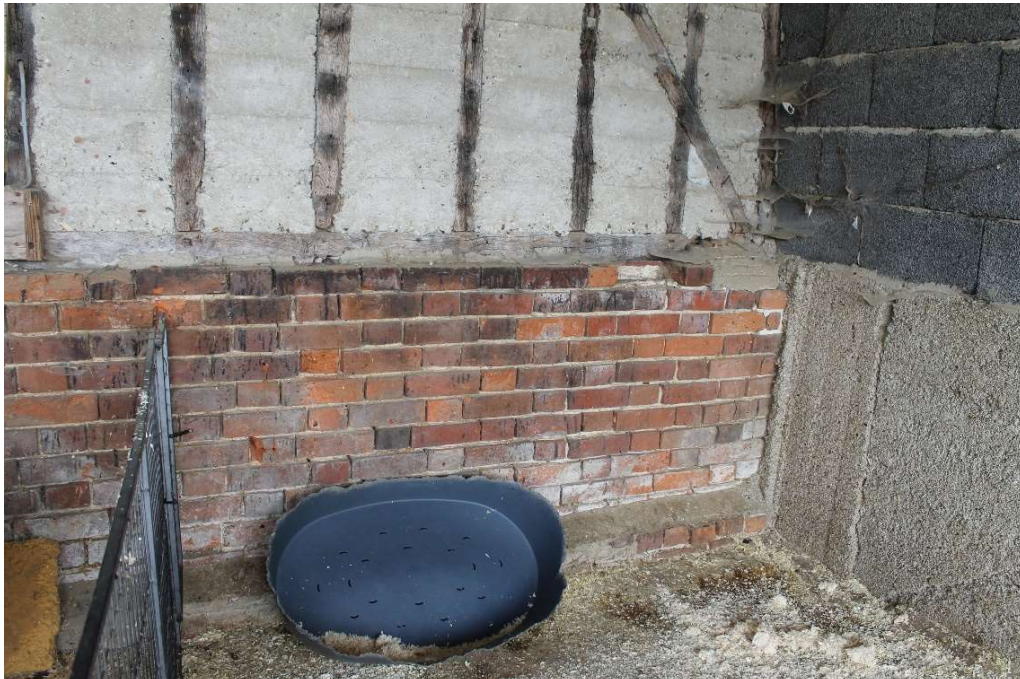
eastern wall of the timber-framed barn is clearly visible in this area and comprises a red brick dwarf wall on top of a brick plinth, both laid in Flemish bond with dimensions of 232 x 106 x 72mm (Photograph 6). The timber frame of the lower register is exposed above the brickwork with the gaps between the studs filled with concrete. The upper register is weatherboarded to the eaves.

Photograph 6 Detail of the dwarf wall and plinth of the barn with infilled timber frame visible above – view west

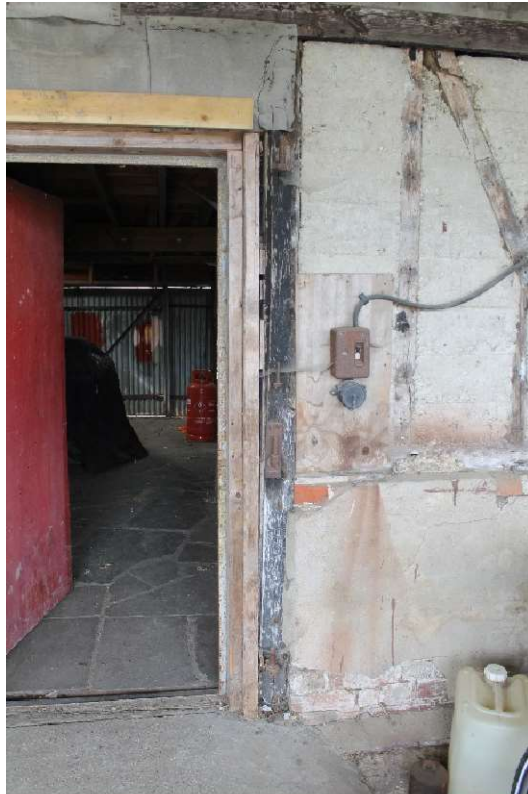
A doorway has been inserted through the brickwork and timber frame in the centre of the wall (Photograph 7). The presence of iron pintels in the frame suggests this was originally a stable door. The whole wall shows signs of multiple repair and patching.

Photograph 7 Doorway inserted into the north-eastern wall of the barn with iron pintels for a stable door bedded into the frame – view south-west

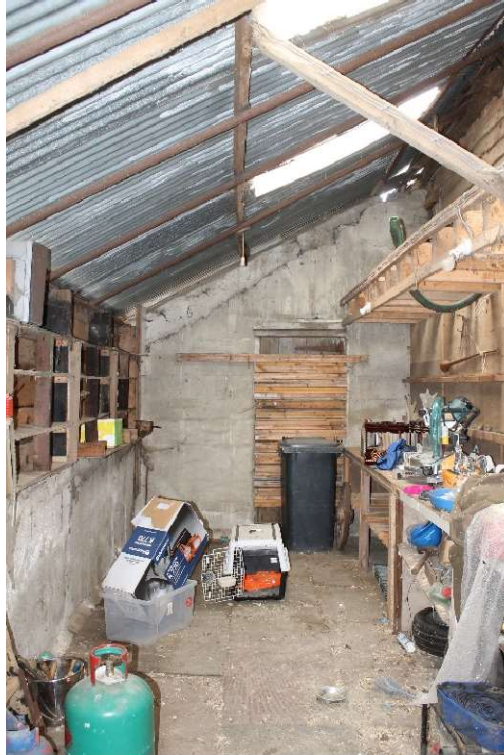
Extension A was used as a workshop (Photograph 8). There is a doorway to the north-west which is blocked but which would have provided access to the north-west lean-to, extension C. There is also a door to the south-east which provides access to extension D and an opening in the north-east wall provides access to the barn.

Photograph 8 Extension A - view north-west

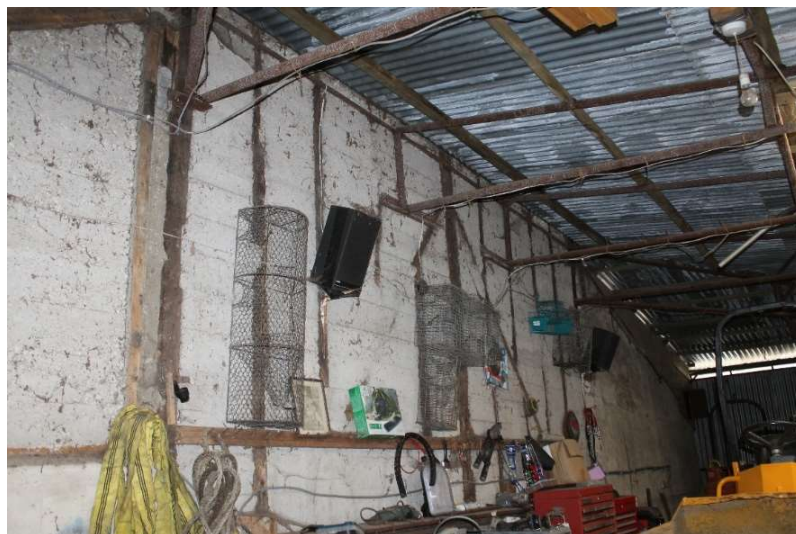
Extension B was used as a vehicle store and workshop (Photograph 9).

Photograph 9 Extension B – view north-east

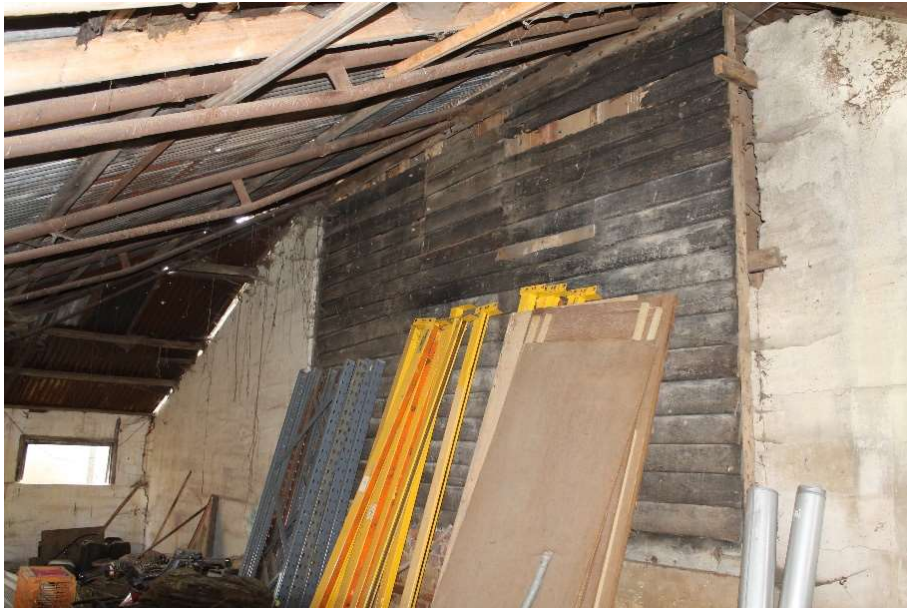
Extension C was used for storage at the time of the survey but it is possible that its original function was to house small livestock (Photograph 10).

Photograph 10 Extension C with the weatherboard of the barn in the centre of the picture – view south-east

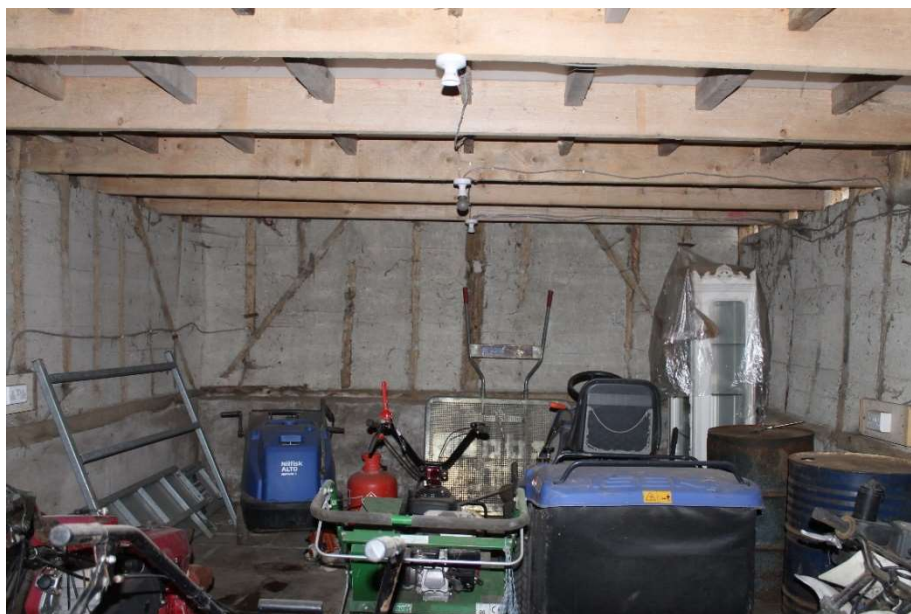
The barn has six bays and an inserted mezzanine accessed by a staircase in the central bay. The original floor has been replaced with concrete slabs laid in a “crazy paving” style. The timber frame has concrete infill between the studs (Photograph 11) except in the north-west wall where the framing is fully exposed and clad in weatherboard. The frame has through bracing falling from the principal posts to the sill-beam (Photograph 12). The frame is a composite of machine-cut timbers, hand-sawn timbers and re-used timbers. The re-used timbers display mortices and peg-holes (Photograph 16).

Photograph 11 The interior of the barn with the modern concrete infill between the posts of the frame - view south-east

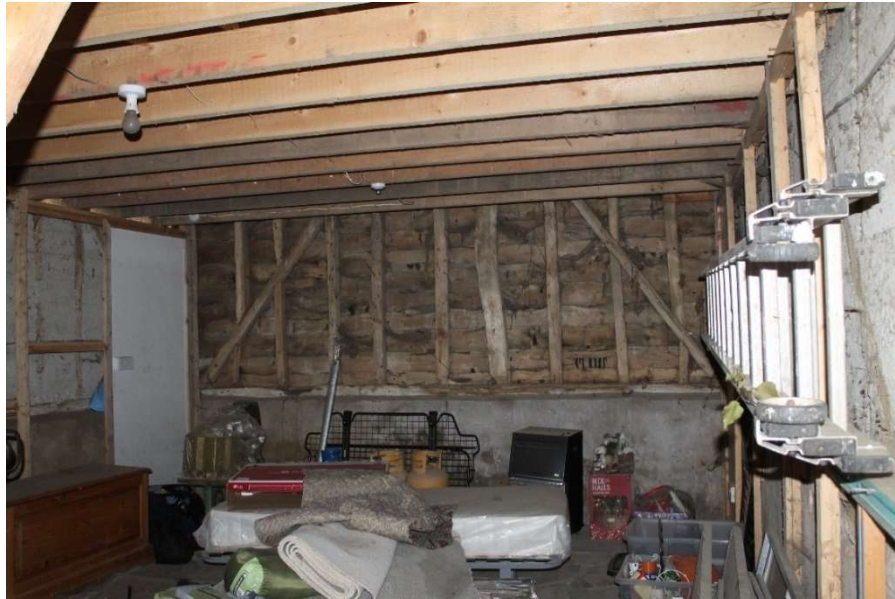
Photograph 12 Interior of the barn showing the surviving timber frame of the north-west wall – view north-west

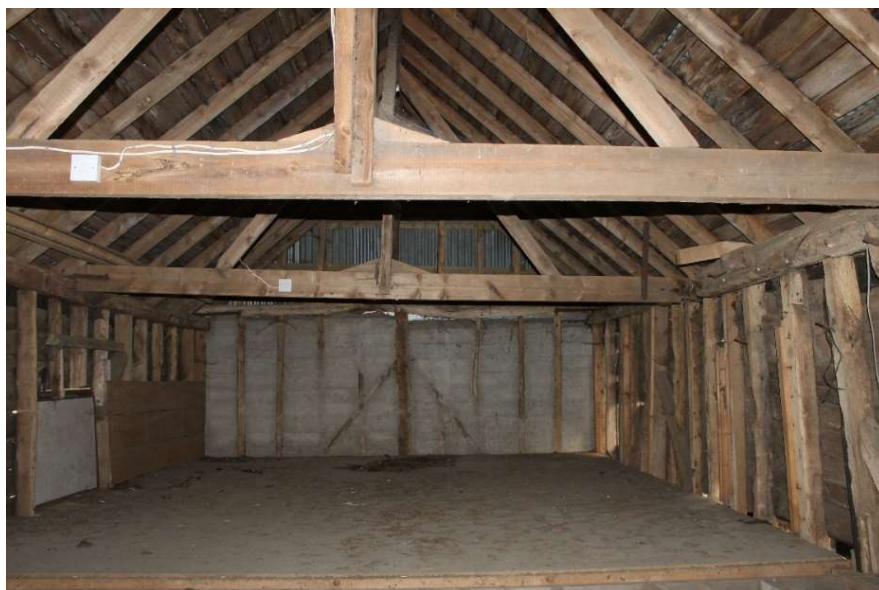
The inserted mezzanine provided close access the upper timbers of the frame and the roof. The mezzanine is divided into two chambers, a large open area at the southern end (Photograph 13) and a smaller enclosed area at the north-western end where the frame is covered by plywood sheeting, suggesting this area may have been used for grain storage.

Photograph 13 The inserted mezzanine of the barn - view south-east

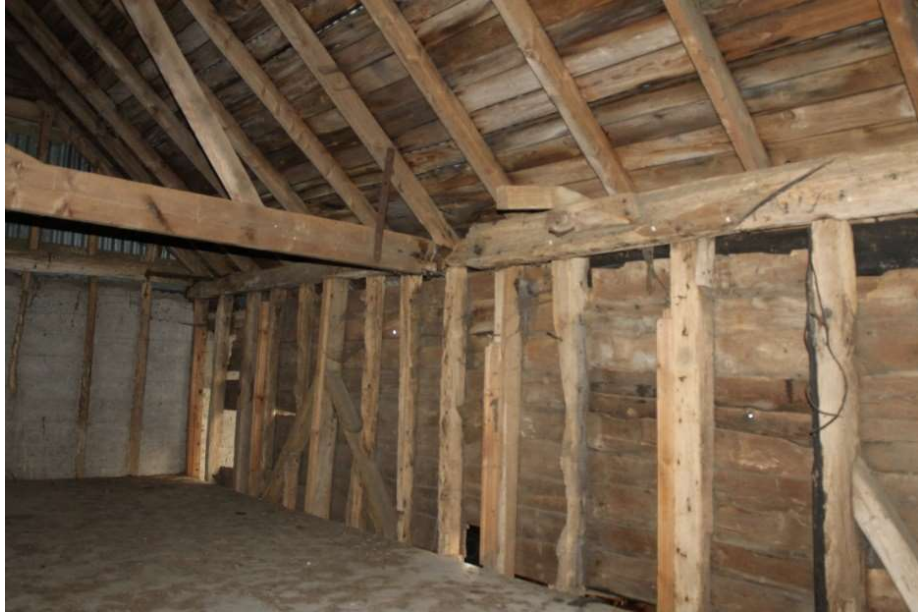
The timbers of the roof are all modern machine-cut beams and comprise widely spaced common rafters rising from the wall-plate to a ridge board. The rafters support sarking boards which suggests that the original roofing material was slate rather than peg tile which, supporting the mid-19th-century date for the barn indicated by the cartographic evidence (Photograph 14). There are no true trusses. Instead there are three tie-beams regularly spaced along the length of the barn, none of which relate to the principal posts of the frame below. The tie-beams each have a king post, strengthened by inclined struts and there are also longitudinal braces rising from the tie-beams to the head of the adjacent king post (Photograph 15).

Photograph 14 Common rafters rising from the wall-plate with sarking boards above and one of the tie-beams, which do not correspond with a principal post - view south

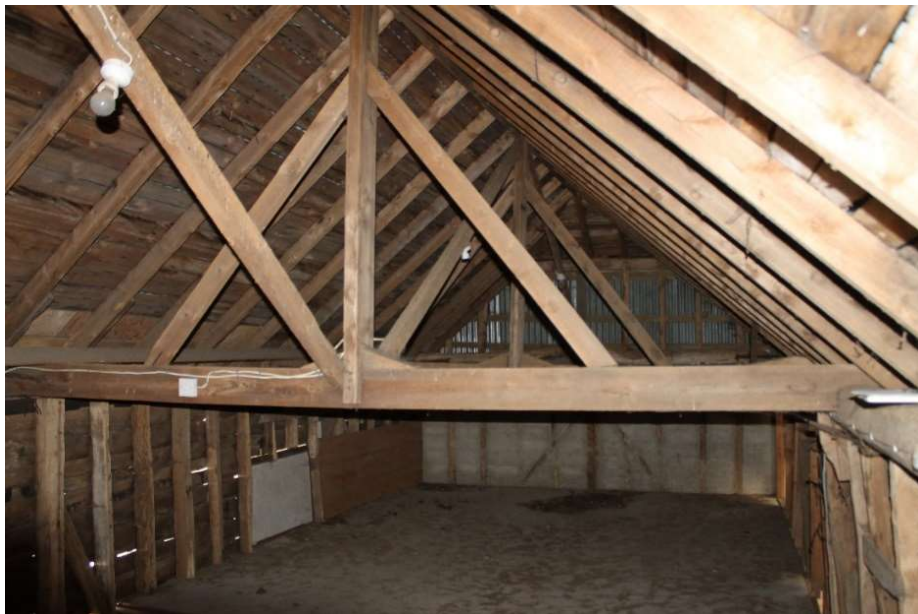
Photograph 15 Detail of one of the tie-beams which have both lateral and longitudinal bracing to the king post - view south-east

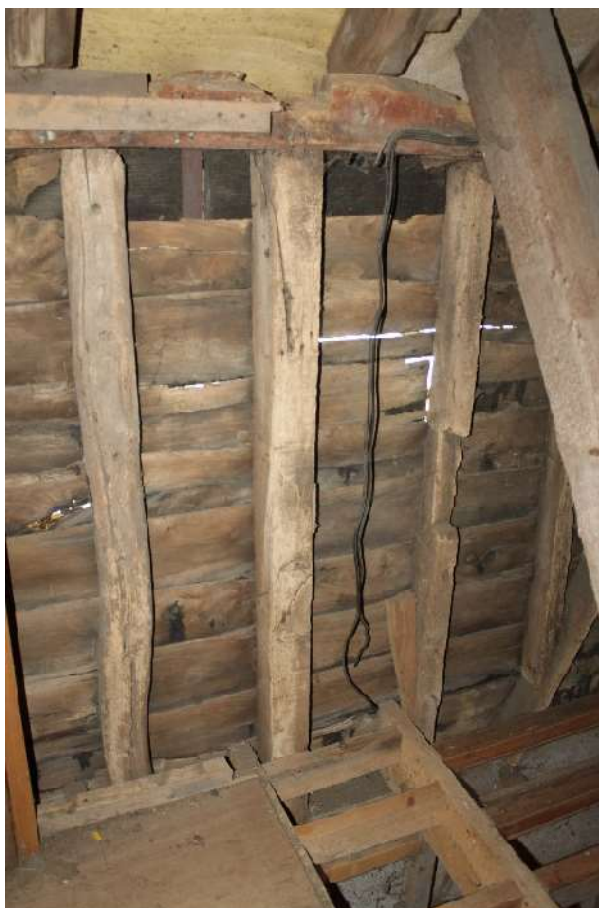
Photograph 16 Detail of the north-east frame showing machine-cut timbers next to hand-sawn and re-used timbers.

The cartographic evidence suggests a date for the barn of 1838-1881 which is in keeping with the mix of hand-sawn/re-used timbers and the machine-cut beams found throughout the frame. This raises the question of where the re-used timbers originated. The barn was constructed as part of the Beardswood Farm prior to 1881 but there is no record of the inhabitants until the 1901 census when it is recorded that the farm was inhabited by Samuel Newington, a farmer, and his wife Blanche. The 1911 census records Joseph Donner as living at Beardswood Farm and being a farmer and an employer of agricultural labourers, although there is no indication from available records how large the farm was. The house and barn appear to have been the only buildings during the latter part of the 19th century, so the farm was probably only a modest enterprise. The change in occupancy during the ten years separating these censuses may indicate that Beardswood Farm was a tenancy rather than owned outright. If the barn was part of a tenant farm and if it was constructed during the agricultural depression of the late 19th century, this could suggest that funds for new materials were limited, hence the inclusion of re-used timbers. The source of these may be from the main estate farm, which is possibly Beechley Farm to the south-west or Parkhall Farm to the east, or it may indicate a well-established trade in second-hand timbers which are commonly found in 19th-century agricultural buildings.
