**CAT Report 2052  
Issued May 2024**

**Historic building recording at Wells Farm, Ivy Barn  
Lane, Margarett, Essex, CM4 0PU**

**NGR: TL 64802 02431**

**Planning district.: Chelmsford  
Planning ref.: 23/01372/FUL**

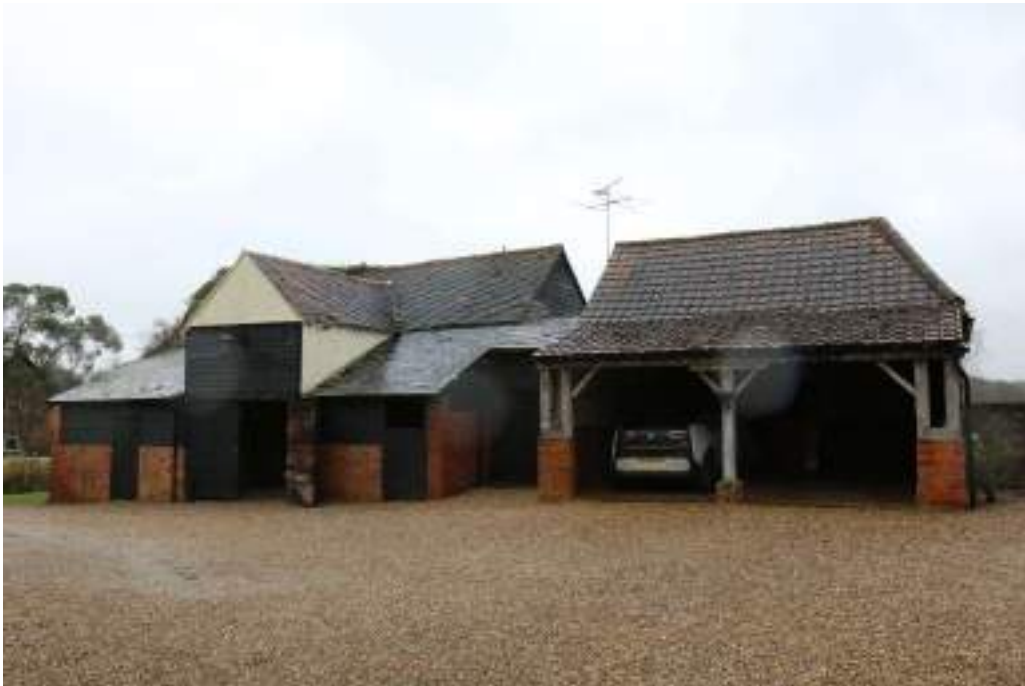
**Photograph 1** Western elevation of building 1. Photograph taken facing north-east.

Most building 1's elevations are clad with black weatherboard, except the midstrey which has a combination of weatherboarding and render.

The midstrey projects from the western elevation of the threshing barn and is flanked by lean-tos 1 and 2. In the centre of the midstrey is a set of replacement barn doors, constructed from sheets of plywood. All three lean-tos have a single vertically-planked door. The door on lean-to 2 is the lower section of a stable door while lean-to 3 has a reused doorpost. The carport is open on this elevation with exposed modern timber-framing.

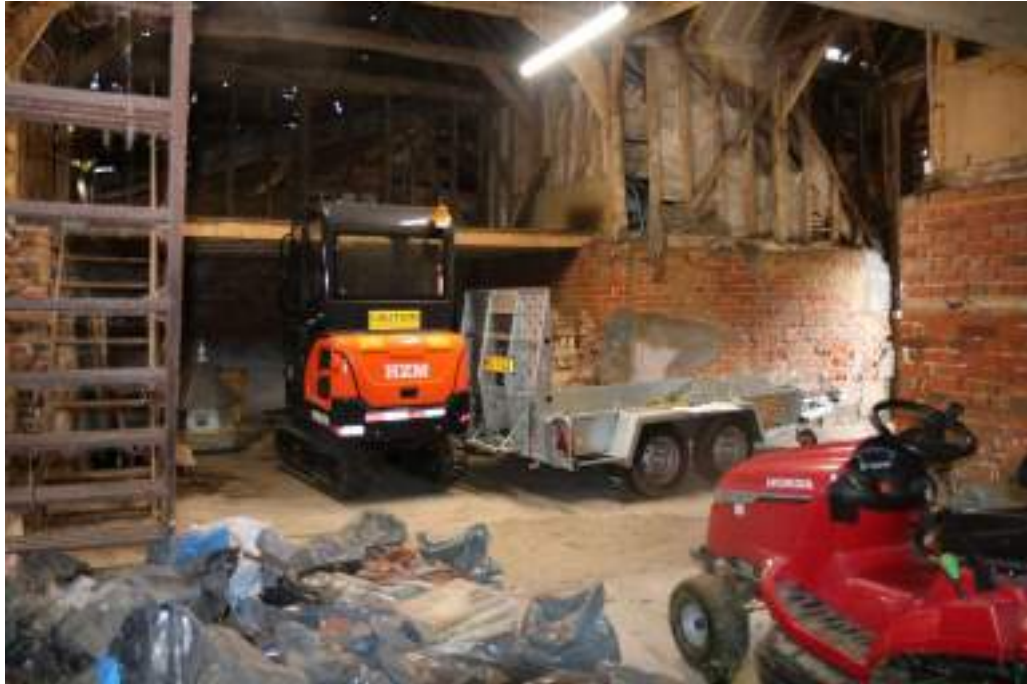
**Photograph 8** Interior of threshing barn. Photograph taken facing south-west.

The original tie-beams have hand-sawn straight braces, with timber pegs securing them, whilst the inserted ones have machine-cut straight bracing with iron nails. The wall-framing has diagonal through-bracing. The timber across the barn is a mix of hand-sawn and machine cut.

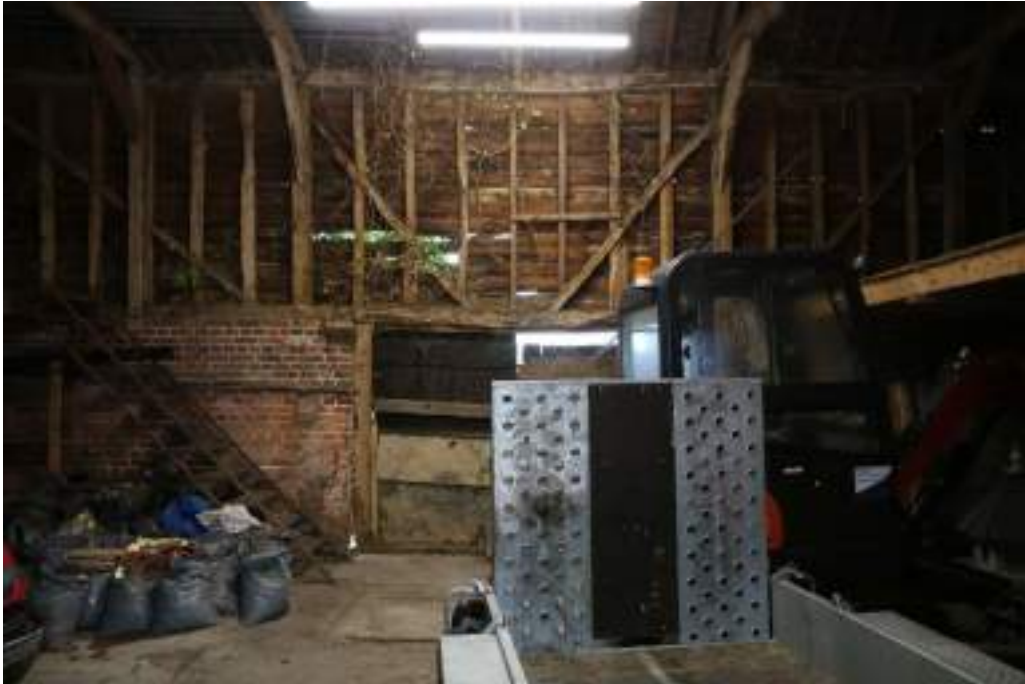
**Photograph 11** Eastern wall of bay 3 of threshing barn. Photograph taken facing east.

The doorway set into the eastern wall of bay 3 appears to be original with replacement doors. The sill-beam above the doorway has two straight bridling of three-quarters with squinted abutments and an over-lipped face scarf-joints, with a third closer towards bay 4. The wall-plate between bay 3 and the midstrey has redundant rafters attached and with an iron kingpost, these features do not interact with the rest of the barns structure so may represent the remains of an earlier roof. The tie-beam between bay 3 and 4 has an iron strap on both the eastern and western ends.

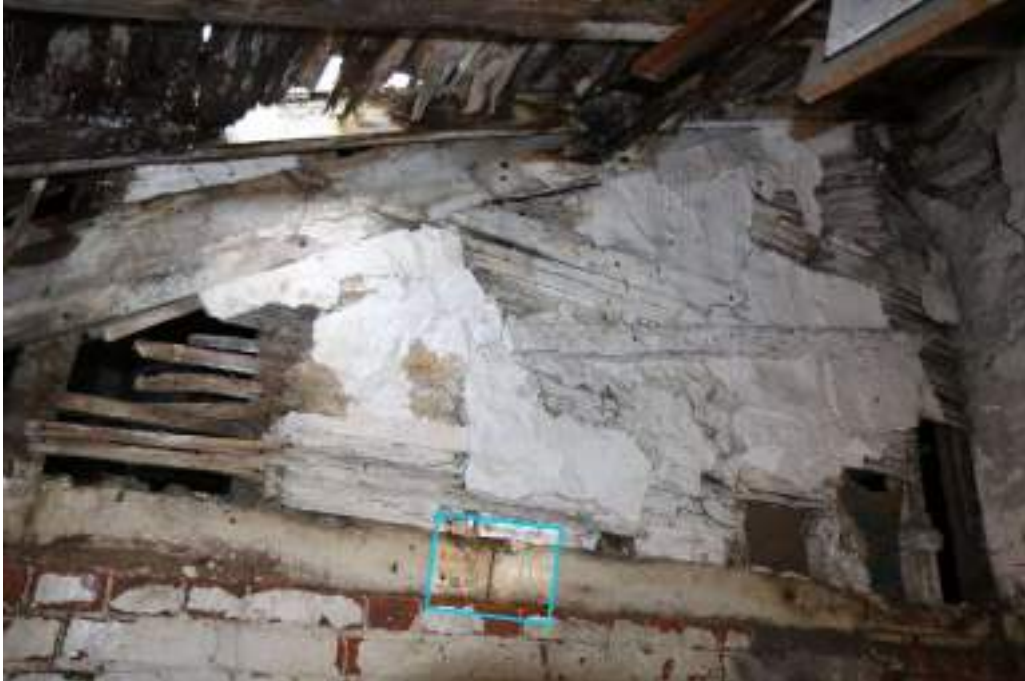
**Photograph 19** Interior of lean-to 2, showing lath and plaster wall. Sill-beam scarf-joint and carpenter's marks highlighted in blue. Photograph taken facing north-east.

The northern and eastern walls are covered with lath and plaster, damage to which has revealed several carpenter's marks on the frame of threshing barn, similar to lean-to 1.

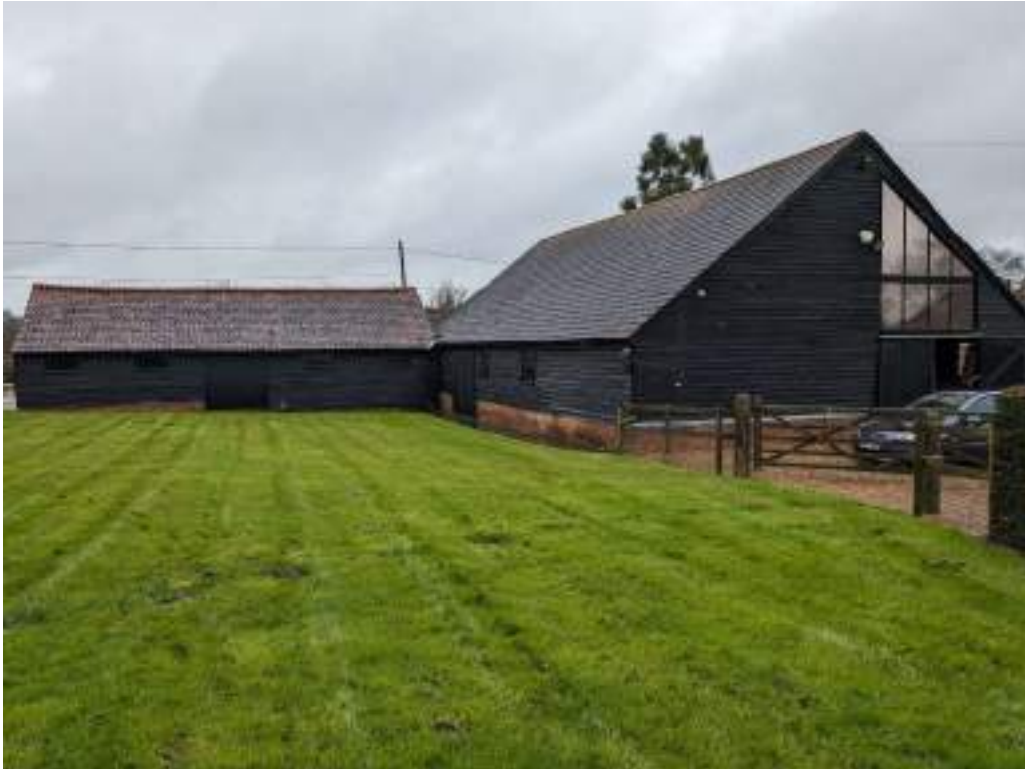
**Photograph 28** Southern elevation of building 2. Photograph taken facing north.

On the southern elevation of the cowshed is an off-centre a pair of vertically-planked timber barn doors, directly above which is a large eight-light fixed timber-framed window. The upper four lights follow the shape of the pitch of the roof. The southern elevation of the small barn also has a set of vertically-planked double doors, either side of which are two single-light fixed windows.

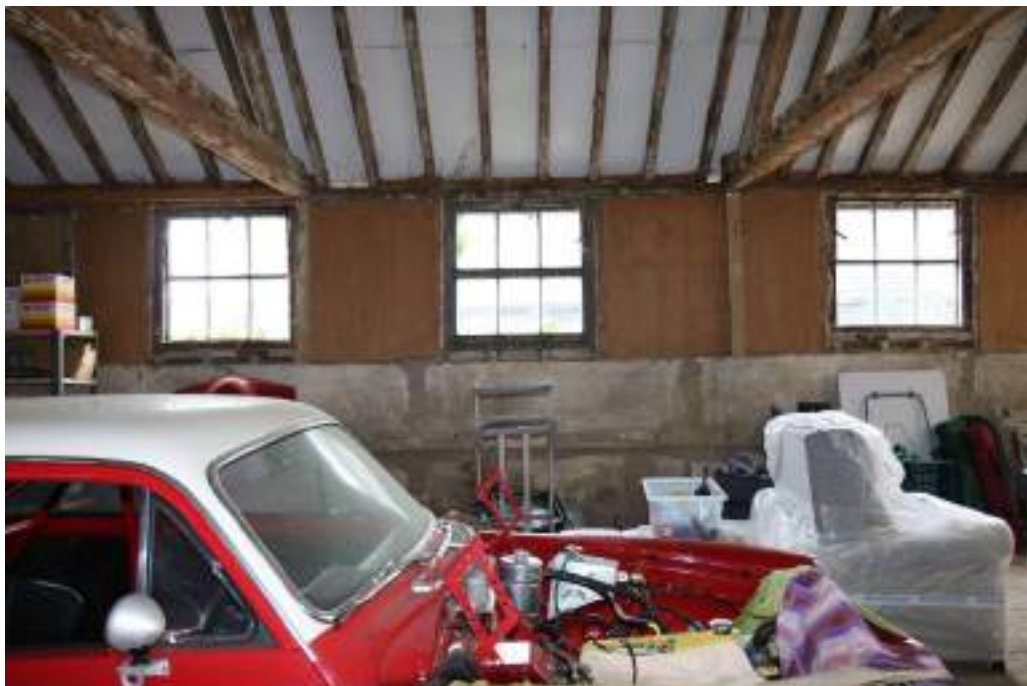
**Photograph 34** Interior of cowshed, bay 4. Photograph taken facing east.

In bay 4, the timber-framed window set in the eastern wall is a replacement while the metal-framed window in the western wall is inserted, again indicated by empty mortices. The wall-plate above the inserted window on the western wall has a side-halved scarf-joint. The lowest purlin on the eastern pitch has a splayed scarf-joint.

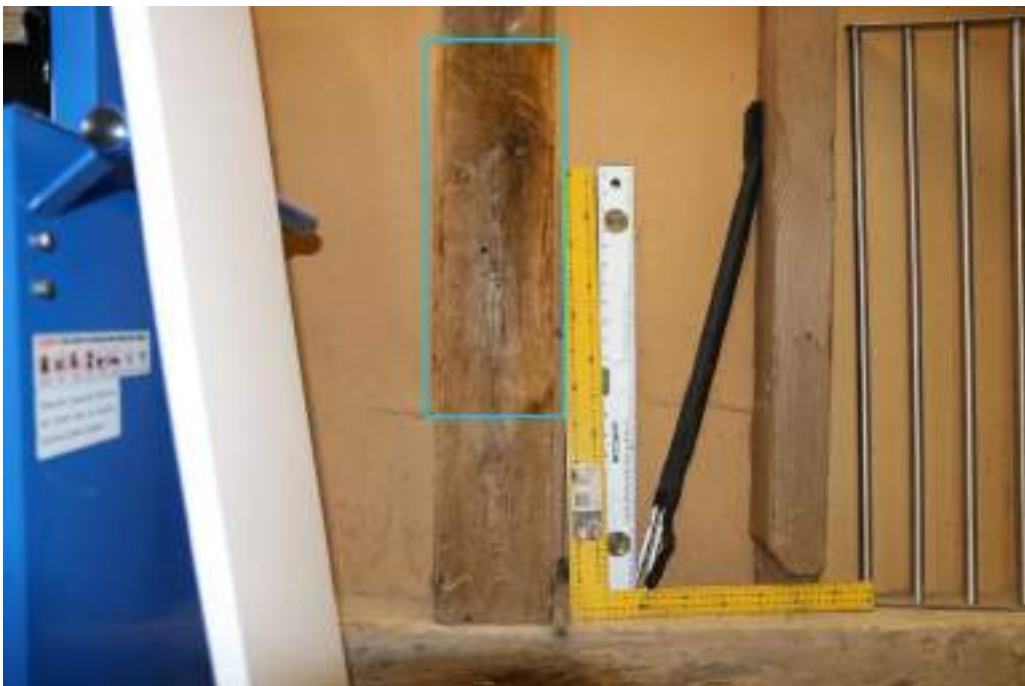
**Photograph 40** Detail of Baltic timber mark on intermediate-post of bay 1 of small barn. Photograph taken facing west.

The timbers in the frame are a mixture of hand-sawn and machine-cut while the roof is wholly machine-cut timbers. The brick plinth is not visible in the eastern wall or the southern wall in bays 4 and 5, suggesting that the small barn may have been partially rebuilt or raised at some point.

The presence of a Baltic timber mark in the roof of the carport can also be used to help with a construction date. The importing of timber into Britain began in the 17th century but increased dramatically during the 19th century (Vandenabeele et al. 2016). The small number of marks identified in the building suggests the building was raised whilst import levels were still relatively low. The collars in roof of the carport are hand-sawn and have lap-dovetail joints at either end, a technique found in timber-frames in the

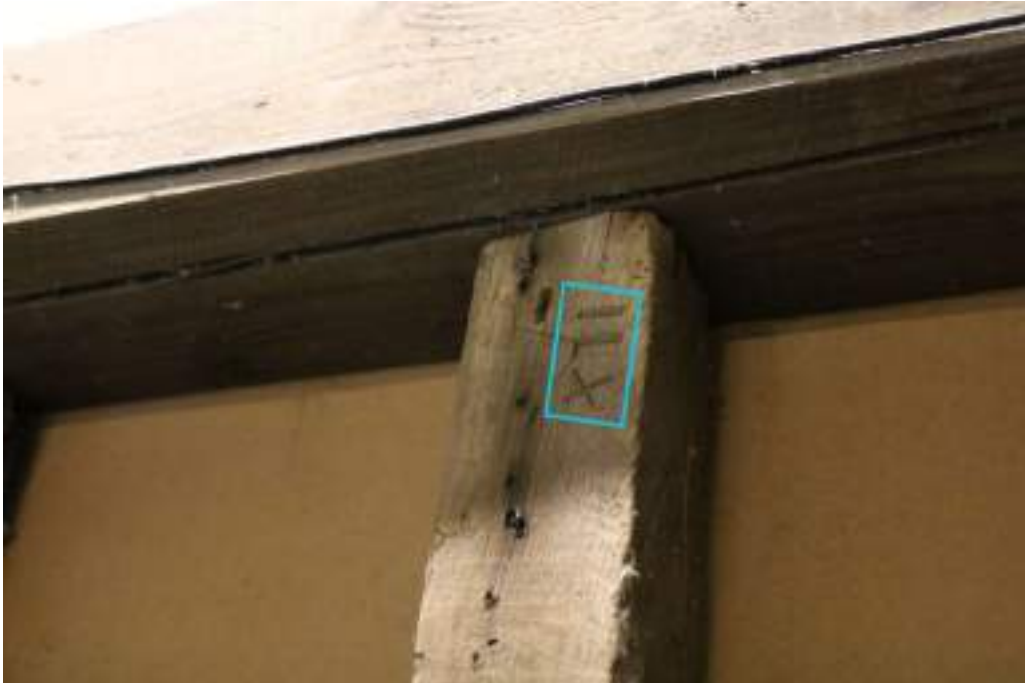
**Photograph 41** Detail of carpenter's mark on stud in bay 1 of small barn. Photograph taken facing west.

In bay 1, the timber-framed window in the southern wall is a replacement. There is an iron strap on the wall-plate in the south-western corner of the bay. In the western wall, eight of the upper studs, the northern wind-brace, the wall-plate and the sill-beam are all reused timbers (all hand-sawn). Also in the western wall, there is a Baltic timber mark on the intermediate post, a "XII" carpenter's mark on the second stud north of the

intermediate post (out of sequence so probably evidence of reuse) and the sill-beam has a cubic volume mark as well as a side-halved scarf-joint.

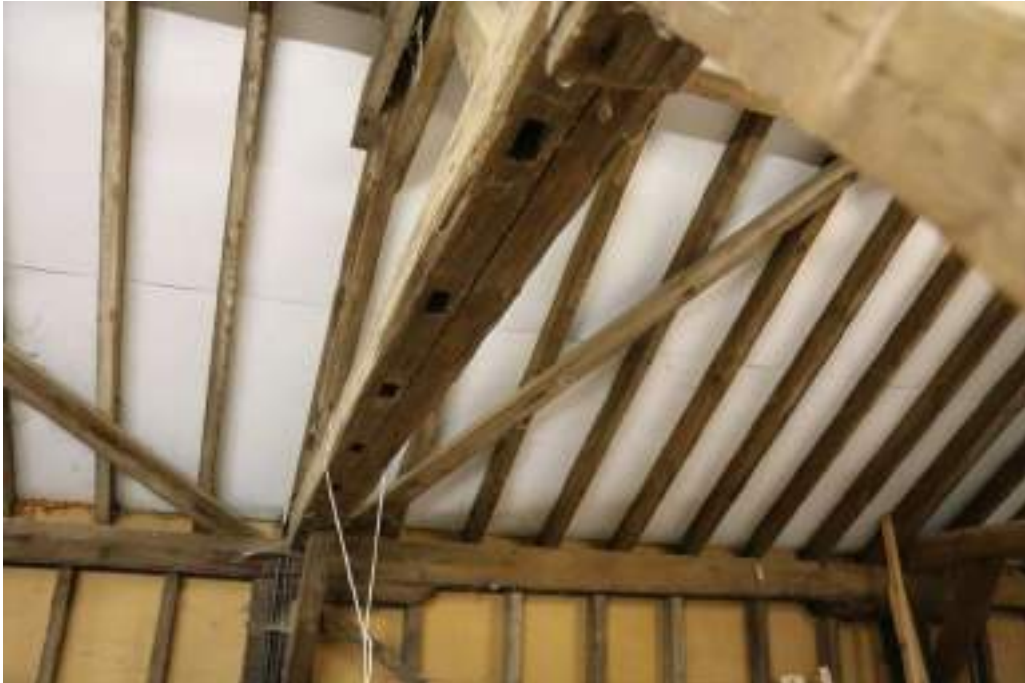
**Photograph 43** Detail of reused tie-beam between bays 2 and 3 of small barn. Photograph taken facing north-east.

intermediate post between bays 2-3 on the northern wall. The timber-framed window a replacement.

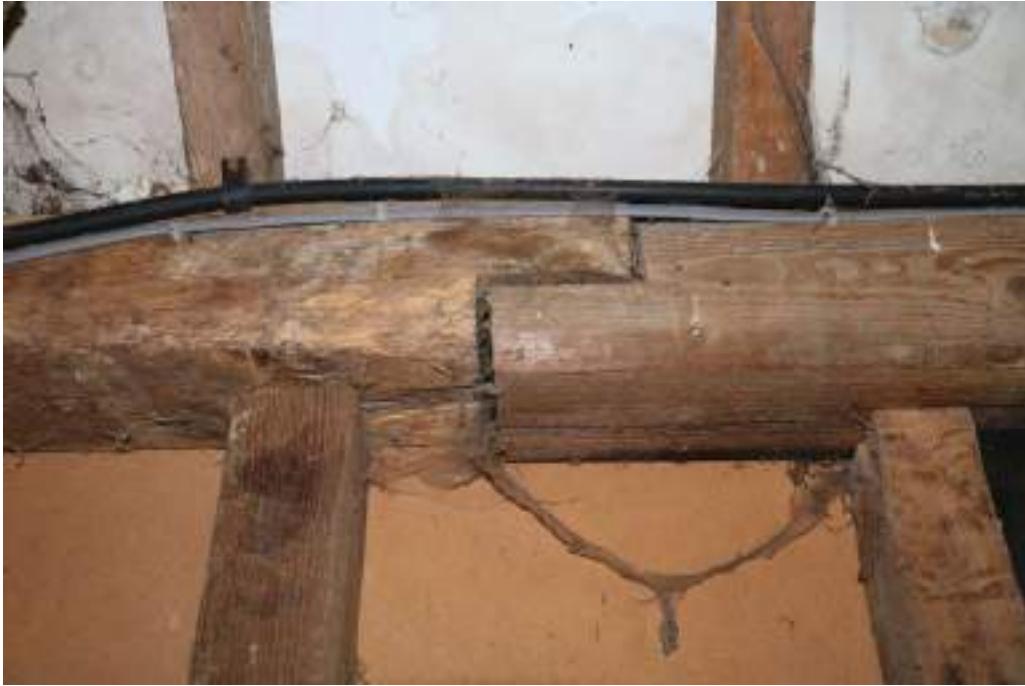
**Photograph 45** Detail of scarf-joint in wall-plate of bay 5 of the small barn.  
Photograph taken facing south.

In bay 5, the south-eastern corner-post is a reused timber, as is the sill-beam and a number of studs in the eastern gable wall. The doorway between the small barn and the cowshed is inserted, evidenced by the empty mortices in the wall-plate. The wall-plate in the southern wall has a side-halved scarf-joint. The timber-framed window in the southern wall is a replacement.

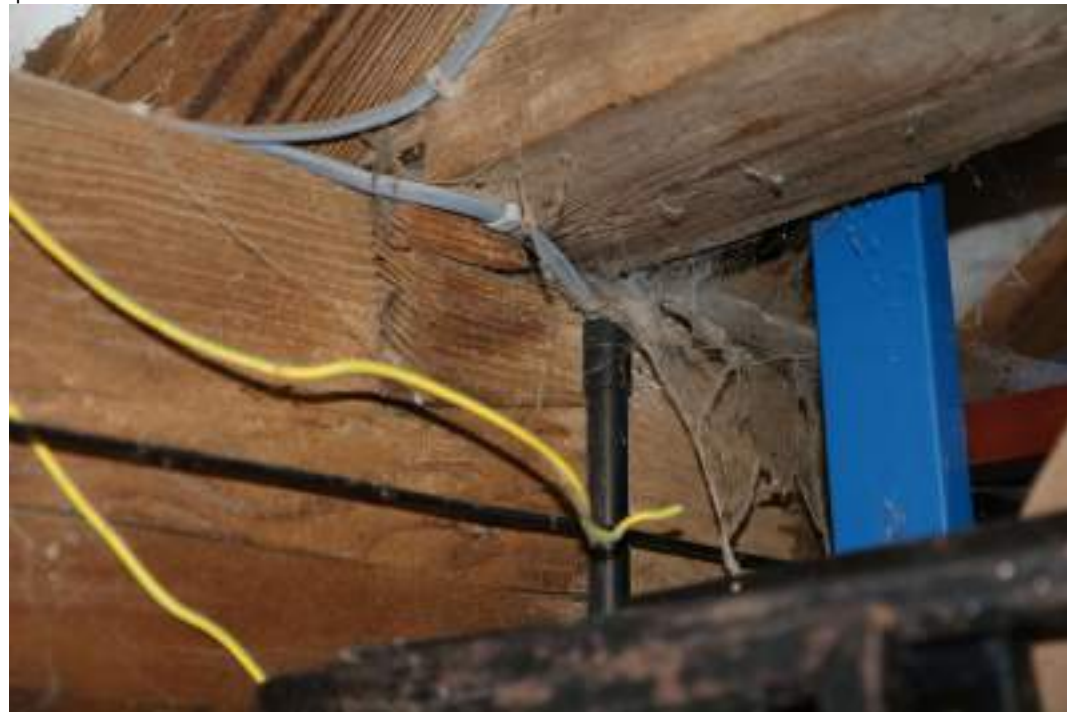
In bay 4, there is a side-halved scarf-joint, with squinted abutments, on the northern wall-plate under the tie-beam between bays 4 and 5. The southern intermediate post between bays 4 and 5 is a re-used timber, as is the southern inclined strut between those bays. The sill-beam also displays signs of reuse and has a replaced section beneath the intermediate post between bays 4 and 5, with a side-halved scarf-joint on its western side, with a simple scarf-joint on the eastern. The timber-framed window is a replacement.

MGWF24\_Phograph\_062  
Interior detail shot of scarf-joint on wall-plate under tie-beam between bays 4 and 5, small barn. Photograph taken facing north-east.

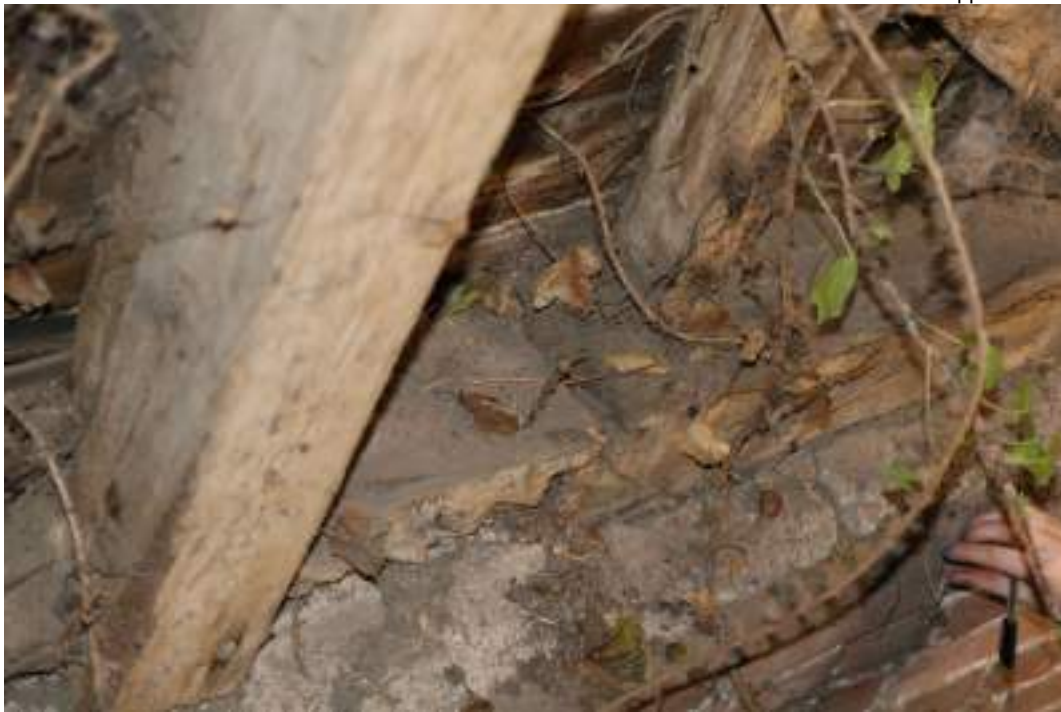
MGWF24\_PhotoGraph\_129

Interior detail shot of degraded side-halved scarf-joint of sill-beam in bay 2 of threshing barn. Photograph taken facing south-east.

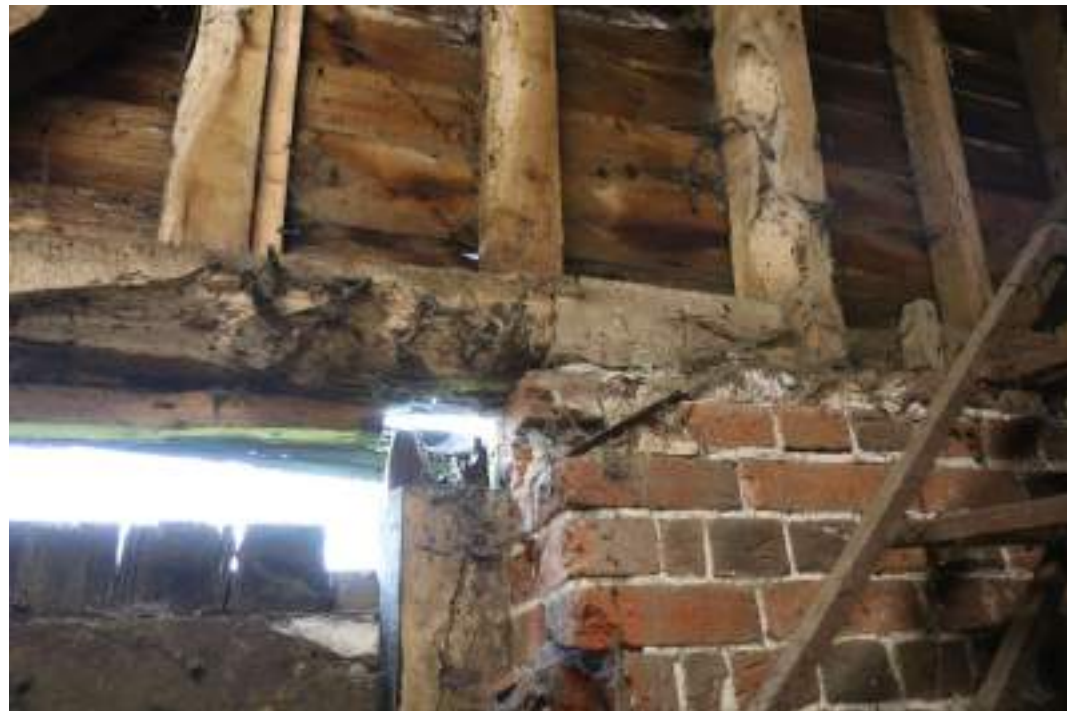
MGWF24\_Phograph\_136  
Interior detail shot of side-halved scarf-joint on sill-beam above doorway in bay 3 of threshing barn. Photograph taken facing east.
