CAT Report 2096
Issued October 2024

**Historic building recording at Camp Poultry Farm,
Mill Lane, Hatfield Heath, Essex, CM22 7AA**

August 2024

**Planning district.: Uttlesford
Planning ref.: UTT/23/1688/FUL**

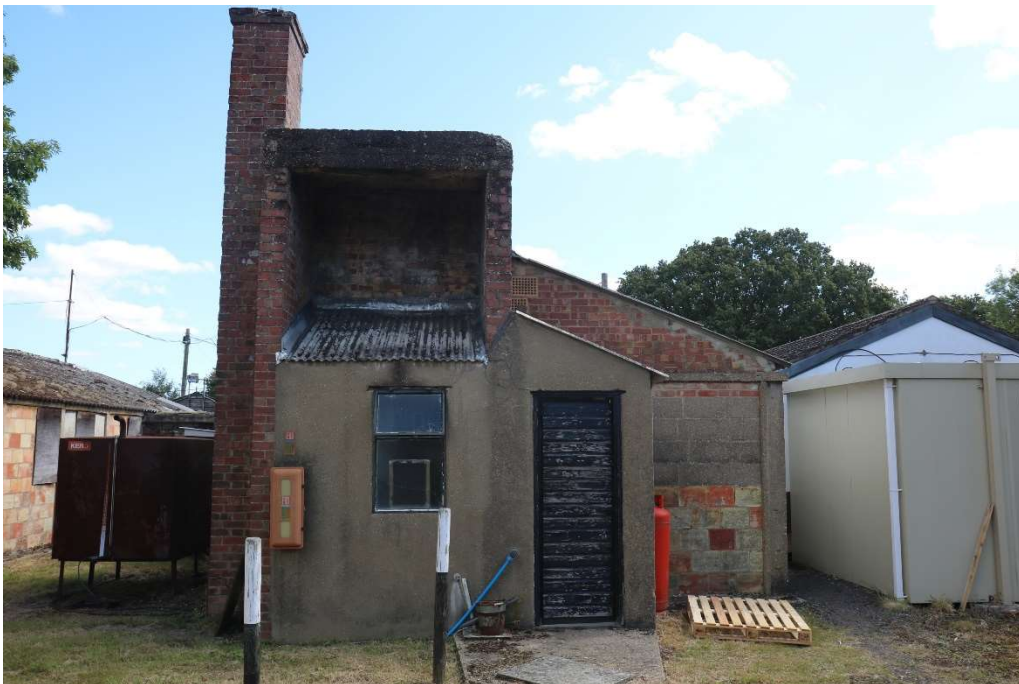
Photograph 7 Western elevation of building 2. Photograph taken facing east.

A red brick structure, with a chimney, projects from the western elevation of building 2 (Photograph 7), in which a small extension has been built. The brick structure seems to be the remains of a tower for a water tank (the tank no longer surviving). It is built from bricks (brick dimensions: 220 x 110 65mm) laid in English bond, as is the chimney. The extension has two mono-pitched roofs clad with corrugated asbestos. The elevations are rendered and there is a two-light window and a doorway. The southern elevation of

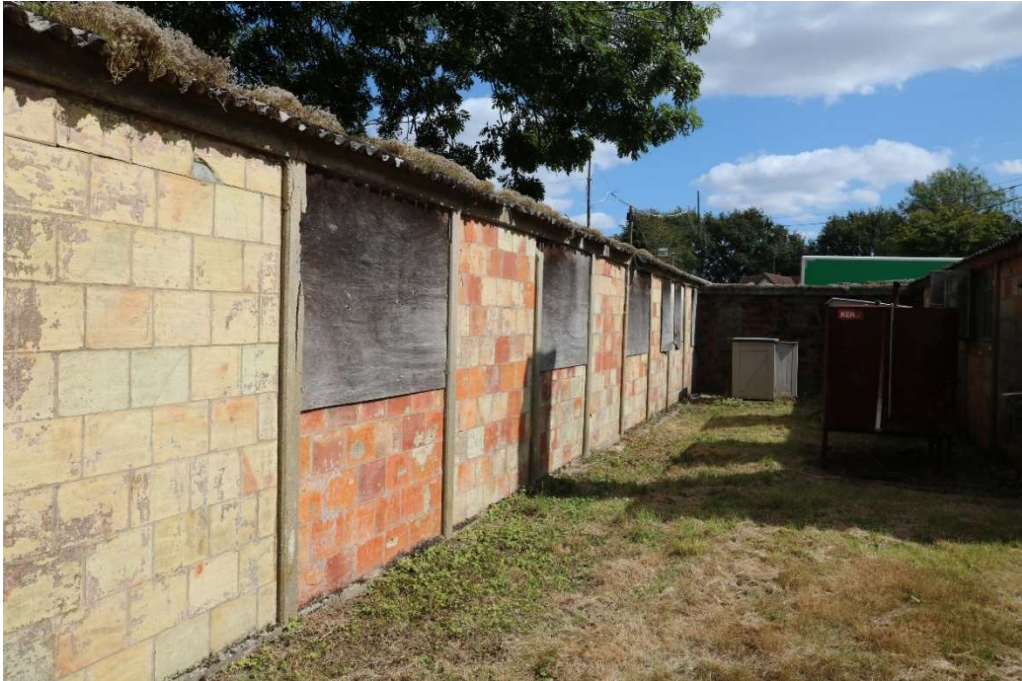
Photograph 8 Southern elevation of building 3. Photograph taken facing north-east.

On the eastern elevation, building 3 has a large, inserted doorway adjacent to a single-light timber-framed window. The northern and southern elevations (Photograph 8) of building 3 have a series of openings blocked with plywood while the western elevation has been completely rebuilt in breeze blocks.

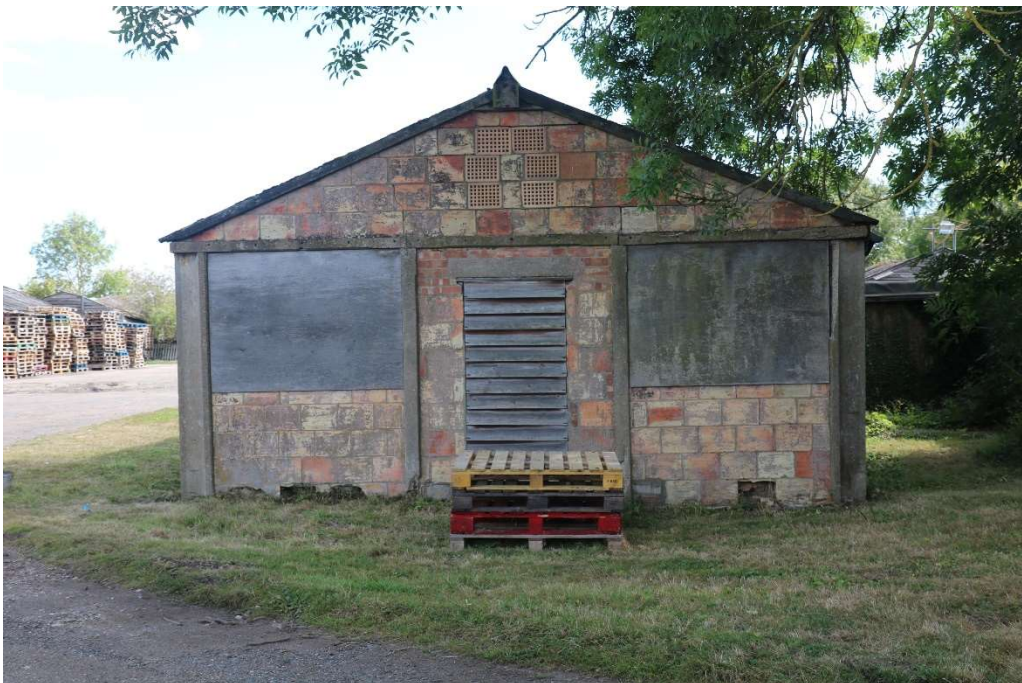
Photograph 9 Western elevation of building 4. Photograph taken facing east.

Building 4 has a large doorway on its eastern elevation, that is likely a larger replacement of a previous opening. On the northern and southern elevations, a number of the panels are half clad with plywood, blocking window openings. The

western elevation (Photograph 9) also has openings blocked with plywood along with a central doorway blocked with weatherboard.

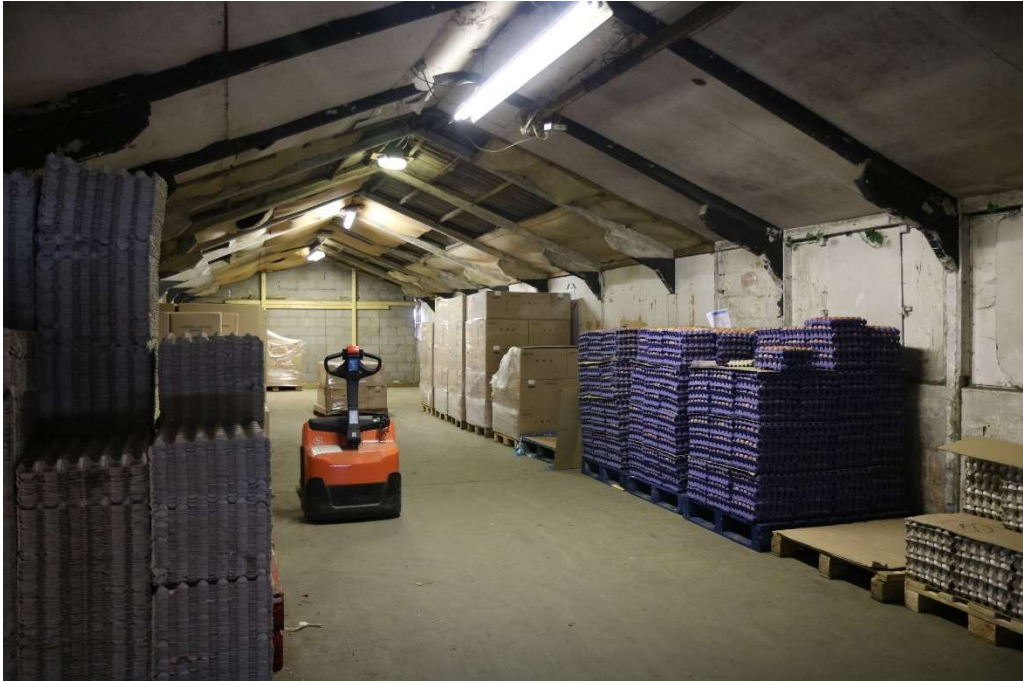
The roof of building 3 (Photograph 11) has been mostly covered with plywood sheets and some of the structure has been painted black. The walls have been covered with plywood, painted white, and the floor is concrete. There is an inserted doorway in the eastern wall along with inserted entrances to passages 1 and 2 in the northern and southern walls. The western wall has been rebuilt and is exposed breeze block. A small office has been inserted into the north-eastern corner of the room; this was inaccessible at the time of recording.

Photograph 11 Interior of building 3. Photograph taken facing north-west.

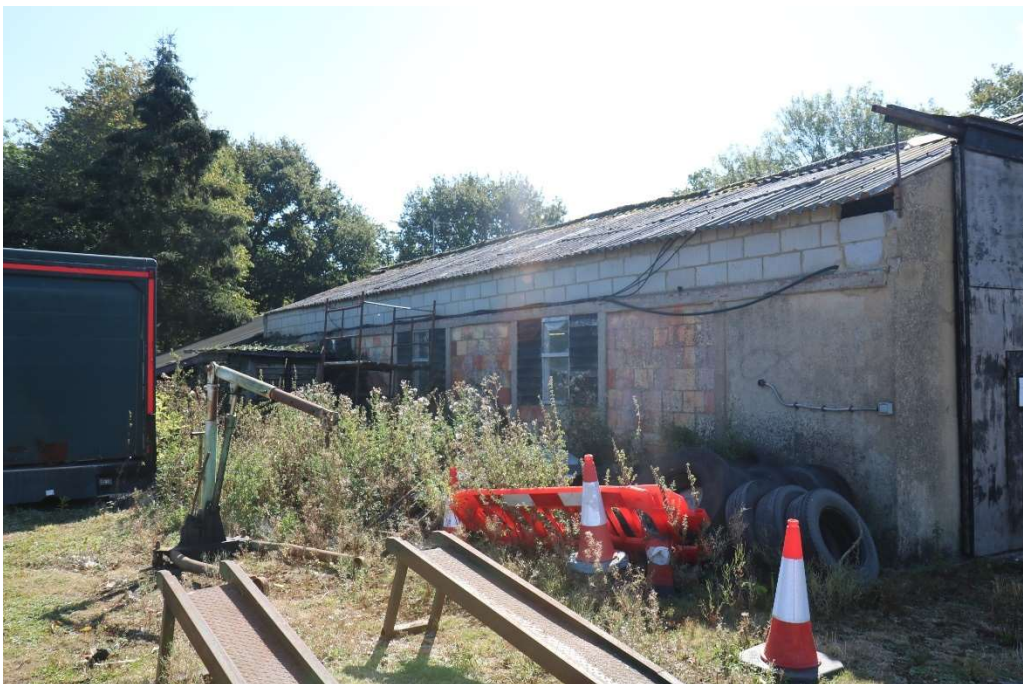
Building 5 is a MoWP standard hut that has had the roof raised, using breeze blocks, and has been extended to the east.

Photograph 12 Northern elevation of building 5, with detail of the raised roof. Photograph taken facing south-east.

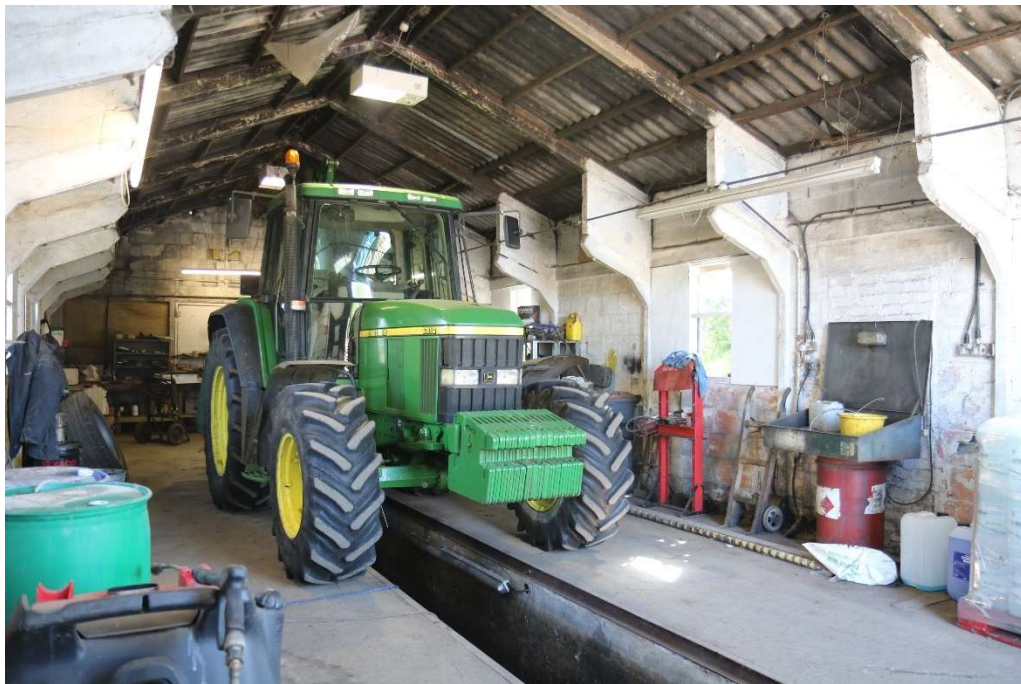
The main roof structure of building 5 has been raised using breeze blocks, with poured concrete between the braces and rafters (Photograph 13). The walls have been painted white and the floor is concrete. A series of windows are present in the northern and southern walls, in opposite panels, along with a bricked-up doorway in the southern wall. There is a large, inserted double doorway that dominates the western wall. The panels of the eastern walls have been replaced with a doorway and timber-framed walling. A vehicle inspection pit has been inserted into the floor.

Photograph 13 Interior of building 5. Photograph taken facing south-east.

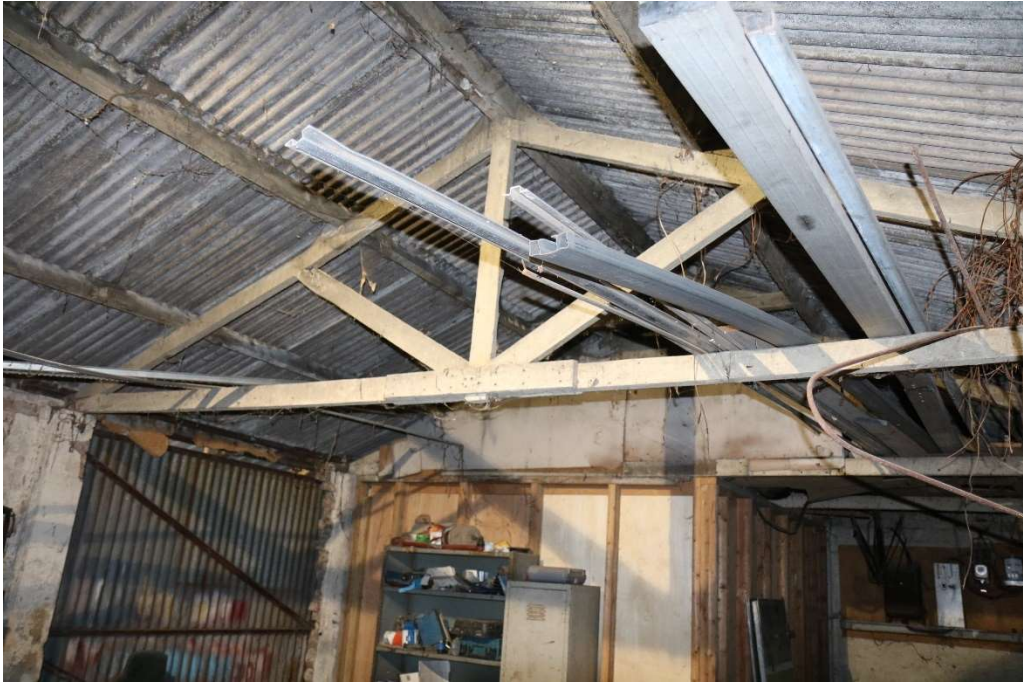
The rear extension of building 5 has different roof structure (Photograph 14) to the main building. It comprises pairs of rafters rising from the tie-beams to meet at the roof's apex, which are supported on a timber king post and two inclined struts, which project from the tie-beam. There is a timber fish-plate on both faces of the tie-beam, suggesting the beam is formed from two shorter lengths of timber joined together. There are three windows in the southern wall and an inserted doorway in the northern wall. A room has been inserted into the north-east corner of the extension, which was inaccessible at the time of recording.

Photograph 14 Roof construction of rear extension of building 5. Photograph taken facing north-east.

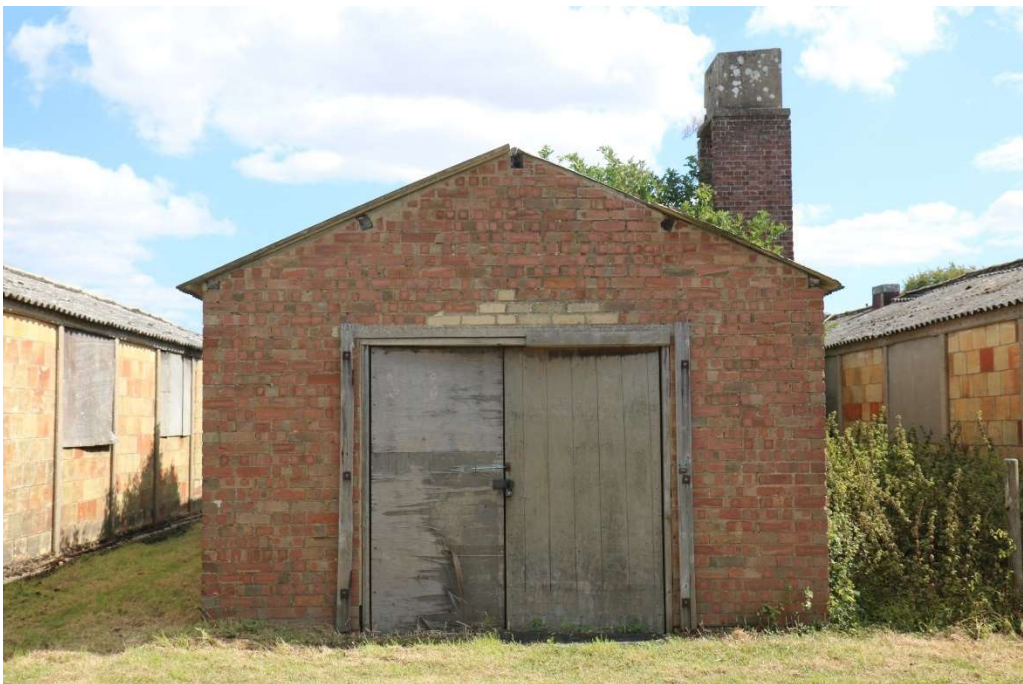
The western elevation (Photograph 15) of building 6 is relatively plain and only has a pair of centrally located double doors. The northern (Photograph 16) and southern elevations are parallels of one another, with two six-light Crittall windows flanking a brick buttress at one end and a further two six-light Crittall windows at the other end. The eastern elevation of building 6 was not accessible at the time of recording.

Photograph 15 Western elevation of building 6. Photograph taken facing east.

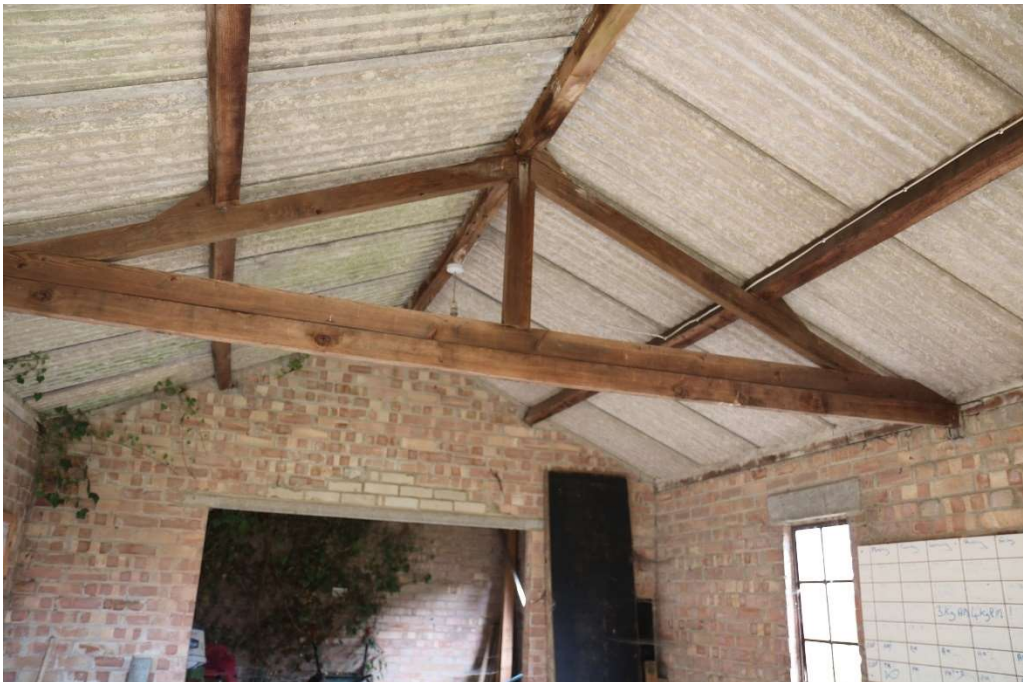
The roof of building 6 (Photograph 17) is supported on one timber truss and an internal brick wall. The timber truss comprises a double-stacked tie-beam, from which two rafters rise to meet the top of a king post, which projects from the centre of the tie-beam. There is a single purlin on each roof pitch along with a ridge beam, all of which are supported on timber cleats. The northern and southern walls have a timber wall-plate, both of which have a side-halved scarf-joint.

Photograph 17 Detail of roof construction of building 6. Photograph taken facing south-east.

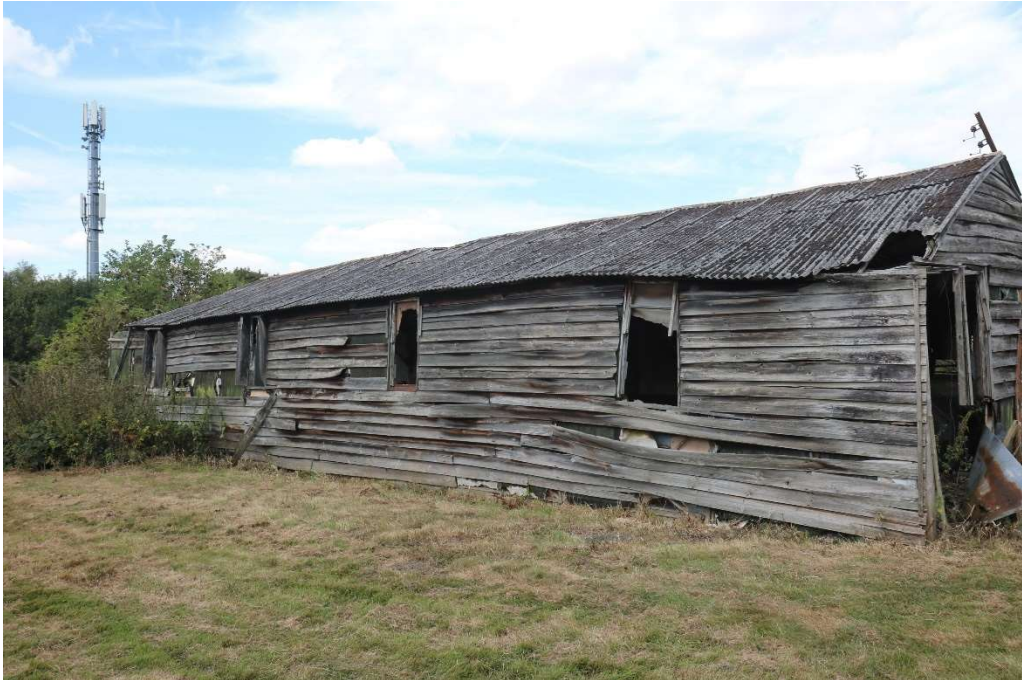
The eastern elevation of building 7 is somewhat dilapidated, with much of the weatherboarding missing. There is a central doorway, with no surviving door, which is flanked by the remains of two timber-framed windows. Both the northern and southern elevations (Photograph 18) have four timber-framed windows, in various states of decay. The western elevation has completely collapsed.

Photograph 18 Southern elevation of building 7. Photograph taken facing north-west.

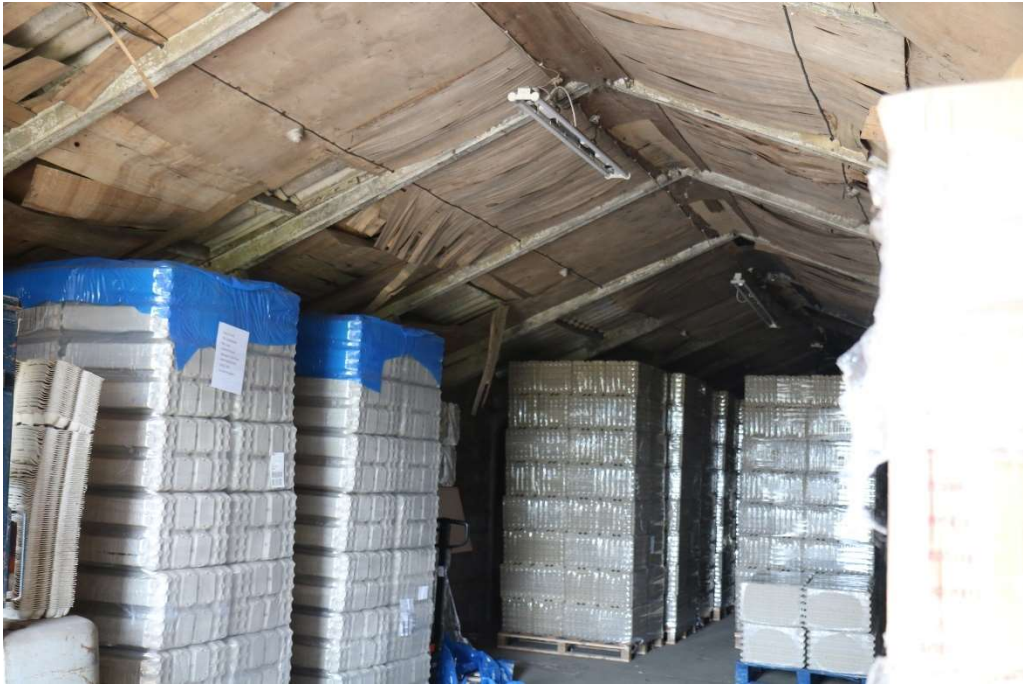
The roof of building 11 is covered with plywood while the walls are exposed clay blocks. The floor is concrete. As the building has been utilised for modern storage, closer inspection of the interior was impeded (Photograph 24).

Photograph 24 Interior of building 11. Photograph taken facing north-east.

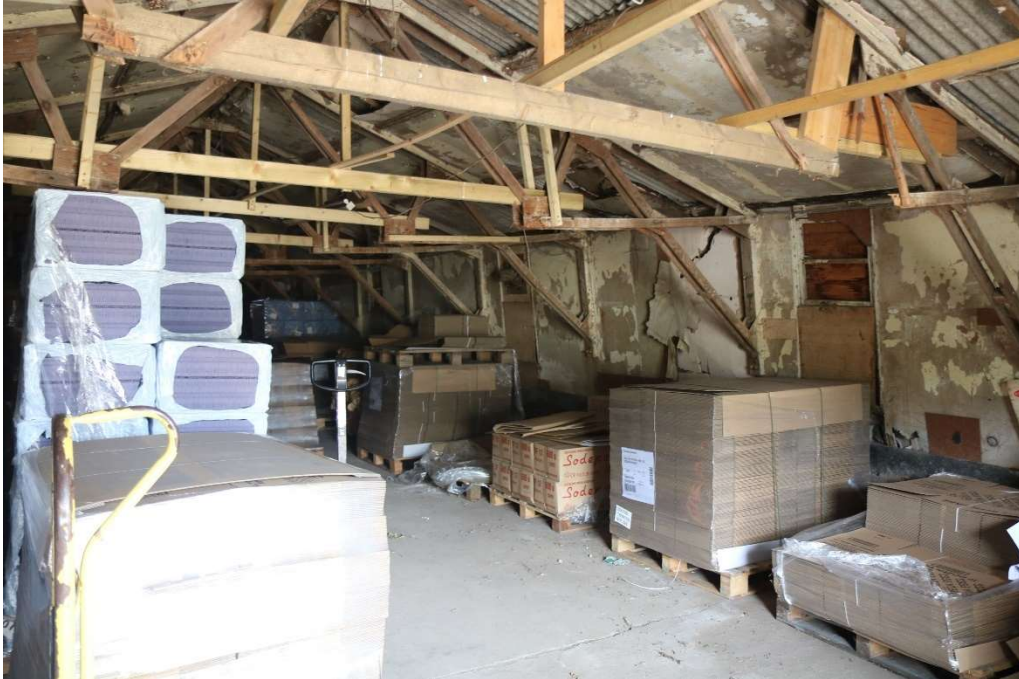
The walls and roof of building 12 are clad with plasterboard, with areas repaired with plywood, and the floor is concrete. Metal sheets have been added to the lower portion of the walls. The roof structure has been altered by modern repairs, which have adjusted the height of the tie-beams and added a king post (Photograph 26).

Photograph 26 Interior of building 12. Photograph taken facing north-west.

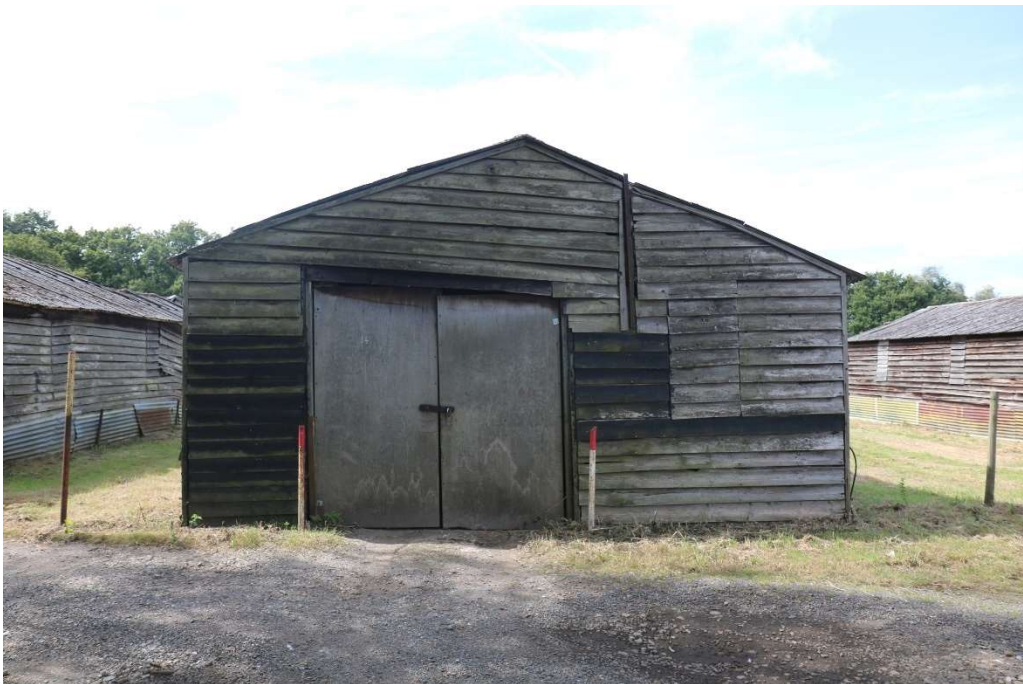
Photograph 28 Eastern elevation of building 14. Photograph taken facing west.

The eastern elevation of building 14 (Photograph 28) has a set of double timber doors, off centre, along with a single blocked window opening. It seems likely the original central door was widened, incorporating a window to create the double doors. Both the northern and southern elevations have five blocked window openings, covered with weatherboarding, with the lower portion of elevation covered with corrugated metal sheets. A number of corrugated metal sheets have been used higher up on the southern elevation, presumably to repair areas where the weatherboard has come away. The western elevation has a central vertically-planked door, although opening it

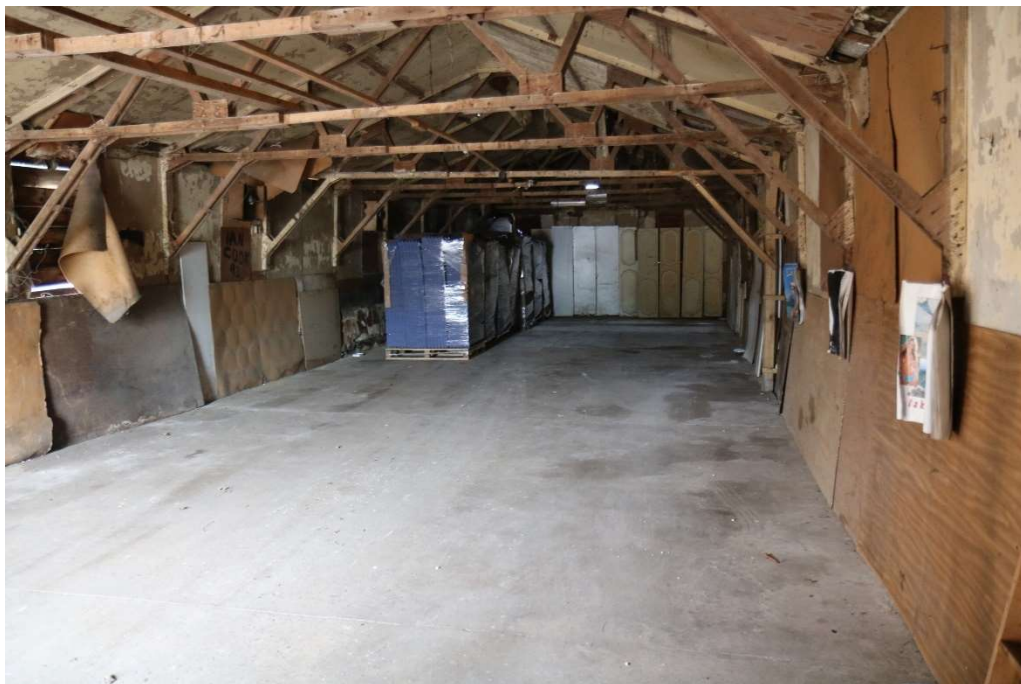
Building 15 has a mixture of plasterboard and plywood covering the walls, with a concrete floor (Photograph 31). As with many of the previously described timber huts, metal sheets have been added to the walls, which have subsequently been covered with plywood.

Photograph 31 Interior of building 15. Photograph taken facing south-west.

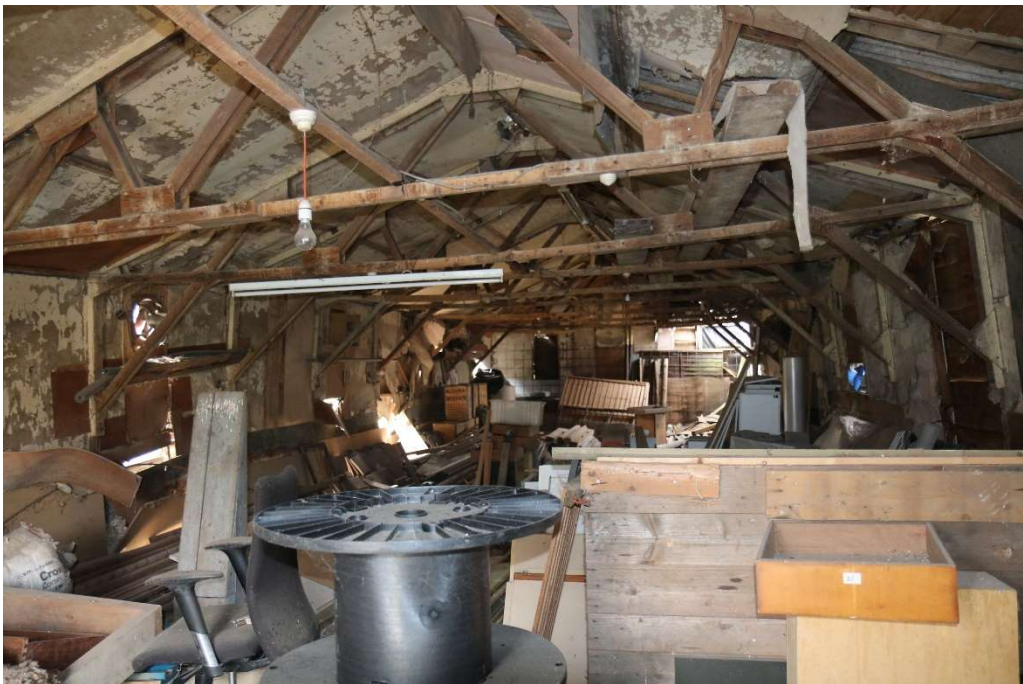
The walls and ceiling of building 16 were clad with plasterboard, with areas of damage covered with plywood, and metal sheets. The floor is concrete.

Photograph 33 Interior of building 16. Photograph taken facing south-west.

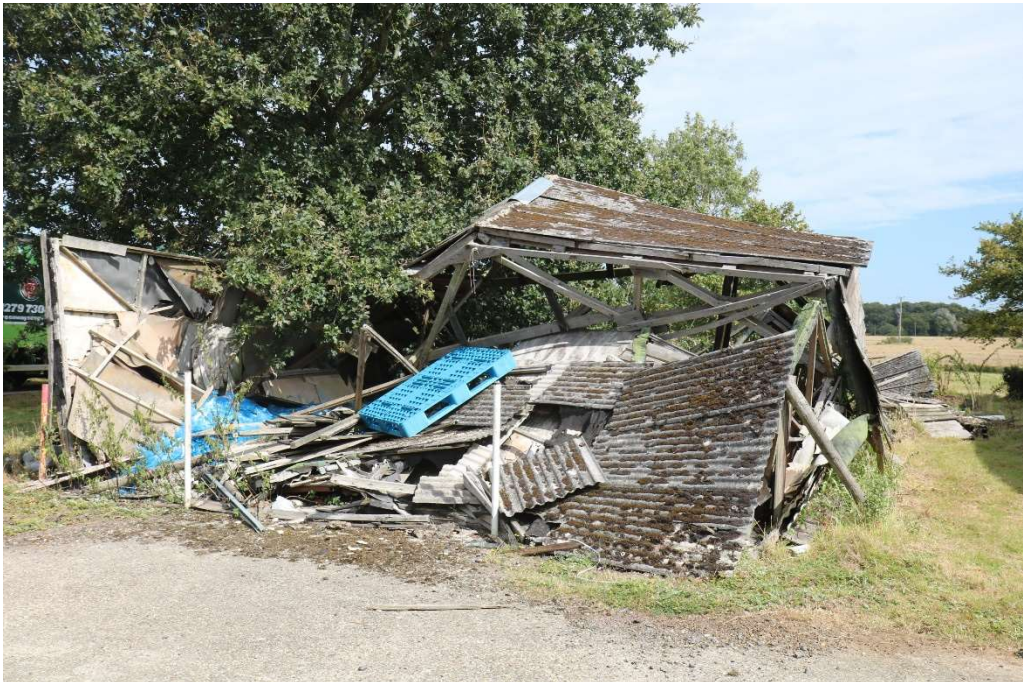
Building 20 was a MoWP hall hut but has collapsed, thus making it not possible to be recorded.

Photograph 38 Building 20. Photograph taken facing south-west.
