## **COLCHESTER ARCHAEOLOGICAL REPORT 3:**

**Excavations at Lion Walk, Balkerne Lane, and Middleborough,  
Colchester, Essex**

PHILIP CRUMMY

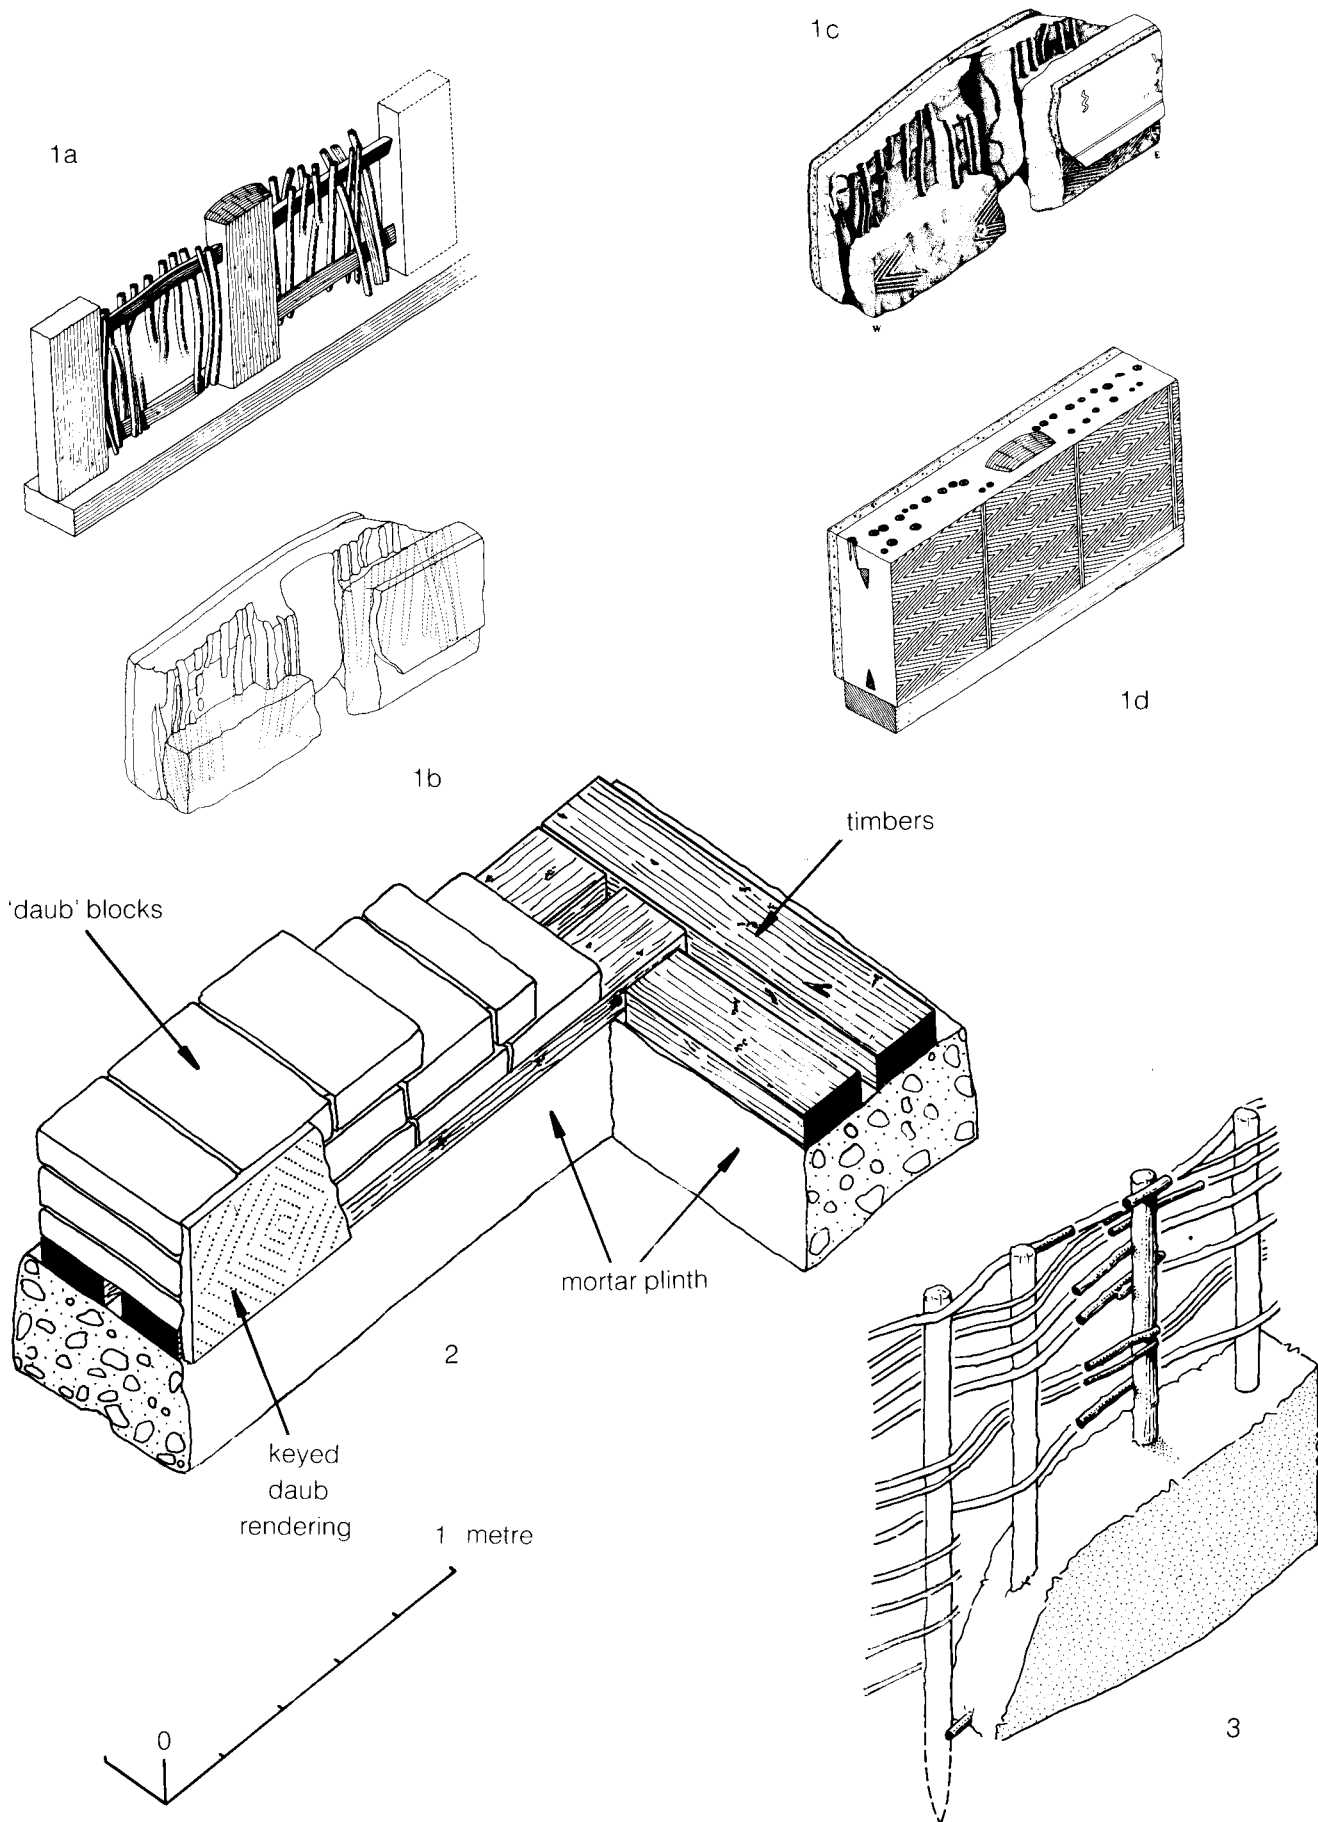
Fig 11 Types of wall: 1...stud-and-wattle (LWC JF312), 2...daub block (Culver Street, BF487), and 3...stake-and-wattle (BKC J, north wall of Building 44). [Pages 20-3]

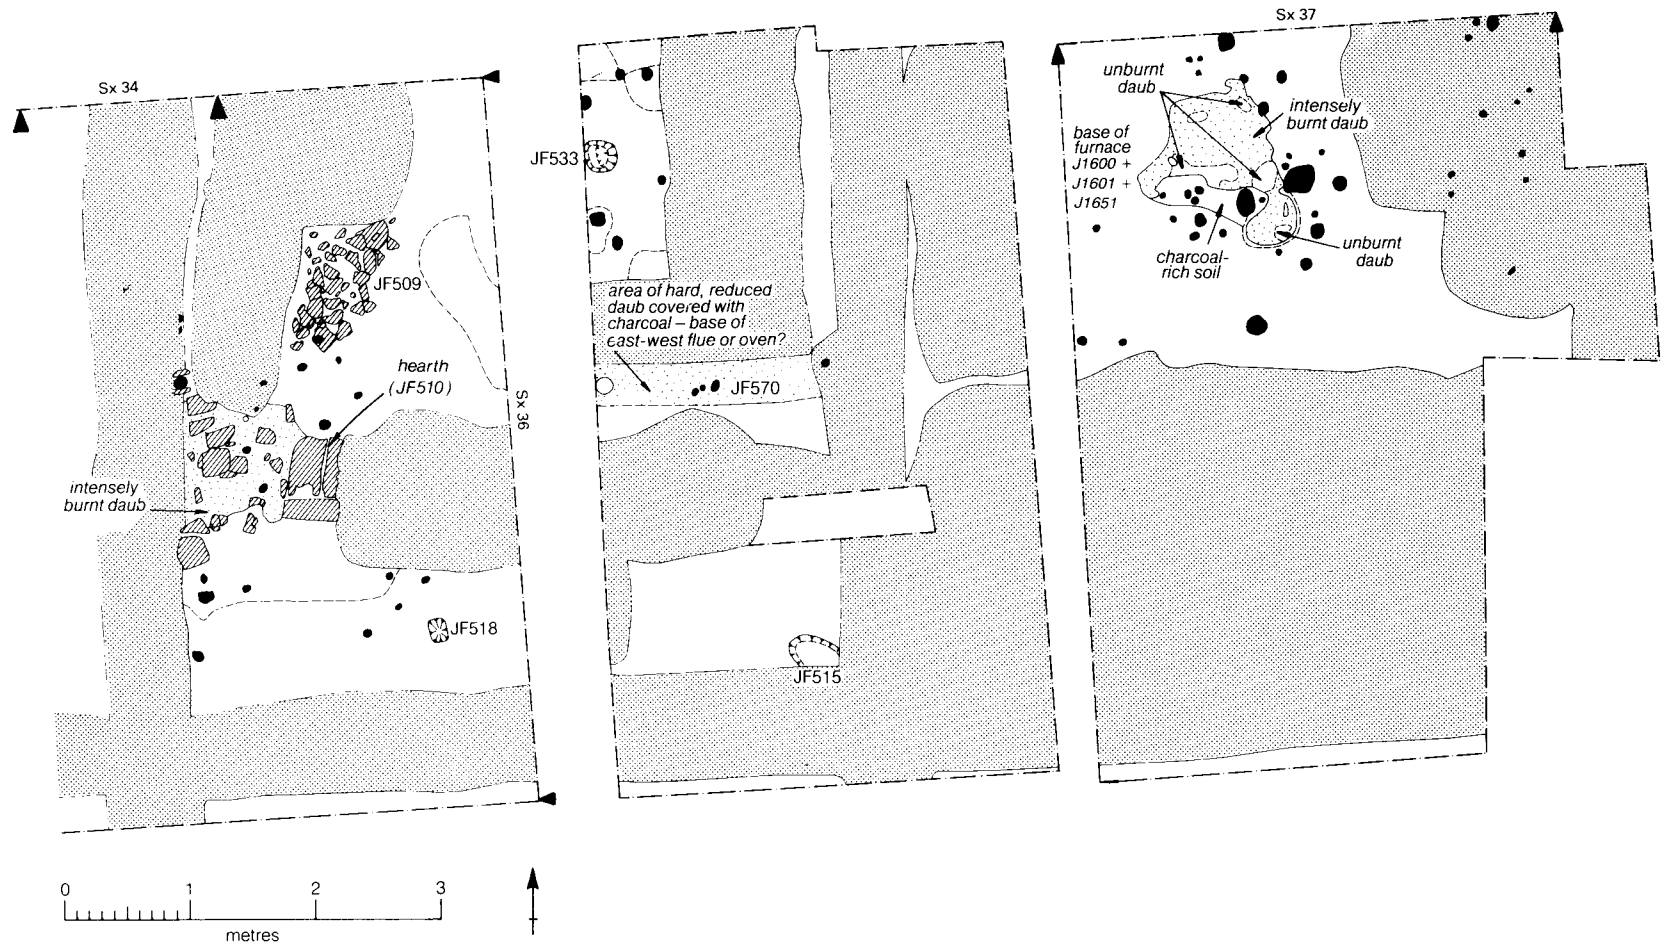
Fig 39 Building 16, room(s) at street frontage. 1:60. [Pages 50-2]

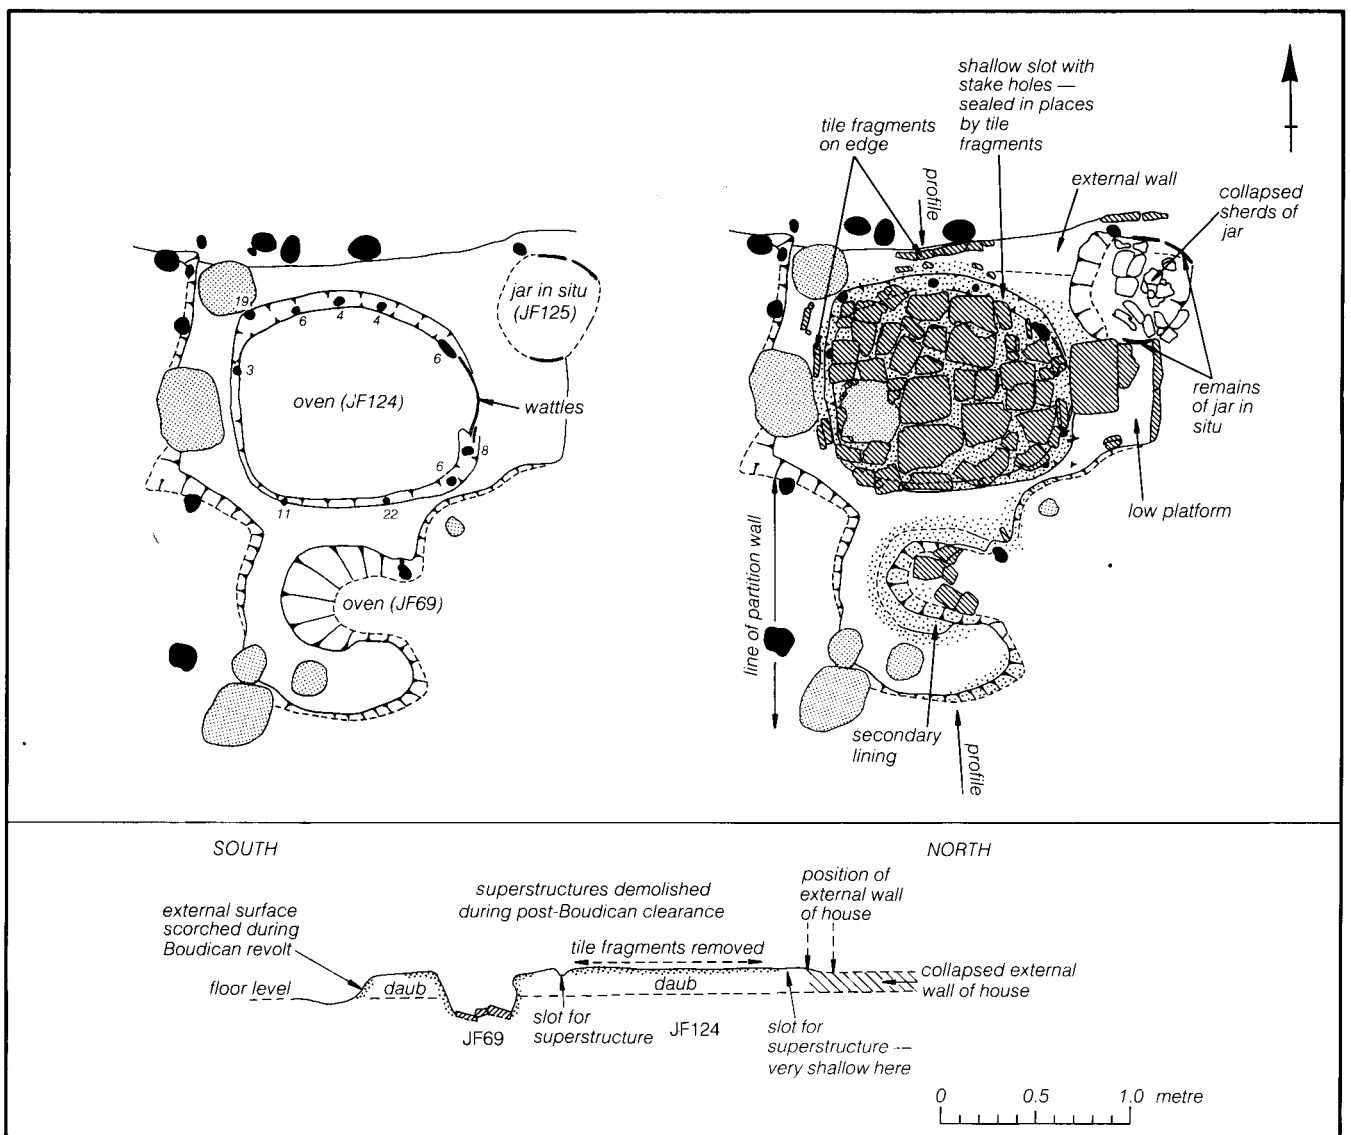
Fig 94 The ovens in Building 44. 1:40. [Pages 106-7]

South of the large oven was another of smaller size (Fig 94; JF69). This had been relined once and like the larger oven survived to a height of 0.15 m. The outer surface had been scorched during the Boudican revolt and inside were found an iron shield boss (CAR 2, 4193) and a *pilum* head (CAR 2, 4196). The boss and the head were on the bottom of the oven and were sealed by post-Boudican destruction debris. Clearly these pieces had been put in the oven before it was destroyed and they must have been scrap since

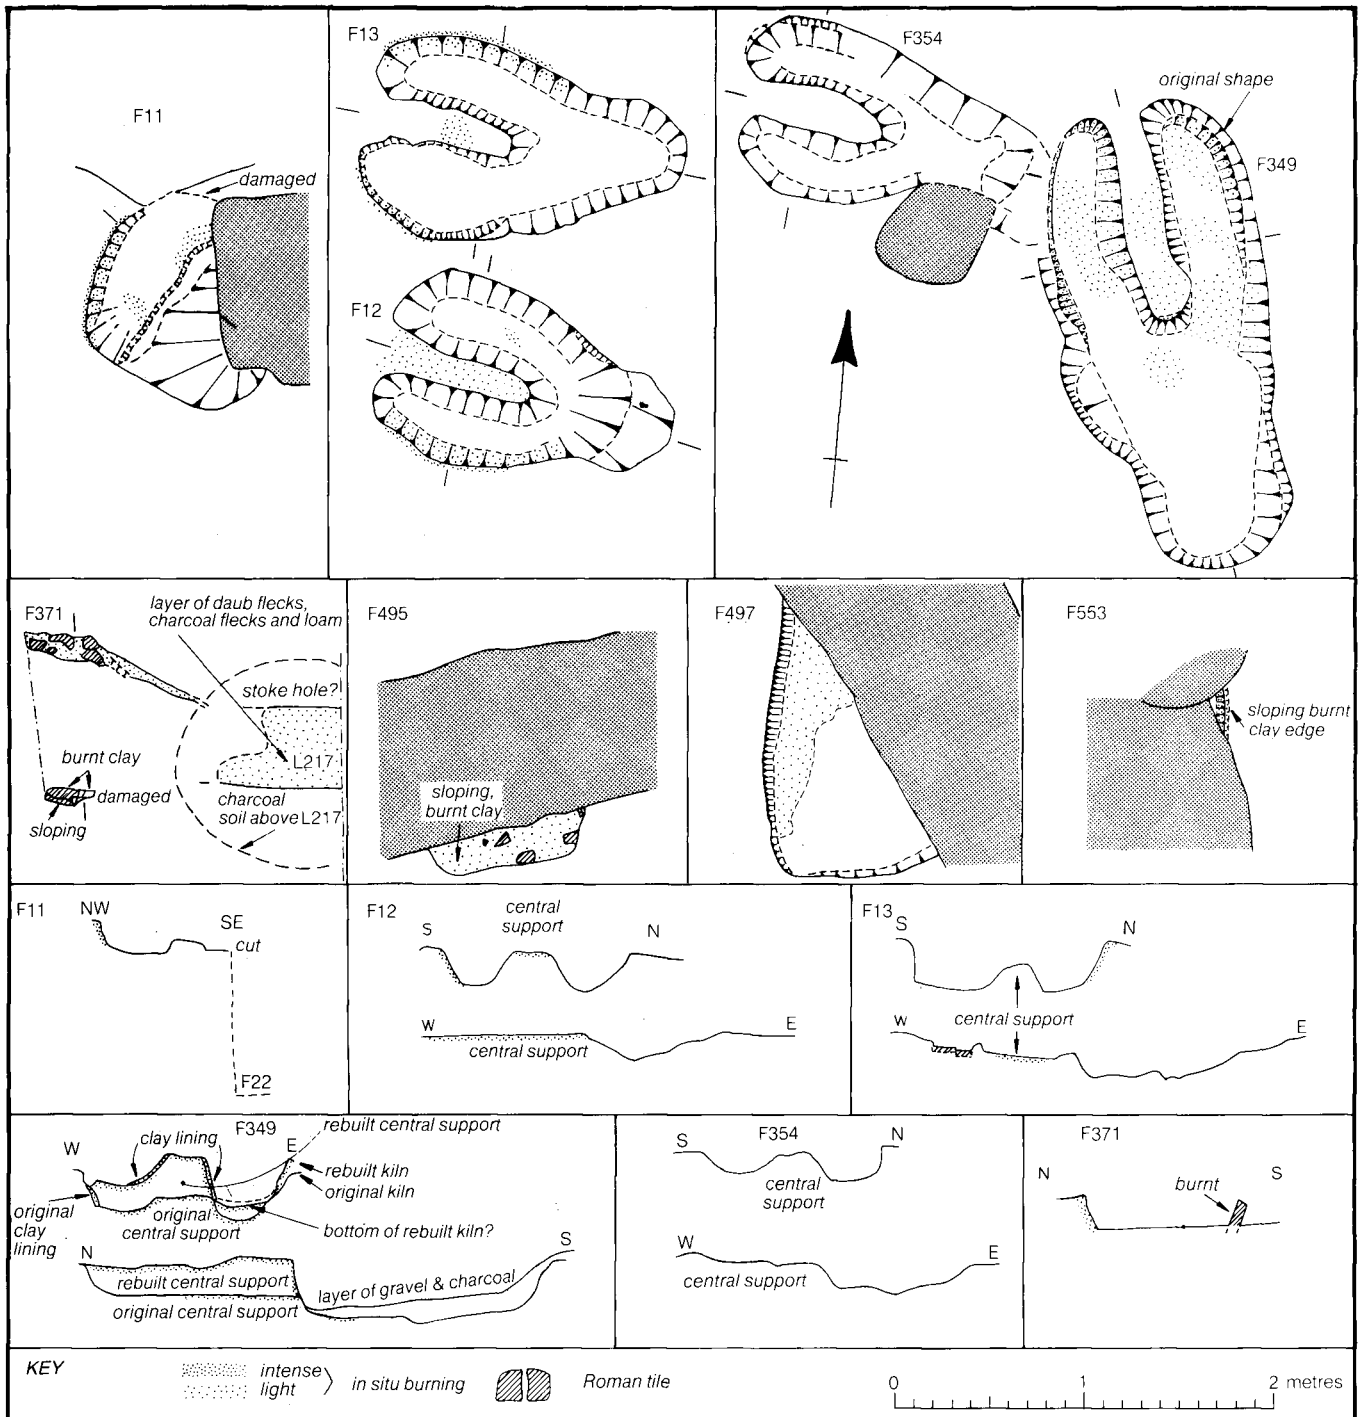
Fig 174 The early medieval pottery kilns. [Pages 186-9]

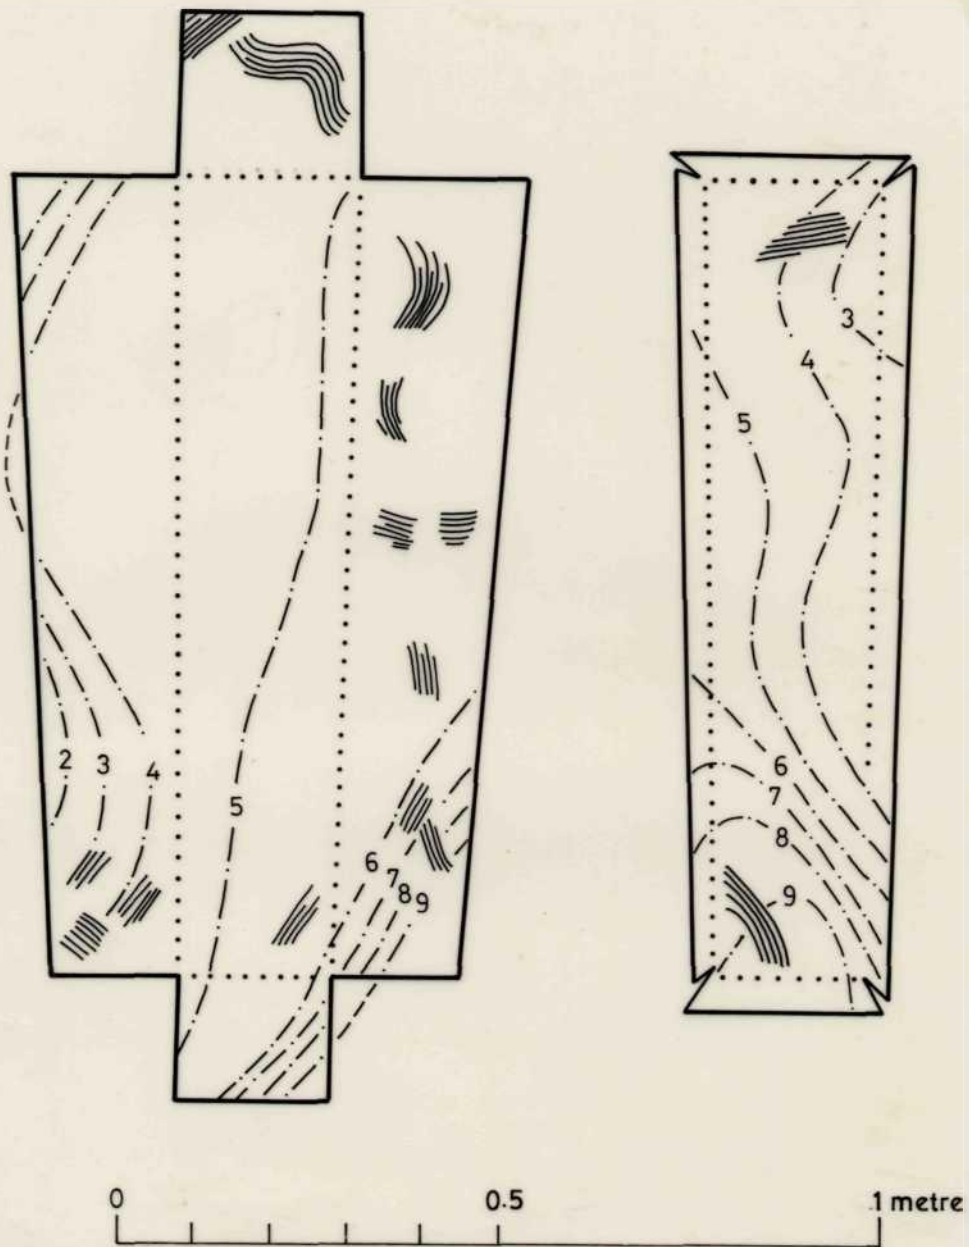
Fig 195 Thickness of the lead forming the coffin, and cooling wrinkles

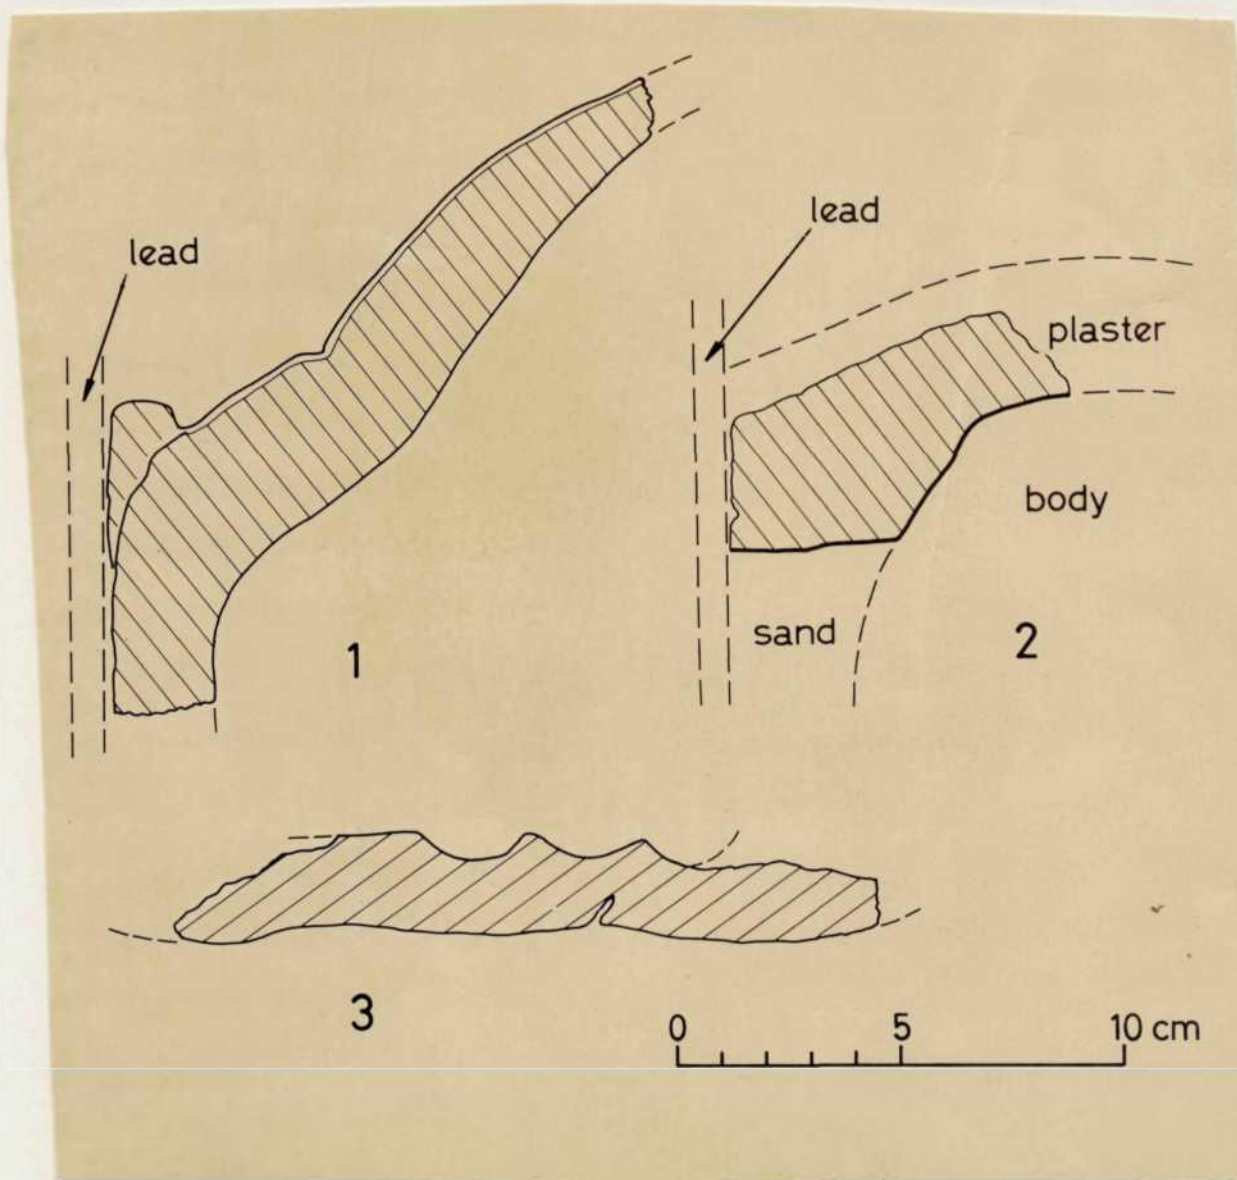
Fig 196 Sections through plaster fragments found in the lead coffin

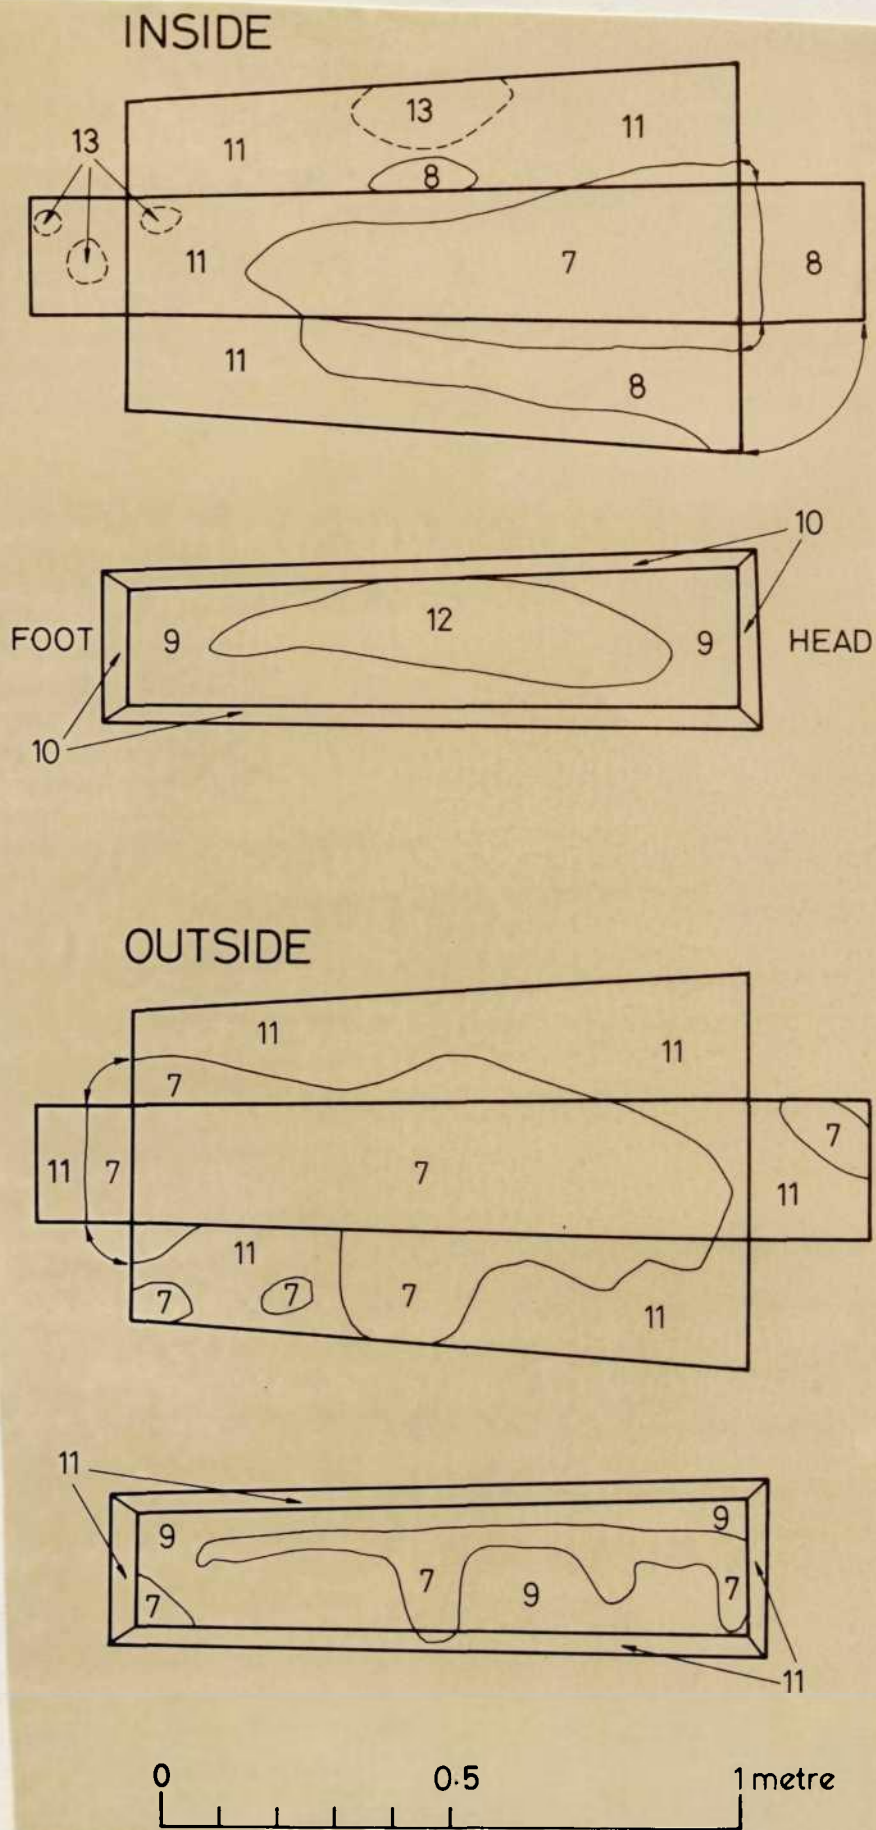
Fig 197 Pattern of corrosion products on the outside and the inside surfaces of the lead coffin

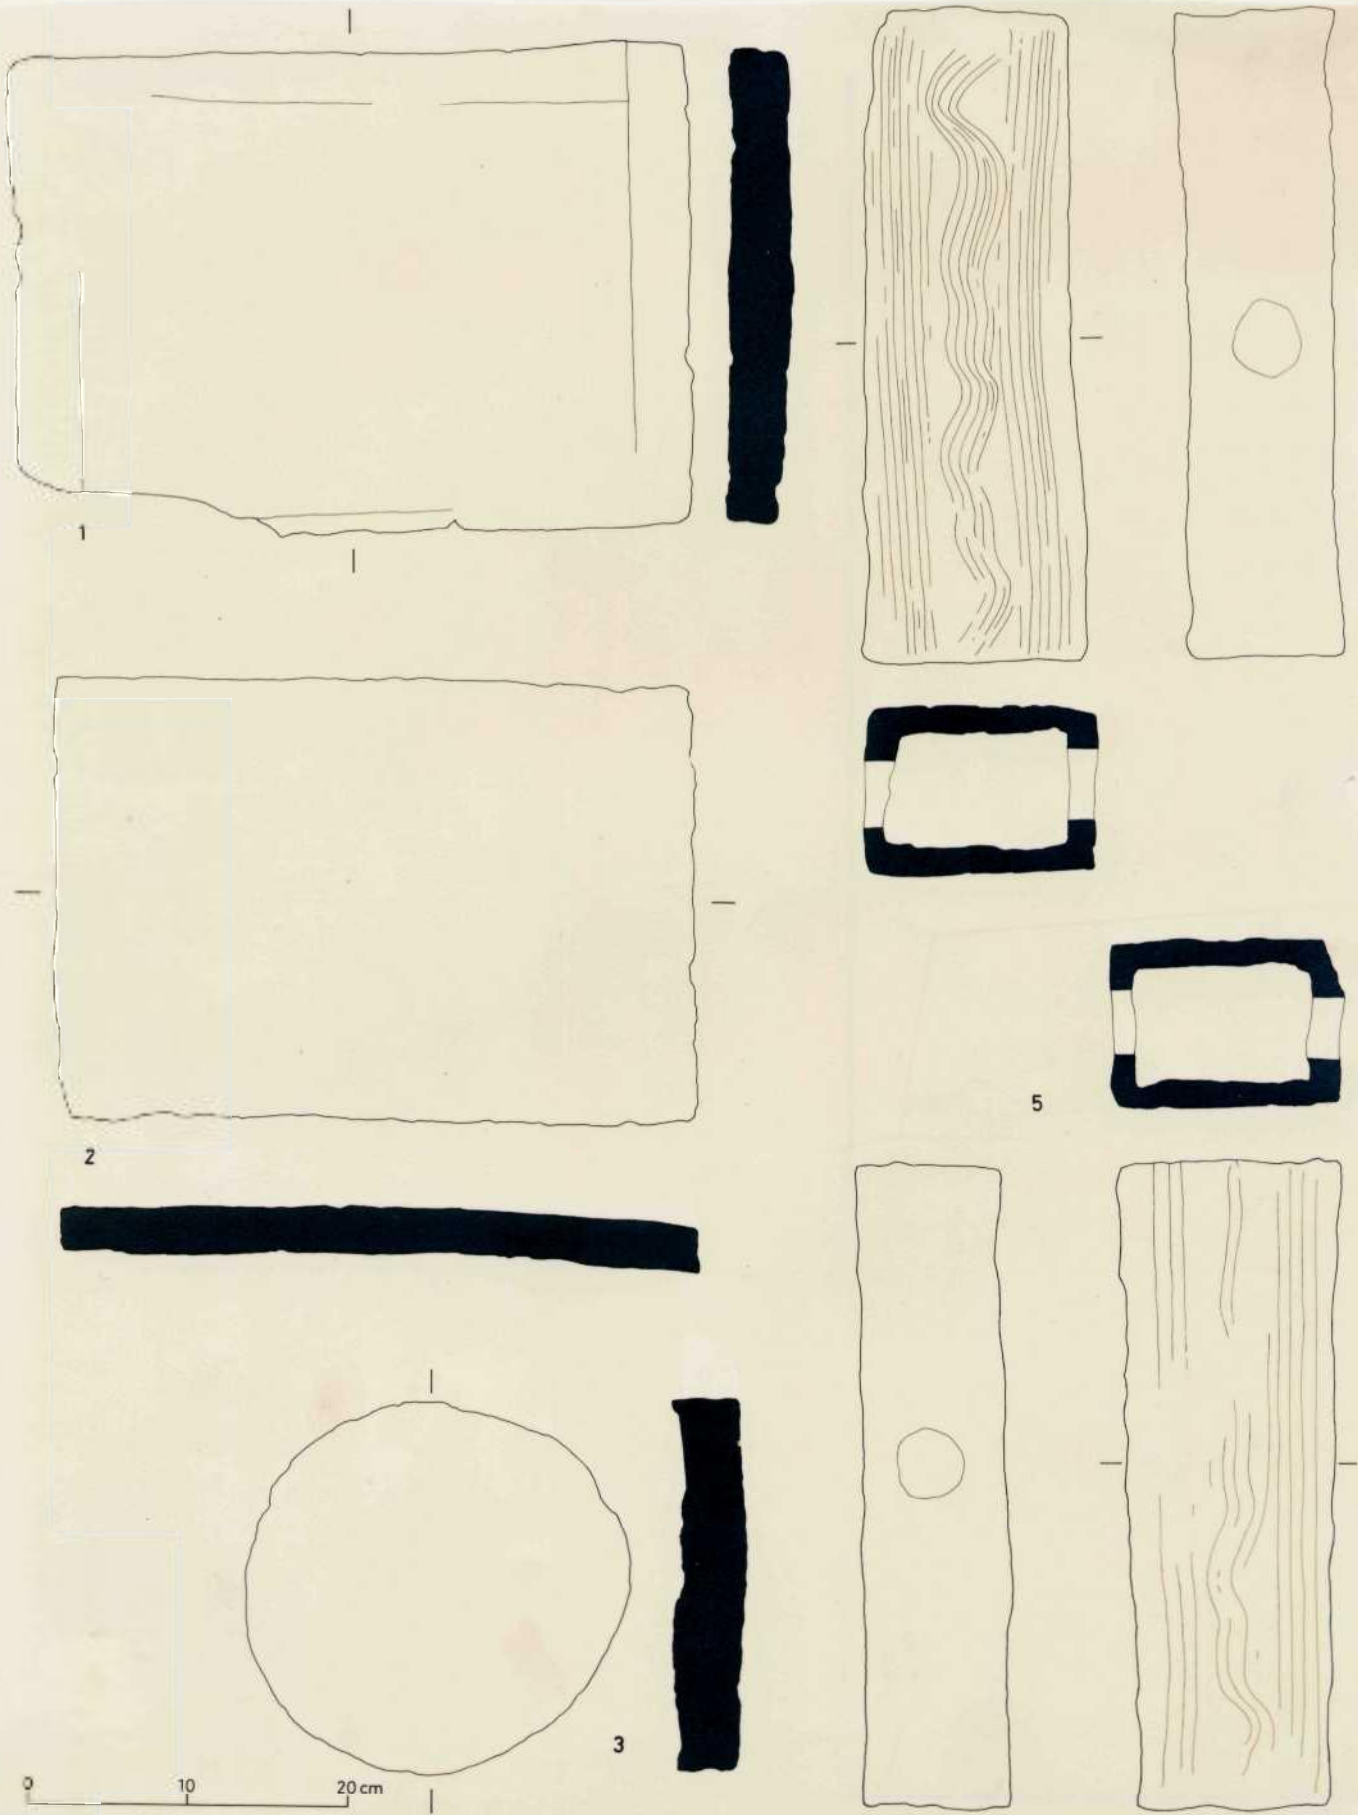
Fig 202 Roman tiles: flat rectangular and round tiles and box flue tiles
