# A report on an archaeological evaluation at the church of St Peter ad Vincula, Coggeshall, Essex

March-April 2000

on behalf of  
the Parish Council of St Peter ad Vincula

**CAT Report 76**

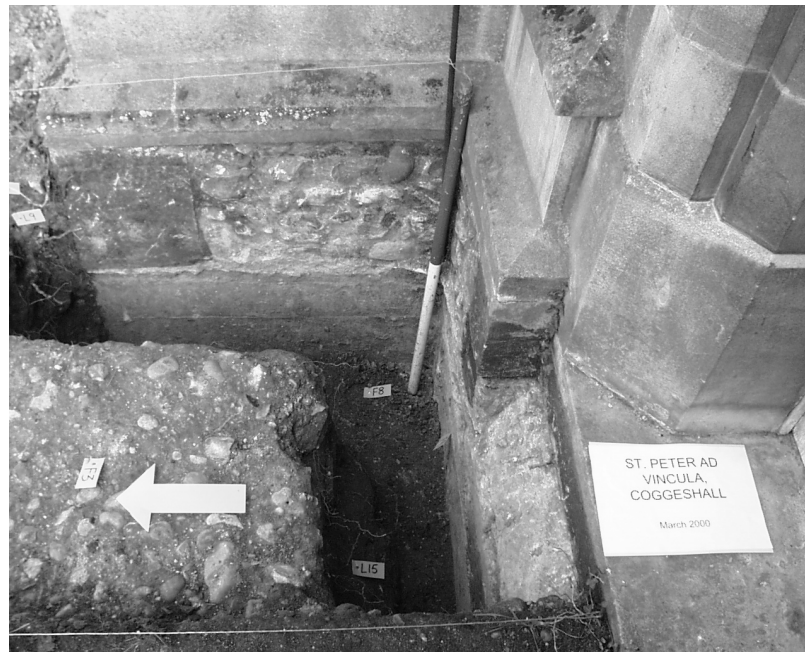
**Fig b Trench 1A showing modern concrete wall foundation.**

- 5.2.1 This section of trench measured 1m wide (E-W) and 1m long (N-S), and was cut 1.45 m deep against the face of the church. The top horizon was a thin band of topsoil (Layer 04 or L04), which peeled off to reveal a thin band of sand (L09) lying over a stone surface (F03). This stone surface consisted of a yellow mortar base, with medium flints and occasional tile and beige brick fragments set in it. The stone surface was cut by a modern drain (F01), and by a shallow cut F06 against the face of the buttress.

- 5.2.2 The brief required a view of the footings of the church; therefore an L-shaped cut was made through F03 in the angle of buttress and church wall by enlarging F06, the cut which had previously been made through the surface. It was expected that F03 would seal undisturbed graveyard soil, or the underpinning which was reported to have taken place under parts of the church wall to repair the WWII bomb damage<sup>7</sup>. In fact, F03 sealed a foundation trench F08, which contained a completely rebuilt church wall F09 and was backfilled with the brick rubble (L14). The details are as follows. The cut for the new foundation was not bottomed at 1.60m below the north door doorstep level (hereafter abbreviated to DL). The outer (ie north) edge of the trench was beyond Trench 1A (T1A) limits, but part of the sloping lower edge of the cut F08 was seen between 0.9m and 1.3m below DL, before it plunged down vertically, cutting through clay

L15. Set in F08 was the newly-built church wall F09, unquestionably the rebuild after the WWII damage. This was concrete from below 1.6m up to 0.7m below DL. Above that level the structural parts seen were two ashlar slabs approximately 320mm (1 foot) deep, the lower one being chamfered to bring the outer edge flush with the masonry above and the top one being the doorstep. On the east edge of the trench, the church wall had been rebuilt in the same character as the old church wall - essentially a flint rubble in mortar with ashlar dressings. The lower edge of this work was at 0.75m below DL, with two post-medieval bricks included in the fabric where they would be below a ground level defined by the laying of stone surface F03 above the rubble infill (L14) of the foundation cut (F08) at 180mm (6 inches) below DL.
