**An archaeological watching brief on
an electricity cable-trench through the
North Countryman's Club gardens
and along the Church Street footpath,
Colchester, Essex
February 2003**

**report prepared by
Laura Pooley**

CAT Report 221
February 2003

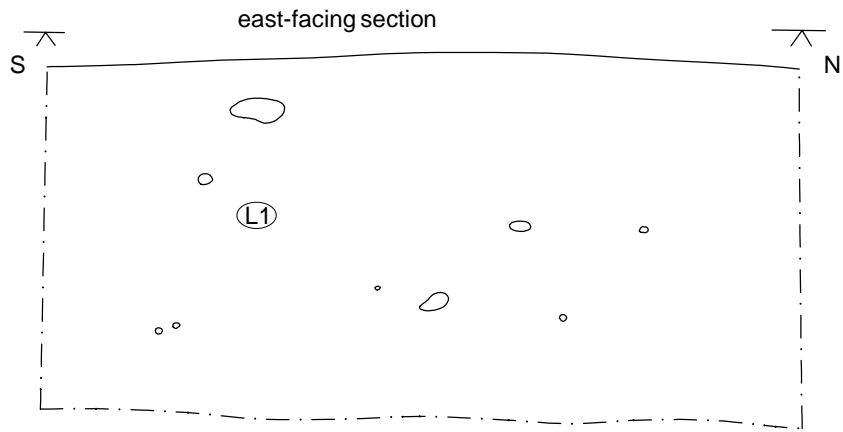
Fig 2 Section drawings.

The cable-trench was dug to a depth of approximately 600mm through a mid-dark brown silty loam/topsoil (Layer or L1). Finds from L1 include a large amount of modern brick and building debris as well as a small quantity of earlier, probably residual, material:

Only one feature was recorded; this was the remains of a modern brick wall (Feature or F1).

representative section through the cable-trench extending across the North Countryman's Club gardens

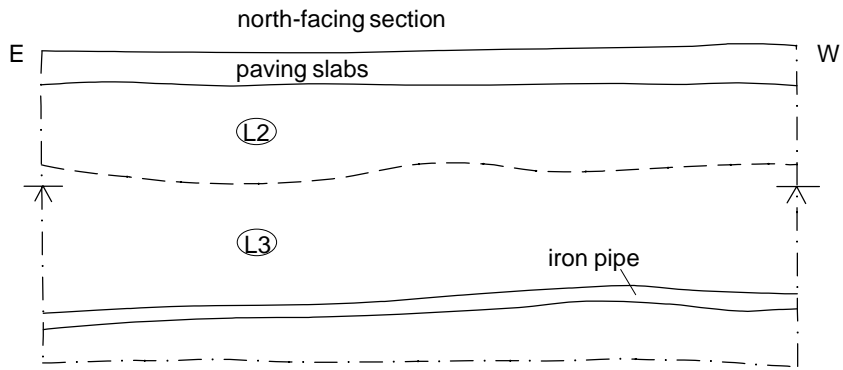
The cable-trench was dug to a depth of approximately 600mm through a concrete and rubble layer (L2, approximately 300mm deep) into which the footpath slabs were set. Beneath L2 was a mid-dark brown silty subsoil (L3); this contained brick and other modern material. No archaeological features or finds were recorded.

representative section through the cable-trench extending along the Church Street footpath
