**A watching brief at  
St Nicholas' Church,  
Little Wigborough,  
Essex  
February 2005**

**CAT Report 308**  
February 2005

*A trench was dug by contractors to investigate the cause of subsidence in the north-west corner of the nave of the 15th-century church of St Nicholas, Little Wigborough. The 1.55m-deep trench exposed intact stone foundations beneath the north and west return walls. At the junction with the tower, the stone foundation had been removed and replaced with modern brickwork as part of the reconstruction works following the 1884 Essex earthquake. No early floors were found. Two layers of modern tile flooring and underlying mortar occupied the uppermost 25cm, beneath which was a disturbed soil which extended to the natural subsoil.*

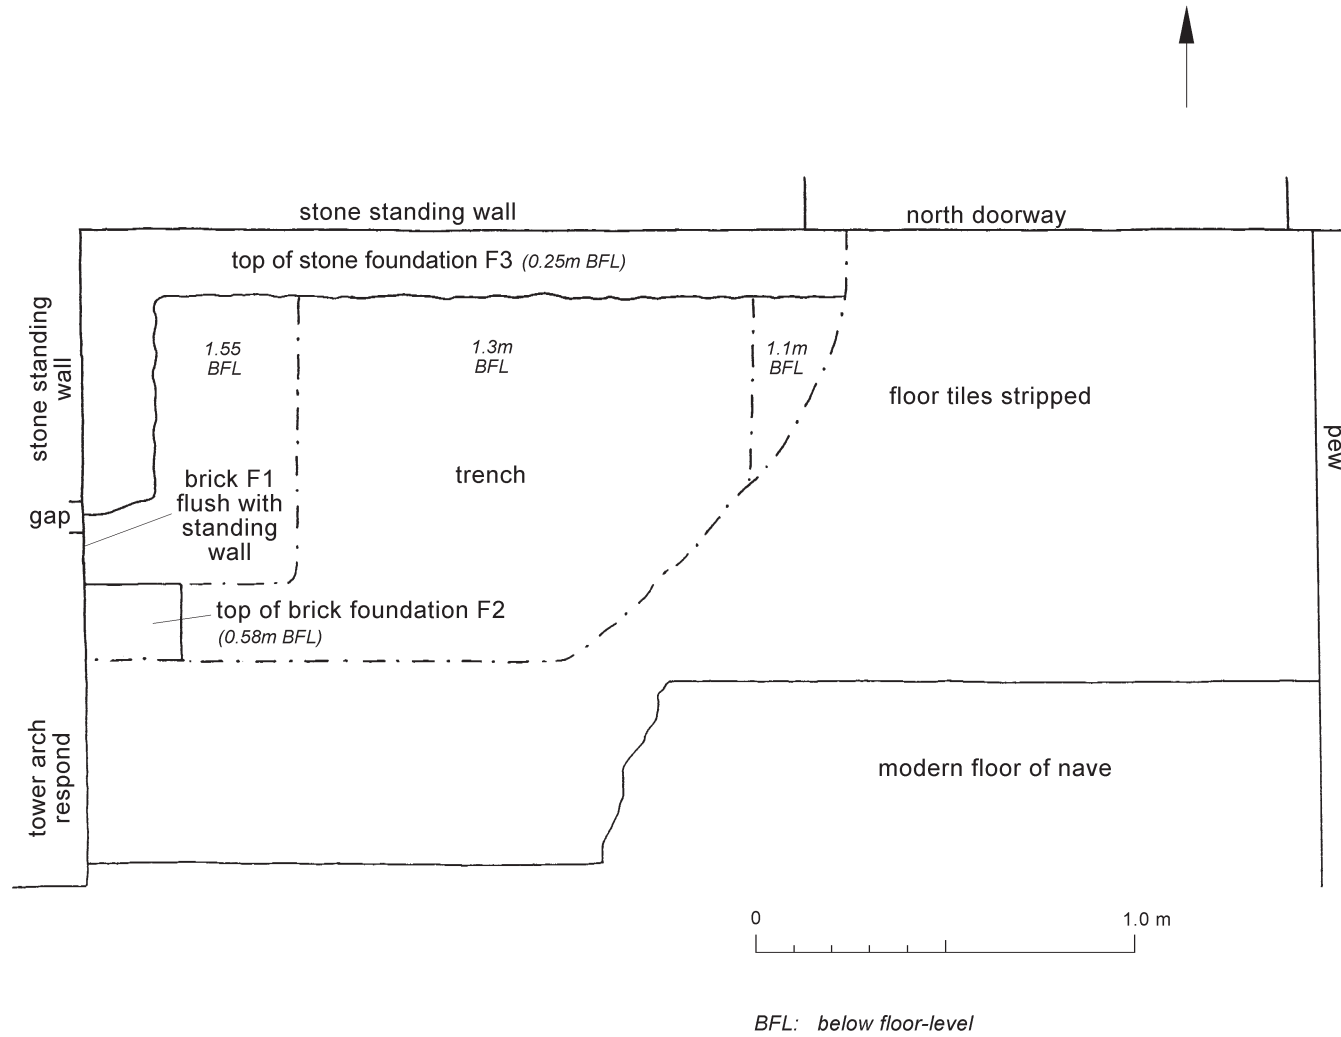
Fig 1 Trench plan.

At the north-west corner of the nave, the inner face of the standing wall continued to 25cm below floor-level, where it was found to rest on a mortared stone foundation (Feature or F3), the top of which typically projects 18cm beyond the wall face. The foundation was constructed of variously-sized stones including septaria, flint and ragstone, and was more heavily mortared in the uppermost 15cm. The bottom of the foundation extends 25cm into the clay subsoil and lies at an overall depth of 1.55m

below floor-level. In the area of the junction between the west nave wall and the north side of the tower, the original stone foundation had been removed and replaced with modern brickwork. Structurally, this is in two parts, coded F1 and F2 in Figures 1 and 2. The face of the upper part (F1) is more or less flush with the adjoining stone standing wall to the north and continues above floor-level. Below floor-level, F1 extends to 58cm depth where it sits on a footing (F2) which projects 22cm beyond the east face of F1. At the north side of the interface between the two, F1 overhangs F2 by 14cm as indicated in Figure 2. F2 extends to at least 1.14m below floor-level. The nature of the solid material below that point in the corner of the trench was uncertain. F1 and F2 were constructed of identical orange-red bricks each measuring 22 x 10 x 6.5cm (8<sup>3</sup>/<sub>4</sub> x 4 x 2<sup>5</sup>/<sub>8</sub> ins). These are assumed to be contemporary and associated with the reconstruction works following the 1884 Essex earthquake.
