An archaeological watching brief at 10/10a East Street, Coggeshall, Essex April 2005

CAT project ref.: 05/4c
Braintree Museums accession code: BRNTM 2005.1
NGR: TL 8507 2256

CAT Report 321
June 2005

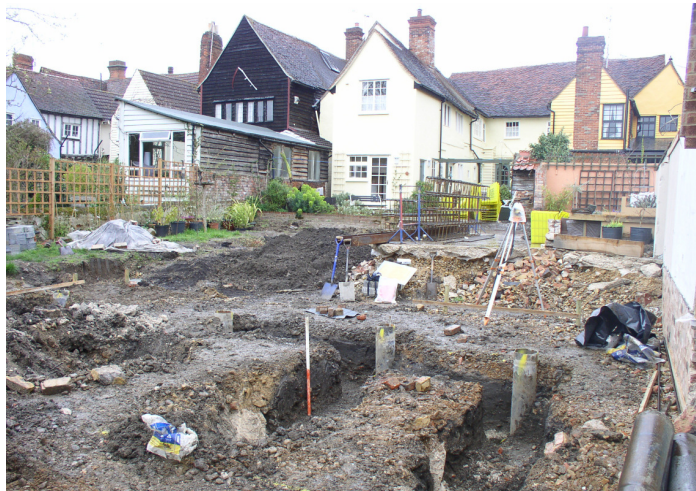
- Plate 1 Rear of the property with watching brief site in foreground, looking north-west (front cover).
- Plate 2 North ground-beam trench (A) with ?disturbance F3 in foreground, surface F2 in middle and post-hole F1 at the far end of the trench, looking south-east.
- Plate 3 East end of north ground-beam trench (A) with surface F2 and post-hole F1 with excavated post-pipe, looking east.

- 2.1 This is the archive report on an archaeological watching brief carried out in the garden of 10/10a East Street, Coggeshall, Essex (Plate 1).
- 2.2 The watching brief was prompted by the proposal for demolition of an existing store building and its replacement with a small dwelling.

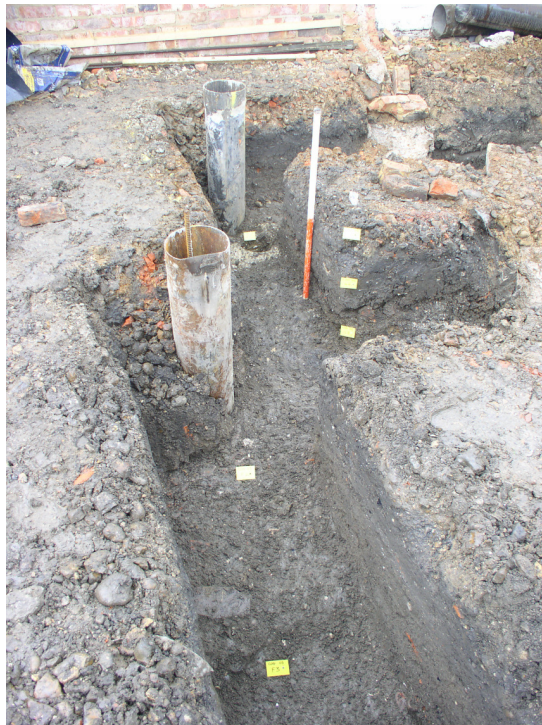
Plate 2 North ground-beam trench (A) with ?disturbance F3 in foreground, surface F2 in middle and post-hole F1 at the far end of the trench, looking south-east.

- 6.8** At the north end of the footprint of the new dwelling, L3 and L4 sealed a rough patchy surface (F2) formed primarily of small stones, with some peg-tile fragments and pieces, and very rare cobble-sized stones (Plate 2). This surface was only clearly present in the north ground-beam trench (A) and in the north end of the east central ground-beam trench (D). It can be noted that on top of this surface were a number of fragments of animal bone which appeared to be comparatively rare finds from other contexts on the site. The area of the surface was roughly planned, and then removed by hand to recover finds for dating. The small quantity of pottery recovered was all of medieval (13th- to 14th-century) or late medieval (15th- to 16th-century) date. There were also a few fragments from thick peg-tiles which are also possibly of medieval date. However, a number of brick pieces from within the make-up of the surface (ie 7, Table 1, F2, bag 6), although not necessarily individually precisely datable, collectively strongly suggest that

the surface is of post-medieval (17th- to 18th-century) date. There was no indication that these post-medieval bricks were intrusive to the surface.

- 6.9** In the central length of the north ground-beam trench (A), an area of the surface appeared to be particularly thin or absent. This was investigated as a potential feature (Feature or F3), possibly a pit. However, on excavation it proved not to have any significant distinct identity from the general spread of material forming the surface F2, and may simply represent a worn or thin area in the surface. A fragment of Tudor brick (15th-16th century) and a rim of a large pottery storage jar or cistern of 17th- to 18th-century date came from this feature.

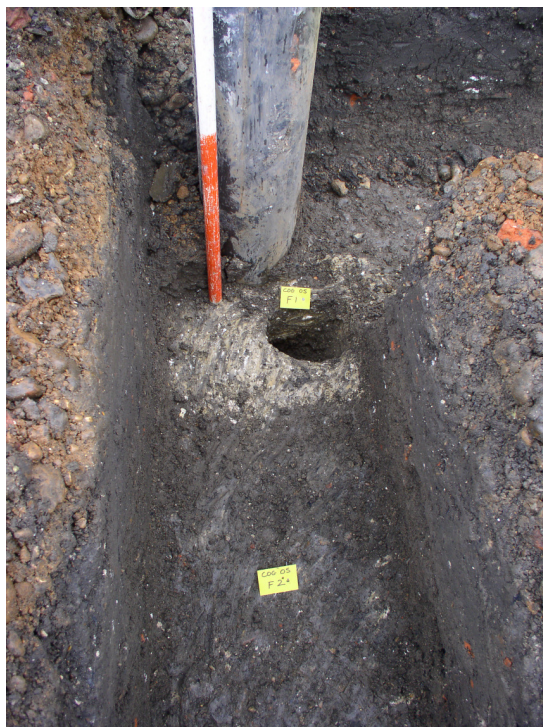
Plate 3 East end of north ground-beam trench (A) with surface F2 and post-hole F1 with excavated post-pipe, looking east.

- 6.10** Three post-holes (F1, F4, F5), and possibly a fourth (F6), were located. Each of the post-holes was sub-rectangular with a packing of clean pale yellow-brown clay which contained fragments of chalk and occasional charcoal flecks (Plate 3). This clay was only associated with the post-holes, so that the edge of a clay patch seen in one of the ground-beam trenches (F6) almost certainly represents a fourth post-hole. Within the clay packing, the post-pipes of the former wooden posts could be clearly seen, so that the posts had not been removed and the lower parts of the posts must have rotted *in situ*. The post-pipes of F4 and F5 were square, while that for F1 was slightly more rounded. Only one of the post-holes (F1) was investigated, and only the post-pipe of this was excavated. The post-pipe in F1 was 270 mm deep, and no finds were found within its fill. The base of the post had penetrated a medium brown silty clay below the post-pipe. It is not known if the soil glimpsed in the base of the post-pipe was archaeological or was undisturbed natural subsoil. It appears that the post-holes can be associated with the gravel surface F2 as they were also sealed by L3, and the gravel surface could not be traced on the east edge of the footprint of the new dwelling beyond the post-holes F1 and F4. It appears, therefore, that F1 and F4 correspond to the eastern extent of the surface.

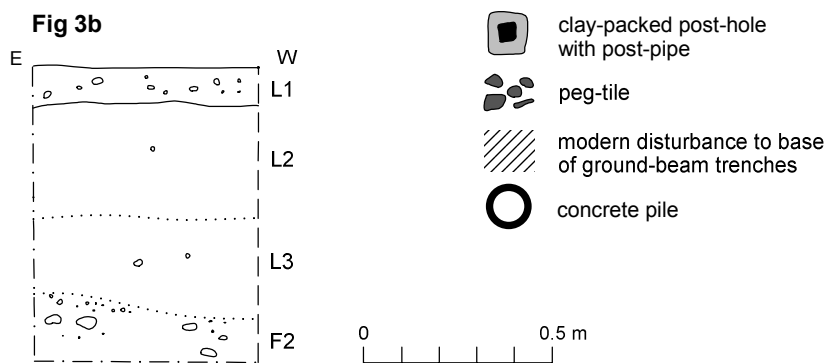
Fig 3b Section.

- 6.4** The present construction surface level over the footprint of the new dwelling was covered by a layer of stones and sand about 10 cm thick (Layer or L1). This is the remnants of modern make-up for the floor of the former store building or garden terracing and had been imported onto the site.

- 6.5** Between approximately 10 cm and 40 cm below the present ground-level, and sealed by the L1 make-up, was a very dark clay loam soil (L2). This contained moderately common fragments of peg-tiles, small patches of degraded pale brown sandy mortar, small stones, charcoal, oyster shell and occasional brick fragments. This represents a disturbed post-medieval or modern soil accumulation. Though it produced no datable finds (a few small fragments of brick were observed during machining and in exposed sections), it can be dated to at least the 17th-18th century as it seals archaeological contexts with clear associations of finds of that date.

- 6.6** The dark soil sealed a lighter-coloured (medium brown) silty clay (L3). This contained moderate to common peg-tile fragments, occasional small stones, chalk and charcoal flecks. Although, on the central part of the footprint of the new dwelling, this layer sealed earlier archaeological deposits (L4), where these were absent it appeared to extend to at least the base of the ground-beam trenches (approximately 80 cm below the present ground-level) without apparent change. Finds from L3 were few in number, and most were collected when hand excavating at the base of the layer. The finds are predominantly of late medieval or earlier post-medieval date. However, they include a small pottery sherd of Fabric 40 (dated late 16th-18th century) and a pottery sherd of Fabric 48d (dated 19th-20th century).

- 6.7** Towards the central part of the footprint of the new dwelling, and sealed by L3, was a spread of peg-tile pieces and fragments (L4). The soil matrix surrounding them was indistinguishable in appearance from L3. No datable finds were recovered from this tile spread. Although some of the peg-tile pieces were quite large (representing most of a tile), they graded in size down to small fragments, and none of the tiles were whole. All the tile pieces observed appeared to be of the usual, relatively thin, probably medieval/post-medieval peg-tile type. Almost all were lying flat, although, despite this, they did not give the appearance of being a laid surface as they were frequently found to overlap in small groups or heaps, and appeared to represent dumped demolition material, presumably from a roof.
