**An archaeological watching brief  
at nos 1-3 Queen Street  
(Colchester Visitor Centre),  
Colchester, Essex  
May-July 2005**

**report prepared by  
Mariusz I Górnjak**

**on behalf of  
Colchester Borough Council**

**CAT Report 376**

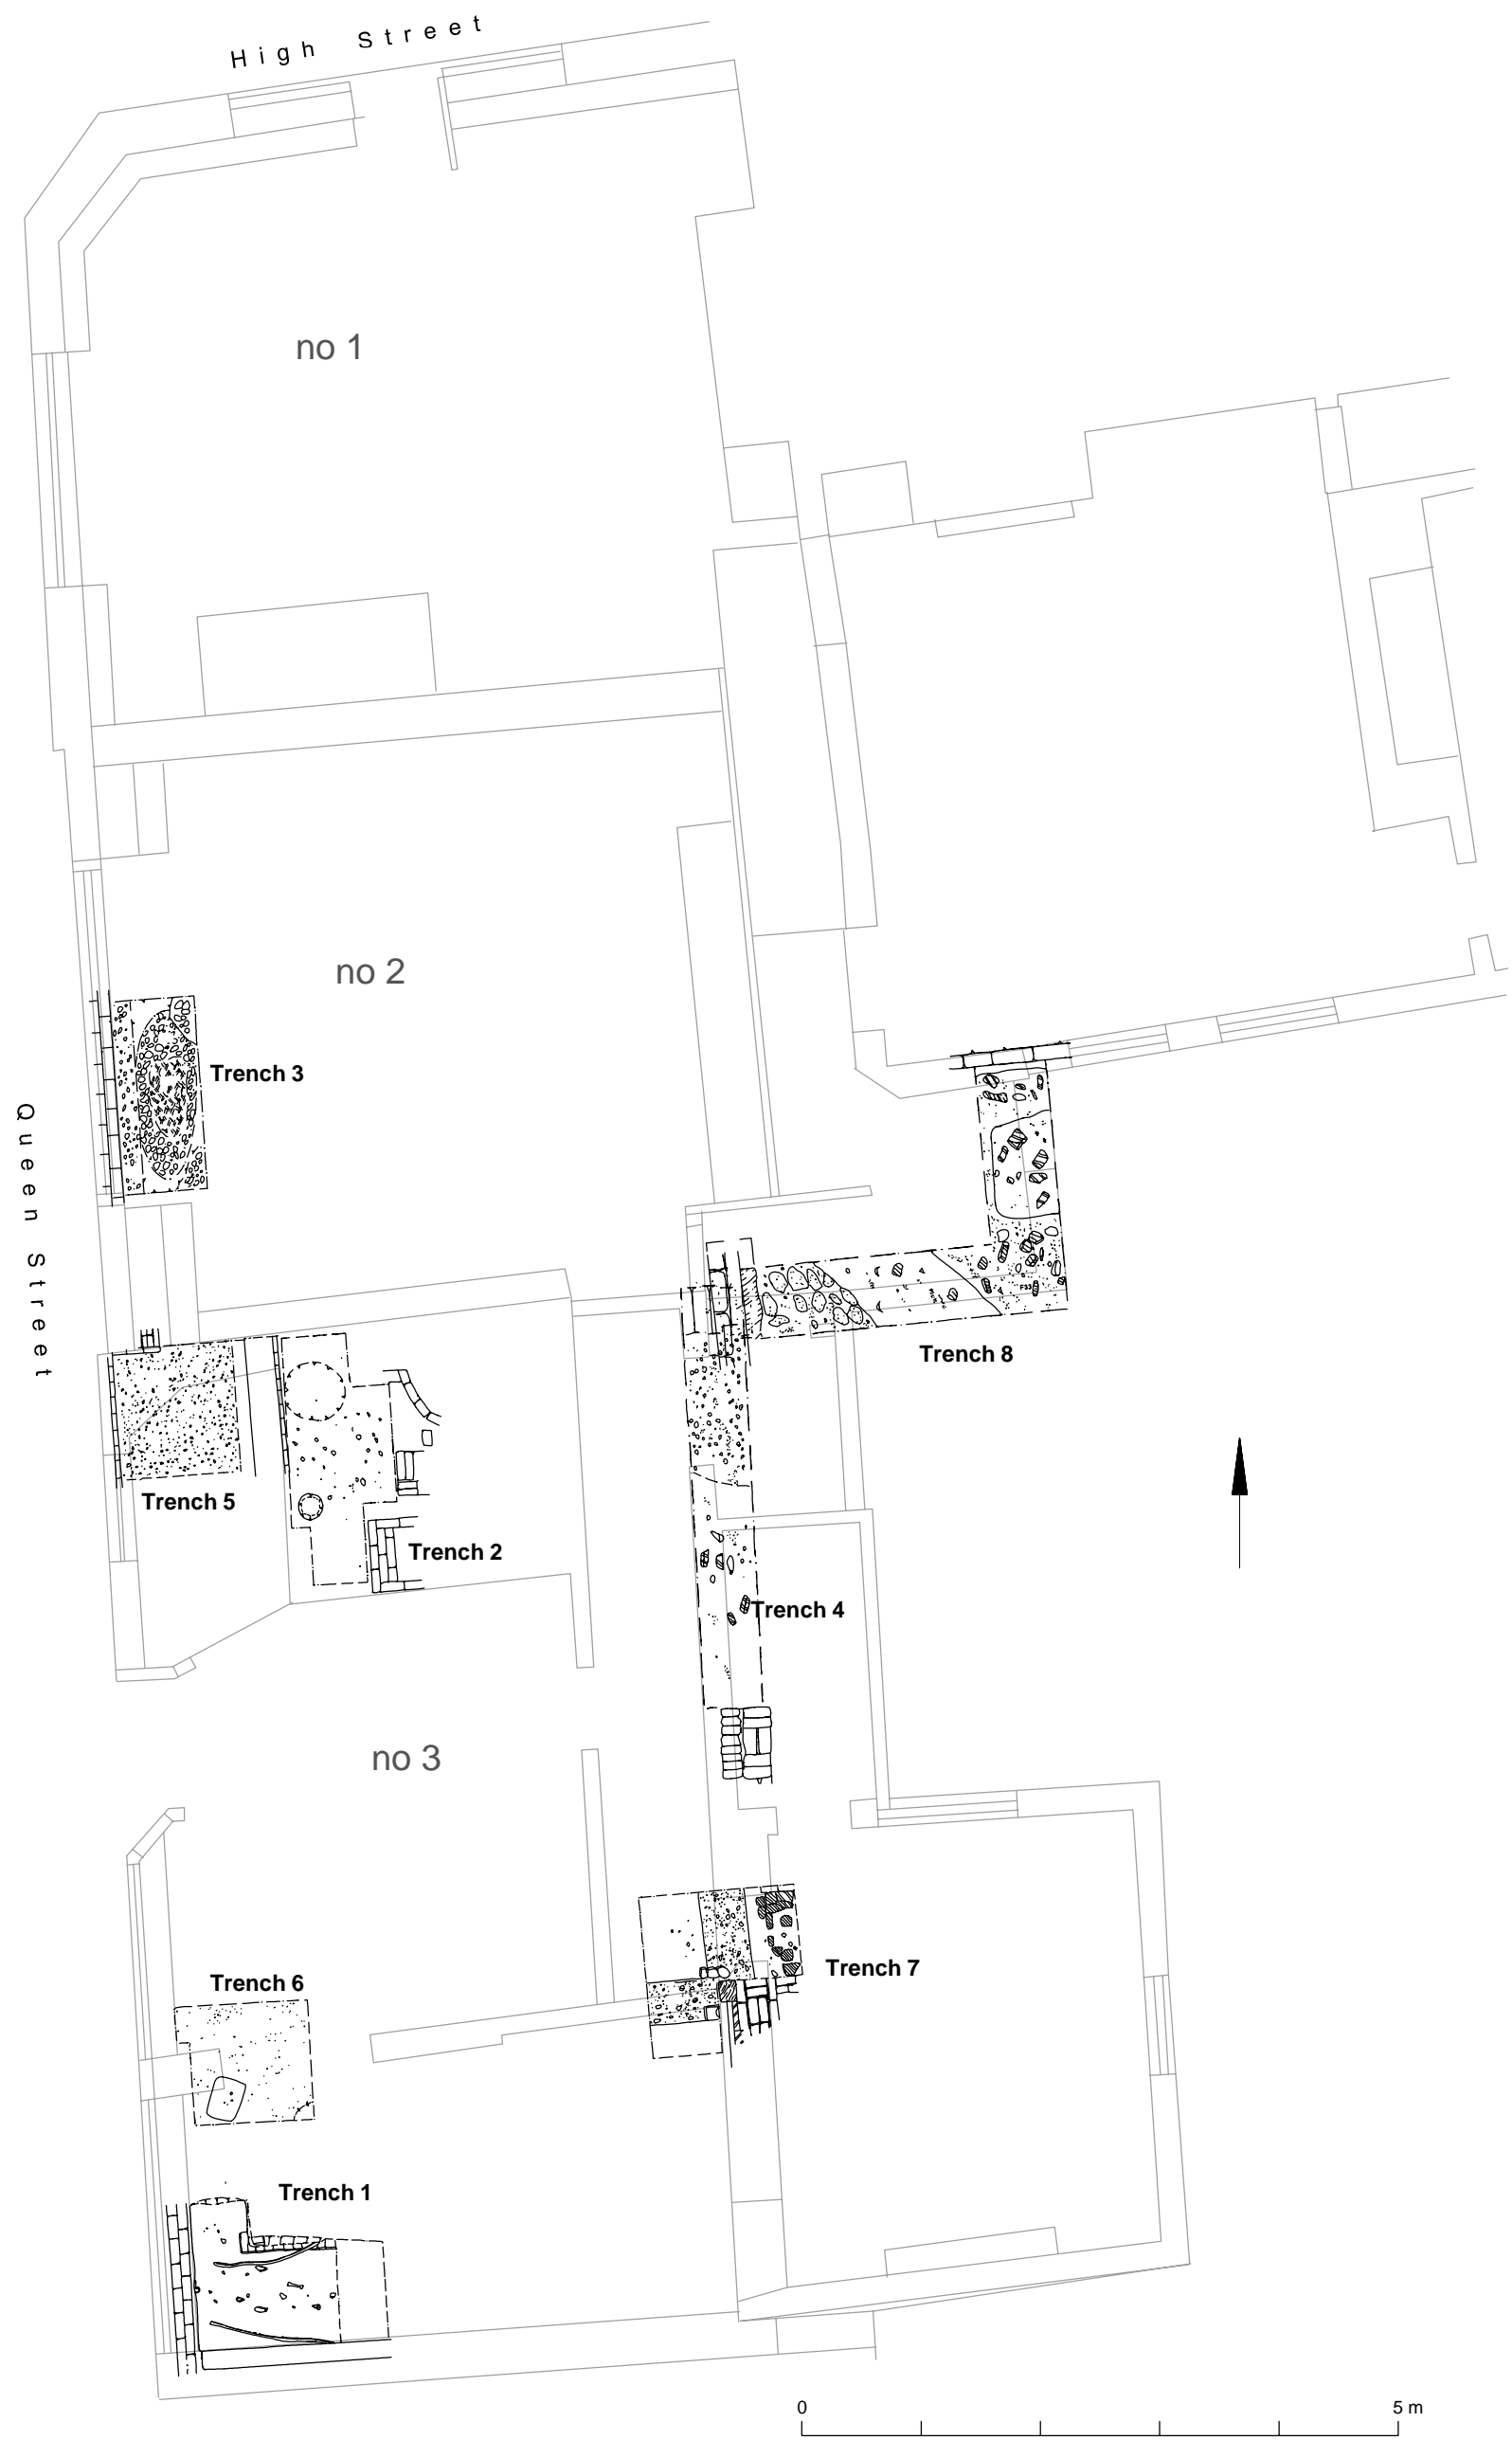
Fig 2 Nos 1-3 Queen Street: ground-floor plan with location of the trenches.

Nine trenches were excavated by the contractor's employees and recorded by a CAT archaeologist (Fig 2). The size and depth of the trenches varied (Table 1). Altogether, they covered an area of 11m<sup>2</sup>, with an average depth of 0.67m (from 0.28m to 1.02m). Six trenches were located within no 3 Queen Street (Trench or T1, T2, T4, T5, T6, T7), one trench was excavated within no 2 Queen Street (T3), one trench (T8) was excavated behind the eastern outer wall of no 2, and one trench (T9) was dug in the property's inner courtyard (not recorded in detail because of its purely late Victorian-modern contents). In total, 62 contexts were recorded, dating from the Roman, early medieval, late medieval, post-medieval and early Victorian to late Victorian and modern periods. Relatively scanty dating material was supported by the analysis of the building's superstructure. This allowed for relatively secure phasing of some of the recorded contexts. However, dating of many of the features remains quite doubtful.

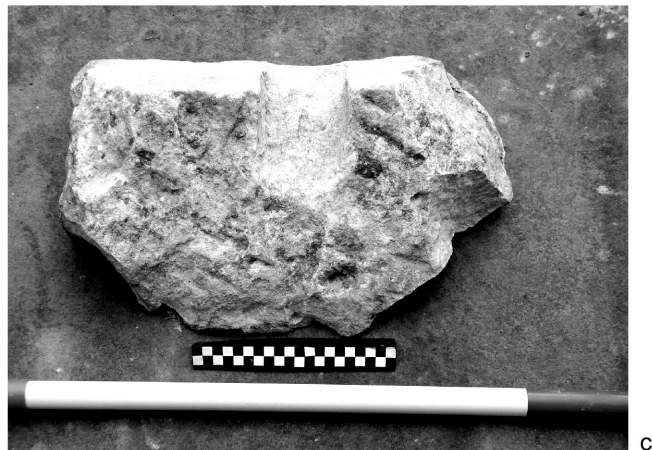
Another interesting find was recorded in the fill of T4, ie Find no 10 (Fig 14). Unfortunately, it cannot be ascribed to any of the identified features. It is a large piece of worked limestone. The stone is clearly broken from a larger piece. It has two smooth and flat surfaces (0.36m x 0.15m; 0.54m x 0.32m), four flat and rough surfaces (0.21m wide), and a slot (triangular in section and rectangular in plan – 0.82m wide). Considering the proximity of the site of the temple of Claudius and other Roman public buildings, a Roman date for the stone is possible.

Fig 14 Carved limestone block from Trench 8:  
a drawing  
b photo. of ??  
c photo. of ??
