An archaeological watching brief at 57 Church Street, Harwich, Essex August 2006

report prepared by Kate Orr

CAT project ref.: 06/8g
Colchester Museums accession code: COLEM 2006.110
NGR: TM 2606 3264

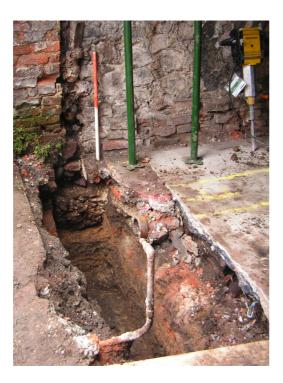
At the rear of the building, part of the southern wall was exposed and seen to be of a septaria stone construction, partly patched with modern brick. The excavation of a 1m-deep trench for new footings gave an opportunity to expose and record the foundation of this stone wall. Where the wall and the foundation met, there was a facing of modern and post-medieval brick. The foundation was seen to be 750mm deep and its upper part consisted of a large septaria block faced by peg-tile and cobbles. This block had been set into a white lime mortar containing septaria chips. Underlying this was a dirty clay with septaria chips. At 750mm below ground-level, a clean yellow brown clay was observed. This appeared to be part of the foundation because, although it underlaid the septaria chips, it also faced them. The yellow clay sealed a dirty grey clay with stones and charcoal, starting at 850mm below ground-level. This deposit was clearly not natural clay and may have been a previous occupation level, pre-dating the existing building. Unfortunately there was no dating evidence from this layer.

Plate 1 Footings trench at the rear of the building, view south-east.

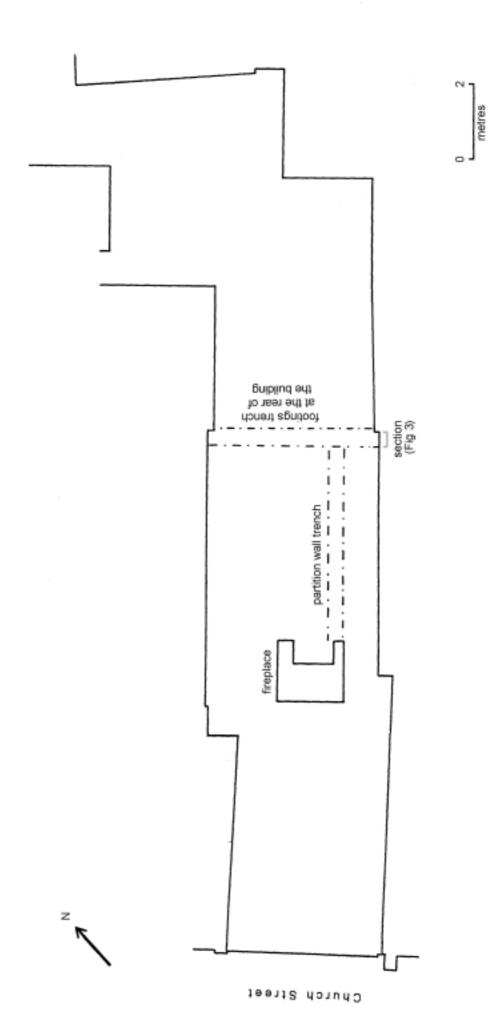
The watching brief was carried out in response to planning permission which was granted to erect an extension at the rear of the existing building. The extension was built on a raft foundation which involved a ground-level reduction. Two visits were made by Stephen Benfield of CAT to carry out the watching brief on two footings trenches. One was dug at the rear (east) of the existing building and a second footings trench for a partition wall was dug inside the building. However, the second trench was shallow (570mm deep) and did not reveal anything of archaeological significance.

Fig 2 Ground-plan showing the trenches monitored.

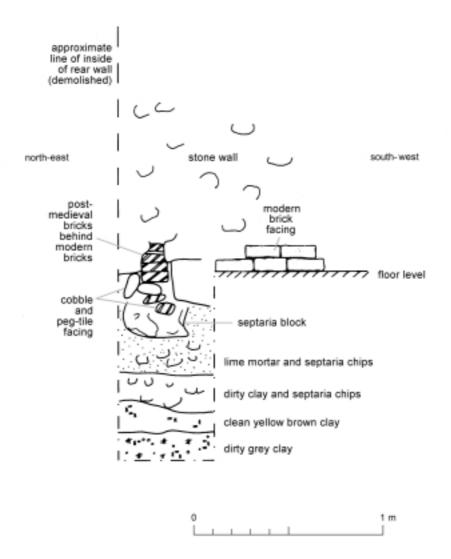
Fig 3 Footings trench at the rear of the building: north-west-facing section and elevation.

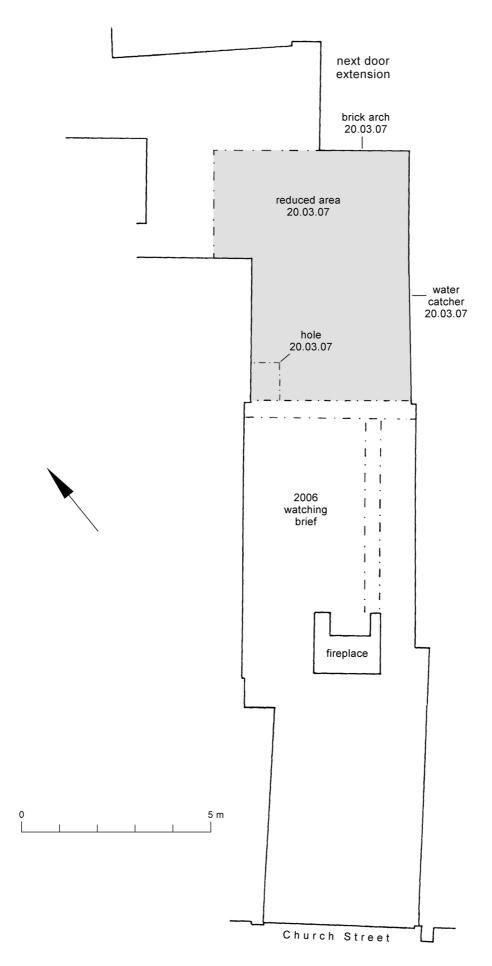
In the south-west corner of the yard a small hole was dug to expose a drain. This was approximately 400mm deep i.e. the bottom of the hole was 800mm below the former ground level. Possible occupation layers and make up layers were seen in the section of the hole as follows; 40mm of yellow brown clay overlaid 100mm of greyish brown clay with flecks of charcoal and mortar. In turn this sealed 260mm of yellow brown clay containing red patches and daub (presumably from burning). Natural ground was not reached but this was to be expected as excavations elsewhere on Church Street have found natural to be 1.8m below ground level (Andrews et al, 1990, 64). Unfortunately there was no datable material such as pottery from any of the layers at no 57 Church Street. However a comparison with the other sites along Church Street where archaeological levels have been recorded may give pointers for dating. From 1.8m below ground a succession of occupation layers divided by thick layers of make up material dating from the 13th century to the present day have been recorded (Andrews

A modern-looking square brick rainback/cistern for catching rainwater was seen on the south-east side of the yard, next to the boundary wall. This had been partly machined away and what remained was filled in with brick rubble.

On the north-east side of the yard, the ground reduction had exposed the head of brick arch. The modern extension to the adjacent property (on Kings Head Street) had been built over it. With such a small area exposed it was not possible to see what the arch was for. It seems to be in the wrong place for a cellar to either to 57 Church Street or the property on Kings Head Street, being in the middle of the two properties. Another rainback seems probable and a brick vaulted parallel has been recorded at 50 Church Street (Andrews at al 1990, 69). Alternatively it could be a brick well that had been capped off with a domed vault. Something similar was recorded at the Methodist Church site on Church Street (Andrews et al, 1990, 69).

The attached plan shows the areas I am referring to. I hope this will do as a report but if you would like me to write a proper report I will be happy to do so.

Fig 1 Ground plan showing trenches monitored in 2006 and area monitored March 2007.
