**A survey of three groups of  
air-raid shelters at  
Areas C2, J1 and P1  
of the Garrison Urban Village,  
Colchester, Essex  
April 2004-May 2007**

**report prepared by  
Chris Lister**

**commissioned by  
RPS Planning  
on behalf of  
Taylor Wimpey**

**CAT Report 467**  
May 2008

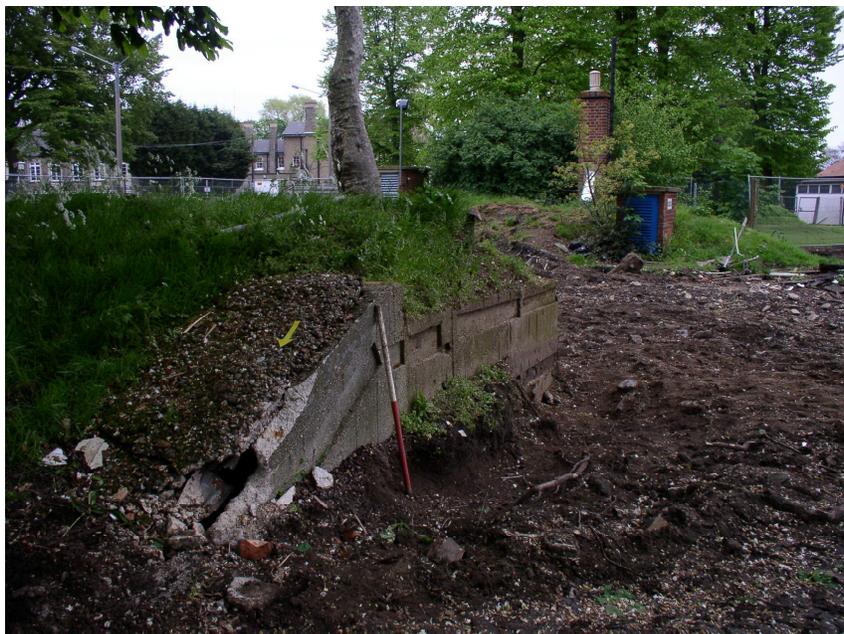
**Plate 1 (above): Shelter 1, Area C2 – south-western corner, looking east, with shelter 2 in the background.**

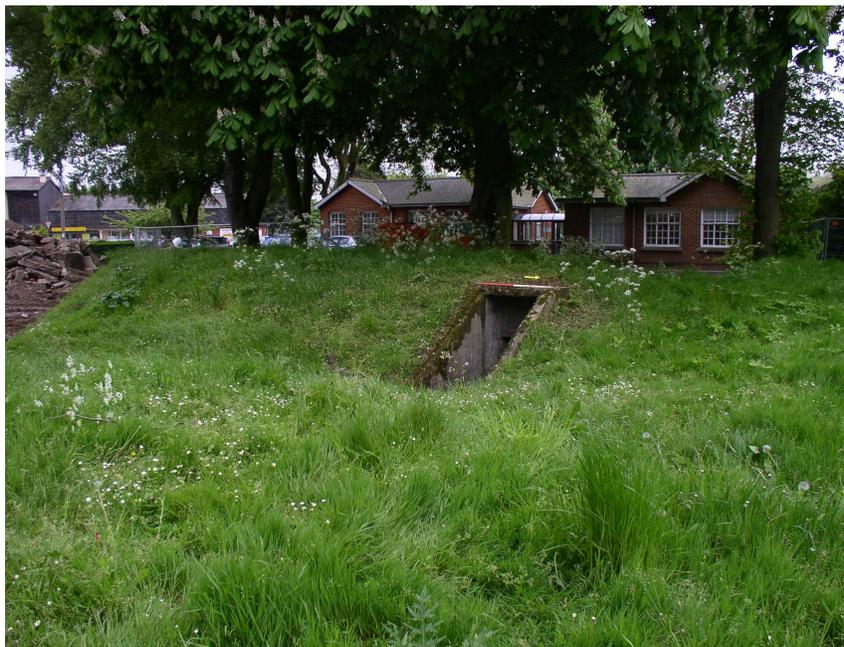
**Plate 2: Shelter 1, Area C2 – north-eastern entrance, looking west, with former Army Radio offices in the background.**

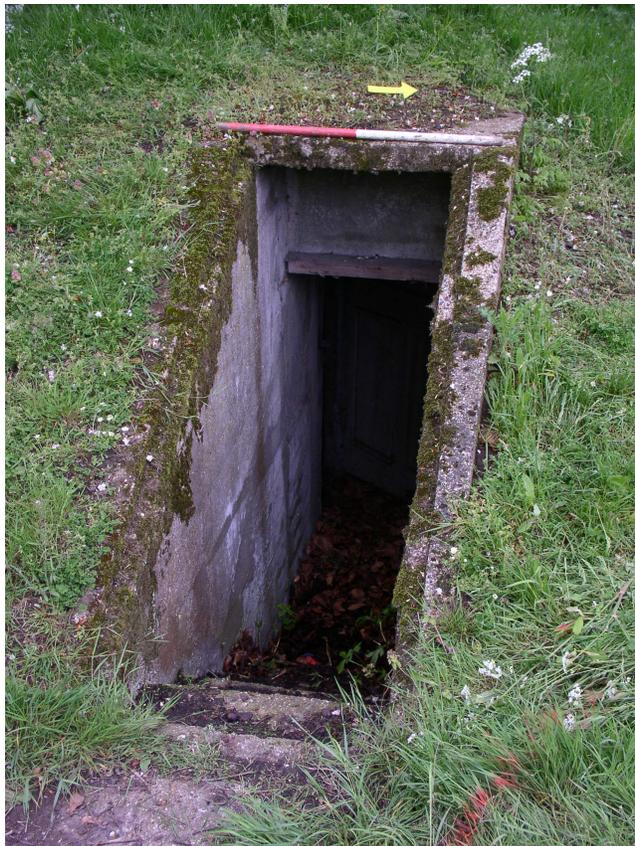
**Plate 3: Shelter 1, Area C2 – north-eastern entrance, looking west.**

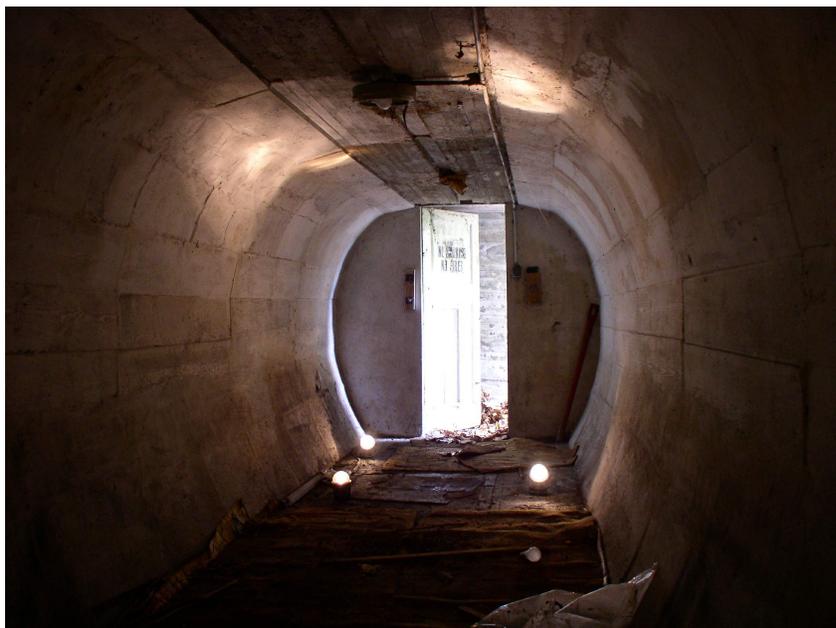
To the left of the corridor was a wooden door (72cm by 1.97m) set into a dividing wall and opening in towards the corridor. Eighty per cent of the external face of the door was covered by a metal plate, which was attached to the door with screws, and painted white. A simple curved iron latch was affixed to the left-hand side of the door approximately one-quarter of the way down. The door was supported on two hinges, each 30cm from top and bottom, screwed directly into the concrete wall. A painted square divided into two red and one blue upright bars with the letters 'S3 COY (U)' above it was positioned in the centre of the door at the same height as the handle.

Upon opening, it was clear that the door was set into a recess so that it could not be opened or blown into the chamber by an explosion. The internal face of the door was painted off-white and had a replacement panel covering the lower left-hand quarter. An A2 poster held in place by masking tape covered the upper part of the door. On this was printed, in upper case:

**Plate 4: Shelter 1, Area C2 – internal view, looking north-north-east towards door.**

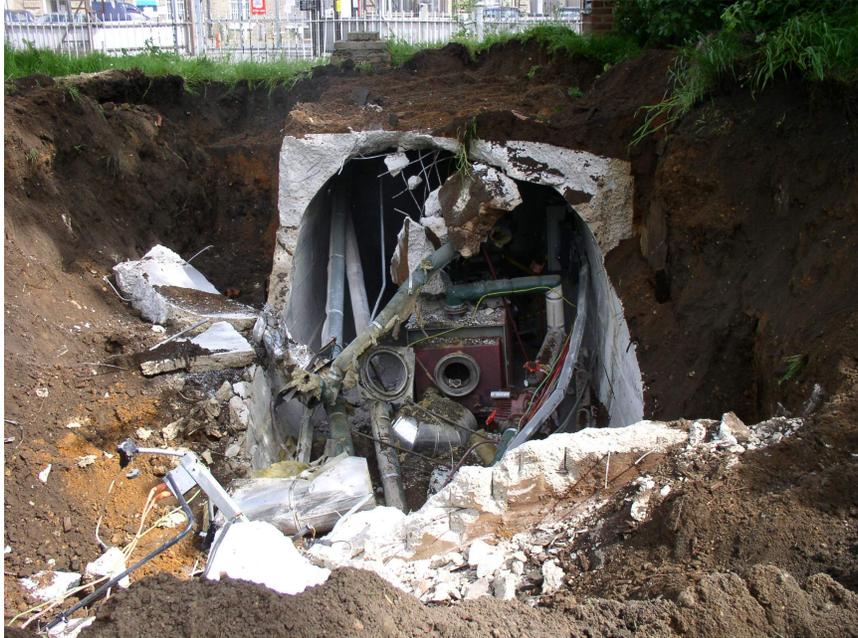
The external mound of this shelter was planned using a Total Station. It was photographed during demolition. Detailed internal planning of this shelter was not possible as it had been converted to a boiler room and still contained all the equipment and pipe work at the time of the survey. This shelter appears to have been identical in design to shelter 1.

**Plate 5: Shelter 2, Area C2 – south-western end during demolition, looking north north-east.**

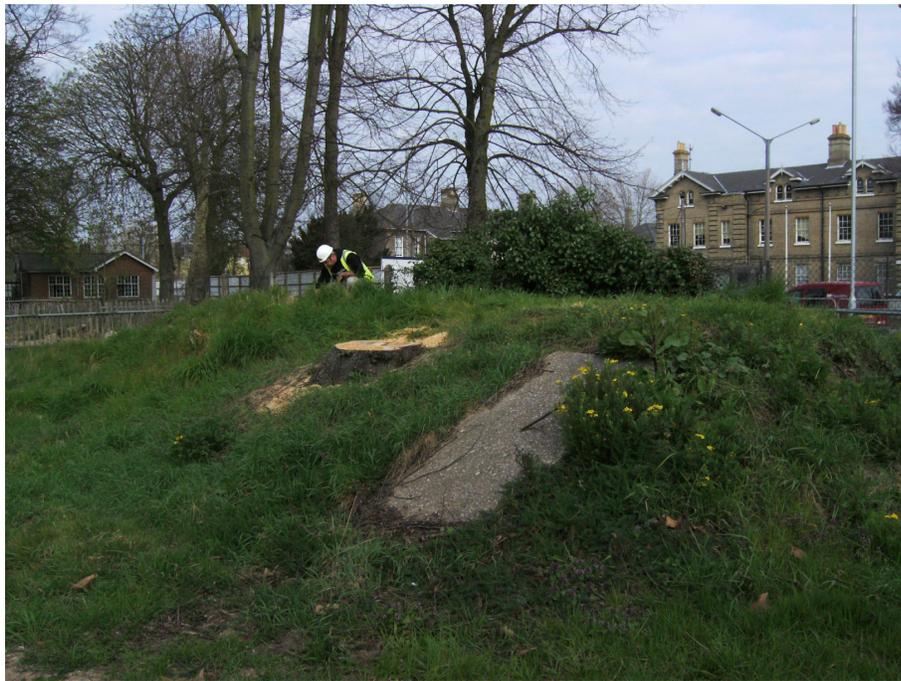
**Plate 6: Shelter 3, Area C2, with Flagstaff House in the background, looking north-west.**

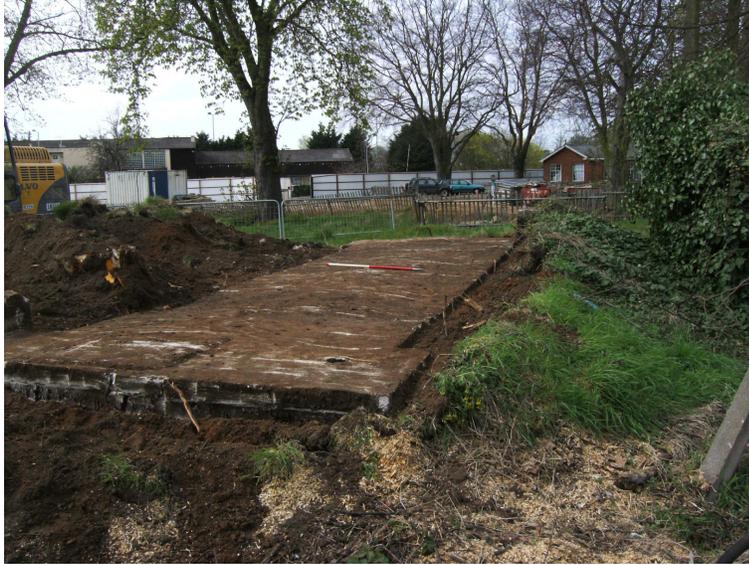
The central chamber externally measured 7.35m long by 2.45m wide by 2.45m high with an internal measurement of 2.25m at the widest point and 1.7m at its base. The sub-circular chamber was unpainted and was constructed of reinforced concrete, evidence of shuttering being clearly visible. The construction technique was clearly the same as for shelter 1, producing fifteen distinct panels of concrete – plus the floor – around the circumference of the chamber. Twelve 60cm by 60cm concrete slabs extended down the centre of the chamber beneath which was a channel, 18cm deep by 46cm wide, and lined with wood, which was divided into five sections.

**Plate 7: Shelter 3, Area C2, with earth mound removed, looking south-west.**

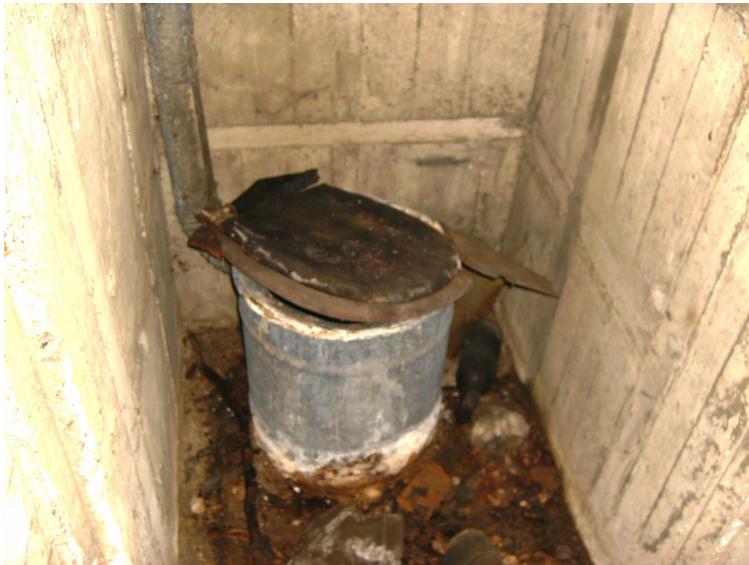
walls were each 15cm thick. The recess was approximately 87cm deep and occupied by a rudimentary toilet. This comprised a straight-sided metal cylinder with a hinged wooden seat and lid. The toilet had a metal pipe connected at the rear, which rose vertically through a centrally-located hole in the roof, presumably acting as an outlet for waste gases. This hole was 10cm in diameter. The floor of the corridor was of poured concrete with five 60cm by 46cm concrete slabs set into it.

**Plate 8: Shelter 3, Area C2 – detail of toilet in west recess, showing waste-gases pipe, looking south.**

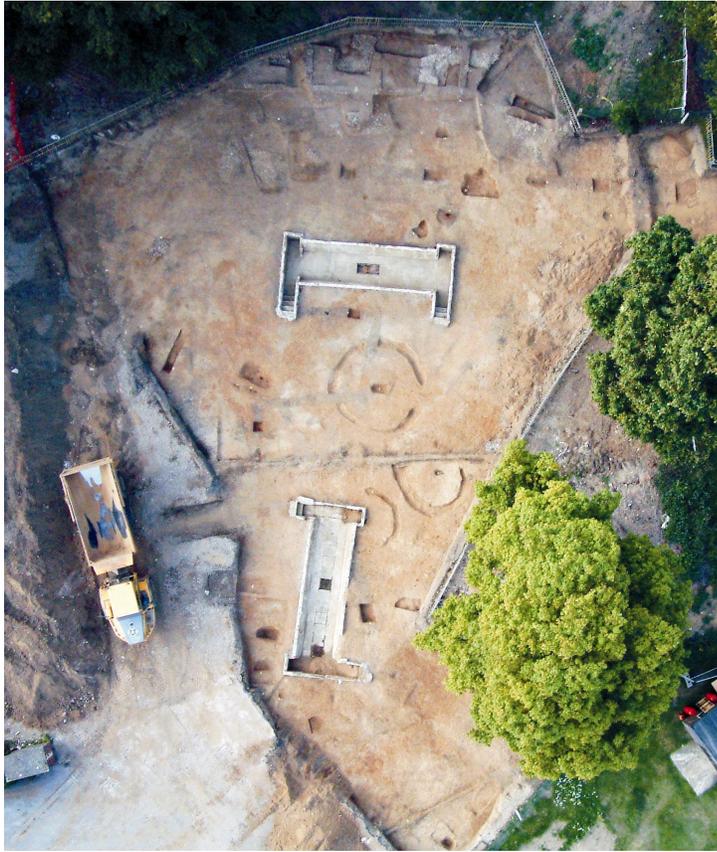
**Plate 10: Aerial photograph of Area C2, showing shelters 5 (below) and 6 (above). North is at the top of the photograph.**

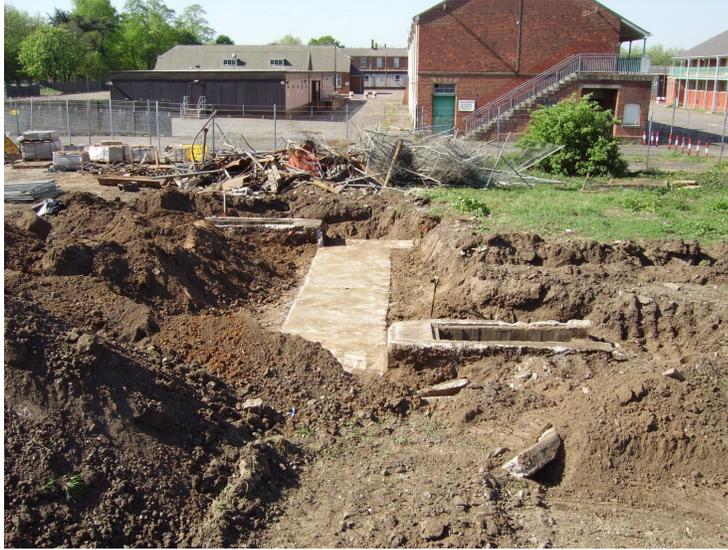
This structure was completely below ground with raised entrances level to the surface. The shelter was aligned north-east to south-west, and, once the shelter was exposed, it could be seen that both entrances were 52cm above the roof of the central chamber. The entrances were sealed by a cap of corrugated iron covered in concrete, which sat on a recessed lip within the entrance walls, 5cm deep at the sides and the entrance and 10cm deep at the chamber end. This appeared to be part of the original construction and is an indication that the shelters had some form of door or hatch. Both entrances were identical in design; each measured 5.55m by 1m in length and had eleven steps leading down to a corridor ending in a recess (87cm deep). The width of this corridor was 70cm, indicating that the walls were 15cm thick. Directly above the recess was a centrally positioned circular hole (10cm in diameter) in the roof. This is interpreted as either an air vent or an exhaust vent for waste gases. The floor was poured concrete with five 60cm by 46cm concrete slabs set into it.

**Plate 11: Shelter F1, Area J1, looking south-west, with Cavalry Barracks in the background.**

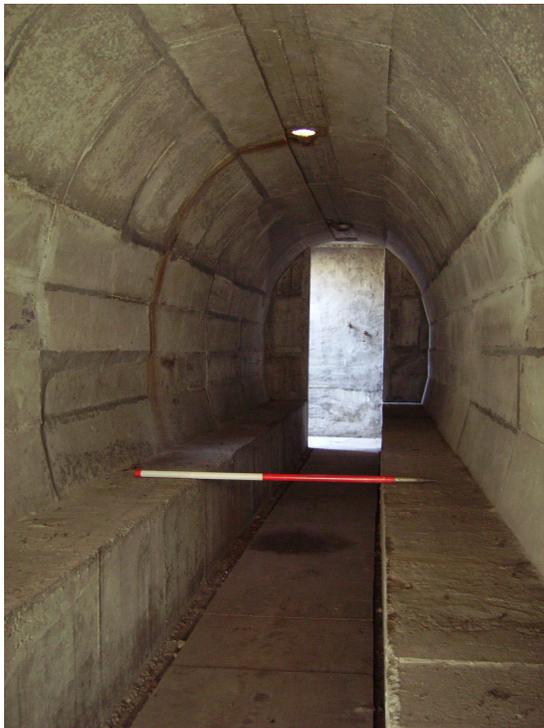
The central chamber externally measured 7.4m by 1.85m by 2.45m high with an internal measurement of 1.54m at its widest point. The chamber was of unpainted concrete and had a bench extending along the external wall on either side. These benches were 46cm high by 35cm deep and were formed of the same concrete as the entire structure. Evidence of shuttering is clear and the principle of the construction technique is similar to that of the shelters on Area C2, although in this instance a different shape was achieved using the same number of facets (fifteen visible above the benches). This produced a narrower, ovoid section compared to the sub-circular cross-section of the shelters in Area C2. Sixteen 60cm by 46cm

**Plate 12: Shelter F1, Area J1 – internal view, looking north-east.**

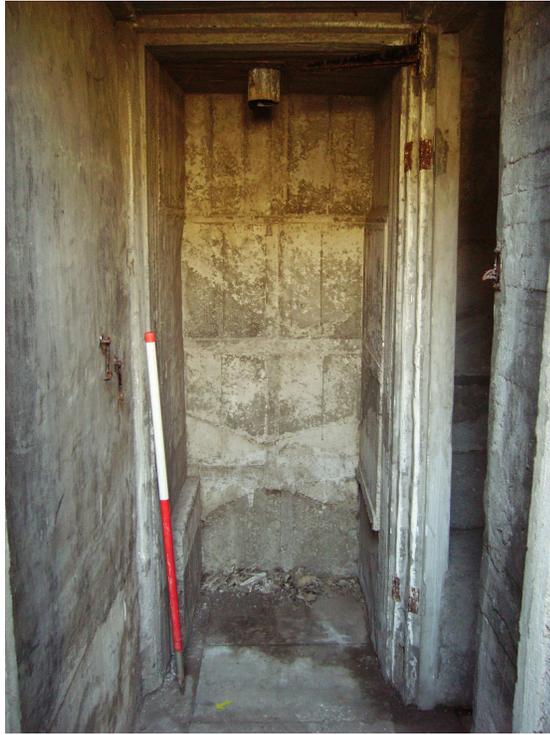
Both the recess and the internal doorways had the remains of iron hinges and the internal door had the remains of an iron latch, indicating that doors were at one time present. Iron hook latches were affixed to the external wall of the entrance approximately 1m off the floor. The structure displayed inverse symmetry.

**Plate 13: Shelter F1, Area J1 – detail of door hinges and latches, looking south-east.**

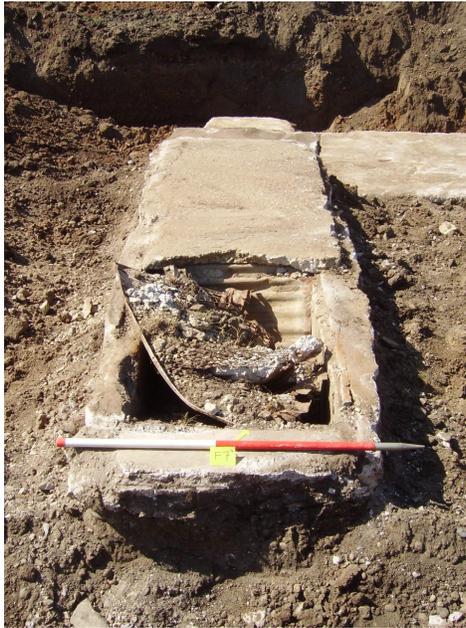
**Plate 14: Shelter F7, Area J1 – detail of concrete-covered corrugated iron cap, looking north-west.**

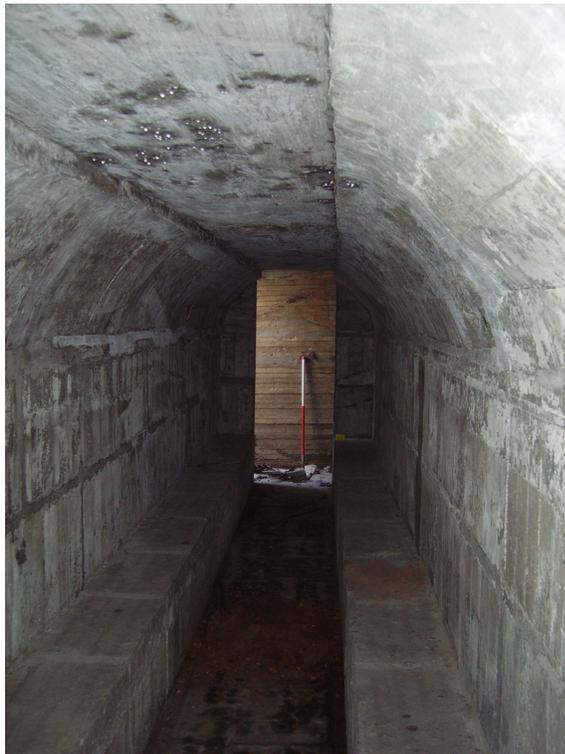
than the other shelters on the site. The chamber was of unpainted concrete and had a bench extending along the external wall on either side. These benches were 45cm high by 33cm deep and were formed of the same concrete as the entire structure. Evidence of shuttering is clear and the principle of the construction technique is similar to that of the other shelters, although, in this instance, fewer facets were poured than in either those types on Area C2 or the other type on Area J1, ie seven were visible above the benches here. Sixteen 60cm by 46cm rectangular slabs extended down the centre of the chamber. Three more exhaust vents were located at equal intervals within the roof.

**Plate 15: Shelter F8, Area J1 – internal view, looking south-west.**

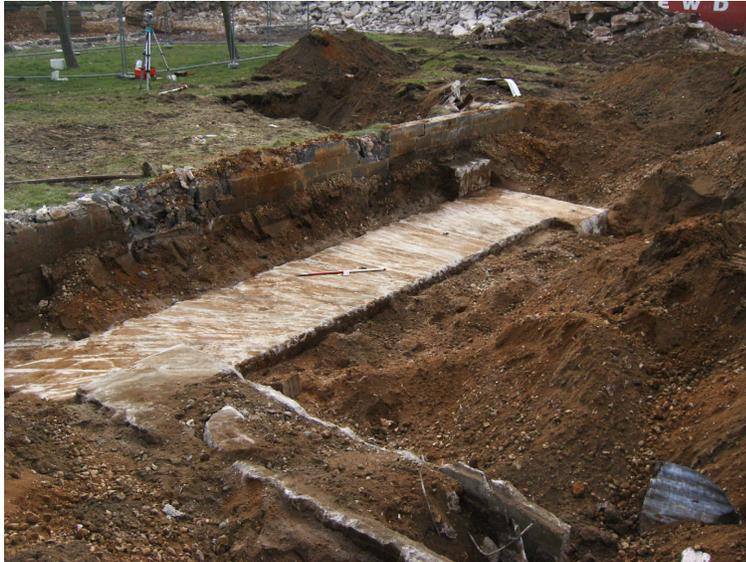
This structure was completely below ground with raised entrances that would have been level with the surface at the time of construction. Subsequent development raised ground-level, totally obscuring any trace of the structure. Once fully exposed, it was observed that the shelter was roughly aligned north to south. The north entrance was 55cm above the roof of the chamber and measured 6.55m long by 1m wide. The entrance was sealed by a cap of corrugated iron covered in concrete, which sat on a recessed lip within the entrance walls, 5cm deep on each side. This appeared to be part of the original construction and is an indication that the shelters had some form of door or hatch. The south entrance was 45cm above the roof of the chamber and measured 6.45m long by 1m wide. The concrete-covered corrugated iron cap sat on an identical-sized lip to that of the north entrance. Both entrances descended eleven steps to identical corridors that terminated in a recess (87cm deep). The width of this corridor was 70cm, indicating that the walls were 15cm thick. Directly above the recess was a centrally-positioned circular hole (10cm in diameter) in the roof. This is interpreted as either an air vent or an exhaust vent for waste gases. The floor was poured concrete with five 60cm by 46cm concrete slabs set into it. A white painted number (46) was observed on a facing panel of each entrance.

**Plate 16: Shelter F1, Area P1, looking south-east.**

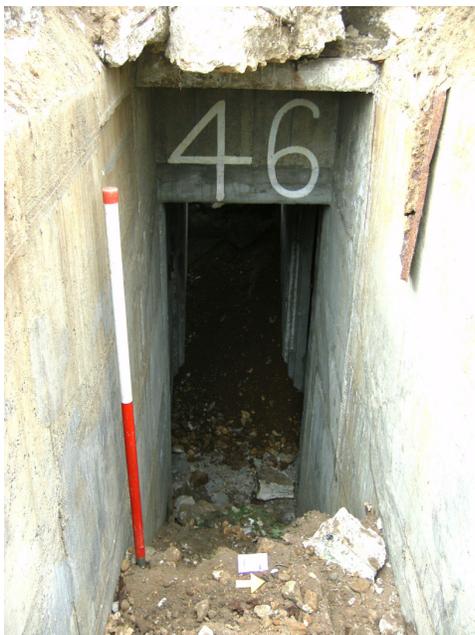
**Plate 17: Shelter F1, Area P1, south entrance, showing white-painted number, looking west.**

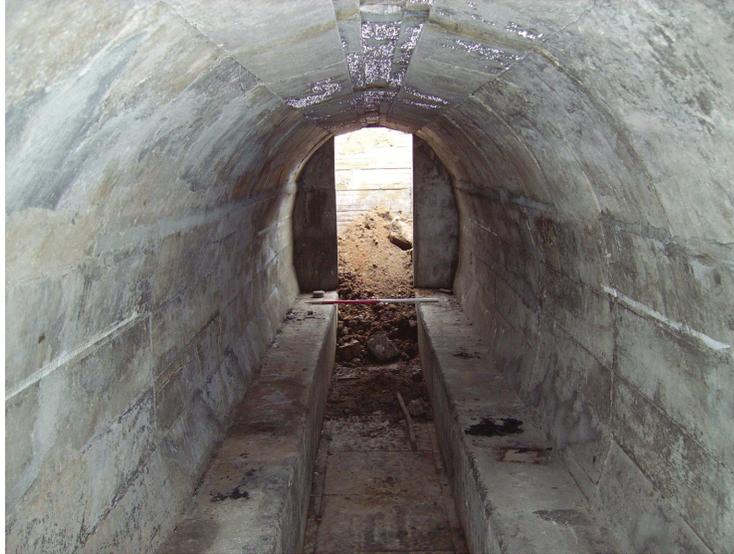
the entire structure. Evidence of shuttering is clear and the construction technique is nearly identical to that of the shelters on Area J1. Here the facets above the benches were identical until the highest central panel, where a 20cm-wide by 4cm-deep recess was inserted. However, this did not significantly alter the ovoid shape of the chamber when viewed in section. Sixteen 60cm by 46cm rectangular slabs extended down the centre of the chamber. Three more exhaust vents were located at equal intervals within the roof.

**Plate 18: Shelter F1, Area P1 – internal view, looking north.**

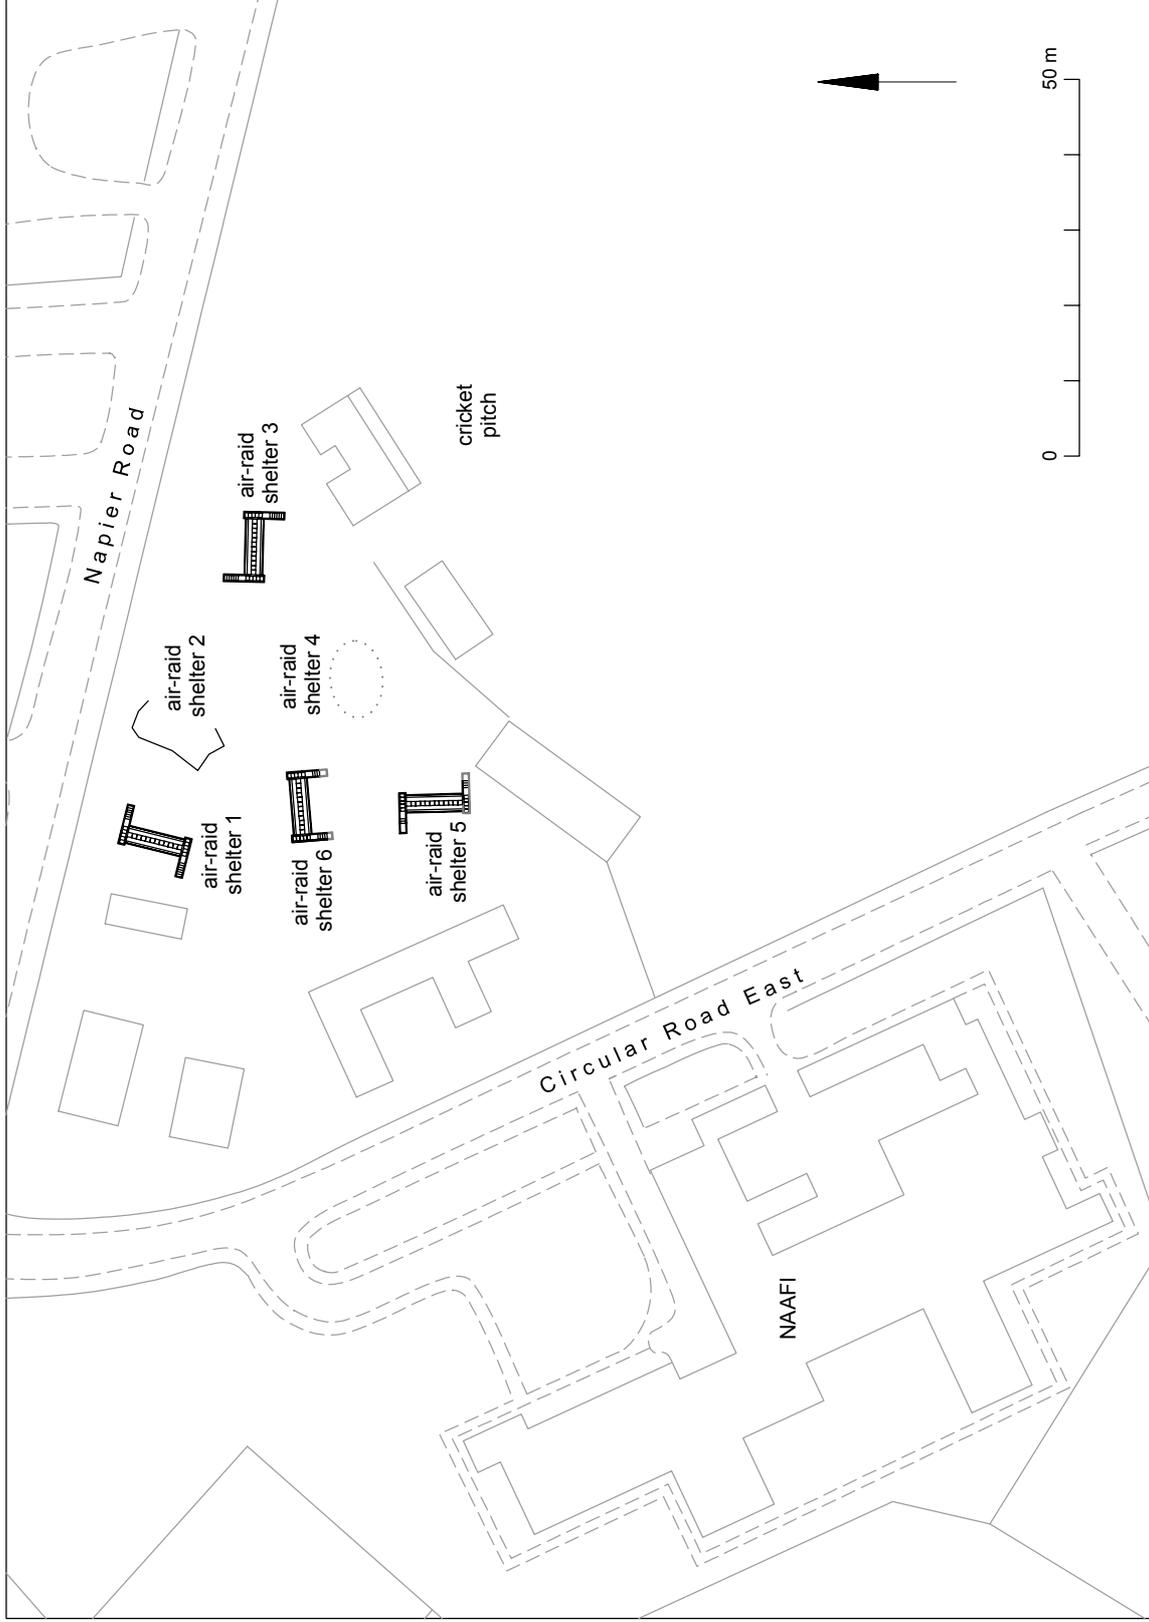
Fig 2 Plan of Area C2, showing air-raid shelters and contemporary army offices.

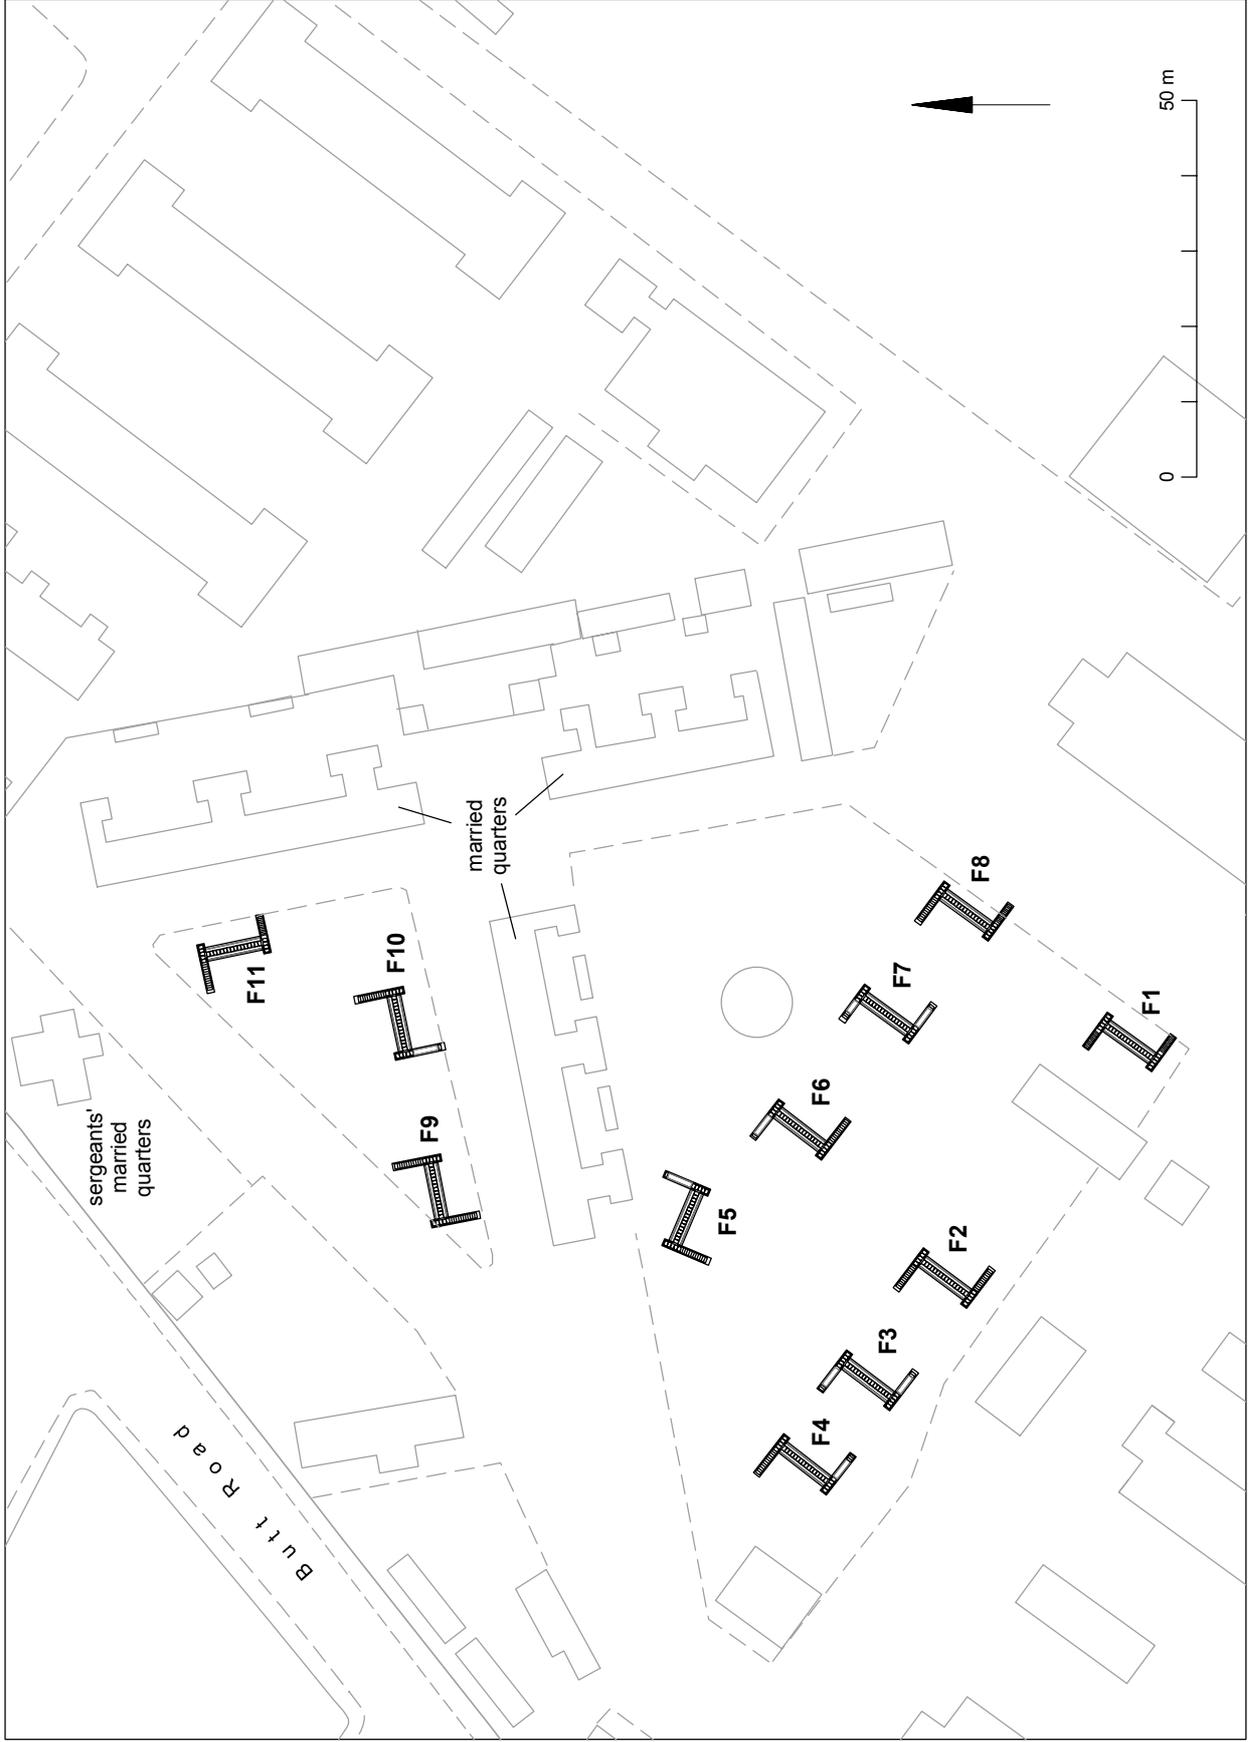
Fig 3 Plan of Area J1, showing air-raid shelters and contemporary barrack buildings.

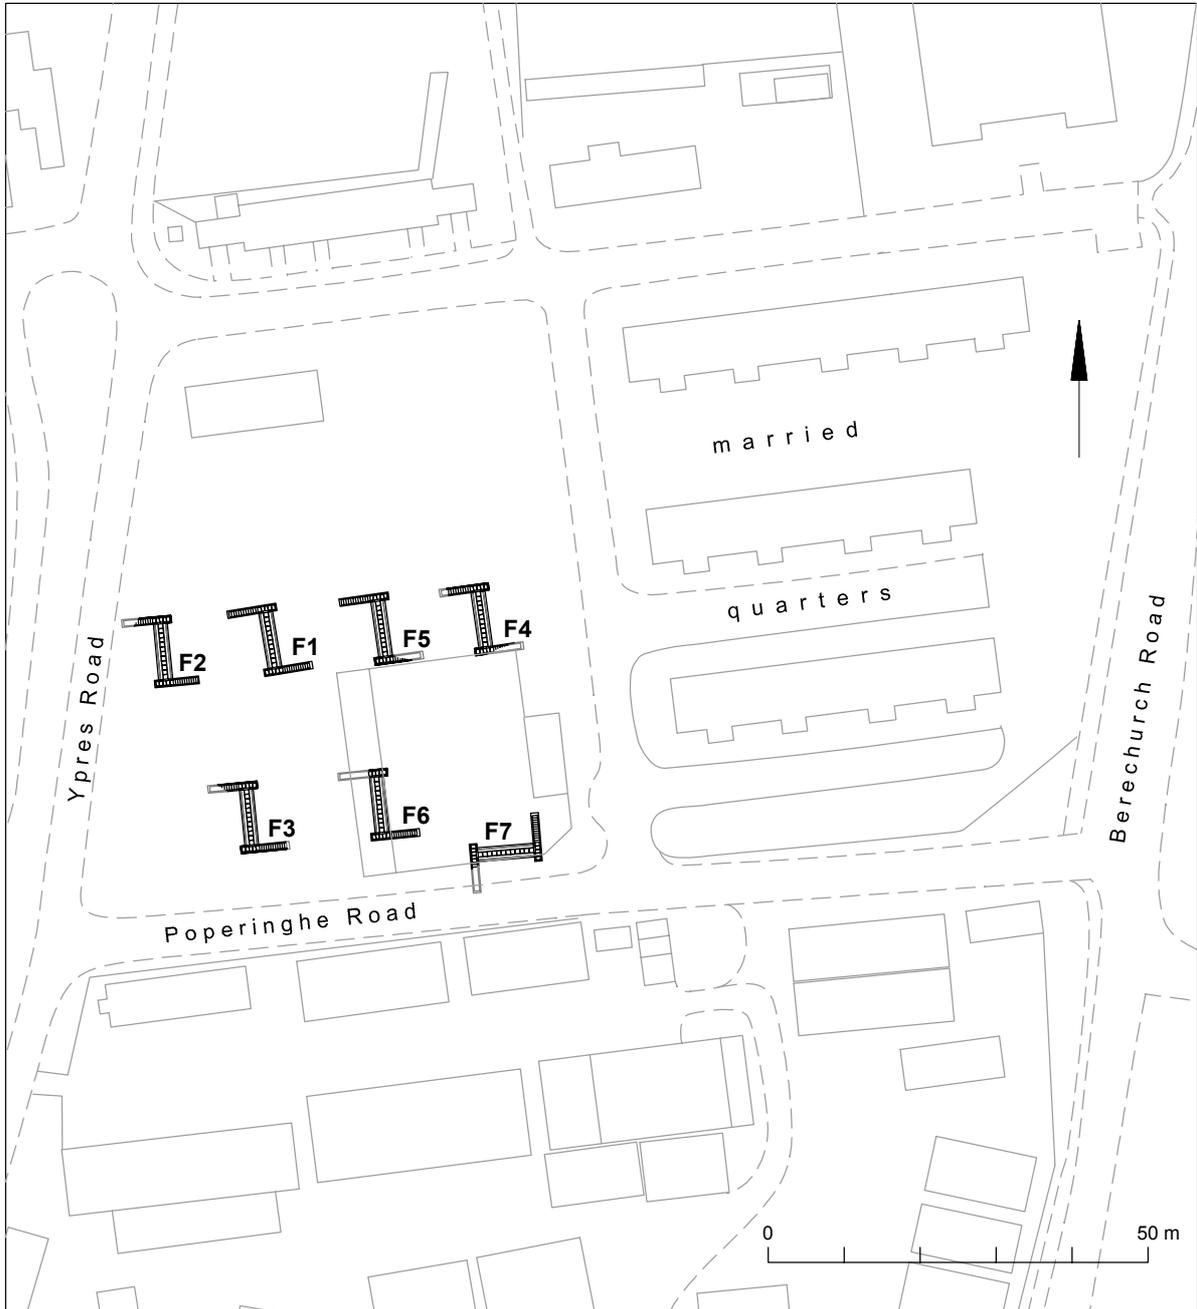
Fig 4 Plan of Area P1, showing air-raid shelters and contemporary barrack buildings.

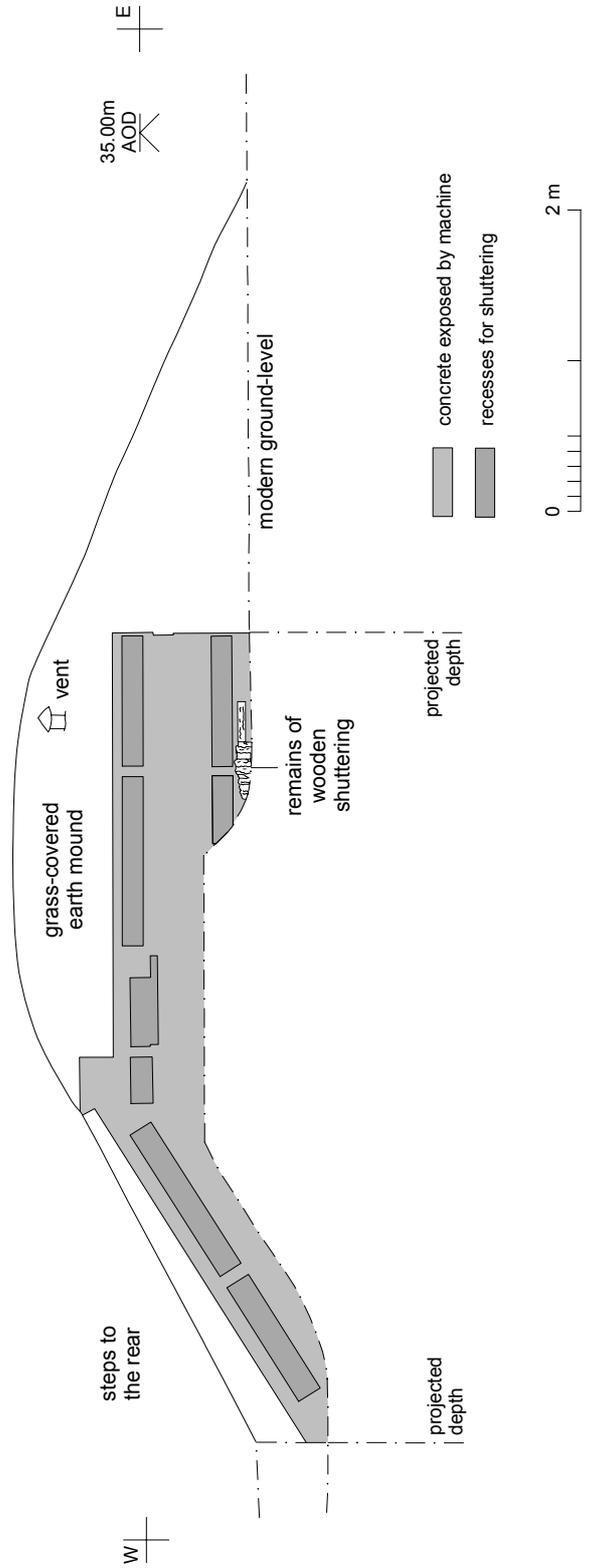
The earth mound stood approximately 1.2m above modern ground-level at its highest point and was partially obscured on the western side by a mature horse chestnut tree. The top of the south-west entrance was 20cm above the roof of the chamber – it was not possible to observe this calculation at the north-east entrance. A slab pathway made of 60cm by 60cm slabs was laid at an angle to the north-east entrance. No concrete cover was present at the north-east entrance and a thick layer of moss indicated that there had not been one for some time. There was, however, a 5cm deep lip around three sides of the entrance walls. Access to the shelter was down the flight of six steps on the north-eastern side, into a short

corridor. The dimensions of this entrance were 5.4m long by 1m wide in plan. The internal width of the corridor was 70cm, indicating that the entrance walls were each 15cm thick. Directly ahead was a recess (approx 87cm deep by 70cm wide) with a centrally-positioned circular hole (10cm in diameter) in the roof. This is interpreted as either an air vent or an exhaust vent for waste gases.

Fig 5 Area C2, air-raid shelter 1: section across the exterior of the southern end.

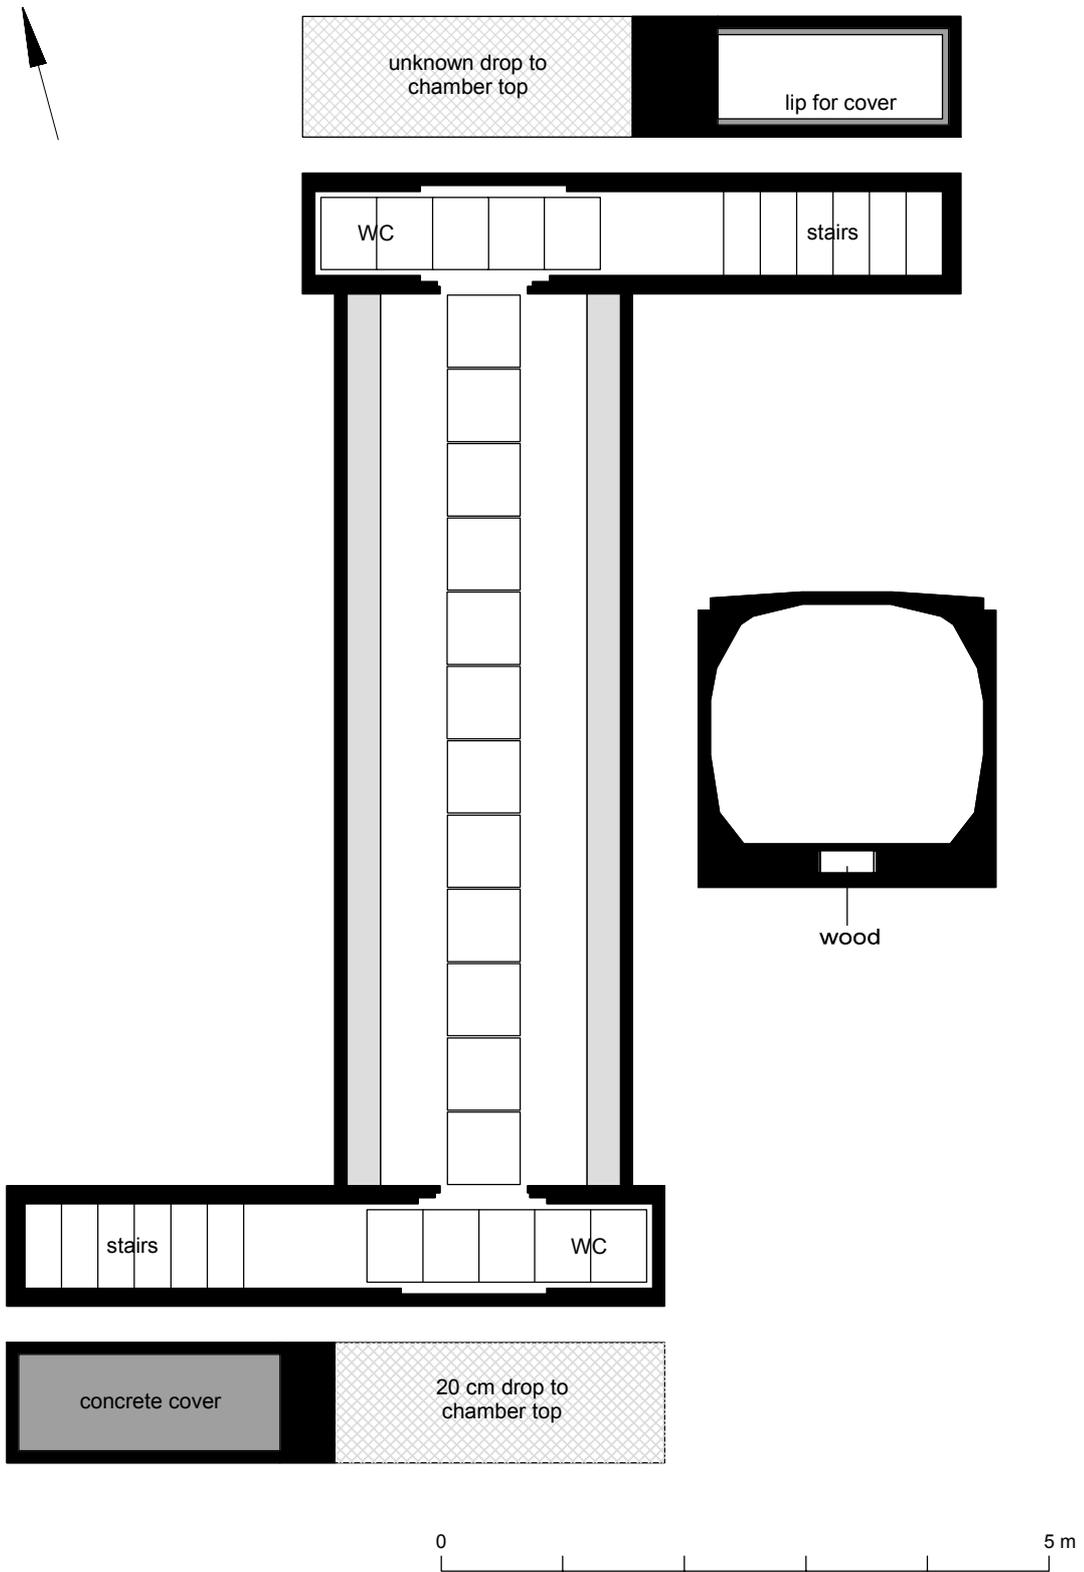
The central chamber externally measured 7.38m long by 2.45m wide by 2.45m high with an internal measurement of 2.24m at the widest point and 1.68m at its base. The sub-circular chamber was painted white and was constructed of reinforced concrete, with evidence of shuttering being clearly visible. It would appear that an internal frame of angled planks was constructed within a larger box and the void filled with steel and concrete. This produced distinct panels of concrete – 15 facets, plus the floor – around the circumference of the chamber. Twelve 60cm by 60cm concrete slabs extended down the centre of the chamber beneath which was a channel, 18cm deep by 46cm wide, and lined with wood, which was divided into five sections.

A light switch was located at the western end of the chamber with a metal-cased wire leading up the wall and along the chamber roof to a centrally mounted bayonet light fitting. It was uncertain if this was contemporary with the shelter's construction. Four more of the exhaust vents were evenly located in the roof. The whole structure, with the central chamber and two sets of stairs at either end, displayed an inverse symmetry in construction, as shown by the plan.

Fig 6 Area C2, air-raid shelter 1: internal plan and cross-section of chamber.

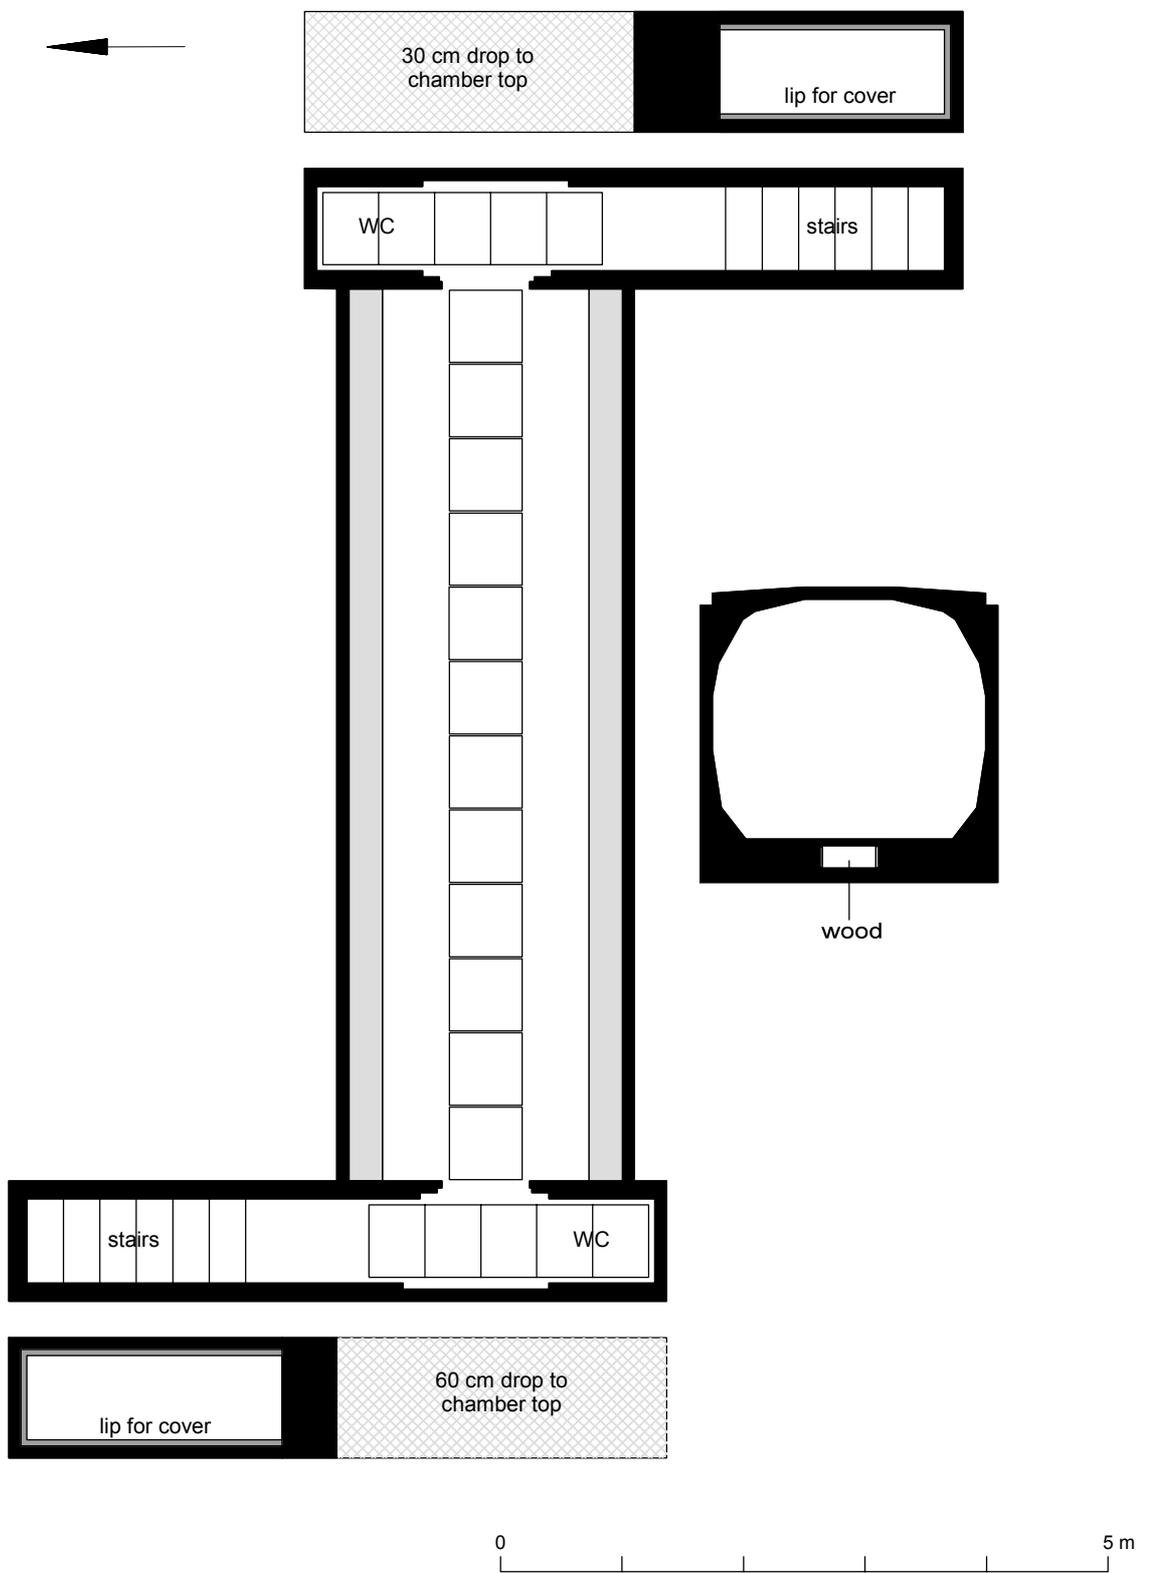
A light switch and junction box were located at the western end of the chamber with a metal-cased wire leading up the wall and along the chamber roof to a centrally mounted bayonet light fitting. It was uncertain if this was contemporary with the air-raid shelter's construction. Three more of the exhaust vents were evenly located in the roof. The whole structure, with the central chamber and two sets of stairs at either end, displayed an inverse symmetry in construction, as shown by the plan.

Fig 7 Area C2, air-raid shelter 3: internal plan and cross-section of chamber.

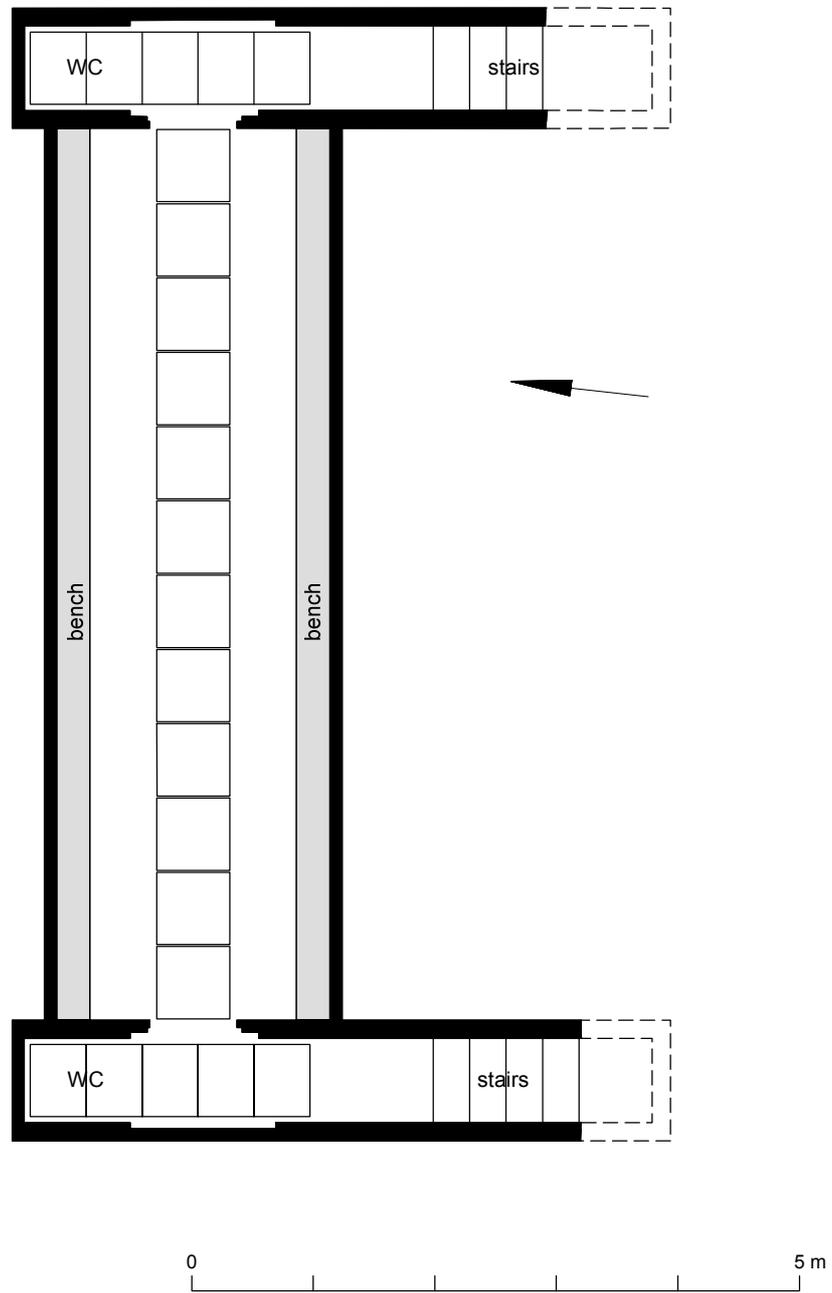
Shelter 6 was aligned east to west and had three remaining steps at the east end and four at the north end. The surviving length of the eastern entrance was 4.4m by 1m wide, the western entrance 4.65m long. Both entrances led into the central chamber from the south and were identical to each other. The remaining steps led down into a corridor that ended in a recess (87cm deep) and had a poured concrete floor with five 60cm by 46cm concrete slabs set into it.

The surviving details of the central chamber were identical to shelter 5 in all respects.

Fig 9 Area C2, air-raid shelter 6: internal plan.
