**A survey of three groups of  
air-raid shelters at  
Areas C2, J1 and P1  
of the Garrison Urban Village,  
Colchester, Essex  
April 2004-May 2007**

**report prepared by  
Chris Lister**

**commissioned by  
RPS Planning  
on behalf of  
Taylor Wimpey**

**CAT Report 467**  
May 2008

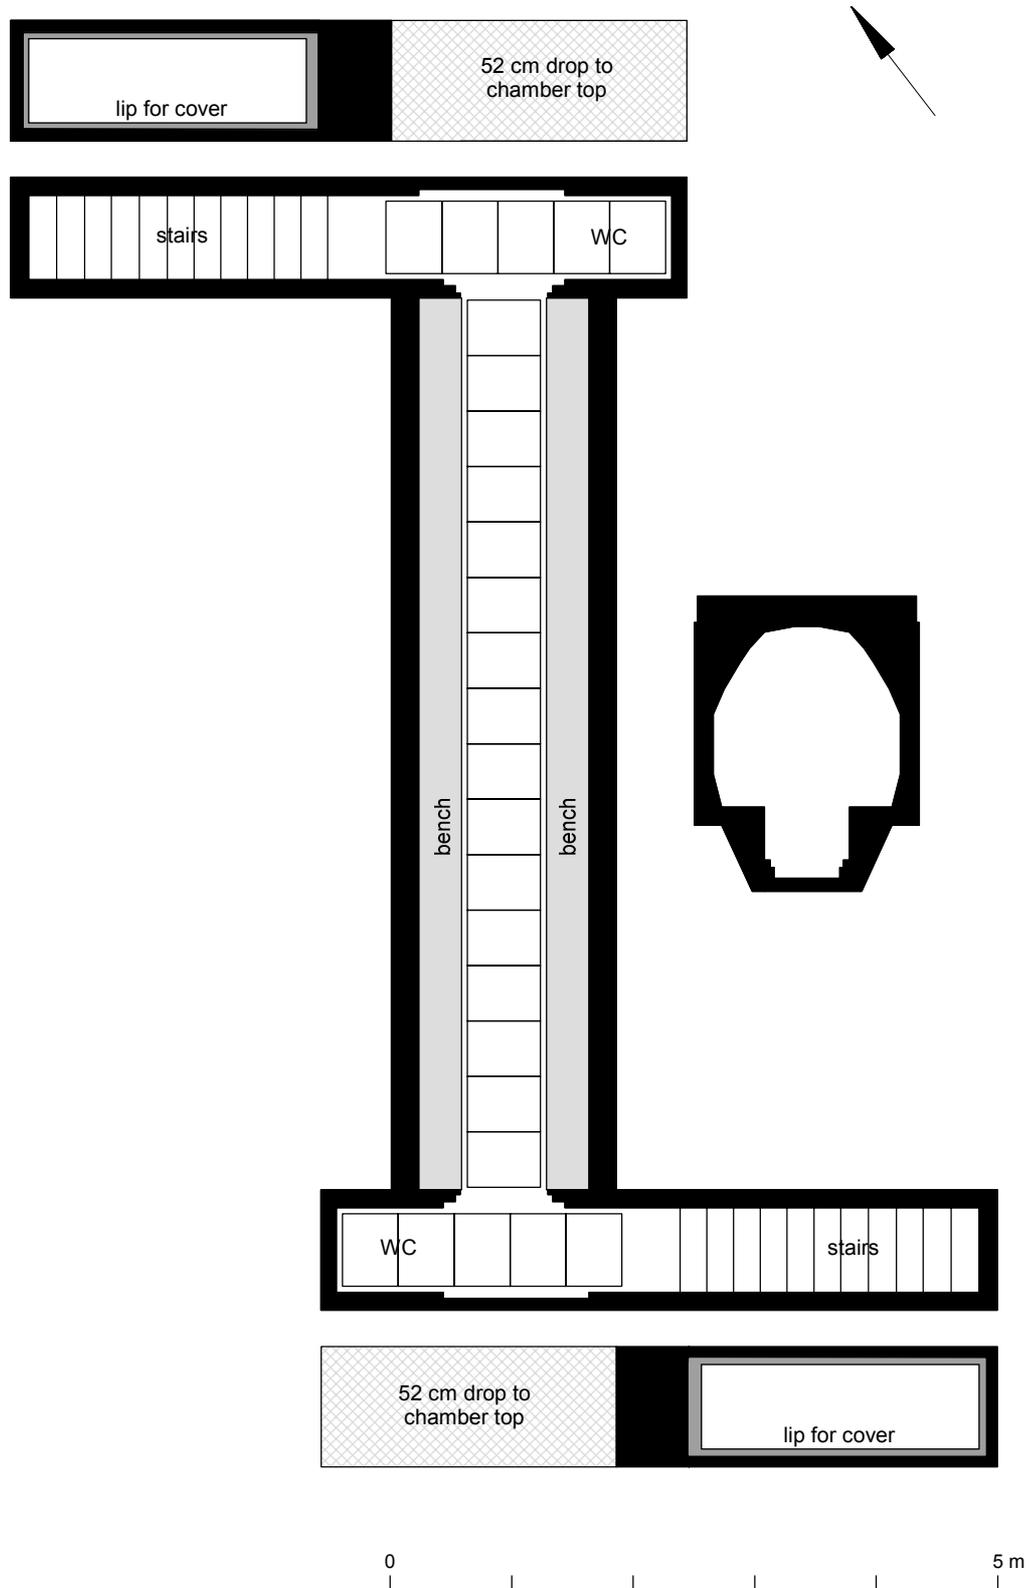
This structure was completely below ground with raised entrances level to the surface. The shelter was aligned north-east to south-west, and, once the shelter was exposed, it could be seen that both entrances were 52cm above the roof of the central chamber. The entrances were sealed by a cap of corrugated iron covered in concrete, which sat on a recessed lip within the entrance walls, 5cm deep at the sides and the entrance and 10cm deep at the chamber end. This appeared to be part of the original construction and is an indication that the shelters had some form of door or hatch. Both entrances were identical in design; each measured 5.55m by 1m in length and had eleven steps leading down to a corridor ending in a recess (87cm deep). The width of this corridor was 70cm, indicating that the walls were 15cm thick. Directly above the recess was a centrally positioned circular hole (10cm in diameter) in the roof. This is interpreted as either an air vent or an exhaust vent for waste gases. The floor was poured concrete with five 60cm by 46cm concrete slabs set into it.

The central chamber externally measured 7.4m by 1.85m by 2.45m high with an internal measurement of 1.54m at its widest point. The chamber was of unpainted concrete and had a bench extending along the external wall on either side. These benches were 46cm high by 35cm deep and were formed of the same concrete as the entire structure. Evidence of shuttering is clear and the principle of the construction technique is similar to that of the shelters on Area C2, although in this instance a different shape was achieved using the same number of facets (fifteen visible above the benches). This produced a narrower, ovoid section compared to the sub-circular cross-section of the shelters in Area C2. Sixteen 60cm by 46cm

Both the recess and the internal doorways had the remains of iron hinges and the internal door had the remains of an iron latch, indicating that doors were at one time present. Iron hook latches were affixed to the external wall of the entrance approximately 1m off the floor. The structure displayed inverse symmetry.

Fig 10 Area J1, air-raid shelter F1: internal plan and cross-section of chamber.

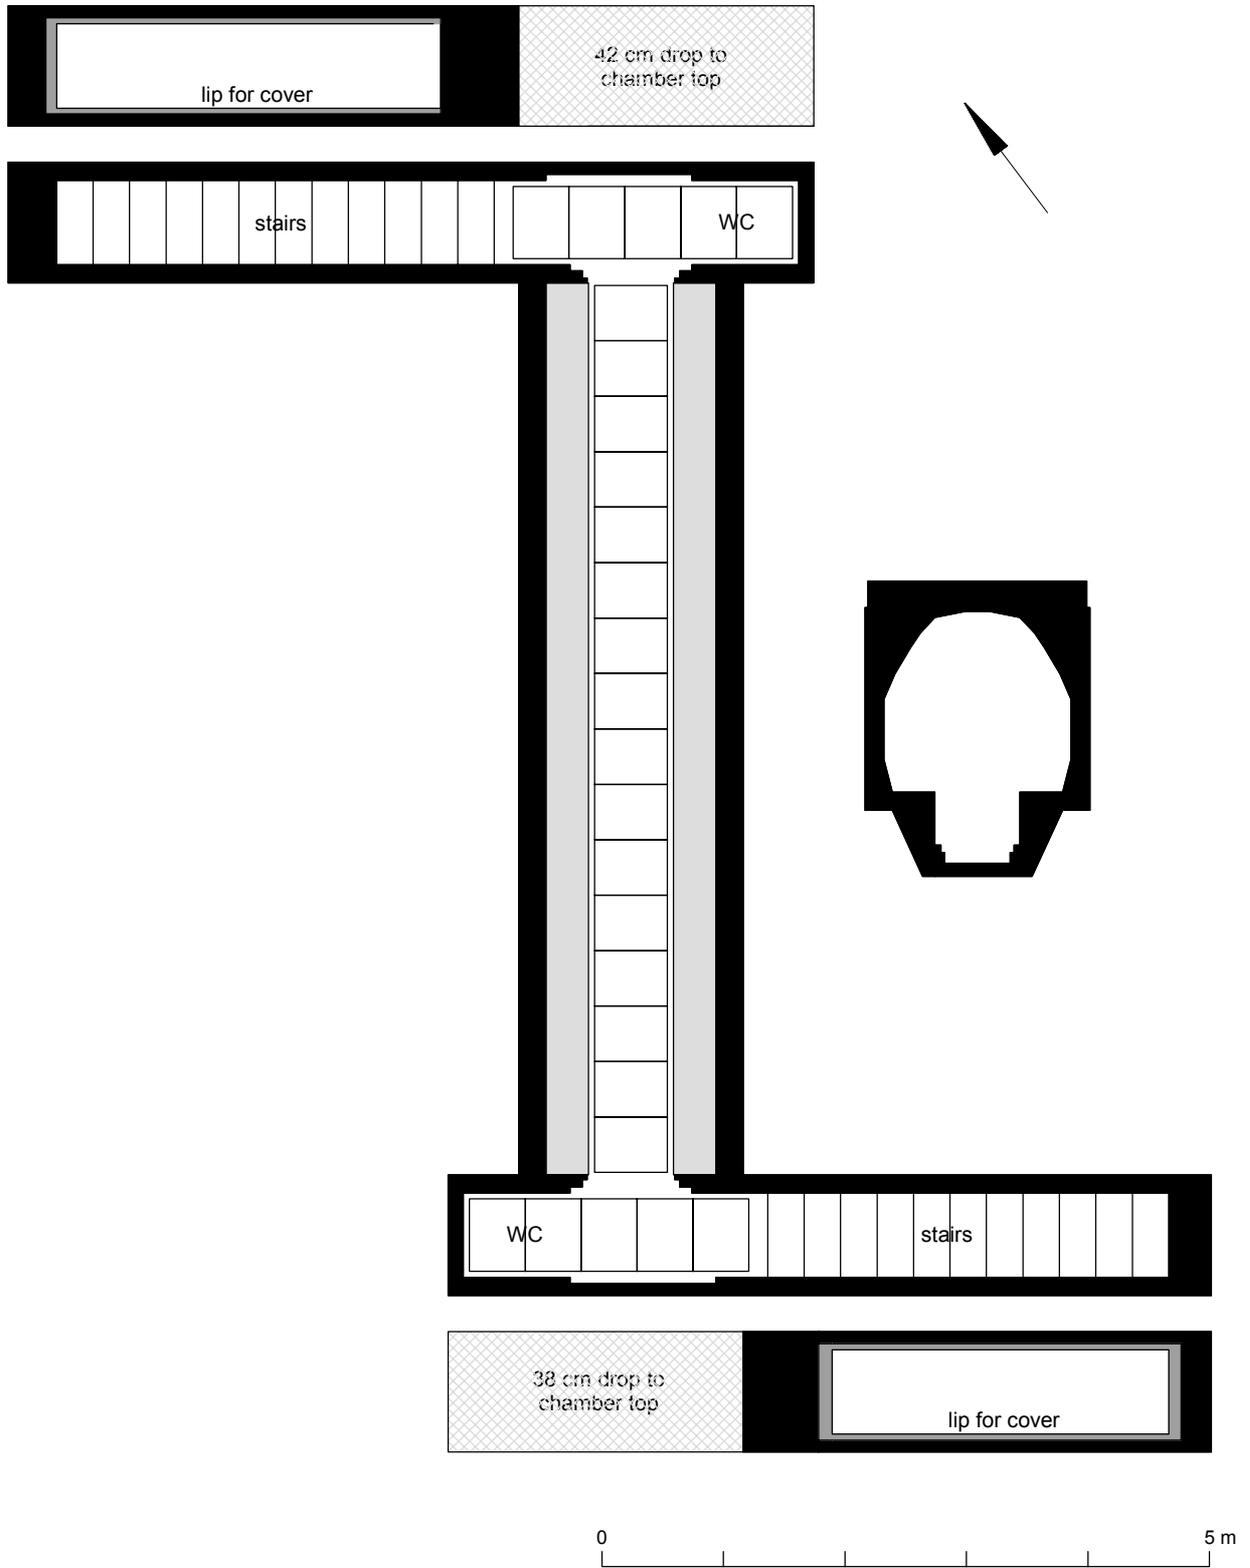
This structure was completely below ground with raised entrances level with the surface. The shelter was aligned north-east to south-west. The north-east entrance was 42cm above the chamber roof and measured 6.55m long by 1m wide. It was capped by corrugated iron covered in concrete, which sat on a lip in the entrance wall, 5cm deep at the sides and 10cm deep at the entrance and chamber ends. Twelve steps led down into a corridor (70cm wide) ending in a recess (87cm deep). The south-west entrance was 38cm above the chamber roof and measured 6.25m long by 1m wide, capped with concrete-covered corrugated iron sitting on an identical-sized lip in the entrance wall. Eleven steps led down into a corridor identical to that of the north-east. Both recesses had a 10cm-diameter exhaust vent centrally located in the roof, and each had a poured concrete floor with five 60cm by 46cm concrete slabs set into it.

The central chamber externally measured 7.4m by 1.85m by 2.45m high with an internal measurement of 1.54m at its widest point. The chamber was of unpainted concrete and had the same benches as shelter F1. Evidence of shuttering is clear and the construction technique is identical to that of shelter F1. Sixteen 60cm by 46cm rectangular slabs extended down the centre of the chamber and three more exhaust vents were located at equal distances within the roof.

Both the recess and the internal doorways had the remains of iron hinges and the internal door had the remains of an iron latch, indicating that doors were at one time present. Iron hook latches were affixed to the external wall of the entrance approximately 1m off the floor.

Fig 11 Area J1, air-raid shelter F2: internal plan and cross-section of chamber.

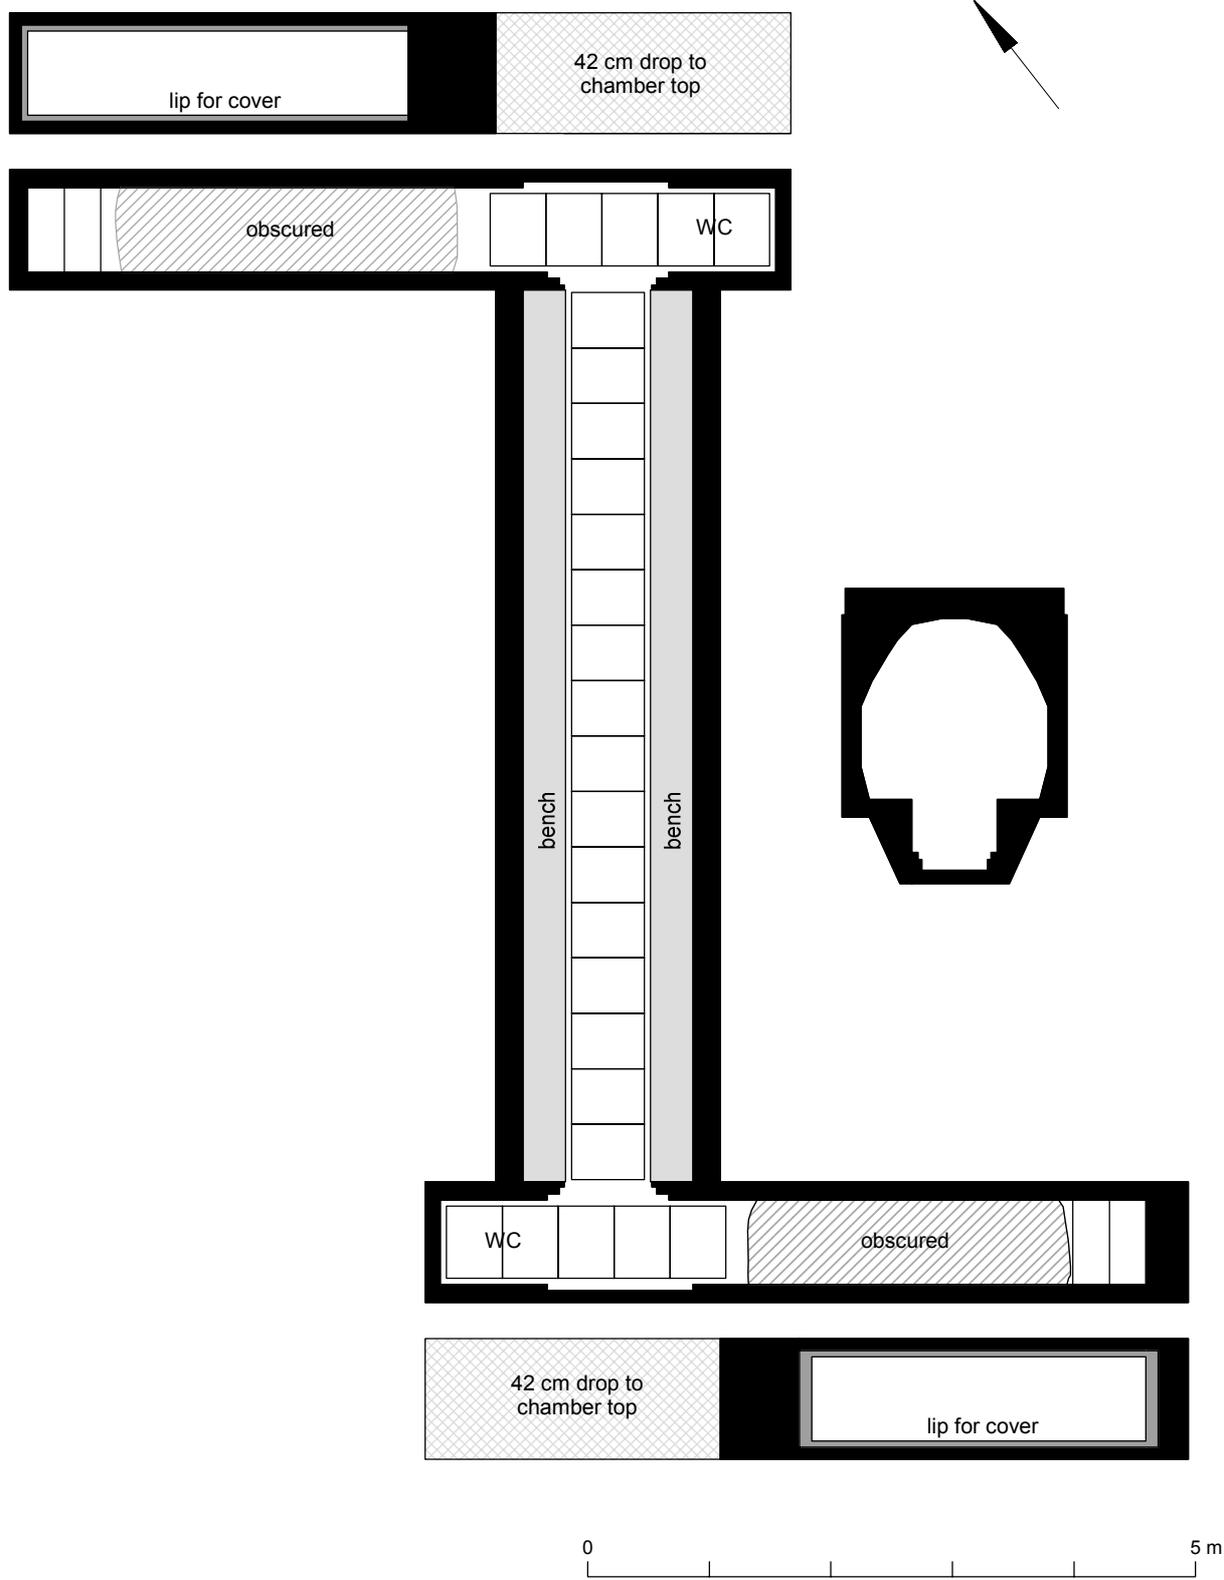
This structure was completely below ground with raised entrances level to the surface and was aligned north-east to south-west. Both entrances were 42cm above the chamber roof and capped with corrugated iron and concrete. The lip for the concrete cap on the north-east entrance was 10cm deep at the chamber end and

5cm deep at the sides and entrance. The lip on the south-west entrance was 5cm deep at the sides and 10cm deep at the entrance and chamber end. Both entrances were completely blocked by earth and rubble that could not be removed; therefore it was not possible to ascertain the number of steps. The north-east entrance was 5.75m long by 1m wide, the south-west entrance 6.45m by 1m wide. Both entrances led down into a corridor that terminated in an 87cm deep recess with centrally-positioned 10cm-diameter exhaust vents, and both had poured concrete floors with five 60cm by 46cm concrete slabs set into them.

Fig 12 Area J1, air-raid shelter F3: internal plan and cross-section of chamber.

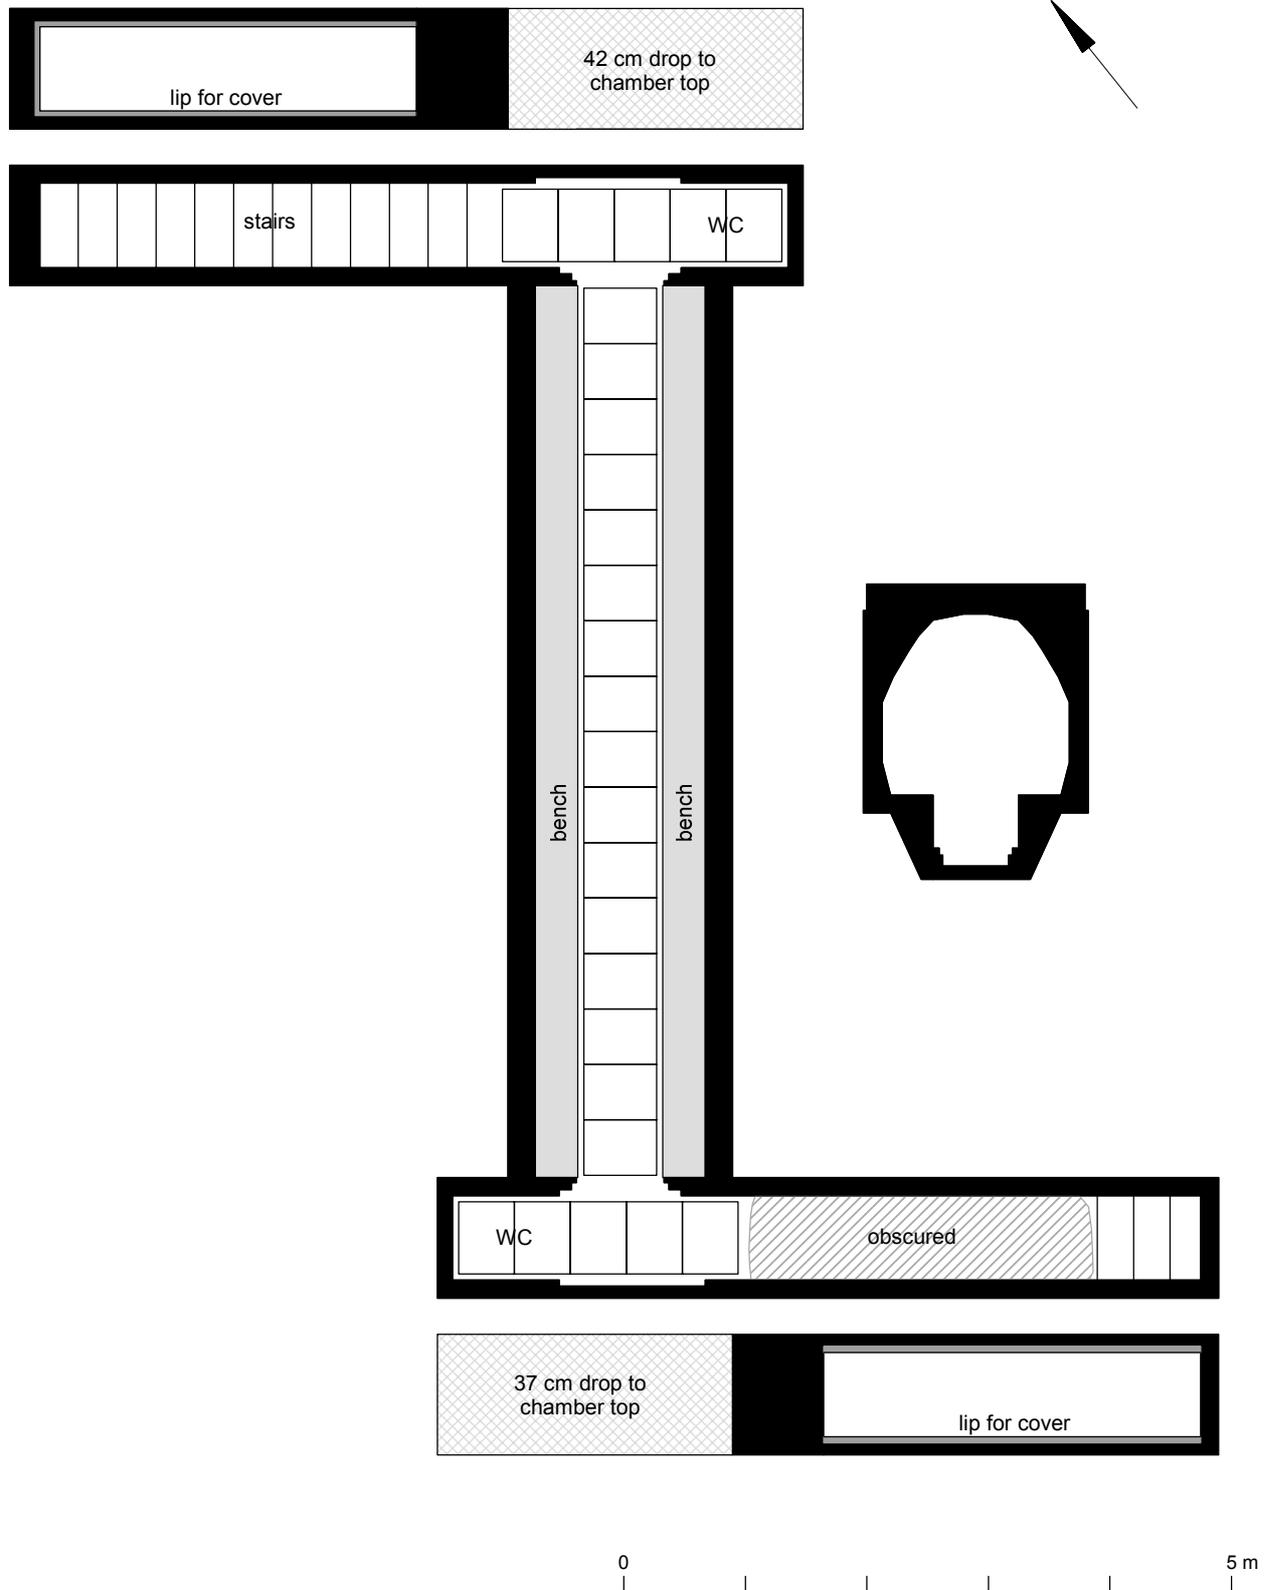
This structure was completely below ground with raised entrances level to the surface and was aligned north-east to south-west. The north-east entrance was 42cm above the chamber roof and measured 6.4m long by 1m wide. It was capped by corrugated iron covered in concrete, which sat on a lip in the entrance wall, that was 5cm deep all the way around the interior. Eleven steps led down into a corridor (70cm wide) ending in a recess (87cm deep), above which was a 10cm-diameter centrally located exhaust vent. The south-west entrance was 37cm above the chamber roof and also measured 6.4m long by 1m wide. This entrance was blocked by earth and rubble so it was not possible to ascertain the number of steps. The south-west corridor was 70cm wide and terminated in an 87cm deep recess with a centrally located 10cm-diameter exhaust vent. Both entrance corridors had poured concrete floors with five 60cm by 46cm concrete slabs set into them.

Fig 13 Area J1, air-raid shelter F4: internal plan and cross-section of chamber.

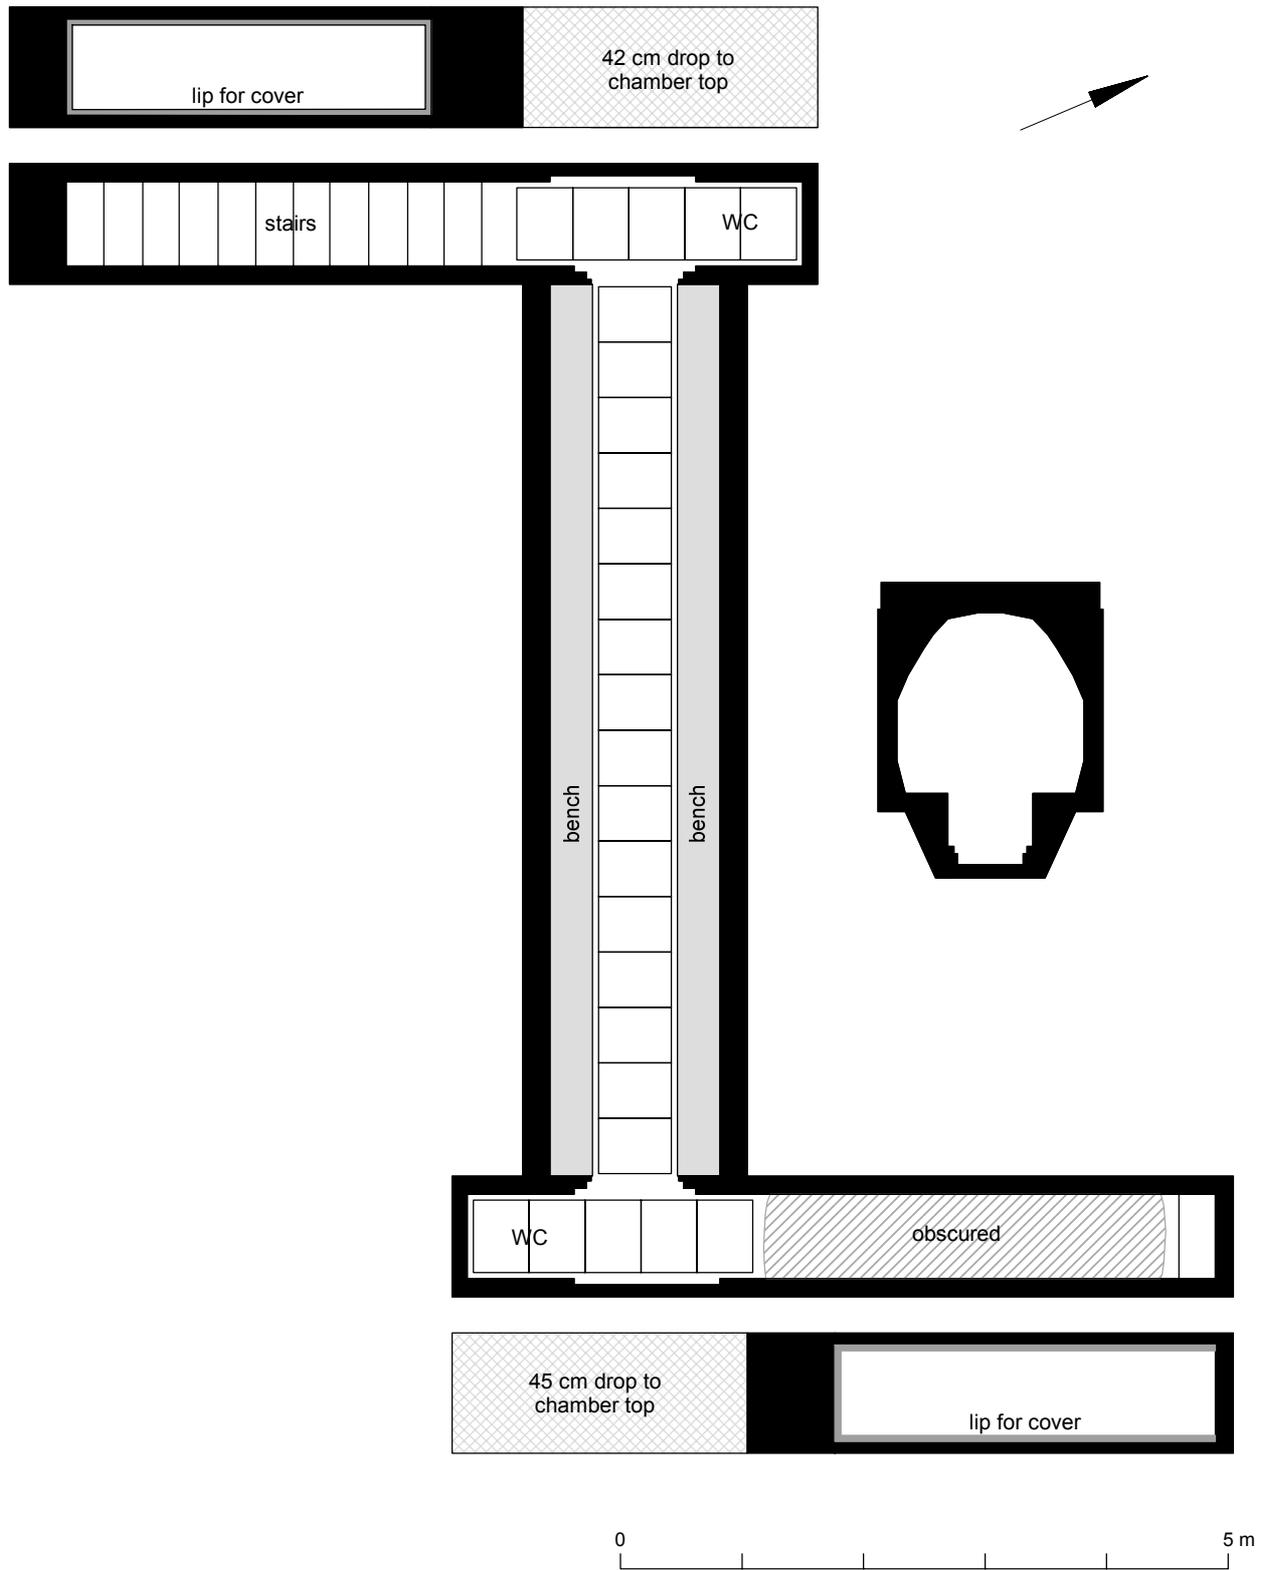
This structure was completely below ground with raised entrances level to the surface and was aligned north-west to south-east. The north-west entrance was 42cm above the chamber roof and measured 6.65m long by 1m wide. It was capped by corrugated iron covered in concrete, which sat on a lip in the entrance wall that was 5cm deep all the way around the interior. Eleven steps led down into a corridor (70cm wide) ending in a recess (87cm deep) with a centrally-located 10cm-diameter exhaust vent. The south-east entrance was 45cm above the chamber roof and measured 6.35m long by 1m wide. This was capped with concrete covered corrugated iron that sat upon a 5cm deep lip at the sides and the chamber end of the entrance. The entrance was blocked by earth and rubble so it was not possible to ascertain the number of steps. However, there was an 87cm deep recess with a 10cm-diameter exhaust vent centrally located in the roof, present at the end of the corridor. Both entrance corridors had a poured concrete floor with five 60cm by 46cm concrete slabs set into them.

Fig 14 Area J1, air-raid shelter F5: internal plan and cross-section of chamber.

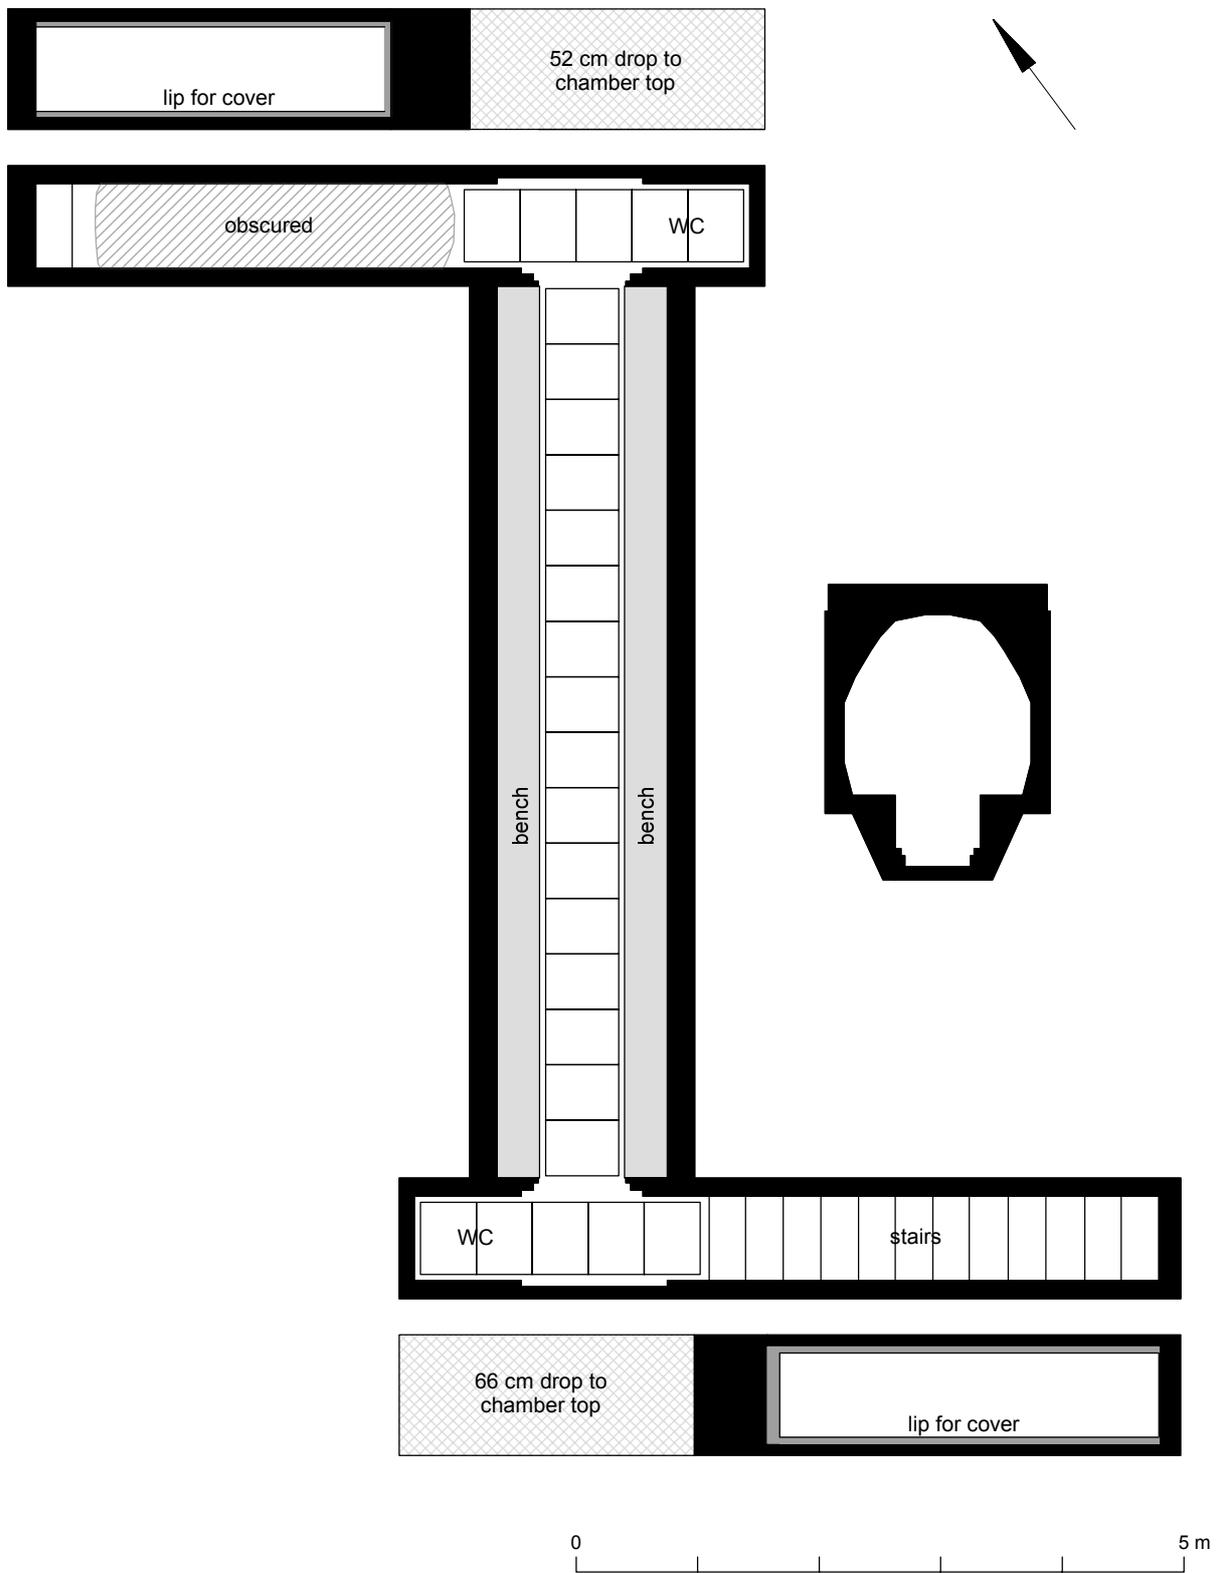
This structure was completely below ground with raised entrances level to the surface and was aligned north-east to south-west. The north-east entrance was 52cm above the chamber roof and measured 6.3m long by 1m wide. It was capped by corrugated iron covered in concrete, which sat upon a lip in the entrance wall, which was 5cm deep at the sides and the chamber end of the entrance. This entrance was blocked by earth and rubble so it was not possible to ascertain the number of steps. The entrance led down into a corridor (70cm wide), ending in a recess (87cm deep), with a centrally-located 10cm-diameter exhaust vent. The south-west entrance was 66cm above the chamber roof and measured 6.25m long by 1m wide. This was capped with concrete covered corrugated iron that sat on a lip that was 5cm deep at the sides and 10cm deep at the chamber end of the entrance. The entrance had twelve steps that led down into a corridor that terminated in an 87cm-deep recess with a 10cm diameter exhaust vent centrally located in the roof. Both entrance corridors had a poured concrete floor with five 60cm by 46cm concrete slabs set into them.

Fig 15 Area J1, air-raid shelter F6: internal plan and cross-section of chamber.

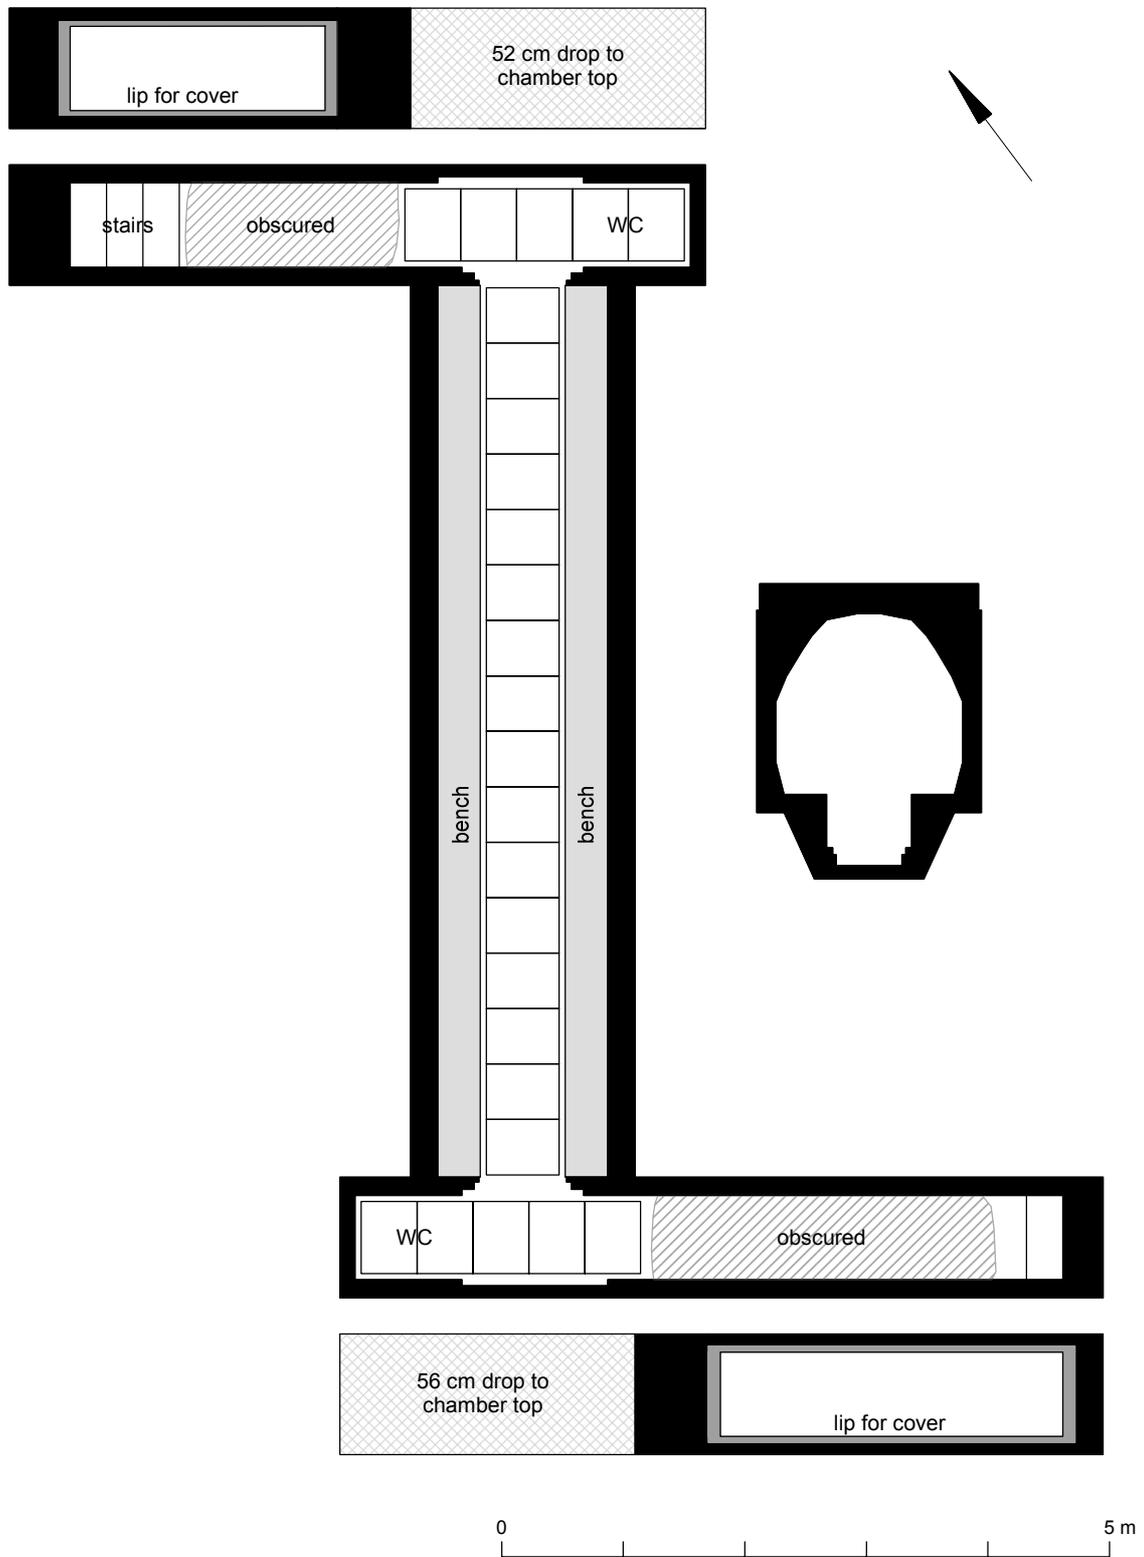
This structure was completely below ground with raised entrances level to the surface and was aligned north-east to south-west. The north-east entrance was 42cm above the chamber roof and measured 5.55m long by 1m wide. The south-west entrance 56cm above the chamber roof and measured 6.15m long by 1m wide. Each entrance was capped by corrugated iron covered in concrete that sat on identical lips in the entrance wall, 5cm deep at the sides and 10cm deep at the entrance and chamber ends of the entrance. Both entrances were blocked by earth and rubble although access was just possible via the north-east entrance. It was not possible to ascertain the number of steps at either entrance but both led to a corridor, each of which contained an 87cm deep recess complete with centrally-located exhaust vents and had poured concrete floors with five 60cm by 46cm concrete slabs set into them.

Fig 16 Area J1, air-raid shelter F7: internal plan and cross-section of chamber.

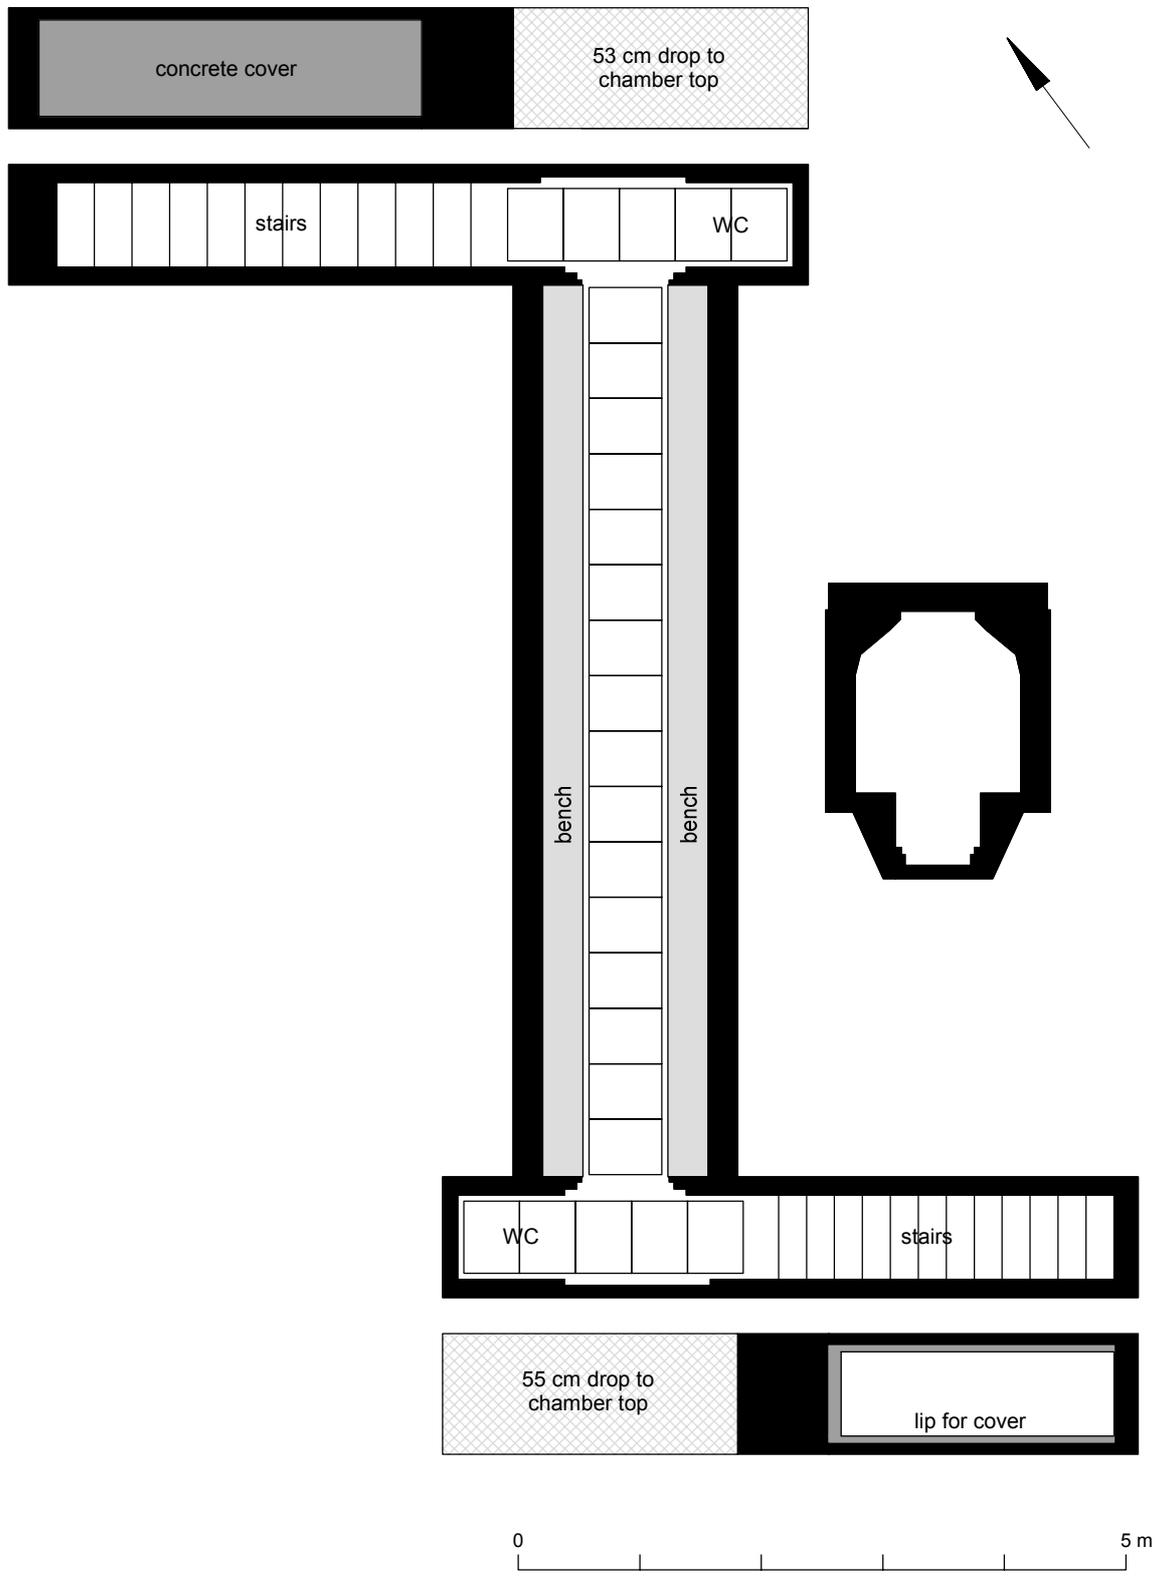
than the other shelters on the site. The chamber was of unpainted concrete and had a bench extending along the external wall on either side. These benches were 45cm high by 33cm deep and were formed of the same concrete as the entire structure. Evidence of shuttering is clear and the principle of the construction technique is similar to that of the other shelters, although, in this instance, fewer facets were poured than in either those types on Area C2 or the other type on Area J1, ie seven were visible above the benches here. Sixteen 60cm by 46cm rectangular slabs extended down the centre of the chamber. Three more exhaust vents were located at equal intervals within the roof.

Both the recess and the internal doorways had the remains of iron hinges and the internal door had the remains of an iron latch, indicating that doors were at one time present. Iron hook latches were affixed to the external wall of the entrance approximately 1m off the floor.

Fig 17 Area J1, air-raid shelter F8: internal plan and cross-section of chamber.

The single Type 3 shelter (Area J1, F8) may simply be an anomaly rather than an intentional third design, appearing as it does within a concentration of Type 2 shelters. The thicker walls and altered profile are probably the result of errors similar to those that caused the inconsistencies within the entrances.

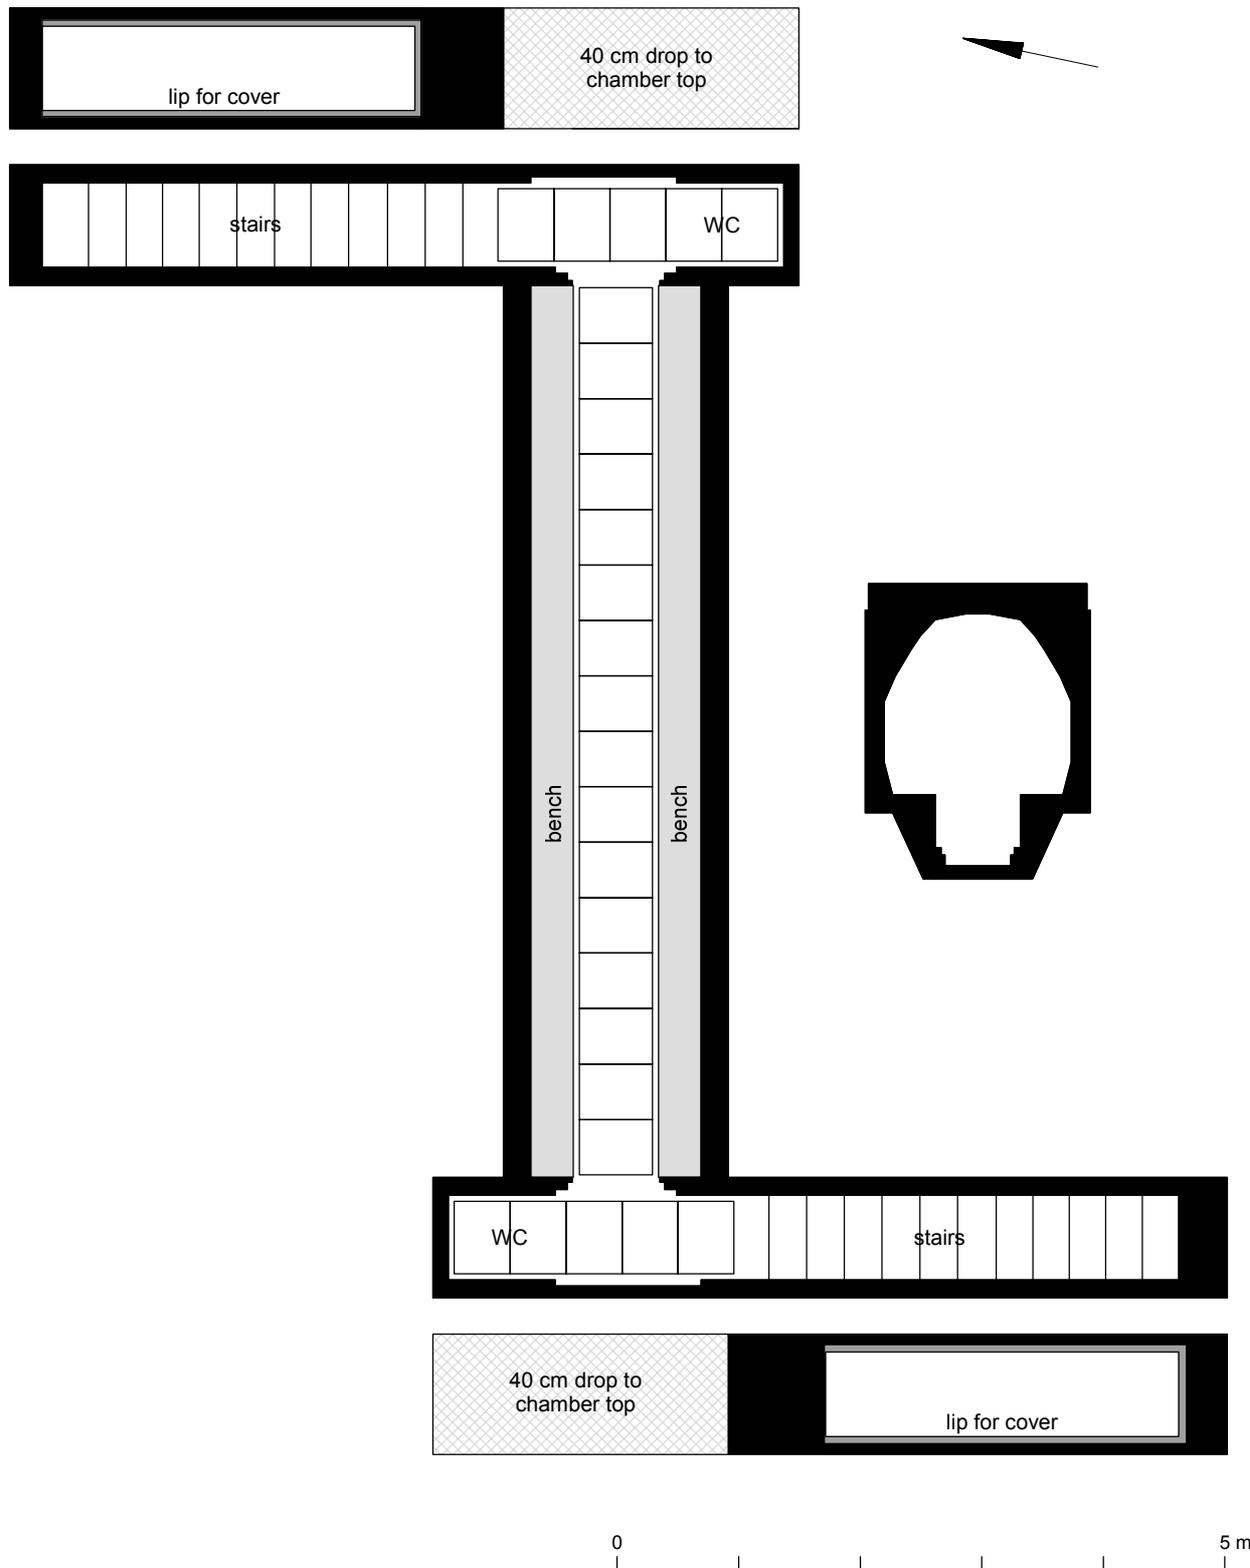
Fig 18 Area J1, air-raid shelter F9: internal plan and cross-section of chamber.

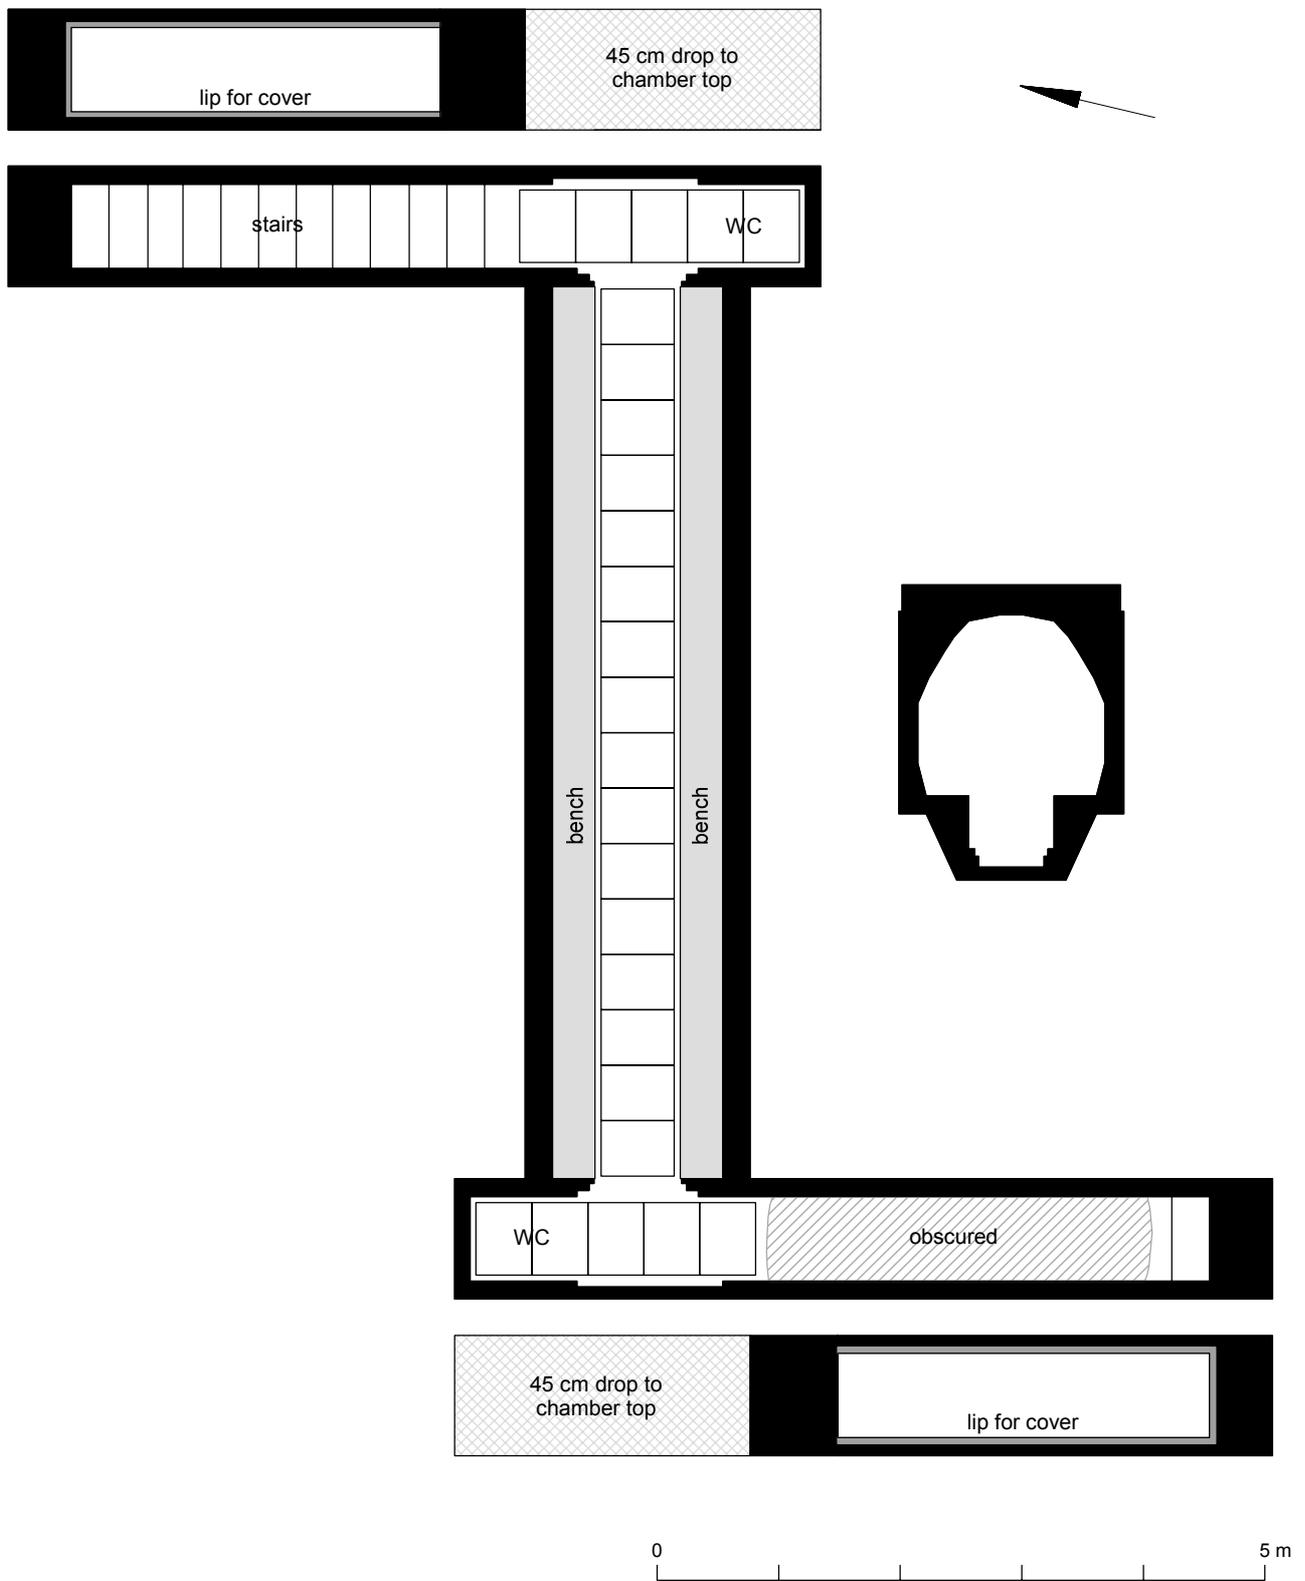
Fig 19 Area J1, air-raid shelter F10: internal plan and cross-section of chamber.
