**A survey of three groups of  
air-raid shelters at  
Areas C2, J1 and P1  
of the Garrison Urban Village,  
Colchester, Essex  
April 2004-May 2007**

**report prepared by  
Chris Lister**

**commissioned by  
RPS Planning  
on behalf of  
Taylor Wimpey**

**CAT Report 467**  
May 2008

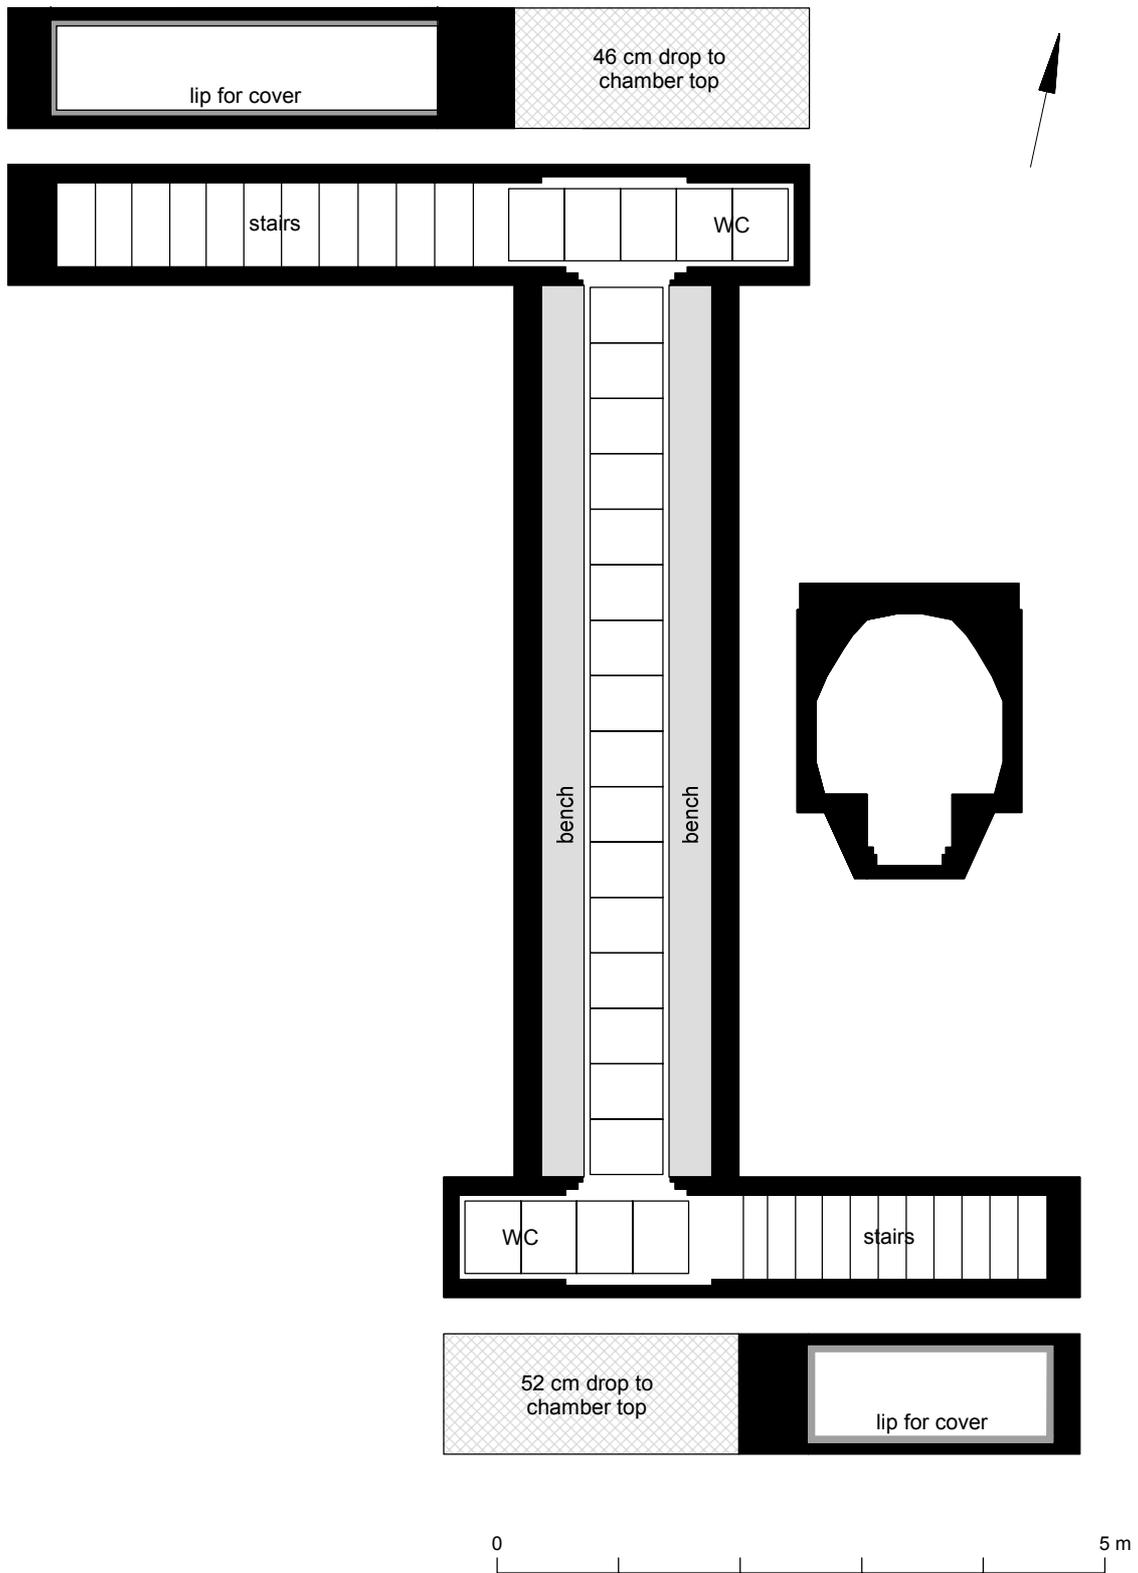
Fig 20 Area J1, air-raid shelter F11: internal plan and cross-section of chamber.

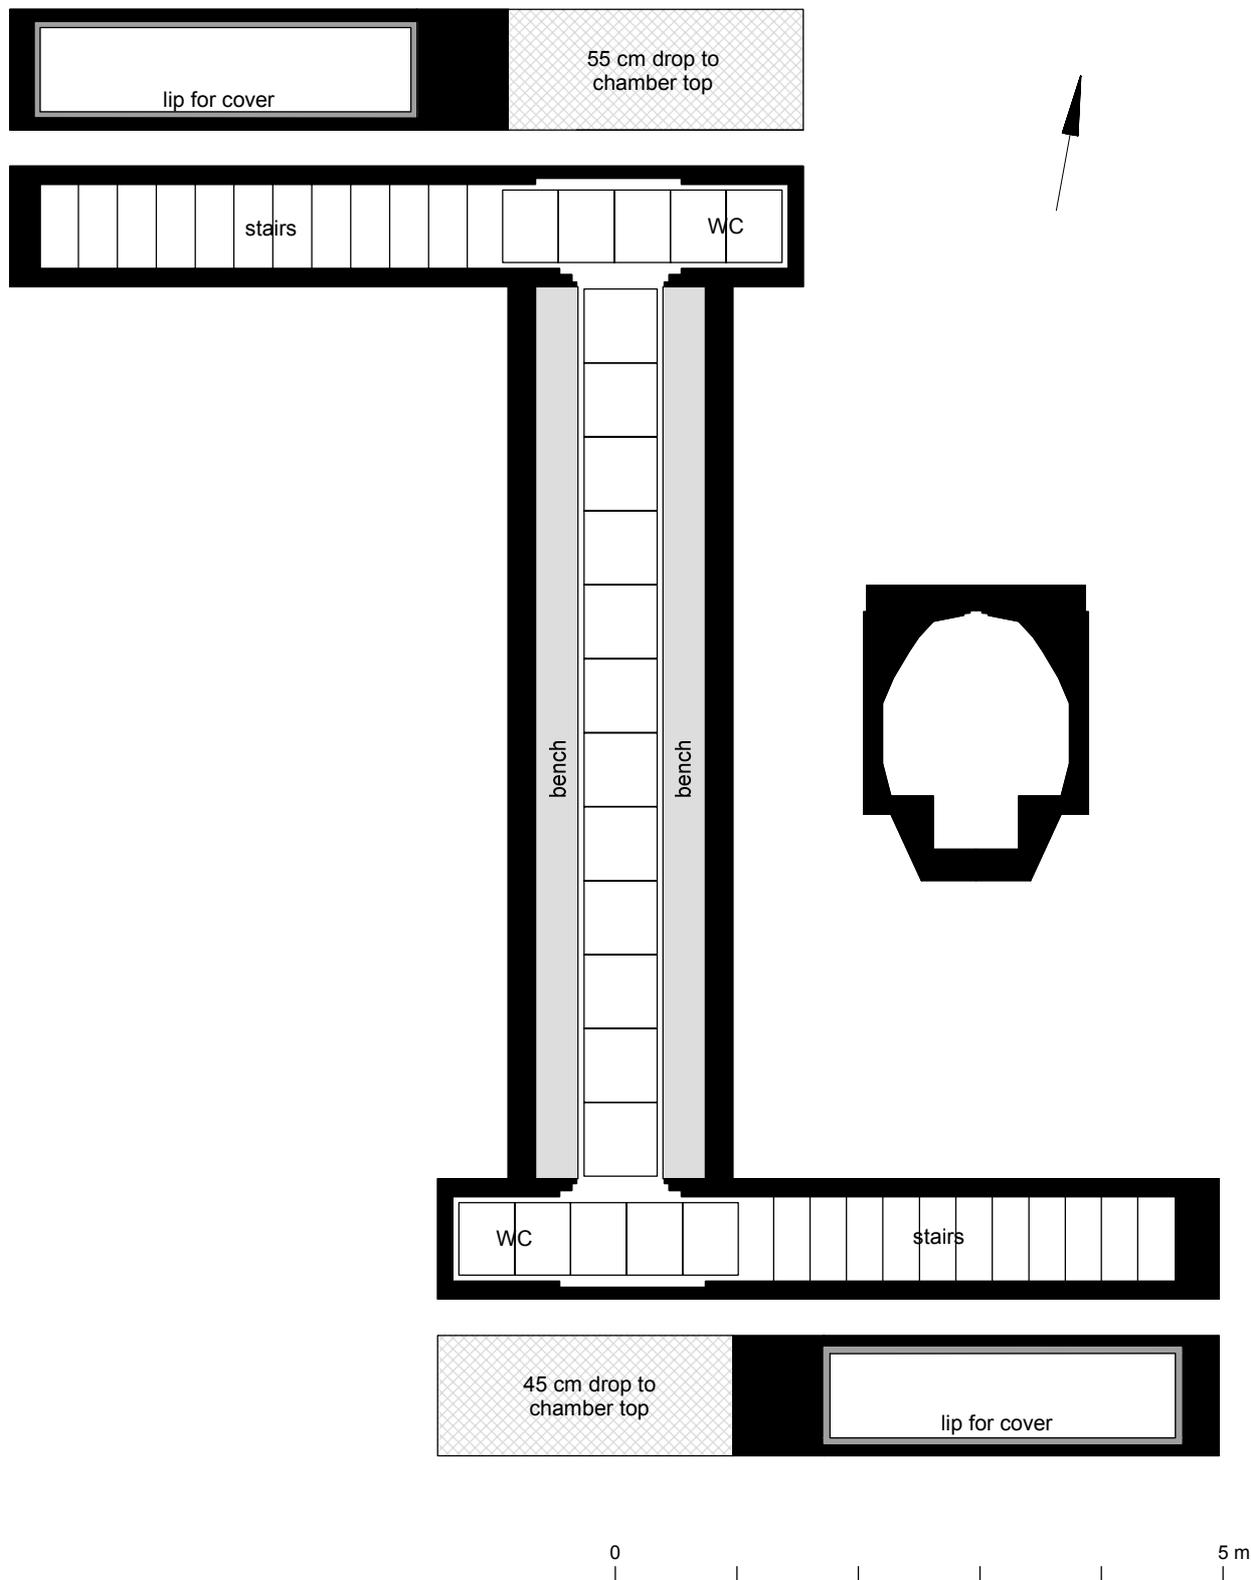
This structure was completely below ground with raised entrances that would have been level with the surface at the time of construction. Subsequent development raised ground-level, totally obscuring any trace of the structure. Once fully exposed, it was observed that the shelter was roughly aligned north to south. The north entrance was 55cm above the roof of the chamber and measured 6.55m long by 1m wide. The entrance was sealed by a cap of corrugated iron covered in concrete, which sat on a recessed lip within the entrance walls, 5cm deep on each side. This appeared to be part of the original construction and is an indication that the shelters had some form of door or hatch. The south entrance was 45cm above the roof of the chamber and measured 6.45m long by 1m wide. The concrete-covered corrugated iron cap sat on an identical-sized lip to that of the north entrance. Both entrances descended eleven steps to identical corridors that terminated in a recess (87cm deep). The width of this corridor was 70cm, indicating that the walls were 15cm thick. Directly above the recess was a centrally-positioned circular hole (10cm in diameter) in the roof. This is interpreted as either an air vent or an exhaust vent for waste gases. The floor was poured concrete with five 60cm by 46cm concrete slabs set into it. A white painted number (46) was observed on a facing panel of each entrance.

the entire structure. Evidence of shuttering is clear and the construction technique is nearly identical to that of the shelters on Area J1. Here the facets above the benches were identical until the highest central panel, where a 20cm-wide by 4cm-deep recess was inserted. However, this did not significantly alter the ovoid shape of the chamber when viewed in section. Sixteen 60cm by 46cm rectangular slabs extended down the centre of the chamber. Three more exhaust vents were located at equal intervals within the roof.

Both the recess and the internal doorways had the remains of iron hinges and the internal door had the remains of an iron latch, indicating that doors were at one time present. Iron hook latches were affixed to the external wall of the entrance approximately 1m off the floor.

Fig 21 Area P1, air-raid shelter F1: internal plan and cross-section of chamber.
