**An archaeological evaluation
and an historic building survey
at 'Imbirds', Souther Cross Road,
Good Easter, Chelmsford, Essex
May and July 2008**

**evaluation report prepared by
Ben Holloway and Howard Brooks;
historic building survey by Leigh Alston**

CAT Report 491
October 2008

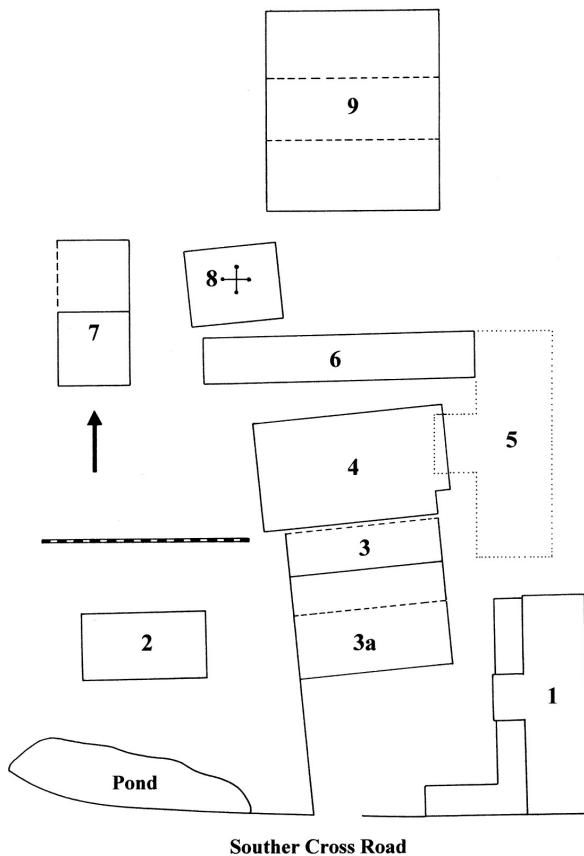
Fig 1 Block plan of farm buildings showing historic elements numbered as follows (25 m scale):

1. Barn. Late 18th- or early 19th-century, timber-framed, part rendered and part weatherboarded, with contemporary porch and later lean-to shelters to western façade. Some re-used timber, including a 12th- or 13th-century storey post with passing-brace trenches. An early 20th-century shelter shed adjoins the south-western corner.
2. Imbirds Cottages. Rendered cottages. Ostensibly 19th century. Not inspected but included for site context.

3. Open-sided shelter sheds. Mid 19th century, with axial brick partition and late 20th-century lean-to addition to south (3a). Originally cattle shelters but converted into pig sheds in 20th century.
 4. Pig shed. Late 20th-century block-work.
 5. Site of second timber-framed barn demolished c 1960s and probably the medieval or Tudor barn depicted on the Walker map of 1623.
 6. Pig shed. Mid 19th-century brick, built as a stable or cattle shed.
 7. Cart lodge. Mid 19th century, formerly open-sided to west but much altered in the 20th century and now used as garaging
 8. Pig shed. Mid 20th century, on or near the probable site of a medieval or Tudor house depicted on the Walker map of 1623 and labelled 'site of Imbers' on 19th-century Ordnance Surveys
 9. Complex of 20th-century pig or calf stalls.
- The site of the original house is marked by a cross.

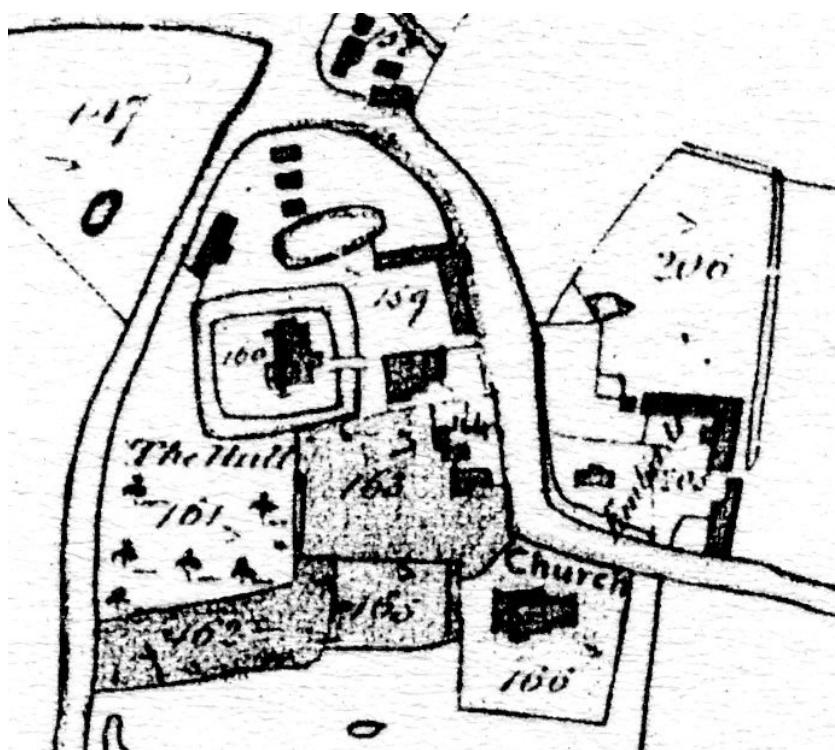
Fig 3 Good Easter as shown on the parish tithe map of 1839 (ERO/DCT 122), showing 'Embirds' to right. The moat at Falconer's Hall is clear, but there is no evidence of anything resembling a moat at Embirds. The present two cottages are shown (or a small house on the same~site) along with two barns and a probable stable range (nos 1, 5 & 6 in Fig 1).

The tithe map of 1839 (Fig 3) appears to show the barn but not the house depicted in 1623, suggesting that the former had been demolished and replaced by a new house on the site of the present pair of cottages (no 2 in Fig 1). A long, narrow building extends to the west from the northern end of the barn, and can probably be equated with the surviving brick range (6), and the surviving barn (1) adjoins the road to the south. The accompanying apportionment refers to the site (marked 205 in Fig 3) as 'Embirds House and Homestall' (ie farmyard), in the ownership of Sophia Jane Maria Beale Bonnell and in the tenancy of Elizabeth Rust. The land to the north (206) is described as an orchard, which probably explains the width of the

ditch which divides it from 'Saffron Field' to the east; additional protection was often necessary to exclude animals and children from orchard sites. The same ownership and occupation is given for Falconer's Hall, suggesting that both Embirds and Falconers operated together as a single and exceptionally large farm of approximately 500 acres. Elizabeth Rust presumably resided at Falconer's Hall, the larger of the two houses, although the moated site (160 in Fig 3) is described as 'Falconer Gate House and garden', suggesting that only the front gatehouse range survived from the courtyard house of 1623. The yard to the east is described as 'farm yard and buildings', but the grade I-listed roadside barn which now contains an early medieval timber frame seems not to be shown. It is possible that the medieval structure may have been moved to its present site after 1839, perhaps from within the moat when the house there was rebuilt in the mid 19th century and the moat filled.

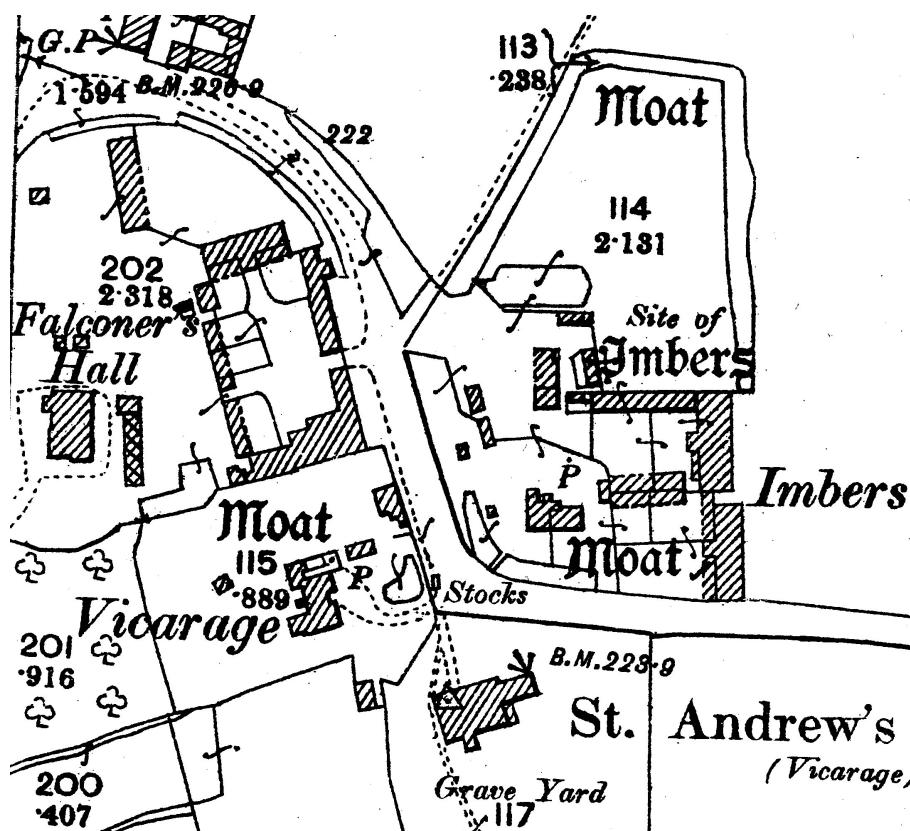
Fig 4 The Second Edition 25-inch Ordnance Survey of 1896, indicating the presumed site of the medieval house with a cross. Open-sided structures are indicated by broken lines.

The Second Edition Ordnance Survey of 1896 (Fig 4) shows a similar layout to that of 1839, and marks the presumed site of the medieval house at 'Imbers' with a cross. This site accords with the map of 1623 but it is unclear what other information may have been available, either physical or reputed, to pin-point it. Ancient sites are not always marked accurately on the Ordnance Surveys. An almost identical layout is shown on the First Edition of 1875 (consulted online but not available in the Essex Record Office). The pond to the south-west and the linear ditch to the north-east are both marked as moats, perhaps (given the lack of any moat-like features on earlier maps) because of the site's well-known history, which might have created the expectation of a moat, than because of any physical evidence. The open-sided shelter shed (3) had appeared since 1839, as had the cart lodge opposite the

western entrance (7), but the shelter shed against the road to the south is not shown. All but the south-eastern corner of the moat at Falconer's Hall had been filled since 1839, the house rebuilt, and the eastern range of outbuildings against the road had taken on their present outline. By 1920 (Fig 6) a new shed had been built on the position of the Imbers cross on Figures 4-5 (probably the surviving shed marked 8 in Fig 1) and the southern shelter shed had also appeared. The various enclosed yards were almost certainly designed for cattle.

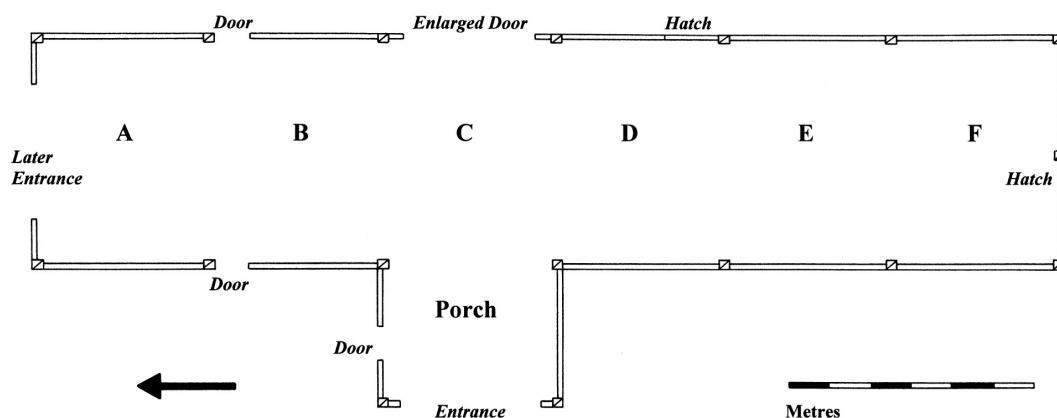
Fig 7 The barn (1). Ground-plan indicating individual bays alphabetically for ease of reference in the text.

The barn at Imbirds Yard is a timber-framed and thatched structure of six equal bays which extends to 25 m in length and 19 m in overall width (82 feet by 19). Each bay is approximately 4 m (13 feet) in length, and the walls rise 4 m from the present ground-level to the roof-plates. The barn is aligned on a north-south axis, with its southern gable adjoining Souther Cross Road, and an original gabled porch projects by 3.4 m (11 feet) to the west from the third bay from its northern gable. The walls contain primary braces which interrupt the common studs and are pegged and tenoned to the mid-rail and storey posts. The original ground sills are either lacking or hidden within shuttered concrete. The storey posts are linked by pegged and tenoned arch-braces to the horizontal tie-beams, except at the two trusses which flank the midstrey where bolted knee-braces were used instead. The roof-plates contain face-halved-and-bladed scarf joints and the rafters rest on clasped-purlins with nailed collars. At approximately 50 degrees, the roof pitch is surprisingly shallow for thatch, and may have been designed for tile. The scantling and species of timber is variable, with many of the larger individual components showing signs of re-use, particularly in the northern half of the barn.

Several storey posts contain empty arch-brace mortises near their feet, suggesting that they were inverted in the 17th-century or earlier structure from which they were salvaged. The post in the western wall between bays A and B, as marked in Figure 7, contains more than one series of redundant mortises and has been re-used on more than one occasion; it is the only example in the barn to contain a passing-brace trench and was first cut in the 12th or 13th century as the arcade post of an aisled building (it is now upside-down, with arcade-brace and tie-beam brace mortises angled towards the ground). Similar passing-brace trenches are found in the nearby grade I-listed roadside barn at Falconer's Hall, but this example lacks carved decoration. The gables and eastern elevation are now clad in 20th-century mortar, overlying earlier weatherboarding, but the western elevation retains its original external cladding of clay-daubed laths above the mid-rail with tarred weatherboarding beneath. Layers of whitewash have been preserved on the roughcast render by the western lean-to sheds. The timber framing is consistent with

a date in the late 18th century or early 19th century, and reflects the transition of that period between arch-braces and bolted knees; it is typical of the many East Anglian barns built in response to the high price of grain during the Napoleonic Wars. The building is relatively intact, and remains a good example of its kind, but has undergone some alteration and is not of sufficient age or rarity to merit listing in its own right.

The barn was entered by its western porch, but as usual was designed with only a small doorway in its opposite, eastern elevation to create sufficient through-draught for threshing and winnowing. The mid-rail of the eastern bay was later removed to create a cart thoroughfare with a full-height door, but this was filled with concrete blocks in the 20th century. The northern elevation of the porch preserves an original side door to allow access without opening the main barn doors in the porch. A pair of small opposing doors was inserted into bay B during the 19th century to create a thoroughfare, both features interrupting earlier wall braces. A number of loading hatches above the mid-rails also appear to be secondary insertions, although the example in the western elevation of bay A was blocked by a mid 19th-century lean-to and may be original. Precise analysis in this respect is hampered by the re-use of material. The southern bays of the barn (D-F) were rendered and whitewashed internally to the height of a missing ceiling just beneath the roof-plates in the 20th century and were probably used as an animal-feed store. The ground sills and plinths of the same bays have also been renewed to a higher level. Open-sided lean-to shelter sheds extend along the western elevation of the barn, flanking the porch. These are shown on the Ordnance Survey of 1896 without the southern extension of the early 20th century which now returns alongside the road (added before the Ordnance Survey of 1920). A 19th-century wagon and tumbrel were parked here at the time of inspection, but these sheds were probably designed as cattle shelters. Like most local farms, Imbirds appears to have been converted from arable to mixed animal husbandry in the mid 19th century (responding to the collapse in grain prices after the Repeal of the Corn Laws in 1846), and various yard divisions are shown on the Ordnance Surveys. The northern lean-to extended to the demolished second barn (5), but does not appear on the tithe map of 1839 and obstructs an earlier loading hatch in the western elevation. With the exception of the changes outlined above, and the insertion of a wide entrance in the northern gable, the barn's structure is chiefly intact, with all but one tie-beam brace *in situ*.

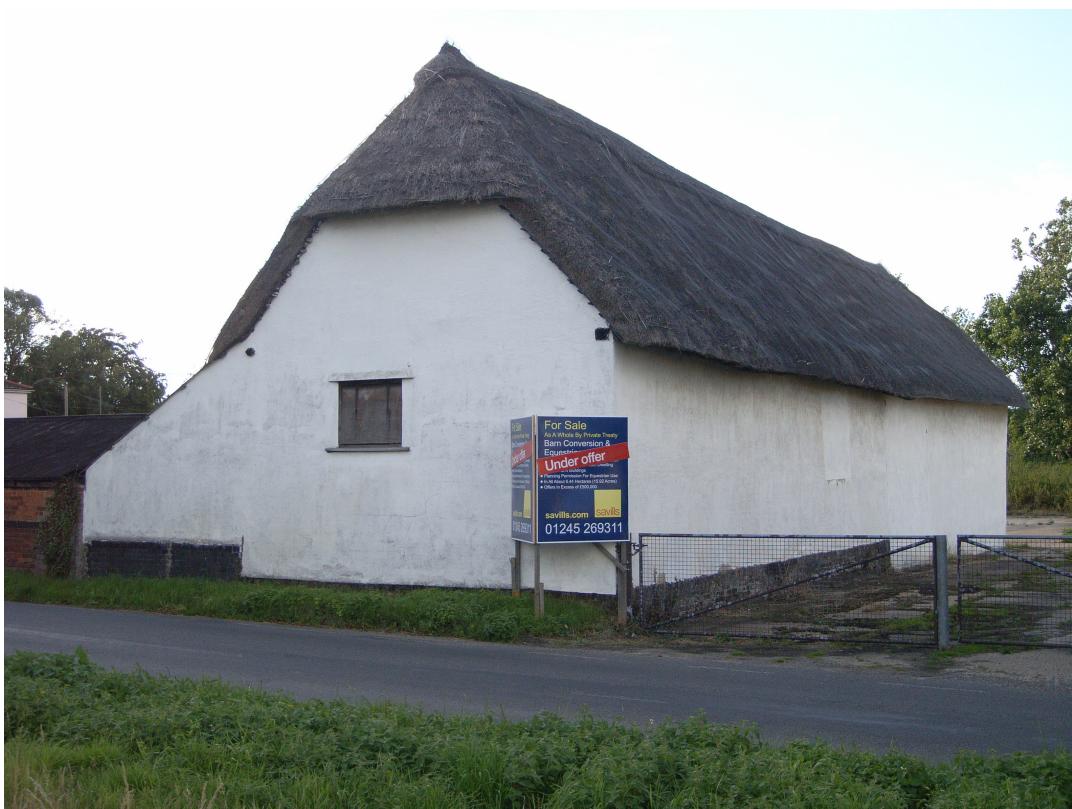
A2.4 Barn (1). Exterior from south-east, showing hatch in southern gable.

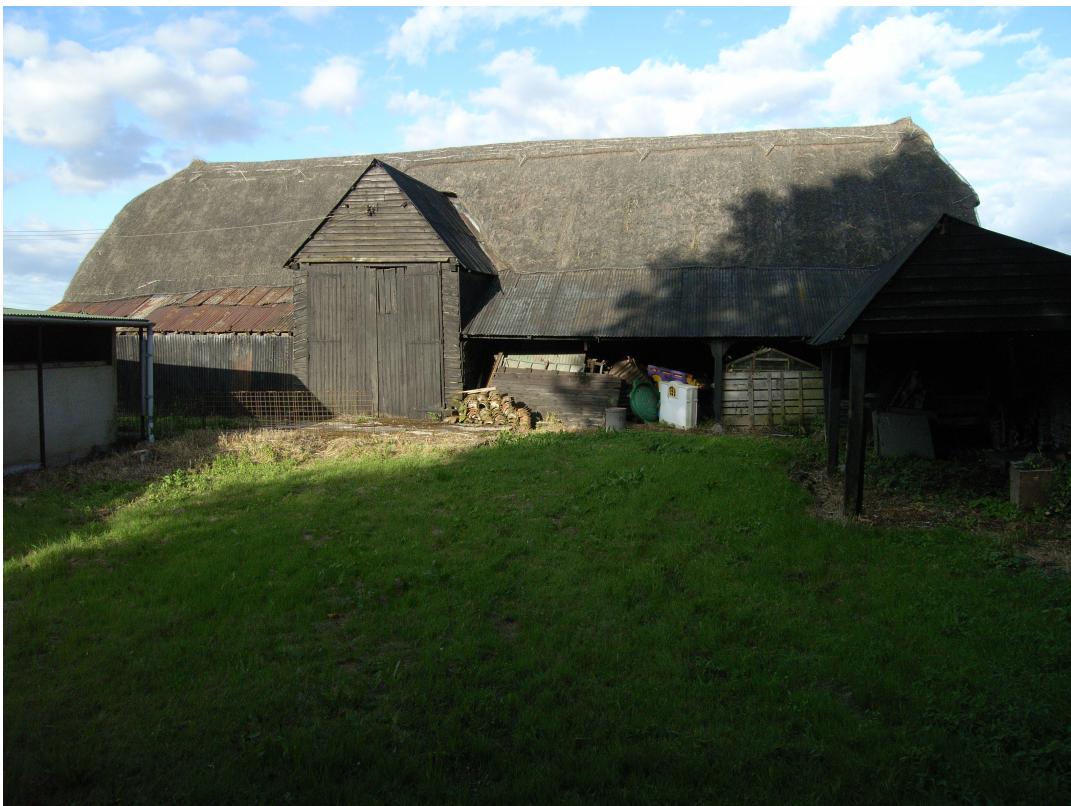
A2.5 Western external elevation of barn (1), showing yard in foreground with shelter shed to right and lean-to sheds flanking porch.

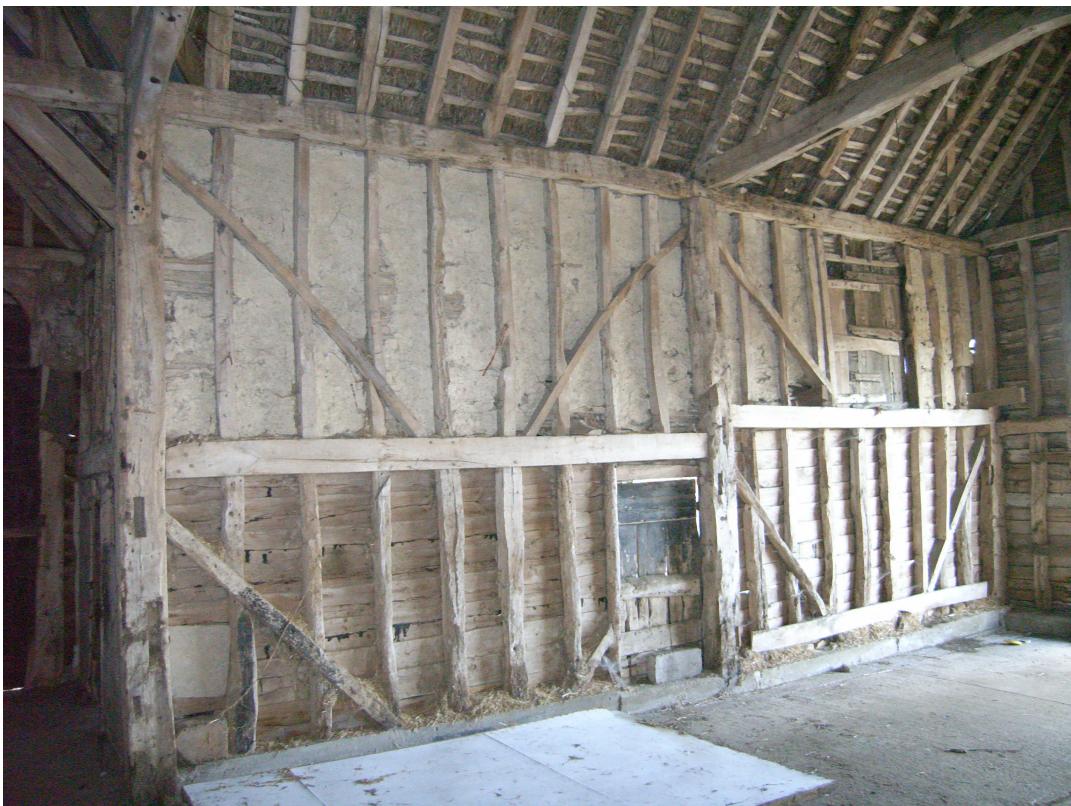
A2.7 Barn (1). Interior of bays B and A (left to right) from south-east, showing door and blocked hatch with re-used central storey post.

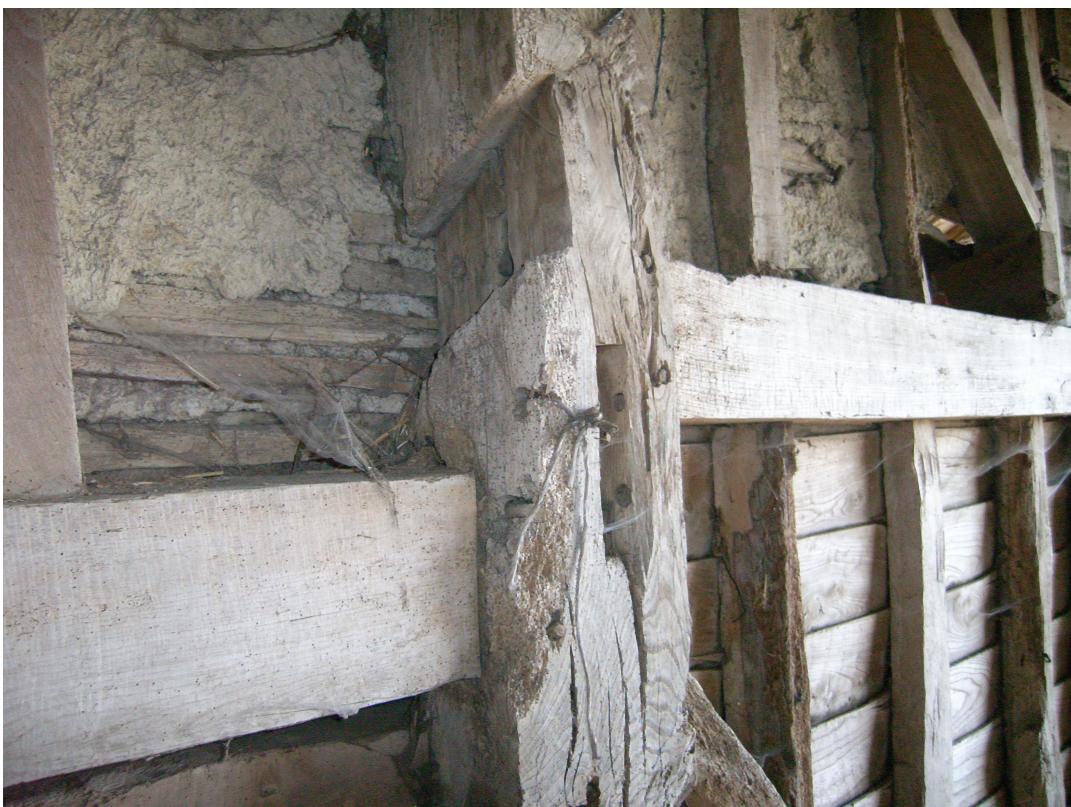
A2.8 Detail of passing brace trench in re-used storey post between bays B and A (left to right).

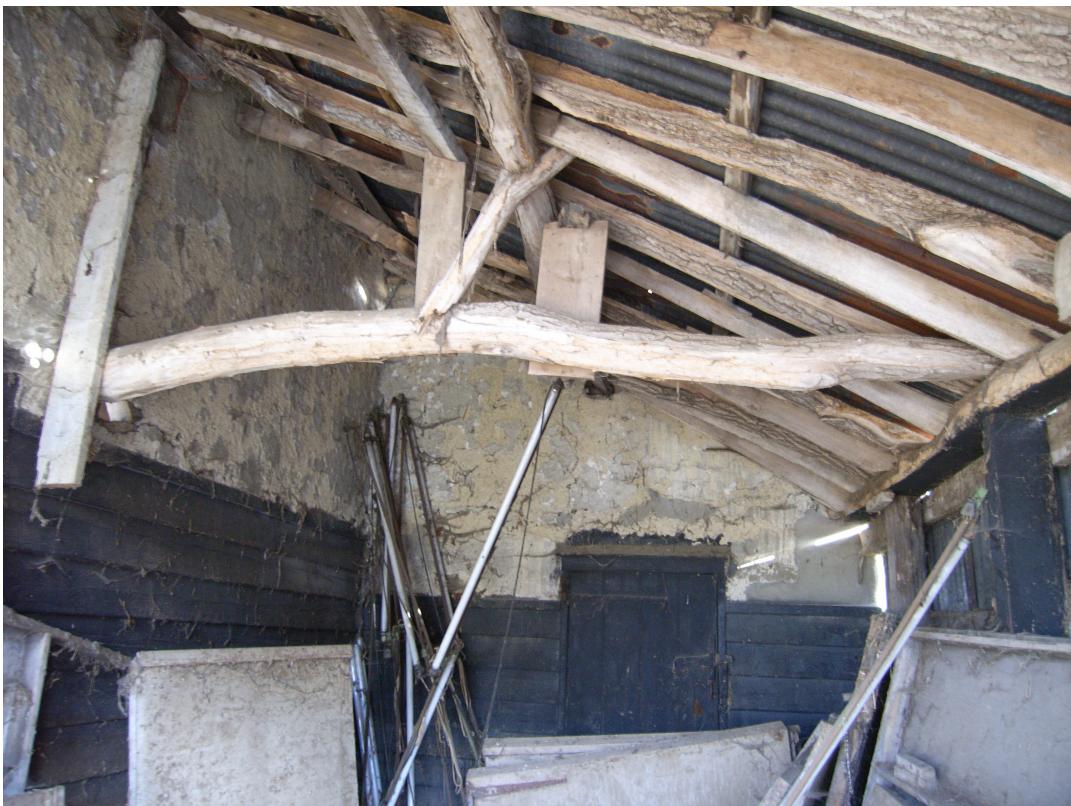
A2.9 Barn (1). Interior of northern lean-to from north, showing side-door of porch and original external cladding of roughcast daub above weatherboarding.

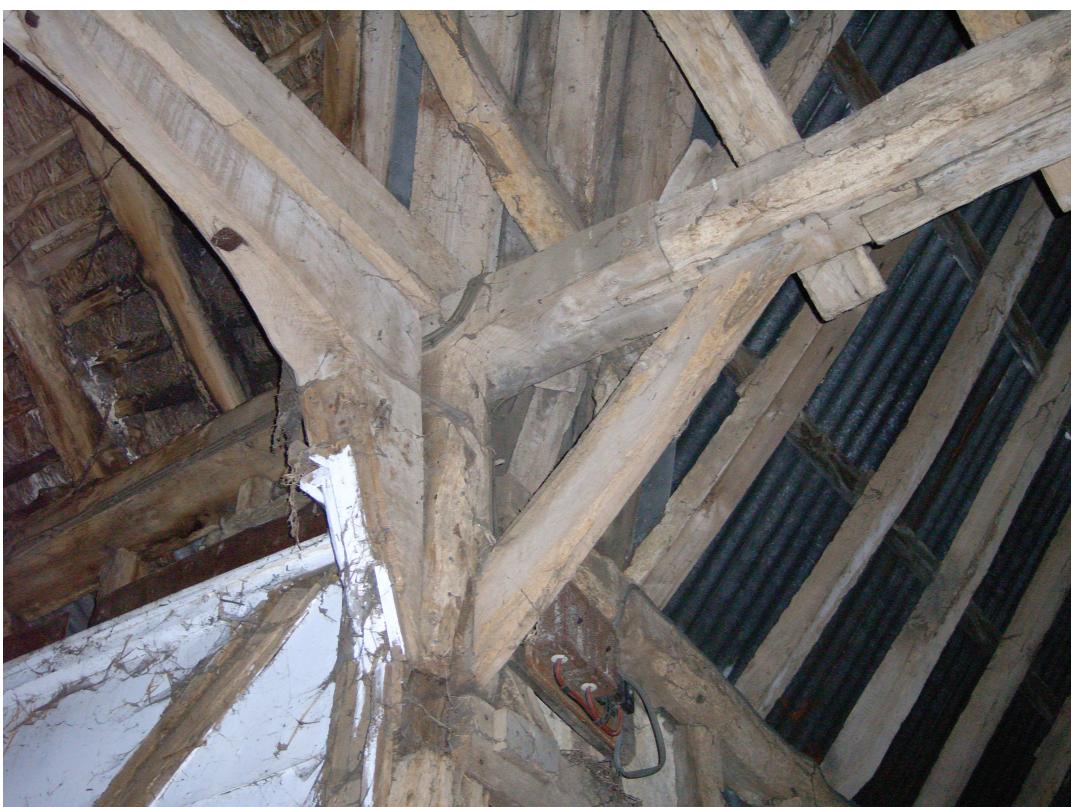
A2.10 Barn (1). Detail of face-halved-and-bladed (right) scarf joint in roof-plate above porch.
