Summary sheet

CAT Report 516
An archaeological watching brief
at the nursery and ranger station,
Upper Castle Park, Colchester, Essex

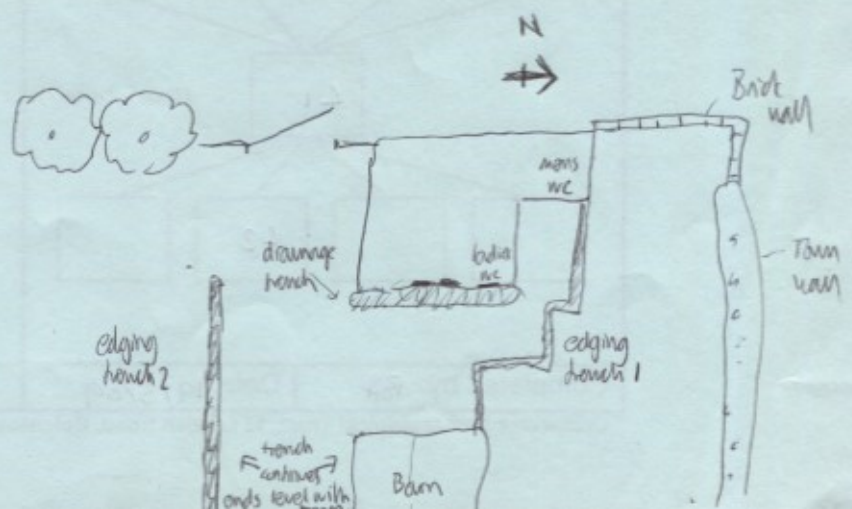
(for plan see back of L2)

Excavation of trench nearest to building for drainage was undertaken using a mechanical excavator down to a maximum depth of 450mm. Only modern layers were disturbed and modern material was observed throughout.

For the construction of the wooden edging the tarmac (L1) was broken out along the desired line using a kango hammer ^(in one place). The trench for the wooden edging was then hand excavated to a depth of around 200mm (max!) (including the 100mm of compacted tarmac L1) and wooden board 100mm thick was then laid on its side in the trench to form the edging (around 30mm of the board is left protruding the surface - testament to how shallow the trench excavated was!). Only modern material was observed in the edging trench.

A similar technique was employed for edging trench 2.

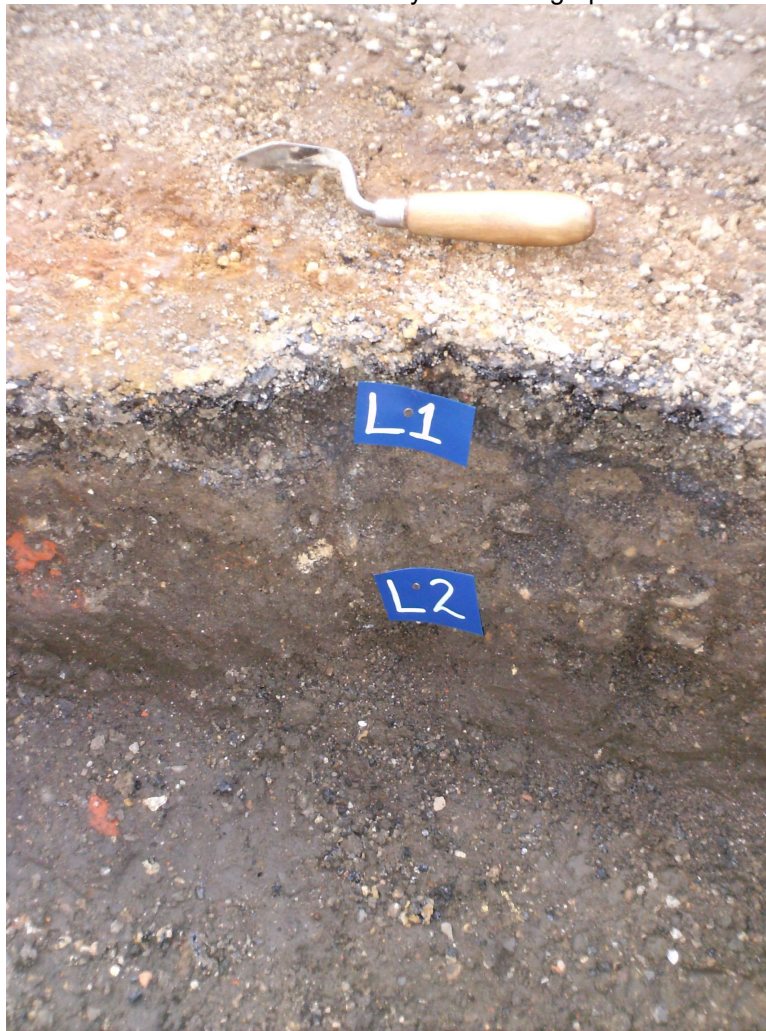
01

Filename	Description
09.05c_PhotoGraph_01.jpg	Trench shot section view east
09.05c_PhotoGraph_02.jpg	Working shot, facing south
09.05c_PhotoGraph_03.jpg	General site shot, facing south-east

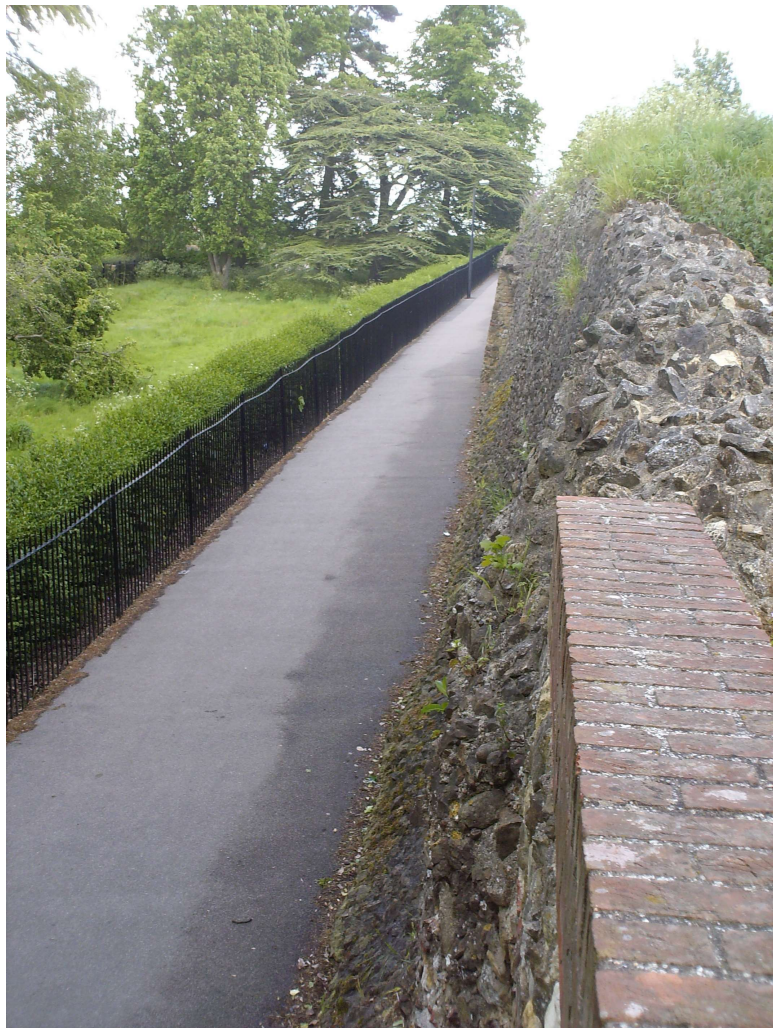
04

09.05c_PhotoGraph_04.jpg	Roman wall line, facing east
09.05c_PhotoGraph_05.jpg	Cleared area, facing south
09.05c_PhotoGraph_06.jpg	Drainage trench view north

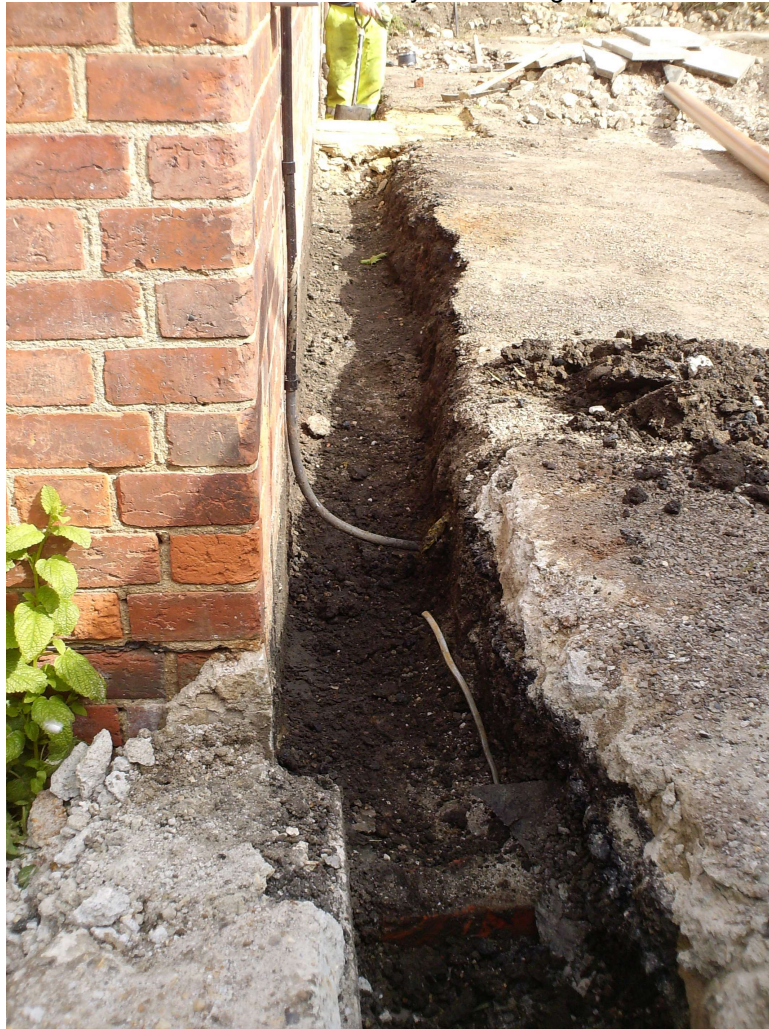
07

09.05c_PhotoGraph_07.jpg	Drainage trench, facing north
09.05c_PhotoGraph_08.jpg	End of drainage trench (L1/L2) facing north
09.05c_PhotoGraph_09.jpg	Working shot, facing north-east

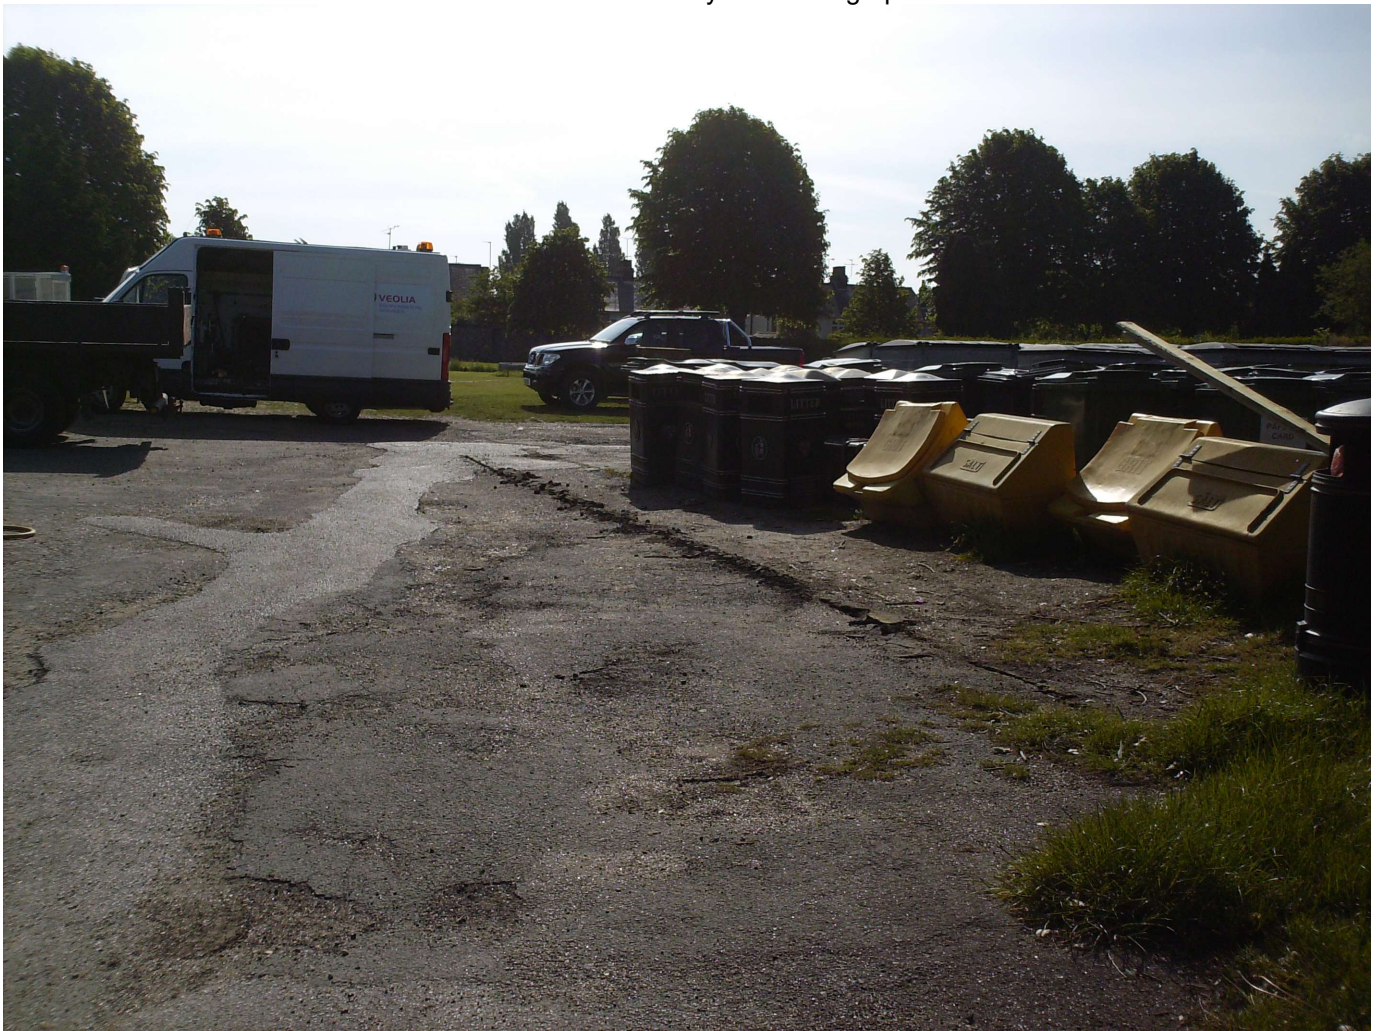
11

09.05c_PhotoGraph_10.jpg	Edging (tarmac in flight) facing north
09.05c_PhotoGraph_11.jpg	Line of new road edging view south-east
09.05c_PhotoGraph_12.jpg	Detail of edging, facing north

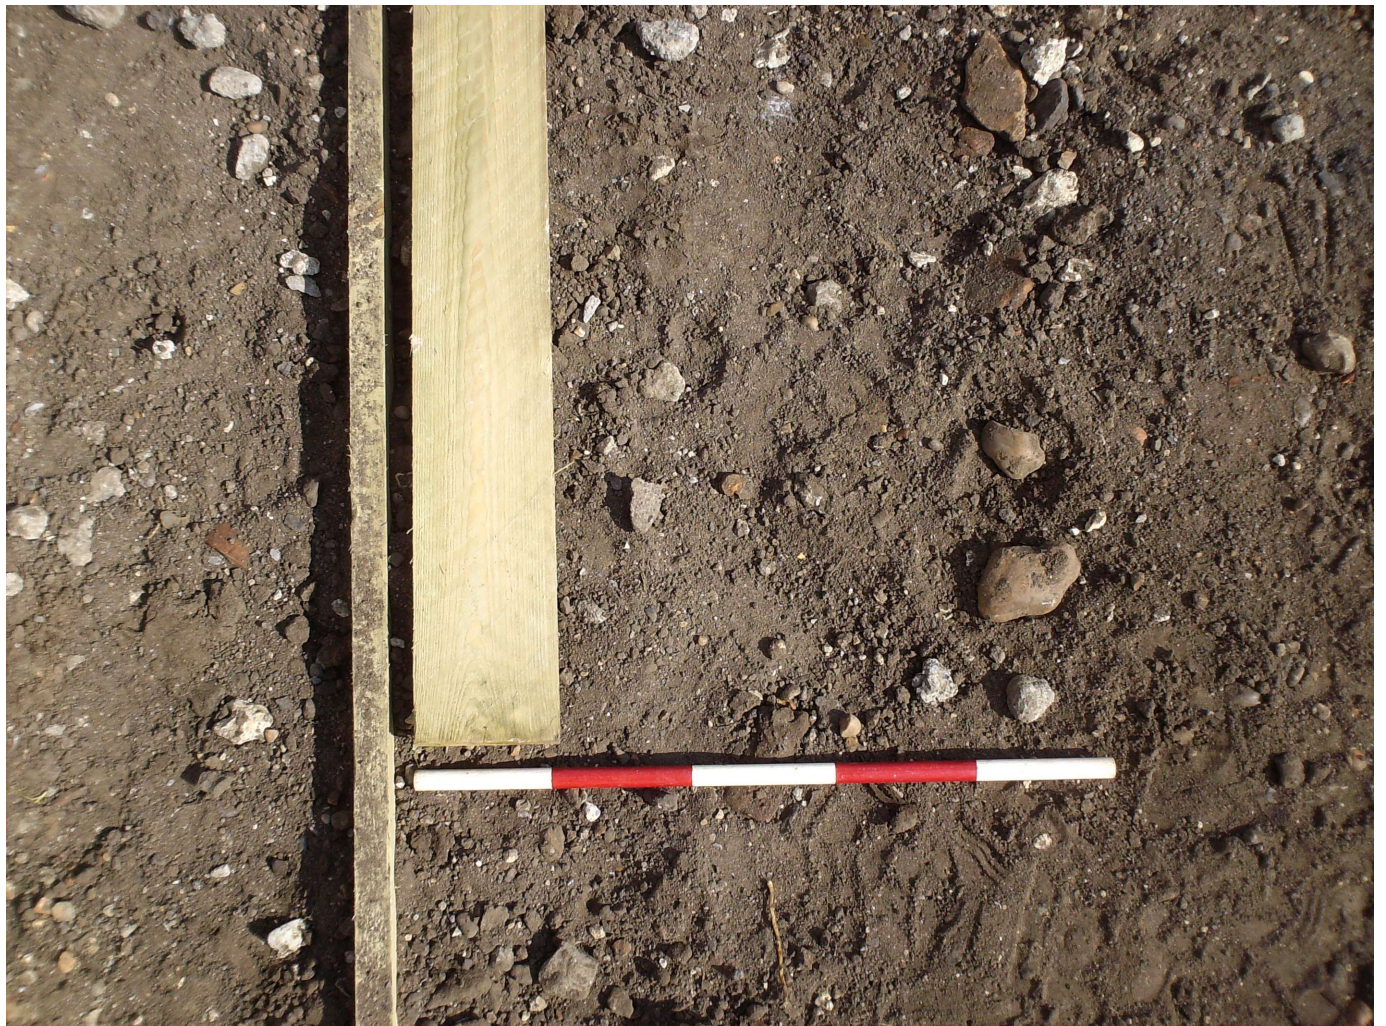
18

09.05c_PhotoGraph_16.jpg	Site shot, facing north-west
09.05c_PhotoGraph_17.jpg	Removal of tarmac for 2 nd edging stretch, facing west
09.05c_PhotoGraph_18.jpg	Edging boards total depth overhead view

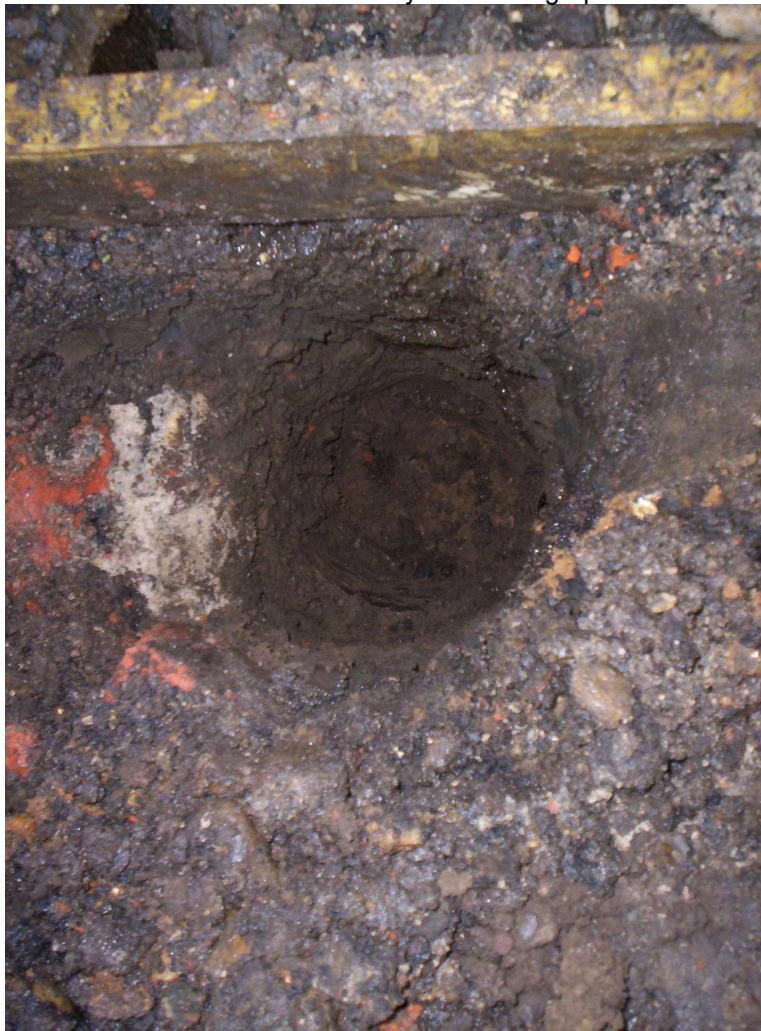
19

09.05c_PhotoGraph_19.jpg	Posthole 1 fully excavated view south
09.05c_PhotoGraph_20.jpg	Posthole 1 fully excavated view south
09.05c_PhotoGraph_21.jpg	Posthole 1 fully excavated view south

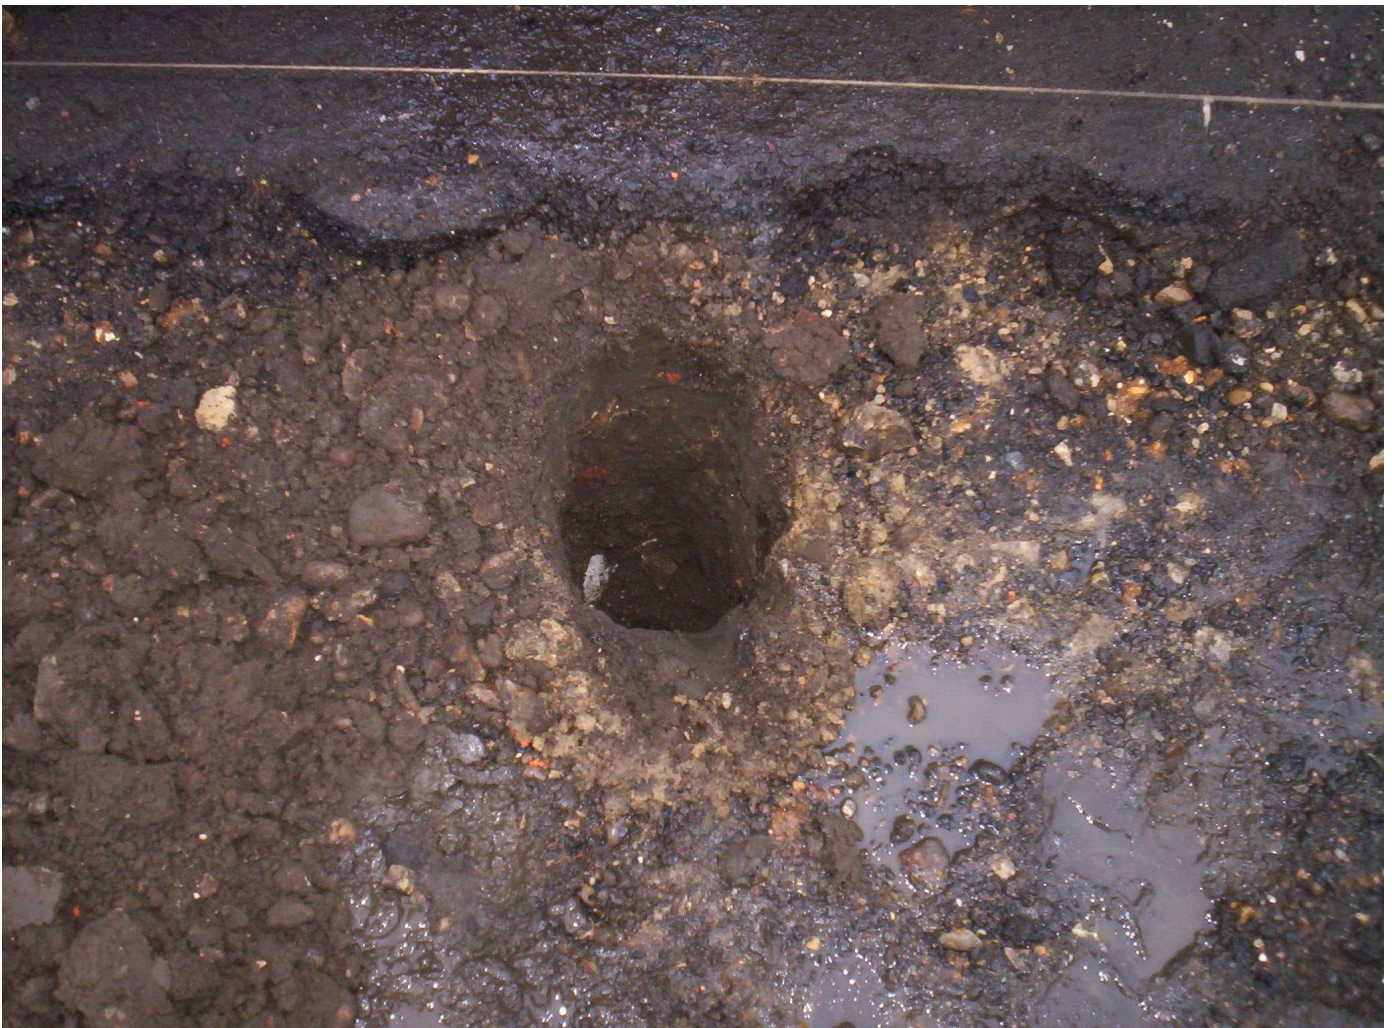
22

09.05c_PhotoGraph_22.jpg	Posthole 3 fully excavated view south
09.05c_PhotoGraph_23.jpg	General shot fenceline view west
09.05c_PhotoGraph_24.jpg	General shot fenceline view west
