**A building recording survey of the former  
Garrison Riding School,  
Le Cateau Barracks, Cavalry Road,  
Colchester, Essex  
February 2011**

**CAT Report 585**

This report provides a written and photographic record of the former Garrison Riding School to the north of Cavalry Road, Le Cateau Barracks, Colchester, Essex (EHER 46846). It is intended to fulfil a condition of planning permission for conversion and restoration submitted to Colchester Borough Council. The written report is accompanied by a CD containing a full photographic record of digital images (Appendix 1). The building was surveyed during February 2011 when the accompanying photographs were taken.

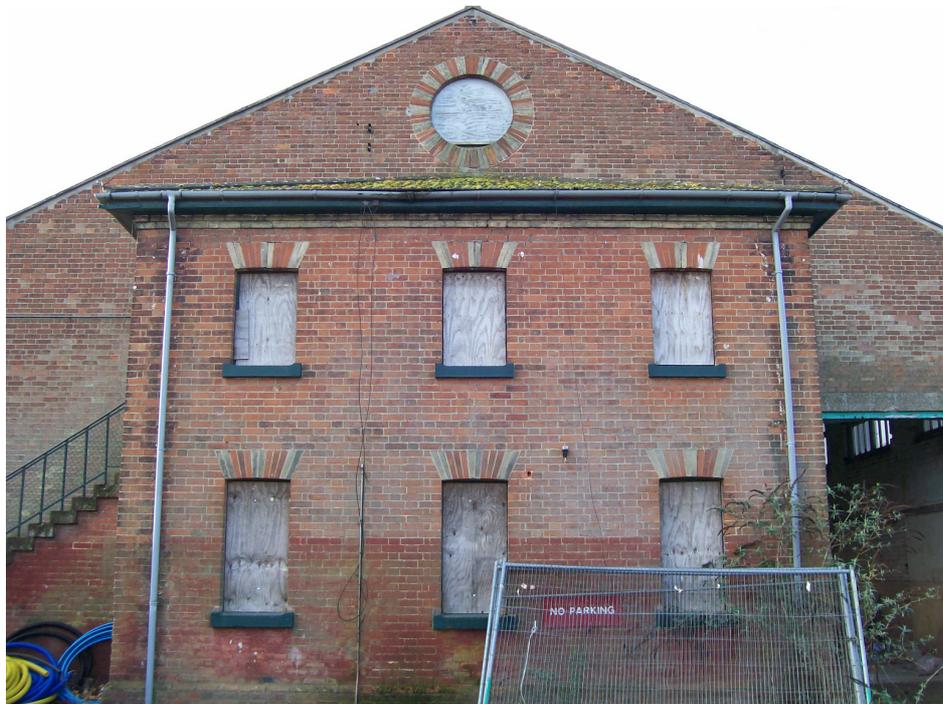
Plate 1. North-east end, three window range annexe with oculus above.

The former Garrison Riding School is constructed of red brick laid in Flemish bond with alternating red and yellow voussoir brick dressing above the doors and windows. It is a single storey rectangular construction (47.2m by 16.65m) except for a projection at the north-east end which, despite being lower in height than the main structure, is a two storey three-window range annexe (3.4m by 7.45m). This has an artificial slate covered hipped roof, six windows obscured by plywood (internal inspection shows these to be plate glass sash windows each with three lights – the upper sash being divided by a glazing bar) with sandstone sills, and two wooden doors on the ground level, one on either side of the window range. The doors and window frames are painted a dark green. Above the apex of the hipped roof is an oculus with alternating pairs of yellow and red brick voussoirs. Plywood covers the opening of this oculus but beneath is a louvred panel. At the east corner there is an external stairway of seventeen sandstone steps with winders leading to a doorway accessing the upper level of the annexe. This stairway has an iron railing with wire mesh welded to the banisters painted in the same green as the doors and windows. To the right of the annexe is a large wooden double door painted in a shade of turquoise. This opens outwards and has a concrete lintel. Above the lintel replacement brickwork can be distinguished. The area around the annexe and the double door are block paved in a herringbone pattern.

The alteration to the centrally located doorway opening into the ground floor of the annexe could indicate that an open archway rather than a door was originally present. The current doorway is narrower than the arch above it and the original opening (whether doorway or open arch) would have been aesthetically pleasing in relation to the three open archways above it.

That the annexe itself is contemporary to the main body of the Riding School is attested to by the presence of the voussoir bricks around the doors and windows and the Ordnance Survey 1st edition map. The upper storey of the annexe with its three large archways looking out over the Riding School floor is clearly what was specified in the 1862 plan from the Inspector General's office. The length of Riding School and annexe combined also fits the requirement that a riding school be three times as long as it is broad.

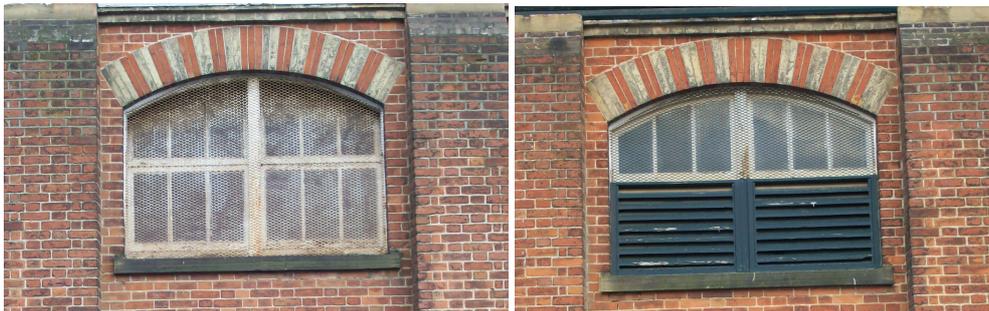
*Plates 2 and 3. South-east wall – differences between windows.*

The south-east facing wall has fourteen bays with fifteen full-height buttresses. Each bay has an identically sized upper segmental-arched window surmounted by a shallow arch of alternating pairs of yellow and red brick voussoirs. The window frame is of white painted wood with a wooden mullion and transom quartering the window. Each quarter is further divided by two vertical glazing bars into three lights. The upper window lights are inward-opening hopper lights. All of the windows are covered by a horizontal diamond-patterned iron mesh painted white. Six of the windows on this side (those closest to the north-east end) have only the upper sets of lights and these are fixed, unable to be opened. Below the transom are instead two green painted louvre panels. The lights above are covered in the same iron mesh as the other windows; only here it is painted the same green as the wooden louvres below. All of the windows have a sandstone sill.

The presence of the six half-louvred windows in the south-east wall is curious. These may represent a subsequent phase and it should be noted that the upper lights of these windows do not open, unlike every other window.

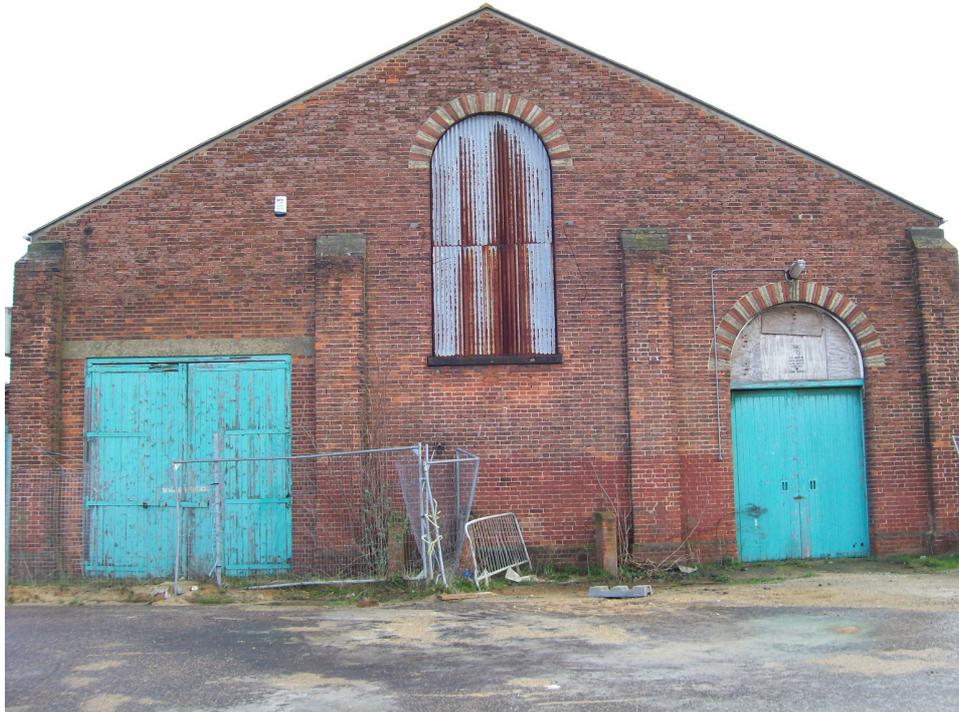
*Plate 4. South-west end.*

The south-west end of the Riding School has three bays with four buttresses. The outer bays each have a large wooden double door painted in the same shade of turquoise as the door in the north-east end. The one nearest the south corner opens inwards. Above the transom is a Roman arch surrounded by alternating pairs of yellow and red brick voussoirs. The interior of this arch is obscured by modern plywood. The external brick edges of the doorway are of rounded brick rather than square-cut. The door near the west corner is both taller and wider. It is painted in the same shade of turquoise as the other and is surmounted by a concrete lintel. This set of doors opens outwards. Above the lintel replacement brickwork can be observed to form a rough arched shape. The height of this replacement brickwork is equivalent to the apex of the voussoirs over the other door. Both doors have a trapezoidal-shaped fan of blue/black stable bricks in front of them. The central bay has a tall Roman arched window with the same voussoir pattern as the smaller door. The interior of this window is blocked sheets of corrugated iron – no trace of any window frame of any period remains. At the foot of this bay are three irregularly spaced brick projections perpendicular to the wall itself. Near to the apex of the roof line an iron hoop on a long shank projects from the brickwork.

The iron mounts found on both corners of the north-east end and on one of the buttresses on the south-west side are difficult to interpret. It is likely that they were flag mounts and are probably original. However, none of the other buttresses show

indications of such fixtures ever being present and the lack of symmetry could suggest a later date. There is no indication as to what purpose the iron hoop at the apex of the south-west end served. The iron rings fixed to the interior of the Riding School are probably original.

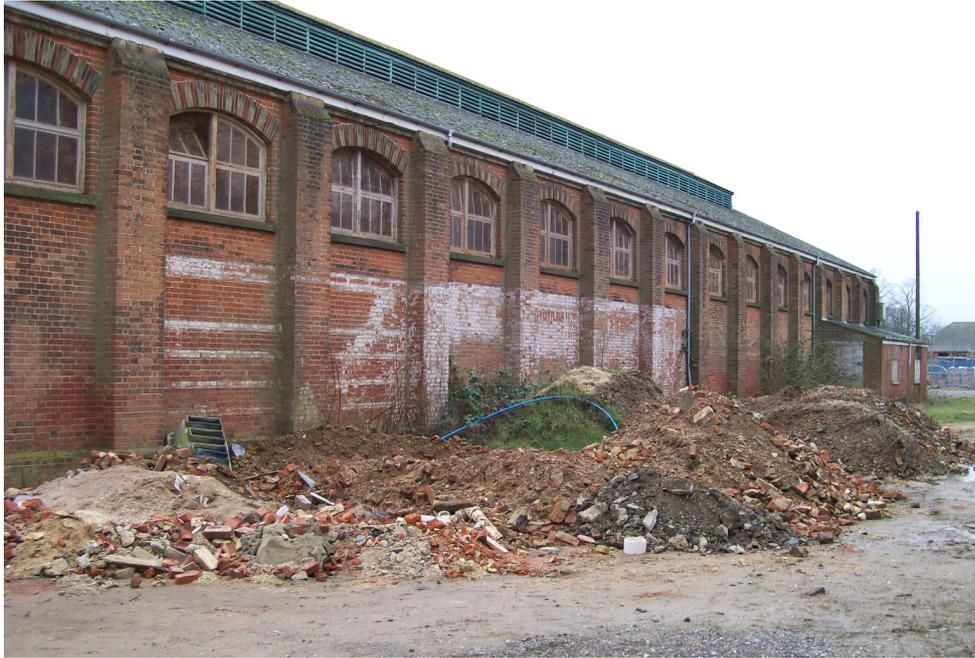
*Plate 5. North-west wall showing additional structure.*

The north-west wall is identical to the south-east in number of buttresses and windows. There are no half-louvred windows on this side, although the second window from the west corner has been infilled with wooden boards as have the upper lights from the window closest to the west corner. Two iron mounts (one at the corner of the north-west and north-east walls; the other on the fifth buttress from the west corner) are present at the same height as that of the one on the east corner. The third to sixth bays from the north corner show traces of either white paint or whitewash. A single storey brick structure adjoins the north-west wall straddling the three bays closest to the west corner. There is visible keying in of this structure's brickwork to that of the buttress of the main building. The structure has a low-pitched slate roof and outward opening wooden double doors to the north-east. The doors are covered in plywood but it is possible to make out the same turquoise paint as covers the doors in the south-west end. A probable second doorway is in the south-west end although this has been in-filled with horizontal wooden planks, again painted turquoise. Both doorways have a concrete lintel. Two rectangular windows covered with plywood are present in the north-west wall, each have a concrete lintel and a wooden sill. Replacement brickwork is distinguishable to the sides of these windows.

The structure adjoining the south-west corner and the one to the north-east of this (suggested by both map evidence and the presence of paint on the external wall) are clearly additions to the original building. Neither had a connecting door to the Riding School and it is likely they served a function as storage buildings. The structure to the north-east would appear to date from before 1921 with the one to the south-west being later. The south-west structure itself would appear to have undergone alterations at some point. The windows were replaced and the doorway at the south-west end in-filled with wooden planks.

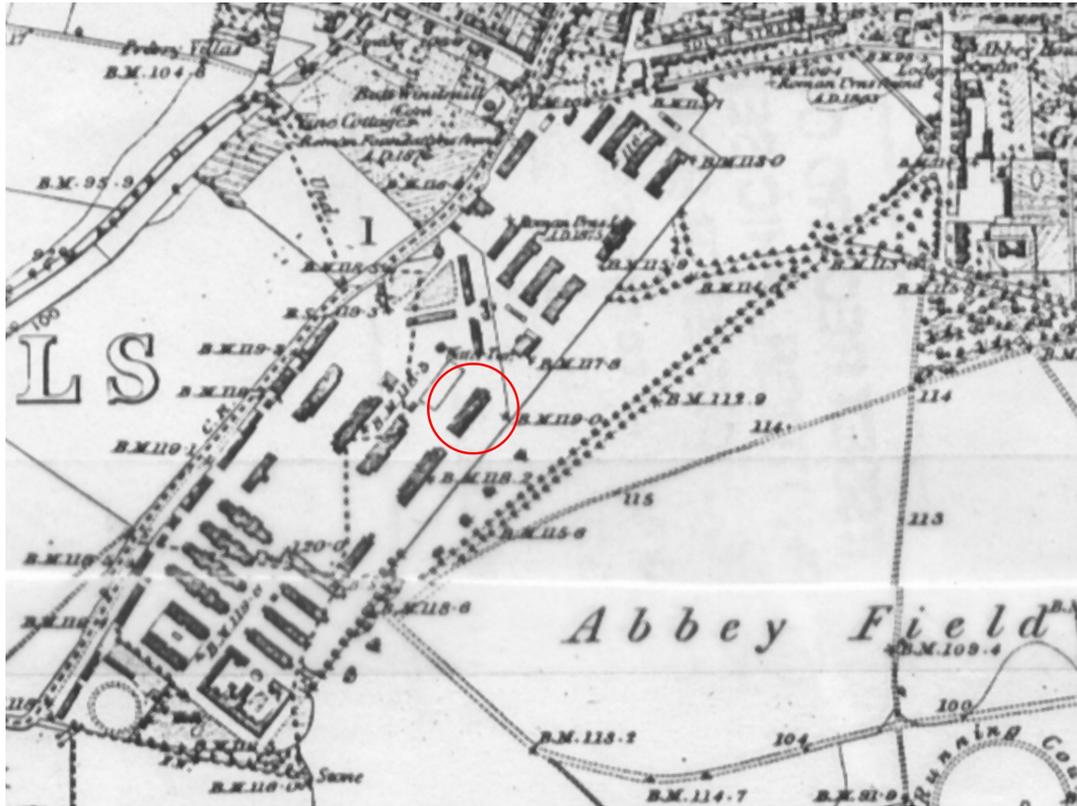
Fig 2 OS 1st edition 1887-1876, Riding School shown circled.

On the 1st and 2nd editions of the Ordnance Survey maps (Figs 2 and 3), the Riding School is depicted as an elongated rectangle with a smaller projection on its northeast end. It is shown as being on the north-east side of the Cavalry Barracks to which it belongs with the Royal Horse Artillery Barracks next to it to the north-east. (The latter was built c 1875 and subsequently renamed the Le Cateau Barracks after the Battle of Le Cateau which took place in 1914). The third edition Ordnance Survey map of 1921 (Figure 4) shows an extension adjoining the north-west facing wall of the Riding School. This extension is not the one present at the time of the

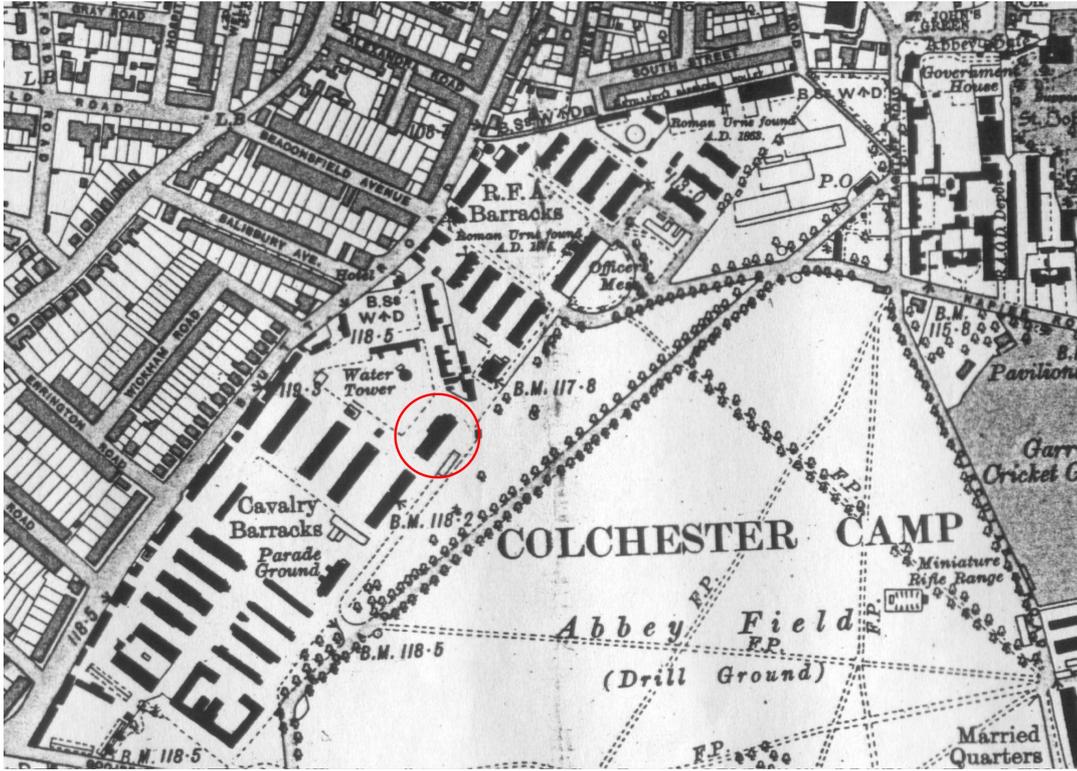
Fig 4 OS 3rd edition 1921, Riding School shown circled.

survey and it is not possible to say for certain from the map evidence when it was removed. Later 20th-century maps depict the Riding School as the first edition, a solid rectangle with an extension to the north-east, whilst modern mapping accurately shows the building as it stands today with an extension at the south-western end of the north-west facing wall. It is quite possible that these two additional structures were contemporary with each other and combined to form (from a mapping point of view) an enlarged version of the original building, until the removal of the north-eastern structure restored clarity to the mapping.

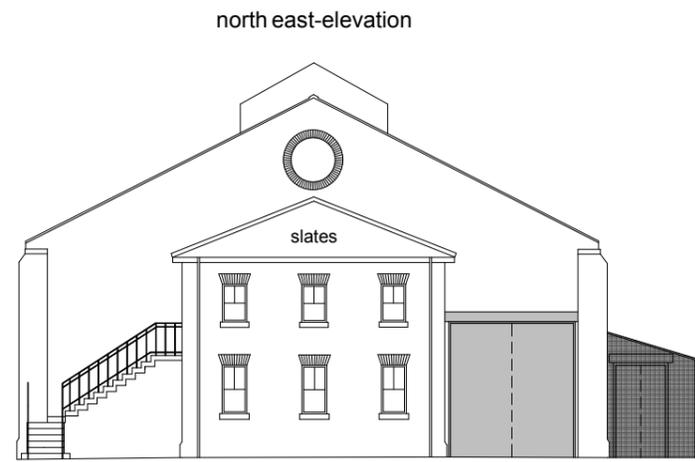
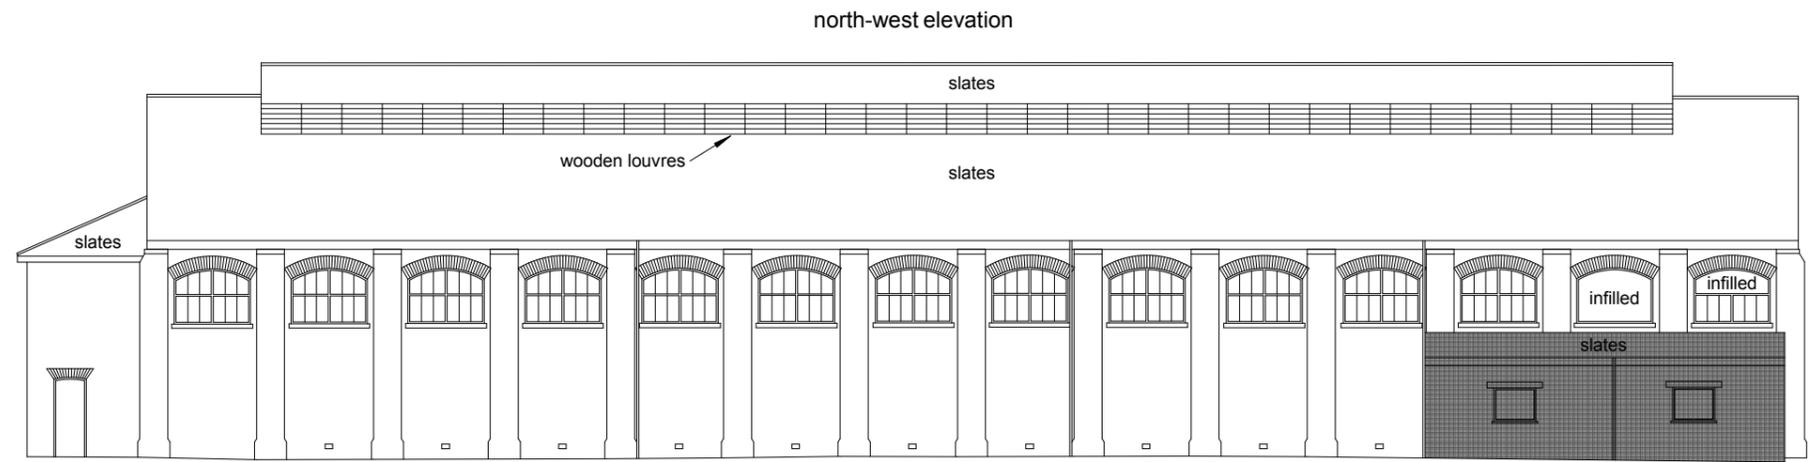
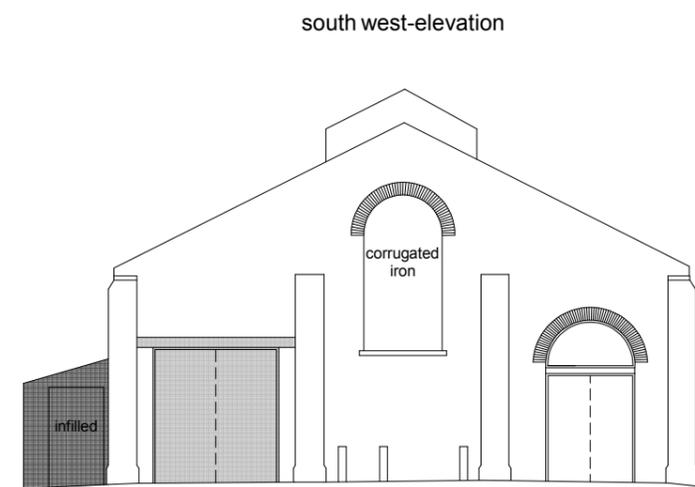
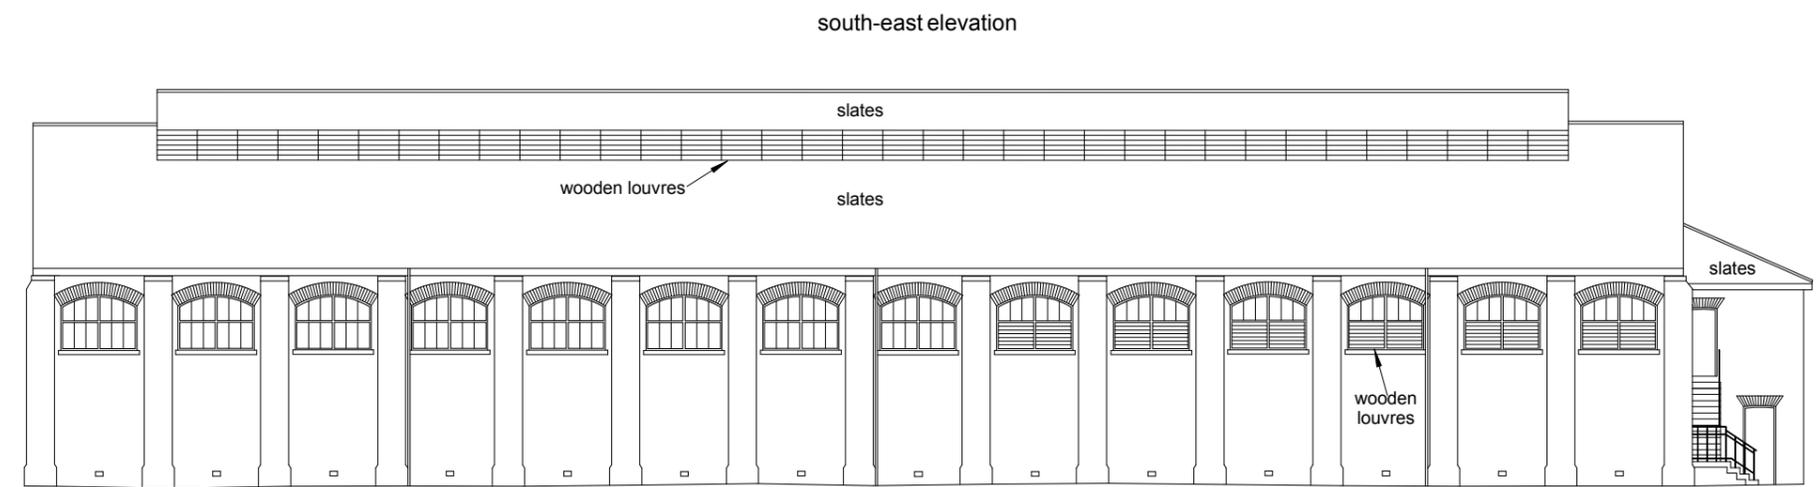
Fig 5 Elevations of former Garrison Riding School.

Alterations to original building.
  Additions to original building.

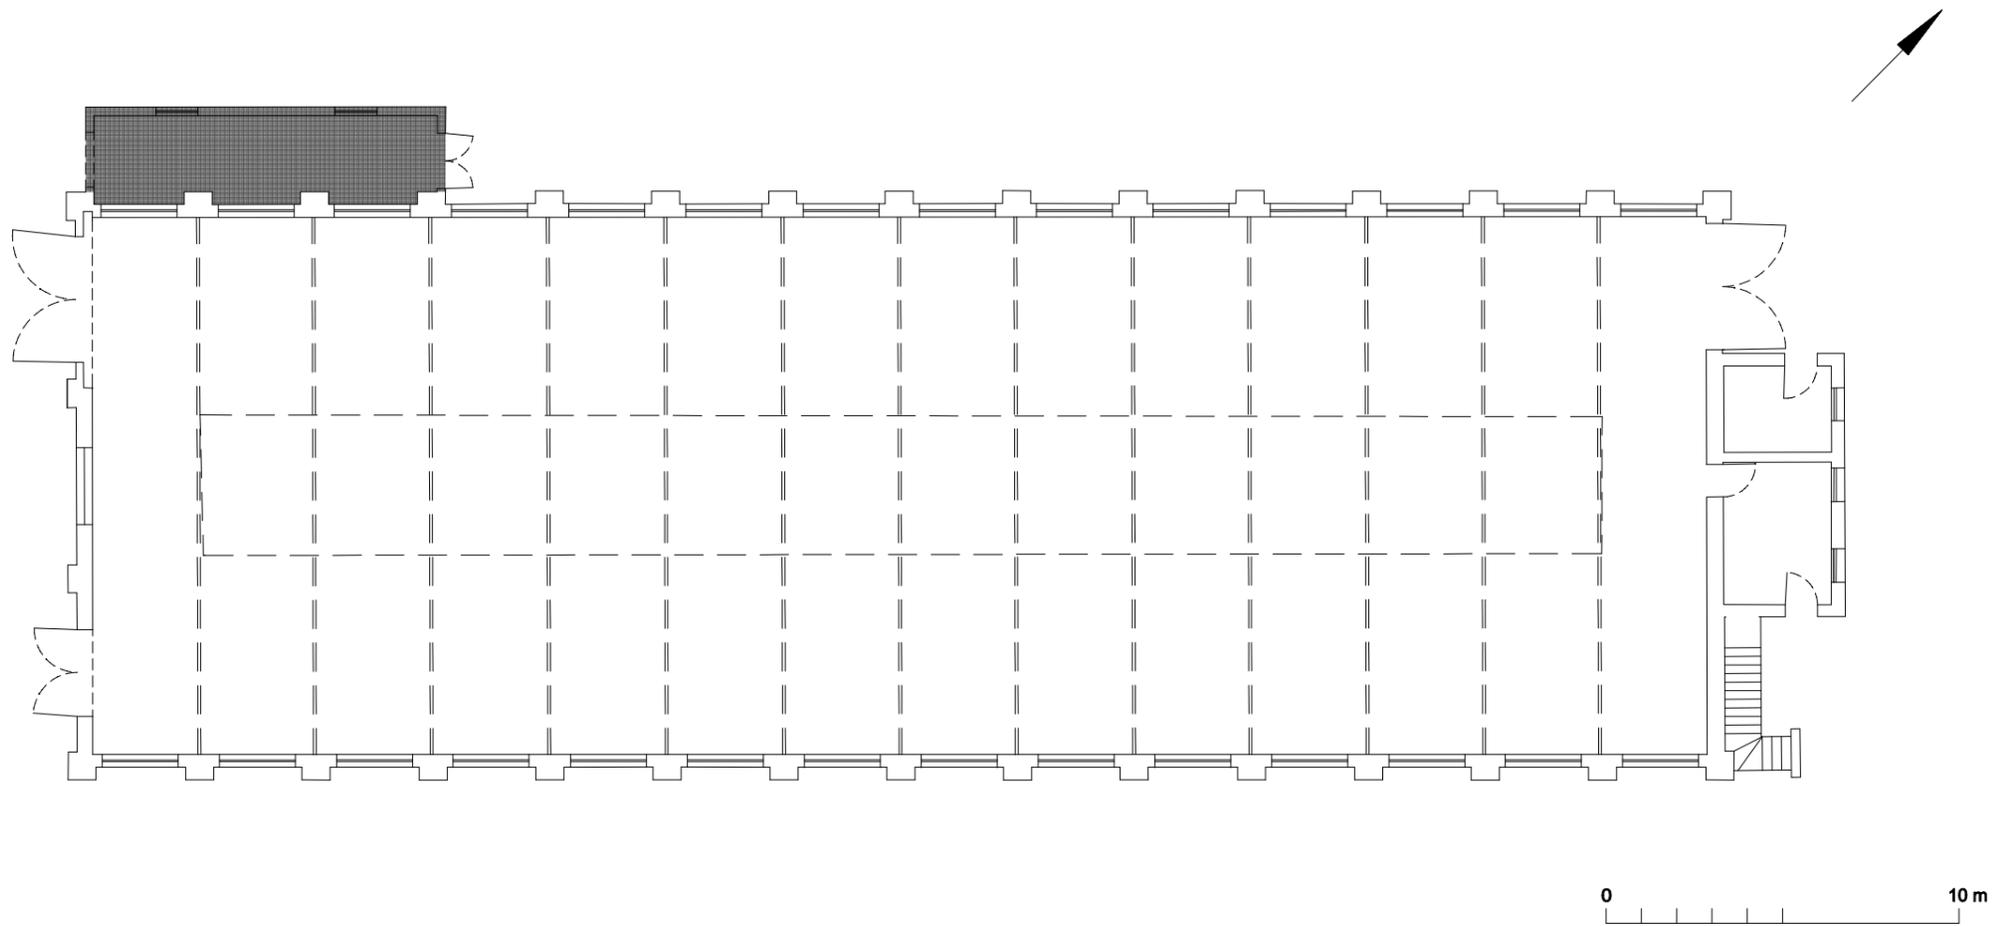
Fig 7 Ground plan of former Garrison Riding School.

■ Additions to original building.
