**Historic building record of the
granary/cart lodge at Clees Hall,
Goulds Road, Alphamstone,
Braintree, Essex
August 2010**

**report by
Richard Shackle
for the
Colchester Archaeological Trust
on behalf of
Mr Welsh**

CAT Report 589
May 2011

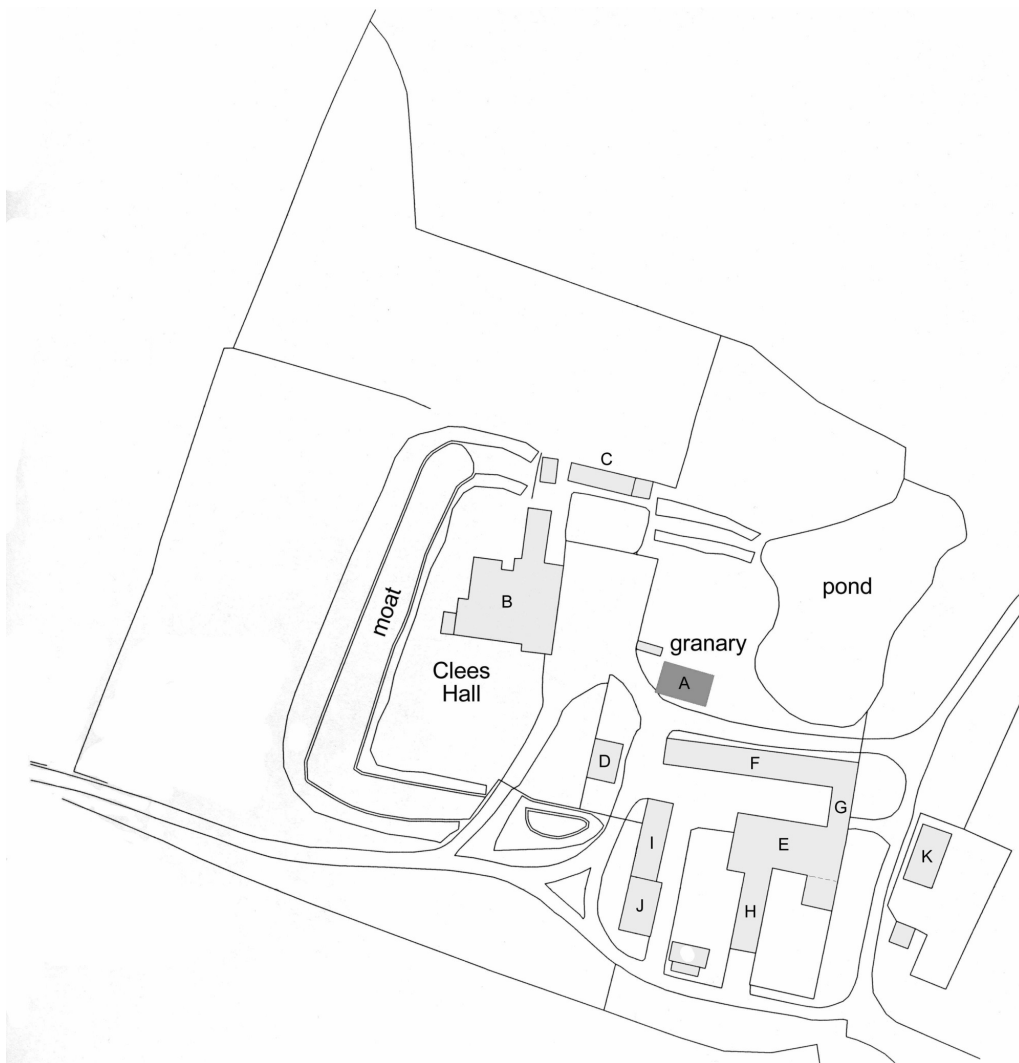
Fig 3 Ground plan.

- A Granary/cart lodge (18th century)**
- B Clees Hall (built between 1876 and 1905 with modern additions)**
- C Three stables all (before 1905)**
- D Farm office (before 1876)**
- E Late 15th/early 16th -century barn with extension and porch**
- F 19th-century cattle sheds , now converted to stables (built before 1876)**
- G 19th-century cattle sheds, now converted to tack rooms (built before 1876)**
- H New stables**
- I 20th-century agricultural building now used as open-fronted garages (built between 1905 and 1928)**
- J Former cart lodge (now garage) (built before 1876)**
- K Modern bungalow (used by gamekeeper)**

The granary (A - see Fig 3) may overlie part of the filled-in moat of Clees Hall. (The extant part of the moat has been dug out again in the last 20 years.) To the west is the gravel yard of Clees Hall (B). The hall itself is a yellow brick building with a clay tile roof entirely built in the late 19th century with no earlier fabric. The cartographic evidence indicates that the hall was rebuilt between 1876 and 1905. Just north of the hall are three stables (C), one of which has been converted into a dog kennel with outside run. Immediately to the north is a small ornamental garden. To the east is an ornamental pond which may have originated as a medieval fish pond. To the south there are several farm buildings. The most westerly is a brick farm office with timber gables and a timber roof (D). This building appears to be shown on the OS map of 1876. The single room is spanned by two large timber tie beams. This room has a door and two sash windows facing east. There are also two sash windows facing south. Formerly, just south-east of this building there was a bridge over the moat and a gatehouse; however, no traces of these structures now remain.

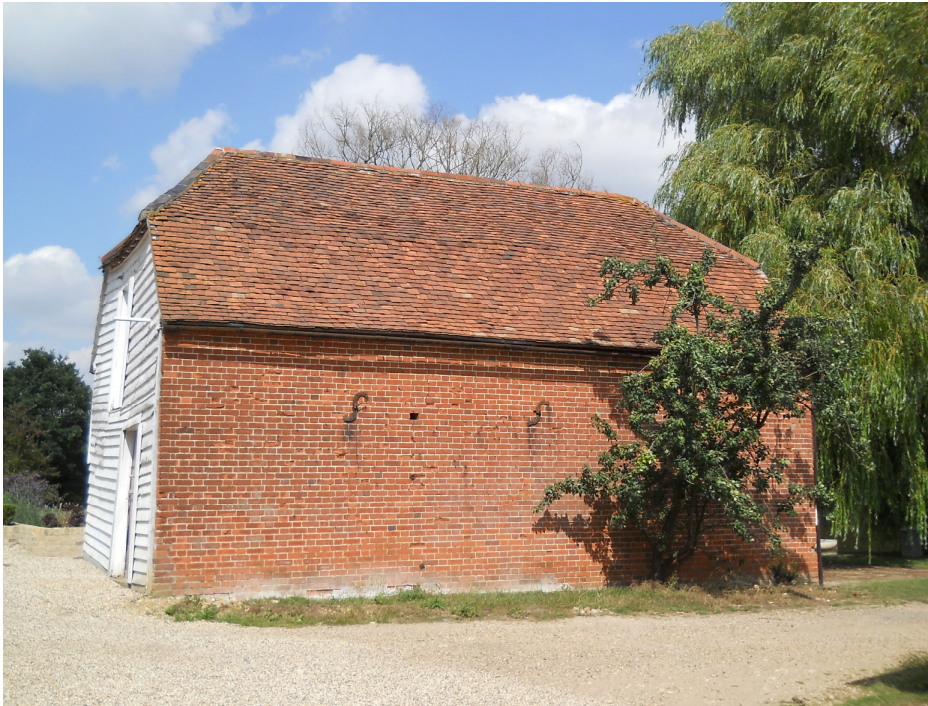
Plate A1 Granary (A): view from south.

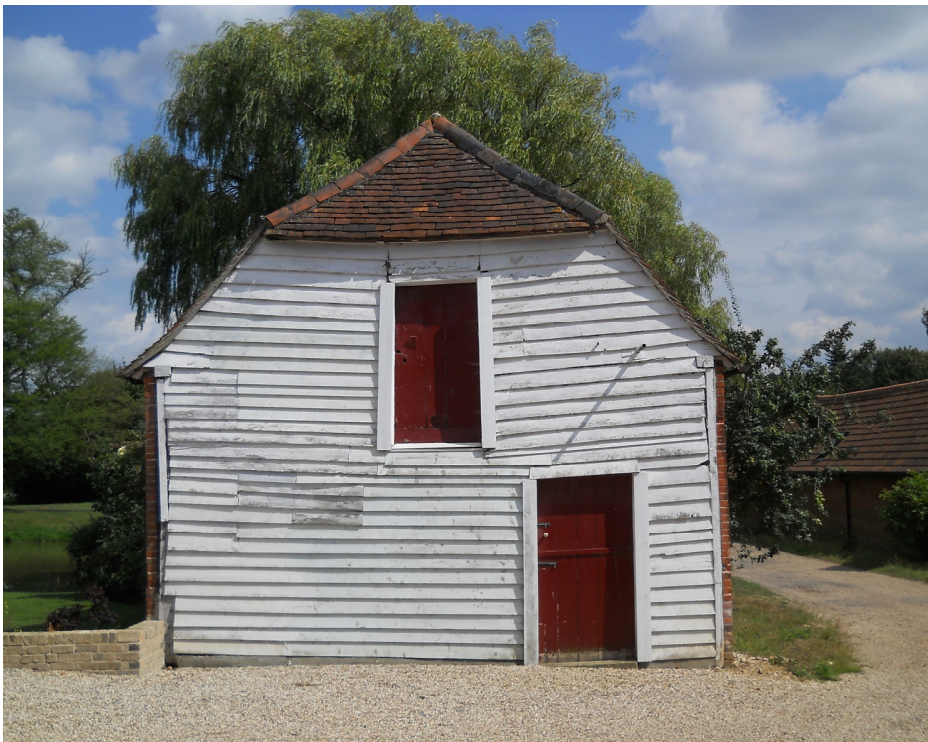
Plate A2 Granary (A): half-hipped roof, weatherboarding, doors, view from west.

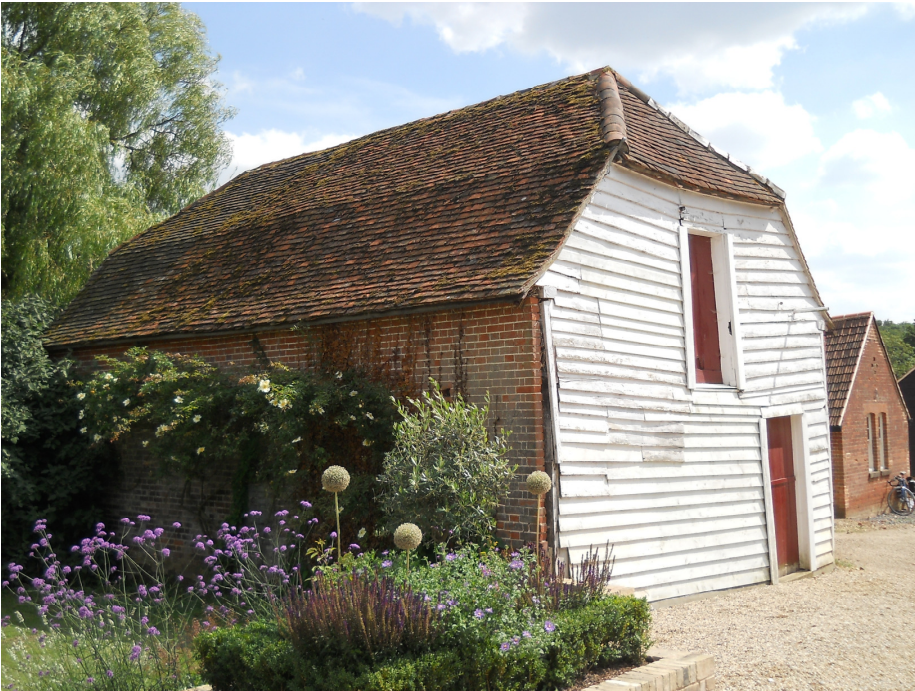
Plate A3 Granary (A): clay-tile roof, brick wall, iron reinforcing plates, view from north-west.

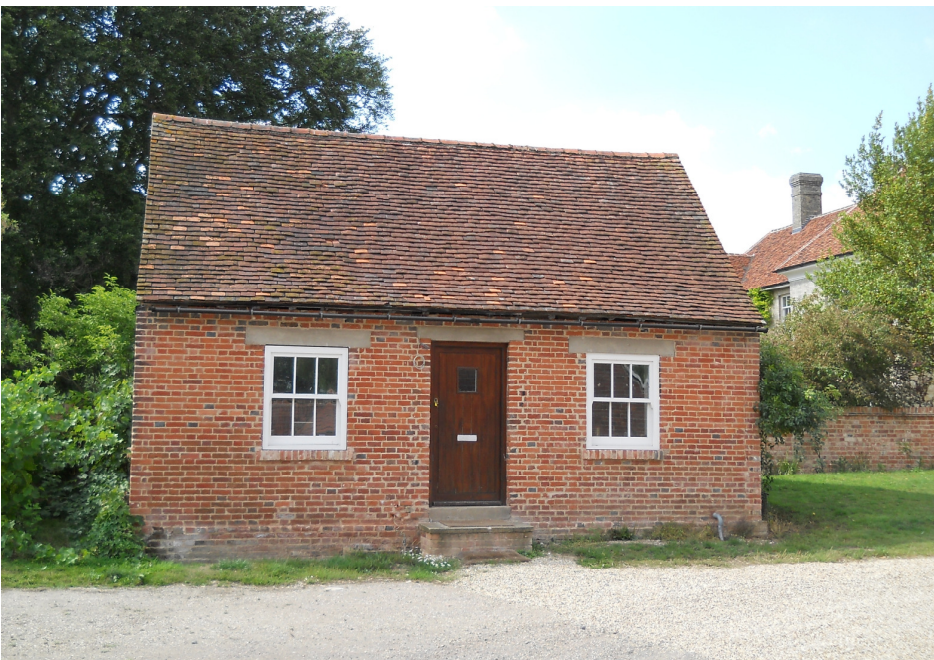
Plate A4 Farm office (D): brick building with clay-tile roof, view from east.

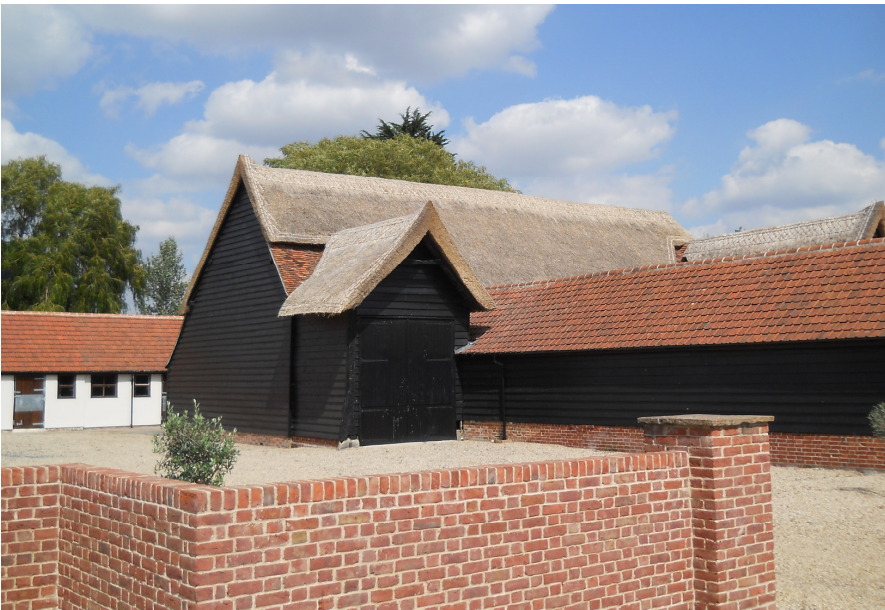
Plate A10 Medieval barn (E) with porch and modern stables (H) to right, view from south-west.

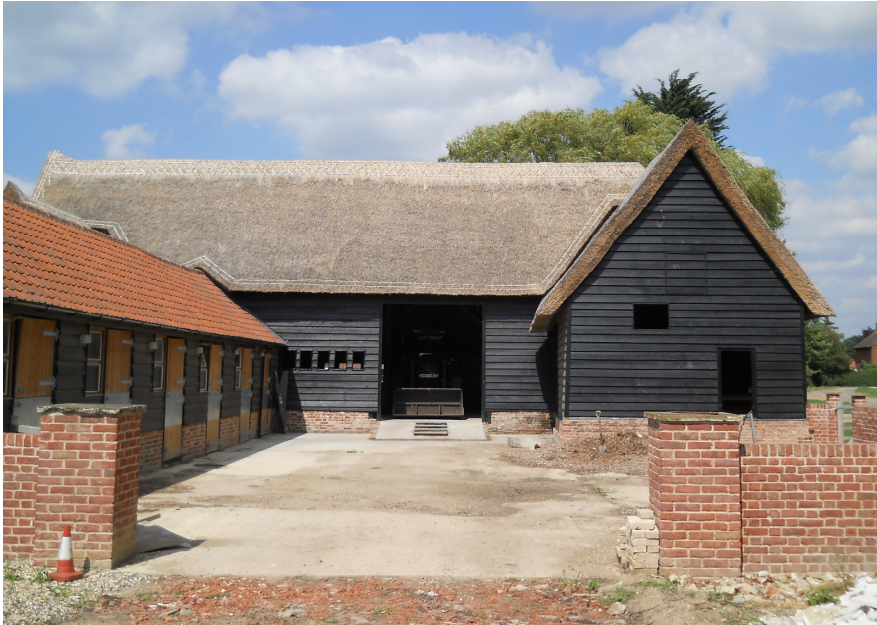
Plate A13 Medieval barn (E) and extension, showing modern stables (H) to left, view from south.

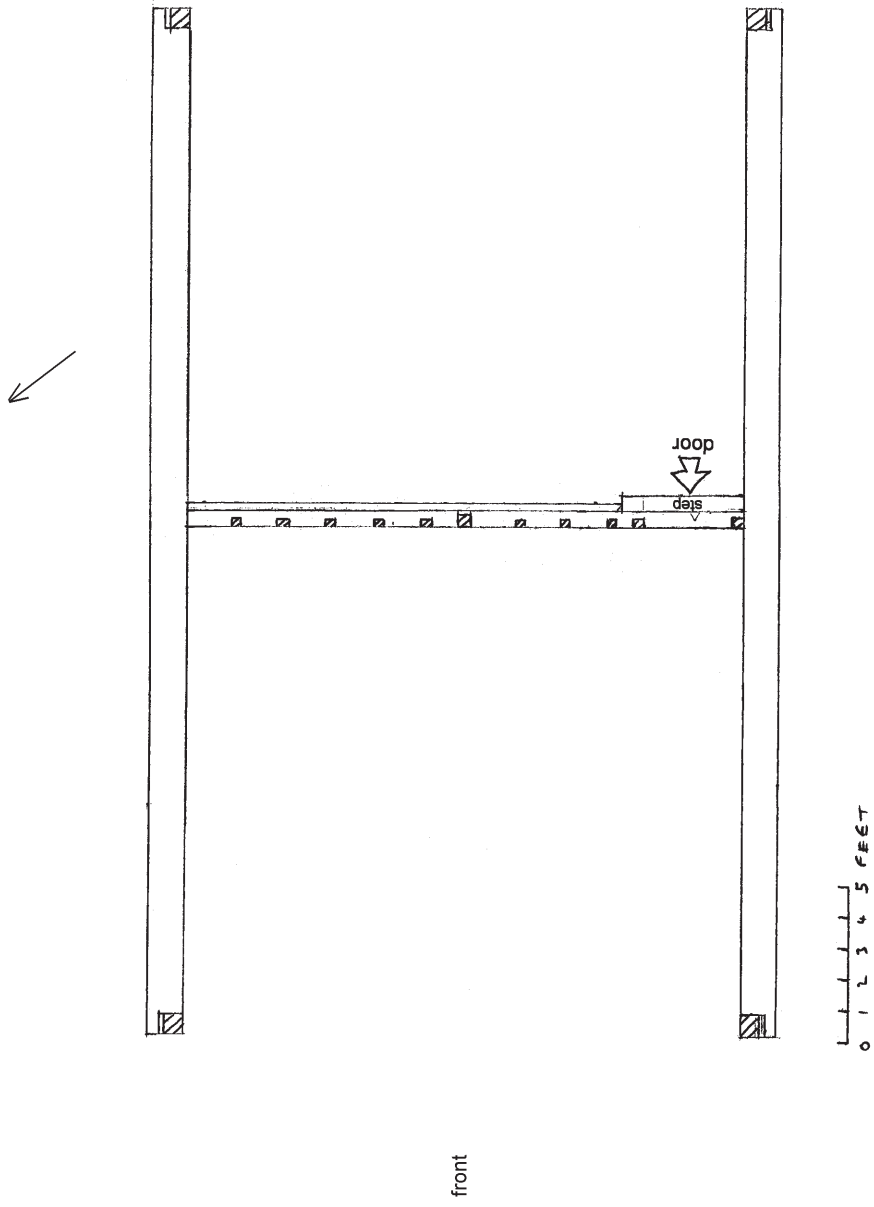
Fig 6a Granary/cart lodge: plan of ground floor.

The ground floor (Fig 6a) was used for storing up to four carts. It is divided in two by a central partition. The partition includes a central post, studs of irregular shape and a lockable door and is made up of rough studs with lath and plaster between them. The partition was later supplemented with boards attached to the north-west side of it. This partition is an original feature. The ground-levels on either side of it are different; it is hard to decide whether the change in levels is original or occurred when garages were created at the south-east end in the 20th century. There is a step down on the south-eastern side of the partition. The blocking of the ground-floor ends are modern and not related to the original granary/cart lodge. At one end, there are two 20th-century garage doors and, at the other, there is a single pedestrian door and later weatherboarding to match the 18th-century boarding above.

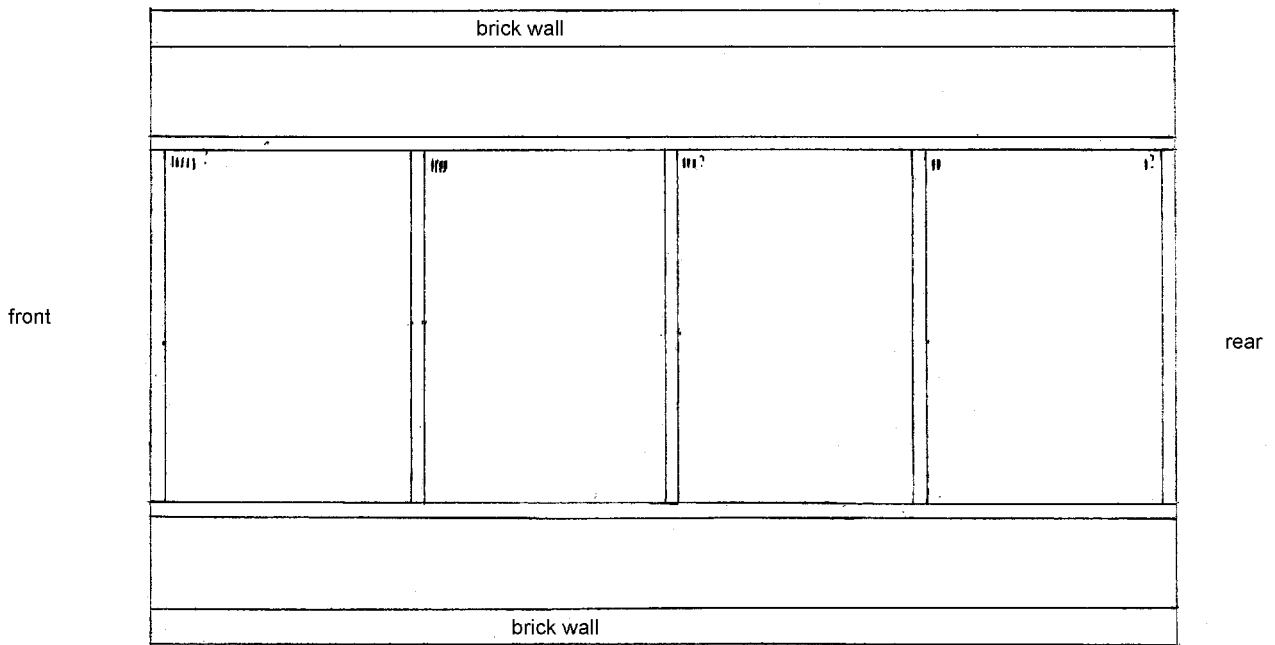
Fig 8 Granary/cart lodge; main frame of gambrel roof.

'... Granary. Mid C18. N and S walls of red brick in Flemish bond, E and W walls timber framed and weatherboarded, roofed with handmade red clay tiles. Gambrel roof half-hipped at both ends. 2 storeys. External ladder access at W end. Hanging knees to beams. Lodged side purlin roof with intermediate collars.'
