**Historic building recording  
on farm buildings at  
Kitchen Farm, Kitchen Hill,  
Bulmer, Braintree, Essex  
December 2012**

CAT project ref: 12/11c  
NGR: TL 8546 4086 (c)  
ECC HEM code: BUKF12  
Braintree Museum  
accession code: requested

**CAT Report 677**  
January 2013

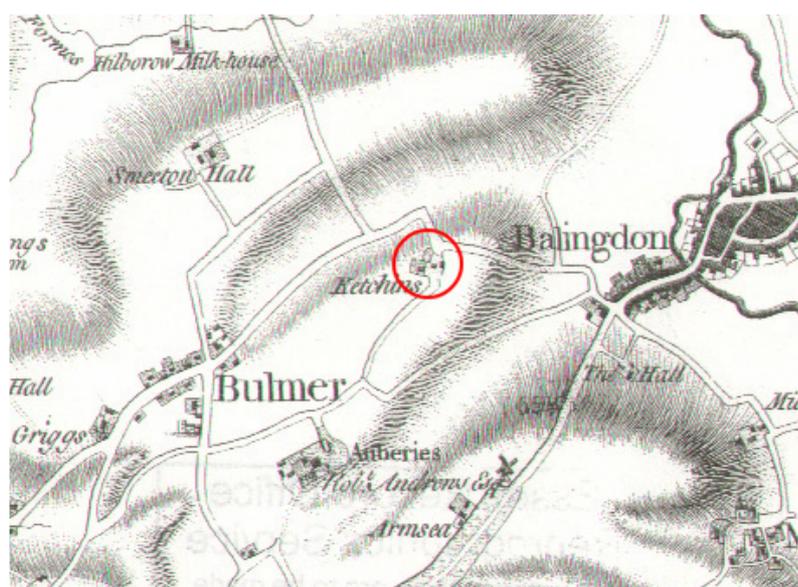
Fig 1 Chapman and André map of Essex, 1777 (Plate III).

A further document from the Essex Records Office records the 1792 sale of the 228 acres of 'all that Manor Farm called Kitchen' to a Robert Andrews from Elis, a 'nice widow' (ERO D/DB T 1549). It is very likely that the farm buildings purchased by Robert Andrews in 1792 were the same structures depicted on the 1777 Chapman and André map of Essex (Fig 1). Here the farm is spelt Ketchins and consists of a farmhouse and two barns.

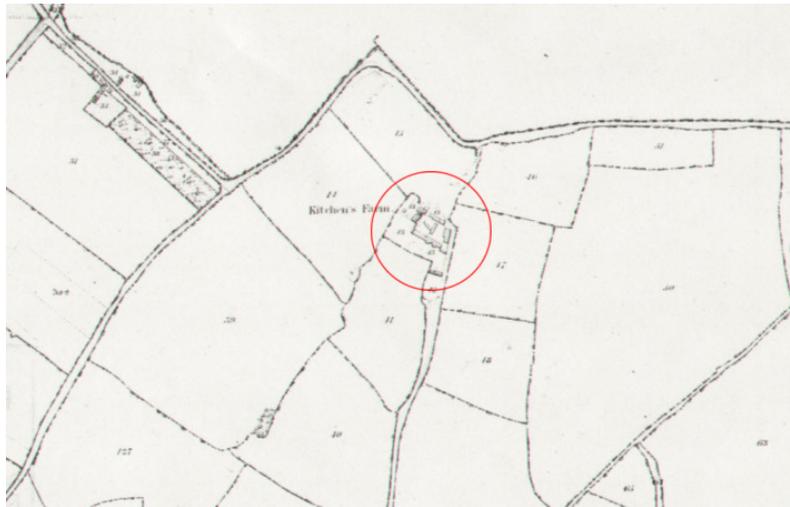
**Fig 2 1840 tithe map (ERO D/CT 56).**

The title award for 1840 (Fig 2) lists 21 parcels associated with Kitchen Farm. Described as Kitchen Farm Homestead and noted on the map as Kitchen's Farm, these parcels were owned by the Rt Hon Earl Howe and occupied by Elizabeth Sawyer. Of the roughly 166 acres included in the farm, 152 acres were given over to arable production, 7 acres to pasture and 5 acres to meadow. The farm buildings have increased in number since the Chapman and André map was drawn. By 1840 Kitchen Farm had a loose courtyard plan with the farmhouse to the west and three ranges of linear barns forming the other sides. An additional linear structure is shown located south-west of the farmyard.

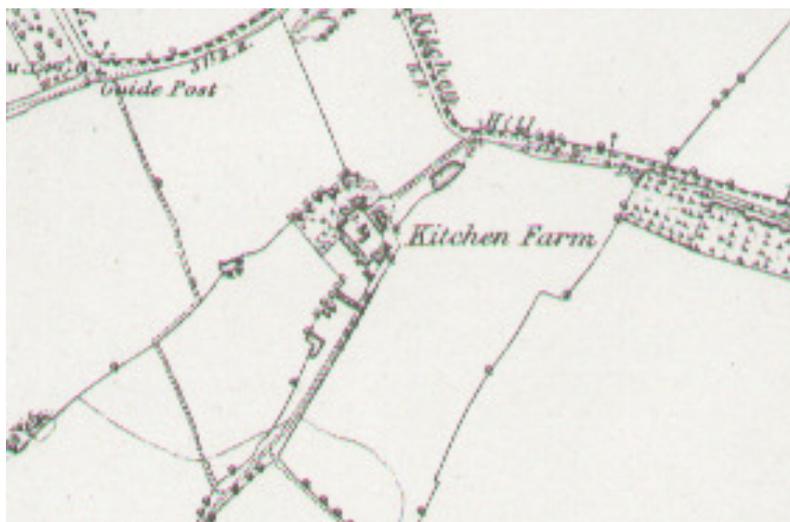
**Fig 3 First edition 6" OS map, 1876 (sheet 12).**

In 1881 Kitchen farm was rented to Edward Baker, a local miller who used the farm for cultivating flax and cereal crops. He requested a reduction in rent from his landlord – this was refused and Baker quit the farm saying he was unable to make it pay (Slaughter 1979). This is the farm that is shown on the 1876 first edition 6" Ordnance Survey map (Fig 3). There appear to have been no structural alterations since 1840.

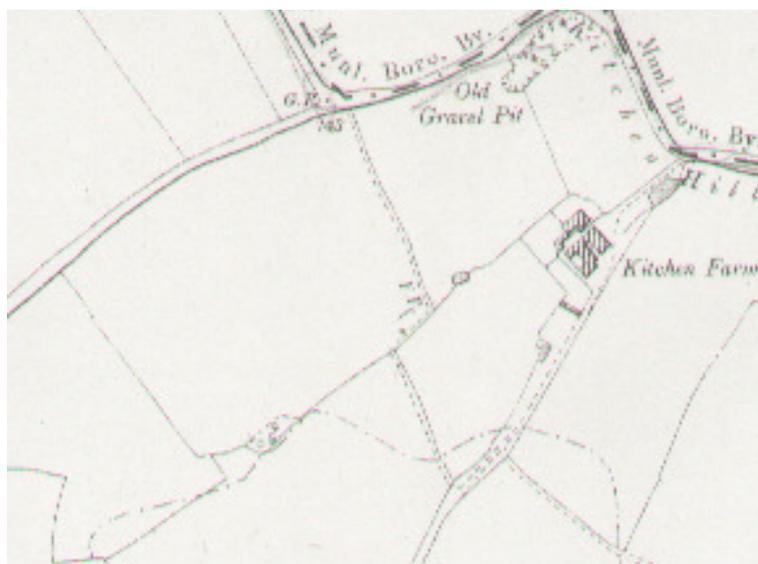
**Fig 4 Second edition 6" OS map, 1898 (sheet 12 NW).**

However, between the time of the 1st edition map and the 2nd edition 6" Ordnance Survey in 1898 major change took place at Kitchen Farm (Fig 4). The loose

courtyard plan has been completely removed and replaced by a complex of back-to-back structures, whose plan form exactly matches those still standing at Kitchen Farm in 2012. The farmhouse does not appear to have been altered at this stage. A subsequent phase of development at Kitchen Farm took place just prior to the First World War. Quoting a contemporary account, Basil Slaughter states that the Kitchen Farm Cottages were constructed in 1912 and that, in 1913, the farmhouse was demolished and replaced by a new building. The contemporary account (the notebook of a local farmer Colonel Burke) suggests the farmhouse was built, at various dates, of timber and plaster with some of it 'very old indeed and with a great brick chamber to the kitchen for smoking meat for winter use' (Slaughter 1979). This was replaced by a large two-storey house, with a half-basement and typical Edwardian architectural embellishments, such as pebble-dashing, prominent gable ends with large barge-boards and a decorative brick string course (Plate 15). In keeping with the farm buildings the main part of the house has a double-hipped roof, whilst the square extension to the main house is fully hipped. The house is roofed in peg-tile.

The linear structure noted on the tithe map of 1840 is the only building associated with Kitchen Farm to have survived these periods of rebuilding. This has survived to the modern day, probably as it appears to have become associated with the Kitchen Farm Cottages.

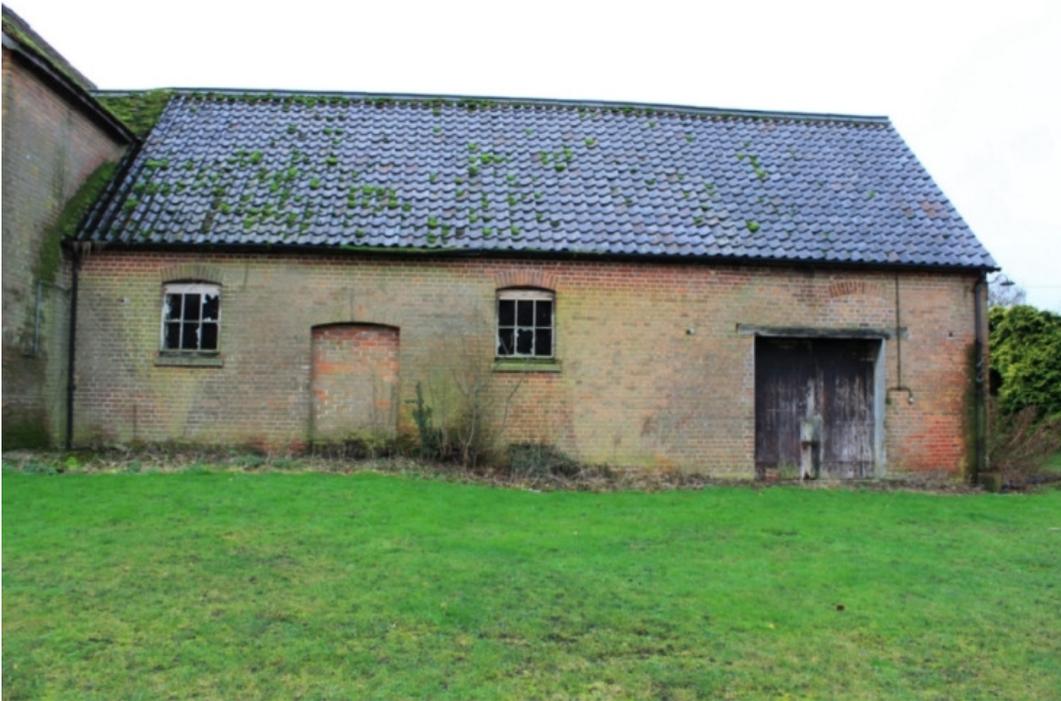
**Plate 1** North-east elevation of shed 6 - view south-west

This structure is a rectangular single storey shed 14.75m long x 7.25m wide, aligned north-west to south-east, in red brick with dimensions of 223 x 109 x 63mm laid in English bond. The roof is of pan-tiles with a single gable to the north-west end, the other end being tied into the roof of the adjoining structure, straw barn 2, with a heel gable (Plate 1).

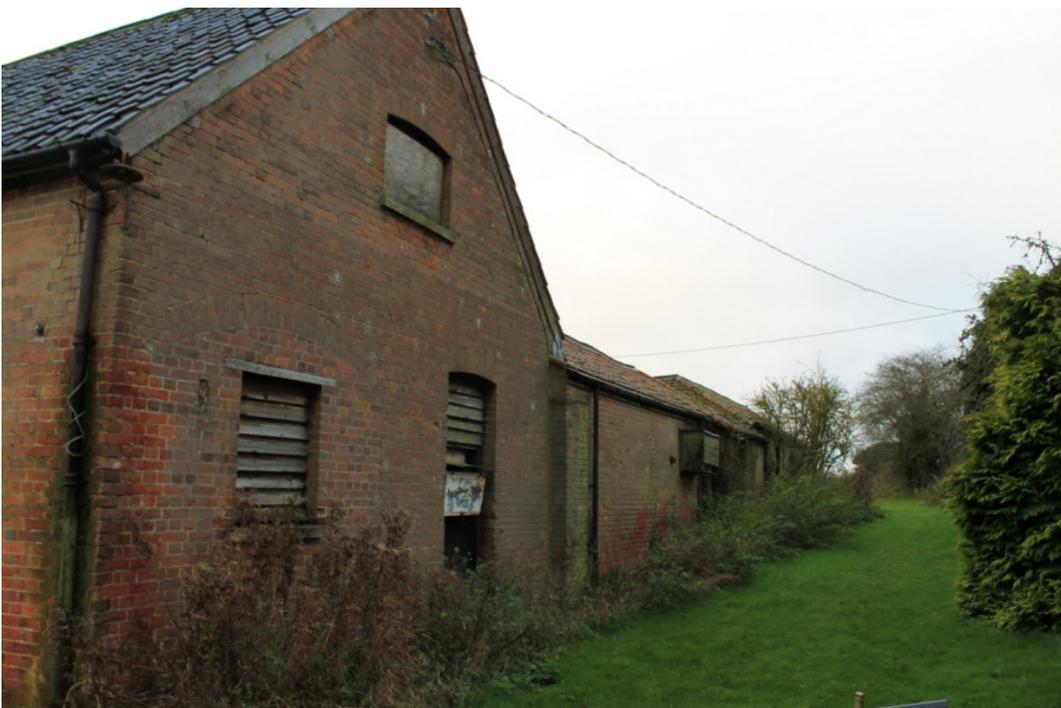
**Plate 2** North-west elevation with shed 1 to the foreground and shelter sheds 4 and 8 to the rear – view south

The north-west elevation continues in English bond and has a window and entrance on the ground level and a centrally-positioned window in the gable (Plate 2). The entrance is original, with a shallow brick arch and an inward-opening door of vertical planks. Above the door, where one might expect to see fixed lights, is a crude louvred panel; this is most likely a later alteration. The gable window also displays a shallow brick arch and has a concrete sill. This window has been boarded over and it is not possible to say if the original lights survive. The window on the ground level is a later insertion with a wooden lintel and displays the same type of crude louvre as that above the door. This window is set into the blocked remains of a large double-width entrance surmounted by the same shallow brick arch as noted on the other original entrances and windows.

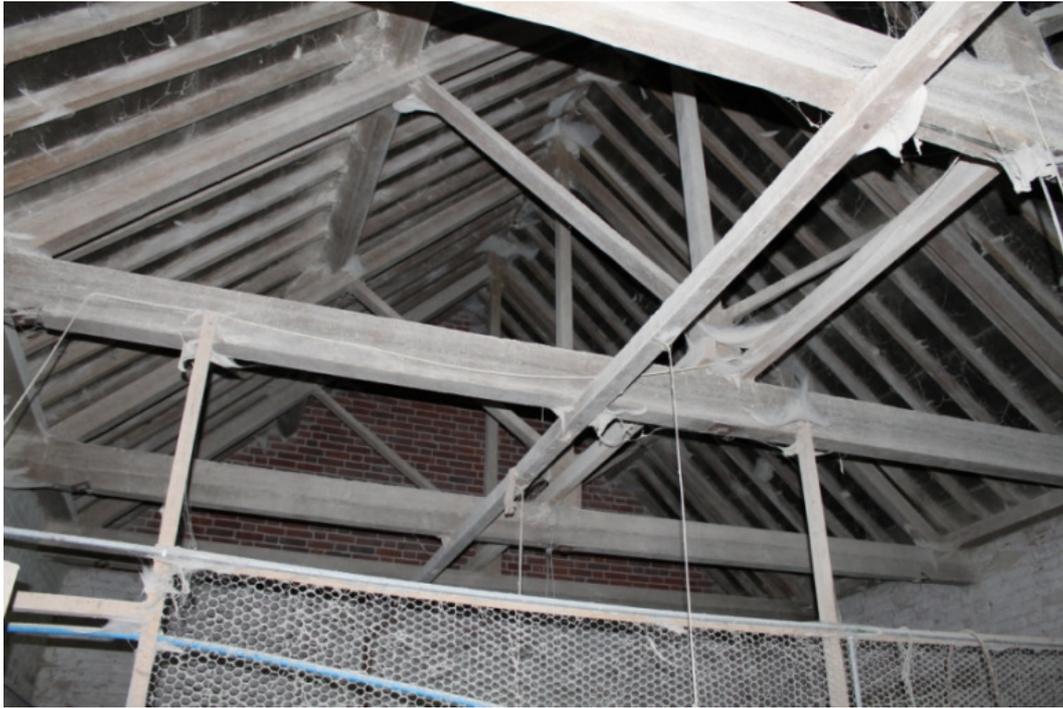
**Plate 3** Shed 1, detail of roof construction

Although originally accessible from the blocked entrance in the north-east elevation, modern access to shed 1 is solely via the interior of the other structures through an opening between shed 1 and shelter shed 4. This opening appears to be an original doorway although all trace of the original door and frame has been removed by subsequent alterations. Once inside shed 1 it can be seen that the structure comprises two rooms separated from each other by an internal brick wall, with a concrete floor. The larger of the two rooms, accessed from shelter shed 4, is 8.95m long and has a modern wood and wire partition. The blocked entrance is centrally located in the exterior wall with the two windows flanking it. The rafters are carried on a single purlin supported on five equally-spaced king post roof trusses. These are held together by bolts rather than traditional wooden pegs and the roof beams are all large section machine-cut timbers (Plate 3).

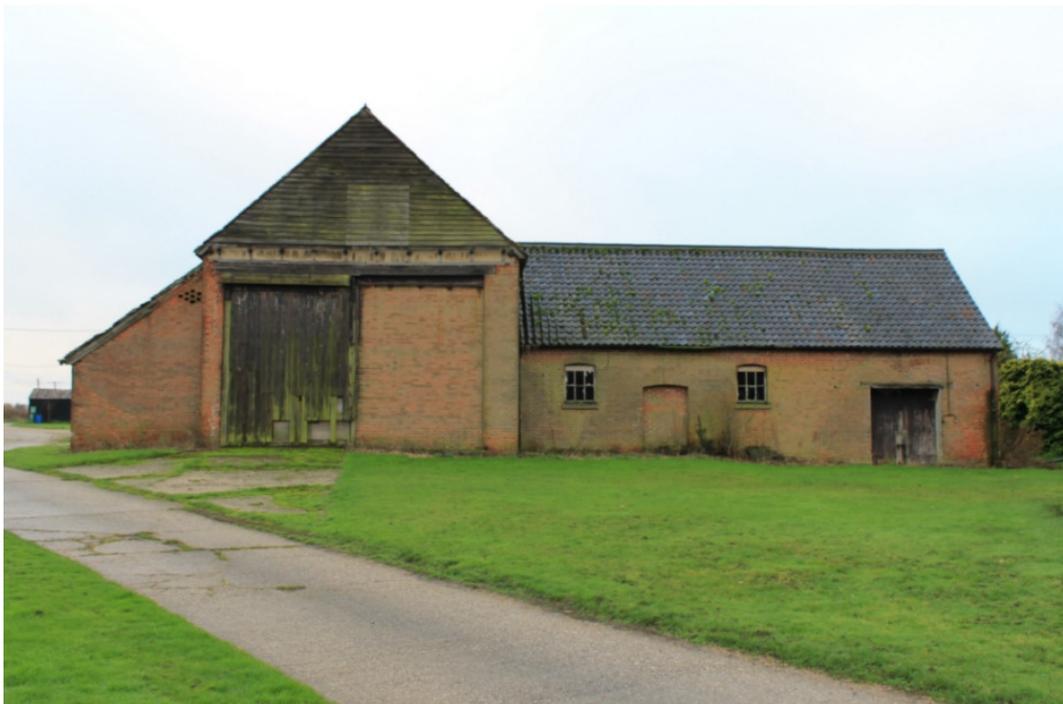
**Plate 4** Straw barn 2, note the sliding door and ornate cornice (with shed 1 to the right)  
- view south-west

This structure is a rectangular gabled barn 8.4 wide x 13.2m long, aligned north-east to south-west, constructed from red brick with those forming the longitudinal sides having dimensions of 223 x 109 x 63mm laid in English bond. The short north-east elevation comprises a sliding door of vertical wooden planks held on an iron rail, half the width of the barn and almost the full height of the walls (Plate 4). Half of the width of the straw barn is taken up by a recessed brick wall laid in irregular Flemish bond. Above the sliding door and wall is a plaster and timber cornice above which the gable is clad in horizontal, black-painted weatherboarding. The south-west elevation has a mirror image of the sliding door, although here the door has been removed and replaced with a timber frame supporting plastic sheeting. However, at this end the gable is solid brickwork rather than weatherboarding. This suggests that the weatherboarded gable, with its attractive plaster and timber cornice facing the approach to the farm, may have been an aesthetic choice rather an architectural necessity.

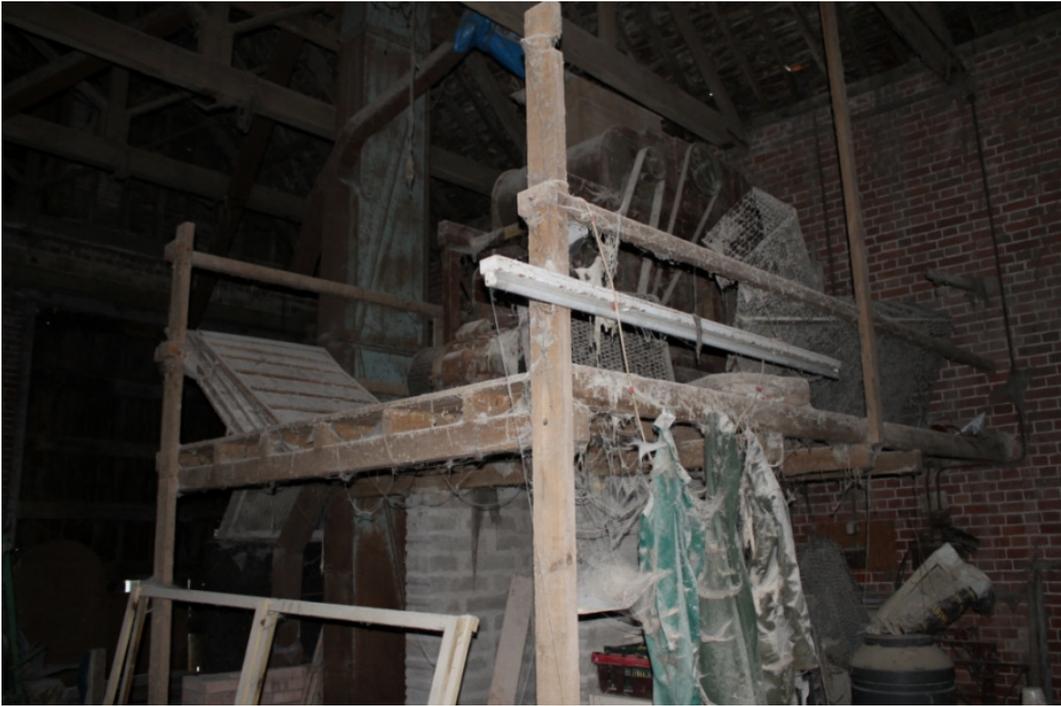
**Plate 5** Straw barn 2, grain hopper converted to chicken feed mixer - view east

The interior of straw barn 2 was cluttered with machinery and paraphernalia associated with the chicken farm filling the entire area. The floor is of concrete, and a vehicle inspection pit is located just inside of the north-east entrance, which must be a later addition. In particular the barn is dominated by a large grain hopper that appears to have been converted for the purpose of mixing chicken feed (Plate 5). A large chute associated with this has been passed through the south-east wall into stable block 3. An entrance in the north-west wall provides access to shelter shed 4 and appears to be original. The interior of straw barn 2 is open to the roof which is carried on seven equally-spaced king post roof trusses supporting two purlins. These trusses are essentially larger versions of those observed in shed 1. No evidence of original internal walls, divisions, fixtures or fittings was noted and it must be concluded that the interior was most likely a large open space for the storage of the farm's straw and possibly threshed grain.

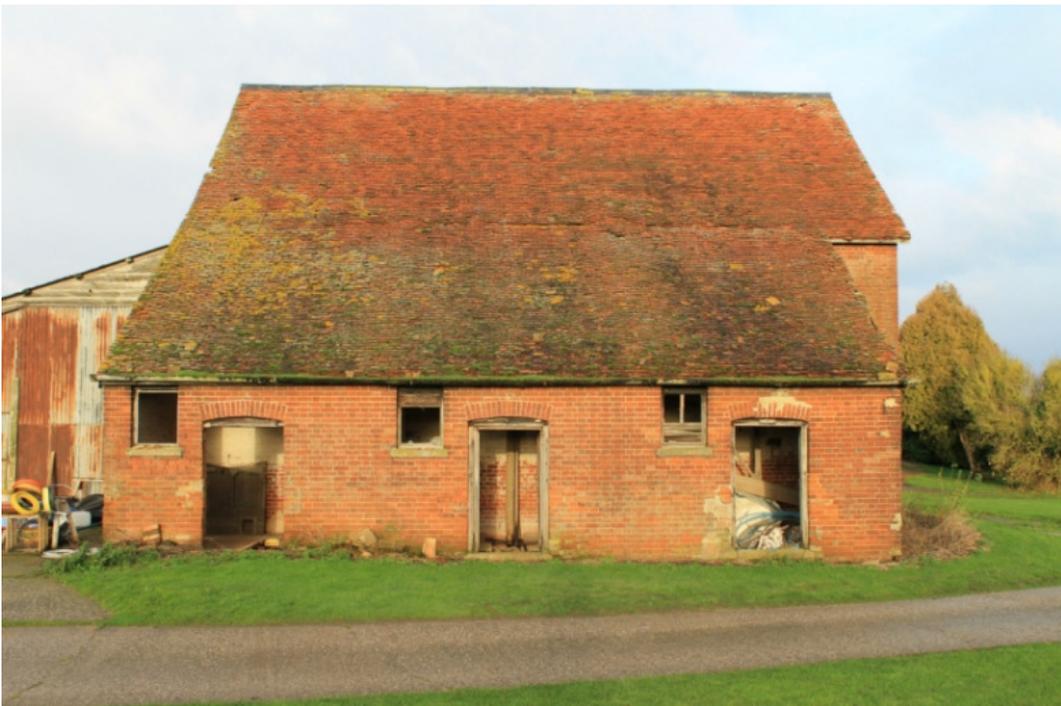
**Plate 6** Stable block 3, with straw barn 2 behind - view north-west

As has already been noted above, stable block 3 is located along the south-east wall of straw barn 2. It measures 11.65m x 3.9m and comprises three separate stalls, each with its own entrance and window (Plate 6). It is constructed from red brick with dimensions of 223 x 109 x 63mm laid in Flemish bond and has a mono-pitched peg-tile roof. The windows are set high in the wall, just below the eaves and have concrete sills. These are wooden framed but do not appear to have been glazed. Although two are damaged one retains a central timber chamfered mullion to which louvres were pegged (Plate 7). The entrances to the stalls have lost the original doors, although two retain the original door jambs and lintels and each is surmounted by a shallow brick arch. The door jambs of the north-east stall are strengthened by iron cramps at their bases.

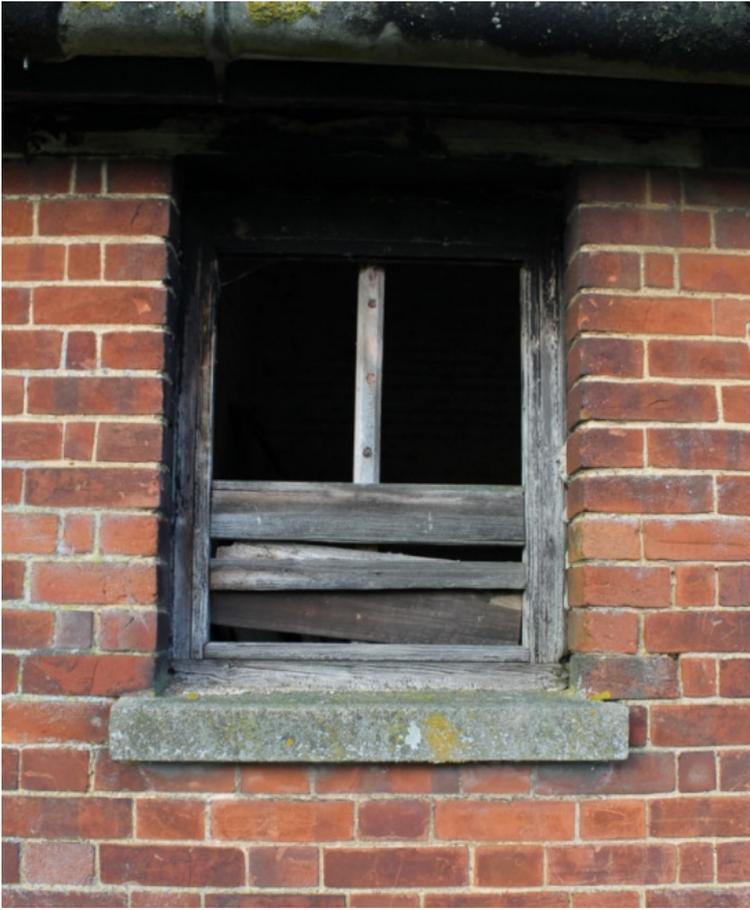
**Plate 7** Stable block 3, detail of window with chamfered mullion - view north-west

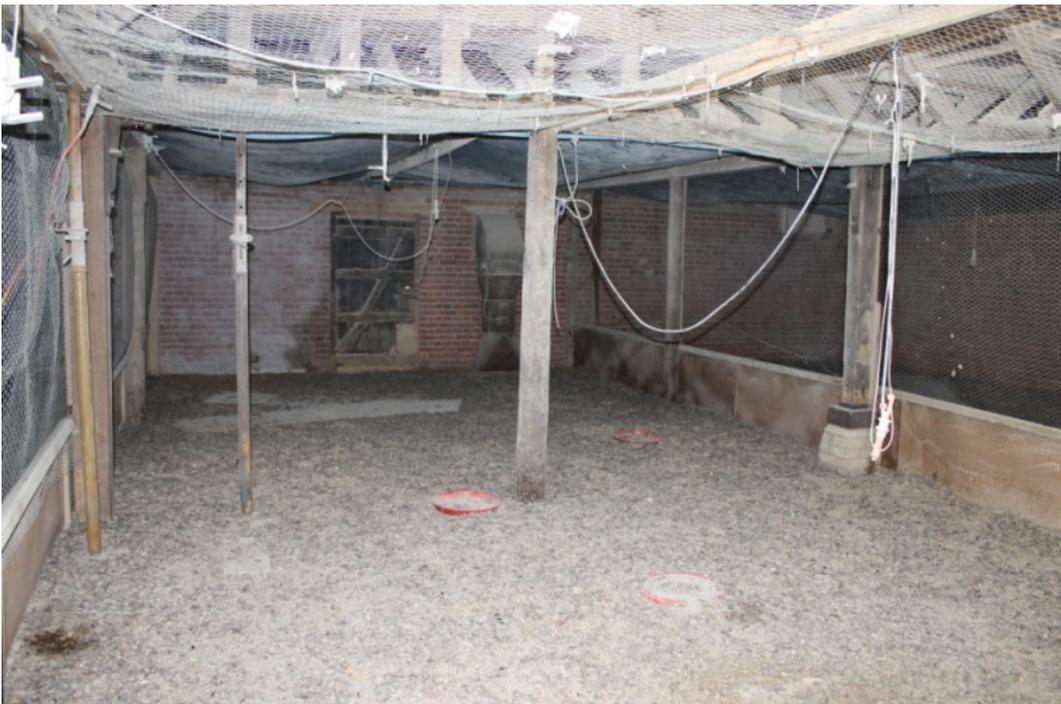
**Plate 8** Shelter shed 4 with later covered yard to the foreground - view north-west

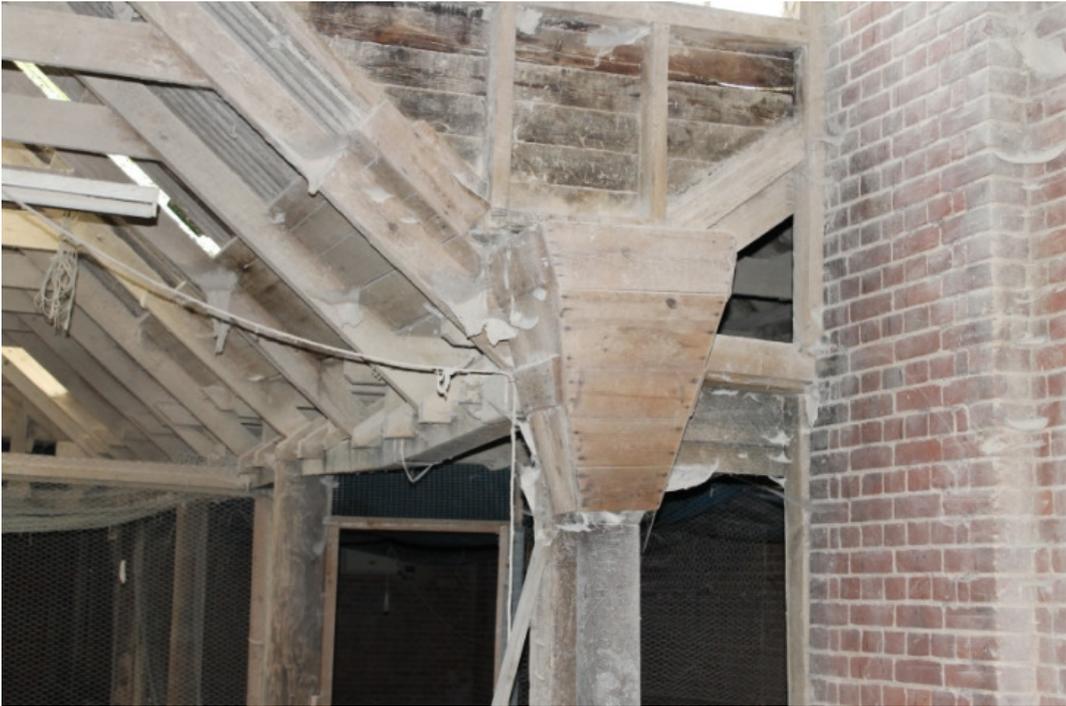
**Plate 9** Wooden rainwater trap for valley formed by shelter shed 4 and later covered yard of shelter shed 4

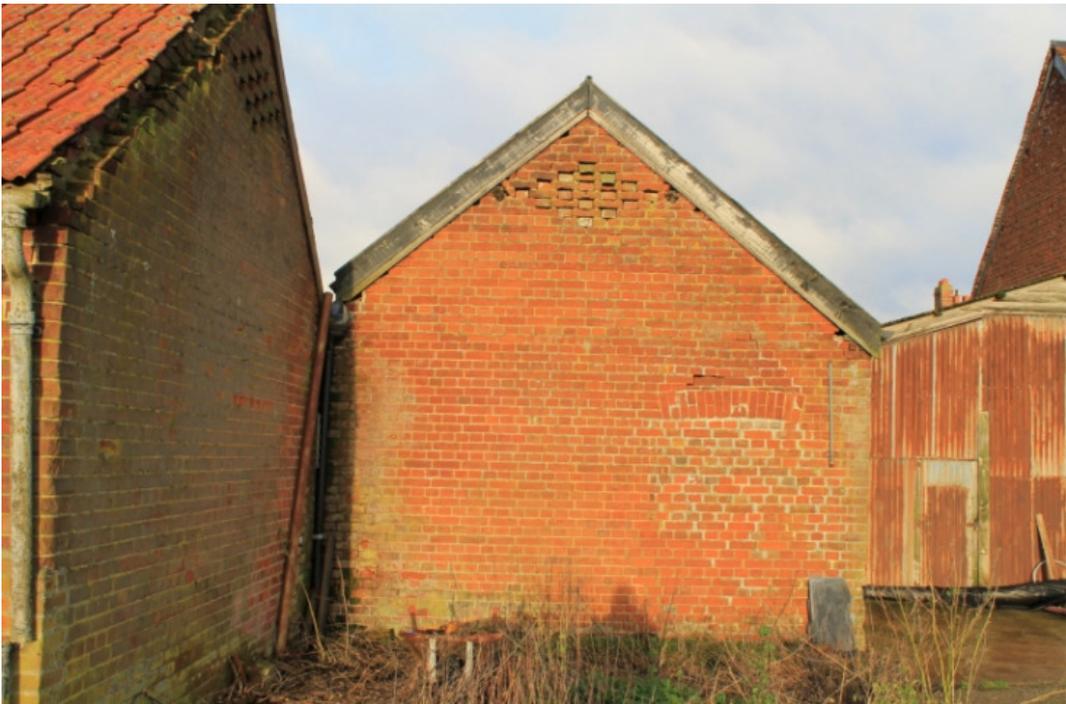
**Plate 10** South-east elevation of shed 6 showing diamond-pattern ventilation and blocked entrance - view north-west

The short sides of stable block 3 are unremarkable apart from each having ventilation formed by omitting bricks in a diamond pattern. These are located high on the wall just below the start of the catslide roof (for a similar example of this see Plate 10).

entrance surmounted by a shallow brick arch. This has been blocked with brick infill (Plate 10). In the apex of the gable there is ventilation formed by omitting bricks in a diamond pattern. This was also observed in the other gable. The north-east elevation contains a wooden-framed window of six lights with a concrete sill and a shallow brick arch above. Towards the centre of the elevation is an entrance granting access to the south-east room. The north-west room has a mechanism and recess for a sliding door, although this has been removed and replaced with a timber and wire partition.

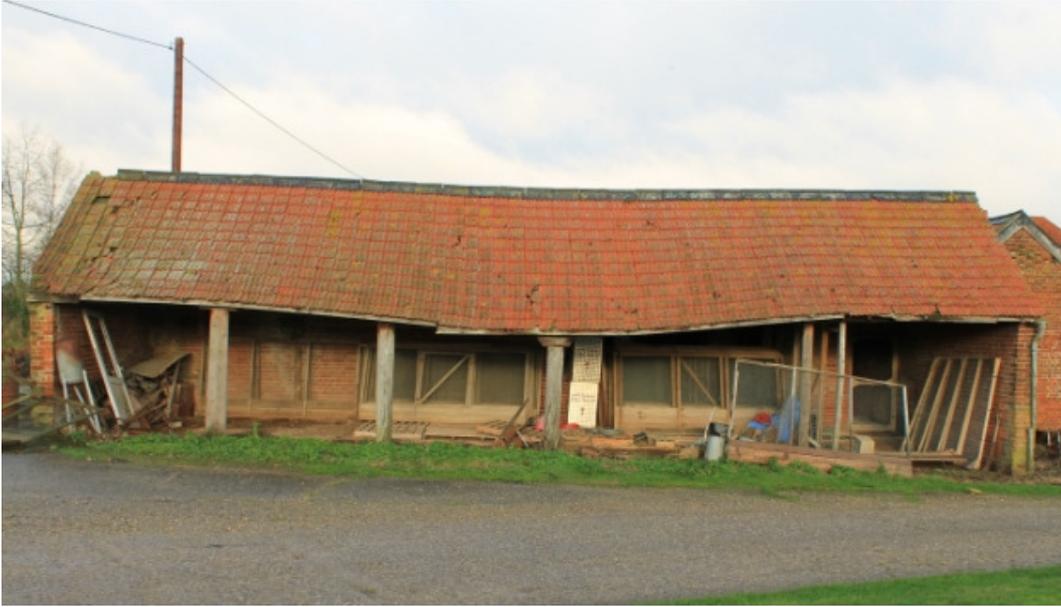
**Plate 11** Cart shed 7 – view north-west

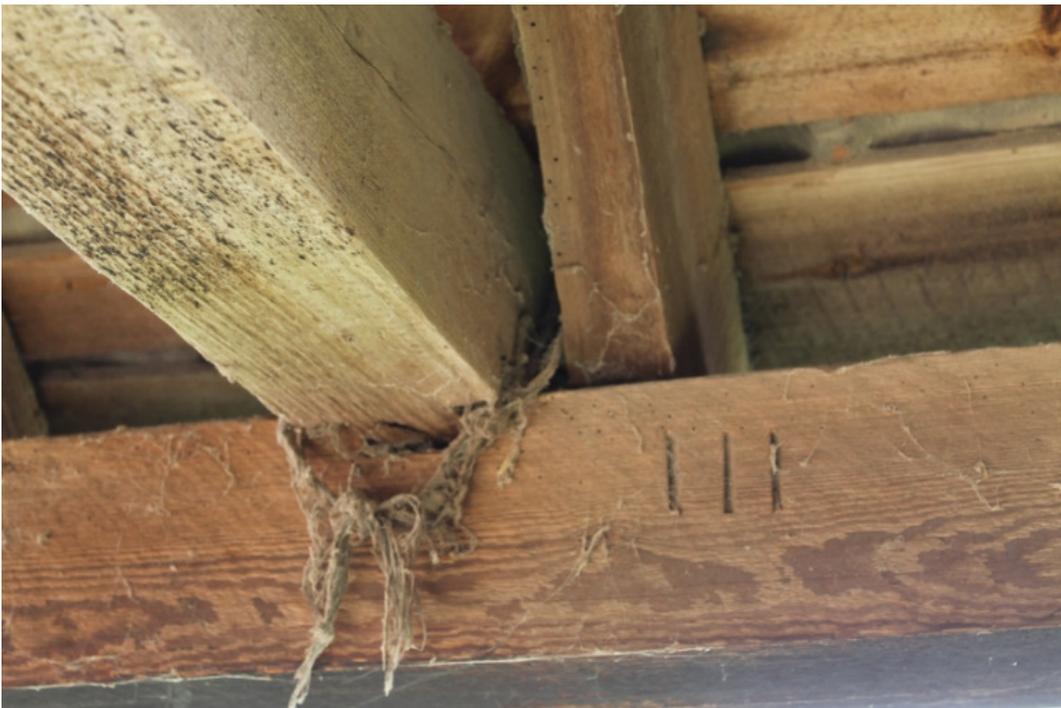
**Plate 12** Cart shed 7, carpenter's mark (III) on eaves plate

There is little to note about the interior of the cart shed. There are four trusses with a collar and a single purlin formed from machine-cut timbers. The eaves plate has a chiselled carpenter's mark next to each of the tie-beam ends (I – IIII from north-east to south-west – see Plate 12) and there is a carpenter's mark (IIII) on the underside of the eaves plate where one of the missing posts was located. A scarf joint is also located in the eaves plate. There is an original entrance to shelter shed 8 in the north-east corner but no sign of any other original fixtures or fittings.

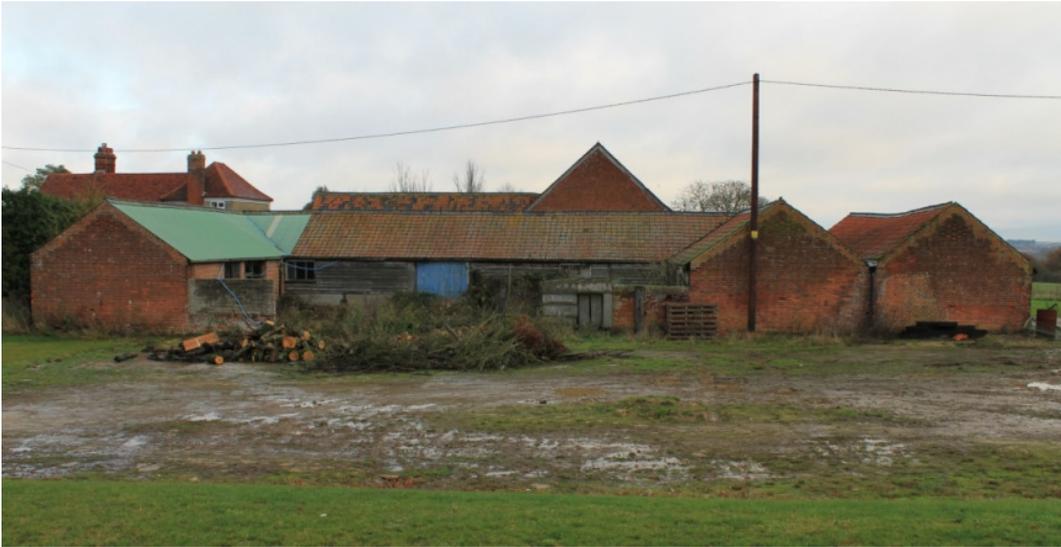
**Plate 13** South-west elevation of Kitchen Farm, with the farmhouse to the rear left  
- view north-east

Shelter shed 8 is a single storey 'U'-shaped structure with the arms of the 'U' forming the short ranges (Plate 13). It is aligned north-west to south-east and extends the entire width of the complex, sharing walls with shelter shed 4, shed 6 and cart shed 7. In plan it is 28.2m long x 15.1m wide and is constructed of red brick with dimensions of 223 x 109 x 63mm laid in English bond. The long part of the 'U' is hipped and roofed with pan-tile, whilst the short parts have gable ends. The inner parts of the 'U' were originally open-fronted surrounding an open yard 16.4m long x 9m wide with a brick enclosure wall with two gates. The open front was supported on square timber posts held in an iron shoe on a square brick plinth of pale yellow stock bricks with dimensions of 200 x 105 x 68mm, with the top course moulded, which are original features (Plate 14). This open front has been infilled with brick, blockwork and horizontal weatherboarding, and subsequent entrances and windows inserted into this.

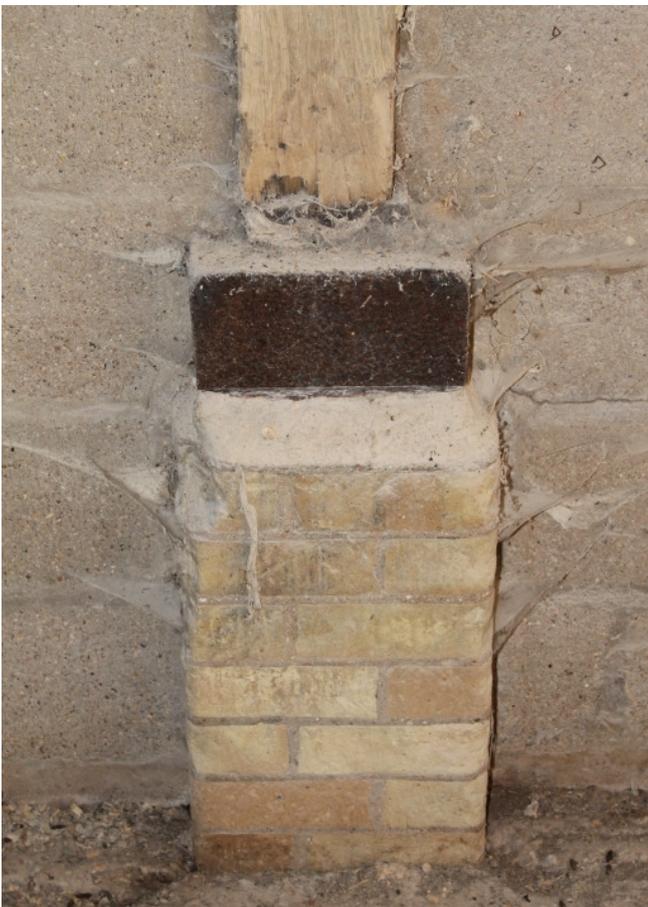
**Plate 14** Detail of brick and iron plinth for timber post of shelter shed 8

The supports for the open-fronted shelter sheds, with their hard stock brick plinths and protective iron shoes, illustrate the thought that was put into the construction materials used. Softer materials stood a much greater chance of being damaged by the animals and would eventually require replacement, costing the landowner money. The drainage system beneath shelter shed 4 reflects the increasing concern with hygiene in agriculture (enshrined in the 1885 regulations for dairy farming) as does the ventilation that is a feature of most of the structures.

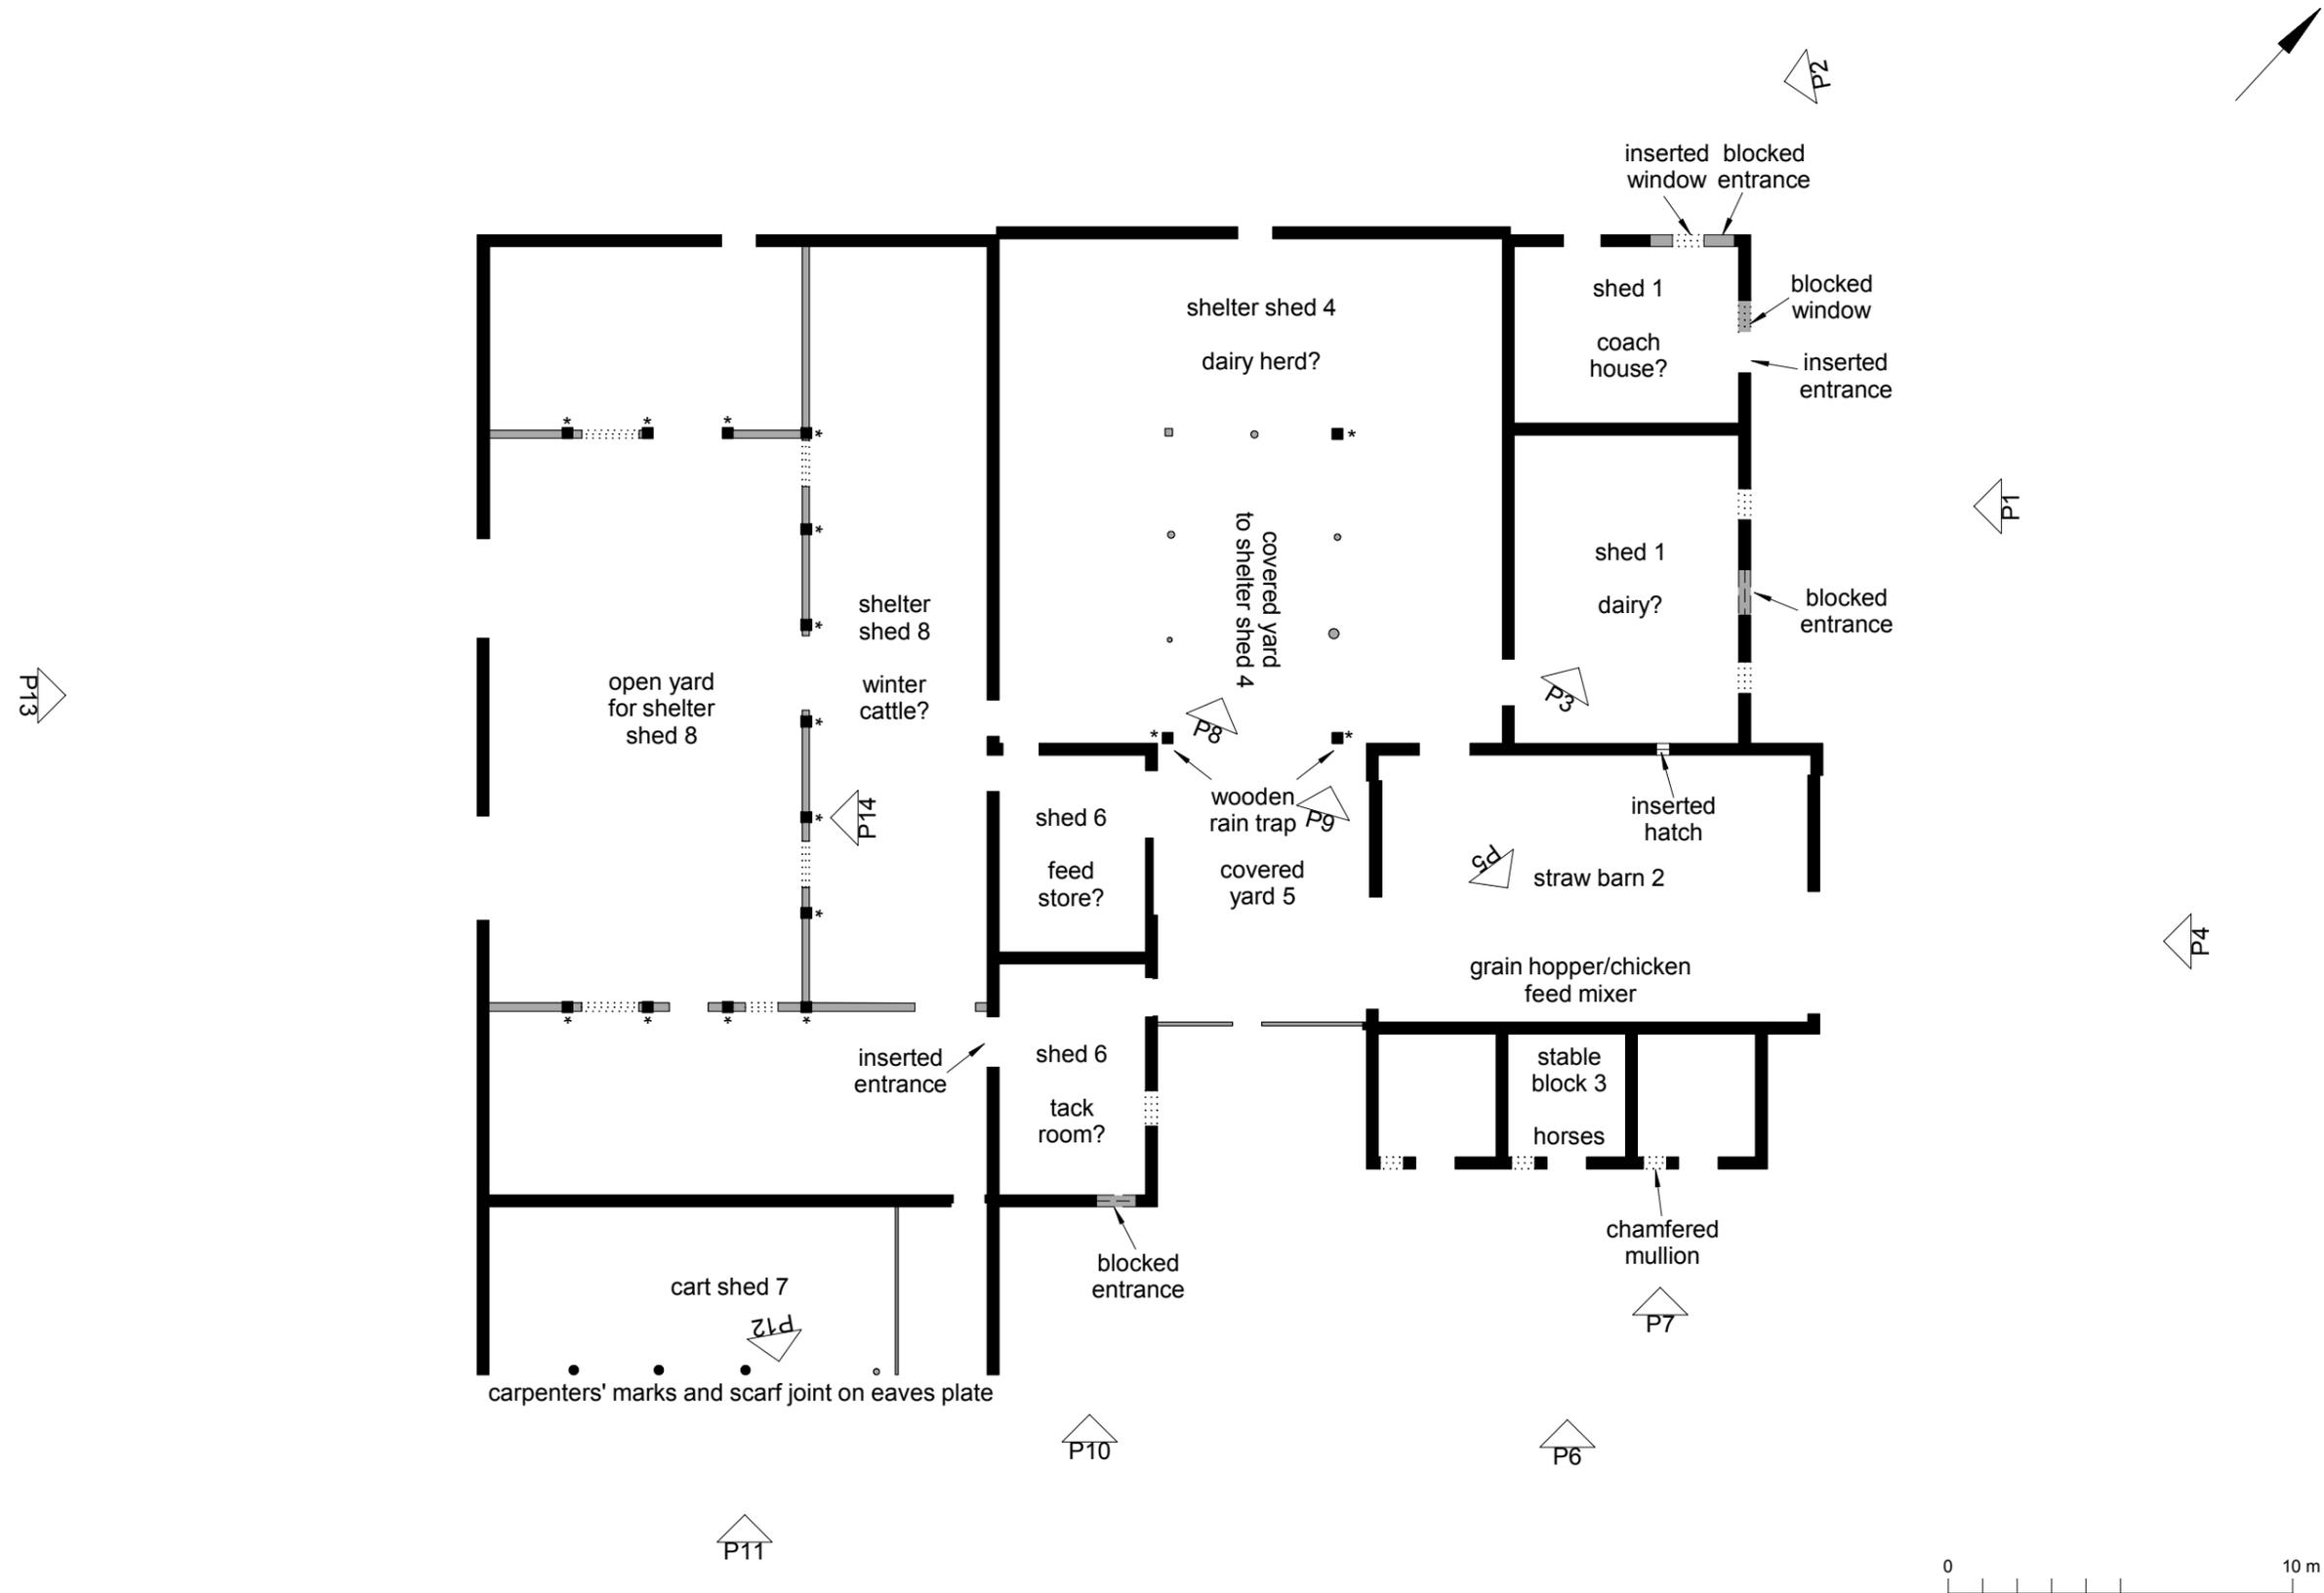
Fig 6 Kitchen Farm floor plan showing location and orientation of photographs included in the report, with alterations shaded grey.

The farm buildings comprise seven distinct structures combined in one large building and constructed in one phase with a covered yard from a later phase forming an eighth structure. These structures have been given an identifying number in the following text which corresponds to those on the floor plan (Fig 6).

\* = brick plinth with iron shoe for timber post

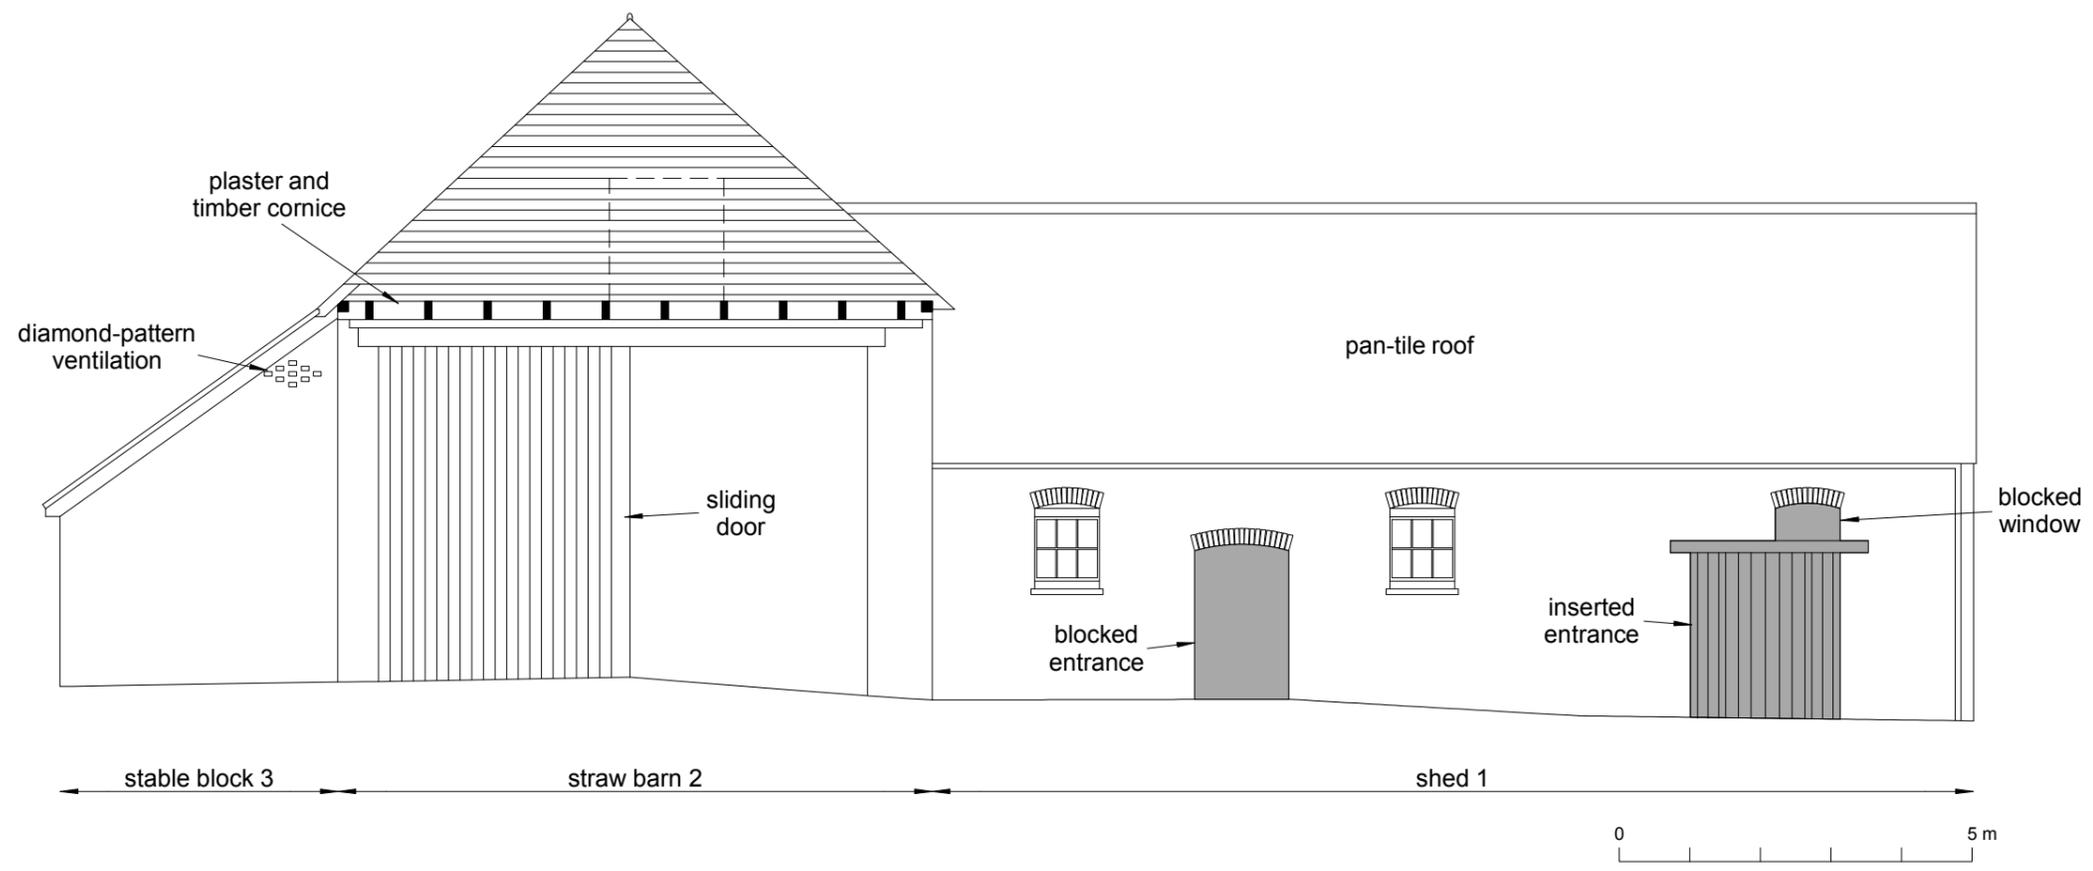
Fig 7 Kitchen Farm, north-east elevation with alterations shaded grey.

The north-east elevation has two wooden-framed windows of six lights with shallow brick arches and concrete sills. Between these windows is an entrance surmounted by a shallow brick arch. This entrance has been blocked by bricks laid in stretcher bond. Around this entrance are several instances of graffiti, initials carved into the brickwork, most visibly *H J* and *D L C B L*. No dates are carved along with these but it can be assumed that the authors were either farm workers at Kitchen Farm or tenants. To the north-west end of the elevation is a wide entrance with inward-opening double doors of vertical planks. This is clearly a later insertion as it truncates a third window with a shallow brick arch, the remains of which have been blocked with brick infill.
