**Historic building recording
of a 19th-century house and workshop
off West Stockwell Street,
Colchester, Essex**

March 2013

**report prepared by
Chris Lister**

CAT Report 691
August 2013

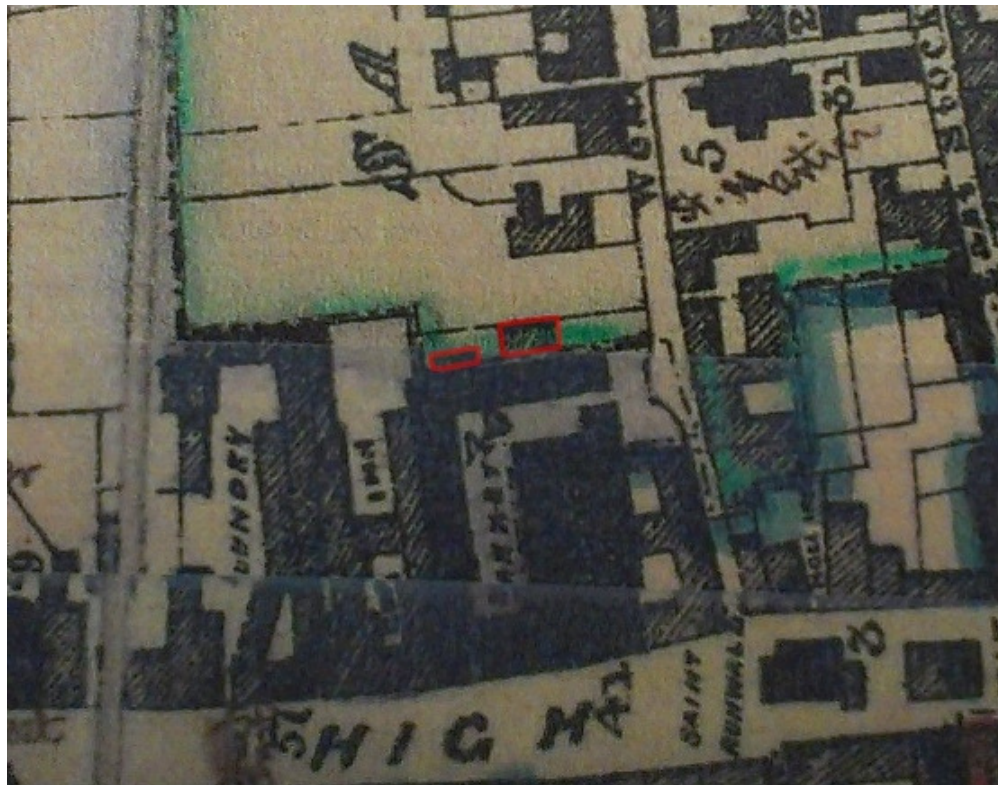
Fig 1 Monson map of Colchester, 1848.

This shows a rectangular structure occupying the centre of the plot (shown in red) with a smaller structure off to the west. The open space to the north is the garden of St Martin's House, whilst to the south there is a large rectangular structure. Although difficult to see on the map, there is open ground between the south edge of the house and the property boundary. This open ground corresponds with the covered yards that lead to the large workshop on the site. The property depicted on the map extends further west than the 1830 house which may indicate the building was originally larger, possibly a back-to-back dwelling.

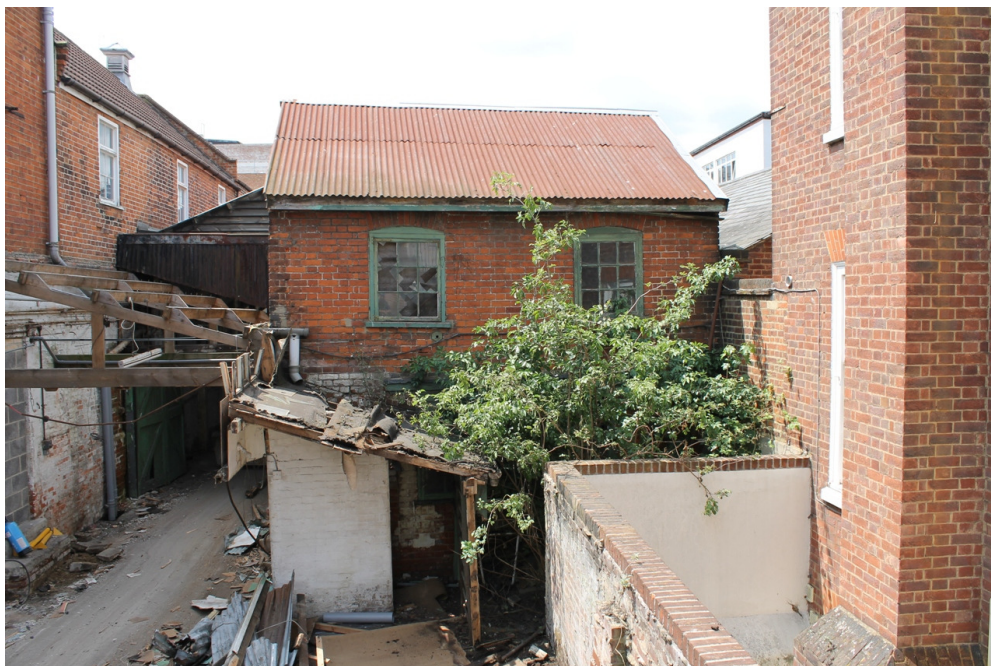
This is a two-storey building constructed of red brick with dimensions of 237 x 111 x 66mm laid in Flemish bond (Plate 1). Only the east wall and the lower portion of the south wall remain of the original fabric, the rest of the building, including the roof, has

Plate 1 East elevation of the converted 1830 house - view west

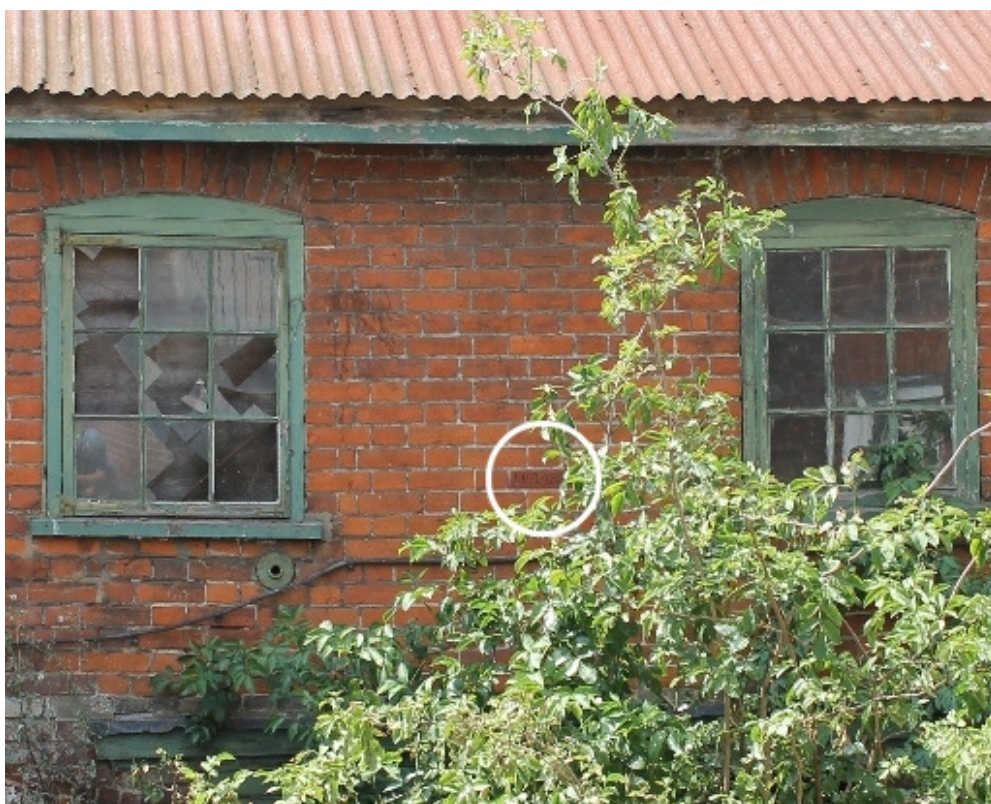
been rebuilt in later materials. The east wall has identical doorways surmounted by shallow brick arches, indicating that the structure was divided into two dwellings. These entrances have been blocked by later brickwork. Between the doorways a wide window has been inserted, presumably replacing original windows. There are two window openings in the upper storey of this elevation, each with shallow brick arches identical to those over the doorways. The window frames are replacement casements with nine lights, rather than sash windows. A date brick with the inscription 'WR 1830' is located between these windows (Plate 2).

Plate 2 East elevation of the converted 1830 house with the date brick circled – view west

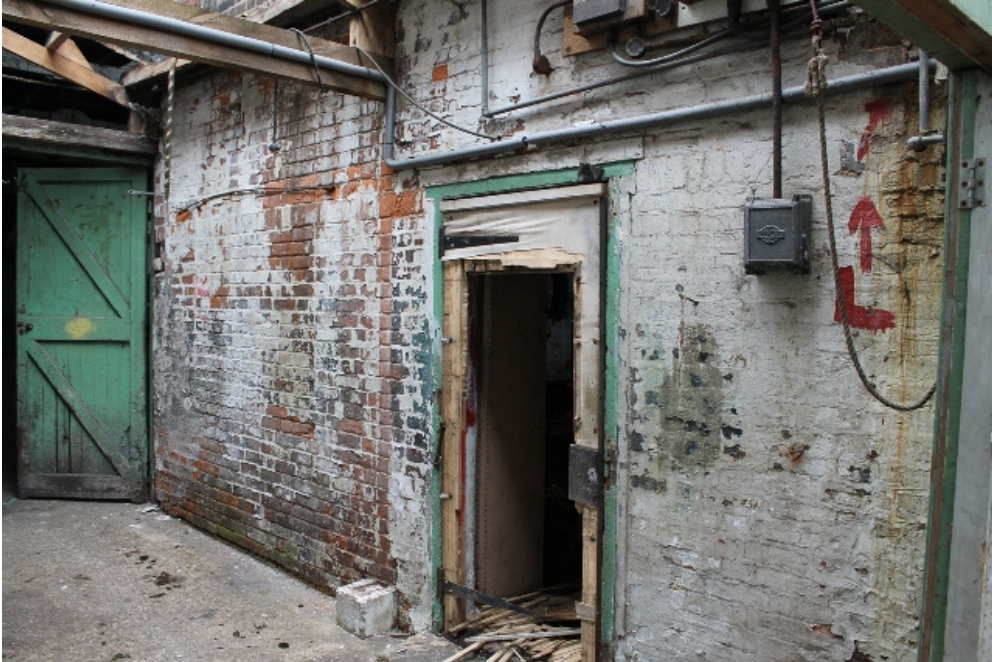
The south wall has a doorway partially inserted through a blocked window in the ground floor and a second blocked window towards the west (Plate 3). The first floor has been rebuilt in red brick with dimensions of 222 x 110 x 66mm laid in Flemish bond. This later wall includes an irregular-shaped window, which has subsequently been bricked-in (Plate 4). The gable has collapsed and been replaced with vertical sheets of corrugated iron.

Plate 3 South elevation of the converted 1830 house, showing the inserted doorway and blocked windows – view north-west

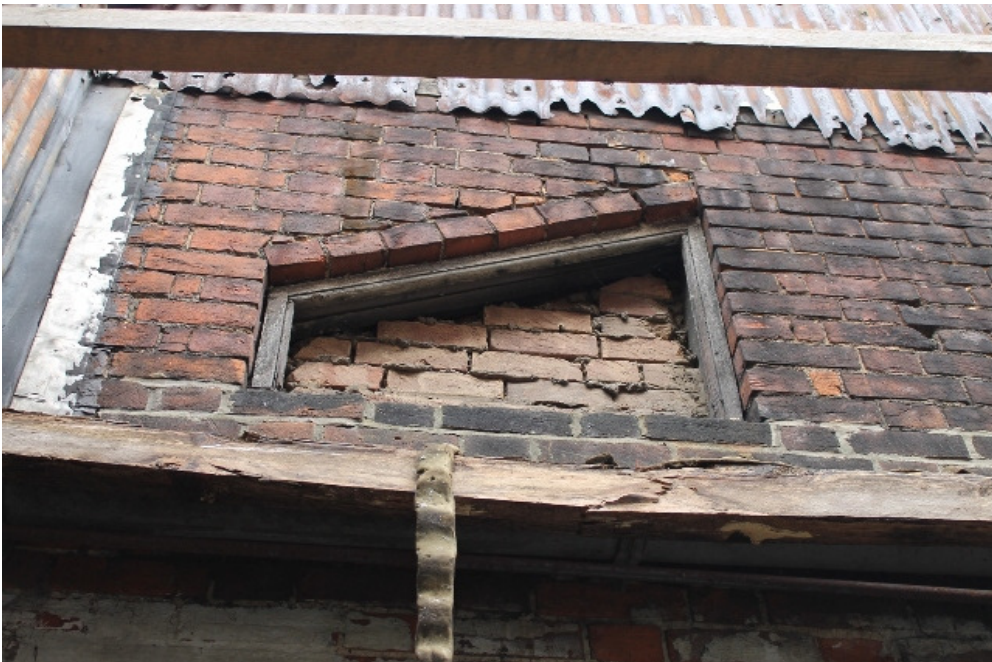
Plate 4 The rebuilt first floor wall of the converted 1830 house, showing the irregular-shaped window – view north

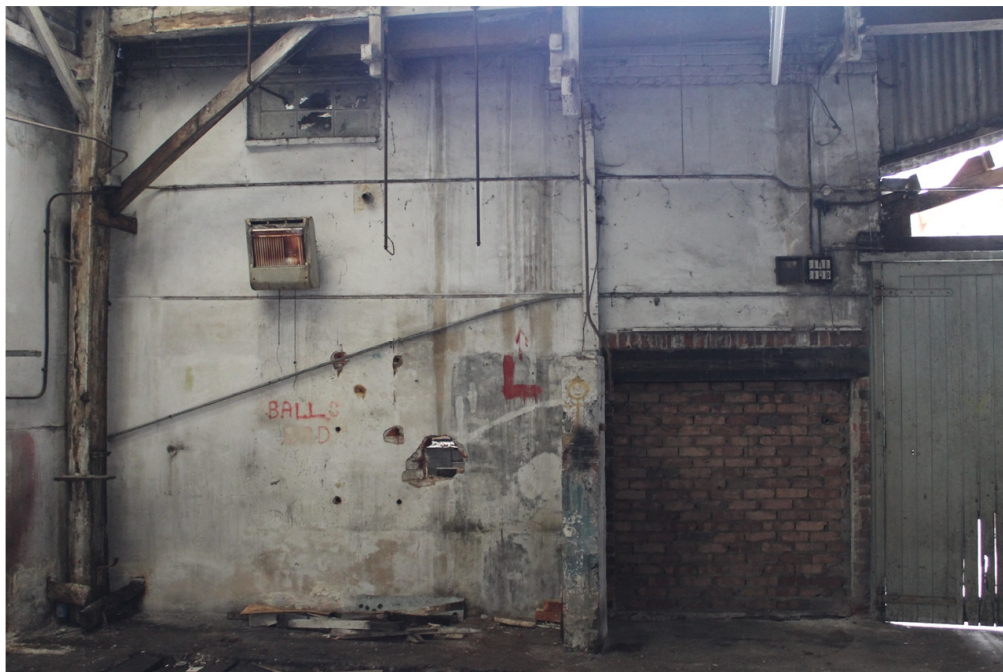
The west wall is a later addition and is at an obtuse angle to the south wall. This has the effect of widening the house from 5.4m to 5.8m. The west wall has a wide doorway on the ground floor that has subsequently been bricked-in (Plate 5). The wall has been rendered and there is a small six-light metal-framed window below the eaves.

Plate 5 The replacement west wall of the converted 1830 house - view east

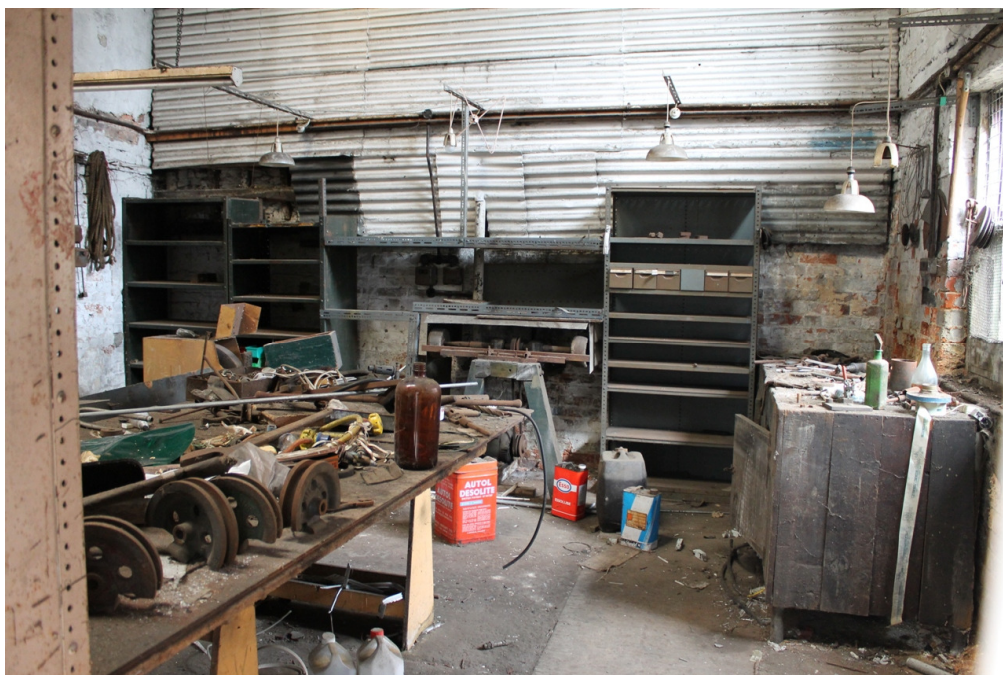
The interior of the house showed that significant alterations have taken place since construction (Plate 6). As well as the changes to the external walls noted above, the first floor has been removed, along with wall dividing the house into two dwellings. Evidence for this can be seen as vertical brick scars in the east and west walls (Plates 7 and 8). As the west wall is a replacement wall, but still displays the scar of the dividing wall, this indicates that the west wall was altered before the first floor and dividing wall were removed.

Plate 6 Interior of the converted 1830 house, showing the Williams and Co workshop
- view north-west

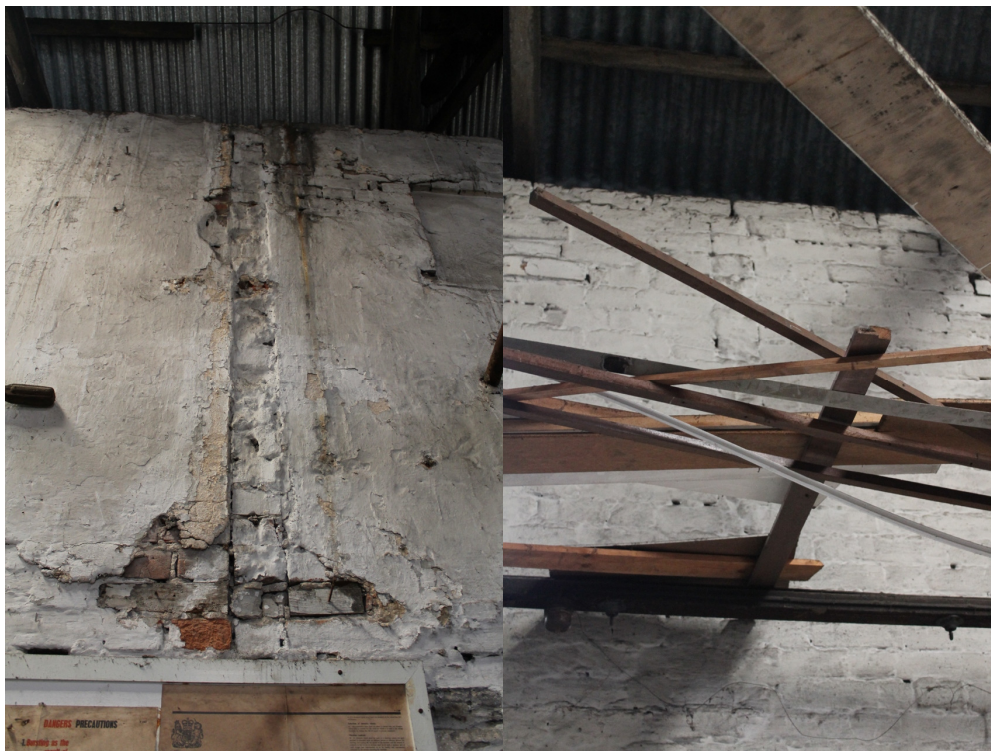
Plates 7 and 8 Evidence for the removed dividing wall in the converted 1830 house

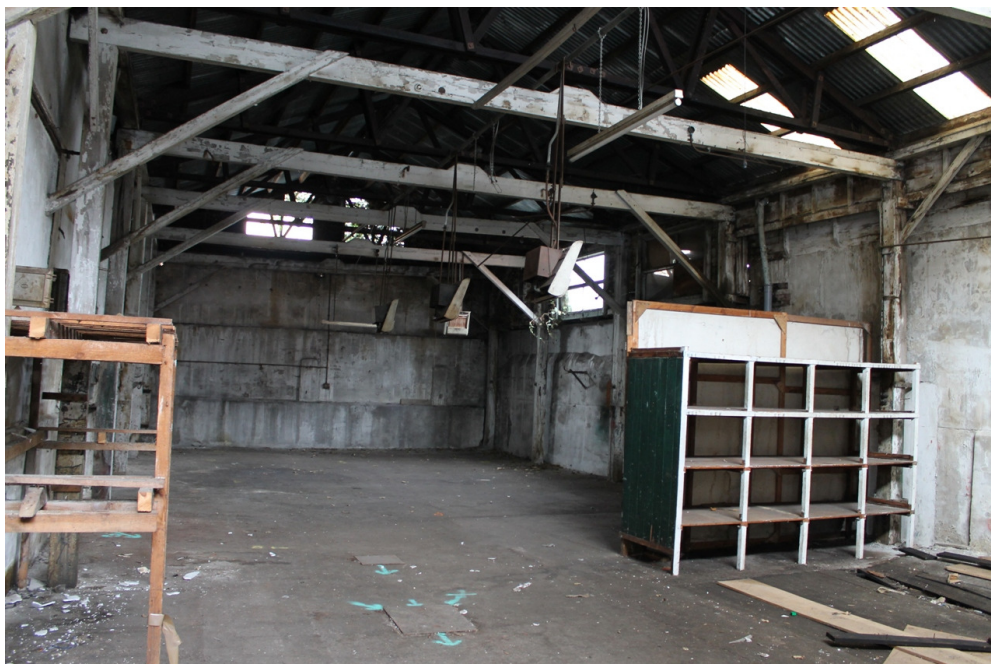
The workshop is a six-bay, open-plan, rectangular building, 19m long x 9m wide, with large-section timber posts that carry straight tie beams with straight braces. The original roof trusses appear to have been carried on king posts, but these have been removed (Plate 9). The timber-frame is independent of the brick walls of the properties to the north, south and west of the workshop and this suggests that the original frame was inserted into the open space between these buildings. The workshop has a later roof of corrugated iron sheeting carried on steel geometric trusses. This is not carried by the original tie beams but is instead supported on the surrounding walls. In places the surrounding walls have been built up or filled in to enclose the workshop. This is particularly obvious on the north wall where the width of the wall gets narrower towards the top and is then replaced by horizontal weatherboarding into which windows have been inserted (Plate 10). The four bays closest to the converted 1830 house each have a centrally located air vent in the ridge of the roof.

Plate 9 Interior of the workshop, showing the original timber frame and the later roof
- view north-west

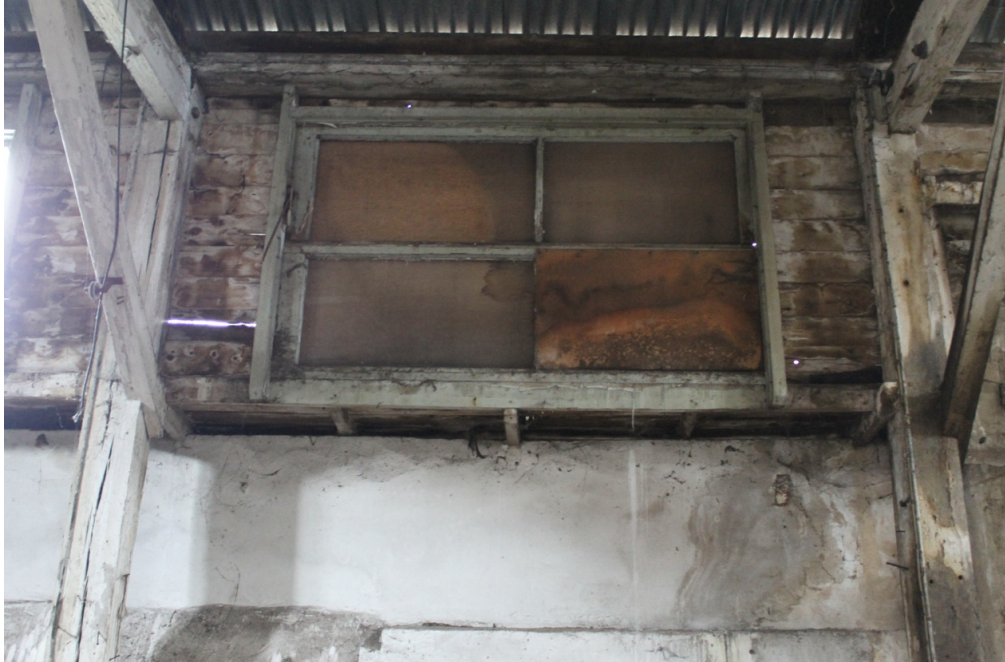
Plate 10 North wall of the workshop, showing the structure built on the adjoining property wall - view north

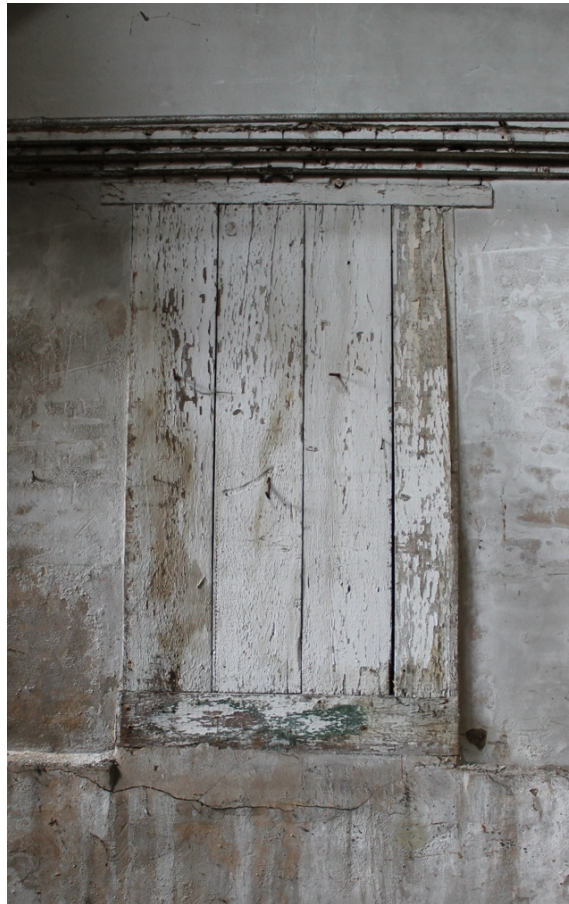
There is a possible access point from the building to the south into the workshop in the easternmost bay of the workshop. Four vertical planks cover an opening 1.12m wide x 1.93m high, which is either a window or more likely a door leading from the adjoining former Cups Hotel stable (Plate 11).

Plate 11 Possible entrance from former Cups Hotel stables into workshop – view north

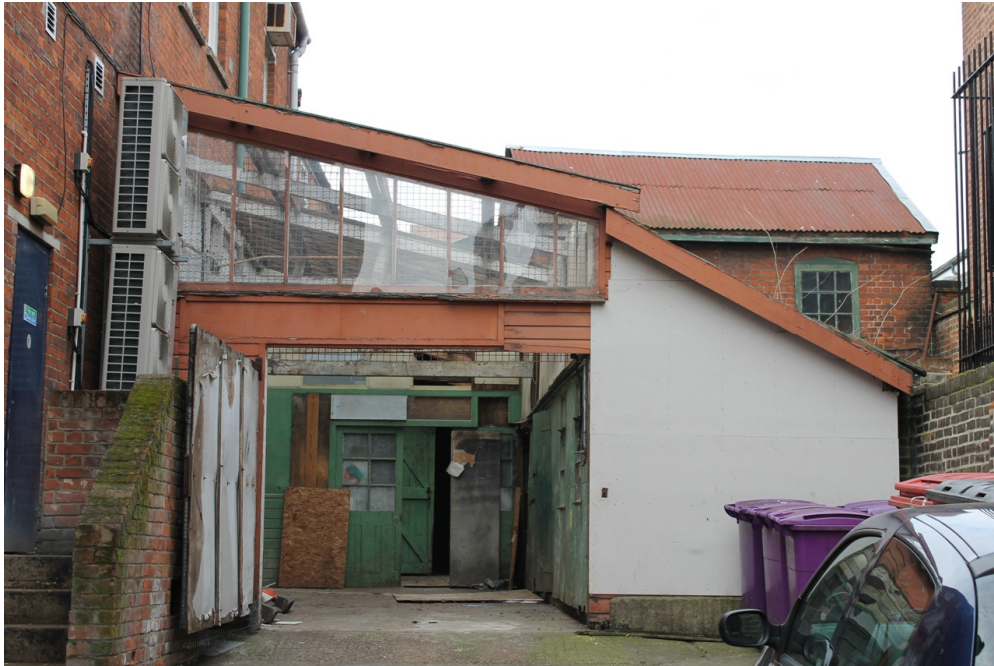
This structure is a single-storey, mono-pitch shed, constructed from timber and consisting of an office and a kitchen (Plate 12). This is a very simple structure that has been repaired several times and has had two metal-framed windows inserted into the south elevation (Plate 13).

Plate 12 The 20th-century mono-pitch shed - view west

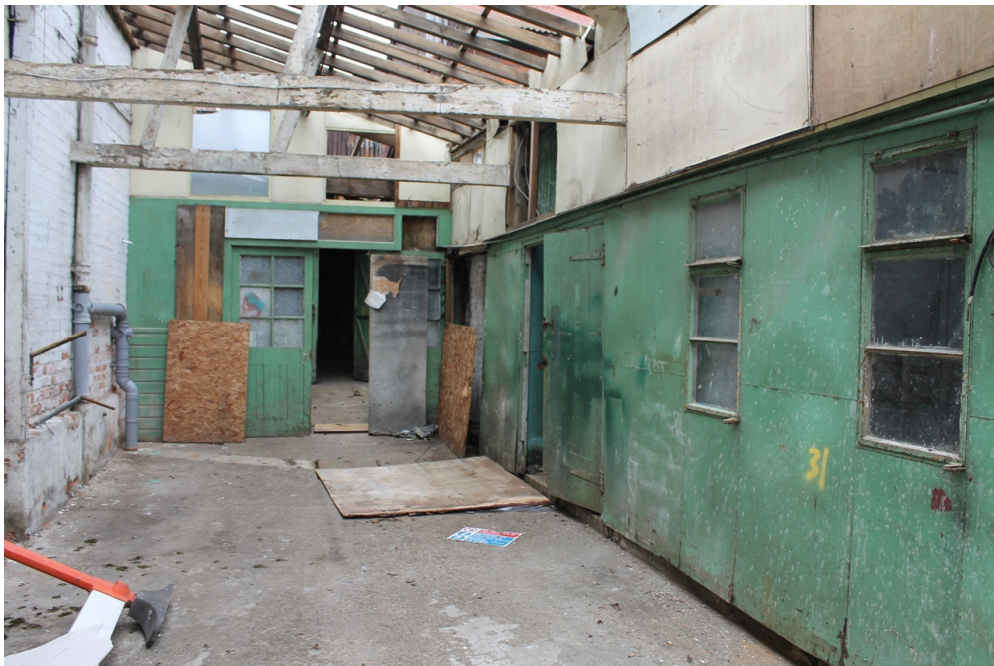
Plate 13 Inserted metal-framed windows in the south wall of the wooden shed – view west

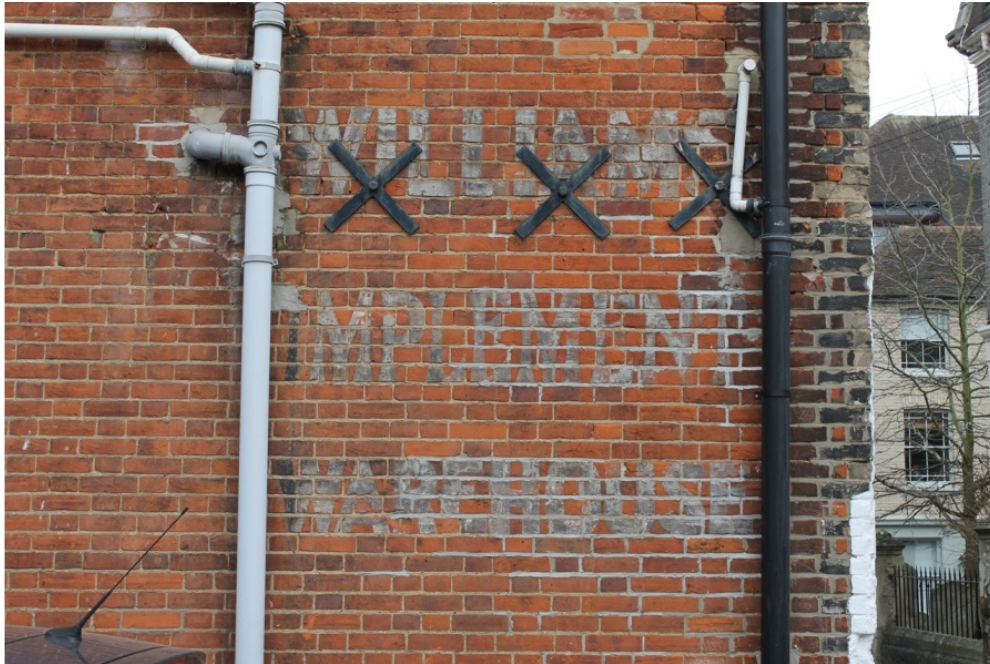
Plate 14 Painted sign on west wall of the Victoria Chambers – view east
