**Archaeological monitoring around
Roman Circus House,
Off Circular Road North,
Colchester, Essex
February 2012 - July 2013**

CAT project ref.: 13/06c
Historic Environment site code: 2013.32
NGR: TL 9942, 2461

CAT Report 722
August 2013

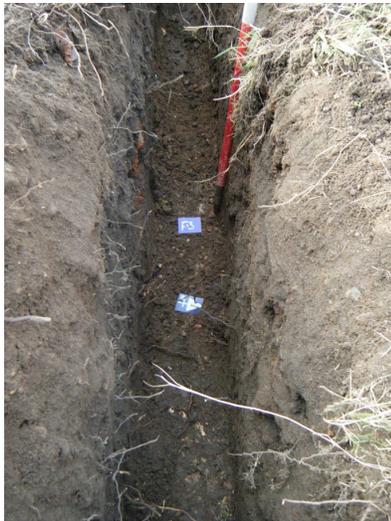
The only feature of interest was F3 (Plate 1). The narrowness of the trench makes interpretation difficult, but it appears to be an intentionally placed surface, possibly a path running north-west to south-east. No finds were recovered from the trench.

Plate 1 Electricity trench, possible path F3. Facing west.

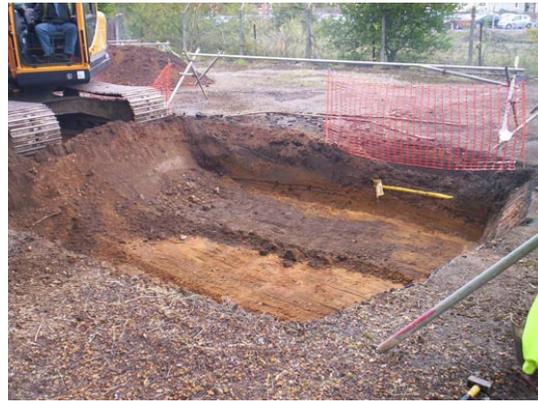
Nothing of archaeological interest was exposed. The only feature observed was a cut for a modern pipe running north-south across the foundation trench (Plate 2). No finds were recovered.

Plate 2 Bat *hibernaculum* foundations, showing modern service. Facing west.

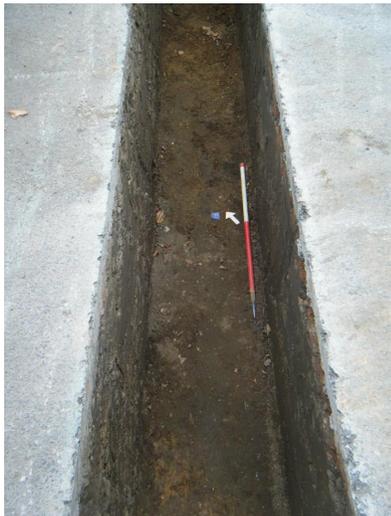
During the digging of the foundations, F1 (Plate 3) was cut into 200-300mm, and F2 (Plate 4) was cut into by 400-500mm, but neither feature was bottomed when foundation trench was fully excavated.

F1 has fragments of a pottery bowl dating from the late 2nd century to 3rd century, whereas F2 has a greyware pottery fragment from a large bowl of a broad Roman date. Both these features would have been associated with the high level of Roman activity to the south of the town, surrounding the Circus.

Plate 3 Archive store footings, ditch F1. Facing north-east.

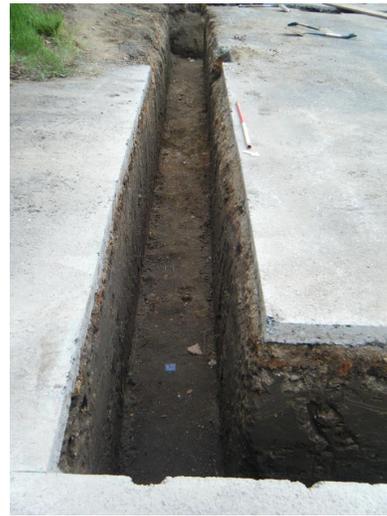
Plate 4 Archive store footings, pit F2. Facing south-west.

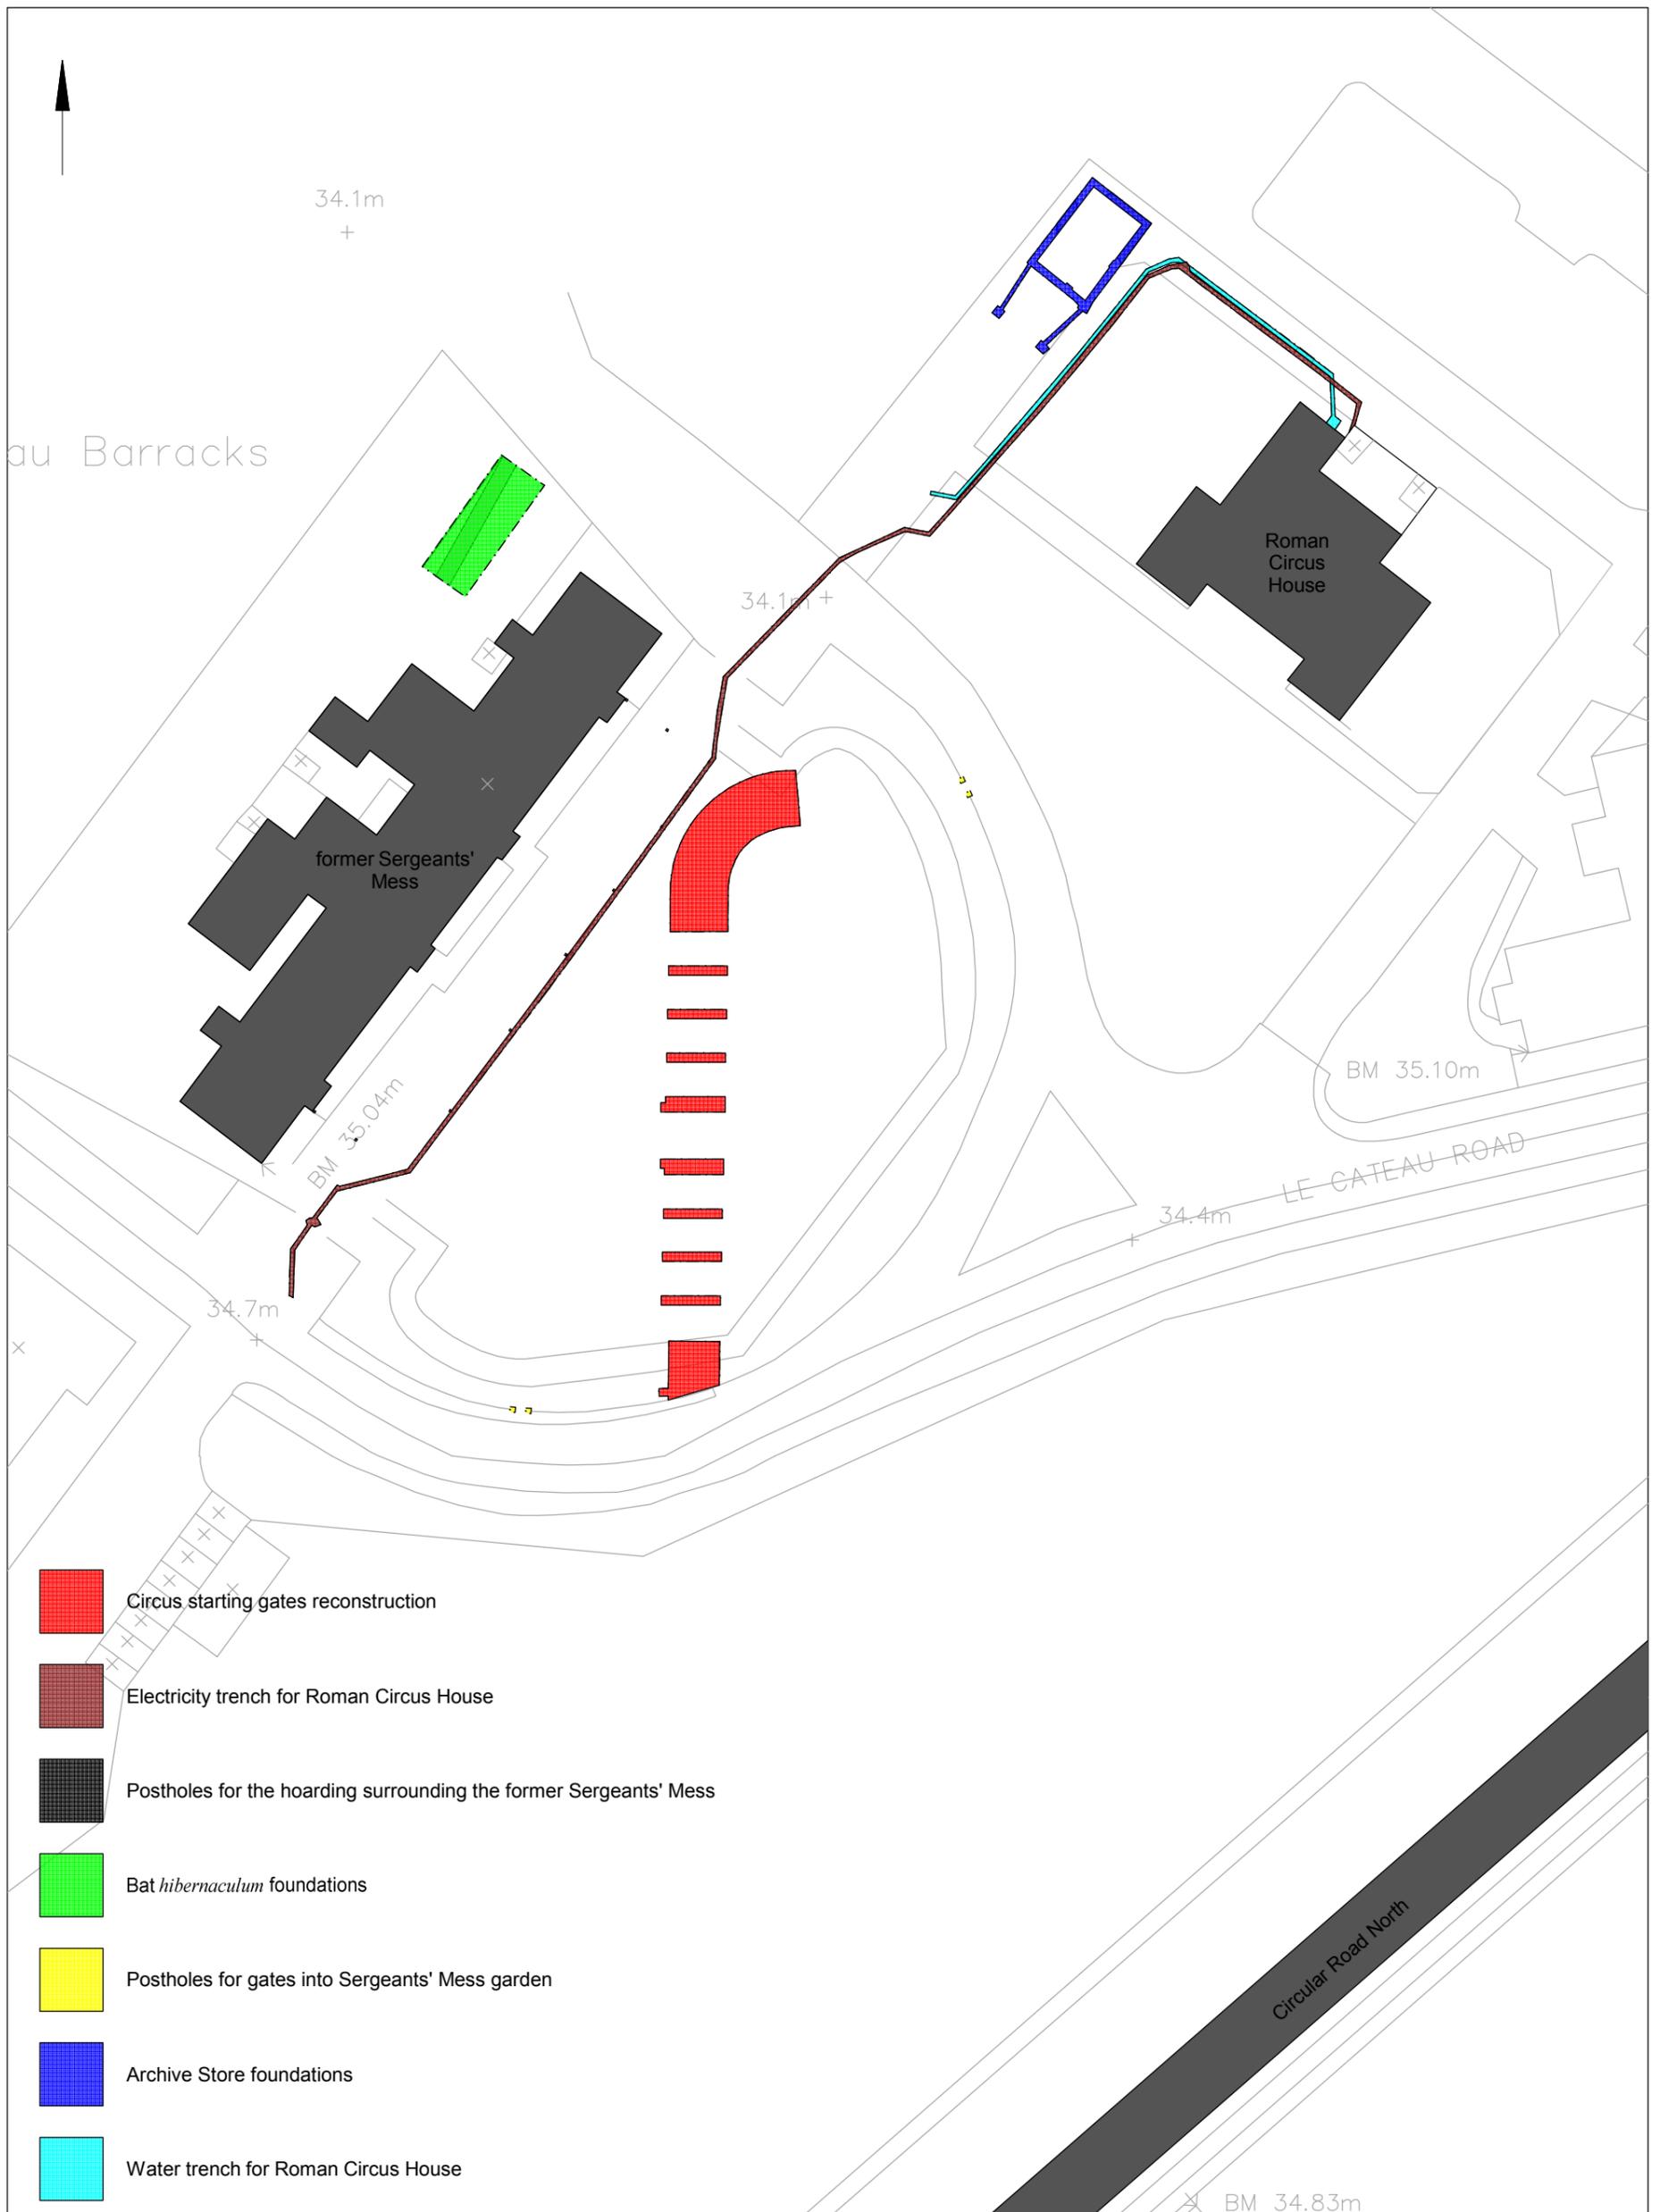
Approximately 160m of trenching (at a width of 350mm-400mm and a depth of 700-750mm) was excavated from the west edge of the garden of the Sergeants' Mess (SM garden) to Roman Circus House (Fig 2).

Four postholes were dug (Fig 2) for the placement of two new gates allowing entrance into the SM garden. They were 300mm square and 550-600mm deep, and cut into the topsoil of grey/brown sandy silt. No archaeology was observed or finds recovered.

Fig 2 Areas observed by archaeological watching brief.

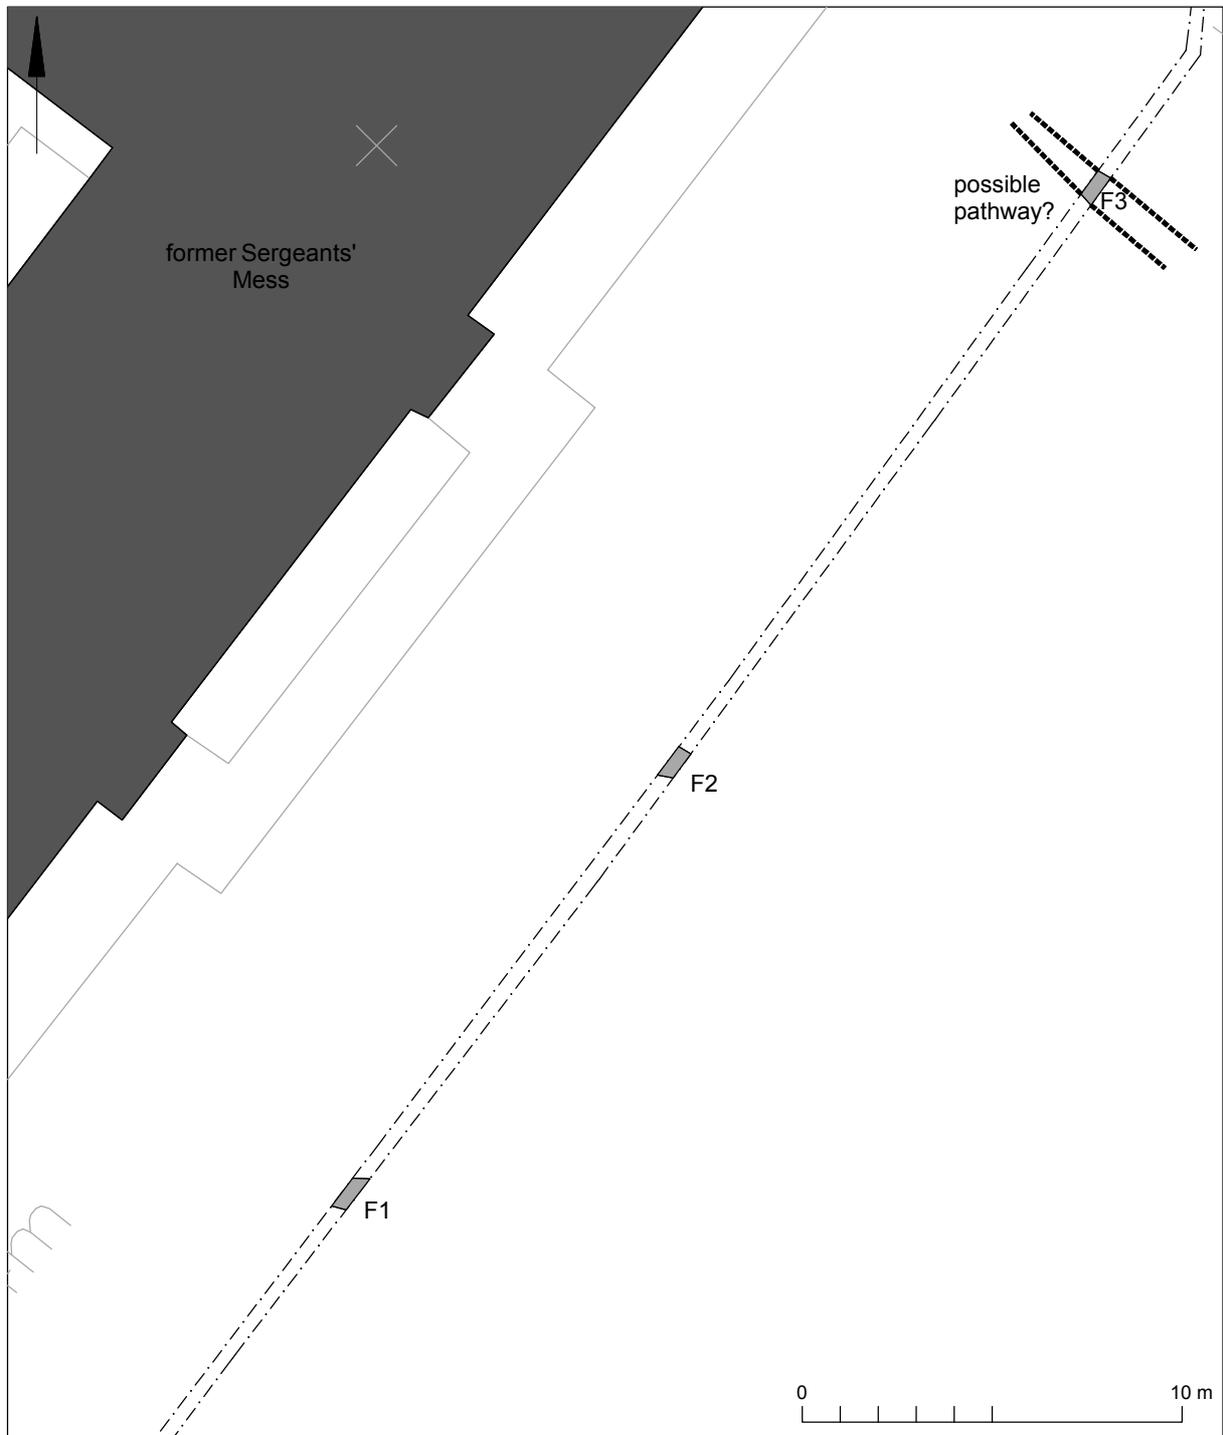
Three features were identified in the SM garden (Fig 3):

Context	Description	Finds	Date
F1	linear(?) with soft, moist light grey/brown sandy silt fill	peg tile (not retained)	post-medieval
F2	linear(?) With soft, moist light grey/brown sandy silt fill	brick (not retained)	post-medieval/modern
F3	700mm wide patch of small CBM/ragstone fragments. pathway?	-	Roman?

Fig 3 Electricity trench for Roman Cirus House watching brief results.

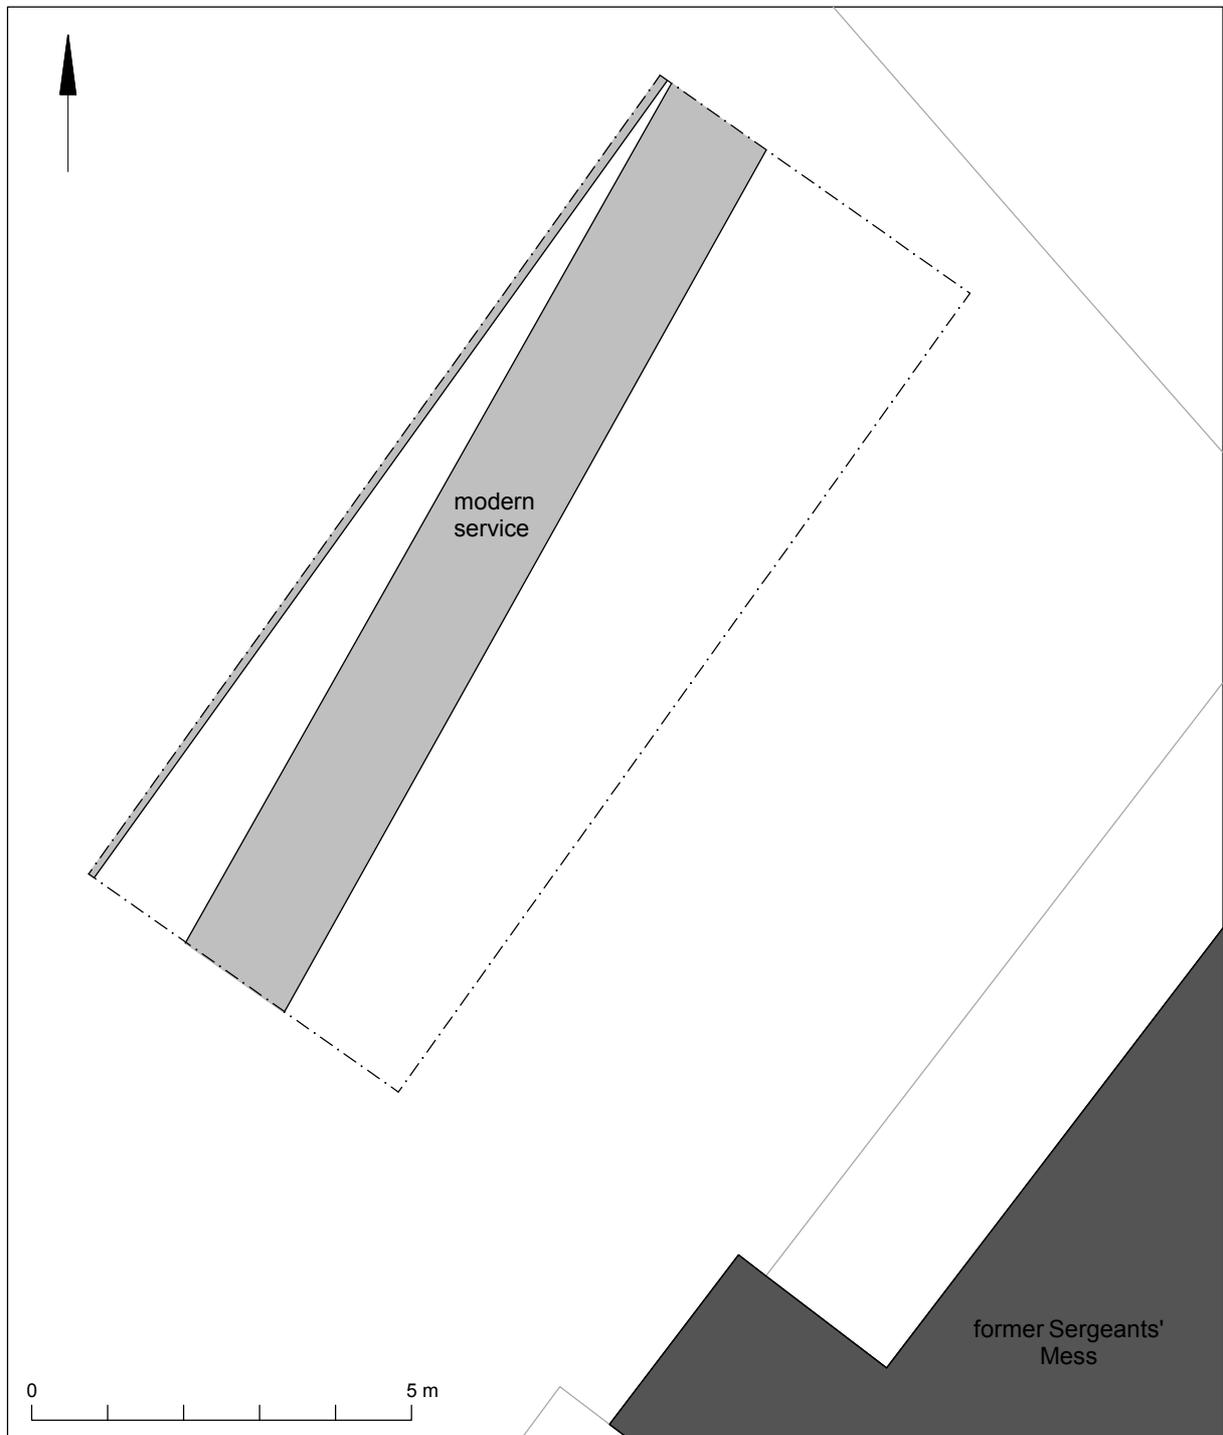
A foundation 13m long and 5m wide was dug under archaeological supervision to the north-west of the former Sergeants' Mess. 300mm of tarmac and crush was dug through before a layer of topsoil 500mm thick was uncovered. Below this the trench cut into the natural orange sand and gravel for 1200mm before it was bottomed.

Fig 4 Bat *hibernaculum* footings watching brief results.

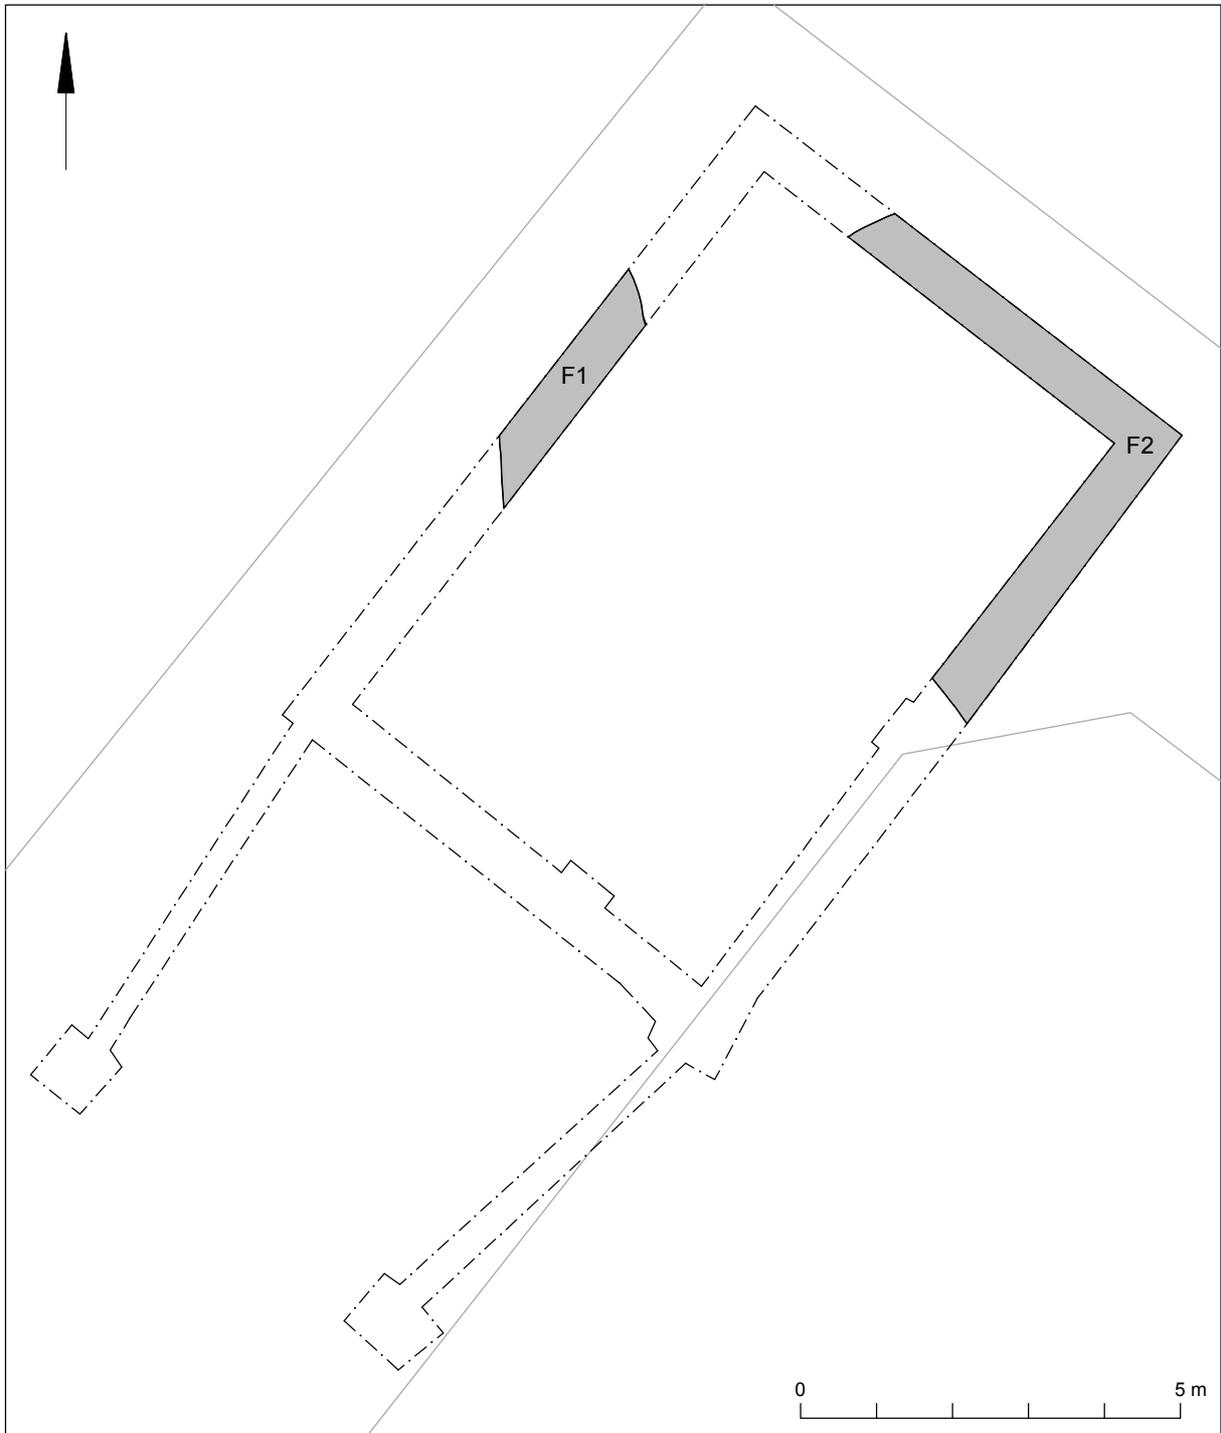
Two archaeological features were observed during monitoring (Fig 5):

Context	Description	Finds	Date
F1	linear with a dark black sandy silt fill, running north-south?	pottery, tile	Roman
F2	large pit(?) with a dark black sandy silt fill	pottery, tile	Roman

Fig 5 Archive store footings watching brief results.
