An archaeological watching brief at St George's Church, Great Bromley, Essex

October 2013

CAT Report 743
November 2013

Summary of archaeological watching brief at St George's Church, Great Bromley

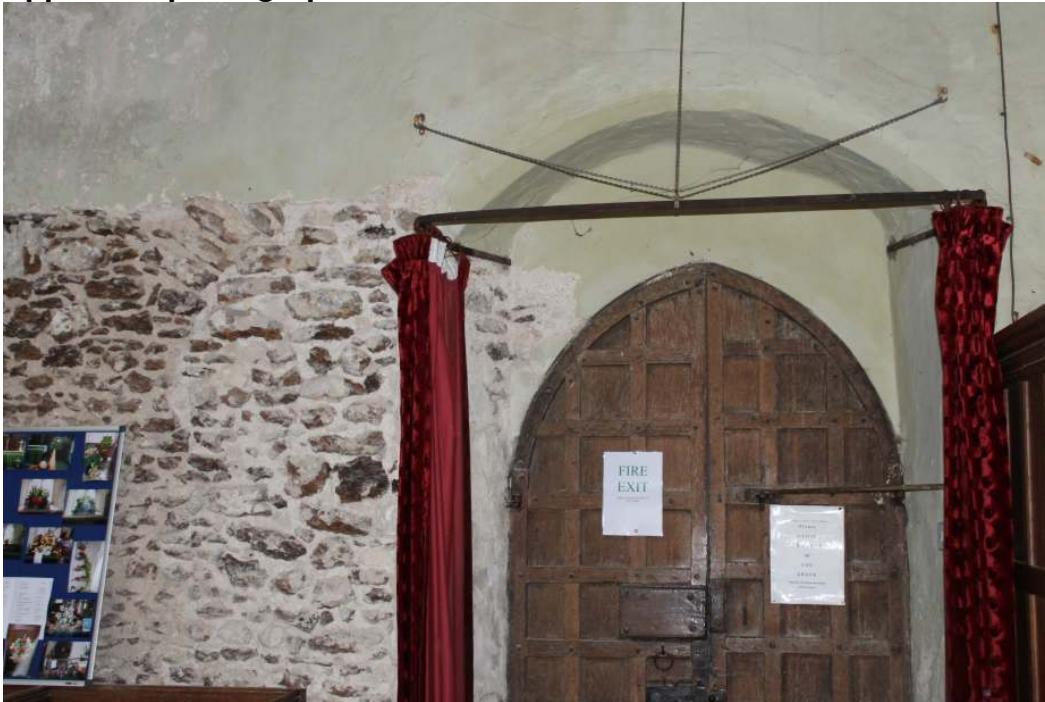
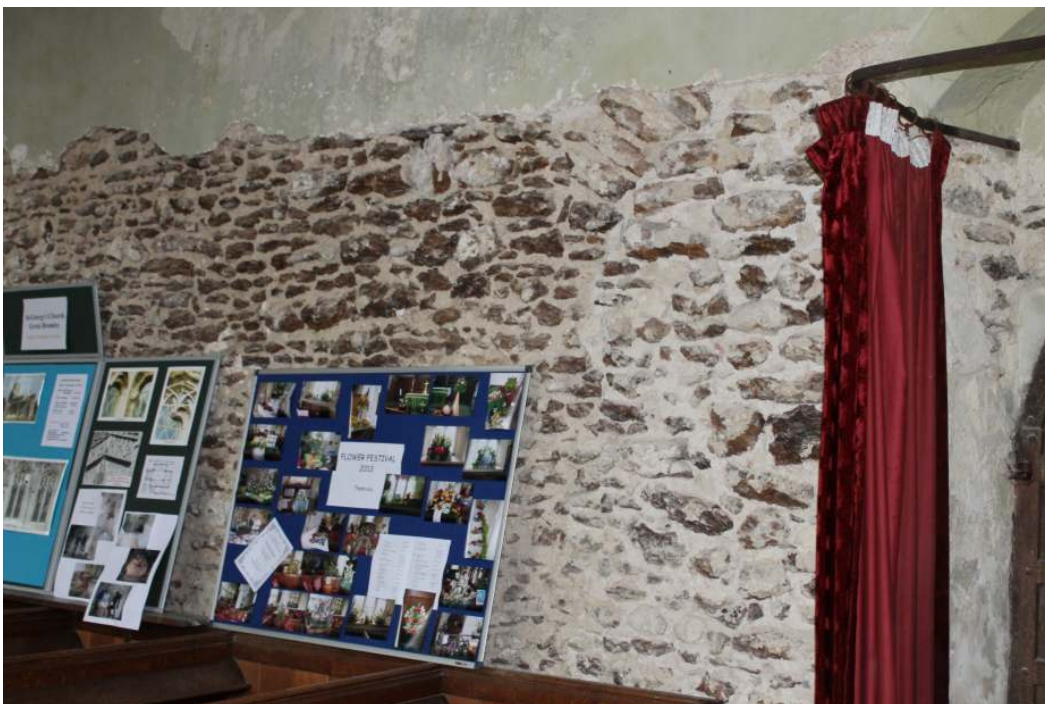
The two photos above of the south wall of the south aisle appear to show a blocked doorway arch immediately east of the present porch, and a blocked ?window approximately 4m to the east (partially hidden by middle notice-board). We share Rodwell's view (*Historic Churches – a wasting asset*. CBA Research Report 19, 1977, page 99) that there must be an earlier medieval church under the 14th/15th century fabric now extant. Could these be part of it?

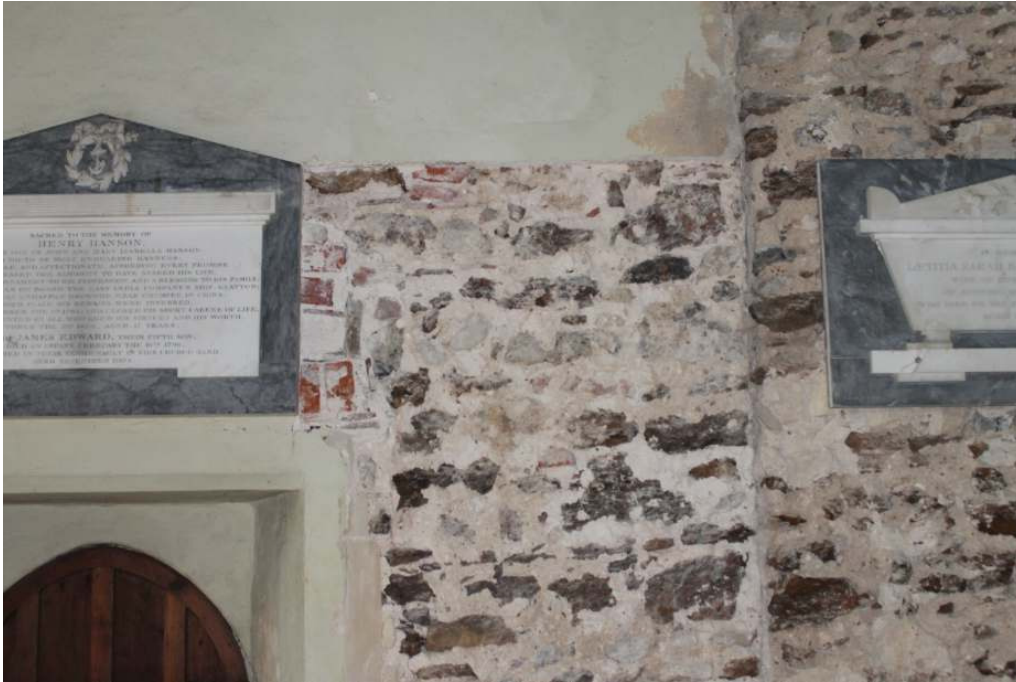
This photograph is farther along the south aisle wall than the previous two. It appears to show two different building styles (ie, periods) near this small door. To the right is older work (original south aisle?) and to the left is more recent work with the external door (extension to south aisle).
