# Archaeological trial-trenching evaluation at Down Hall Residential Home, Down Hall Road, Bradwell-on-Sea, Essex

Planning ref: 13/00751/MAL

**CAT Report 747**

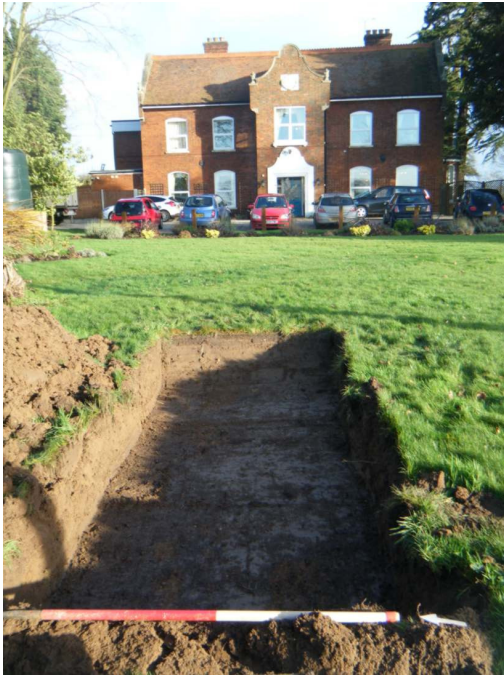
**Plate 1: Trench 1, view east towards Hall**

T1, located on the northern site edge, contained no archaeological material or features.

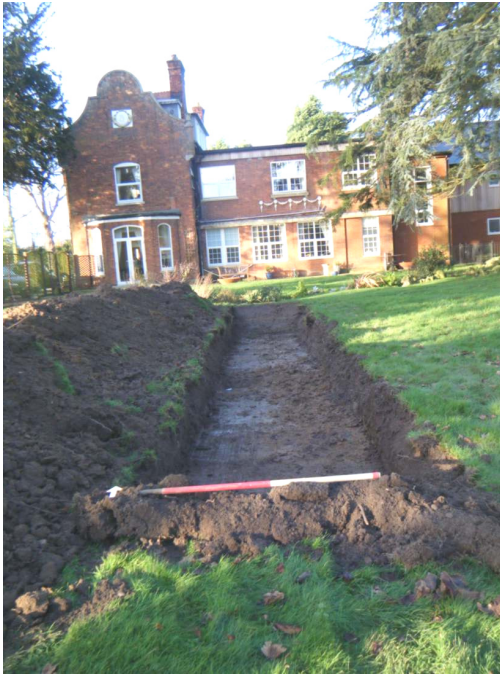
**Plate 2: T3, view north towards Hall**

T3, located in the centre of the site, contained a ditch F4, and a modern service run (unexcavated). The ditch is probably a boundary or drainage ditch associated with the grounds of Down Hall, dated to the post-medieval period by the brick and peg-tile fragments in its fill.
