**Historic building recording  
at Betts Farm, Stebbing Road,  
Bardfield Saling, Essex  
December 2013**

**report prepared by  
Chris Lister**

**commissioned by  
Andrew Stevenson Associates  
on behalf of  
Mr and Mrs Escott**

**CAT Report 748**  
January 2014

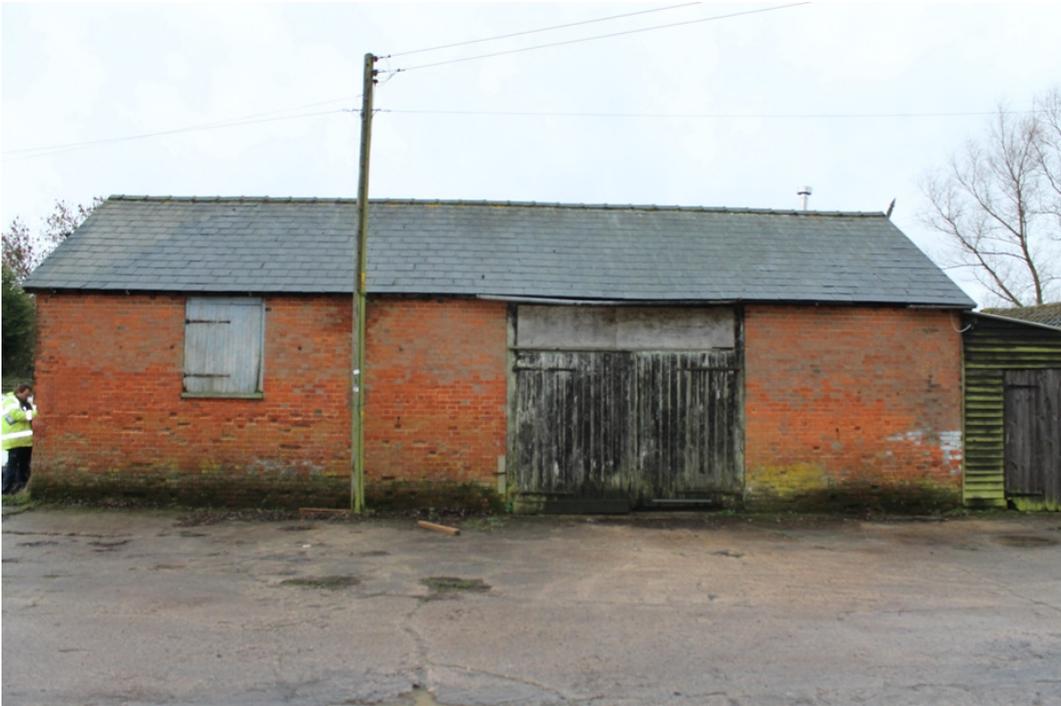
**Plate 1** Brick barn at Betts Farm, north-east elevation, with ?original pitching door and later cart doors - view south-west

The barn is a single-storey structure aligned north-west to south-east, 14.8m long x 6.15m wide (Plate 1). It is constructed from red brick with dimensions of 230 x 110 x 70mm, laid in Flemish bond, although the gables are in stretcher bond. Below the gable of the south-east elevation, the wall is constructed from Fletton bricks with dimensions of 220 x 105 x 70mm, laid in Flemish bond. Due to the attached garage it was not possible to ascertain if the lower portion of the north-west elevation is also constructed of Fletton bricks, although this seems likely. The gabled roof has a slate covering with plain barge boards and a turned finial at the apex of the north-west gable (Plate 2). Staining on the apex of the barge boards of the south-east gable indicates the location of a second finial.

The north-east elevation (Plate 1) has a pair of off-centre cart doors with iron strap hinges held on pintels. The cart door opening is the entire height of the wall, but the upper portion of this opening is boarded over, indicating the doors are replacements, although the hinges appear to have been re-used from the original doors. There are small iron hooks attached to the brickwork to hold the cart doors open (Plate 3). As these are attached to the brickwork by Phillips head screws (invented 1936), they cannot be an original feature, which suggests they are associated with the replacement doors. There is a second, smaller door to this elevation, raised off of ground level to shoulder height. This door is original to the structure and has similar iron strap hinges held on pintels as those on the cart doors. The height of the door indicates this would have been a pitching door.

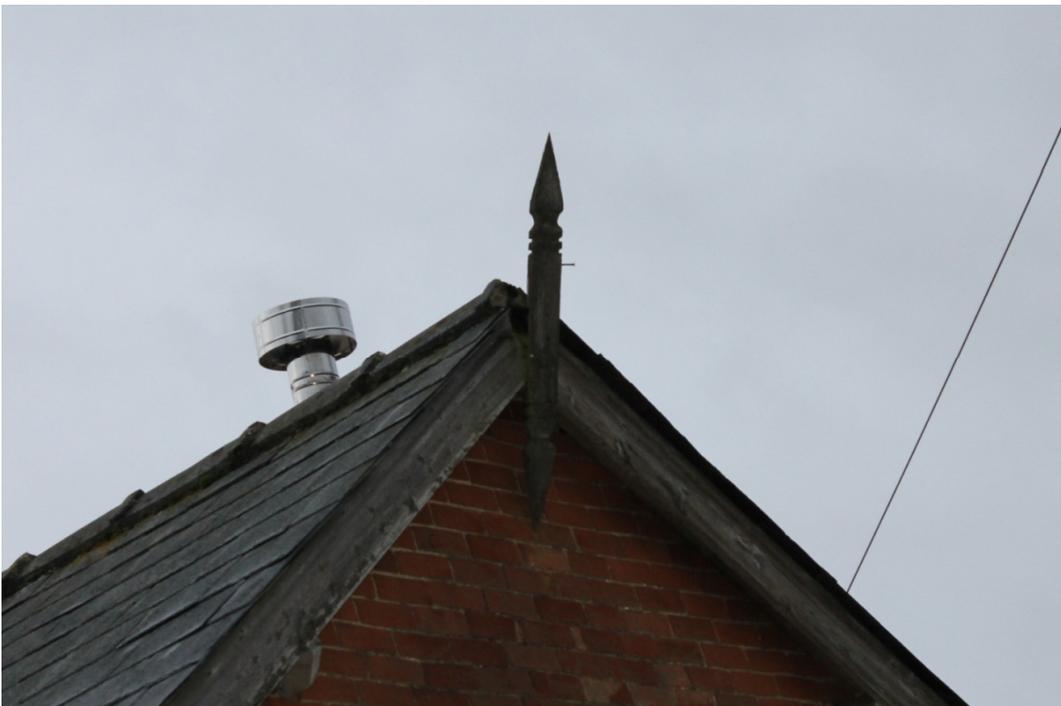
**Plate 2** Turned finial on apex of north-west gable – view south-west

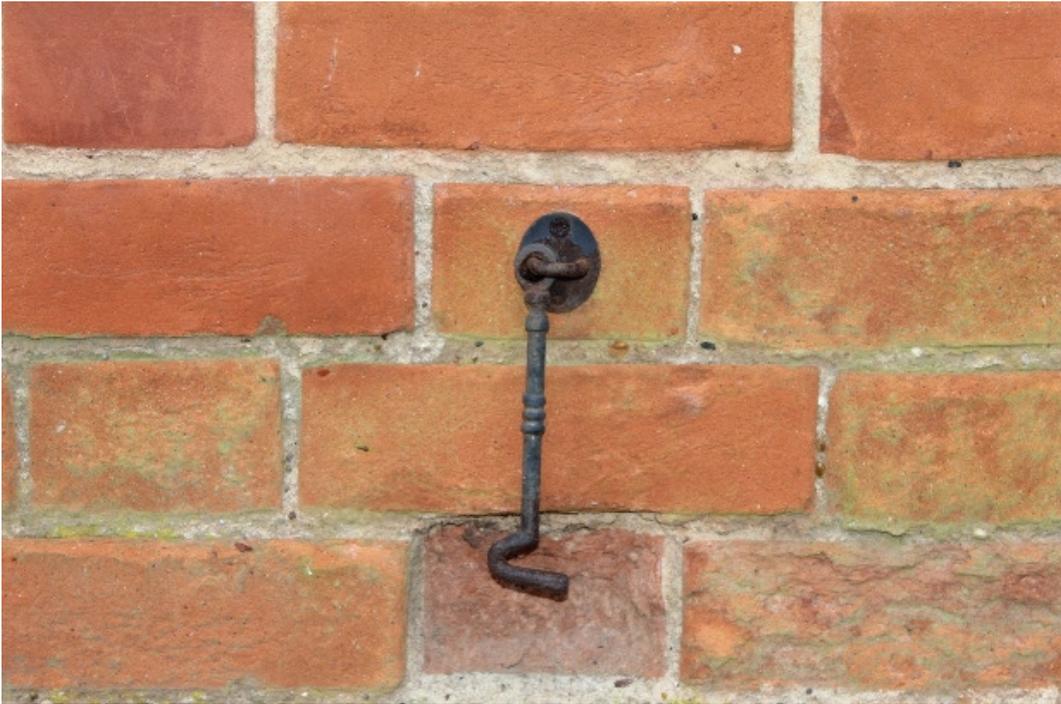
**Plate 3** Hook for holding open cart doors on north-west elevation – view south-west

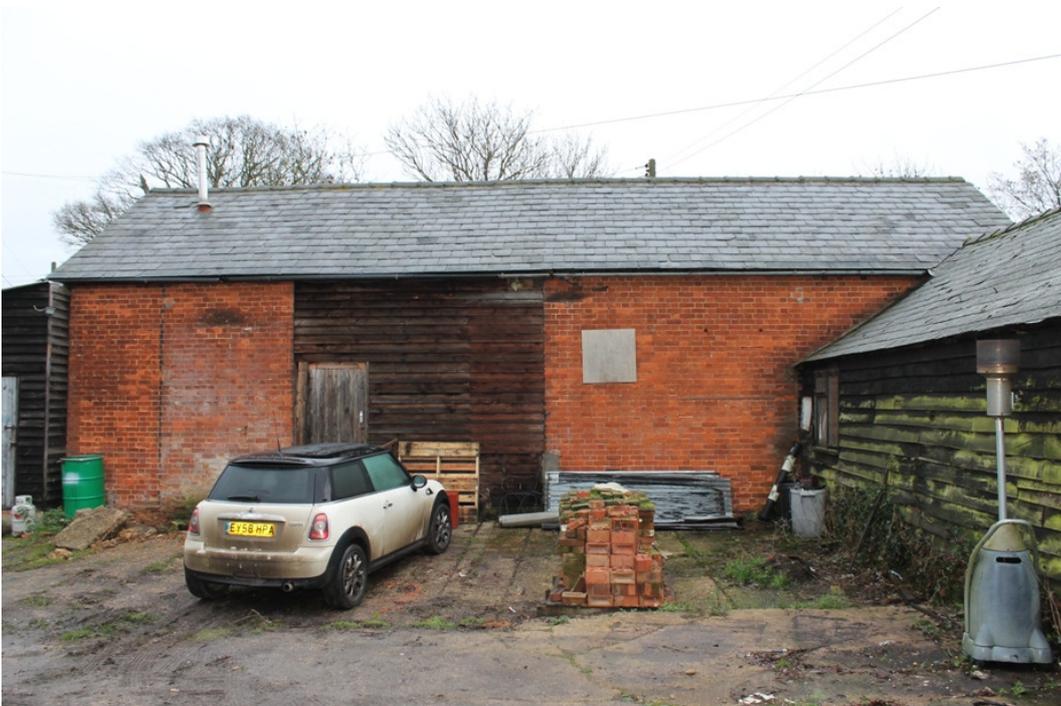
**Plate 4** South-west elevation of the barn, with the blocked cart door opening – view north-east

The south-east elevation has an opening in the brickwork opposite the cart doors of the north-west wall (Plate 4). This opening has subsequently been blocked with horizontal weatherboarding, into which a small doorway is inserted. As the opening is in line with the cart doors on the opposite side of the building and is the same size and shape, it is logical to assume that this opening also originally had cart doors.

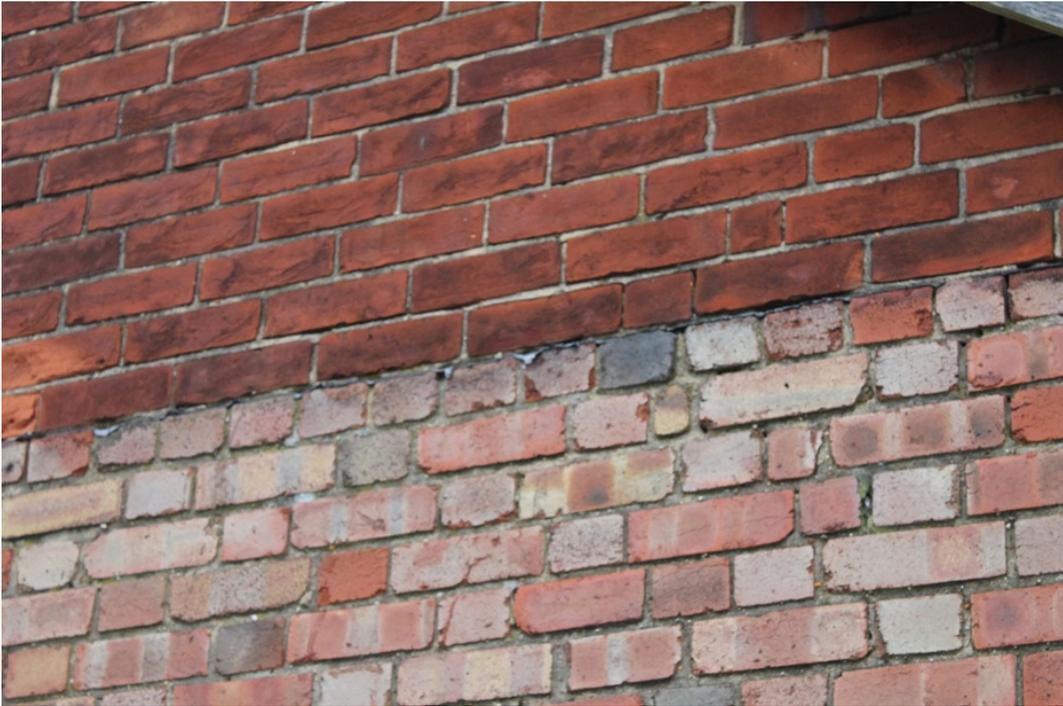
**Plate 5** Remains of lead flashing between the Fletton bricks and soft reds of the gable on the south-east elevation of the brick barn, indicative of a mono-pitch lean-to - view north

The south-east wall has the remains of lead flashing embedded with the mortar where the Fletton bricks meet the soft red bricks of the gable (Plate 5). This suggests a mono-pitch lean-to was originally located against the main building, although no further evidence for this was observed.

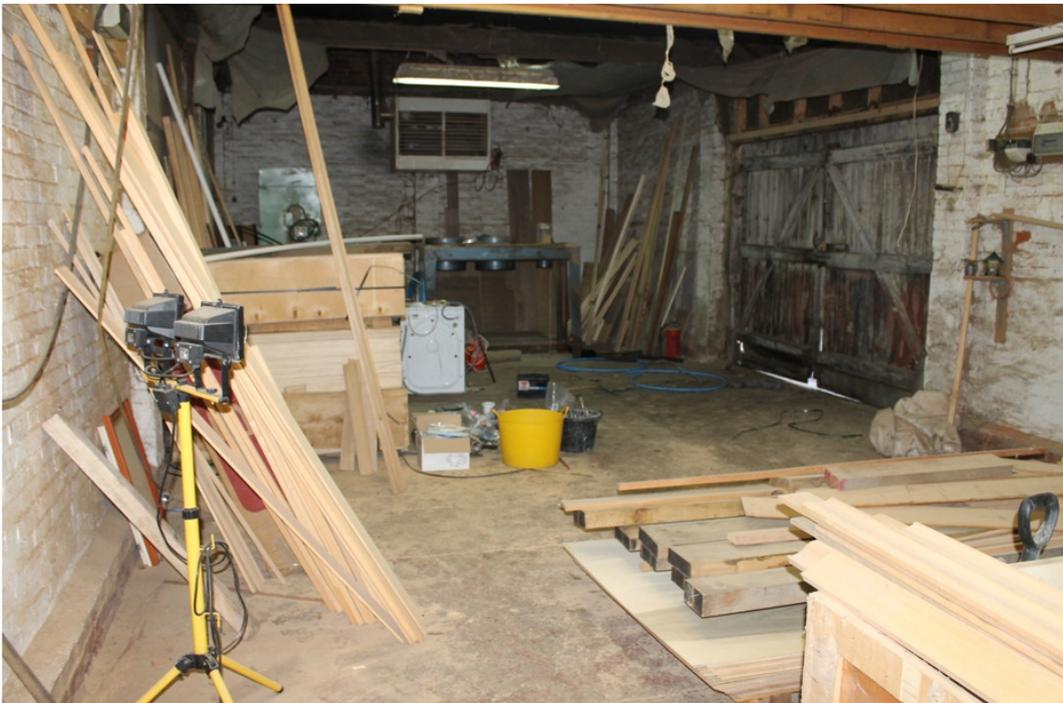
**Plate 6** Interior of the brick barn - view north

The interior of the brick barn is an open space, without divisions, illuminated by modern strip lighting (Plate 6). At the time of the survey the barn was in use as a workshop for the owner's joinery business, and was cluttered with piles of timber and modern machinery. The interior showed that the walls sit on a brick plinth, 35cm wide, with piers rising from this at the corners and at intervals along each of the walls, dividing the barn into four bays.

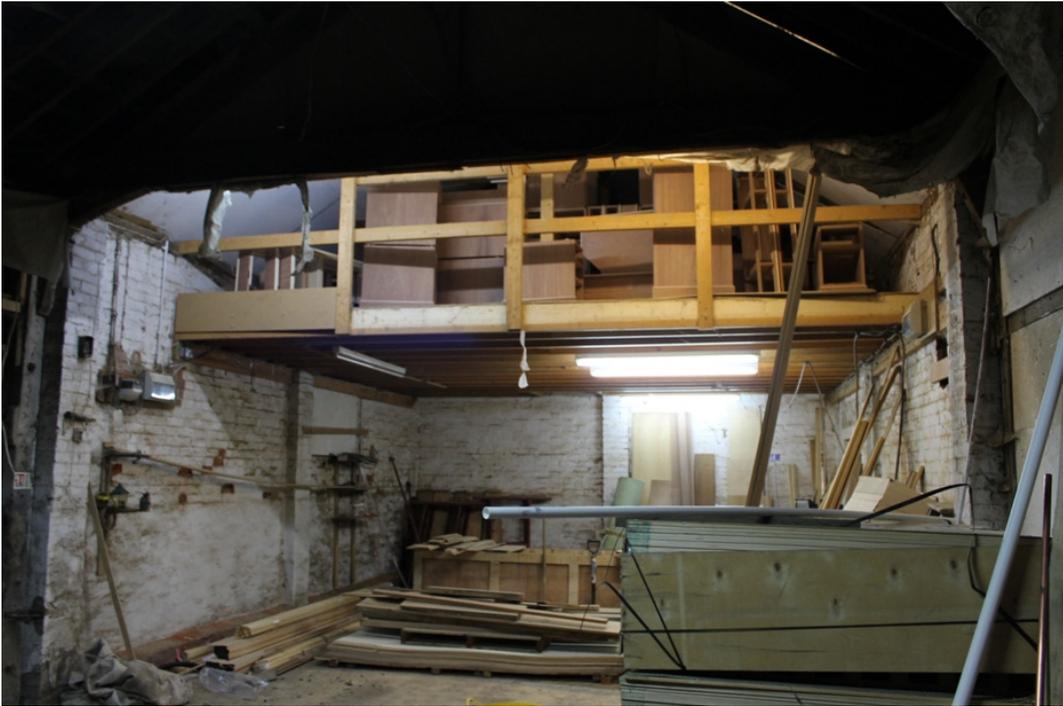
**Plate 7** The interior of the brick barn, showing the modern mezzanine blocking the pitching door – view north-west

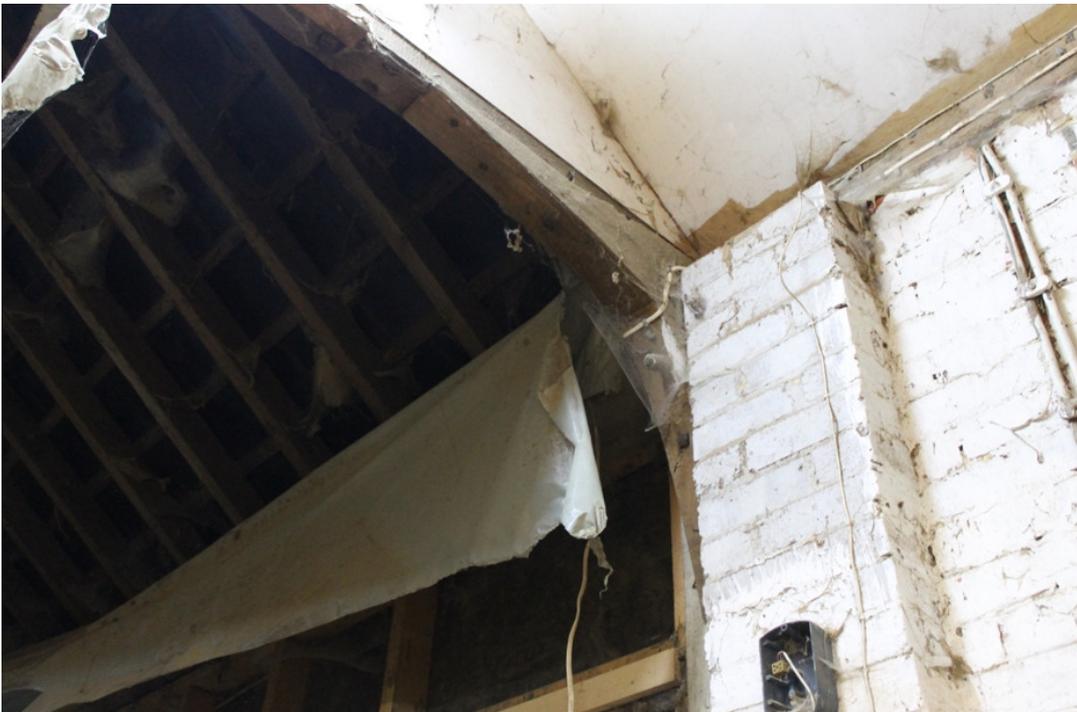
**Plate 8** Bolted knee brace to truss B of bay 2 and brick pier of the wall – view north-east

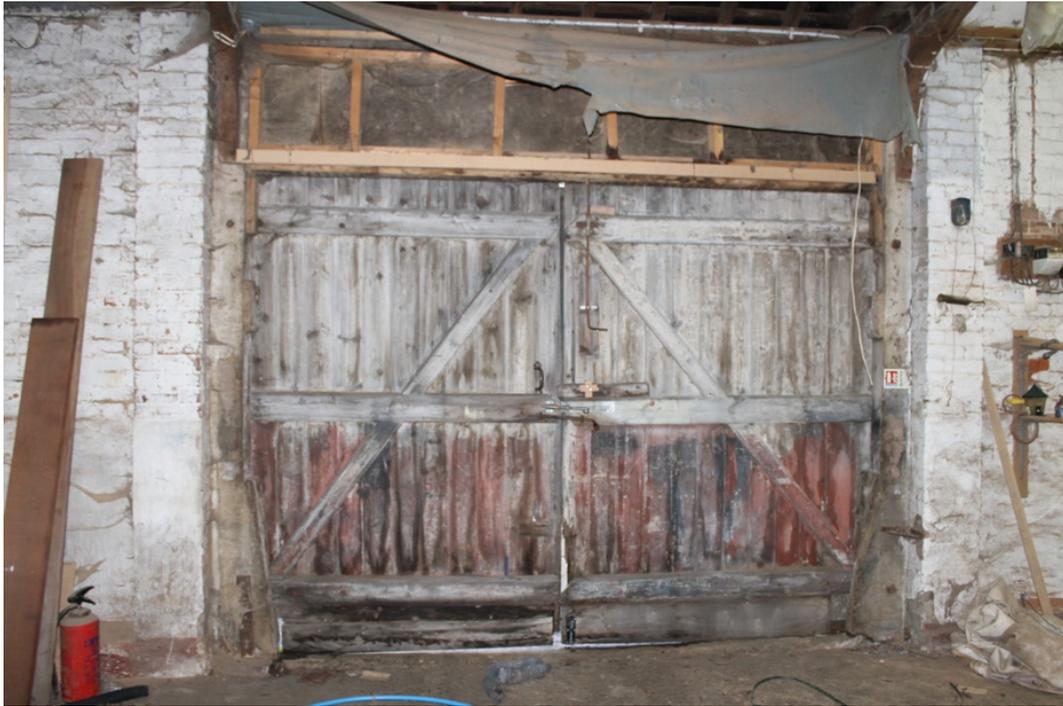
**Plate 9** Bay 2 of the brick barn, showing later cart doors attached to original doorposts, sawn from single timbers and incorporating flared bases - view north-east.

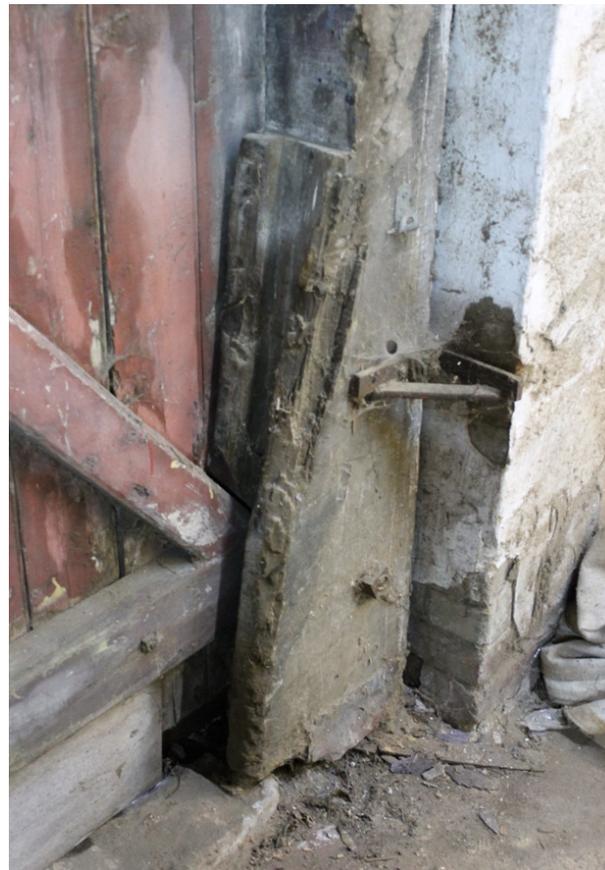
**Plate 10** Flared base to truss B, with recess for threshold leap, damaged by the later cart door - view east

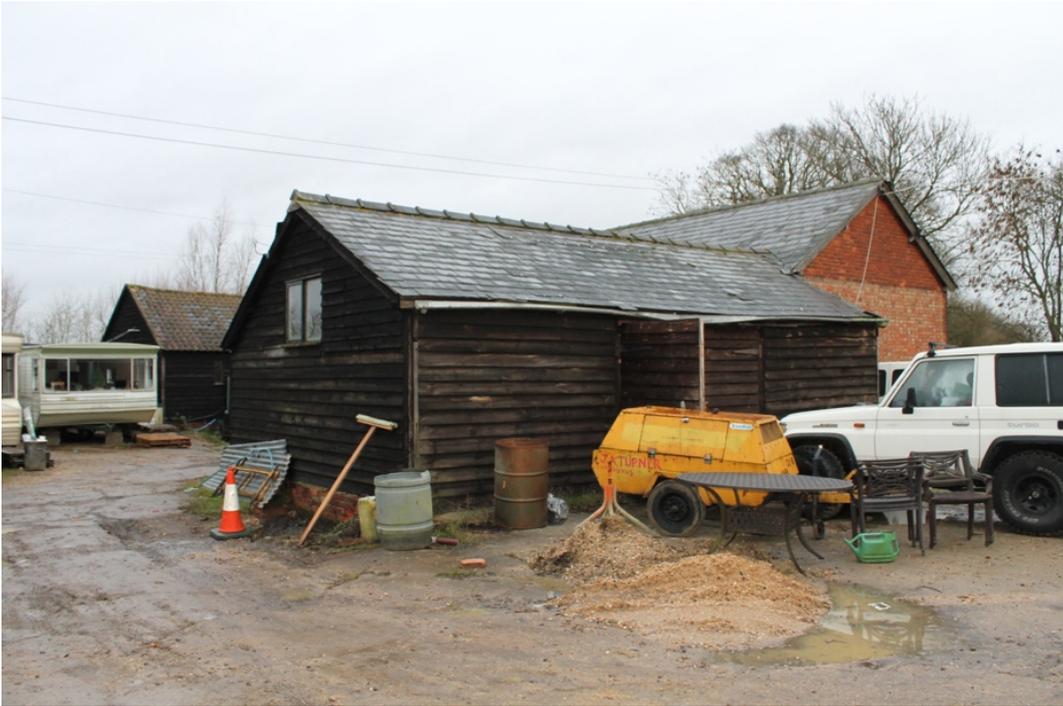
**Plate 11** Former loose boxes, showing the asymmetrical roof and the blocked openings that would have faced the yard – view north

The former loose boxes form a rectangular structure aligned north-east to south-west, 9.3m long x 5.6m (Plate 11). It is clad in black-painted, horizontal weatherboard and two walls sit on a brick plinth with dimensions of 215 x 110 x 70mm, laid in English bond. It has an asymmetrical gabled slate roof and the original open front, facing south-east, has been blocked, with a pair of outward opening doors inserted to the centre. Casement windows have been inserted into the gable and the north-west wall.

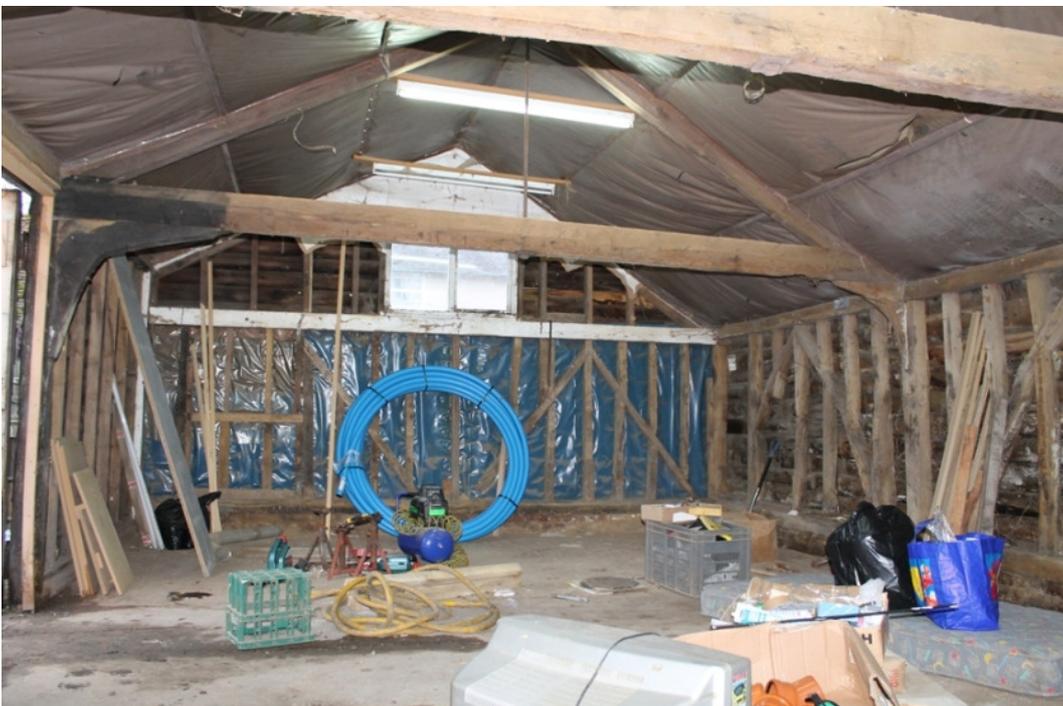
**Plate 12** Interior of the converted loose boxes, with the blocked openings on the left and the rebuilt gable with the inserted casement window to the rear - view south-west

The interior showed that the structure is a softwood timber-framed building, divided into three bays (Plate 12). The brick plinth is present only on the rear wall and the gable wall (the north-west wall and the south-west wall). The north-east wall is formed partially by the brick barn, whilst the original open-fronts to bays 1 and 3 have been infilled by timbers rising from a modern sill beam sitting directly on the concrete floor. The timber frame carried by the brick plinth comprises hand-sawn studs with primary bracing, straight to the frames of the gable end but arched to the frames of bays 2 and 3 (Plate 13). The individual shapes of these arched braces clearly derive from tree branches rather than timber sawn from the trunk of a tree, and perhaps indicate that the materials for the loose boxes were sourced from the farm itself, rather than being bought-in timber. The 1919 sales catalogue listed timber rights for the occupant of the farm, a potential source for the studs and braces.

The trusses are of king bolt construction with a straight tie beam (Plate 12). On the north-west side the tie beams sit on top of the wall plate (Plate 14), whilst at the south-east

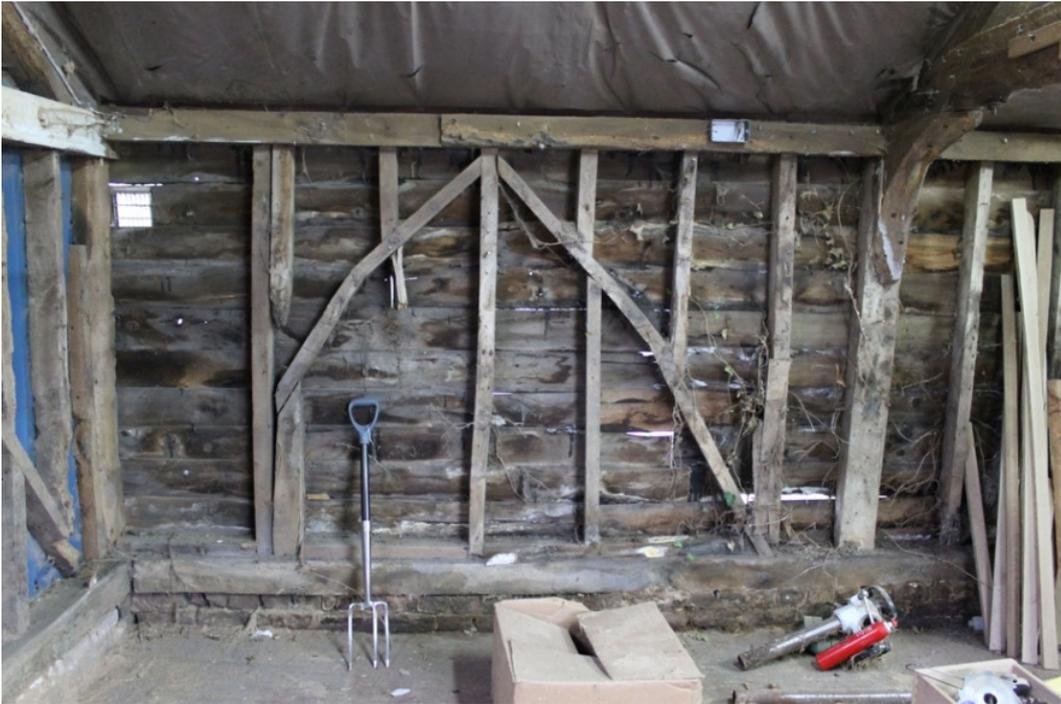
**Plate 13** Former loose box, timber framing of bay 3 with arched primary bracing and scarf joint in wall plate – view north-west

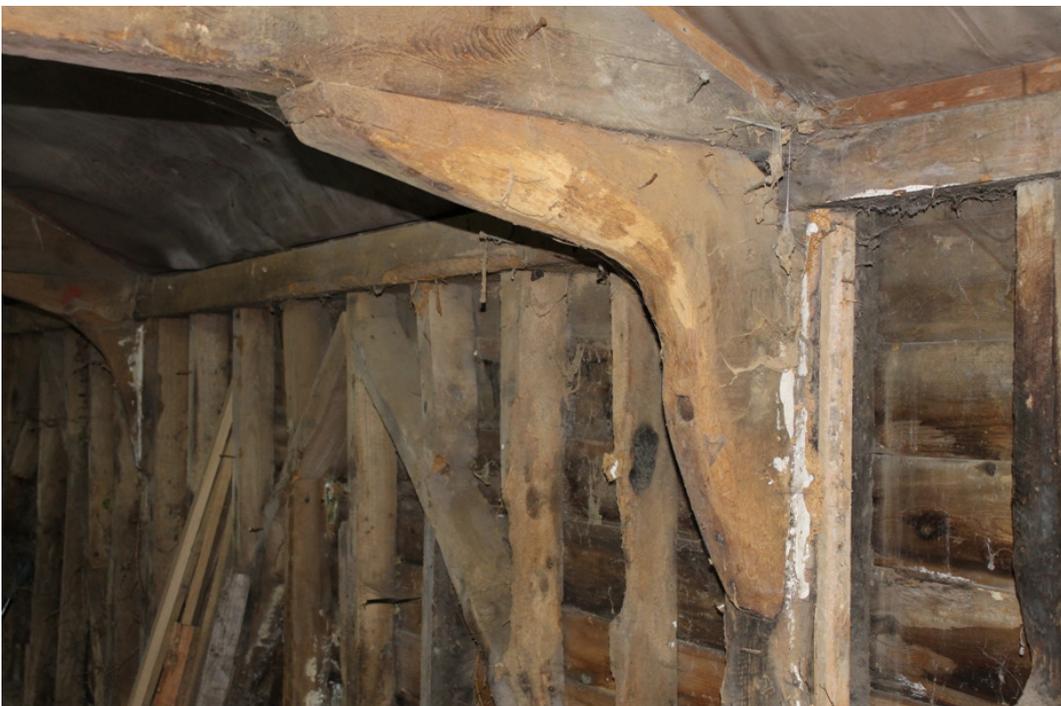
**Plate 14** Knee brace to north-west post of truss A, with tie beam sitting on top of wall plate - view south-west

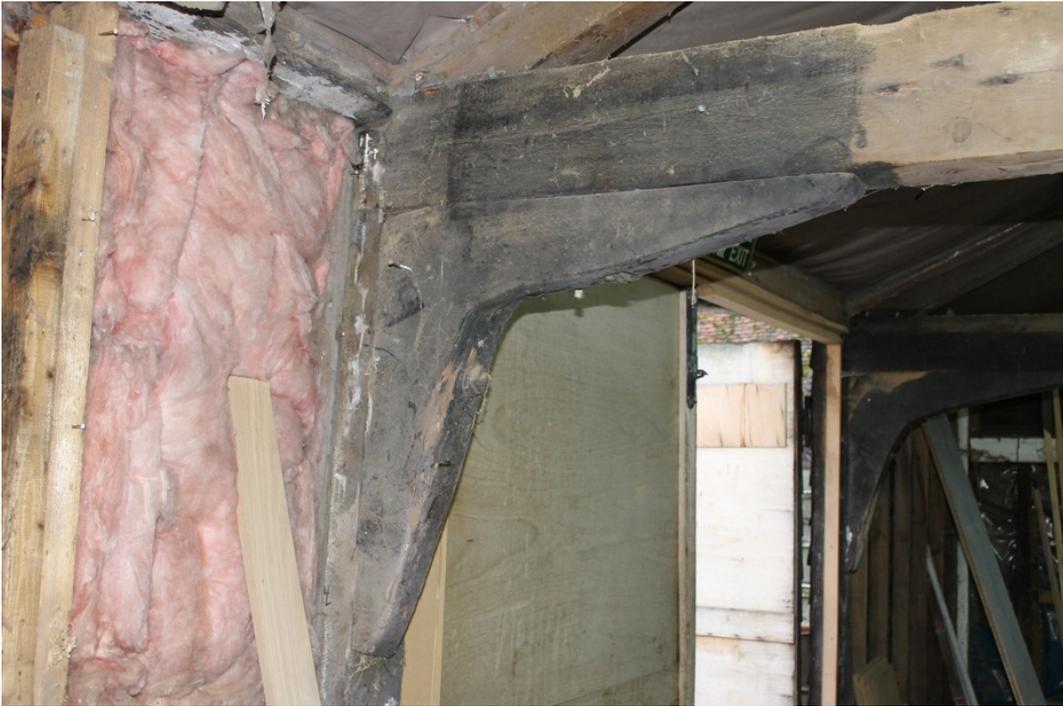
**Plate 15** Knee brace to south-east post of truss A, with tie beam carried on the head of the post and the wall plate supported by the tie beam - view east

side the tie beams sit directly on top of the posts, with the wall plate carried by the tie beams (Plate 15). It is this arrangement that causes the asymmetrical roof pitch. At both sides the tie beams are strengthened by bolted knee braces with iron strapping to the tie beams. The principal rafters of the truss rise from the tie beams supporting two purlins to each pitch; these in turn carry sarking boards to which the slate roof covering is attached. The similarity of the trusses to those of the brick barn, combined with the slate roof covering, suggests the loose boxes were re-roofed when the brick barn was built. As the map evidence indicates the north-east end of the loose boxes was demolished to make way for the brick barn, it is logical to assume that some form of repair would have been required. The south-west gable supports this theory, as above the wall plate the gable studs are all machine-sawn timbers, rather than hand-cut. It is possible that the roof was originally half-hipped, a style that would have reflected the earlier buildings in the farmyard, such as the 17th-century barn (Plate 16).

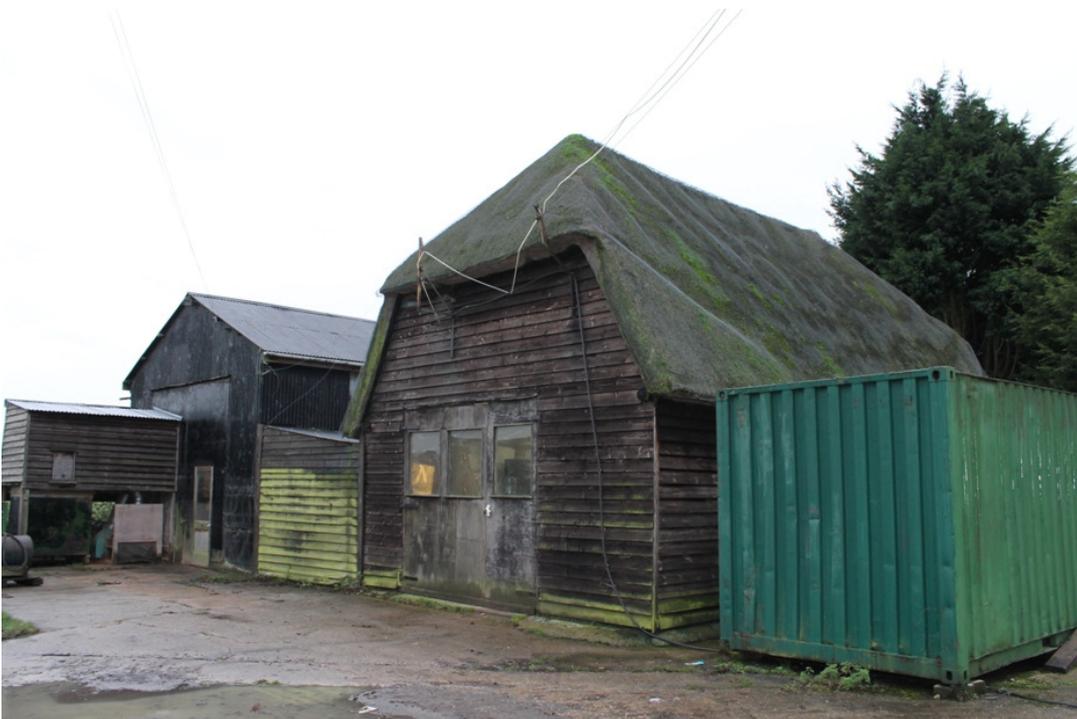
**Plate 16** The listed 17th-century barn with half-hipped roof, possibly reflected by the original roof of the loose boxes - view south

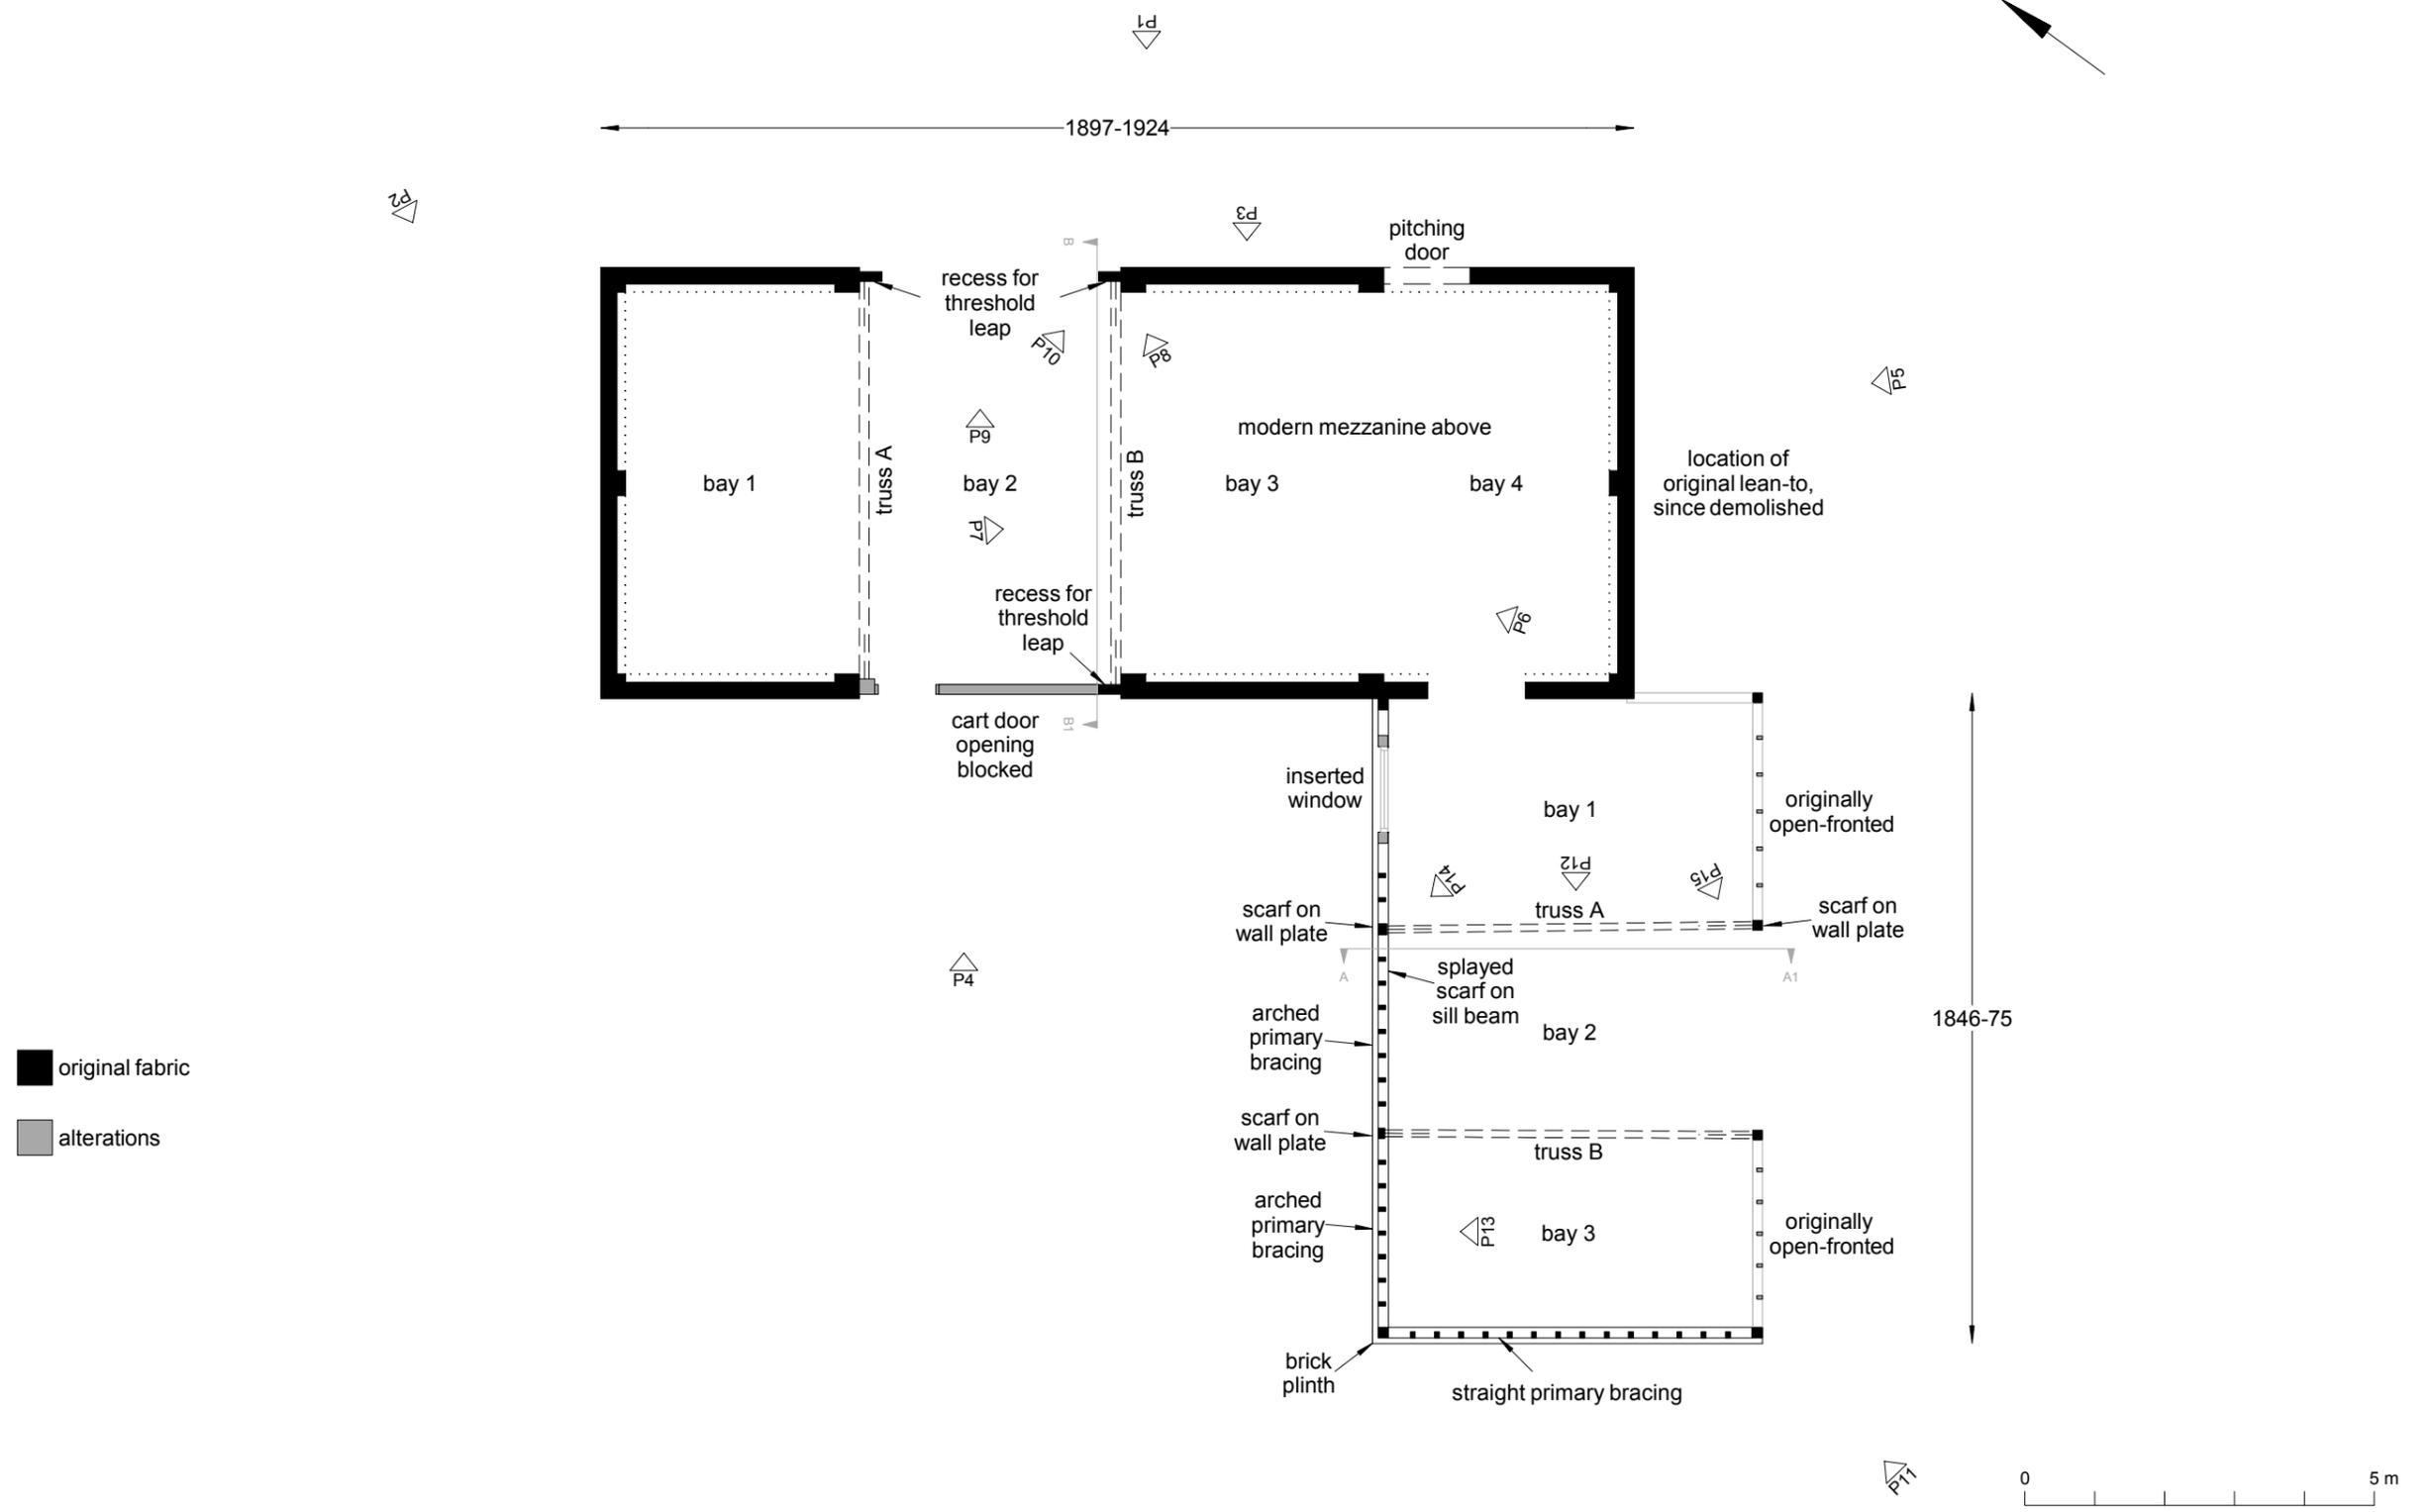
Fig 8 Floor plan of the brick barn and former loose boxes, with alterations shaded grey. The location and orientation of photographs included in this report are indicated by the numbered arrows.

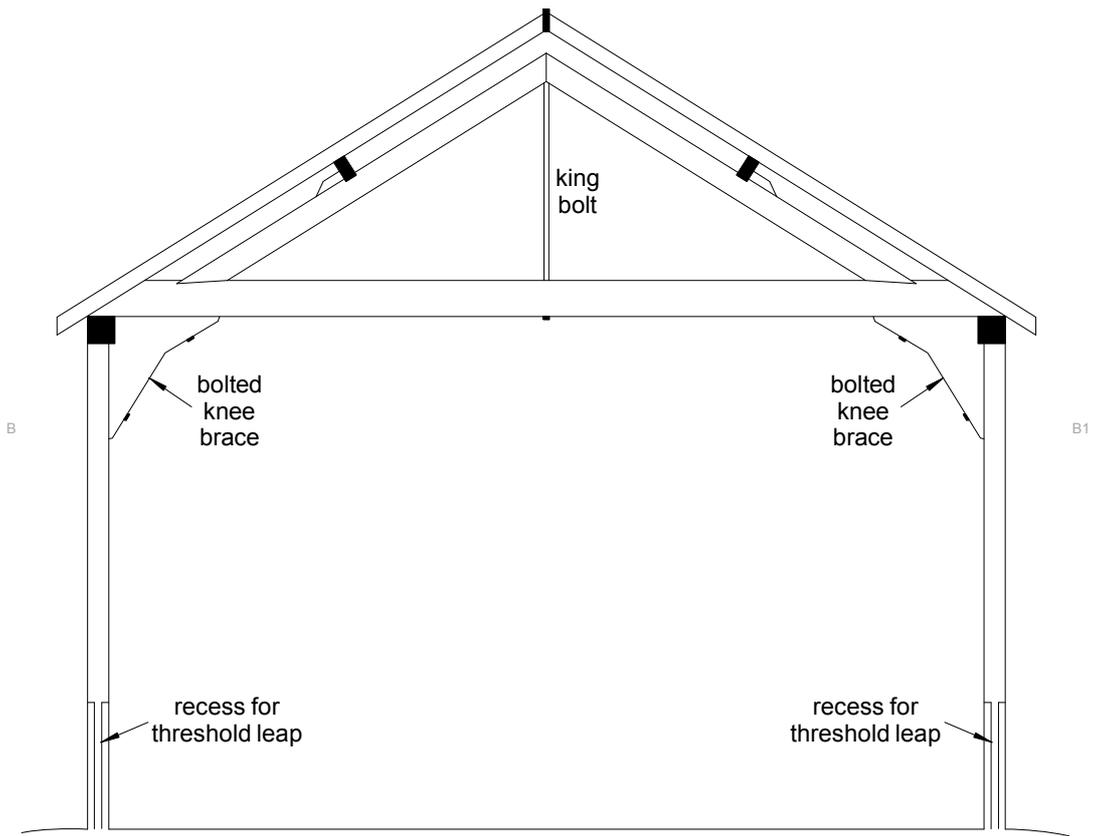
Fig 9 Brick barn: cross-section of truss B.

Bays 1 and 2 are open to the roof and show that the rafters are closely-spaced, machine-sawn timbers rising from a wall plate on top of the brickwork to a ridge board. The rafters are carried on a single purlin to each pitch, the ends of which are bedded into the gable walls. The slate roof covering is supported on battens nailed directly to the rafters. There are only two trusses to the roof: these are found in bay 2 and are formed by the posts supporting the cart doors. The posts rise to the wall plate which supports straight tie beams, the bases of a pair of king bolt trusses. These provide intermediate support to the purlins. The trusses are strengthened by bolted knee braces (Plate 8). Three of the four doorposts are original and have flared bases, more than twice as wide as the main body of the post, but sawn from a single piece of lumber. The large size of the posts is explained by the presence of vertical recesses cut into the post bases (Plates 9 and 10). These recesses were intended to hold a threshold leap, a low gate installed during threshing to keep livestock out of the barn and the threshed grain from flying out into the farmyard. All three of the original posts have this recess which indicates both doorways had threshold leaps and identifies the function of the building as a threshing barn.

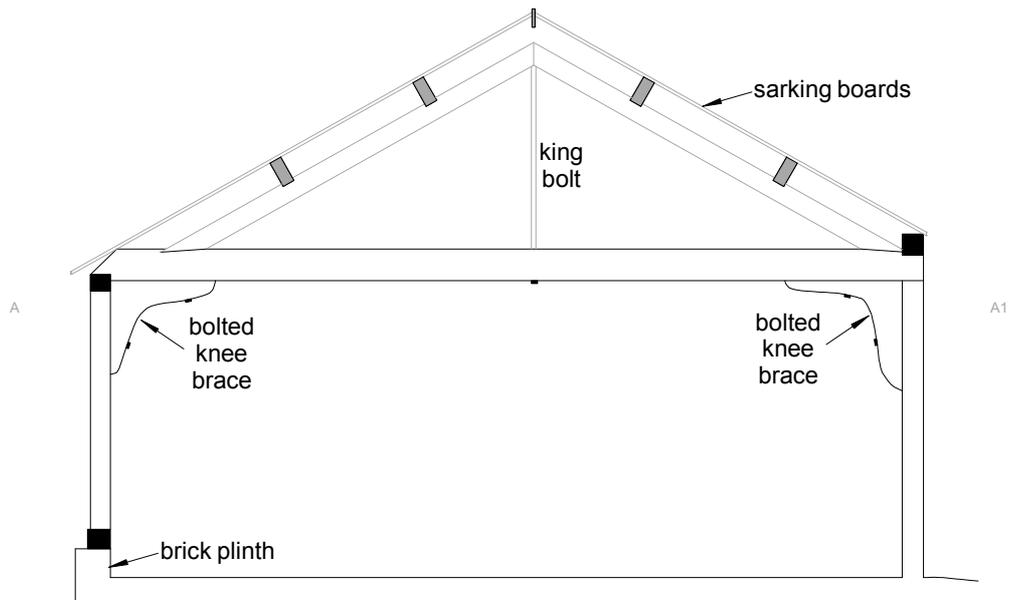
Fig 10 Former loose boxes: cross-section of truss A.
