# An archaeological evaluation by trial-trenching on land at Lady Knights Barn & Yard, Pentlow Lane, Pentlow, Essex

CAT project ref.: 15/03a  
Historic Environment code: PLLK15  
NGR: TL 81804 46116 (centre)

**CAT Report 824**  
April 2015

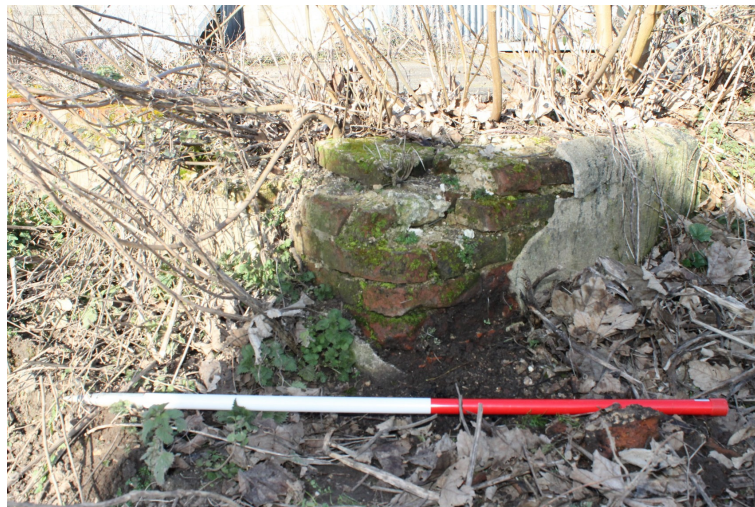
Of particular interest was the exposed south-east corner, which was formed from rounded brickwork and indicates there was a moulded brick offset (Plate 1). This indicates both an aesthetic and a practical architectural aspect to the barn, although this was probably part of a later extension (referred to in the list entry), rather than a feature of the original barn.

**Plate 1: South-east corner of the brick plinth, showing the rounded corner, facing north-west.**

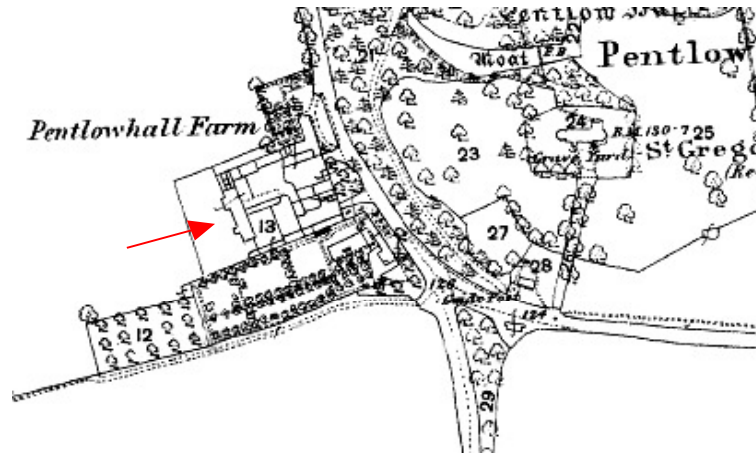
Early map evidence for the barn suggests it had two midstreys. The Ordnance Survey 2nd edition of 1886 (Illustration 1) shows two different-sized structures projecting from the south-west side of the barn, indicating the barn was used for threshing. The 10 bay size indicated by the list entry is also interesting as this would have been a very large barn in the 15th century. It is more likely that the outer bays (as suggested by the list entry) were later additions, although, at 8 bays, this would still have been a very large barn. The extra bays were probably added in the late 18th or early 19th-century when grain production was at a high during the 'Golden Age' of British farming. This in turn suggests that the two midstreys were also a later addition rather than original features.

**Illustration 1: 2nd edition Ordnance Survey map, showing the presumed midstreys on the south-west side of Lady Knight Barn (red arrow).**

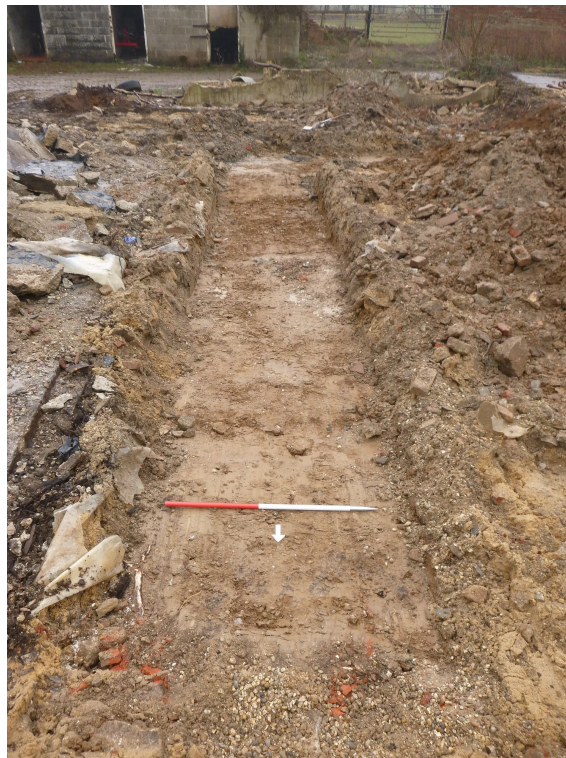
The concrete floor of the 20th-century lean-to barn was laid on a thick layer of sand, gravel and crushed concrete/brick (L1), which, in turn, directly overlaid the orange silty-clay natural (L2). Based on the height of the surviving plinth wall and the height of the natural clay to the west of the foundation, it was apparent that the ground level in this area had been reduced by approximately 0.8m prior to the construction of the modern barn (Plate 3). No archaeological deposits survived the reduction of the ground level and no features were observed cut into the natural clay (Plate 2).

**Plate 2: Trial-trench, facing south-east**

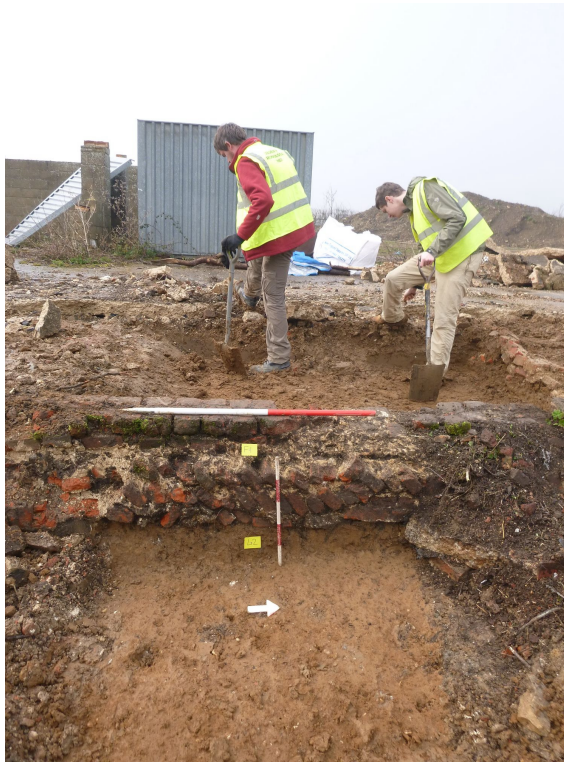
The external face of the historic barn's plinth wall (F1) was fully exposed by the removal of the late 20th-century barn. To the west of the wall, both the soil layer L3 and the natural clay L2 appeared to abut the plinth with no evidence for a foundation trench. The base of the plinth was c 200mm below the top of the natural clay. It is possible that the internal face of the plinth was constructed tight up against the edges of the foundation trench. The surviving plinth was c 500mm high and 480mm wide. The bricks were bonded with lime mortar. The centre of the wall appeared to contain more mortared flint nodules

**Plate 3: The surviving plinth wall of Lady Knights Barn, facing south-west**

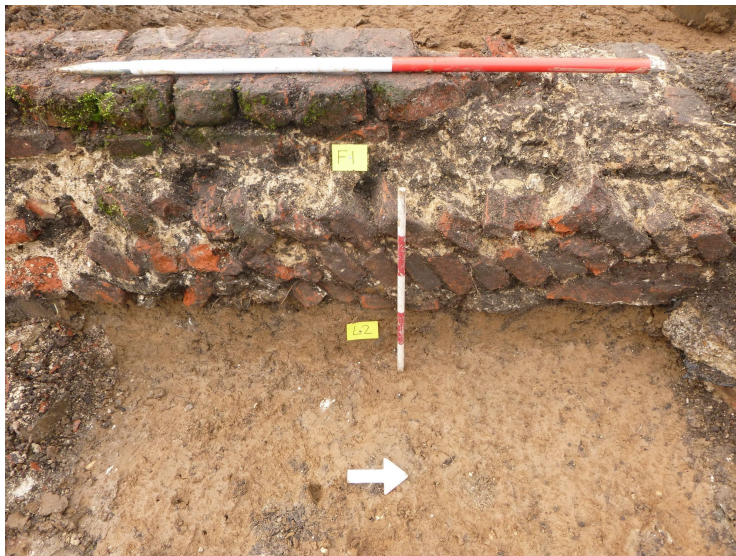
than the external faces and the angled bricks present on the external face did not appear to continue through the wall (possibly suggesting that they fulfilled a decorative function) (Plate 4). The mortar was similar throughout the wall and it was not possible to discern different phases of construction.

**Plate 4: The external face of the plinth wall.**

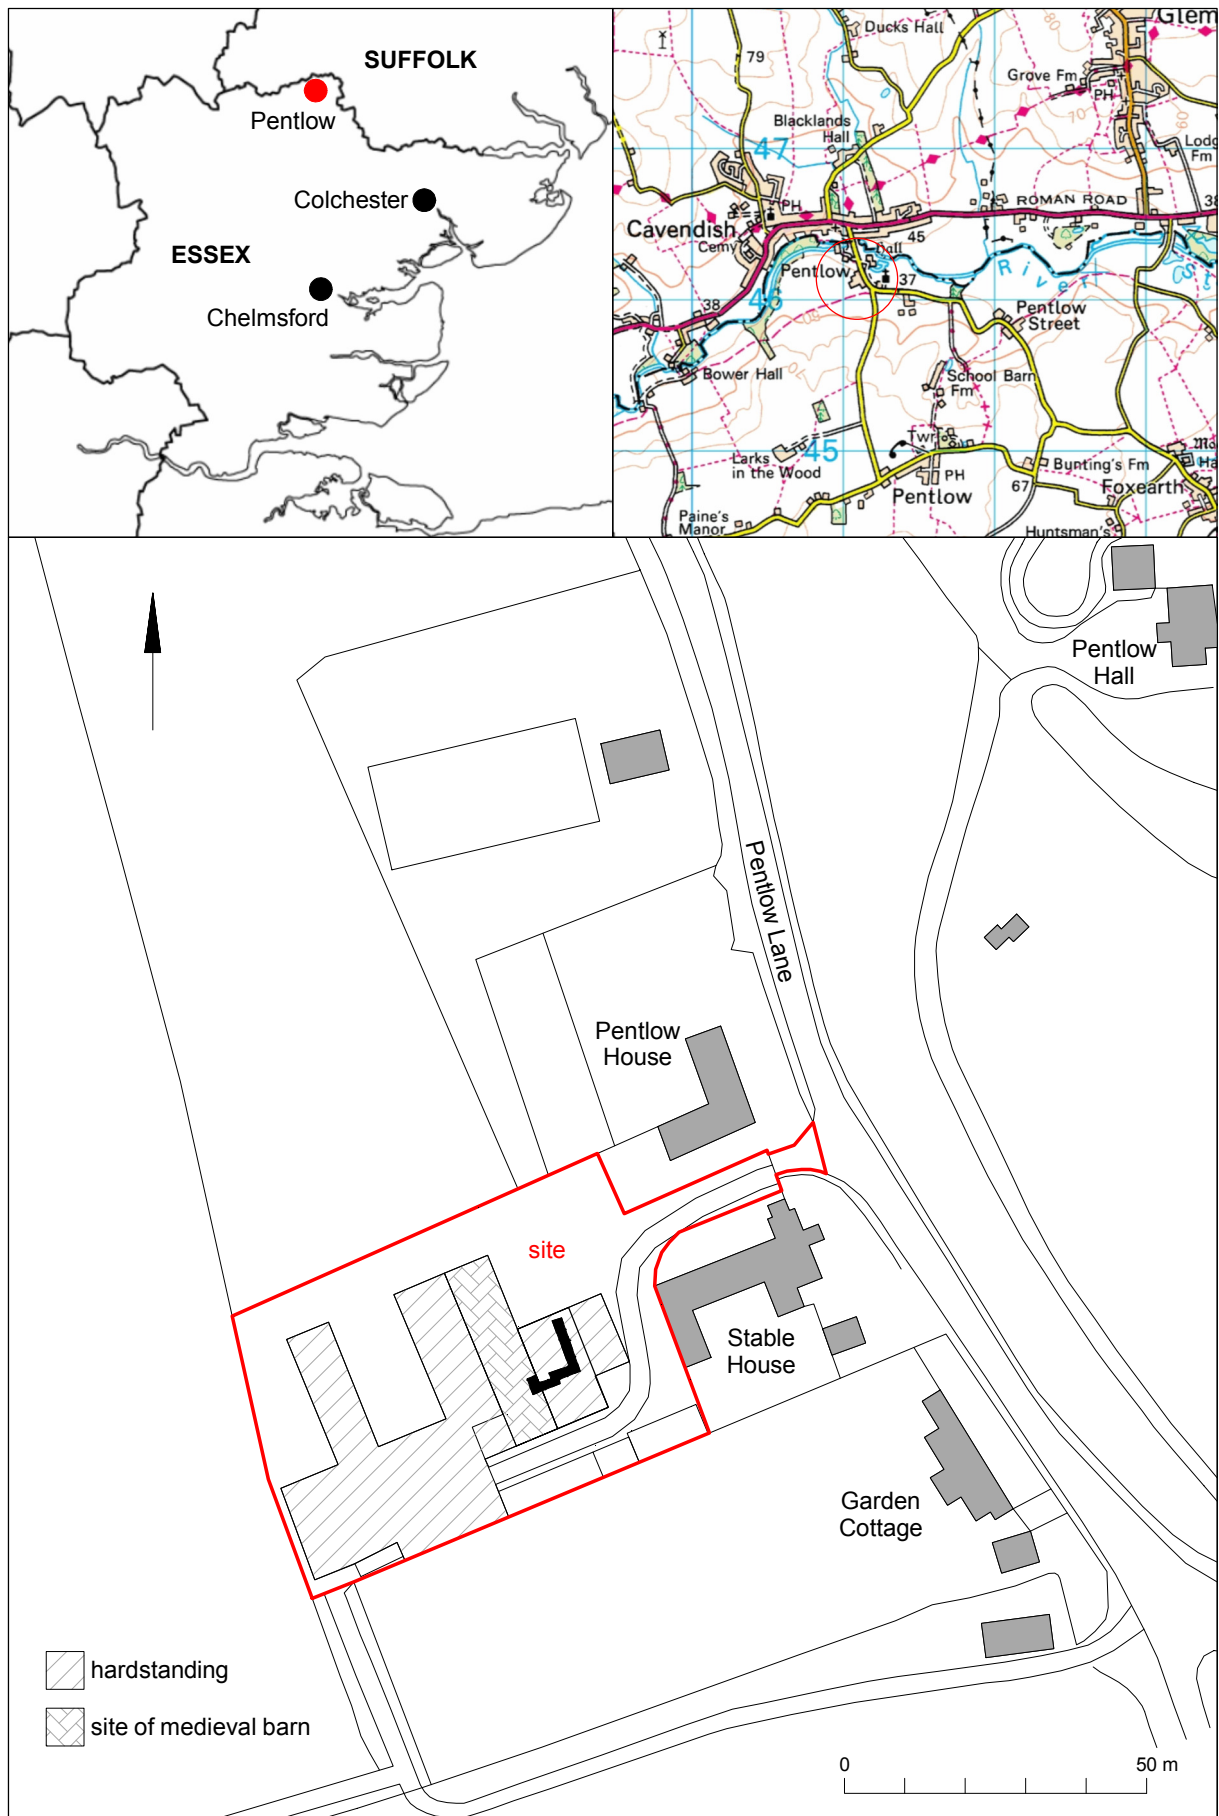
Fig 1 Site plan showing the location of the evaluation trench.

This is the archive report on the archaeological evaluation by trial-trenching carried out by the Colchester Archaeological Trust (CAT) at Lady Knights Barn and Yard, Pentlow Lane, Pentlow, Essex (NGR TL 81804 46116) (Fig 1). The site is situated within the historic farm complex at Pentlow Hall Farm on the western side of Pentlow Lane.

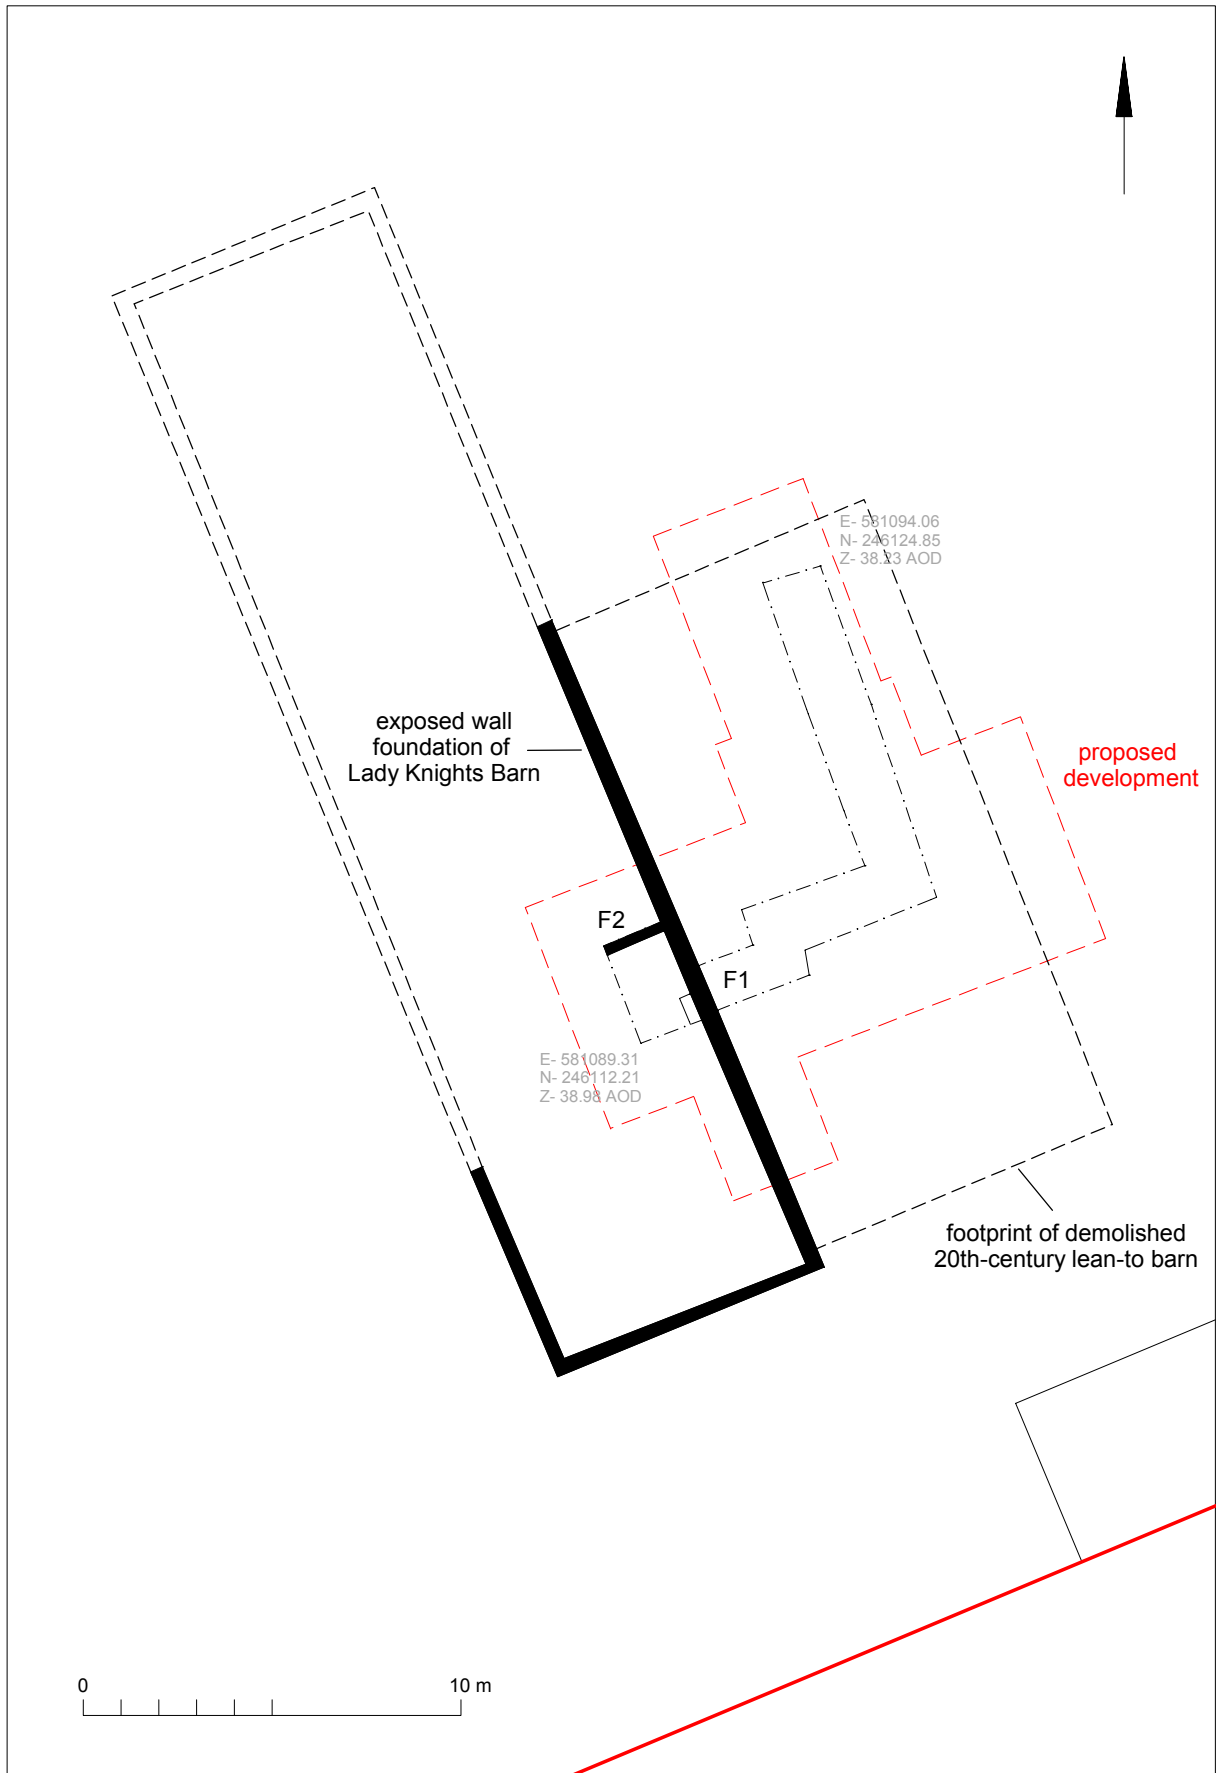
Fig 2 Results.

A single trial-trench was excavated under archaeological supervision using a tracked excavator equipped with a toothless ditching bucket. The trench was L-shaped, 1.8m wide and totalled 19m in length. It was located within the footprint of the proposed dwelling so that it overlapped the surviving north-eastern plinth wall of Lady Knights Barn (Fig 2).

A wall foundation (F2) aligned north-west to south-east was identified in the footprint of the historic barn. This foundation was constructed from soft red unfrosted bricks, broken into rough halves, with surviving dimensions of 65mm x 110mm. The bricks were laid two courses deep in a very loose lime mortar. F2 had been laid directly onto the surface of the natural clay (L2). The wall would have been perpendicular to the external wall of the historic barn and is likely to be from an internal division within the barn, probably dating to the early 19th century, based on the brick type.

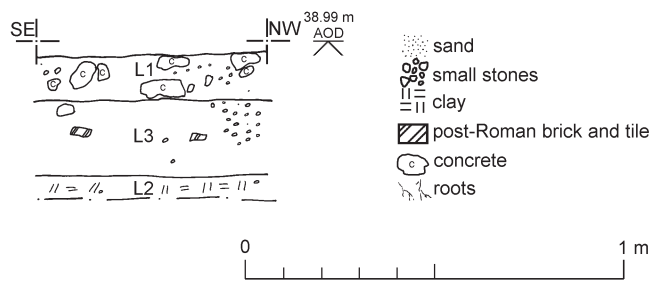
Fig 3 Representative trench section.

To the south-west of the surviving plinth wall, the modern concrete floor of Lady Knights Barn overlaid crushed concrete, brick and sand (L1), which, in turn, overlaid a medium brown clayey-silt (L3) (Fig 3). L3 contained small charcoal and brick/tile flecks, but no datable finds. L3 overlaid the orange silty-clay natural clay (L2). No historic floor surfaces within the footprint of the timber-framed barn were observed in the evaluation trench.
