Emergency archaeological recording of a service trench at Napier Road, Colchester, Essex

CAT Report 981
July 2016

An emergency archaeological recording was carried out in a service trench on the north pavement of Napier Road, 2-3m away from the remains of the inner cavea wall foundation of the Roman circus. Four layers and one feature were observed in section, the feature possibly being related to the demolition and robbing of circus material during the early Medieval period.

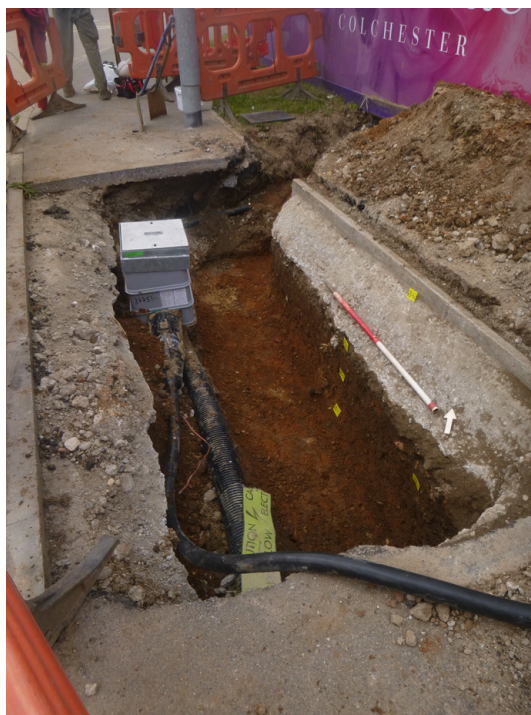
Cover: general photograph of trench, photograph taken facing north.

When the archaeological recording began, the trench had already been dug out to its full depth (c 200mm into natural sand and gravel), so all archaeological layers and features were only observed in section.

The trench was dominated by the existing service run it was dug to intercept. The only area where archaeology was observed was in the north section of the trench.

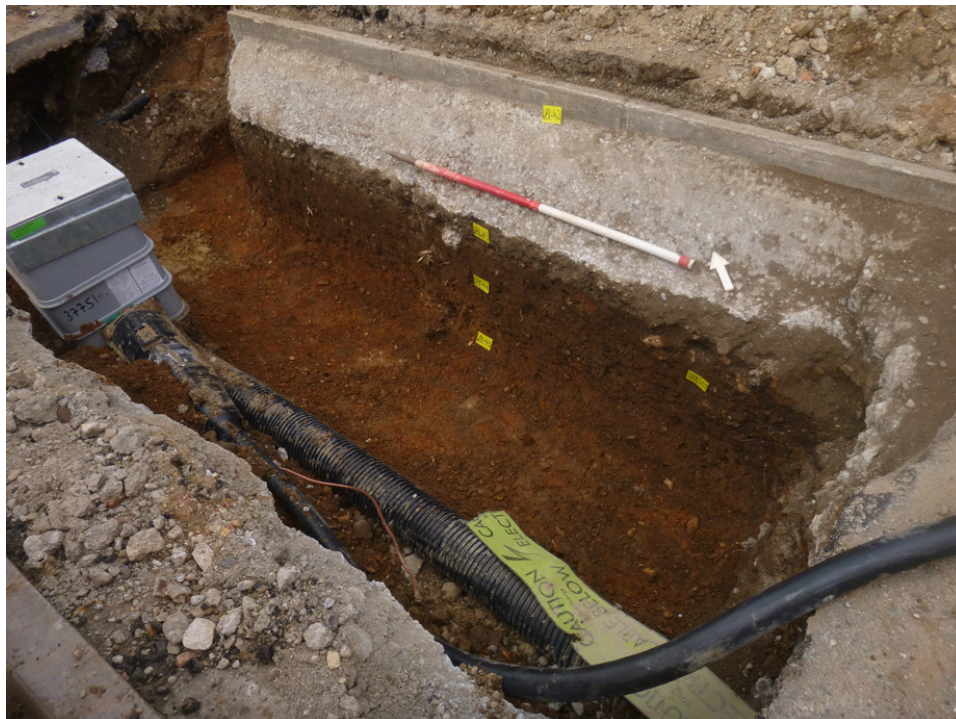
Photograph 1 Service trench, photograph taken facing north.

The trench was machined through four layers, modern concrete and tarmac (WBL42, c 310mm thick), a sub-base for the pavement (WBL43, c 90mm thick), and a medium brown sandy silt post-Roman subsoil (WBL44, c 360mm thick) which sealed yellow/orange mottled natural sand and gravel (WBL45).

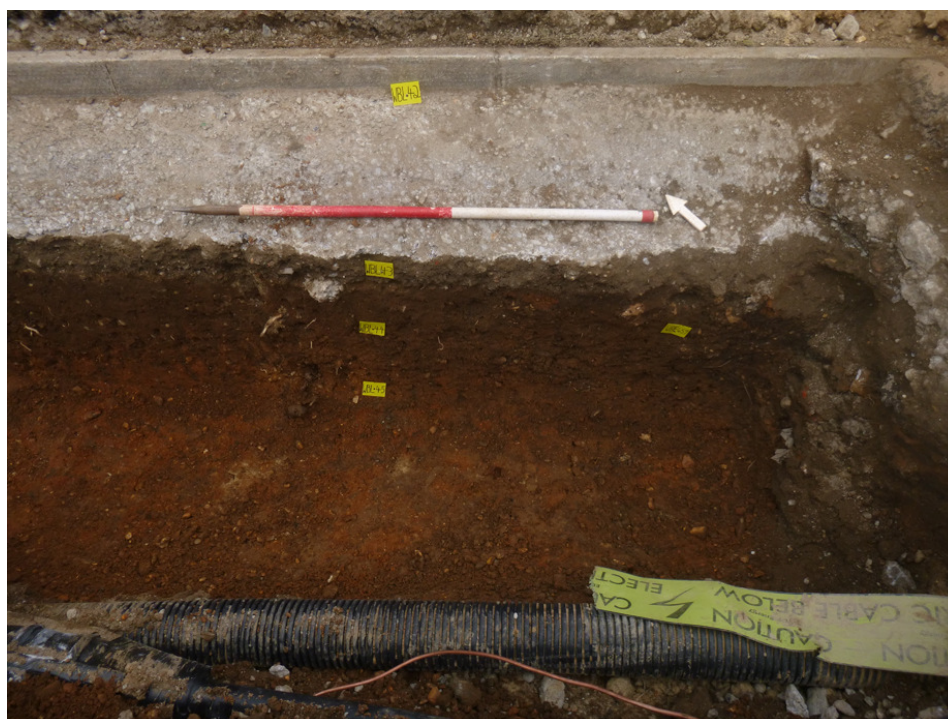
Cutting into WBL44 on the south-eastern end of the trench was a feature (WBF459) containing fragments of lime mortar, septaria and tile fragments. This feature was itself cut by a straight edged modern disturbance on its eastern side.

WBF459 was 400mm deep and sloped to the south-east. The subsoil WBL44 and natural WBL45 also sloped in that direction.

Although the trench was largely disturbed by a modern service run, the north-east section was a view into the surviving archaeology in this area.

The one feature, WBF459, is situated at the south-eastern end of the trench. It is in close proximity to a layer of circus demolition material observed during monitoring along Napier Road in 2010.

Photograph 2 Section of trench, photograph taken facing north-east.

WBF459 does not appear to be filled with circus demolition material – it contains septaria in its fill and the Roman circus, as far as we can tell, was only constructed of flint and Kentish ragstone. Ultimately, because the feature was truncated and only observed in section it is difficult to assign a date or interpretation. It may still be associated in some way with the demolition and robbing of the circus in the medieval period, it could be associated with the construction or demolition of the abbey wall in some way, or it could just as easily be a modern feature that has been backfilled with disturbed Roman building material.
