# Archaeological evaluation on land to the rear of Swan View, The Street, Hatfield Peverel, Essex, CM3 2DP

January 2017

**CAT Report 1062**

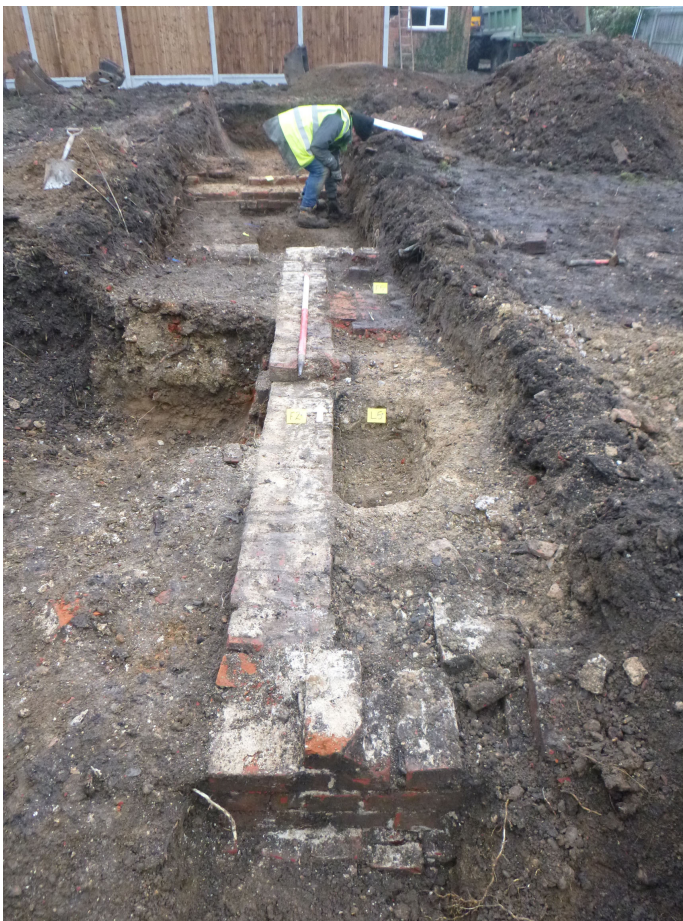
Wall foundation F2 formed a square/rectangular structure built out of red bricks and mortar. The structure measured 3.2m long by at least 1m wide and continued into the section edge. The wall itself measured 0.2m wide (the length of one brick). Inside the structure brick floor F5 had been laid on L5, a layer of loosely compacted mortar.

**Photograph 1** Wall foundation F2, floor F5 and mortar base L5, looking NNW

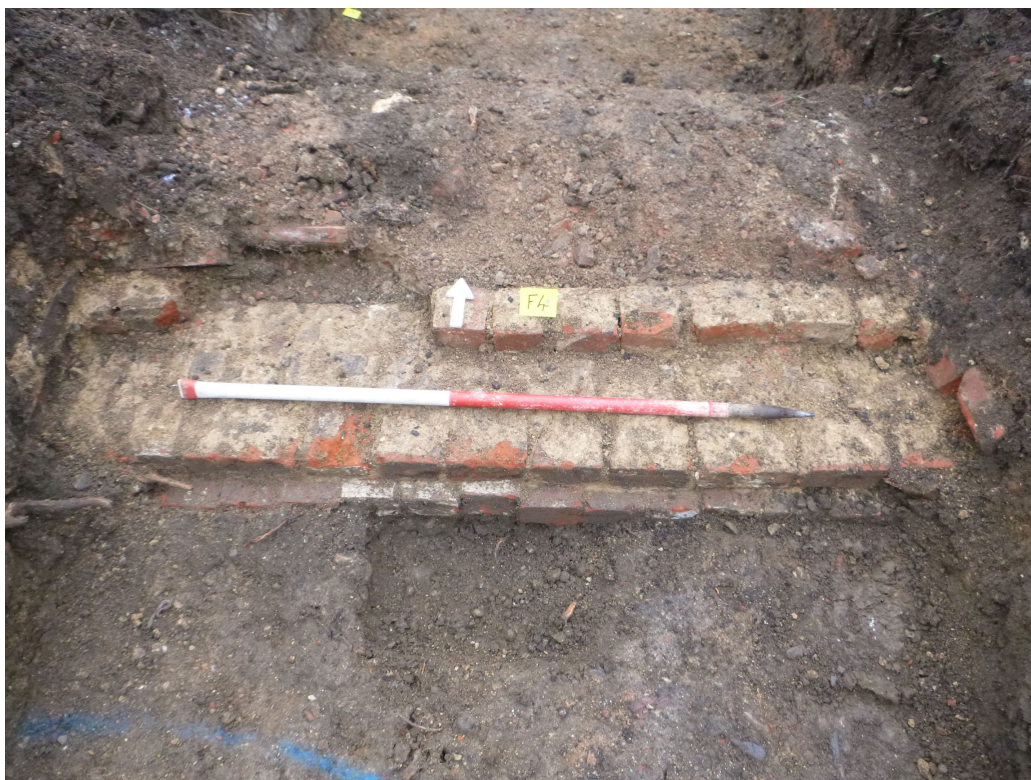
To the north of this structure was a second brick wall, F4, running across the evaluation trench. Also constructed out of red brick and mortar the wall measured 0.4m wide and was made with three courses of brick. No trace of any floor or internal structures were identified to the north of F4.

**Photograph 2** Wall foundation F4, looking NNW
