# Archaeological monitoring and recording at Duncan's Gate, Castle Park, Colchester, CO1 1UN

September 2017

**CAT Report 1171**  
October 2017

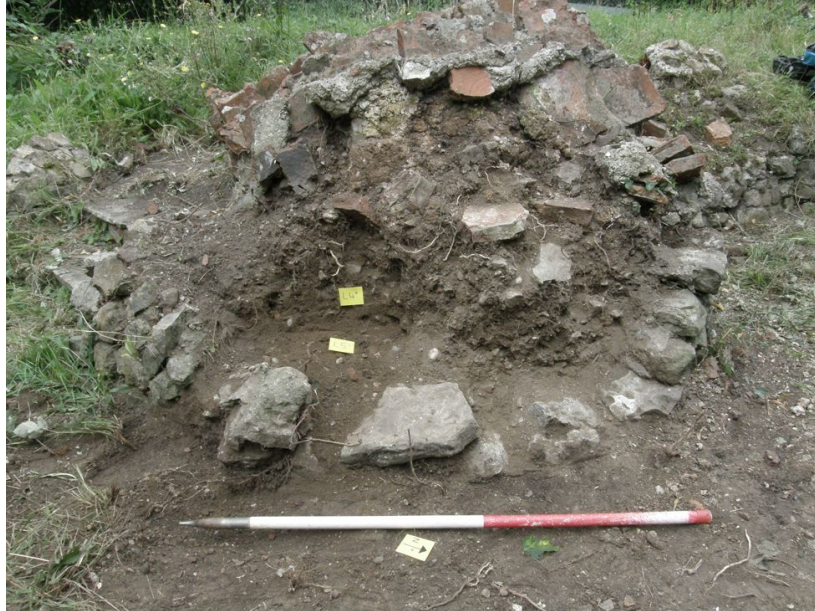
**Photograph 1** Section of collapsed masonry after cleaning. L4 and L5 visible. Photograph taken facing south-west.

This cleaning allowed the width of the collapsed masonry to be measured (at its northern end). It varied from 244mm (at the edge of the masonry) to 569mm (in the centre).

During the cleaning, behind where the retaining wall would have stood, two layers were encountered. L4 was a 310-360mm thick loose dry medium/dark brown sandy silt, with occasional inclusions of brick and tile. Roman pottery sherds and fragments of animal bone were recovered from this layer. The Roman pottery sherds (3 sherds, weight 16 g) are all greyware (Fabric GX) body sherds and are simply dated as Roman. The animal bone (5 pieces, 88 g) include part of a sheep tibia, a femur from a juvenile - probably a pig, a humerus from a medium-large mammal and two other undiagnostic bone fragments.

Below this layer was L5, which was similar in all respects, except it was lighter in colour, a more light/medium brown. No finds were recovered from L5.

Neither of the layers encountered appear to be the “very black earth” described by Hull as being present beneath the collapse. It seems far more likely they originate from the construction of the retaining wall, and the consolidation of the collapsed masonry in the early 20th century. The Roman pottery recovered from L4 is residual in its context (as was the pottery recovered from the test-pit excavated in 2016 – see CAT Report 1022). The “dark earth” Hull described is probably further underneath the collapse, and cannot be exposed without undermining and causing structural issues to the masonry.

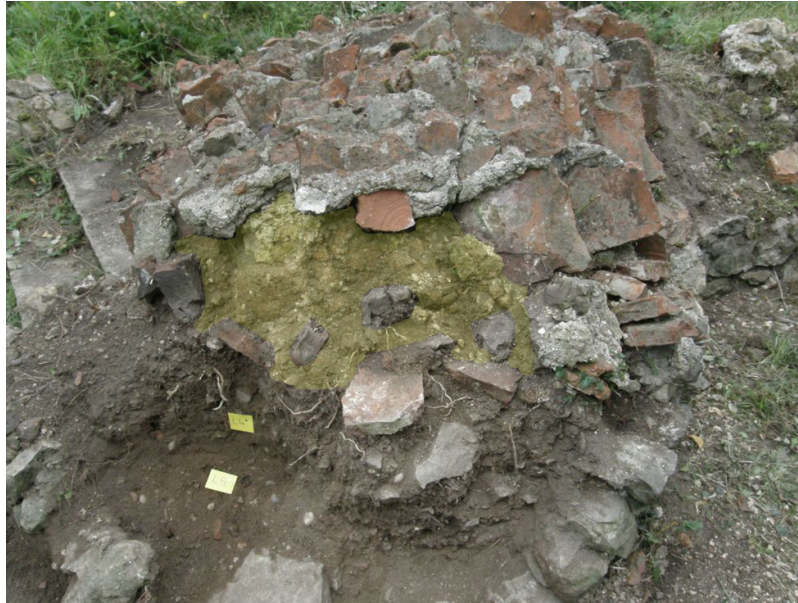
Although original Roman lime mortar was observed bonding tiles in section (Photograph 2), most of the tile that was to be re-attached to the collapsed masonry was entirely encased in modern concrete. This presumably means that this part of the remains had been reconstructed during the conservation work in 1920s, and may not accurately represent the original extent of the collapse.

**Photograph 2** Detail of collapsed masonry after cleaning. Original Roman mortar highlighted in section. Photograph taken facing south-west.

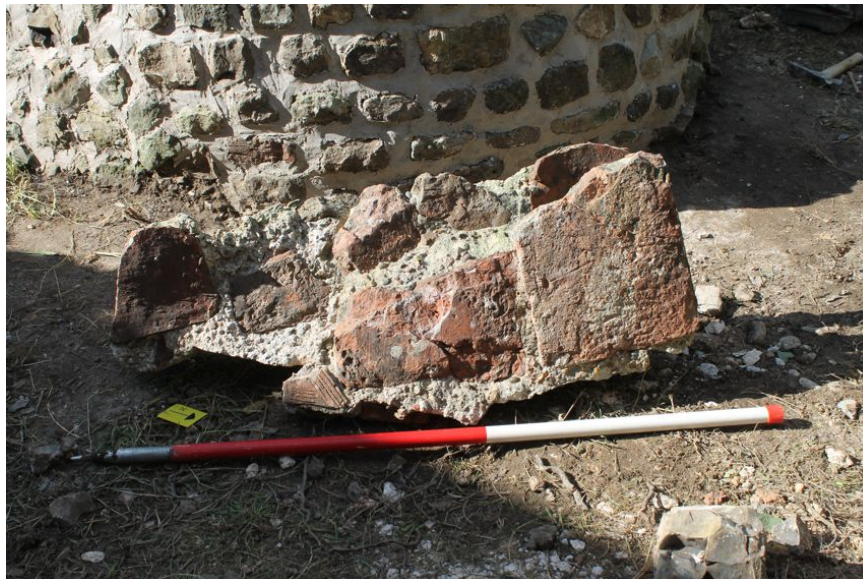
The recently-fallen tile courses were in a poor state of repair, and most could not be accurately reattached to each other or the collapsed masonry, apart from the two largest fragments (Photograph 3). It was evident where most of the fallen tile courses had fallen from, but due to the damage they had received it was not possible to attach them seamlessly (Photographs 4 and 5).

**Photograph 3** Detail of tile courses that were successfully reattached together after falling.

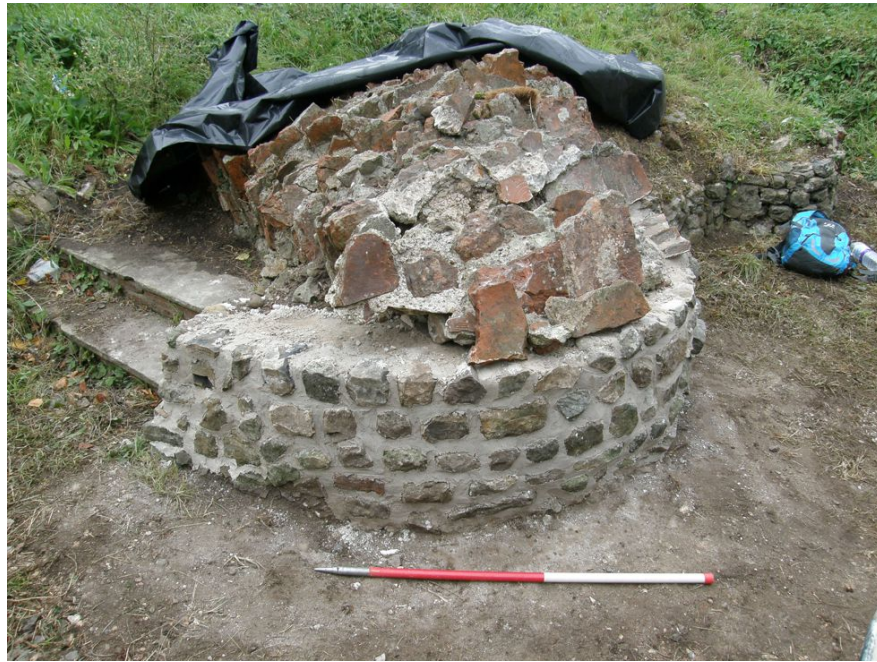
**Photograph 4** Masonry during conservation work, showing partial reattachment of tile courses. Photograph taken facing south-west.

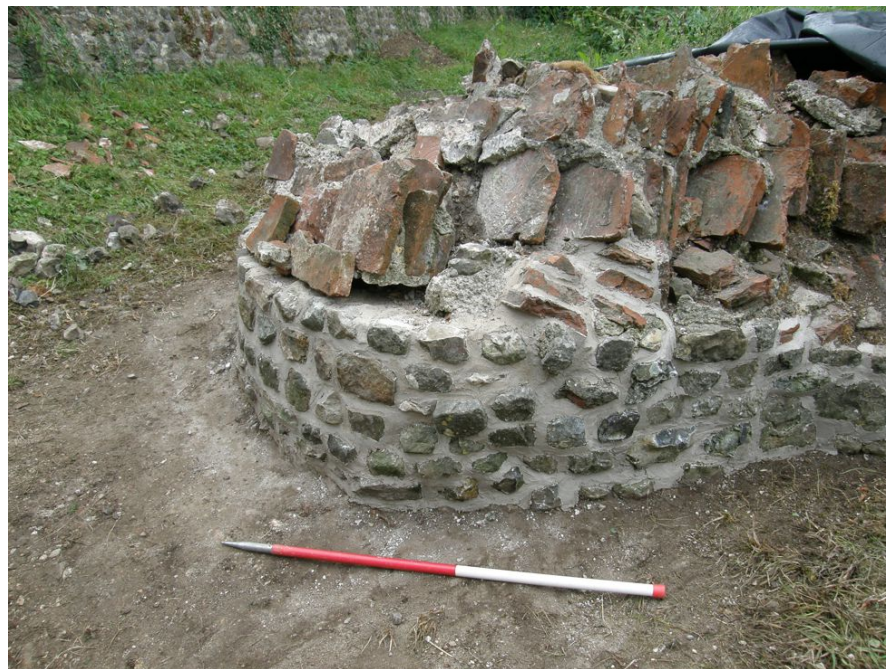
**Photograph 5** Masonry during conservation work, showing partial reattachment of tile courses. Photograph taken facing south-east.

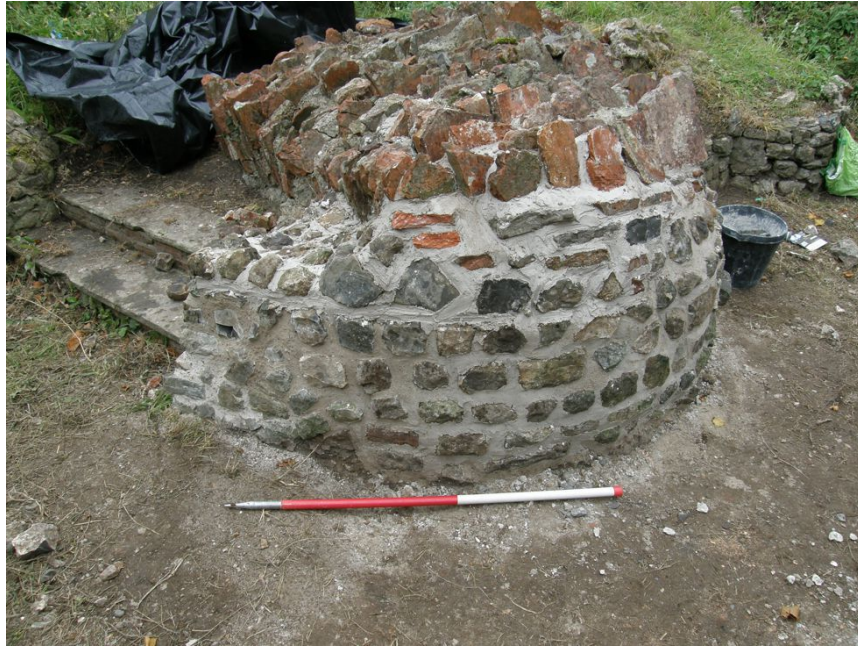
**Photograph 6** Collapsed masonry after complete conservation.  
Photograph taken facing south-west.

The resulting reconstruction, after the retaining wall was fully rebuilt, is intended to be as accurate as possible, while also adequately protecting the remaining intact Roman material in the centre of the collapse (Photographs 6 and 7).

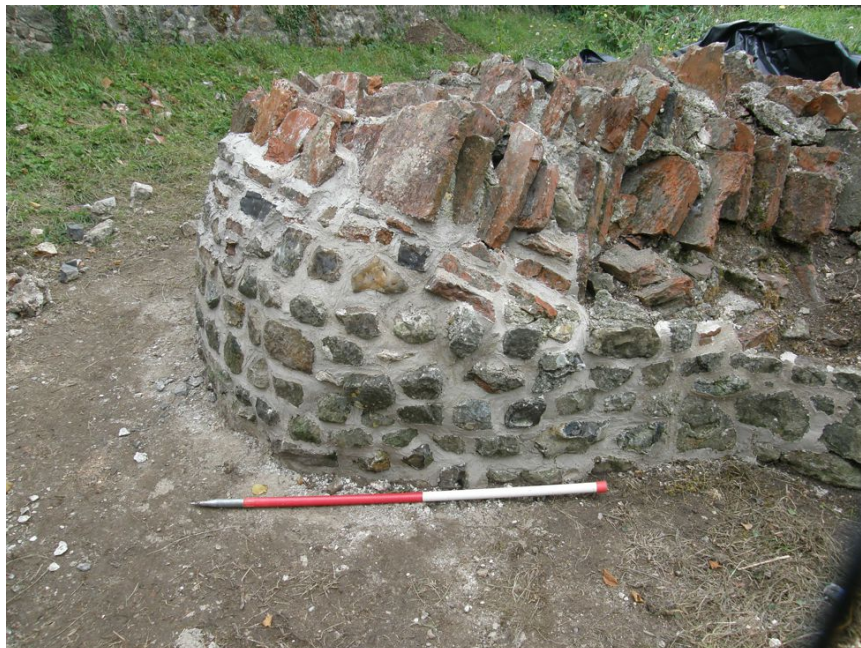
**Photograph 7** Collapsed masonry after complete conservation.  
Photograph taken facing south-east.

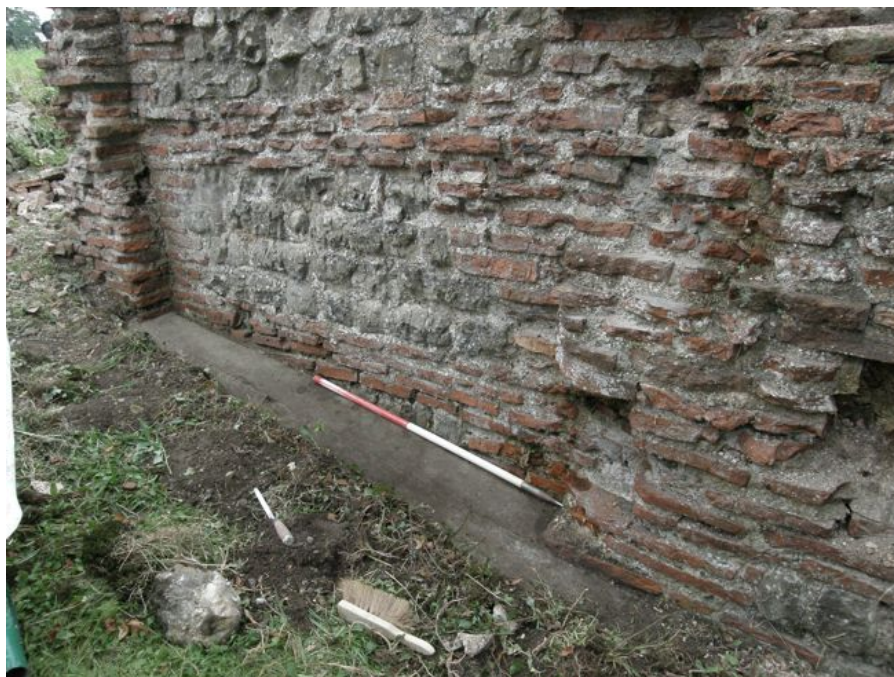
One discovery of note was that cleaning of vegetation at the base of the western side of the gate revealed a concrete drainage channel (Fig 2 and Photograph 8). This is not visible in any photographs from Hull's report (Hull 1958, Plates VI and VII), and presumably must have been added to the gateway sometime after the conservation carried out in the early 20th century.

**Photograph 8** Concrete drainage channel adjacent to the western side of Duncan's Gate. Photograph taken facing south-west.
