**Historic building recording at
the Bricklayers Arms, 61 Hadham Road,
Bishops Stortford,
Hertfordshire CM23 2QY**

April 2018

CAT Report 1263
May 2018

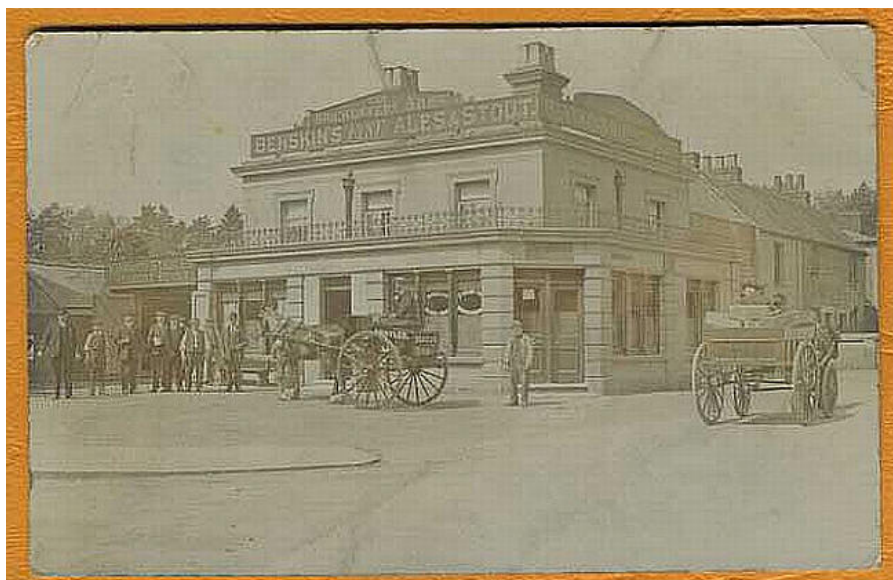
Photograph 1 The Bricklayers Arms in the early 20th century. 63 and 65 Hadham Road (since demolished) visible to rear of building. Extensions A and B also visible. Pub owned by Benskin's Brewery. Taken from <https://pubshistory.com/HertsPubs/BishopsStortford/BricklayersArms.shtml>.

Two early 20th-century photographs of the Bricklayers Arms show the pub as being owned by Benskins Brewery (Photographs 1 and 2). Benskins Brewery purchased Hawkes & Co in 1898 (<http://www.hertsmemories.org.uk>). They also show that extension B originally had large double doors on its south-east elevation.

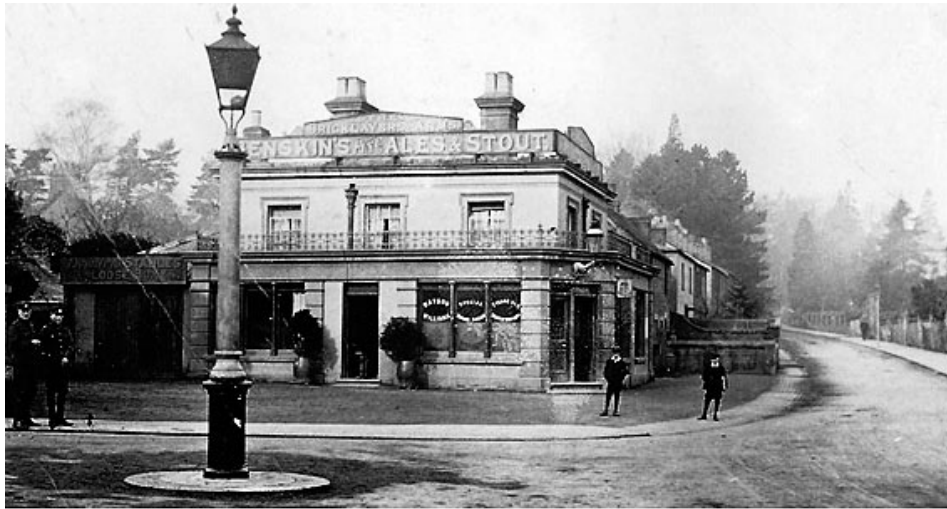
Photograph 2 Bricklayers Arms around the time of World War 1 (note the soldiers to the left of frame). Original windows visible. Pub still owned by Benskin's Brewery. Note large double doors leading into extension B (to left of pub). Taken from <http://www.stortfordhistory.co.uk/guide5/bells-hill/>.

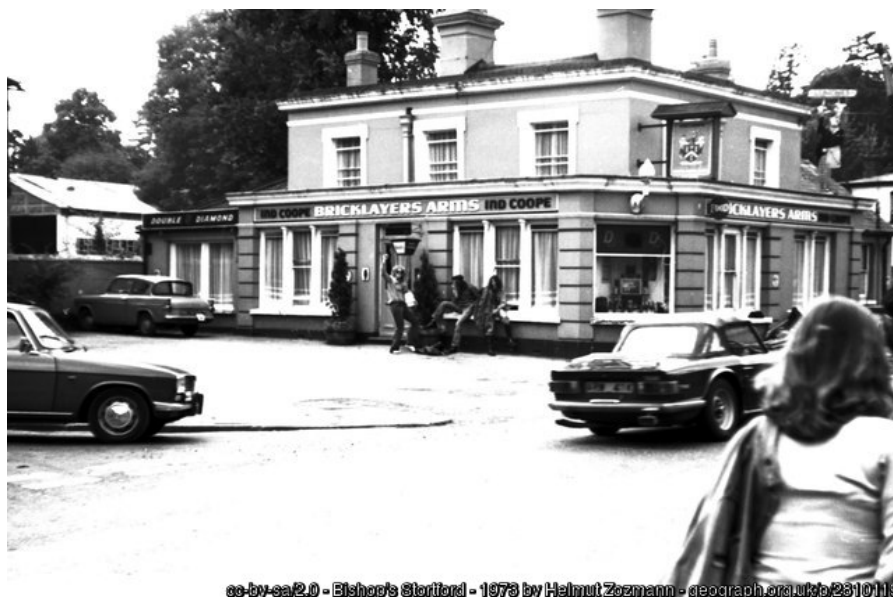
Photograph 4 Bricklayers Arms in 1973. Inserted windows in place of original double doorway on the pub, and on extension B, both visible. Pub owned by Ind Coope. From www.geograph.org.uk.

Photos of the pub taken in the 1970s (Photographs 3 and 4) show its owner as Ind Coops, who purchased Benskin's Brewery in 1957 (<http://www.hertsmemories.org.uk>). The photos show the current window-frames (although the glass has since been replaced) and an earlier pub sign.

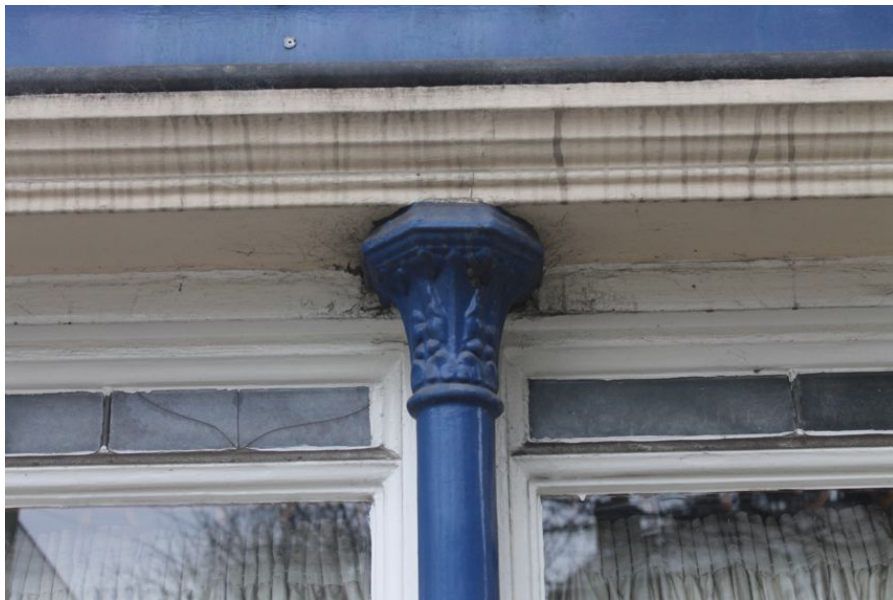
Photograph 11 Detail of decoration on apex of metal post between windows on the north-east elevation of pub. Photograph taken facing south-west.

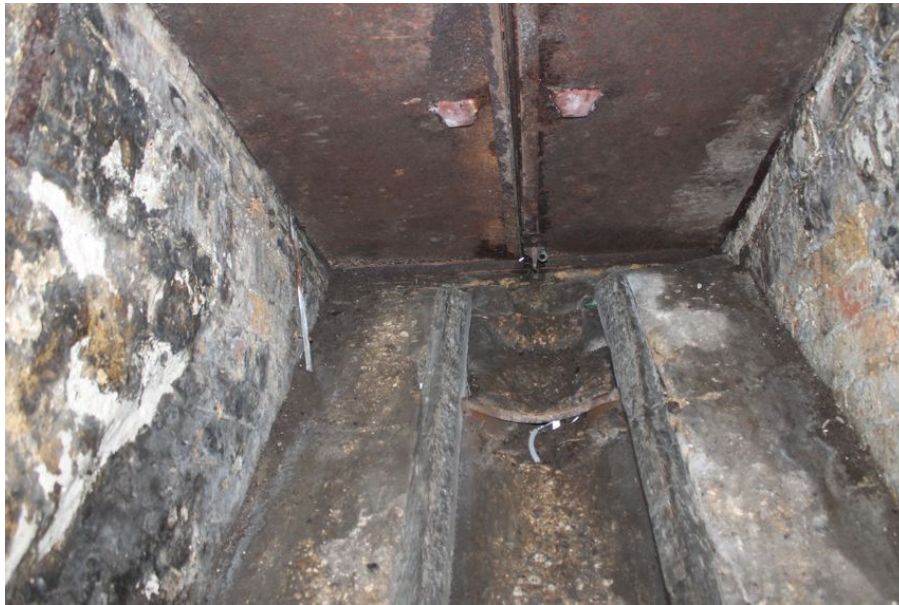
Photograph 12 Interior of cellar, showing hatch onto pavement and chute into cellar. Photograph taken facing north-west.

Extension A has a cellar beneath it, accessed both from a stairway within the pub and by a chute from the exterior of the building. The chute is brick- and concrete-lined, with two wooden and iron rails in the centre, designed to guide beer kegs and barrels into the cellar (Photograph 12). The door at the top of the stairway has four-panels, and is probably original (Photograph 13).

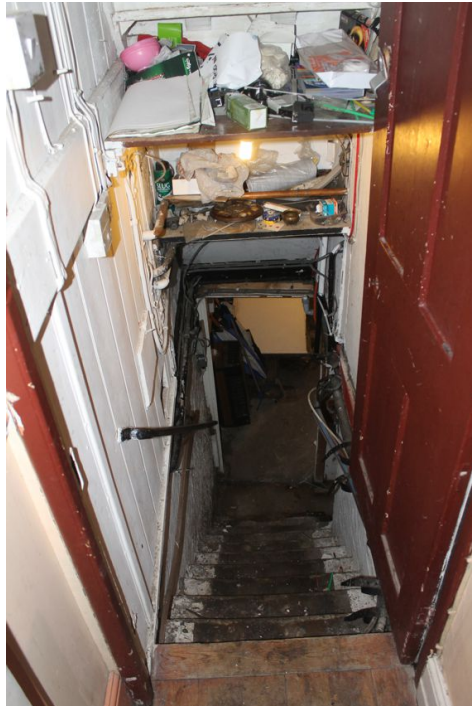
Photograph 13 Entrance into cellar from ground-floor of pub, with four-panel door visible to right. Photograph taken facing north-west.

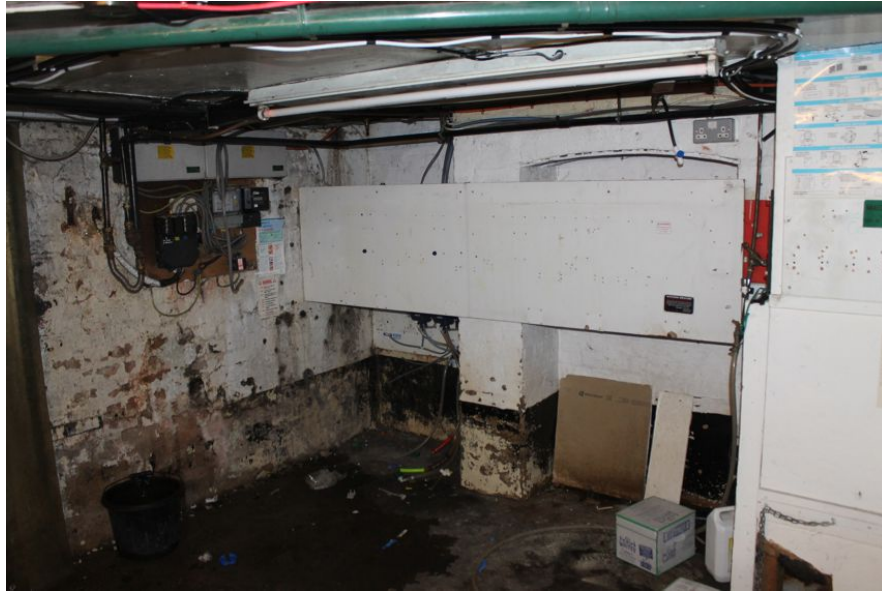
Photograph 14 Interior of cellar, showing brick arch supporting chimney-stack on upper floors. Photograph taken facing east.

The walls of the cellar are constructed of brickwork laid in English-bond with brick dimensions of 225mm x 110mm x 65mm. Within the cellar are several modern shelving units. On the south-east wall is a brick archway, supporting the chimney and fireplaces on the ground- and first-floors (Photograph 14).

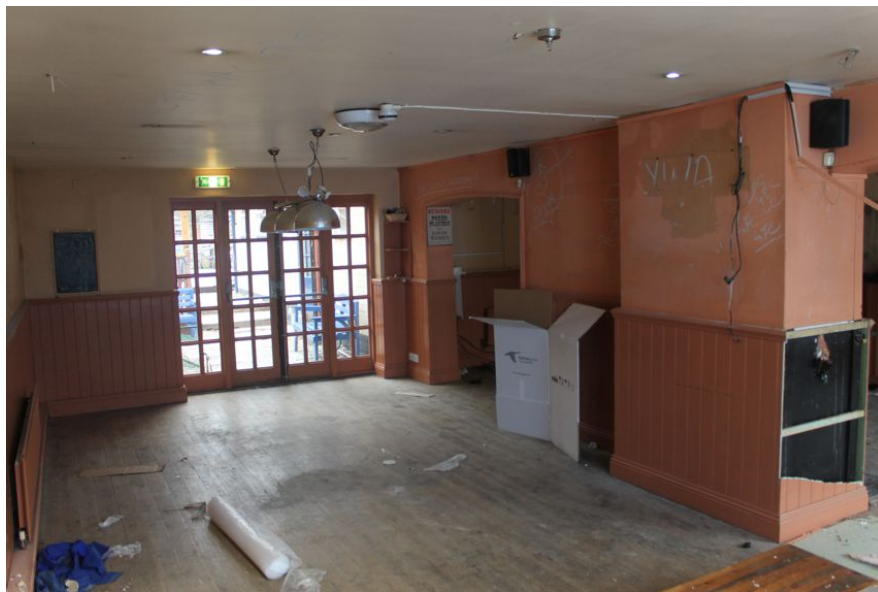
Photograph 15 Interior of extension B, showing dado-rail and blocked fireplace. Photograph taken facing north-west.

The interior walls of the ground-floor of the pub and extension B are rendered over and have a wooden-panelled dado, with an associated dado-rail (Photograph 15). The public entrance into the pub leads into a small foyer, and from there into two separate bars: a smaller one to the south, and a larger one to the north (Fig 4).

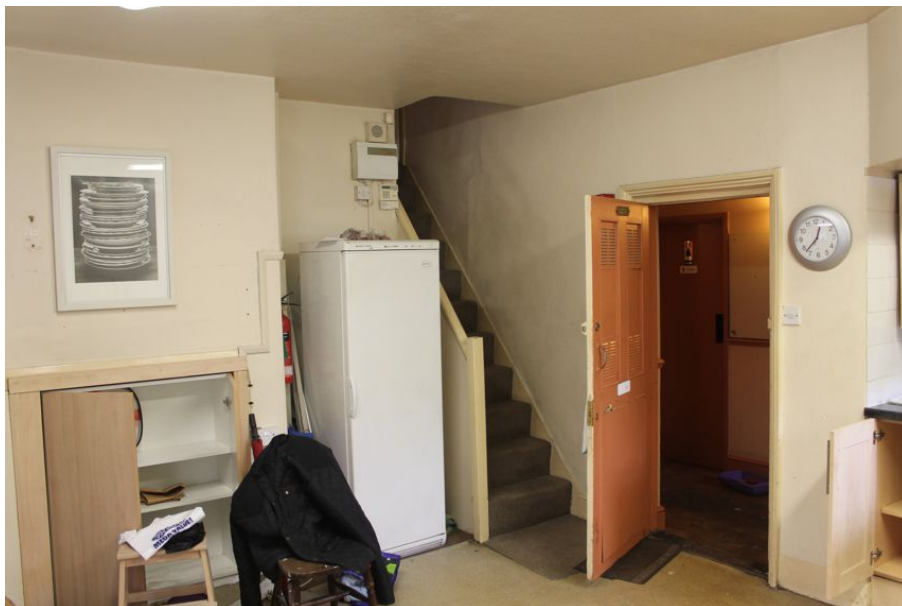
Photograph 20 Interior ground-floor of extension A, showing the blocked fireplace, door into corridor and stairway to first-floor. Photograph taken facing south.

The only private area of the ground-floor is extension A, which contains a blocked fireplace and the modern kitchen (Photograph 20).

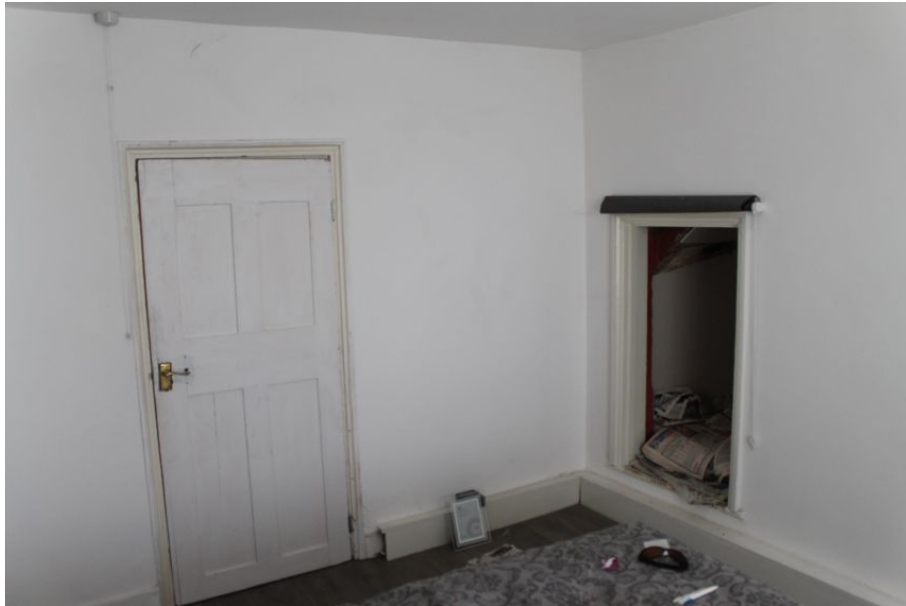
Photograph 23 Interior of northern bedroom in pub, showing original door (to left) and crawl-space into loft of extension A (to right).

The loft of extension A is accessible via a crawl space from the northern bedroom of the pub (Photograph 23). There is lath and plaster nailed to the rafters, which may be original (Photograph 24). Also visible in the loft is the chimney-stack for the fireplace below (Figs 3 - 4).
