Archaeological excavation for a water main replacement at the Upper Castle Park, High Street, Colchester, Essex, CO1 1UN

February 2019

CAT Report 1382

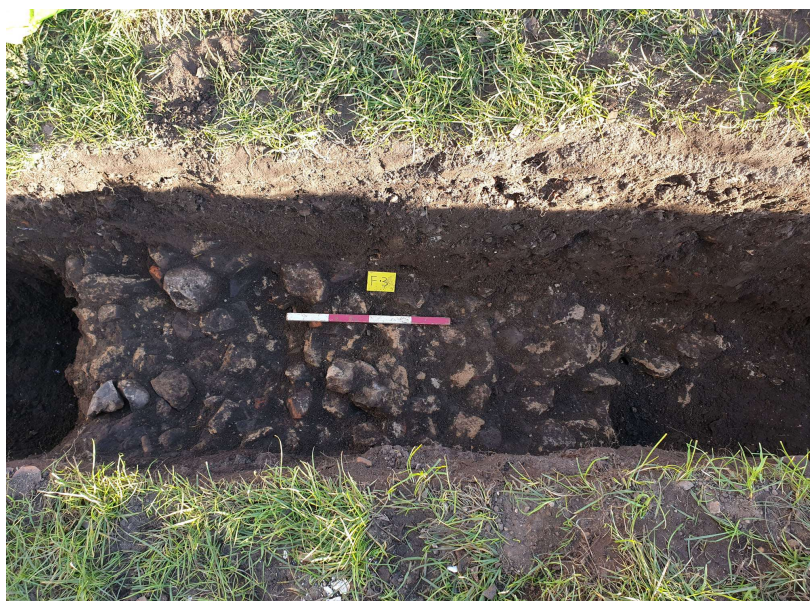
Photograph 1 Wall foundation F3, looking east

Wall foundation F3, which was of likely 11th- or 12th-century date, was situated just to the north of the path and lay on a WNW-ESE alignment. It extended across the width of the trench and so its full dimensions could not be ascertained, but its exposed extent was 1.3-1.7m wide and 0.18m deep. The foundation of the castle's barbican, F6 – much of which already stands above ground immediately to the west of the footbridge – was uncovered. It was also probably of 11th- or 12th-century date.

A wall foundation was also uncovered. While no dating material was recovered from this foundation owing to the protected status of the castle, it is composed of the same materials as the chapel and barbican, and it is almost certainly also of 11th- or 12th-century date. While the wall foundation was 1.3-1.7m wide, similar to the barbican, it lies some 0.5m higher, and it would appear that it forms part of a separate structure, possibly part of the castle's defences.

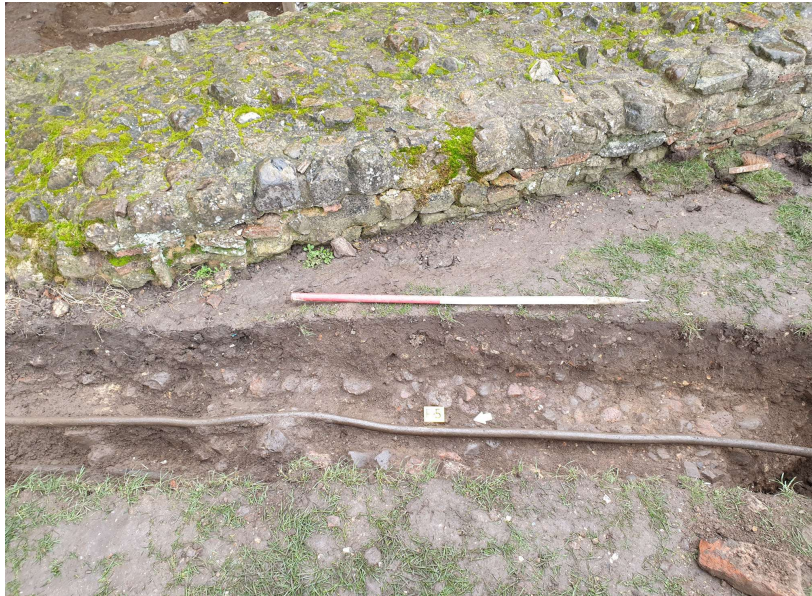
Photograph 2 Demolition spread F5, looking east southeast

Modern debris spread F2 lay to the north of F3. It was 0.76m wide and 0.09m deep. A further deposit of demolition material or robbing debris, F5, which was of possible post-

medieval date, was uncovered just west of the footbridge. This feature extended beyond the limit of excavation, but its exposed extent was approximately 1.8m wide.

Excavations within the bailey of Colchester Castle revealed a number of archaeological features. Immediately adjacent to and overlying the barbican wall (F6) lay a spread of demolition material or robbing debris, composed of Roman CBM, septaria and ragstone (F5) which is likely the product of the demolition works carried out on the castle during the late 1690s. It should be noted that a similar layer of material was uncovered approximately 4m to the west during excavations conducted during 1931-33 (Drury 1982, 314). F5 sealed a further deposit of silty-loamy-sand with abundant oyster shell fragments which appears to be an occupation layer.
