Archaeological excavation at 5-6 St Nicholas Street, Colchester, Essex, CO1 1DW June-July 2019

commissioned by Colchester Amphora Trading Ltd

CAT Report 1614 September 2021

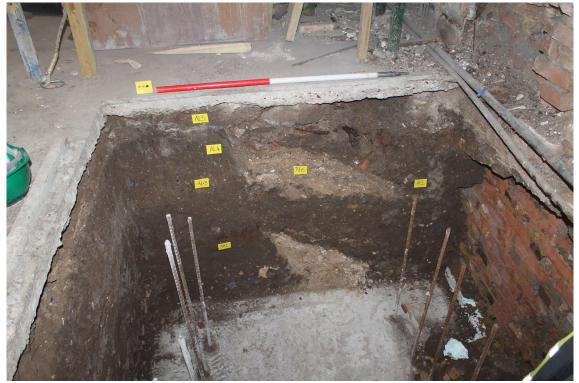
Photograph 1 Pad A Sx A3, upper section, AF1, AF6, AL1, AL3, AL4 and AL5, looking east.

The interpretation of the archaeology in this pad is difficult, largely due to the lack of excavation and associated dating evidence. If AF3 is of post-medieval date, then all the other contexts in Pad A are later, which produces a remarkable depth of accumulation layers within the heart of the timber-framed building. No previous evidence has been found for a cellar underneath Building A (such as cellar walls), but these post-medieval contexts could be interpreted as layers of backfill within a cellar that had been put out of use.

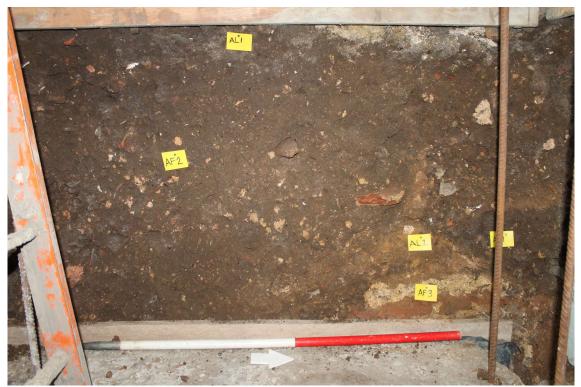
Photograph 2 Pad A Sx A3, lower section, AF1, AF2, AF3, AL1 and AL2, looking east.

If however, there proves to be no cellar, perhaps we should instead question whether the two bricks forming AF3 were in fact *in situ*. Given its location at the base of AF1, AF3 could potentially be debris associated with the construction cut. This would mean that all the features and layers above AF3 date from the 14th century onwards as peg-tile was recorded in section in all of them. They could then be accumulation layers that pre-date the construction of the building, although this does not satisfactorily explain the truncation of Roman remains in this area.

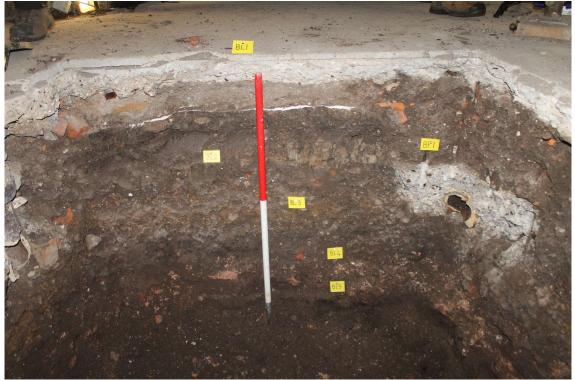
Photograph 3 Pad B Sx B3, upper section, BF1, BL1, BL2, BL3, BL4 and BL5, looking northeast. Also showing depth of archaeology excavated without archaeological intervention.

Beneath BL2 was metalled surface BL3. The metalled surface was also recorded in Pads F (FL4) and I (IL5) to the south covering an area at least 2.3m wide by 8m long to the rear of Buildings A and C. Across all three pads the surface was recorded at between 25.74 and 26.03m AOD, ranging in thickness from 0.06m to the south to 0.28m to the north. As the metalled surface covers the entirety of Pad B, the surface presumably dates from the late 19th-century when the small extension was added to the rear of Building A. This was also the period when Buildings A-D were in use as a single property (CAT Report 1222). Interestingly, the surface was not present in test-pit 2 of the 2017 evaluation which was located immediately to the west of Pad I (CAT Report 1125), so the surface was confined to quite a small area at the back of the buildings.

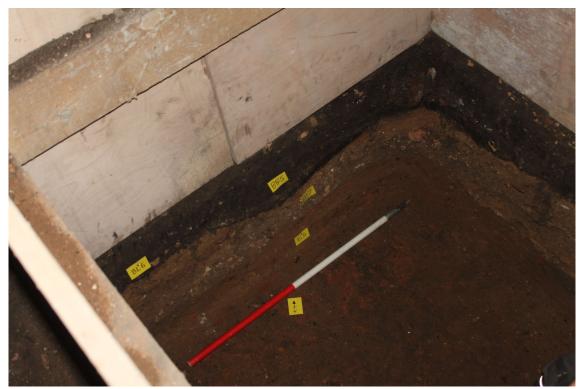
Photograph 4 Pad B Sx B4, charcoal horizon BL6 and BF5, with demolition debris BL7 and BL8, looking southeast.

Beneath the layers of dark earth, BL6 (including BF5) had a dense deposit of charcoal at its base (*c* 0.1m thick) and this charcoal horizon was present across the development site (in all but Pad A) at depths ranging from 24.97-25.33m AOD. Finds from BL6/BF5 included a 4th-century pottery sherd, and the horizon in general produced a significant quantity of late Roman material with evidence suggesting a later 4th century date (see Pad G). Other finds from the horizon in Pad B included a small quantity of CBM (some burnt), a fragment of window glass, industrial debris, a piece of copper-alloy wire and fragments of copper-alloy sheet.

The charcoal horizon overlaid two layers of demolition debris, BL7 and BL8, which sealed the post-Boudiccan remains. Fragments of CBM, mortar, daub and pottery came from the debris, with BF3 likely representing a spread of demolition/robbed-out remains.

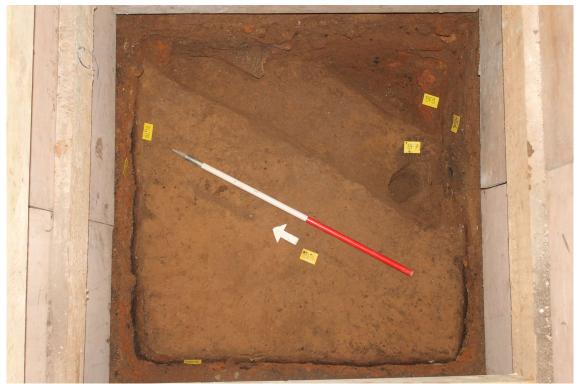
Photograph 5 Pad B, plan of linears BF6 and BF8 with posthole BF7 and natural ground level BL14, looking northeast.

At a depth of c 2m below current ground level (24.4m AOD), sealed beneath BL8, was *in situ* Boudiccan destruction debris BL9. This debris had been cut by BF6, a wide, flat-based linear which ran through the pad on a rough north-south alignment. Post-hole BF7 in the base of BF6 is probably related, and together would perhaps suggest that the features are structural from a phase of post-Boudiccan activity on the site. This could be the construction cut for a Roman wall foundation or perhaps a later Roman robber-trench. It had been backfilled with a quantity of building material, mainly roofing tile, with a sherd of pottery and tegula lower cut-away dating from the mid 2nd century onwards. If there was a Roman wall foundation at this location than it would be aligned parallel to, and c 5.2m apart, from to the large foundation identified to the west (see Pads C, G and I), and would be perpendicular to wall foundations in Pads F and H. Interestingly, there is no floor layer in Pad B associated with this phase.

Cut by BF6 (see above) and on the same alignment with it was north-south linear BF8 which had been backfilled with Boudiccan destruction debris. It is possible that this is part of a construction cut or robber trench for a similar feature to the wattle and daub wall seen in Pads F and G, and would be aligned at a right-angle to that wall. If originally part of a wall foundation, this feature would presumably be contemporary with floor layers BL10-BL12.

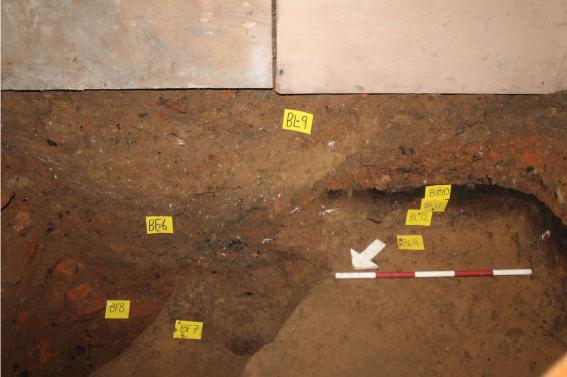
Photograph 6 Pad B Sx B2, Boudiccan destruction debris BL9 (label in wrong place, should be above BL10), floor layers BL10, BL11, BL12, grey silt BL13 and natural BL14 all cut by linear BF6, also showing posthole BF7 and linear BF8, looking northwest.

Boudiccan destruction debris BL9 consisted of a high concentration of charcoal and fragments of clay-block/daub from the demolition and levelling of structural features burnt during the revolt of AD 61. Sealed beneath this debris was silty-sandy floor BL10 which had been burnt black. Beneath floor BL10 was make-up layer BL11, and this overlaid an even earlier sandy-clay floor, BL12. The presence of these floor layers indicates that Pad B was located inside a Roman building that was burnt down during the Boudiccan revolt. A thin lens of grey silt, BL13, at the base of the pad sealed natural sand BL14. This lens was either a thin remnant of the buried topsoil or dirty material deposited during the construction of the early Roman building. Intrusive Roman pottery from BL10 (2nd century) reveals some later Roman disturbance/truncation of the Phase 1 remains, probably during Phase 2.

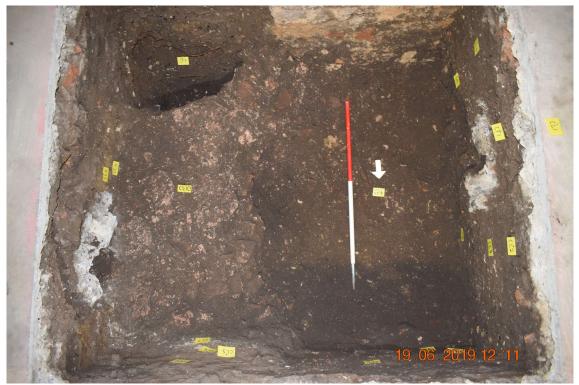
Photograph 7 Pad C plan, showing partially excavated pit CF3 and robber trench CF4, with demolition debris CL11 in between, looking south.

Sealed beneath imported soil CL2 was pit CF3 and robber trench CF4. Based on the pottery dating evidence, pit CF3 is most likely to date to the late 15th to 16th century. Among the numerous pottery finds, an incomplete bunghole cistern was found placed upright near the base of the pit and had been filled with numerous objects, mostly of iron. The date of the pit and deliberate placement of the vessel therefore suggests that it was buried during the construction of Building A in the late 15th century, possibly as an apotropaic (protective) deposit.

North-south robber trench CF4 had been excavated to remove building materials from a large Roman wall that stood on foundation CF8 (see below). Pottery dating evidence from CF4 (which includes CL4, CL8 and CL9, which were excavated as layers but were actually fills within the feature), ranges from the mid 12th to the mid 16th centuries, with the presence of a single piece of peg-tile suggesting a date from the 14th century onwards. The evidence would therefore suggest that the Roman wall was extant in the medieval period until at least the 14th century, and it is likely that the wall was demolished in advance of the construction of Building A in the late 15th century.

The presence of both these features, CF3 and CF4, at only 0.2m bcgl with only modern layers above demonstrates that all the later floors associated with the timber-framed building had been previously removed, probably during the 20th-century alterations to the building.

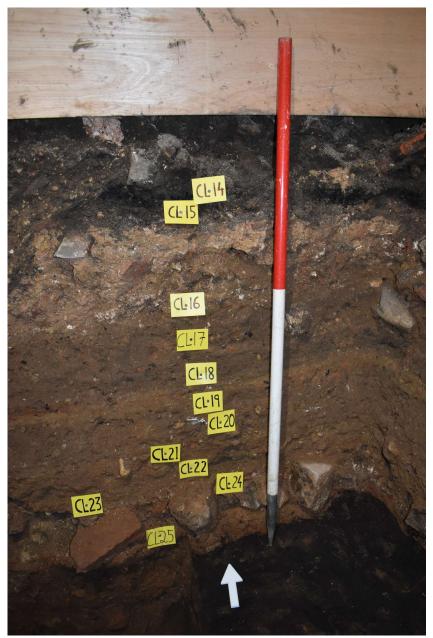
Photograph 8 Pad C Sx C1, close-up of layers CL14-CL25 with burnt floor CL26 unlabelled at the base of the pad, looking north.

Beneath Boudiccan destruction debris CL25 was sandy-clay floor CL26, *c* 0.35m thick, that had been heavily burnt across the top 0.2m. The dark grey/black material on top of the burnt floor gradually graded into a dark brown/red colour and became lighter and lighter until the natural sand, CL27, was reached. The reddish/brown material could be part of an earlier floor affected by the fire, or it could be scorched natural from the heat of the fire above.

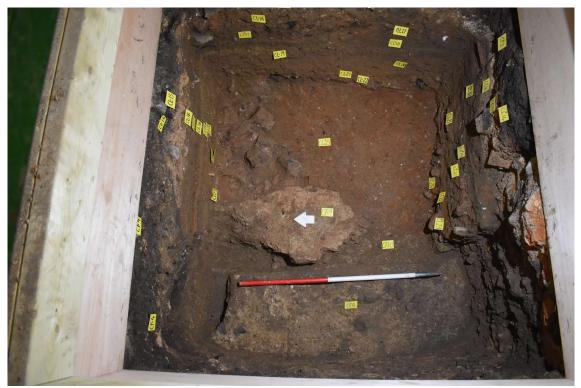
Photograph 9 Pad C plan, showing wall foundation CF8, mortar floor CF9 and layers CL14-CL25, looking east.

Several floor layers were associated with this phase. Three floor or levelling/make-up layers (CL22, CL23 and CL24) were the earliest, with a remnant of a possible mortar floor, CF9 embedded into CL24. Above these layers was compact metalled surface CL21 (0.06-0.18m thick) made from small to large water-worn pebbles pressed into a sandy-silt. This metalled surface was also recorded in Pads F, G, H and I, at a depth of 24.29-24.58m AOD across the development site. Above the metalled surface was make-up layer CL20, followed by floor layers CL19 and CL18 at the top of the sequence. Small rounded stones had been pushed into the surface of both CL18 and CL19, with compact occupation layers (trample) also recorded in

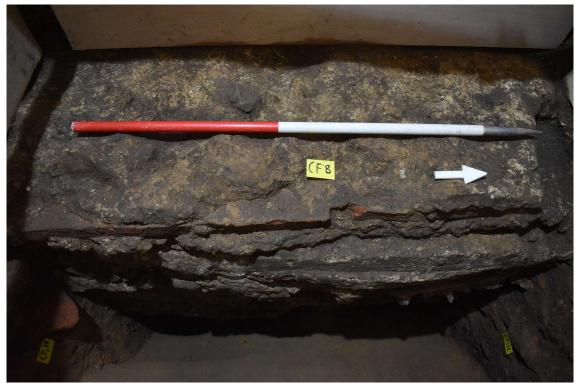
Photograph 10 Pad C, wall foundation CF8, looking west.

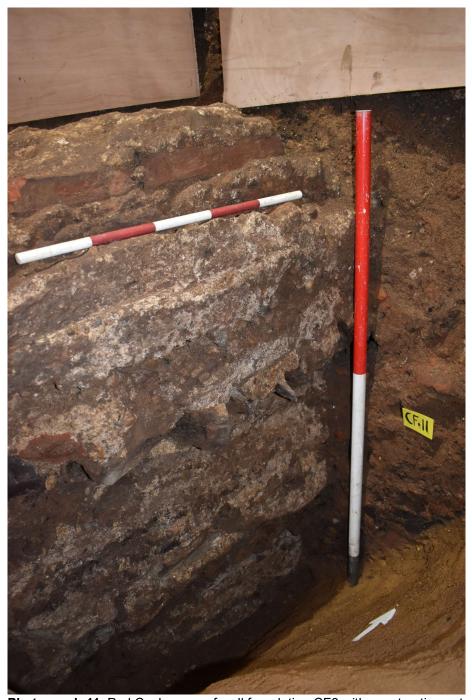
Photograph 11 Pad C, close-up of wall foundation CF8 with construction cut CF11, looking northwest.

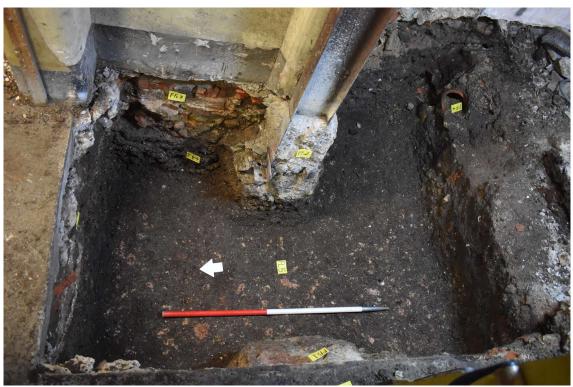
Photograph 12 Pad F, general shot of upper contexts, looking east.

Underneath metalled surface FL4 was dark earth deposit FL5 which contained a quantity of Roman demolition debris along with sherds of medieval pottery (mid 12th to late 14th century). Pit FF8 is also likely of post-Roman date.

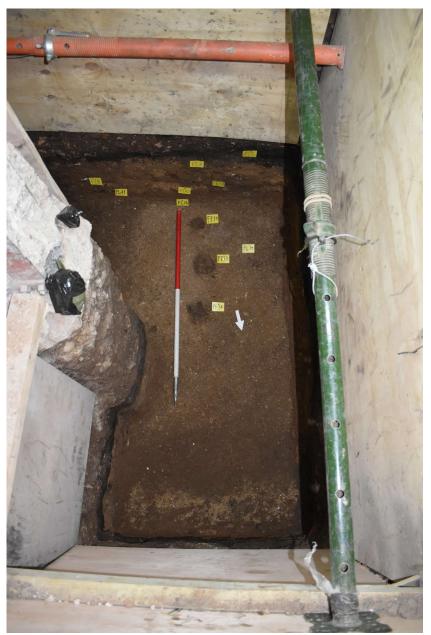
Photograph 13 Pad F, plan of postholes FF12-FF14 cut through metalled surface FL14, looking south.

only find from the metalling layers. A row of six postholes/stakeholes, FF12-FF17, cut FL14, with posthole/stake-hole FF24 cut into FL15.

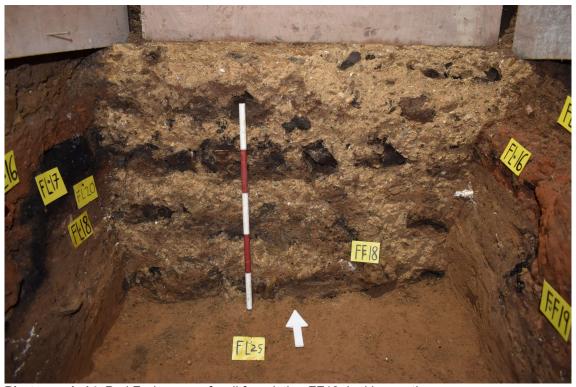
Photograph 14 Pad F, close-up of wall foundation FF18, looking north.

Along the northern edge of Pad F and aligned east-west was wall foundation FF18 which had cut through the Boudiccan destruction debris. The foundation stood at a height of c 0.6m and had been constructed from pebbles and small septaria pieces set in a yellow/brown mortar. There was no trace of the wall continuing into Pads C or G to the west.

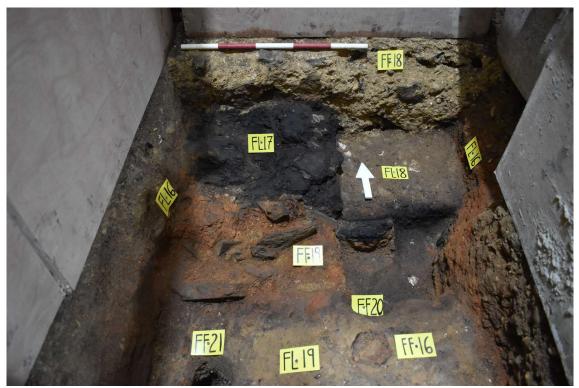
Photograph 15 Pad F, close-up of wattle and daub wall foundation FF19, looking north.

Roman Phase 1 – Boudiccan and pre-Boudiccan (Fig 11, Pad F Plans 3 and 4) Sealed beneath Boudiccan destruction debris FL16 and FL17 were the *in situ* burnt remains of a pre-Boudiccan building. Wall foundation FF19/FF22 was aligned east-west, was 0.3m wide and was part of the same foundation identified in Pad G (GF24). Made of wattle and daub, there was evidence that the wall foundation had been constructed on a timber ground plate, which was sunk deeper in the western half of the pad (FF22) than the eastern (FF19). Two iron hinge pivots from FF19 likely indicate a threshold within this shallower eastern section. Debris from the wall included some painted wall plaster, with *in situ* burnt plaster recorded on the surface of the wall in Pad G. A layer of sandy-clay, FL18/FL19, surrounding the wall was probably a backfilled construction cut.

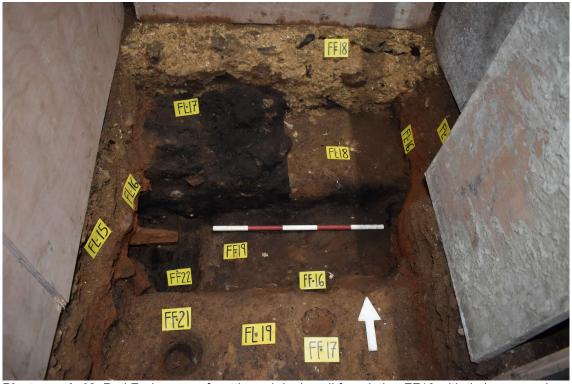
Photograph 16 Pad F, close-up of wattle and daub wall foundation FF19 with timber ground-plate FF22, looking north.

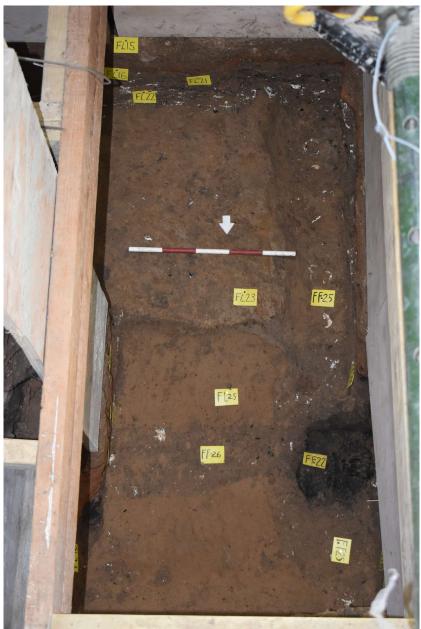
Photograph 17 Pad F, construction cuts FF25 and FF26/FF27, looking south.

At the base of the pad, cut into natural ground level (FL25), were north-south linear FF25 and east-west linear FF26/FF27 (including fill FL24), which was located directly underneath the wattle and daub wall. The precise function of these two features is uncertain. They appear to be contemporary with each other, with pottery from FL24 and FF25 dating to the mid to late 1st century. Given the location of the wattle and daub wall over linear FF26/FF27, this feature could be associated with ground preparations before the construction of the wall or could potentially be the cut for an earlier wall on a similar alignment. There was no trace of this continuing underneath the wall in Pad G though. North-south linear FF25 could similarly represent another wall alignment along the western edge of Pad F. As there is no trace of linear FF25 continuing into Pad B to the north, it is likely that the feature actually terminated on the southern edge of FF26/FF27.

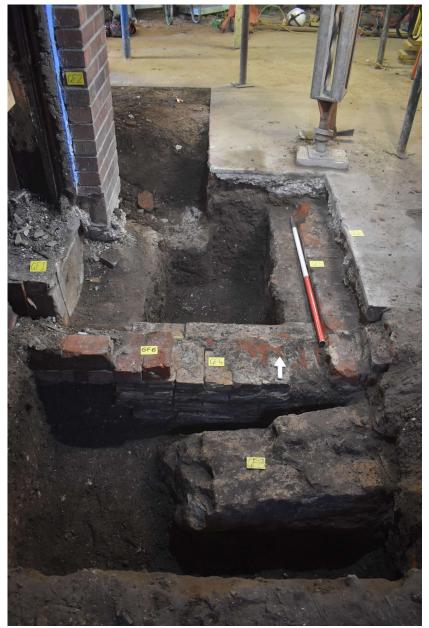
Photograph 18 Pad G, plans of GF1-GF6, looking north.

On the western side of the pad, the base of a concrete pillar (GF1) and modern brick wall (GF2) supported an iron girder, and just below the concrete floor were three wall foundations. Wall foundation GF5 was L-shaped and aligned north-south along the eastern side of the pad before turning 90 degrees east, and continuing eastwards on an east-west alignment. The north-south foundation consisted of a concrete base on top of which was a single row of red frogged bricks.

Also aligned east-west, and butting against the concrete foundation of GF5, was wall foundation GF4. This foundation was constructed of five courses of thin, cream/yellow unfrogged bricks. Foundation GF4 only appeared to be 0.7m long by 0.35m wide, and had been overlaid at the western end by GF6, two rows of red frogged bricks. Wall foundations GF4, GF5 and GF6 appeared to be contemporary, dating from the mid 19th to the 20th century, although their function is unclear. They could be internal wall foundations, brick supports for earlier floor joists (as seen in Test-pit 2 of the 2017 evaluation, CAT Report 1125) or perhaps could be associated with the construction of a modern staircase previously in this location.

Wall foundation GF3 was located immediately to the south of GF4/GF6. It was aligned east-northeast to west-southwest, and appeared to terminate to the west-southwest within the pad. There was no trace of the wall in the adjacent Pad F. It was comprised of occasional horizontal peg-tile fragments, post-medieval brick fragments, fist-sized and smaller septaria fragments and pieces of greensand stone, all mortared into a crude but very solid wall. Like foundations GF4-GF6, the precise function of this wall foundation is uncertain.

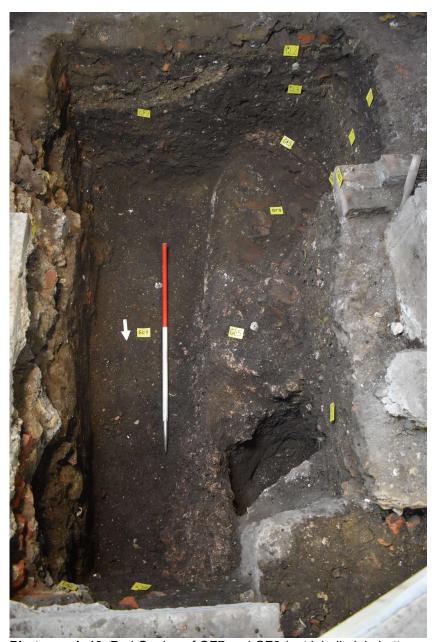
Photograph 19 Pad G, plan of GF7 and GF8 (not labelled, in bottom right-hand corner), looking south.

Sealed beneath imported soil GL2 was pit GF8. The top of the pit had been cut away by a concrete pillar and all that remained was the base of the feature. Pits GF8 and CF3 in Pad C are the same feature, and an apotropaic deposit found at the base of the pit in Pad C dates from the late 15th to 16th century, indicating that the pit is contemporary with the construction of Building A.

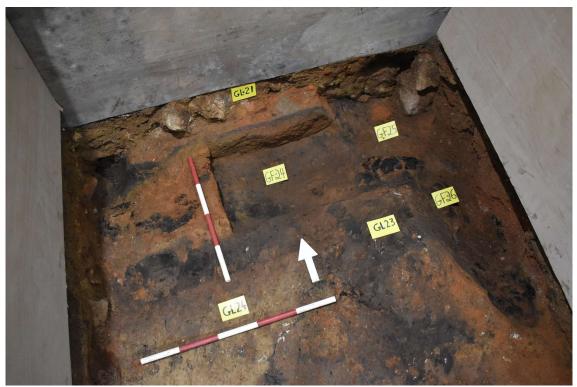
Photograph 21 Pad G, close-up of wattle and daub wall foundation GF24, looking northeast.

Roman Phase 1 – Boudiccan and pre-Boudiccan (Fig 13, Pad G Plans 5 and 6) Beneath GL21 were two layers of Boudiccan destruction debris, GL22 and GL26. This debris sealed the *in situ* burnt remains of pre-Boudiccan east-west wall foundation GF24, which was also present in Pad F (FF19/FF22). Little remained of the 0.3m wide wall foundation aside from a burnt timber ground plate in a shallow construction trench. The ground plate formed the base of a wattle and daub wall, and fragments of both burnt wattles and daub were recovered from the destruction debris above. Also surviving on the northern side of the wall were the remains of the plastered face of the wall (GF28). Here, two distinguishable vertical plaster layers had survived, both now more sand than mortar, which had been scorched a grey colour by the heat of the fire.

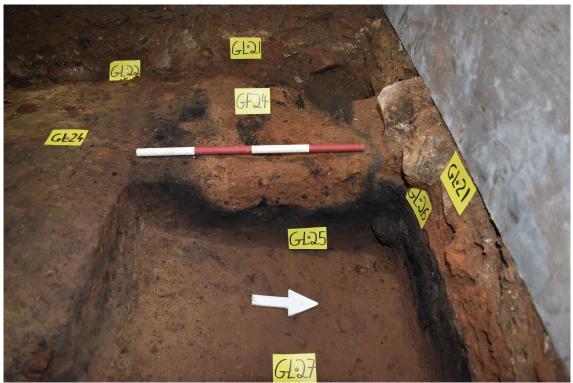
Photograph 22 Pad G, close-up of wattle and daub wall foundation GF24, looking west.

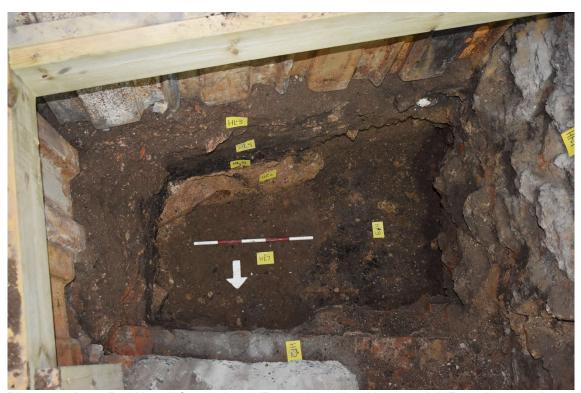
Photograph 23 Pad H, wall foundations HF1 and H2 with robber trench HF3 and layers HL3 and HL5-HL8, looking south.

Post-medieval wall HF2 was L-shaped, aligned east-west and north-south, and had been built against HF1 to the west. Made of bricks bonded in lime mortar, it extended into the pad for a depth of over 2m below modern ground level. Given the depth of these walls, the most likely interpretation is that they belong to a previously unknown cellar located underneath Building C. There was no indication of this cellar in either Pad G to the north or the 2017 evaluation test-pit immediately to the east (CAT Report 1125), so the cellar was considerably smaller than that underneath Building B and was perhaps little more than a small storage space. At the base of the cellar, layer of compacted silty-clay HF9 was either the cellar floor or made-ground onto which the cellar was constructed. The cellar had been backfilled with soil and rubble (HL4 and HL18), although there did appear to be a short section of *in situ* east-west brick wall (HF7) to the north of HF2 in the northwest corner of the pad with a possible layer of bricks at the top (HF11).

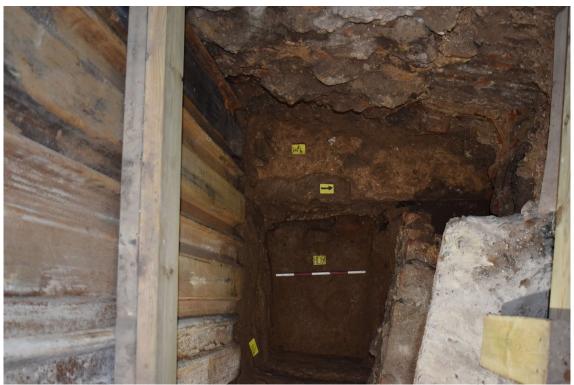
Photograph 24 Pad H, post-medieval cellar wall foundation HF1 built on top of Roman wall foundation HF4, looking west.

Cutting HL5 was robber-trench HF3. The trench was dug to rob-out materials from the Roman wall built on foundation HF4 (see below).

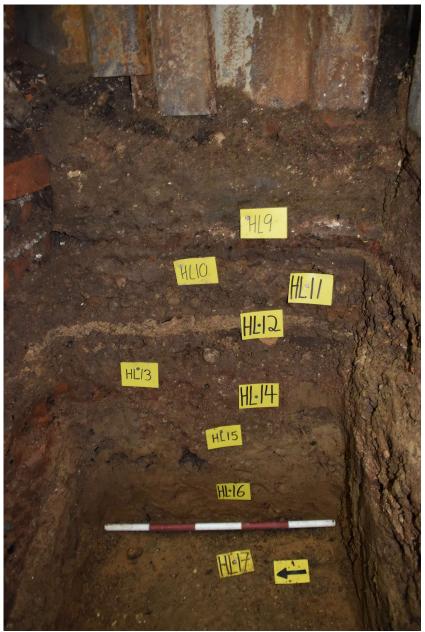
Photograph 25 Pad H Sx H2, close-up of metalling layers HL10-HL15 with layers HL16-HL17 below, looking east.

A layer of Boudiccan destruction debris, HL19, sealed pre-Boudiccan clay floor HL16. The floor showed no evidence of being heat-affected, and had been laid on natural ground HL17.

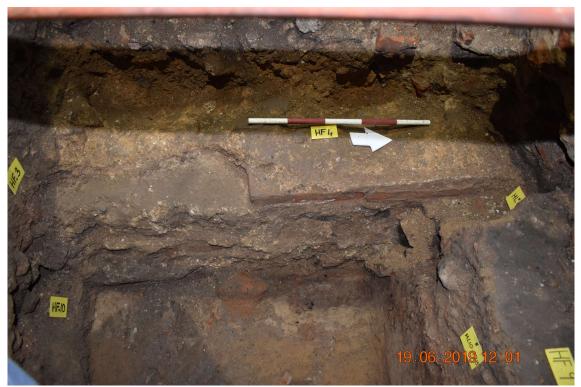
Photograph 26 Pad H, close-up of Roman wall foundation HF4, looking west.

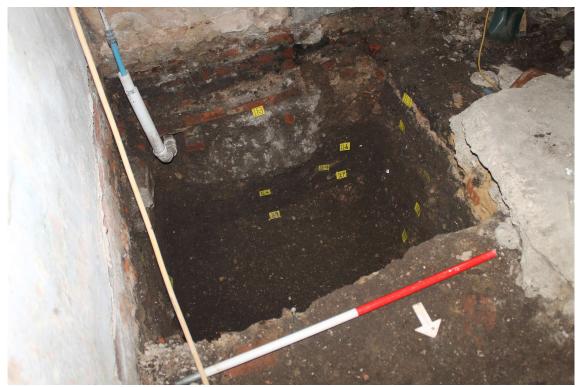
Photograph 27 Pad I Sxs I1 and I2, excavated to top of IL9, looking southwest.

For a depth of approximately 0.9m beneath metalled surface IL5, were five layers of accumulation with some Roman demolition debris scattered throughout. They were, in stratigraphic order from the top IL6, IF4/IL11, IL7, IL8 and IL9. Clay block IF5 is almost certainly a piece of demolition debris within layers IL7/IL11. No post-Roman finds were recovered from these layers for post-excavation analysis, but post-Roman ceramic building material was recorded in section in IL9, and they presumably pre-date the construction of Building C. It is uncertain if pit IF7 is of late Roman or post-Roman date.

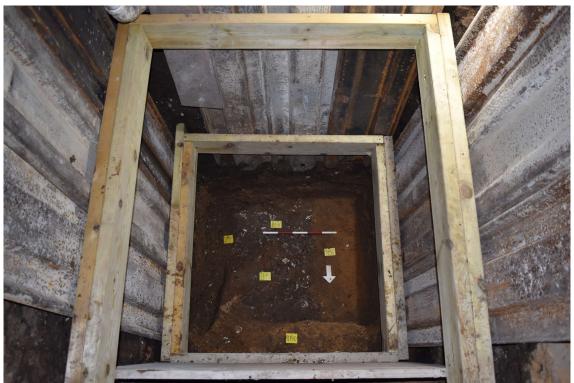
Photograph 28 Pad I, plan of IF9, IF10, IF11, IF12 (mistakenly labelled as IL16) and IL15, looking south.

Feature IF12 was recorded on site as a quarry pit. It was certainly very deep, recorded at over 1.1m before excavation ceased. However, the pit is straight-sided which would be unusual for a quarry pit given the potential for the sides to collapse. Excavation of this feature reached a depth of 23.06m AOD, and the only other pad where this depth of archaeology was recorded was in Pad C, where wall foundation CF8 in construction cut CF11 were recorded to a depth of 22.74m AOD. It is possible therefore, that IF12 is actually a construction cut for another north-south Roman wall to the west of the pad as the feature is aligned parallel to wall foundation CF4/HF3. Like construction trenches CF11 and GF23, IF12 is also sealed by the metalled surfaces seen across the development site which appear to be contemporary with the walls. However, unlike IF12, construction trenches CF11 and GF23 had gradual sloping-sides and were backfilled with Boudiccan destruction debris.

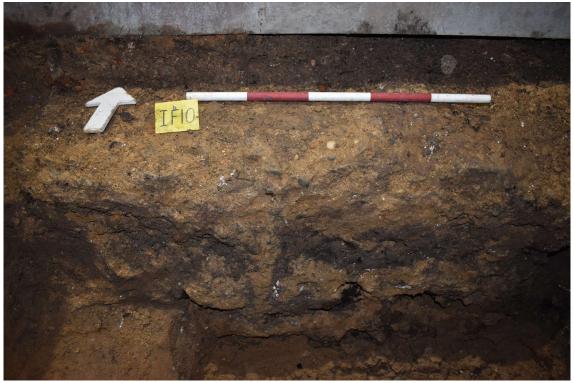
Photograph 29 Pad I, close-up of Roman wall foundation IF10, looking north.

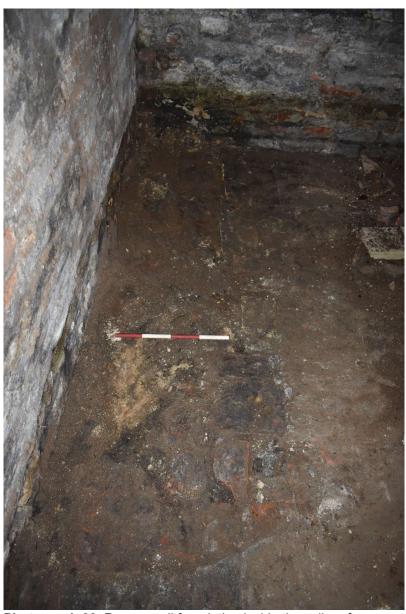
Photograph 30 Roman wall foundation inside the cellar of 6 St Nicholas Street, looking south.

The top of Roman wall foundation WBF1, located at floor level inside the cellar of 6 St Nicholas Street, was cleaned, photographed and planned. The eastern wall of the cellar had been built on top of the Roman wall foundation, and it is part of the same foundation recorded in Pad C (CF8) and Pad H (HF4).

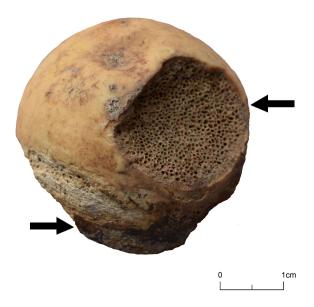
Photograph 32 Partial femoral head from FL16. The top arrow shows the slice removing part of the femoral head, the bottom arrow shows the area where the other slice has completely separated this fragment from the rest of the femur.

Context	Finds no.	Element present	Age	Sex	Pathologies
FL16	F32	Femoral head, right, incomplete	?adult	n/a	Two perimortem sharp- bladed slices
GL8 (lower)	G23	Tibia shaft, incomplete	adult	n/a	none
GL8	G30	Lower 1st molar, deciduous	1.5-2 years old	n/a	none

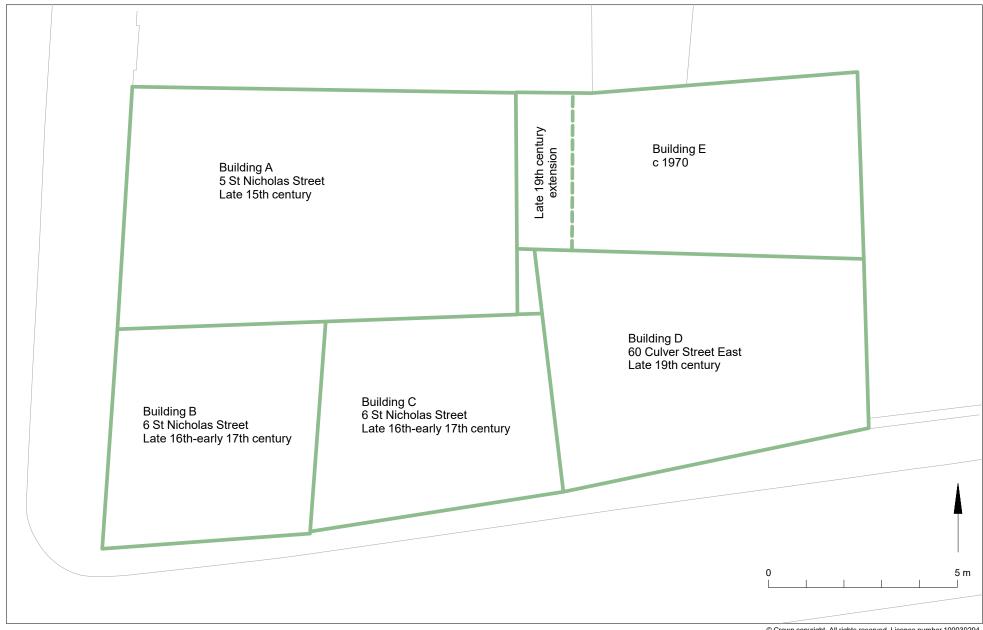
Fig 2 Outline plan of Buildings A-E (from CAT Report 1222)

A Historic Building Recording carried out by CAT in 2017 (CAT Report 1222, ECC4001) concluded that five standing buildings (Buildings A-E) exist on the development site (see Fig 2 for locations). A summary is presented below and these building designations have been used throughout this current report.

The Historic Building Recording carried out by CAT in 2017 (CAT Report 1222, ECC4001) concluded that five buildings (Buildings A-E) existed on the development site (see Fig 2 for locations).

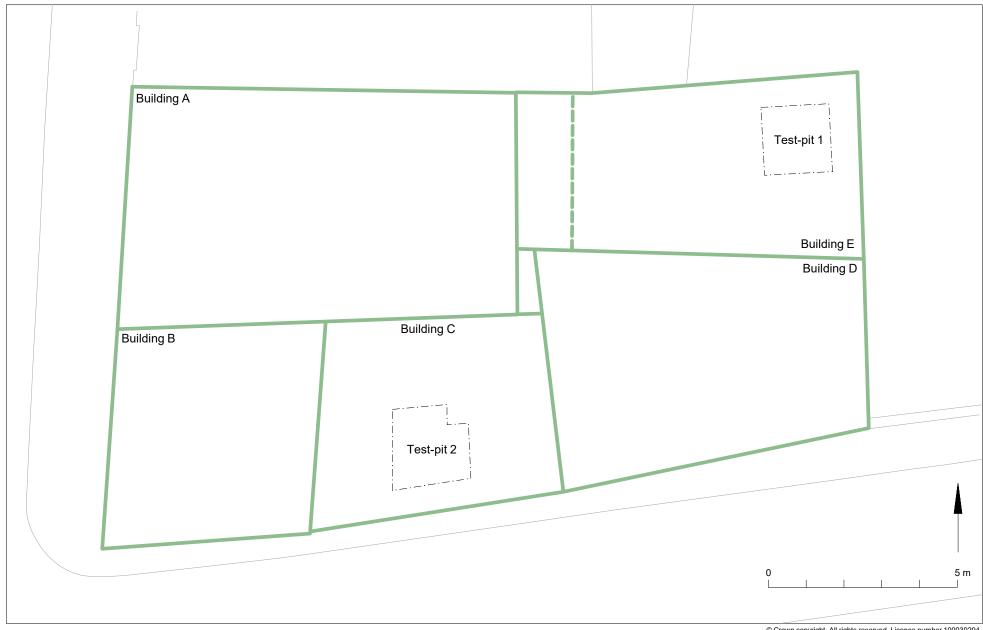
Fig 3 Location plan for 2017 evaluation test-pits (CAT Report 1125)

In advance of the current project, CAT carried out a test-pit evaluation on the development site in 2017 (CAT Report 1125, ECC3985) (see Fig 3 for locations). Due to safe-working depths, excavation ceased at the top of Roman horizons. Test-pit 1 was located inside Building E and was excavated through layers of post-medieval/modern activity associated with the original rear yard of the buildings. Some medieval and late Roman contexts were revealed beneath, with Roman contexts identified at a depth of 25.13m AOD (1.44m below ground level). Test-pit 2 was located in the centre of Building C. Modern and post-medieval layers sealed Roman contexts which were identified at a depth of 25.48m AOD (1.08m below ground level).

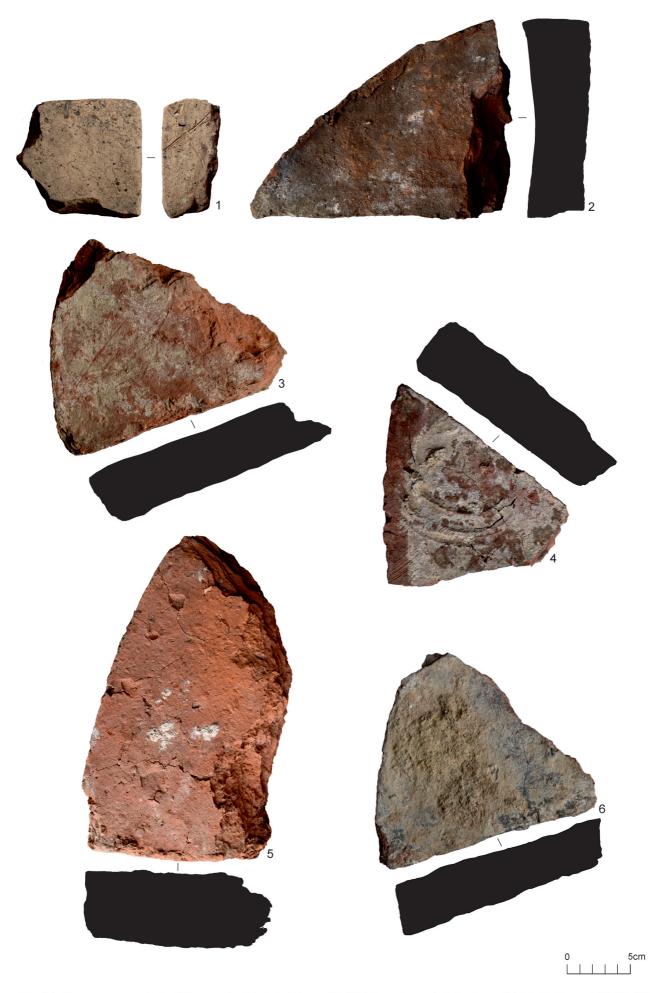
Fig 24 Roman ceramic building material: brick from CL12 (1), column bricks from CL15 (2-5) and GL10 (6).

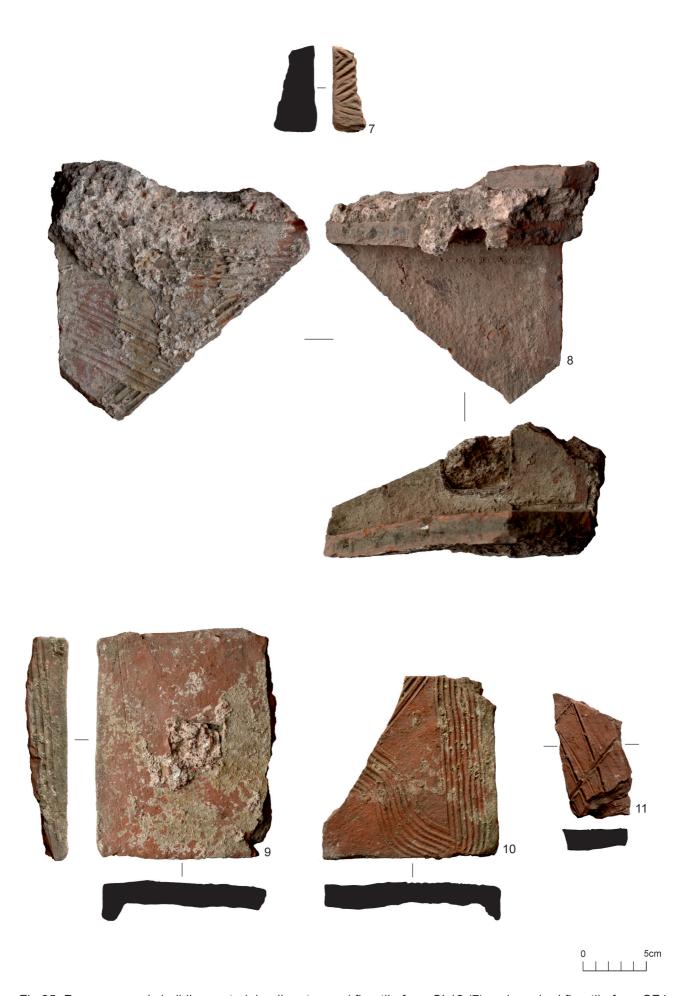
Fig 25 Roman ceramic building material: roller-stamped flue-tile from CL12 (7) and combed flue-tile from CF4 (8-9) and CL10 (10-11).

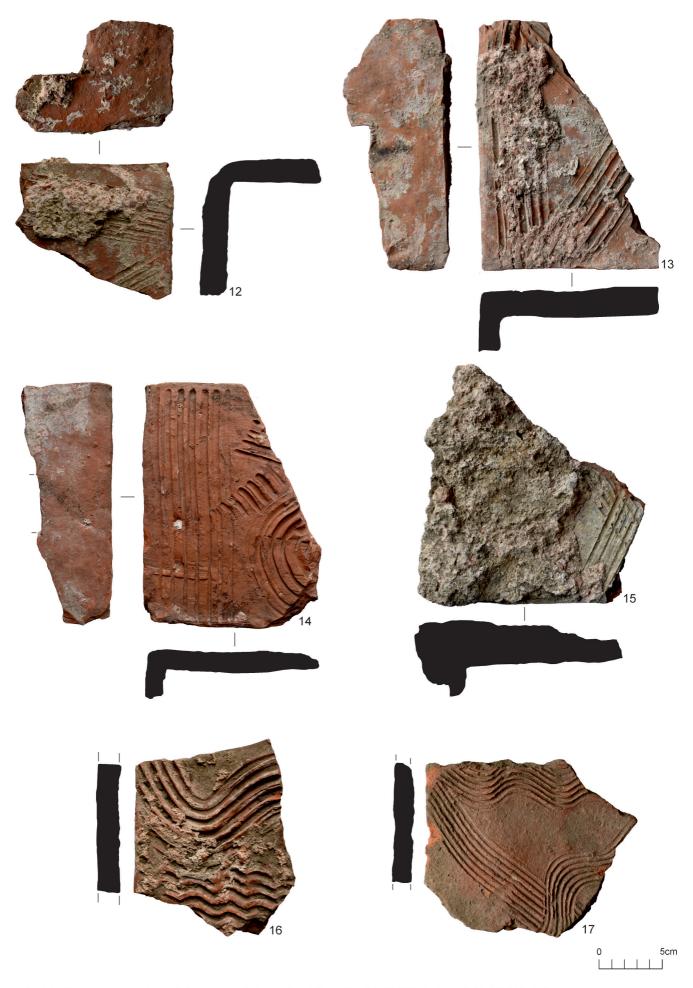
Fig 26 Roman ceramic building material: combed flue-tile CL10 (12-15) and CL11 (16-17).

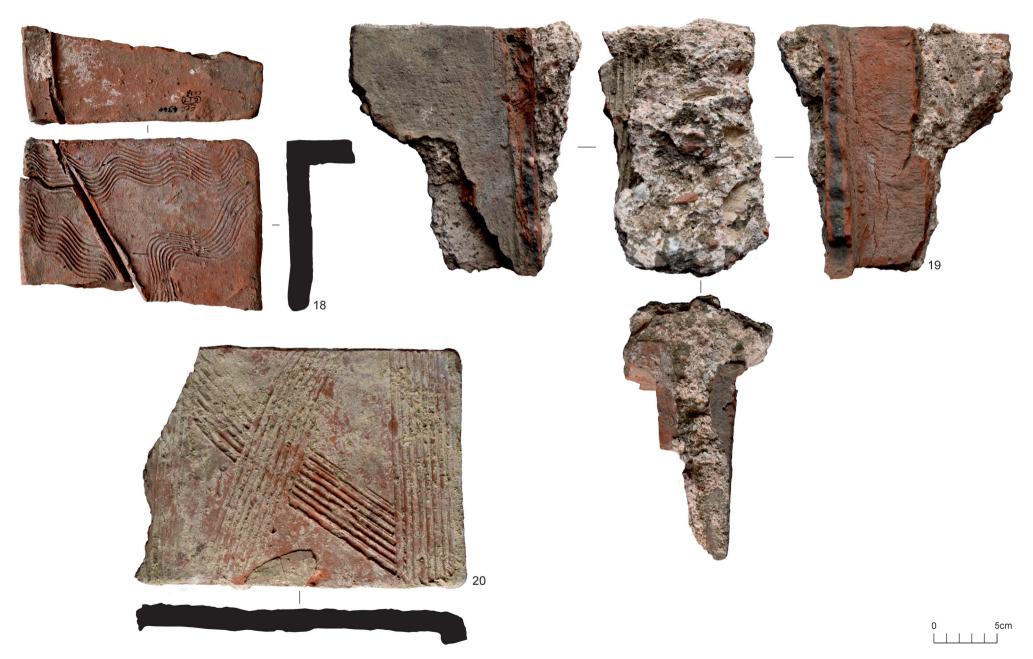
Fig 27 Roman ceramic building material: combed flue-tile CL13 (18), GL5 (19) and GL5/6/7 (20).

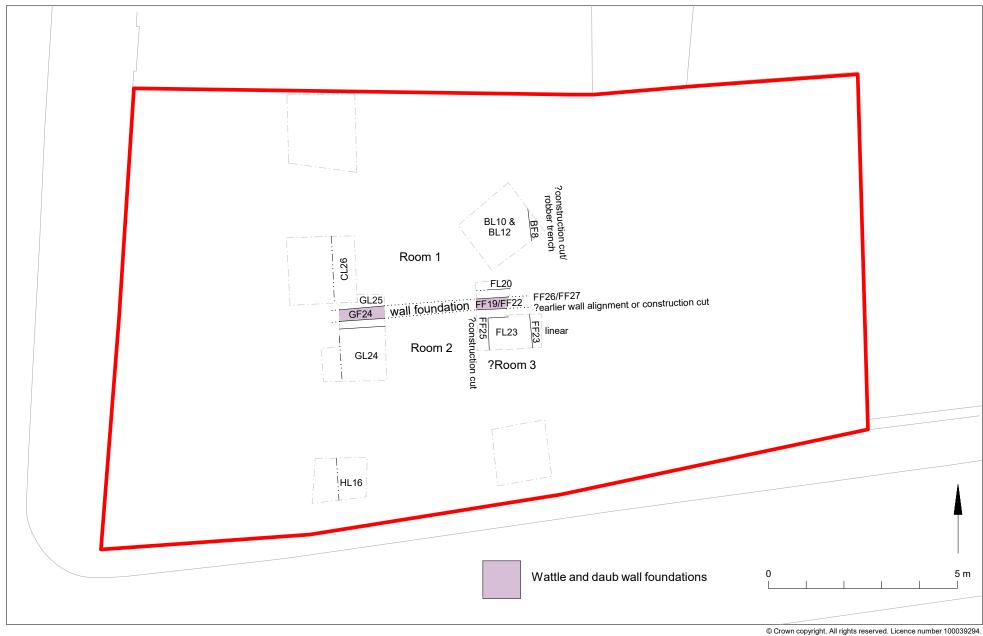
Fig 34 Roman Phase 1, pre-Boudiccan structural remains

Excavation revealed three phases of Roman activity. Phase 1 is of early Roman date, ending at the Boudiccan revolt of AD 60/1. Structural remains included a single east-west aligned wattle and daub wall foundation, with three further linear features potentially representing other wall alignments. The structure had a tiled roof, the wattle and daub wall had been plastered and painted, and fragments of window glass were also found among the debris indicating a relatively high status building. The building which was damaged during the Boudiccan revolt was subsequently demolished and the site levelled.

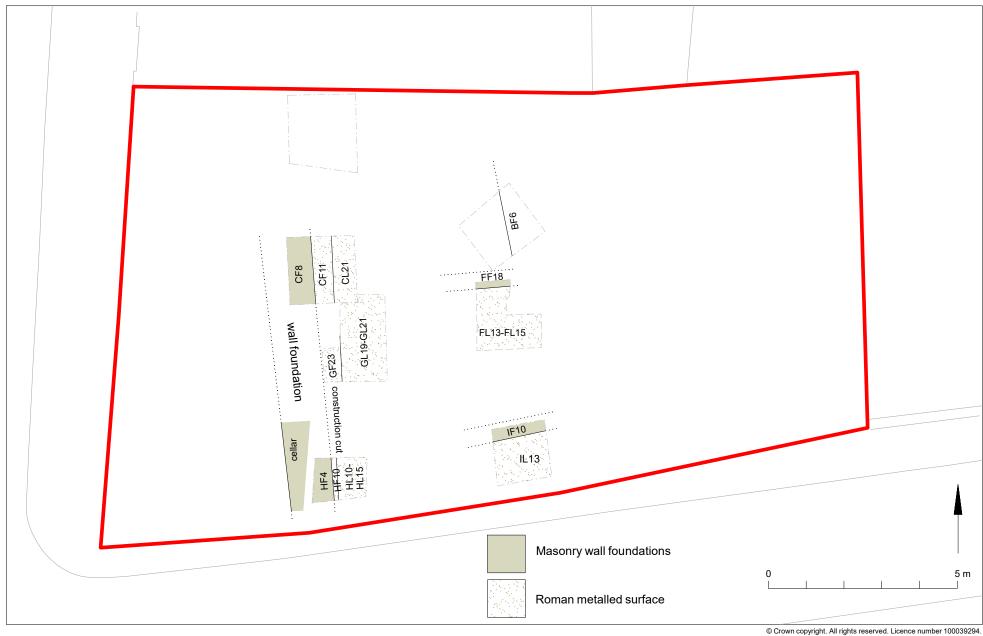
Fig 35 Roman Phase 2, post-Boudiccan structural remains

Phase 2 dates from the early 2nd to the 3rd century. Structural remains included a substantial north-south aligned wall made of courses of septaria and tile in mortar. Two smaller east-west wall foundations of more irregular construction probably represent other wall alignments along with a linear feature. Metalled floor surfaces sealed the Boudiccan destruction debris with some later floor surfaces laid above. Debris from the destruction of this building included large quantities of ceramic building material including box-flue tile and some column bricks and hollow voussoirs, along with window glass, painted wall plaster, stucco and marble, indicating another high status building.
