**Historic building recording at
Town Wall Sections 6-8,
St Johns Street, Osborne Street
and Vineyard Street,
Colchester, Essex, CO2 7DL**

May 2021

**commissioned by
Colchester Borough Council**

CAT Report 1692
July 2021

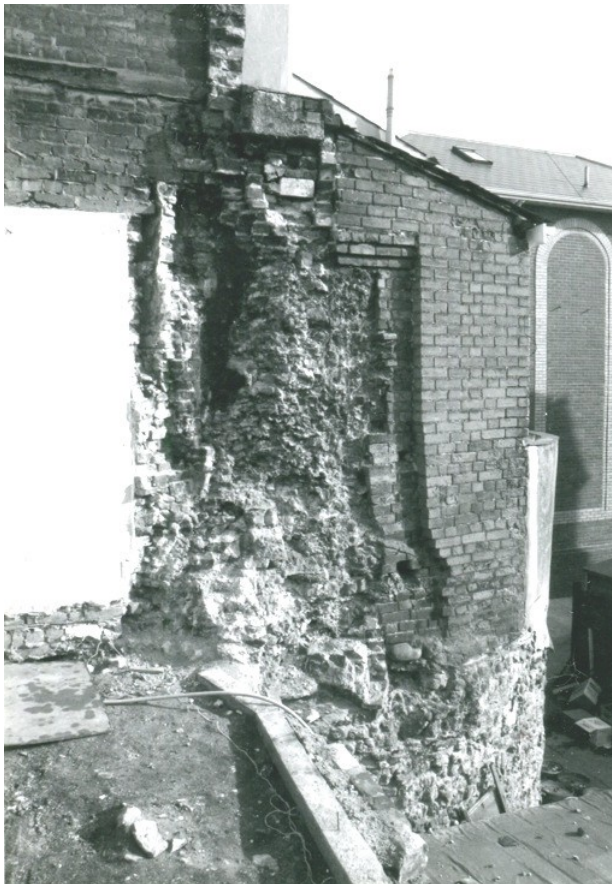
Photograph 1 1988 photograph showing the western side of bastion 6, with modern brick-built structure on top. Photograph taken facing south-east.

In 1988 the trust carried out an investigation immediately to the west of section 8 and bastion 6 during the redevelopment of 11 Short Wyre Street (CAT Report 113). The Roman internal wall facing was well preserved in the cellar of the building, and a Roman tile-built arched drain was discovered. Additionally, evidence of late medieval refacing was observed on the wall's outer (southern) face, and the western side of Bastion 6 (CHER MCC2710) was able to be closely examined (something not possible during the fieldwork for this report; Photographs 1 and 2).

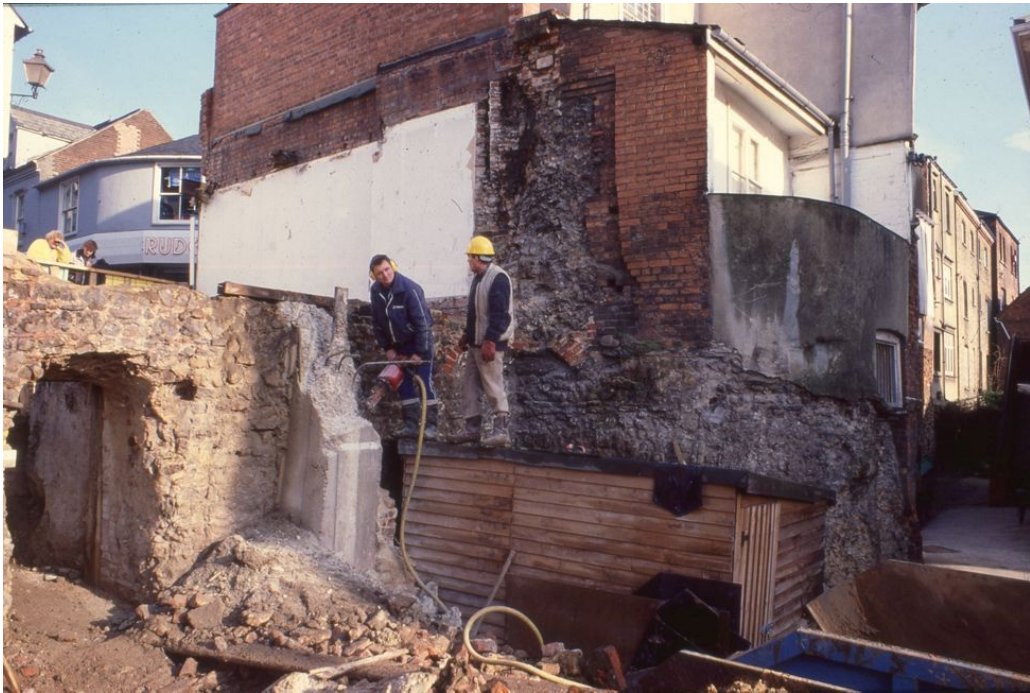
Photograph 2 1988 photograph of western side of bastion six during work on adjacent property. Section 8 of wall visible obliquely to right of frame. Photograph taken facing north-east.

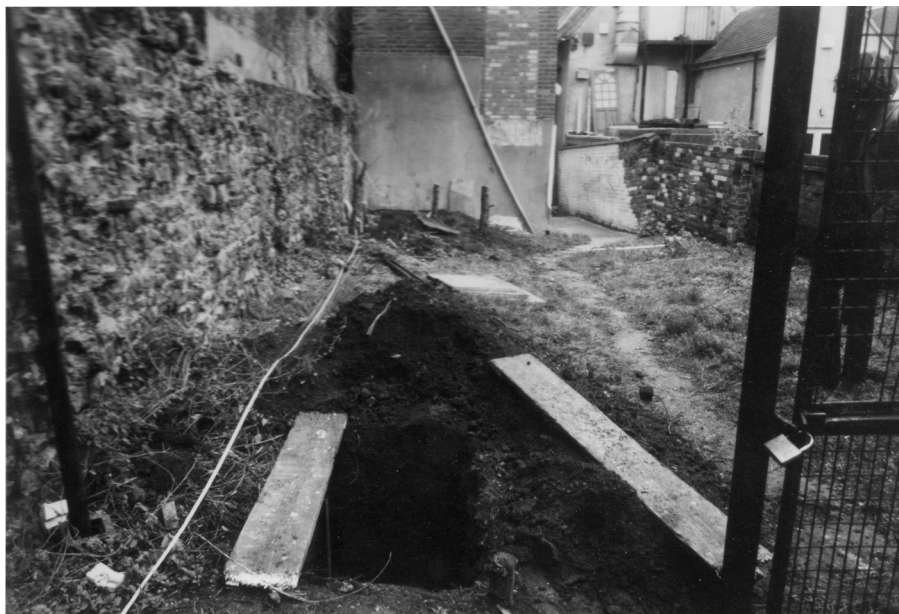
Photograph 3 Site shot showing excavation of test-pits adjacent to section 8 of town wall in 1991. Photograph taken facing east.

Further work was carried out by CAT in 1991 at section 8 of the wall (site code 91/11c; detailed in CAT Reports 144 and 1000). Two small test-pits were excavated in close proximity to the surviving wall (Photographs 3 and 4). One pit immediately adjacent to the wall uncovered a battered face identical to that found at Lion Walk (some 150m to the west), where it was shown to be part of the late medieval refacing dating to c. 1382-1421 (CAR 3, 84-5). The other pit failed to show any part of the wall.

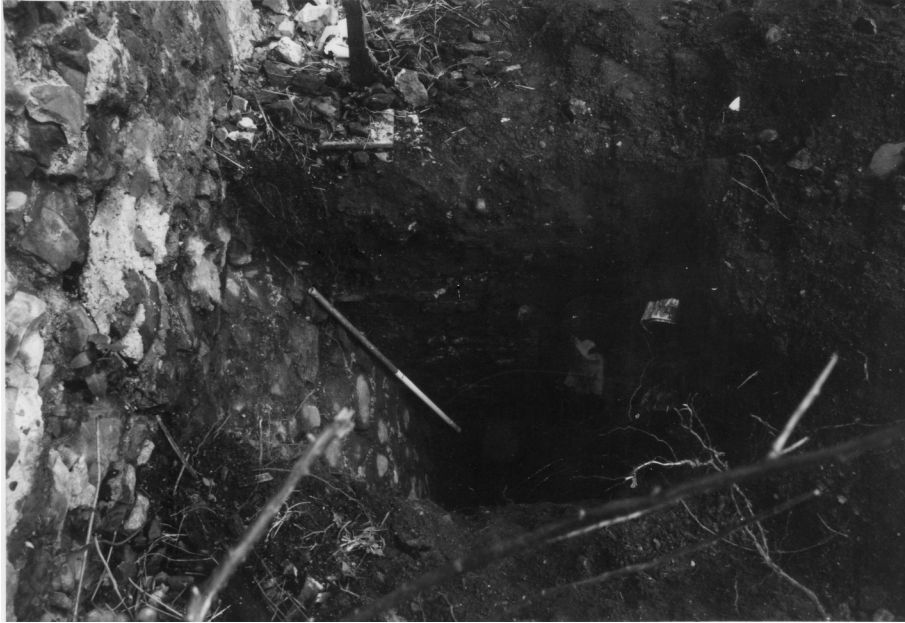
Photograph 4 Detail of test-pit from 1991 showing battered medieval face of town wall. Photograph taken facing east.

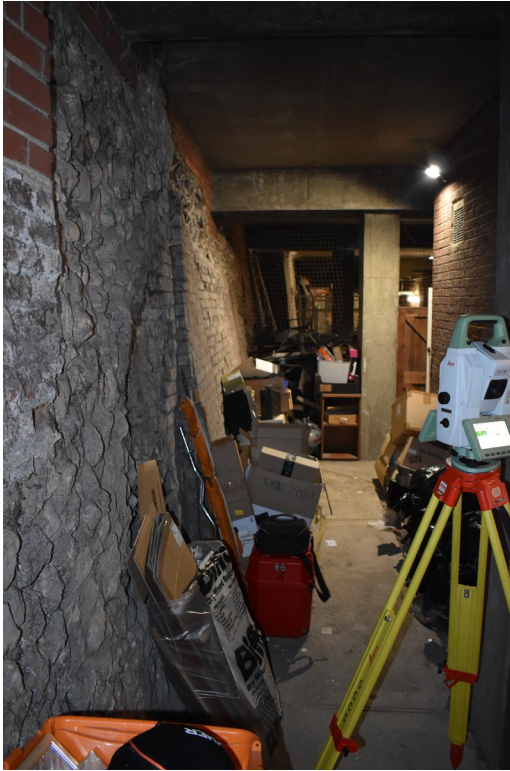
Photograph 5 Oblique shot of section 6 behind St John's Street, showing re-used septaria and wall to the east. Photograph taken facing north-east.

Section 6 is entirely hidden behind the row of shops fronting onto St John's Street and the properties forming Culver Square above. The part of section 6 recorded for this report begins in the rear of 35 St John's Street and is 57.5m in length, projecting to the east (Photograph 5).

The wall in this area survives to a height of approximately 2.8-3.5m above modern ground-level (although what is visible is almost entirely modern in origin). The original height of the wall would have been at least 6m (Crummy 1997, 89), although it should be noted that at other sections (such as section 10 to the east) modern ground-level outside the walls appears to be below the base of the wall foundation.

This section of wall is constructed almost entirely of modern brickwork, which has very clearly been patched and repaired on several occasions. In addition, in three locations along the wall there are sections of re-used septaria interspersed within the brickwork (Photograph 6 and Fig 3). The majority of the brickwork and septaria is bonded in cement mortar, although there is lime mortar present in areas, perhaps suggesting that some of the brickwork is earlier in origin, perhaps 19th-century. To the east the wall has an 800mm high concrete buffer at its base, providing further support.

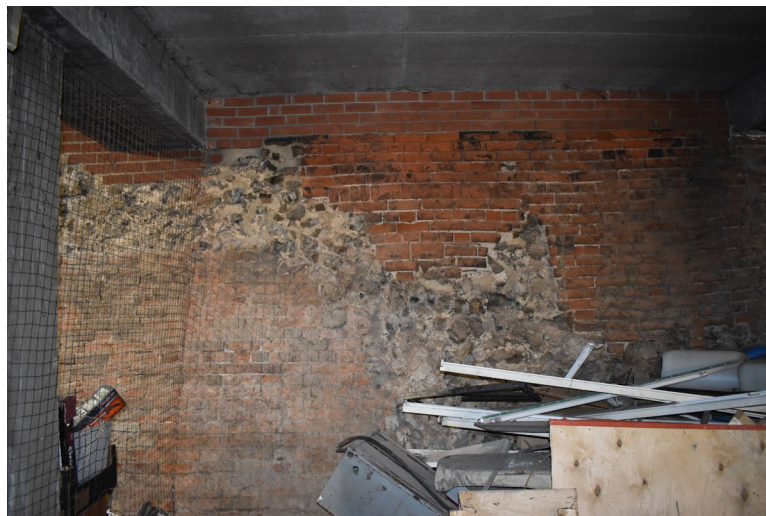
Photograph 6 Detail of section 6, showing modern brickwork alongside re-used septaria. Photograph taken facing north.

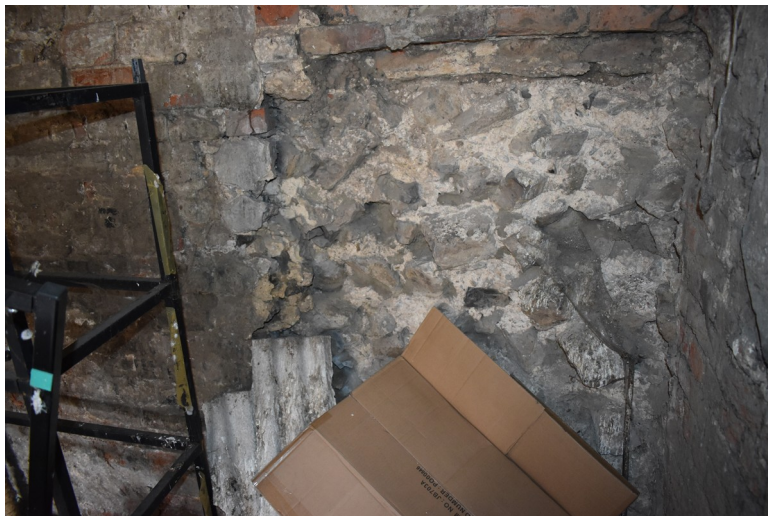
The only evidence for any *in situ* Roman fabric in this section is at the western end, behind 36 St Johns Street, where a small patch of brick facing has collapsed, exposing what appears to be a segment of original septaria and lime mortar core (Photograph 8).

Photograph 8 Detail of exposed area of septaria and mortar core in section 6. Photograph taken facing north.

Although not as in poor of a condition as some other parts of the wall, the sections recorded during the survey for this report all require regular maintenance to maintain their stability. In particular, in areas where later repairs have failed and the original core of the wall is exposed, it will deteriorate without further consolidation.

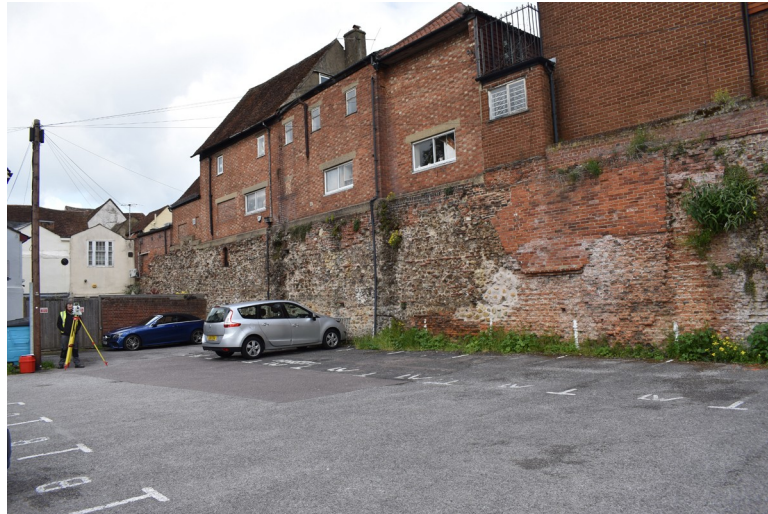
The wall at section 7 survives to a height of approximately 4.5m, and is constructed largely of a mix of septaria and Roman tile, interspersed with large areas of brickwork (Photographs 9-10). Several sections of the wall have been the subject of modern repairs, and these are noted on the plans (Fig 4). Also of note is that some of these repairs are not visible on the survey of the wall in the 1980s-90s, and so must have been carried out in the last 30 years. Most of these modern repairs re-use Roman

septaria and tiles, but some other stones are present, including ragstone and some apparent pieces of worked limestone.

Photograph 9 Western end of section 7, showing medieval refacing along with modern brickwork. Photograph taken facing north-west.

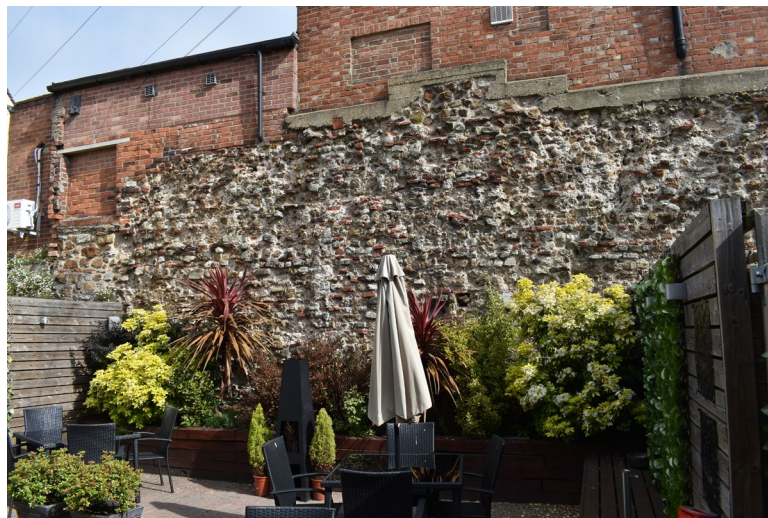
Photograph 10 Detail of medieval refacing behind 32 Osborne Street. Photograph taken facing north-west.

The brickwork on this section of the wall is quite varied, with several clearly distinct phases of repair. Apart from the most modern areas, all the brickwork is quite badly degraded. Dating any of this brickwork with any accuracy is a difficult prospect, but some of the thinner bricks may date from the 16th or 17th century, although whether they have been re-used from other structures and added to the wall at a later date is impossible to say.

The majority of this section of wall (disregarding the brickwork) is the result of medieval repair work, and has been refaced re-using Roman tile and septaria (Fig 4). The exception to this is the eastern end (approximately 45m), where several large areas of Roman core, consisting of septaria, lime mortar and occasional tile fragments, is exposed (Fig 5). This area of exposed core is probably the result of a collapse of the medieval facing, and indeed, the modern repairs to this section of wall are focused in this area. Also surviving in this section of wall is an original Roman culvert, although it appears that this too has been refaced (Photograph 11).

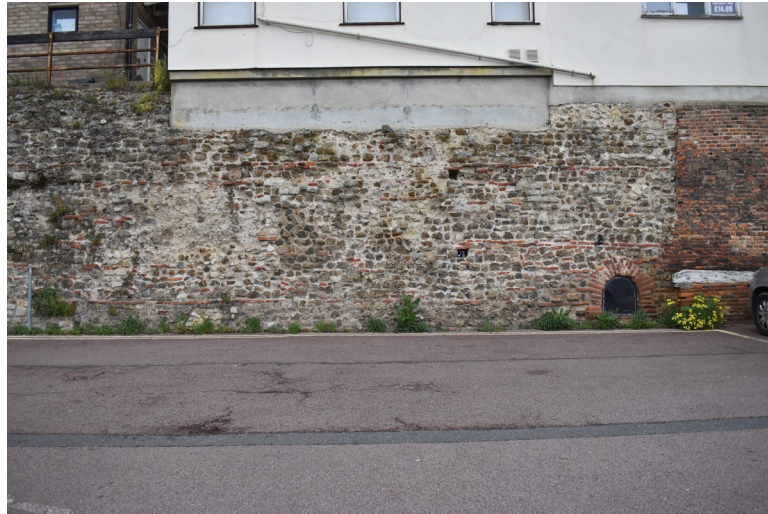
Also present along this section of wall are several medieval 'putlog' holes (Photograph 11).

Photograph 11 Detail of section 7, showing medieval 'putlog' holes and refaced Roman culvert. Photograph taken facing north.

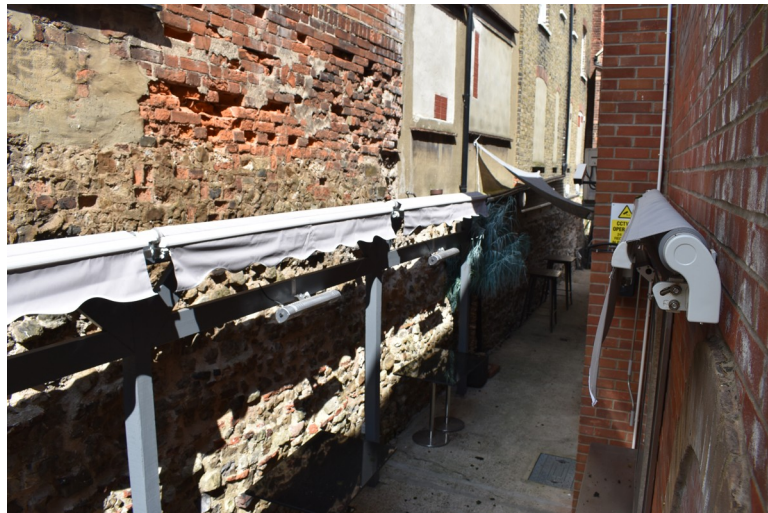
The western end of section 8 of the town wall is to rear of 18 Vineyard Street, and extends eastwards for approximately 34m (Fig 6, Photograph 12). The western half of the section survives to a significantly higher height than the eastern, with the western end approximately 3.5m-4.1m tall and the eastern only 1.9m-2.2m tall. At the western end of the wall section is Bastion 6, one of the eight medieval bastions added to the town wall in the late 14th-early 15th century (see historical background above).

Photograph 12 Section 8 of wall, projecting to the east. Photograph taken facing north-east.

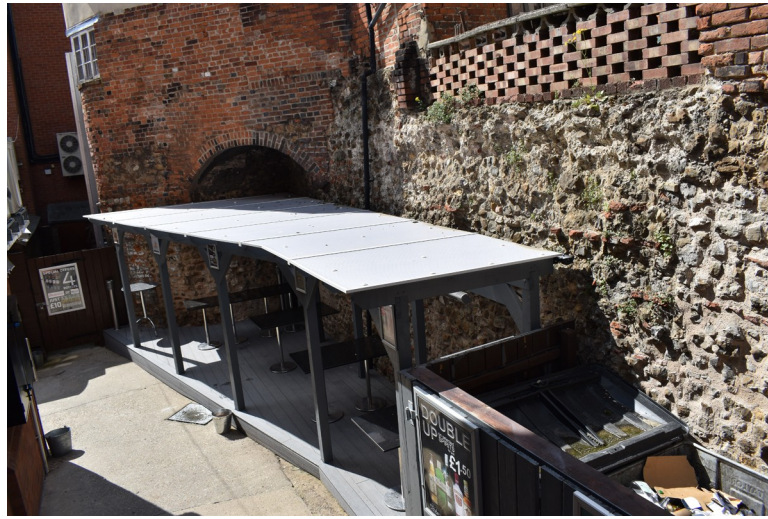
The entire face of the wall at section 8 is the result of medieval repair work, with several 'putlog' holes. No Roman core was observed at any point along this section, and work carried out in 1991 (CAT Report 144) shows that this medieval facing

continues below the current ground-level. As with the medieval facing elsewhere on the wall, at section 8 it is largely constructed of re-used Roman septaria and tile, although in places other materials have been used (Photograph 13).

Photograph 13 Section 8 of wall, with Bastion 6 visible at rear. Photograph taken facing north-west.

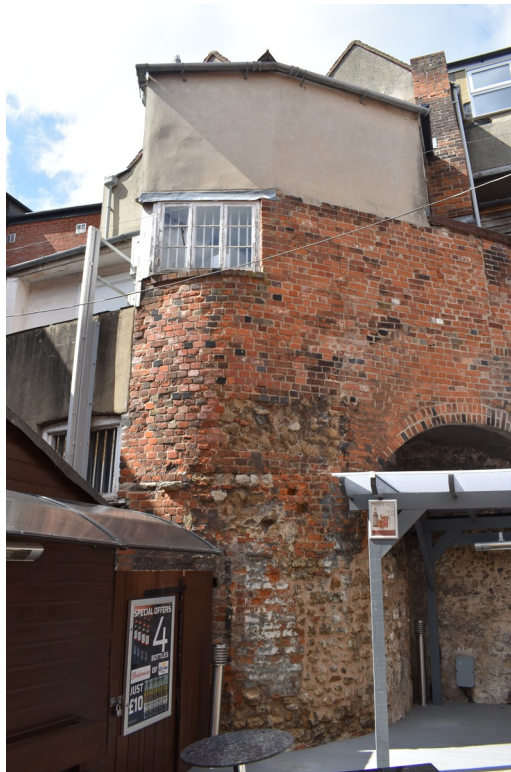
This wall section has been extensively built upon, and in particular bastion 6 is topped, and has been repaired, by substantial amounts of modern brickwork (Photograph 14). Only the eastern side of bastion 6 was accessible during the survey for this report, but the western side was exposed during an excavation carried out on the adjacent property in 1988 (see CAT Report 113 and historical background above).

Photograph 14 Detail of eastern side of bastion 6, showing modern additions. Photograph taken facing north-west.

As with the other medieval bastions, Bastion 6 is constructed of re-used Roman septaria and tile (disregarding the masking modern brickwork at its apex). The bastions were added to the wall sometime in the late 14th-early 15th century during extensive restoration works (as detailed by Morant 1748, 6). Its facing appears entirely contemporary with the medieval facing (Photograph 14), which again is in keeping with the other bastions along the wall (see discussion below).
