**CAT Report 1940
October 2023**

**Archaeological monitoring and recording at
St Peter's Church, North Hill, Colchester, Essex,
CO1 1DZ: March-May 2023**

**CAT project ref.: 2023/01m
CHER code: ECC4798**

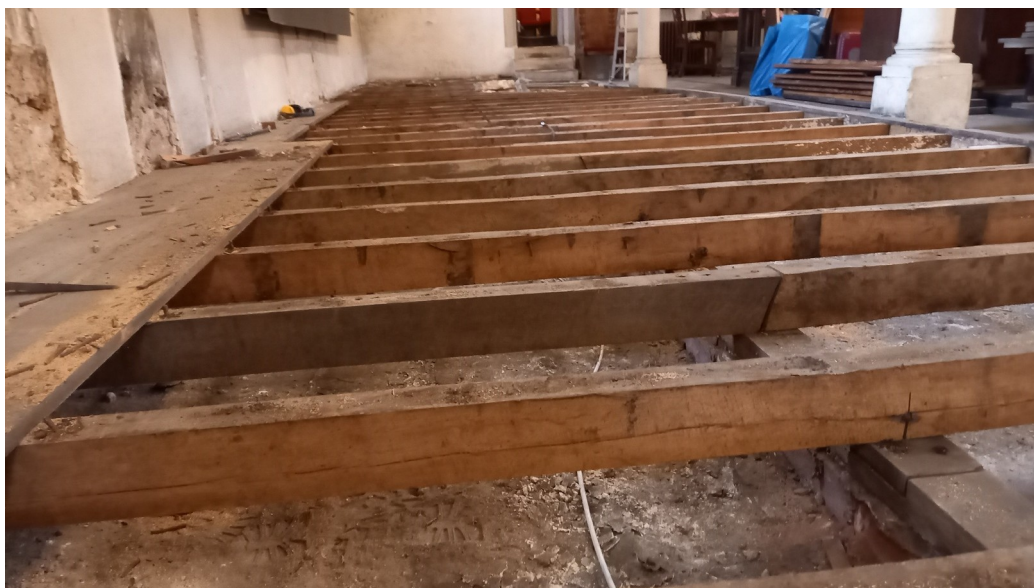
An area measuring 58m² was reduced by 0.1-0.3m along the northern wall of the church. Wooden floorboards were first removed, followed by supporting wooden battens and bricks. There was a small amount of rubble underneath this but no soil was found or removed.

Photograph 1 General shot of wooden battens and bricks after floorboards removed in north aisle. Taken by Bakers of Danbury.

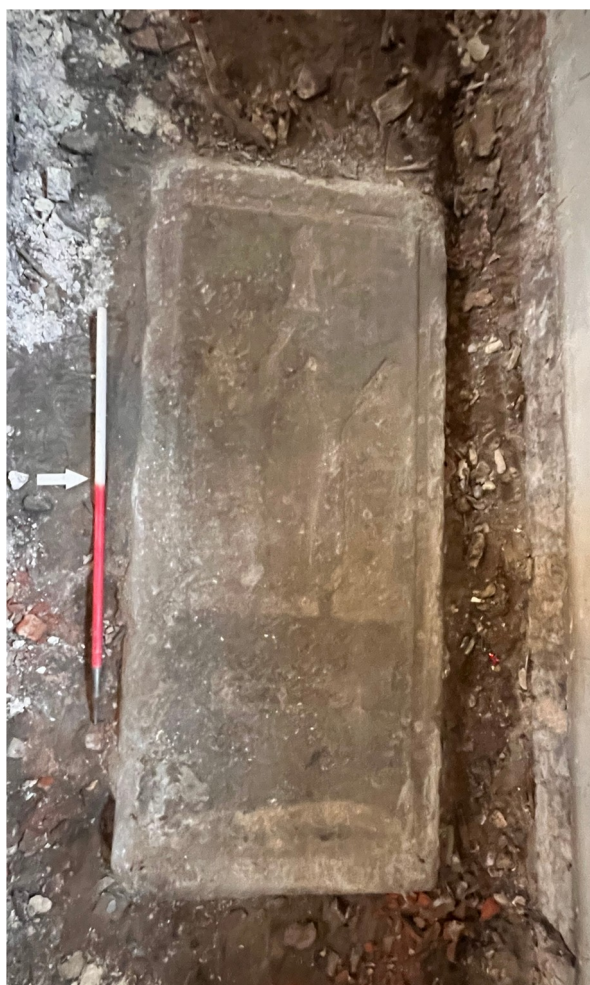
This reduction revealed the remains of a monument slab (F1) and a burial vault (F2). F1 consisted of a rectangular limestone slab measuring 2.1 x 0.9m and orientated east to west. It was located at the far east end of the area of reduction. Inlays were seen on F1 to indicate a brass monument or similar incised slab (David Andrews pers. comms.). These consist of a border, three similarly-looking shapes in the centre, and a "key-hole" shape at the top. There is a darkened, rectangular shape at the bottom which may have originally been a foot-plate. The original latten, if any, was not present; either it did not survive, was destroyed, or was robbed. F2 was a rectangular brick vault. It was 2.4 x 0.9m and also orientated east to west. It was located at the far western end of the area of reduction.

Photograph 2 F1 in plan.

Assessment of the monument slab (F1) was conducted over email by Martin Stuchfield (Hon. Conservation Officer of the Monumental Brass Society). It is specifically an indent for a monumental brass memorial, with the latten or brass removed, lost or no longer surviving.

The indents comprise a civilian at the top of the slab, two wives, a possible figure of Christ, and a scroll in the centre, plus an inscription at the bottom. There is also a border in the form of a marginal inscription, with roundels at each corner. It is dated to around c1525AD. It is not known who the memorial commemorates. A possible candidate is Thomas Clere (Martin Stuchfield pers comms). Thomas Clere (1462-1520) is buried at St Peter's Church (Find a Grave 2023; memorial ID 128200983).

The design of F1 is similar to some brass monuments at Queens' College, Cambridge (Queens' College 2023), which commemorated individuals who died in the mid-late 16th century. The north and south aisles of the church were added in the 15th century, so it is likely F1 was added to the church during this period at the earliest. It also could have been moved from its original position from elsewhere in the church. Brass monuments were largely used as grave markers between the 14th and 17th century (Badham 2009). As brass monuments were used as grave markers, it is likely a vault or tomb lays beneath F1. The three inlays in the centre likely originally depicted individuals to whom the memorial was made for, with the foot-plate detailing their names, a poem, or Bible verse. The inlay at the top may have been another figure or other religious symbol.

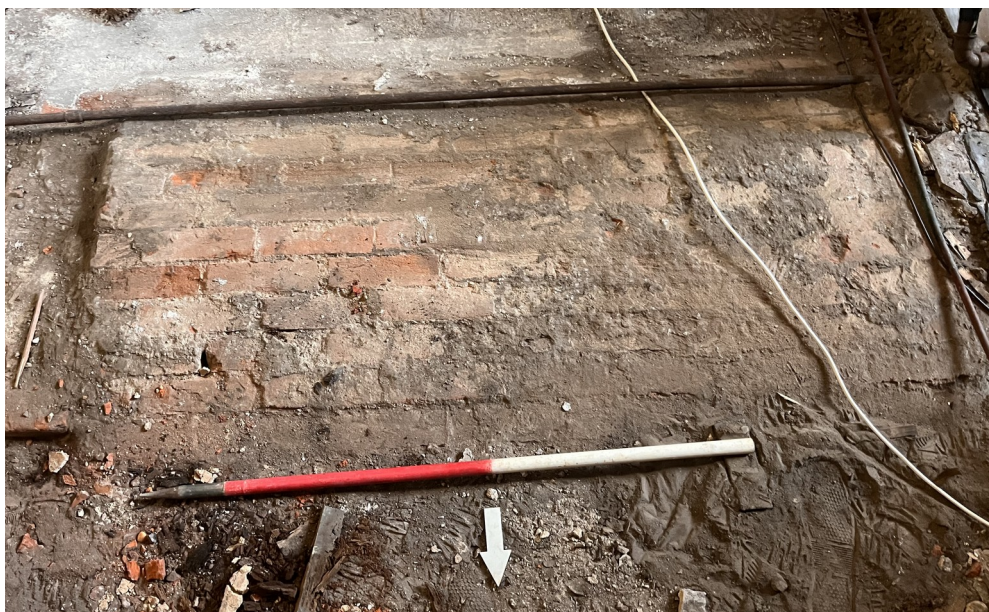
Photograph 3 View of F2 from north side, looking south.

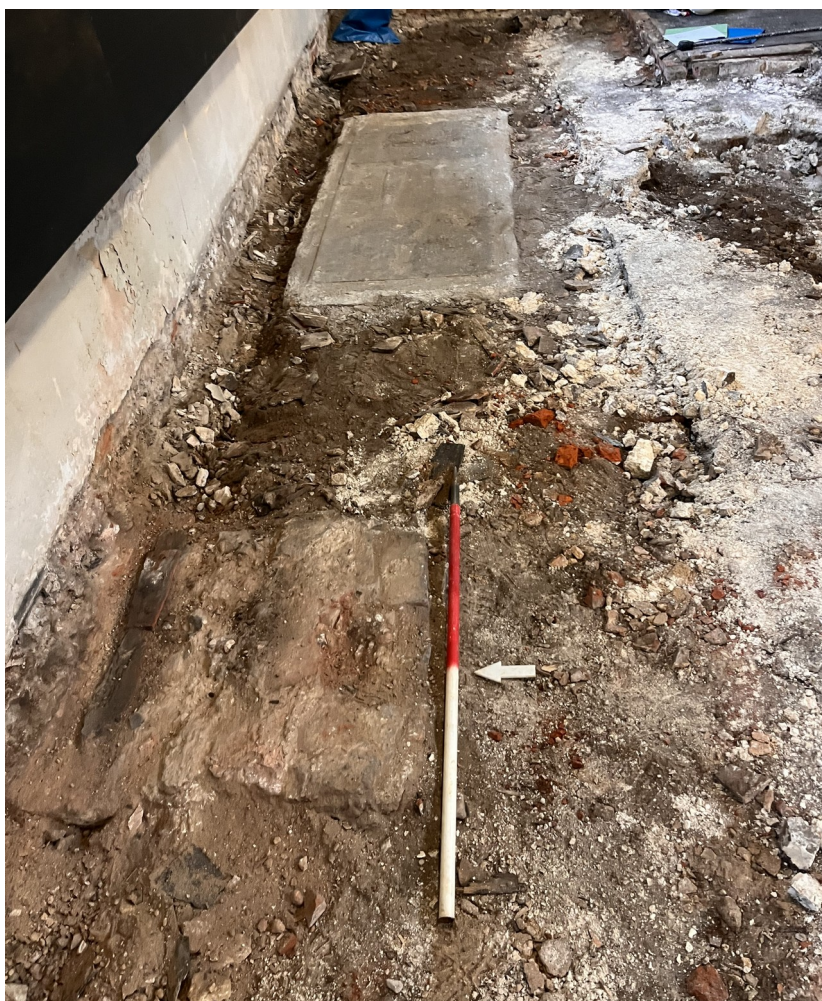
There were also two brick-and-limestone foundations (F3, F4) against the north wall of the church. F3 was 1m west of F1 and measured 0.7 x 0.8m. F4 was almost 5m west of F3 and was 0.45 x 0.8m. The full extent of both of these is unknown but both appeared stepped in form. They do not correlate with the external buttresses and do not match them in form. F3 and F4 may have been foundations for former statues or monuments. Brick could not be recovered from them as they were complete and not fragmented.

Photograph 4 View of F3 (foreground) with F1 in the background, looking east.

The exact nature of F3 and F4 are unknown. However as they do not line up with the external buttresses and are not the same in form, they cannot be buttress foundations. The square shape of F3 may indicate the base of a column and the rectangular shape of F4 suggests a commemorative statue or similar monument. CBM could not be recovered from either feature as they were structurally sound, so dating them is difficult. The brick may have also been reused as has been carried out elsewhere in the church (Rodwell & Rodwell 1977, 28). It is possible F3 and F4 are foundations evidencing earlier versions of the church. Diagram 1 shows an overlay of the plans of the church, and the locations of F3 and F4 do not line up with probable foundations from the earliest part of the church. Nevertheless the original nave may have been shorter than estimated, which means F3 and F4 may have been part of the construction of the north transept.

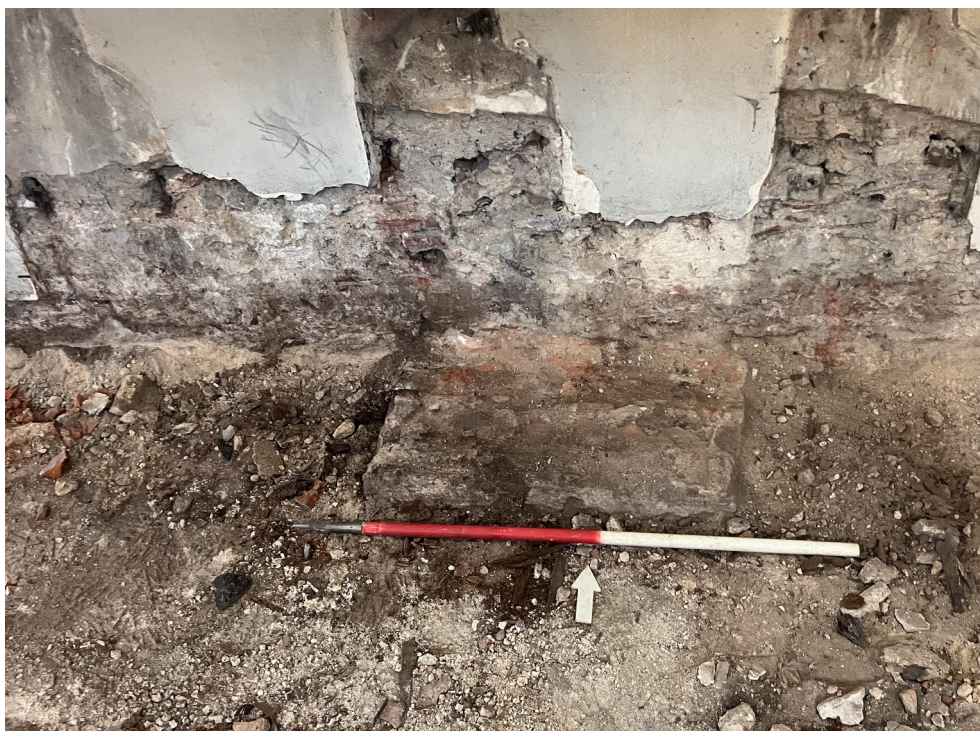
Photograph 5 View of F4, looking north.

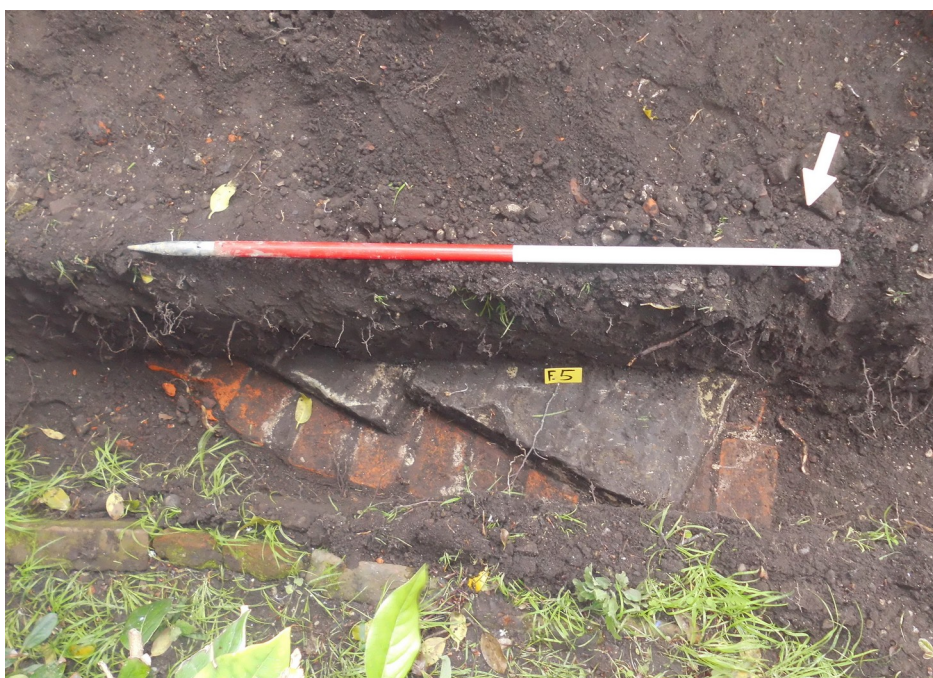
A further three features were uncovered. Most westerly was F5 which is the top of a 19th-century brick tomb with stone capping. It was roughly orientated east/west, and consists of two sandstone stone slabs 0.09m thick laid on a brick plinth. F5 was at least 0.45m wide and 1m long. The full extent was not seen but a void was detected underneath the brick.

Photograph 6 View of F5, looking south.

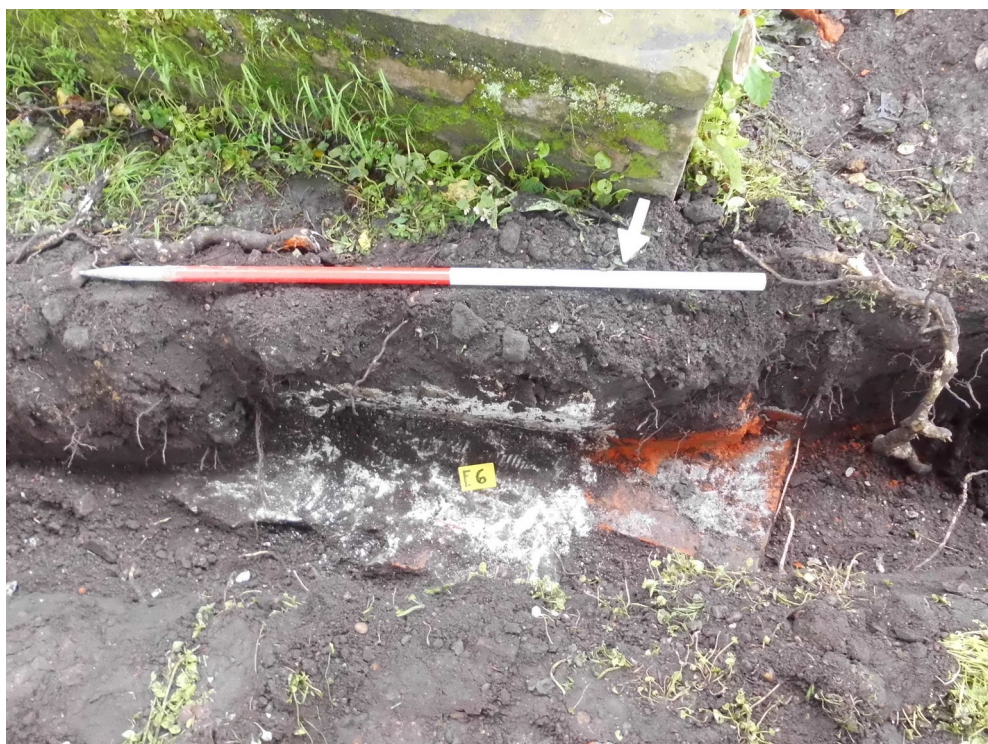
F6 was another tomb, due to a corner in the drainage trench, F6 was seen in two places (Photograph 8). It consisted of a mix of brick and stone mortared together. It was east/west in orientation, at least 0.3m wide and approximately 2m long. F6 is the top of a burial chamber marked by the chest above (Photograph 7). This is a bevelled top chest tomb (Type 1122; Mytum 2000) over F6.

Photograph 7 The western section of F6 seen, looking south.

There were no finds recovered from F6 to date it. However the type of chest tomb related to it were typically popular in the 18th and early 19th century (Mytum 2000, 20). There is no clear above ground monument related to F5, but it may have been moved or destroyed. Brick recovered from the feature dates it to 19th century.

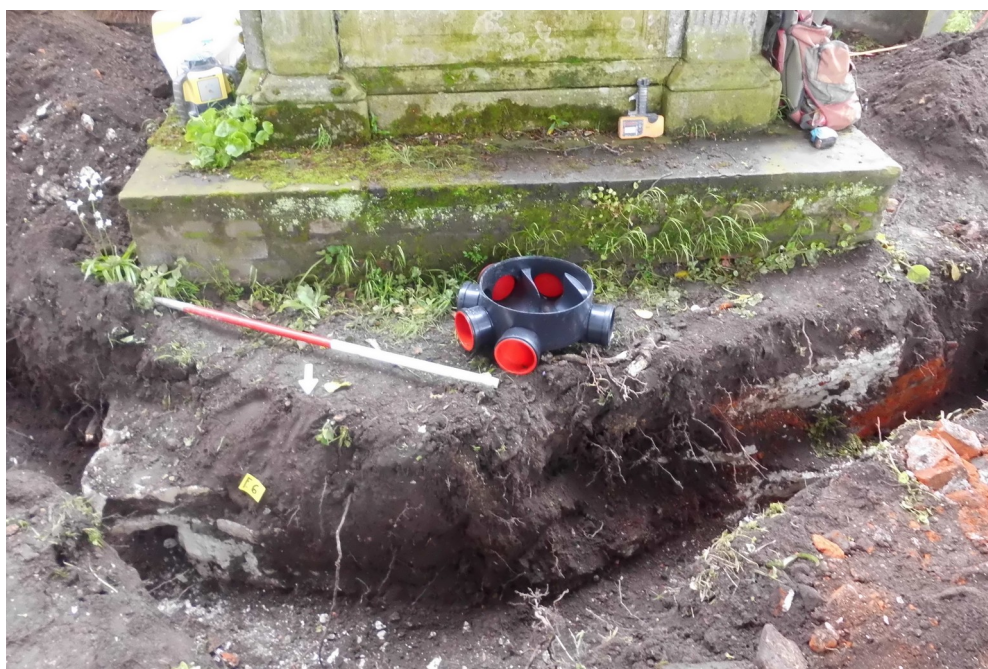
Photograph 8 Full extent of F6 seen, looking south.

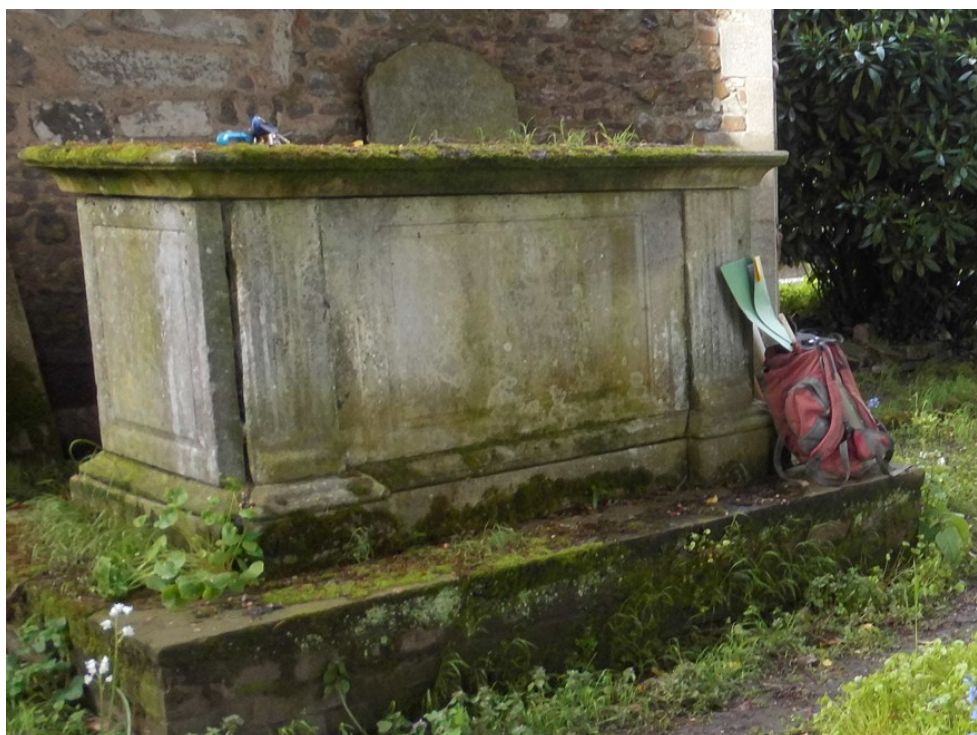
Photograph 9 Another view of the chest tomb above F6, prior to excavation

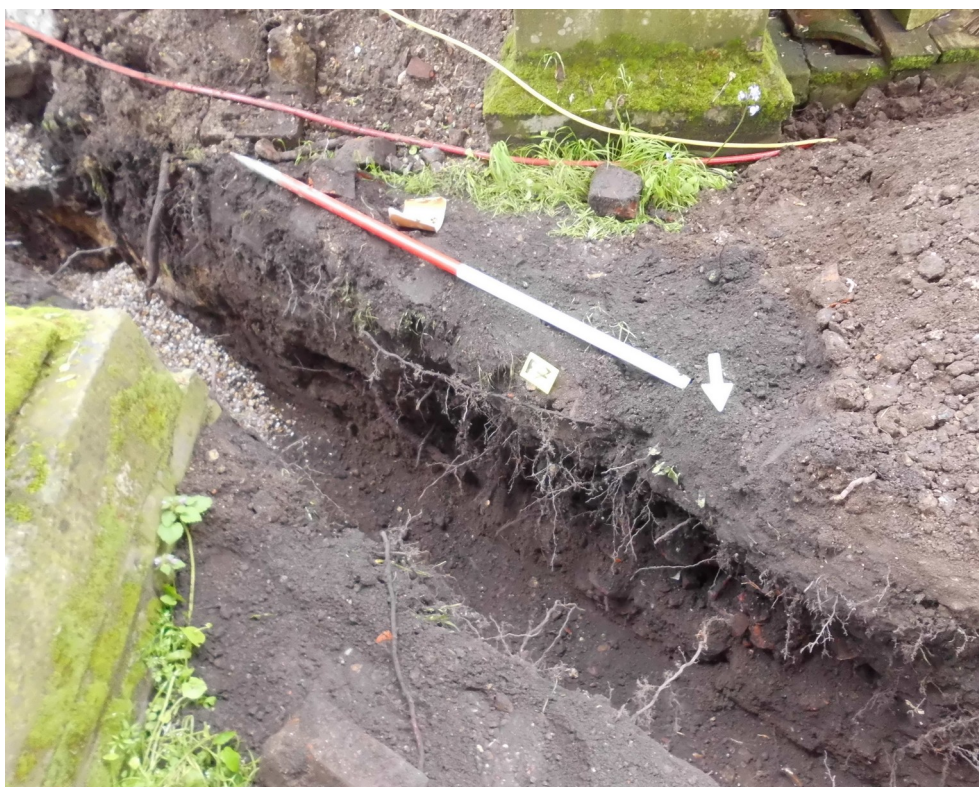
The last feature, F7, was a backfilled pit or soakaway. It was 1.35m in length and at least 0.4m wide. The fill of F7 was a mix of peg-tile, brick, slate and disarticulated human bone. Brick recovered from the fill dates to the 19th-century. The full extent of the feature was not seen.

Photograph 10 F7 in section, looking south.

The finds recovered from the soakaway (F7) indicate it was backfilled or went out of use no later than the 19th century. Due to its proximity to the churchyard, it was likely a soakaway related to the church.

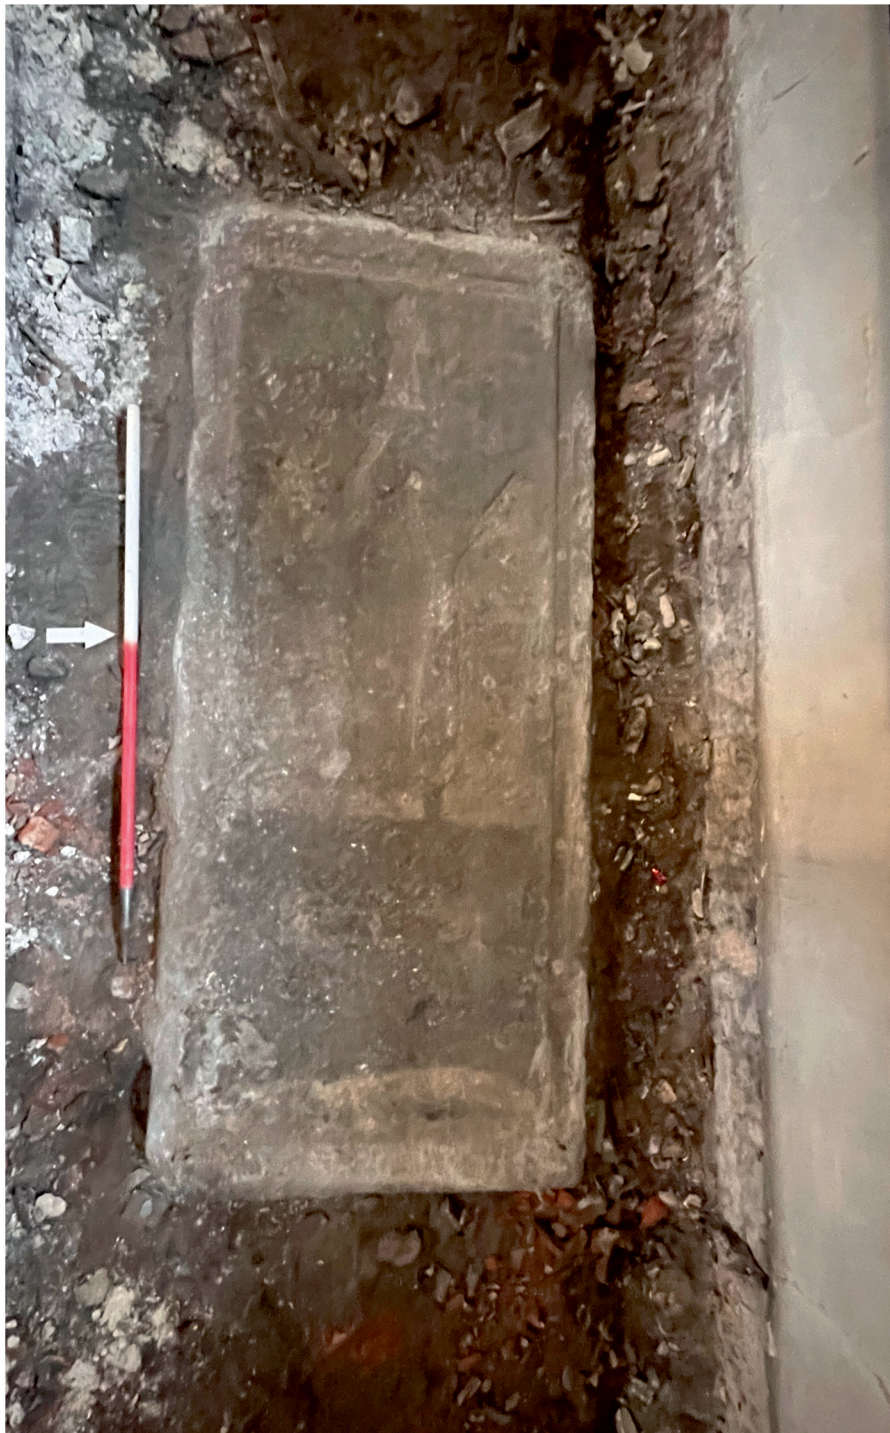
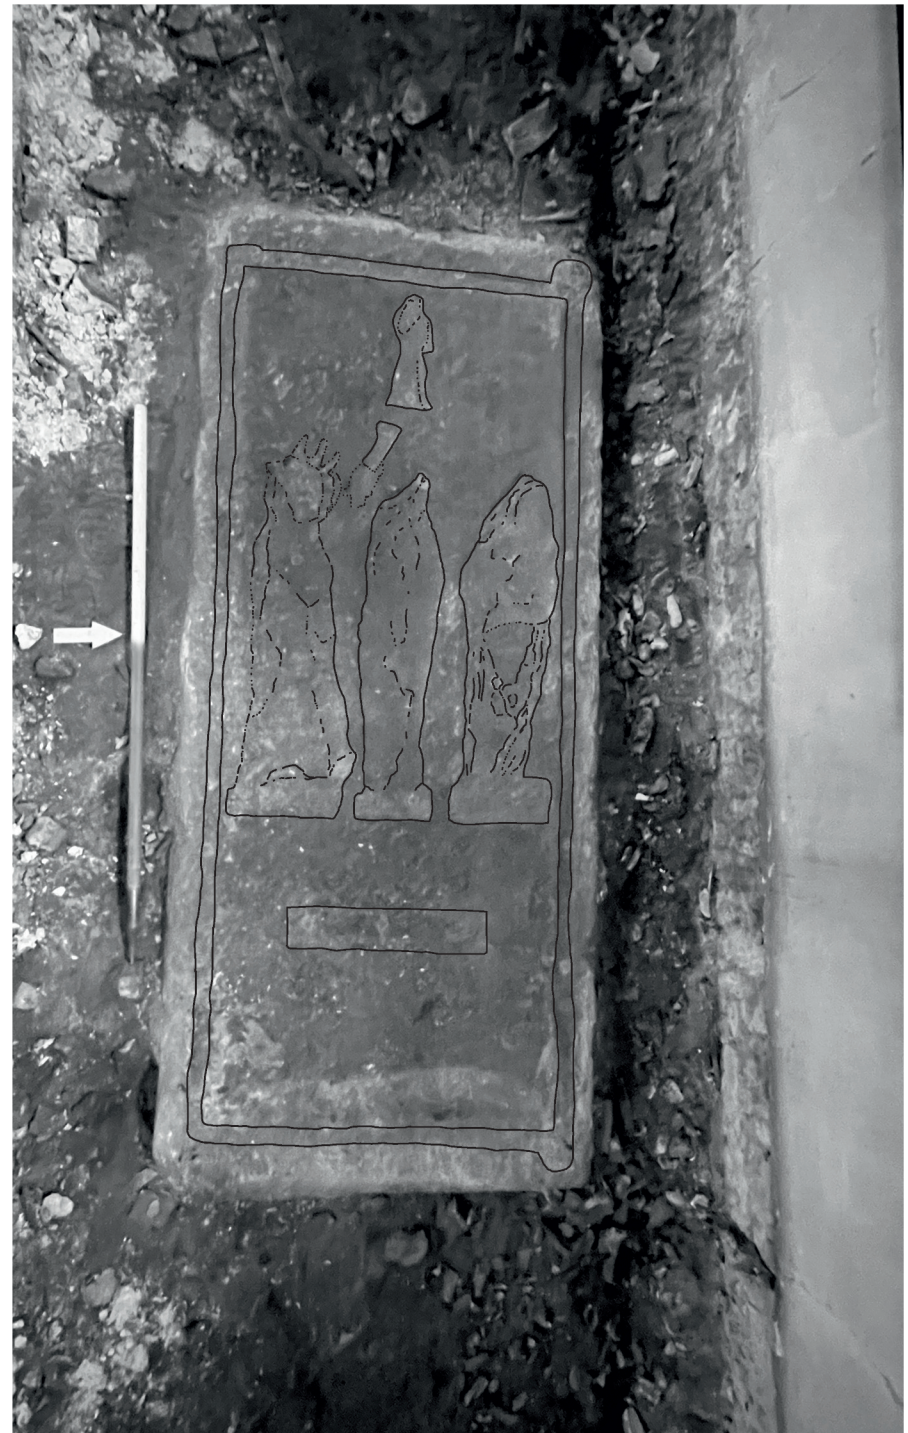
Fig 4 Stone slab with indents left from monumental brasses, original (left) and edited to show remaining lines (right).
