the Colchester archaeologist

**Roman suburb
at St Mary's hospital**

contents

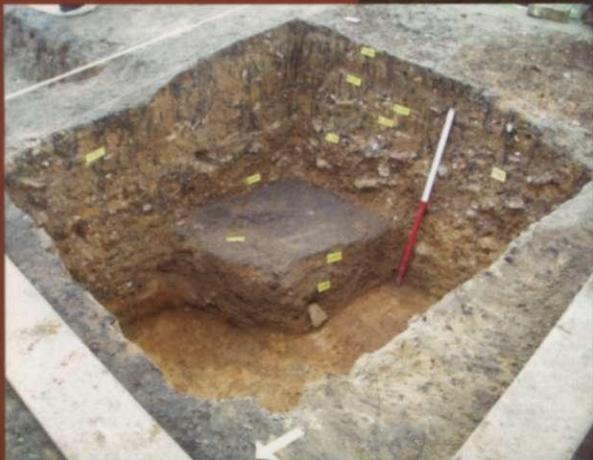
Partly excavated Roman cellar with demolished walls including wall-plaster at the St Mary's hospital site.

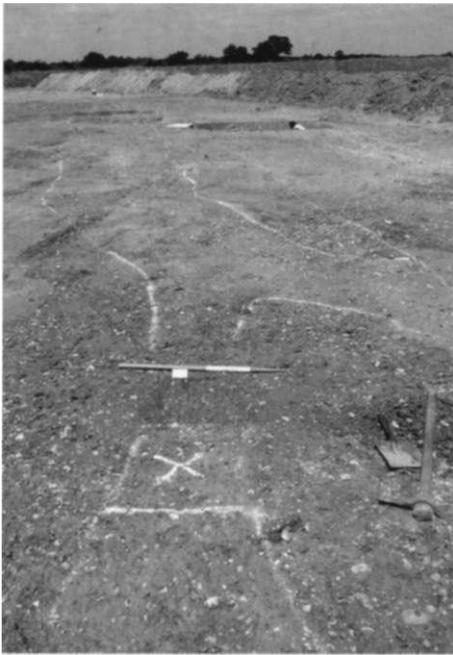
Opposite page -
Top: sketch of a Middle Iron Age round-house.

Bottom: the team marking the positions of the eleven post-holes of the Middle Iron Age round-house.

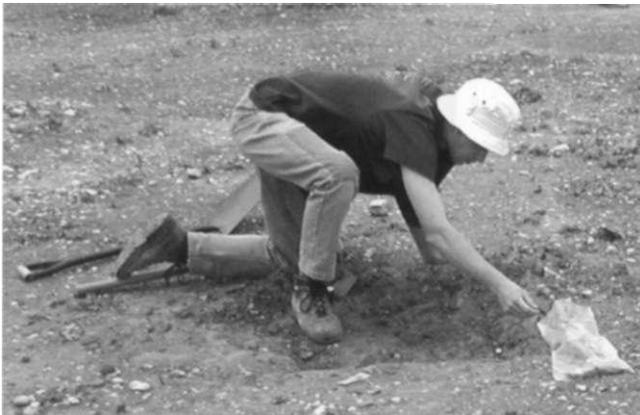
Above: lines were paint-sprayed on the ground to outline the archaeological features as they were uncovered by machine. Parts of the features were then hand-dug so that we could date them, explore their physical characteristics, and recover environmental material.

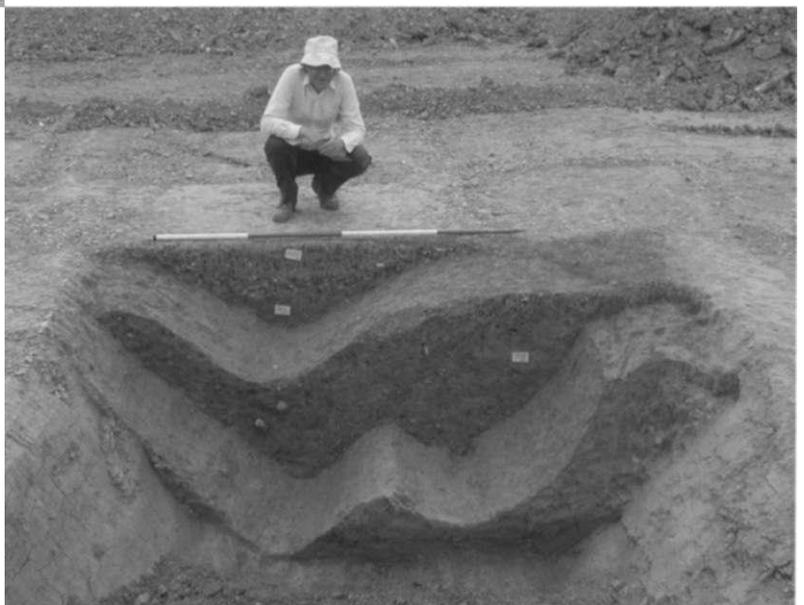
Right: an excavation through two intercutting ditches, with Philip Lomas in the background.

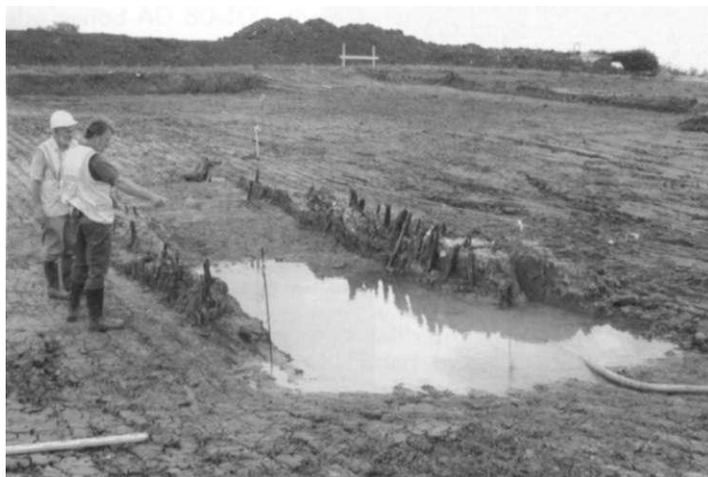
Several test-trenches were then cut over the area of surface finds (see picture). The removal of the ploughsoil revealed the tell-tale red-coloured earth of two separate red hills, and the outline of what may have been clay-lined 'settling tanks' once used in the salt-making process. A geophysical survey by Aline and David Black for the Trust located distinct archaeological 'hot spots' over the area of one of the red hills. Fired clay structures like hearths are particularly susceptible to detection by magnetometry, and it may be that the geophysical survey has located a number of salt-drying hearths on this particular red hill. When the sea wall is breached, the site will be flooded, as it was from Roman times until the construction of the sea wall.

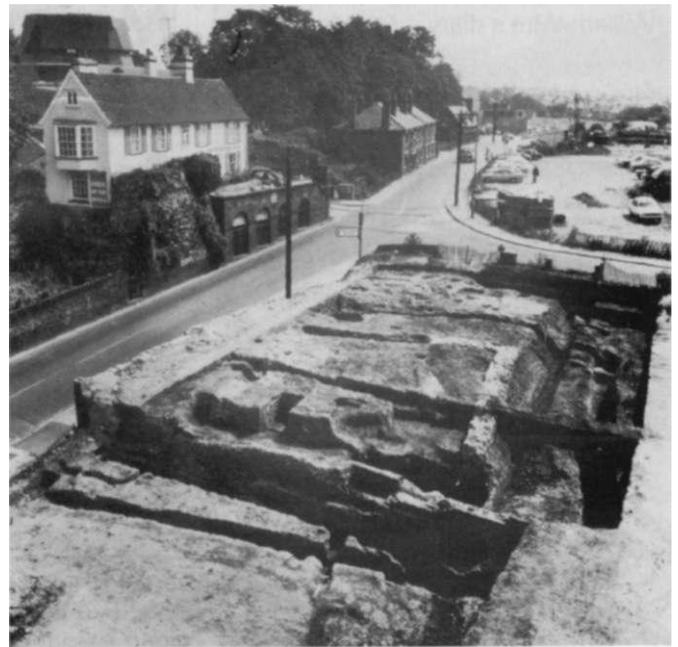
It seemed appropriate that we should find a Romano-Celtic temple (foreground) on a site occupied by a monumental stonemasons' works until 1974.

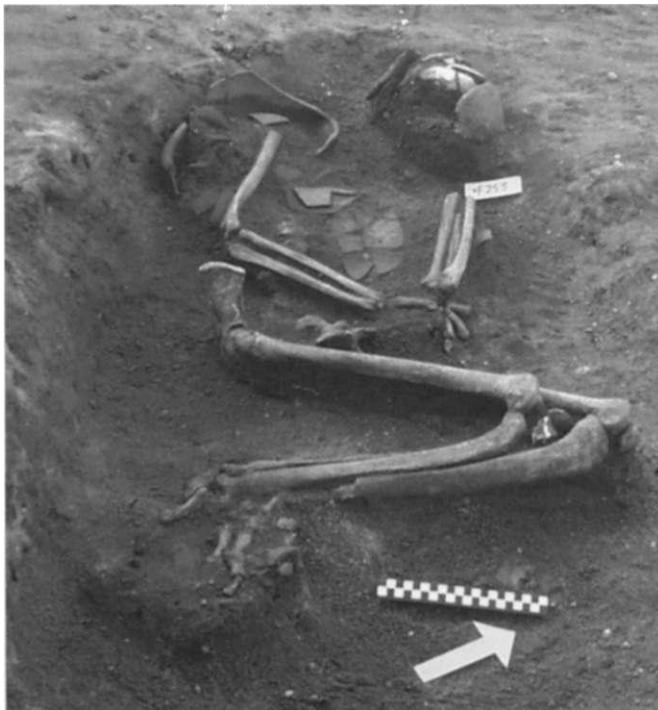
Below right: reconstructed grey ware jar from the crouched burial (below).

Below: the crouched burial with crushed jar.

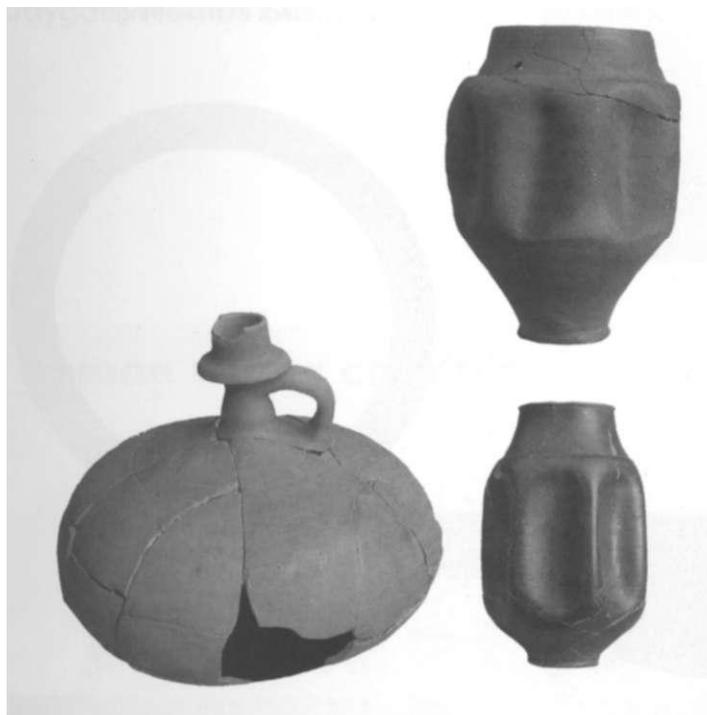
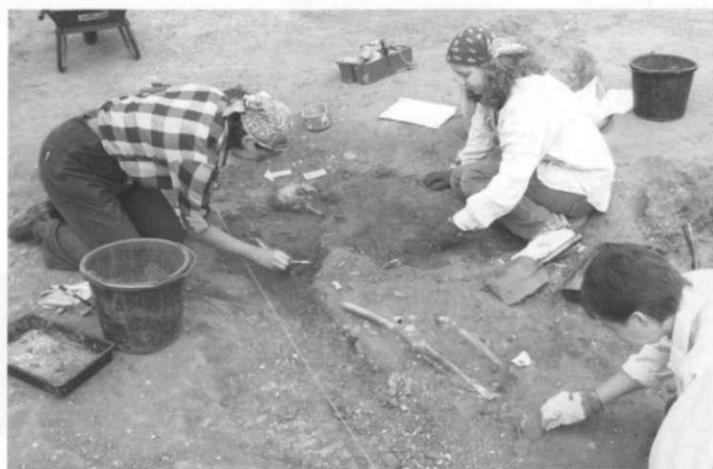
Below: an inhumation burial during excavation.

Bottom: the same burial fully excavated.

Pots from the grave (a flagon and two indented beakers) are shown on the left.

are late Roman, dating from the 3rd century onward. The graves were orientated in a variety of directions and most contained wooden coffins. Organic materials seldom survive: at St Mary's, the wooden coffin planks had completely decomposed, leaving only the iron fixing nails in place. The majority of the dead were buried with footwear. Again, like the wood of the coffins, the leather had not survived but clusters of up to forty tiny hobnails were found either on or very close to the bones of the feet. Some of the burials are accompanied by 'grave goods' (principally pots or items of

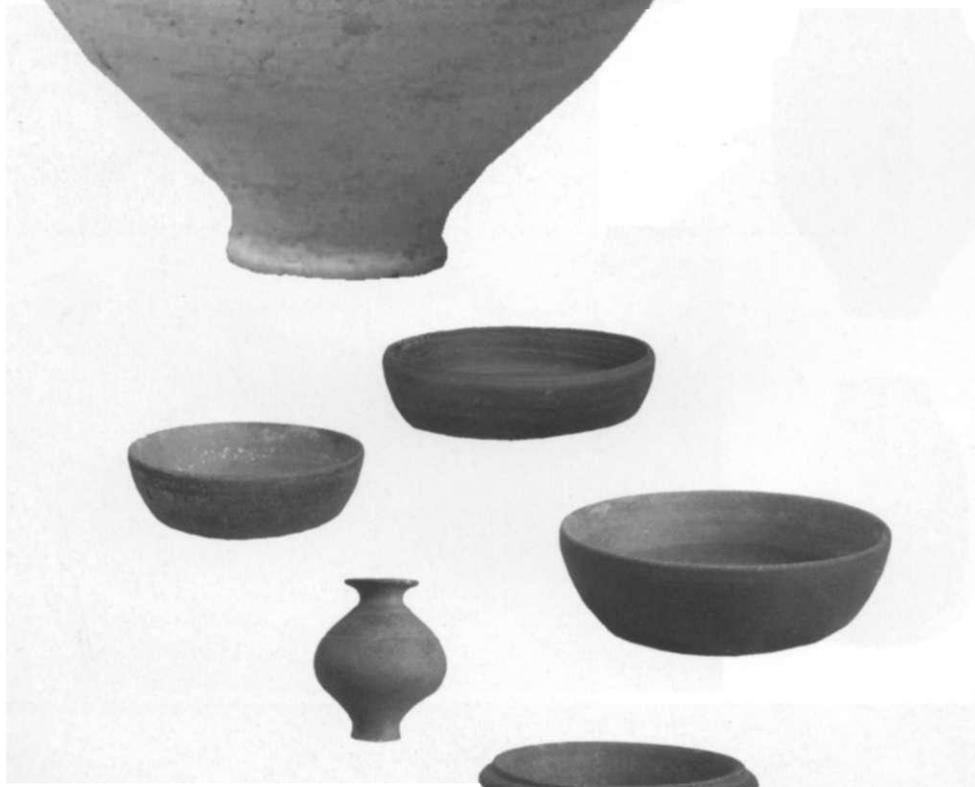
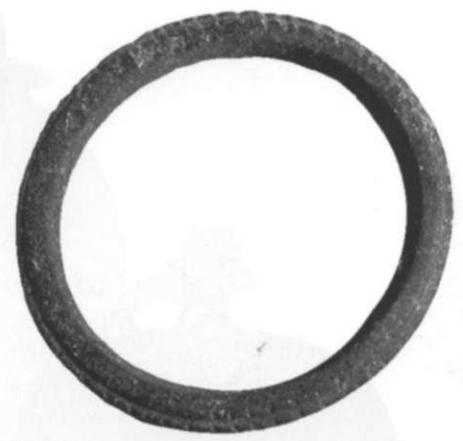
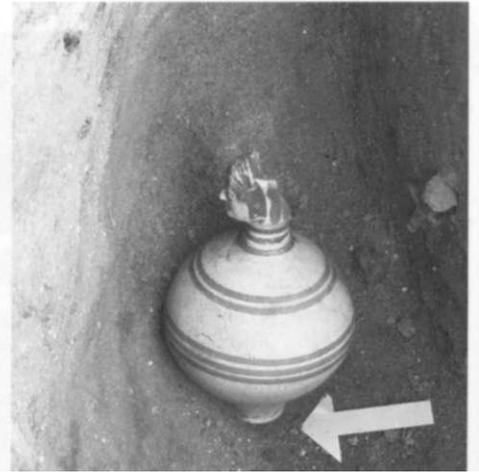
Above: six pots from the box burial for a child - five at 25% actual size, and top, the painted face pot at a different scale (actual size 17.5 cm high). The vessels probably contained food and drink.

Above right: a shale armlet from the box burial, one of eight armlets from the grave, shown at actual size.

Right: the face pot during excavation.

jewellery), including a box burial for a child containing six pots and eight armlets. It is probably true to say that there were Roman burials all over the site - a single inhumation was found by the evaluation in 1997, and the western extent of the cemetery is demonstrated by the two burials found in 2001 at the 'Topfield' site, immediately west of the hospital (see page 9).

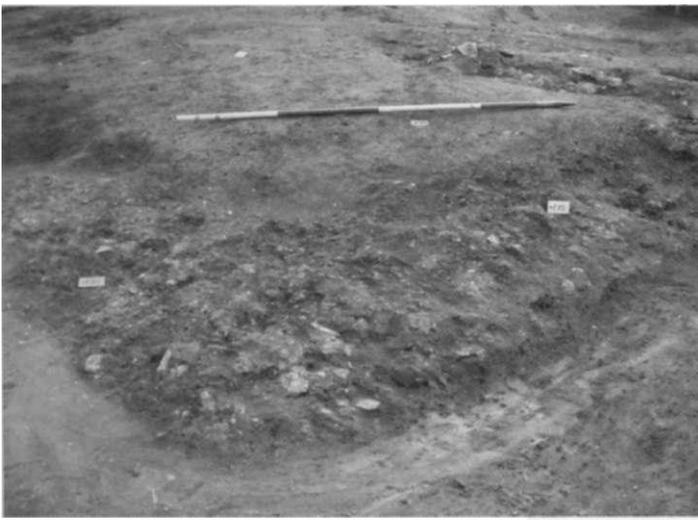
Left: the corner of a Roman cellar backfilled with wall-plaster and 'clay' or 'mud-brick' walls from the demolished Roman house.

Four Roman masonry buildings have previously been recorded on this site, so it is no surprise that these excavations turned up the remains of three more. The 1997 evaluation located one fragment of masonry wall, and the latest excavations have shown that there is not much more of this structure than was found in the evaluation. The only extra information is that a small patch of tessellated flooring is associated with the wall, and that the whole wall/floor unit has only survived because it has slumped into the protective embrace of a large pit. The rest of this structure is missing, presumably robbed away for building materials, but there is a possibility that this is the structure which was mis-identified as a temple. A second structure has been heavily robbed, but survives as a rubble-filled trench.

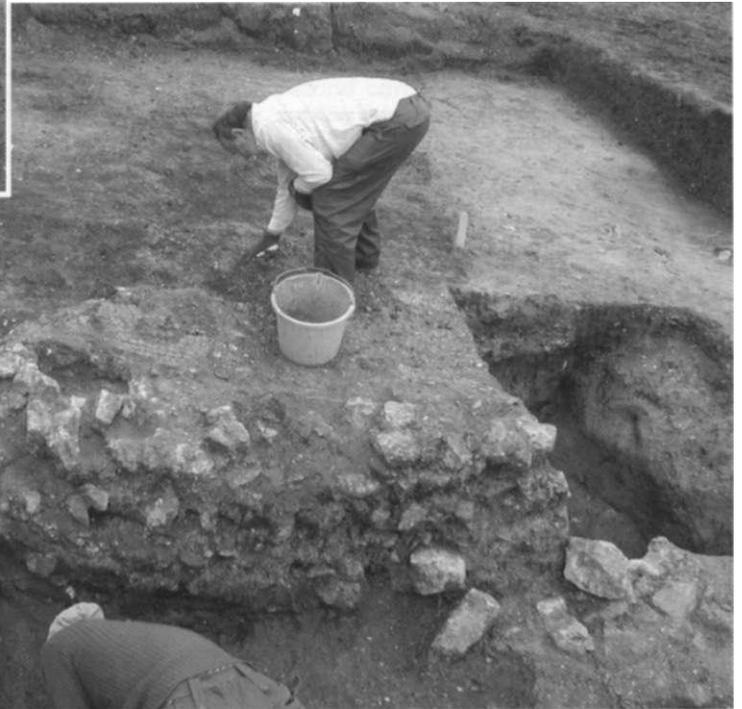
Below: tessellated floor and features which belonged to one of the Roman houses on the St Mary's hospital site.

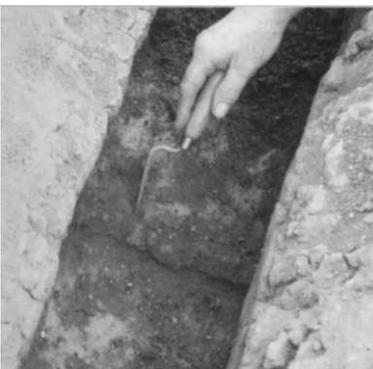
Above: an iron junction piece in the base of the slot in the clay lining. The slot in the clay-lined ditch is the remains of some kind of water conduit, but its form is unclear.

The flat iron junction piece suggests a wood-lined channel whereas other factors point to a standard wooden water-pipe that has been removed.

The most interesting discovery so far is the clay-lined water-channel or supply of some sort. Initially we thought that we had found two gravity-fed water conduits bringing water, one on the east side of the site for the area of the Sixth Form College (inside the town walls) and the other from the direction of the Chiswell Springs. The conduit took the form of a ditch lined at the bottom with clay in which there is a rectangular slot for either a wood-lined channel or a rectangular-sectioned wooden pipe. For various reasons, it now appears most likely that the conduit was a water-main of the sort found at Balcerne Lane in the 1970s (see page 9) but set in clay. Water-mains are usually readily

recognised by their iron collars. But the main on the St Mary's hospital site seems to have been removed in antiquity, which is why no collars were found in its remains.

The pressure of water would have been considerable in the lowest part of the main, hence the use of a clay lining as an extra measure to counteract leakage.

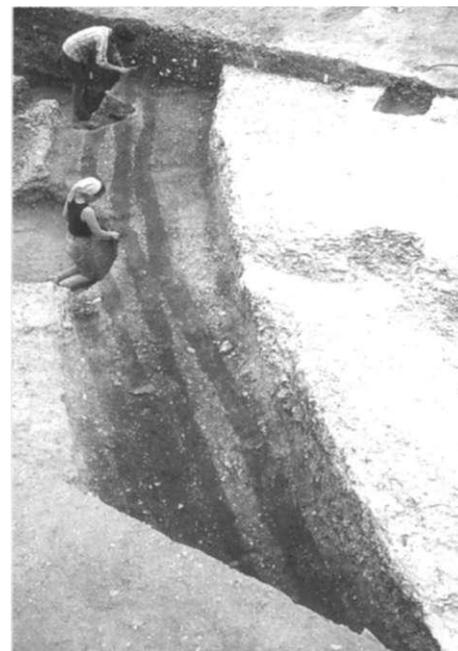
Above: the remains of four wooden water-mains excavated in the 1970s at Balkerne Lane. The mains are curving to pass under one of the carriageways of the Balkerne Gate.

Water is another of life's necessities, so it is no surprise that the paraphernalia required to extract water and deliver it to people is often found on excavation sites in and around the town. The discovery of a water-main or conduit on the St Mary's hospital site adds to our knowledge of the water supply to the Roman and later town.

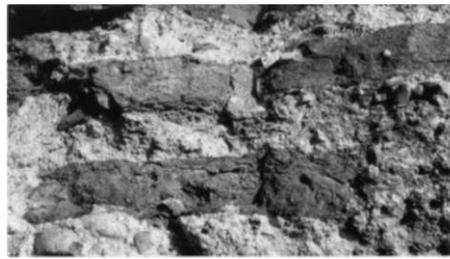
Left: some of the broken brick in the town wall near the Balkerne Gate. It may be the remains of public buildings destroyed during the Boudican attack on the town in AD 60/1.

A surprising feature of the wall is that all the bricks in it appear to be in pieces. It is hard to find any brick which looks as if it might be complete. There are two possible explanations for this curious fact. One is that the brick was deliberately broken up, so that it would make a stronger wall. However, considering how much brick is involved, it seems extraordinary that tilers would make thousands of bricks only for their handiwork to be smashed into fragments. The other explanation is that the bricks are in pieces because the material was salvaged from buildings which had to be demolished. However, this explanation also seems flawed, because had the bricks been reused in this way, we might expect to see lumps of earlier mortar adhering to some of them, and this is not generally the case. A few do indeed seem to have bits of attached earlier mortar, but there is so little of it that the brick fragments must have been extremely well cleaned if indeed they were reused. Thus, although neither explanation can be claimed to be entirely convincing, reuse of the bricks seems by the far the likeliest explanation, and the question then arises as to which buildings the brick came from.

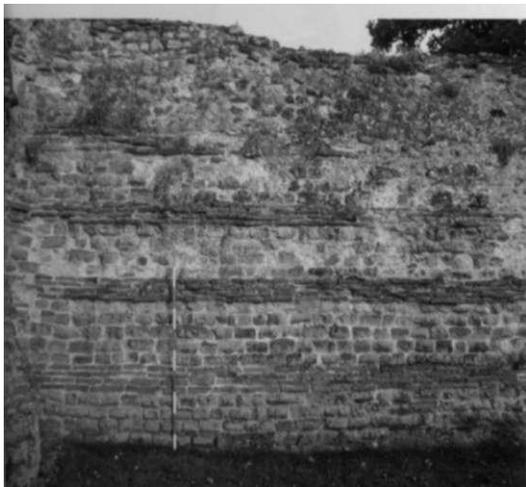
Below: photo, of a section of wall by the Balcerne Gate in 2001.

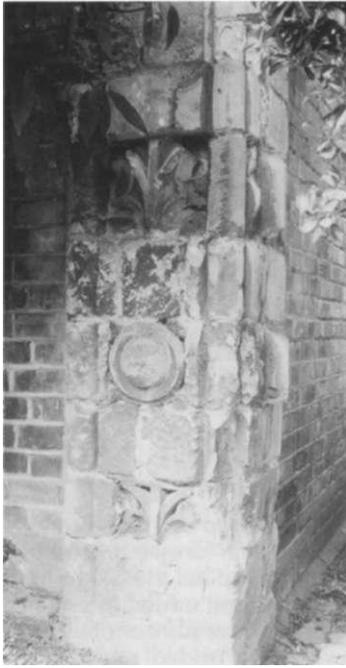
Above: a column of reused stone fragments on the site of the abbey precinct in 2001 (composite photo, by Tim Dennis).

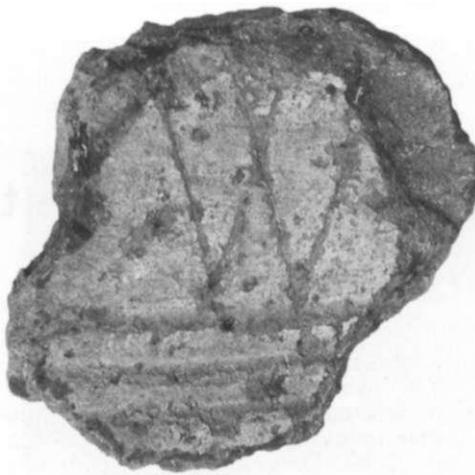
The accompanying photograph shows a particularly interesting fragment (top). It has a letter W (or inverted M) inscribed on the surface so that the resultant casting would have been signed by bearing the moulded letter in relief. Whose signature? Documentary evidence, part published and part deposited in the Essex Record Office, seems to provide an answer.

One interesting discovery during the Trust's excavation at the Head Street post-office site in 2000 was a pit which contained fragments of shaped fired clay moulds. Expert opinion is that these were used in the casting of bronze, especially since the pit also contained pieces of fused metal waste and soot. A bronze foundry in Head Street?

The pottery found with the clay fragments in the pit suggests that they were deposited in the 17th century and of course they could easily have come from the Swanne site just around the corner. Not all the fragments were shaped for a bell and the composition of the bronze waste was not suitable for bell casting; this suggests that, like many bell-founders, the Grayes cast other objects. The fragments shown here were moulds for the legs of a three-legged vessel, perhaps to stand in the fire for cooking. If anyone has an antique bronze vessel standing on three legs and showing a W mark, the Trust would be most interested!

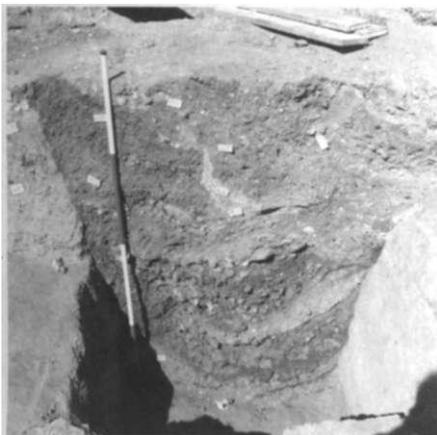
on this page - above: the pit filled with foundry waste on the Head Street site.

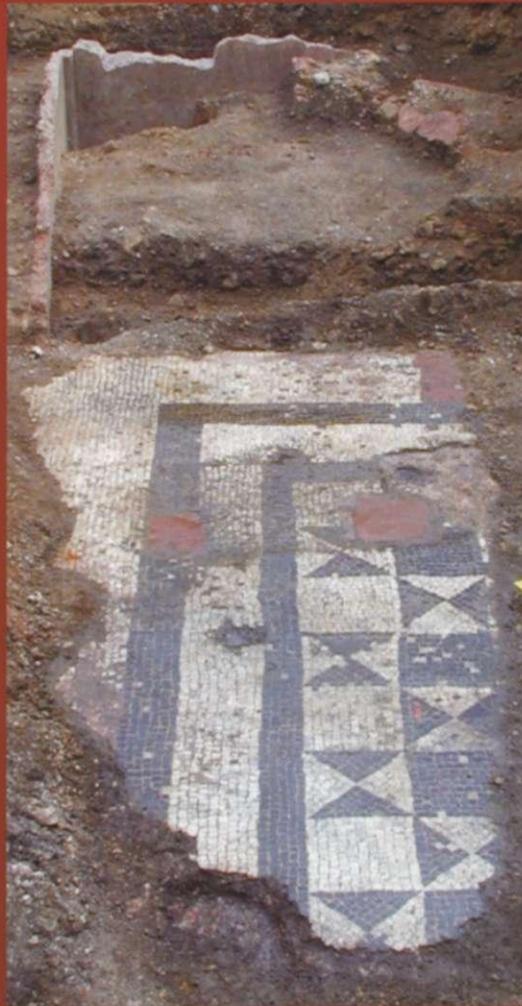
Pictures
Top: the Victoria Inn.
Left: part of a Roman mosaic floor and the *opus signinum* structure. This area of mosaic was patched with tile in three places.
Above: cleaning the mosaic.
Below: some of the fragments of painted Roman wall-plaster. Imagine how vividly coloured the rooms must have been – the colours are typical of Roman houses.

The three trenches at the rear showed that there had been a lot of disturbance in the past, caused simply by people digging large holes in the plot over the last few centuries. However, one Roman masonry wall did survive, but this was at such a depth as to be safe from the proposed building work. The initial interest lay in what appeared to be a free-standing piece of Roman pink mortar wall (*opus signinum*). The lining proved to be the remains of a room with a sunken floor. Nothing like this has been found before in Colchester, and it is hard to imagine what purpose the room served. The remains of demolished clay walls and fragments of painted wall-plaster show that the room was not wholly utilitarian. Roman pink mortar is often used in bath-houses, so the room might be part of a bath-suite in the house.
