**Historic building recording
at King's Farm Barn, Bishops Lane,
Alphamstone, Essex
March 2014**

**report prepared by
Chris Lister**

**commissioned by
Andrew Stevenson Associates
on behalf of
Mr and Mrs Franco**

CAT Report 767
May 2014

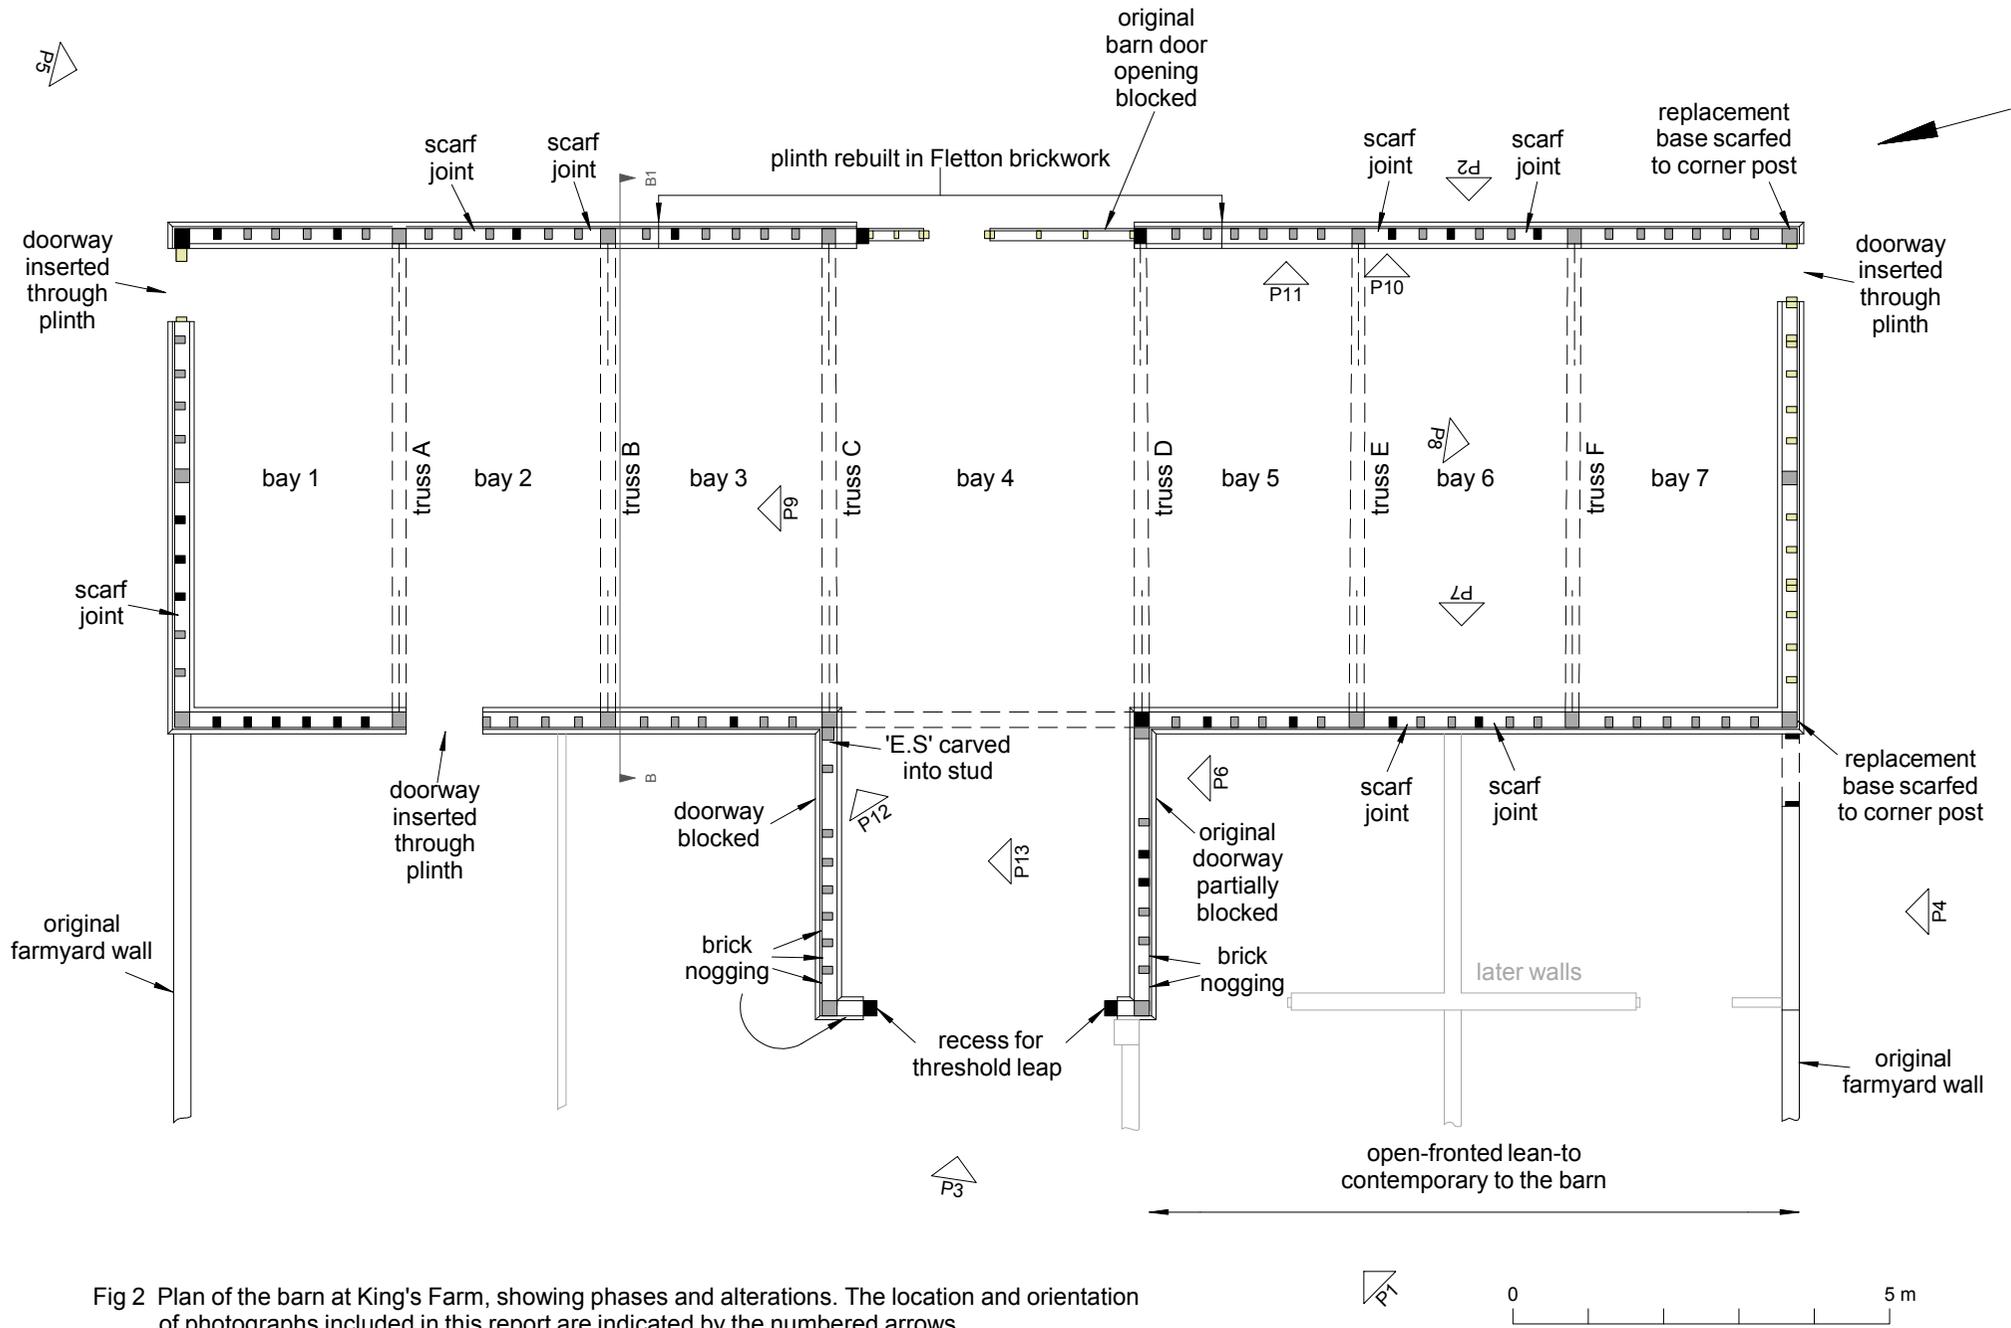
Fig 2 Plan of the barn at King's Farm, showing phases and alterations. The location and orientation of photographs included in this report are indicated by the numbered arrows.

The south-east elevation has an off-centre doorway and two pitching doors below the eaves (Plate 5). The weatherboarding indicates that there were originally full height doors in the centre of the elevation, the opening for which has since been blocked. The plinth to either side of the doorway has been rebuilt in Fletton brick, although a section of this is missing next to the door (Fig 2).

There are a number of scarf joints on the sill beam (Fig 2). These are all simple edge-halved joints secured with two wooden pegs (Plate 10). The wall plate has more varied scarf joints. The south-east wall plate has a face-halved scarf, secured by four pegs, in bay 2 and face-halved scarfs, with bladed abutments secured by four pegs, in bays 4 and 5 (Fig 4, Plate 11). The north-west wall has face-halved scarfs, with bladed abutments secured by four pegs, in bays 2 and 6 (Fig 3). There are edge-halved and bolted scarf joints in bays 3 and 5, close to the heads of the midstrey corner posts.

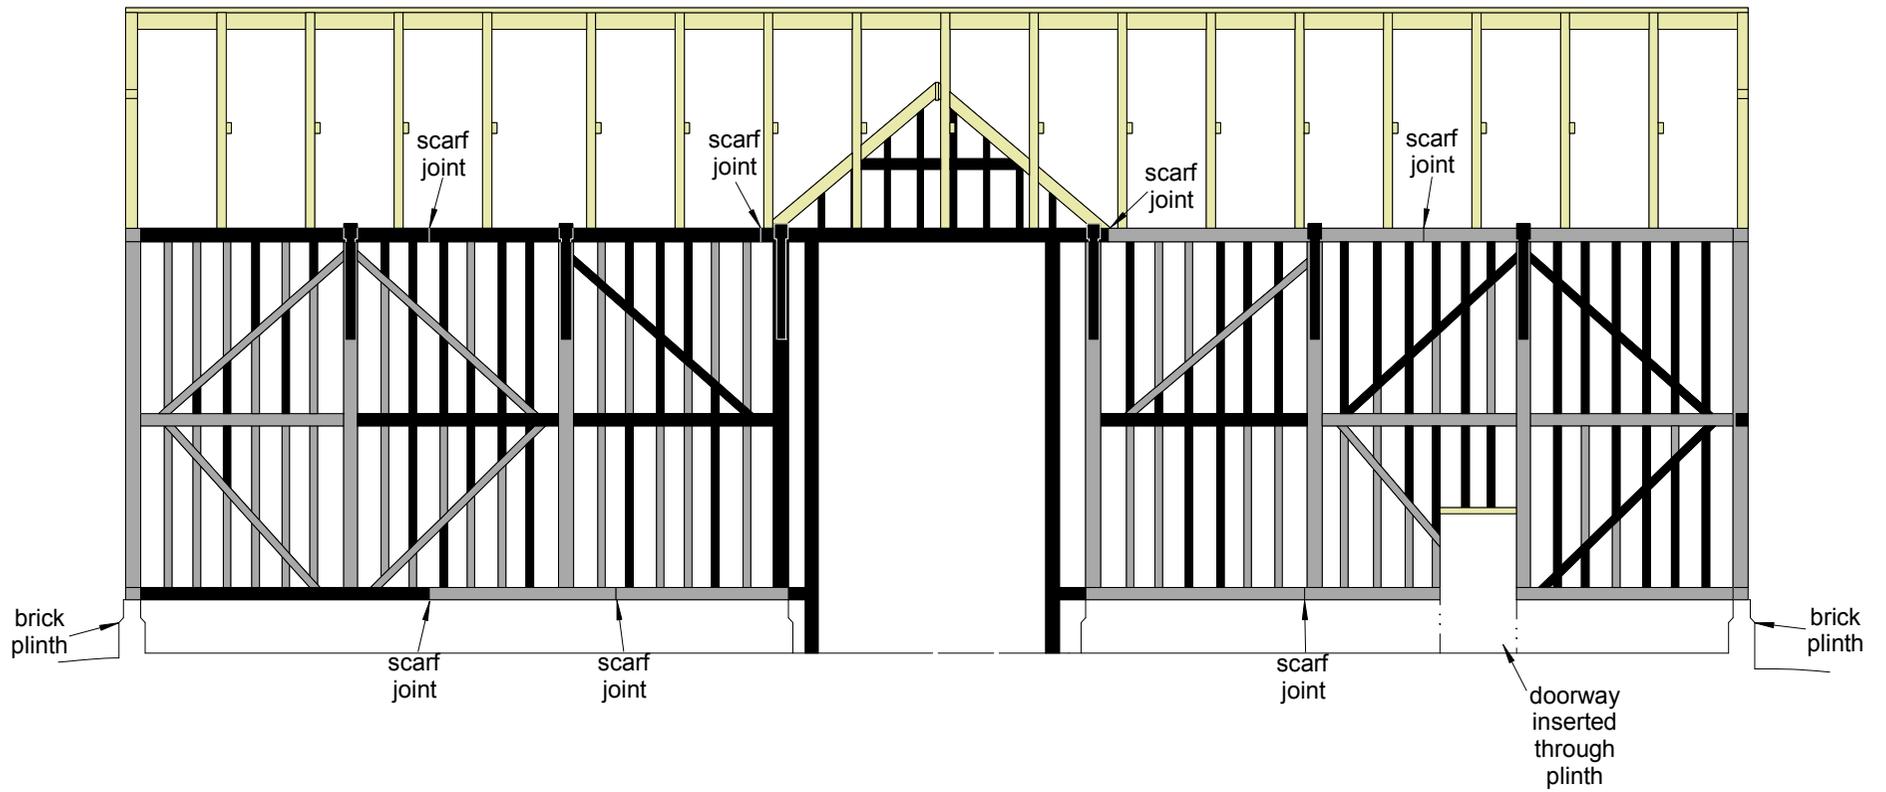
Fig 3 Frame drawing of north-west elevation, indicating the locations of original, re-used and replacement timbers.

The components of the frame are an almost equal mix of machine-cut timbers, original to the structure and re-used, hand-sawn timbers sourced from an earlier building. The re-used timbers all display empty mortices and recesses for bracing. The principle posts of the frame are formed of straight, hand-sawn timbers with variable dimensions of 140-200 x 140-200mm. The intermediate posts are predominantly straight, hand-sawn timbers, approximately 180 x 180mm, joined by girding beams with dimensions of 160 x 160mm. The different sections of the sill beam have variable dimensions of 150 -220 x 160-190mm and the wall plate is approximately 200 x 180mm. The girts, sill beams and wall plates are mainly re-used timbers, with some sections original to the structure. The studs have dimensions of 70-120 x 120-140mm with divisions of 300-350mm, with approximately half being re-used timbers. Bays 1-2 and 6-7 have primary bracing in both registers, forming a diamond pattern, as does the frame of the north-east gable end (Figs 3-5, Plate 7). Bays 3 and 5, flanking the threshing floor, have primary bracing only in the upper registers (Figs 3-

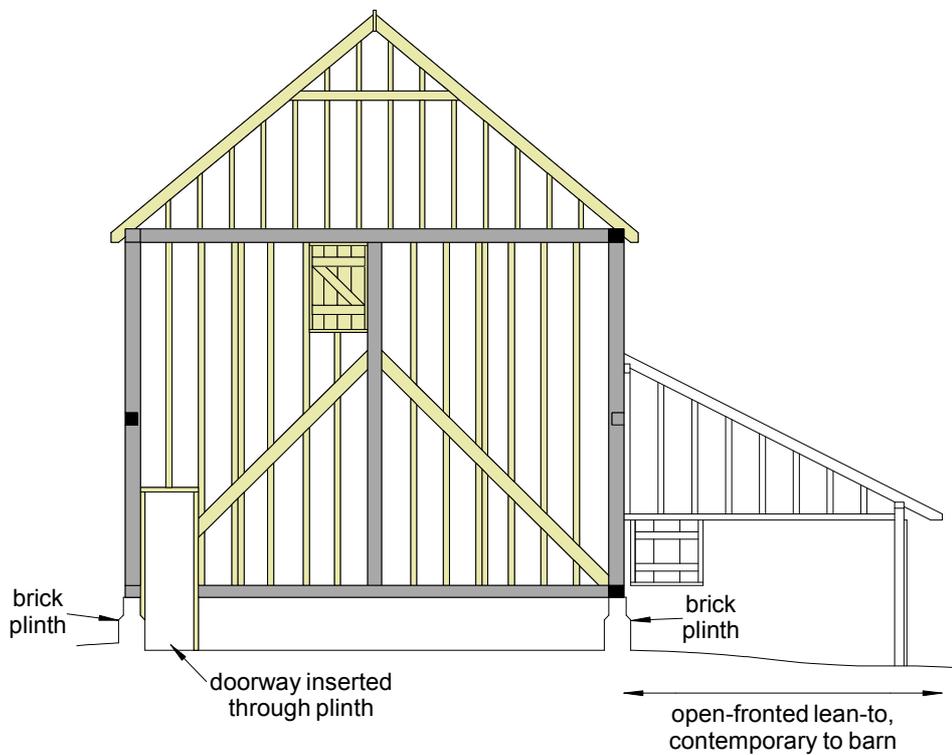
Fig 6 Frame drawing of south-west elevation, indicating the locations of original, re-used and replacement timbers.

4). The frame of the south-west gable end has been completely rebuilt due to collapse. Although the wall plate, sill beam and the corner posts have been salvaged, the latter needing new bases scarfing to the main body of the post, the studding has been replaced with modern machine-cut timbers, reinforced with nailed plank bracing (Fig 6, Plate 8). This collapse was probably caused by pressure placed upon the frame when the sill beam and plinth was cut by the insertion of the doorway at the south-east corner.

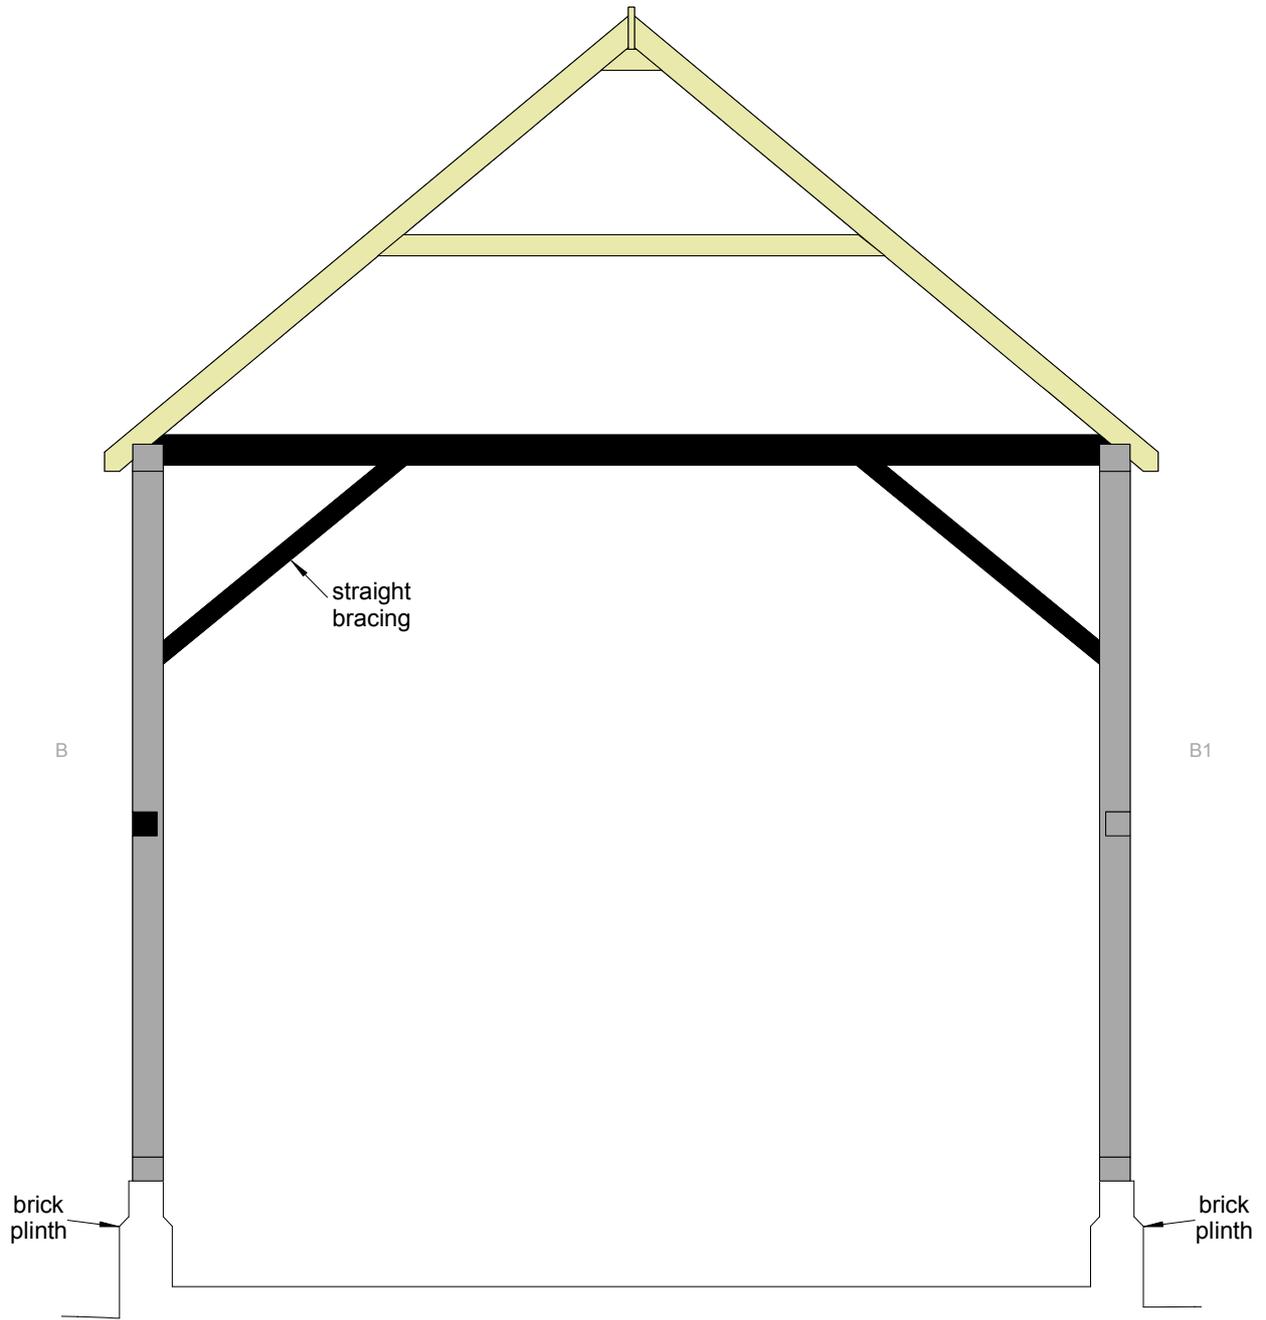
Fig 7 Cross-section of truss B.

The tie beams are original to the building and, although machine-cut, illustrate the difficulty in obtaining straight timbers long enough to span a structure of this width (Plate 9). Several of the tie beams have a sinuous profile, indicating that smaller trees were chosen to provide the timbers, rather than those with a continuous square section which were sourced from larger trees. Straight braces, attached to the intermediate posts and the tie beams by a bolt and two nails, support the tie beams (Fig 7). The heads of each tie are strengthened by iron strapping.
