**Historic building recording
at Shalford Hall Farm barns,
The Street, Shalford, Essex
February 2015**

**report prepared by
Chris Lister**

**commissioned by
Alun Design Consultancy Ltd
on behalf of
Mr Allan Stevenson**

CAT Report 841
July 2015

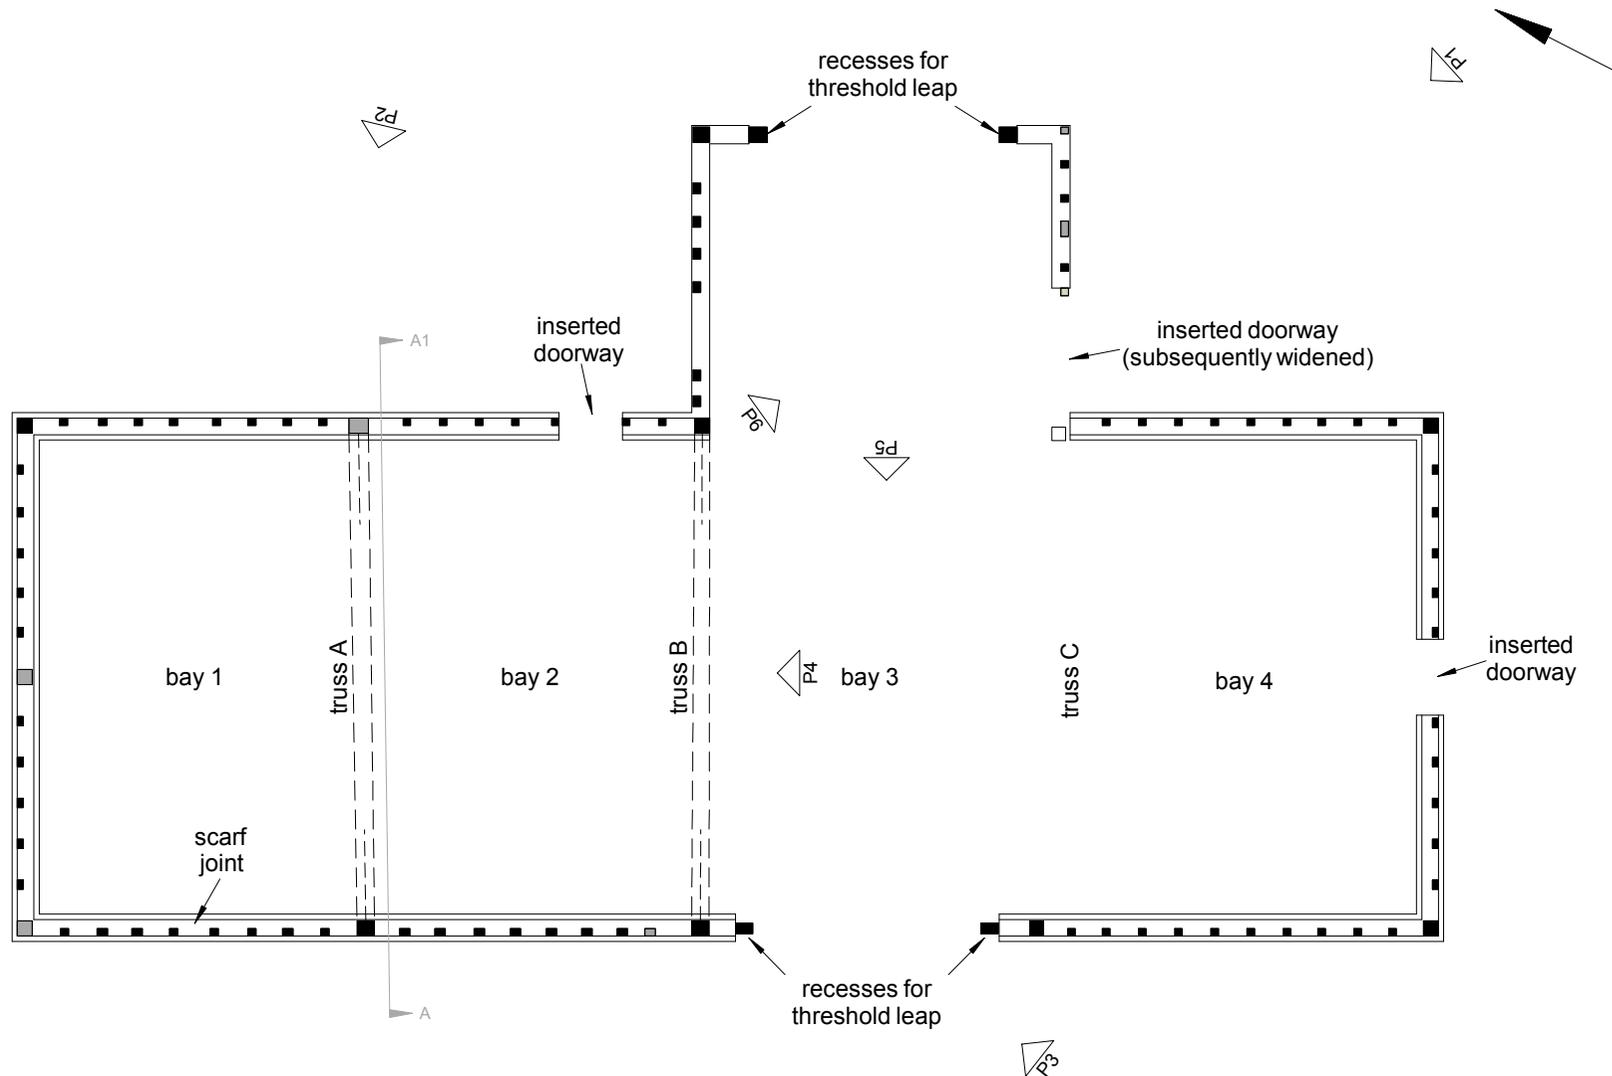
Fig 2 Plan of the Grain Barn at Shalford Hall Farm, showing phases and alterations. The location and orientation of photographs included in this report are indicated the numbered arrows.

A single face-halved scarf joint with bladed abutments was noted in the sill beam of bay 1 (Fig 2) and others were present in the wall plate above the barn door opening in bay 3 (Fig 8) and near the head of the post in the wall plate on the north-east side of truss C (Fig 7). Additionally the bases of the north-east posts to trusses B and C have crude scarf joints, which may have something to do with the rebuilding of the midstreys (Fig 7).

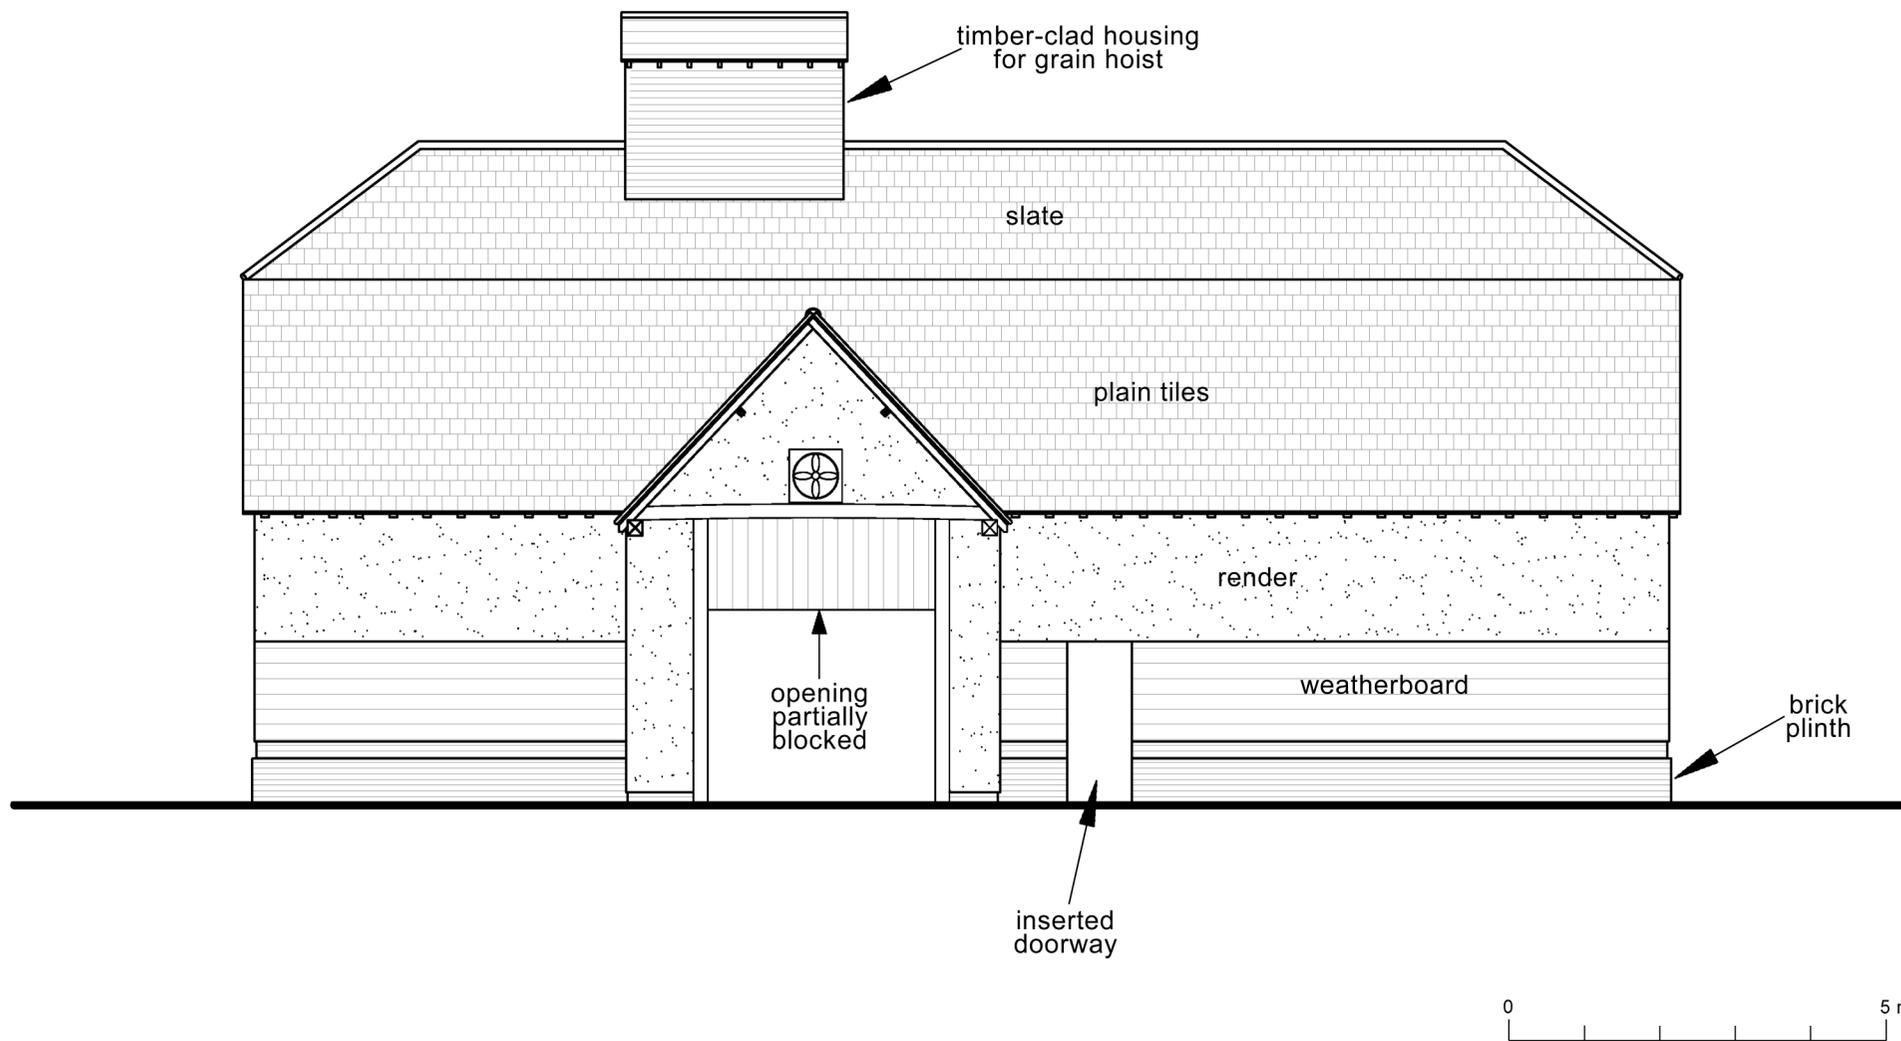
Fig 3 North-east elevation of the Grain Barn.

The north-east elevation (Fig 3) has an off-centre midstrey projecting from it, in line with a pair of full height barn doors in the south-west elevation (Fig 4). The midstrey doorposts have recesses for a threshold leap and there is a modern equivalent of a threshold leap in the south-west doorway, although the recesses have been replaced by iron stanchions. Although the barn doors have been replaced they appear to retain the original strap and pintel hinges (Plate 3).

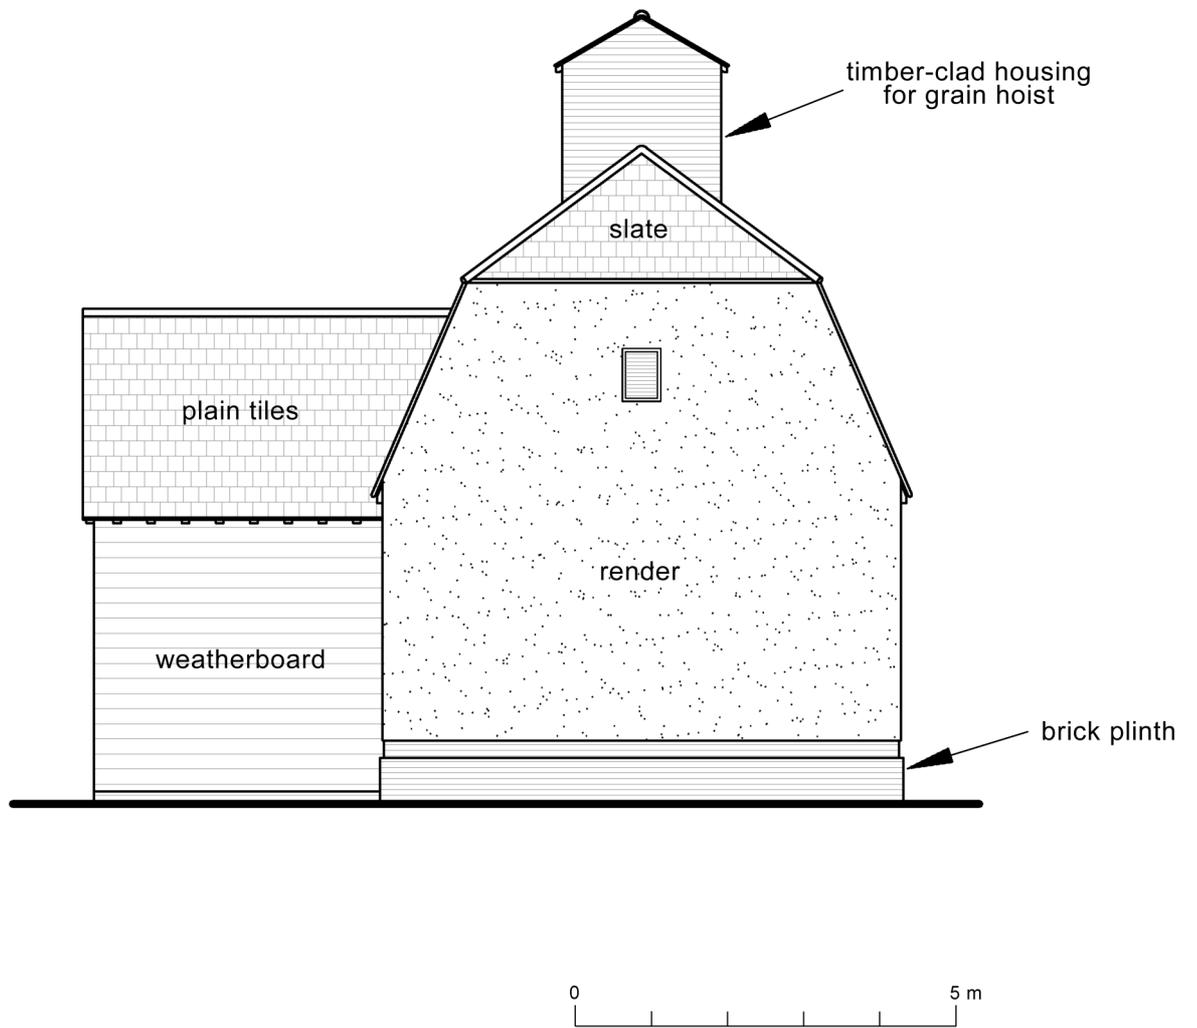
Fig 5 North-west elevation of the Grain Barn.

The north-west elevation is unremarkable apart from a louvre window in the gable (Fig 5). The south-east elevation is obscured by a structure built up against the Grain Barn to house grain silos but the exterior is rendered as the others (Fig 6).

The mansard roof has large-section timbers as common rafters, many of which appear to be re-used timbers. There are no principle rafters rising from the heads of the tie beams; instead there are staggered principle rafters with collars formed from a large-section beam, supported on bolted knee braces (Fig 11). These collars carry the kerb beams for the upper pitch of the roof, from which rise rafters supported by purlins with intermediate high collars. All the timbers above the kerb beams are machine-cut timbers and have probably replaced original high collars. This was probably carried out when the upper slopes of the roof were clad in slate. The lower pitch of the roof in bay 1 has primary bracing falling from the gable on both sides, whilst the roof of bay 2 has primary bracing falling from the principle rafter in two directions on both sides. There is no bracing in the upper pitch of the mansard roof. The north-west frame above the wall plate has primary bracing falling from the sides of the frame to the wall plate. The central post of the gable has been cut by the insertion of an opening, subsequently reduced in size and incorporating a louvre window (Fig 9).

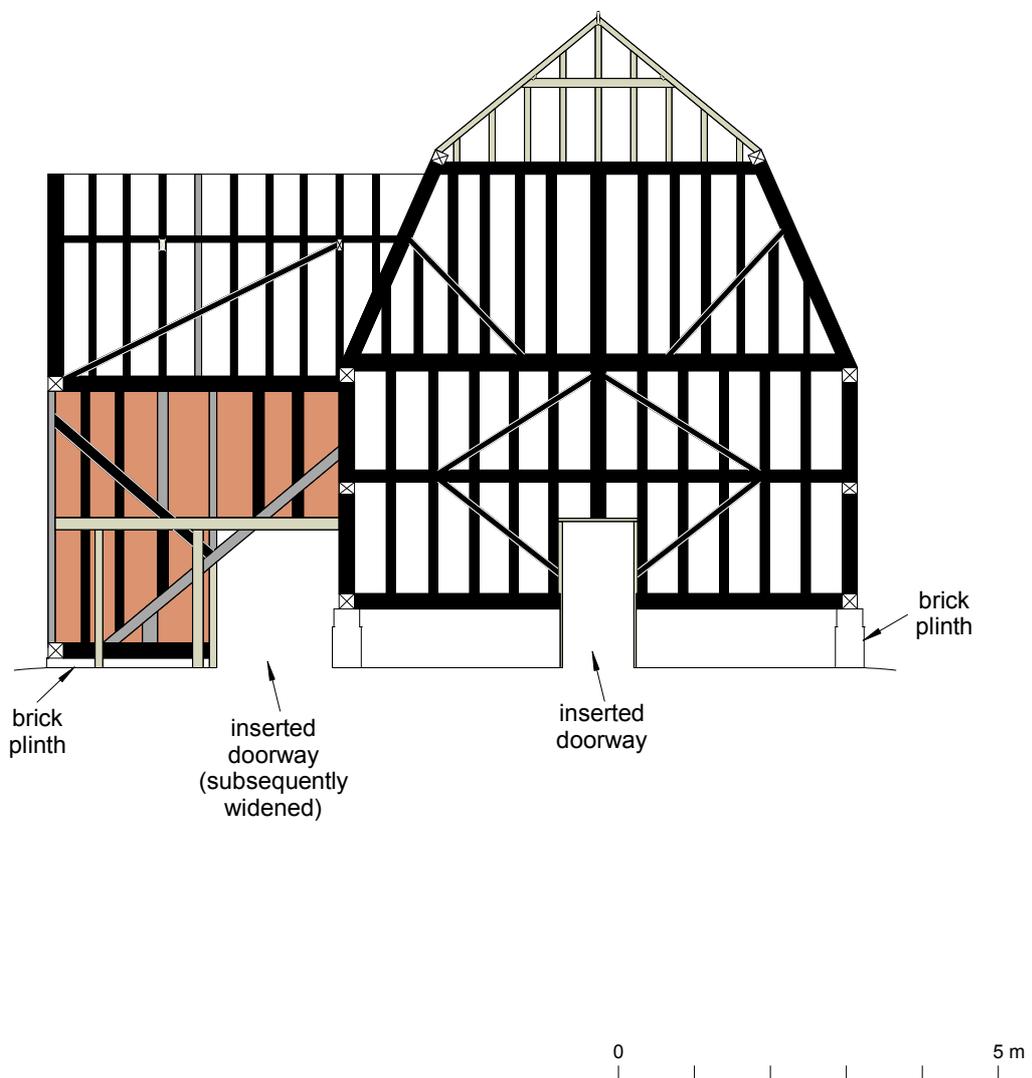
Fig 10 Frame drawing of the south-east wall to the Grain Barn, indicating the locations of original, re-used and replacement timbers.

The final bay, bay 4 has been completely obscured by steel grain bins; however, limited visual access down the side of the grain bins suggests that the frames have primary bracing to upper and lower registers. The south-east frame is obscured by the grain bins, but probably mirrors the north-west frame which has diamond-pattern primary bracing in both upper and lower registers (Figs 9 & 10). A doorway has been inserted through this end frame, providing access to the external grain silos.

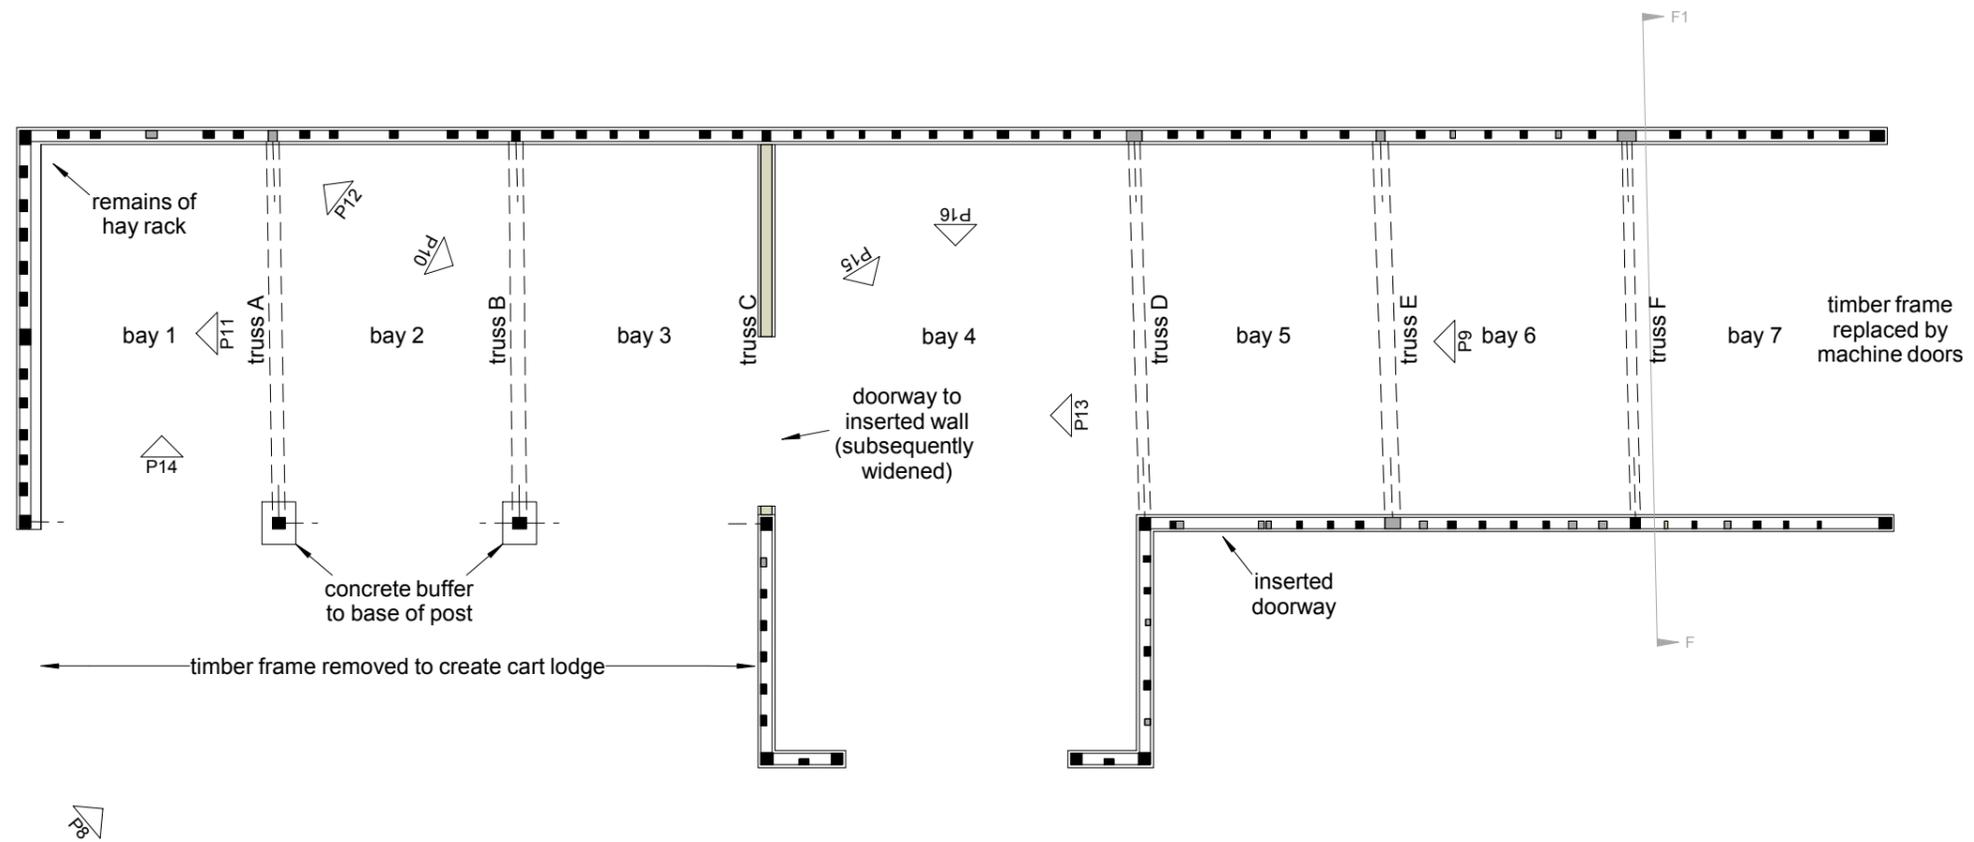
Fig 12 Plan of the Church Barn at Shalford Hall Farm, showing phases and alterations. The location and orientation of photographs included in this report are indicated the numbered arrows.

The interior of the Church Barn is divided into seven bays, three roughly equal-sized bays to either side of the midstrey bay which is much wider (Plate 9, Fig 12). The frame consists of hand-sawn hardwood timbers with posts of varying dimensions, girding beams and wall plates, all of which include many re-used timbers (Figs 17-21). The studs are not of uniform scantling and consist of both re-used timbers and timbers original to the building, although the deteriorated state of the posts and studs makes differentiating this very difficult.
